86 Princess St

Water Ingress

Repair Proposals 2 of 2

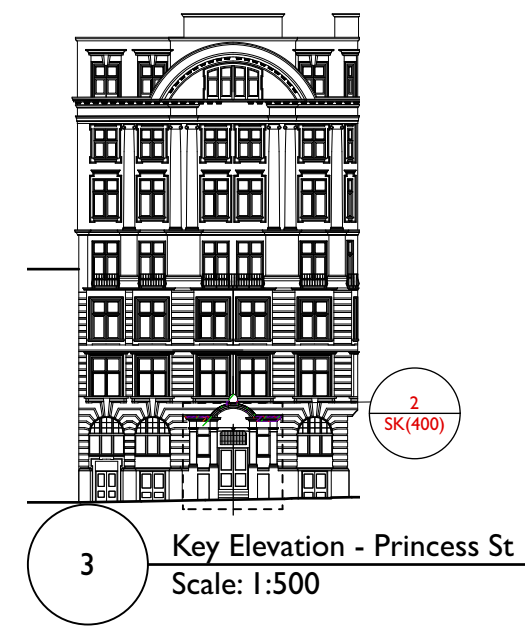
- Indicative urn/cartouche sculpture
- Replacement stone pieces to base of crouched
- New lead cover to hood and side pediments
- Localised redressing of loose and friable stone edges
- Stone redressed with lime mortar to form slight falls towards outer face of hood/pediment

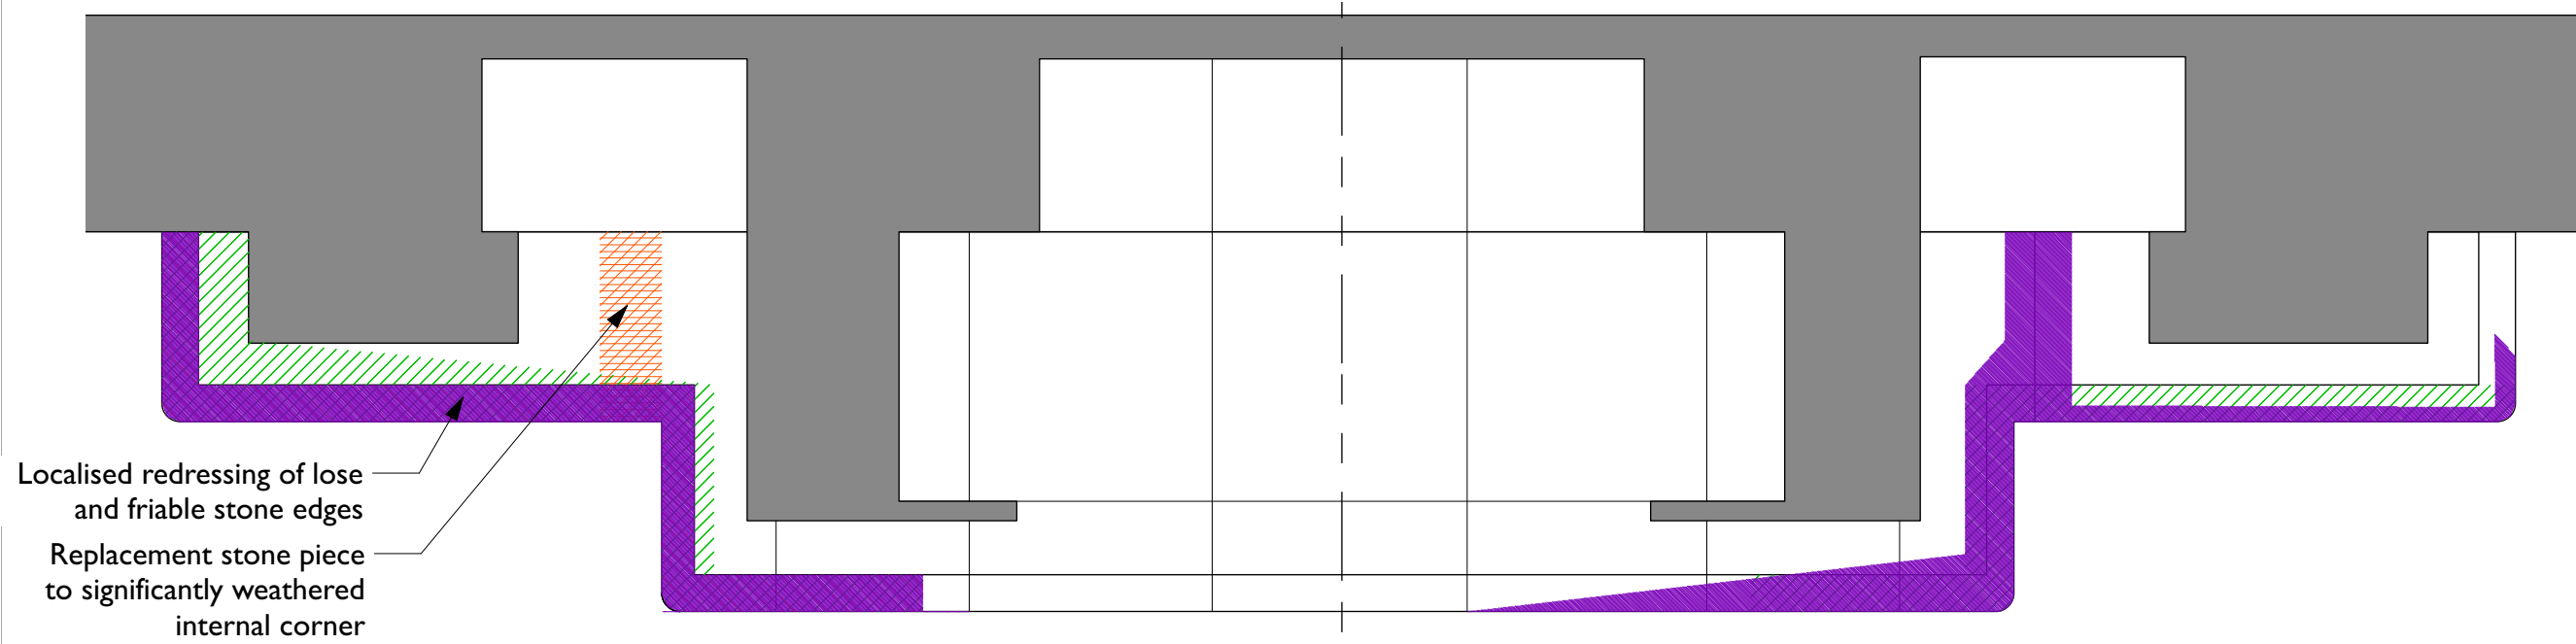
2 Proposed-Reflected Plan - Underside of Hood  
Scale: 1:20

- Localised redressing of loose and friable stone edges
- Replacement stone piece to significantly weathered internal corner
