86 Princess St

Water Ingress

Condition Survey 1 Of 2

scheme 1944  
drwg no. E(401)  
revision A

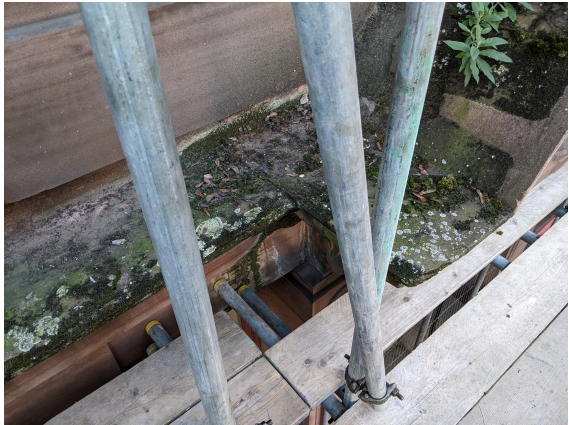
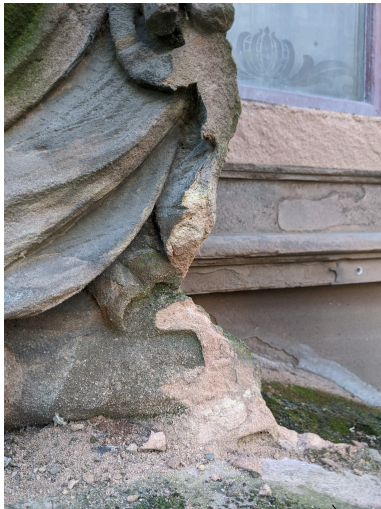
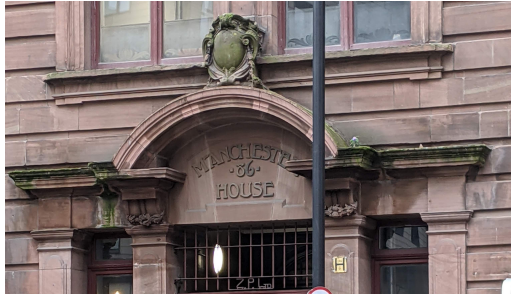
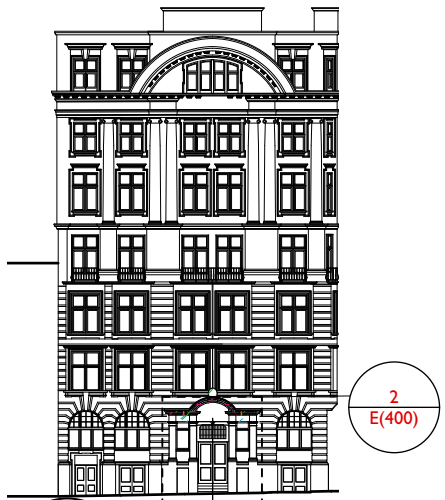
Key Elevation - Princess St  
Scale: 1:500

Areas and extents of condition, primarily viewed from ground level only. Subject to review once high level access is arranged.

A Updated following scaffold level inspection. HW HW  
Rev Note DRN CHK

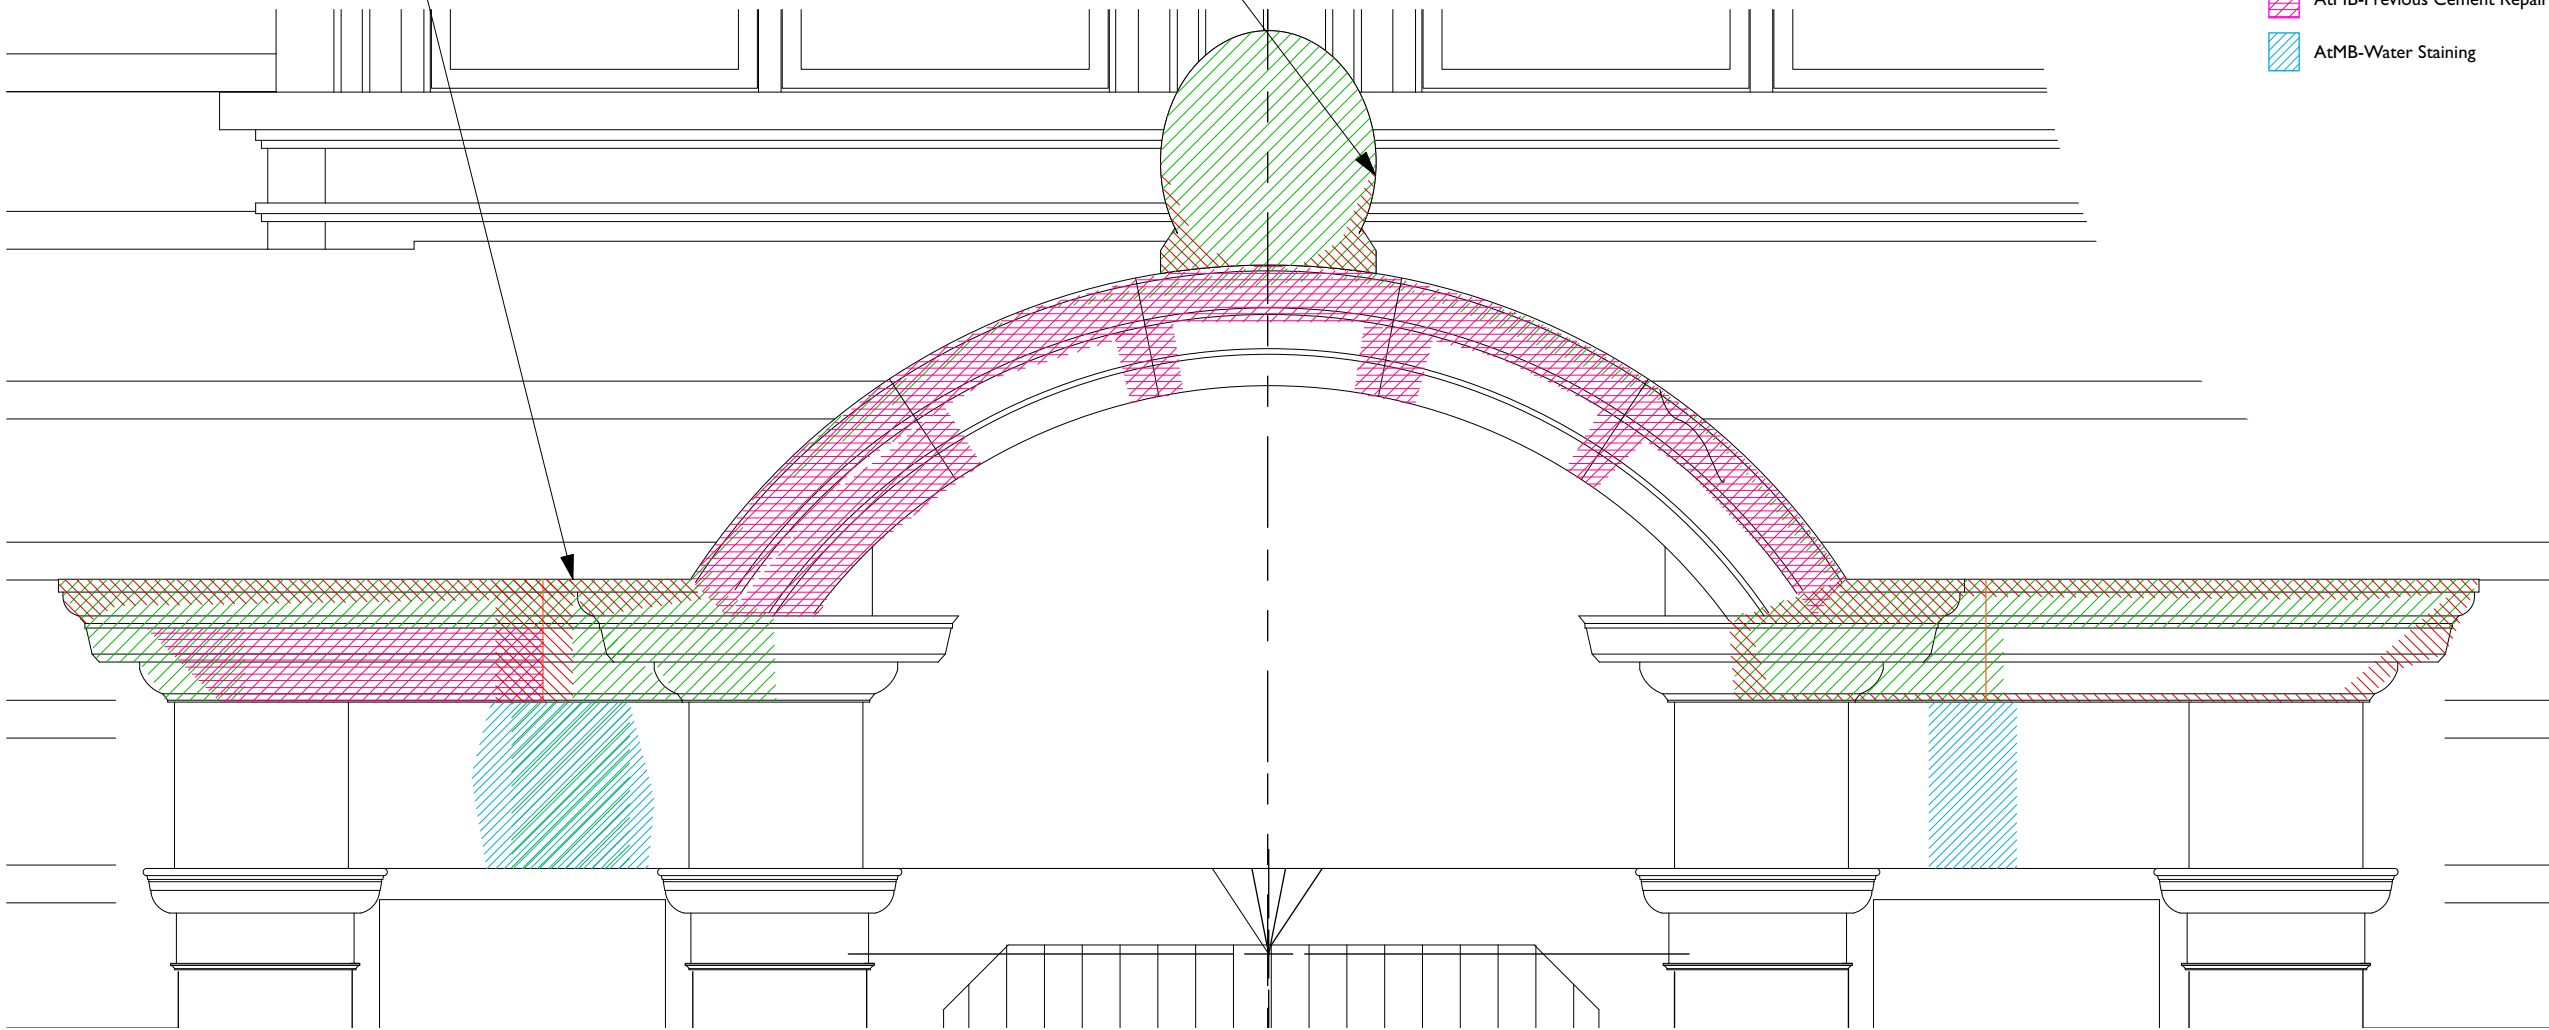
- AtMB-Biological Growth
- AtMB-Eroded or missing pointing
- AtMB-Eroded Stone
- AtMB-Previous Cement Repairs
- AtMB-Water Staining
