## **The Northern Tennis Club Floodlight Replacement Verification Report**

This document is to verify the floodlighting installation replacing the existing external court lighting at the Northern Tennis facility has been installed and is operating in accordance with the lighting design within the approved planning permission.

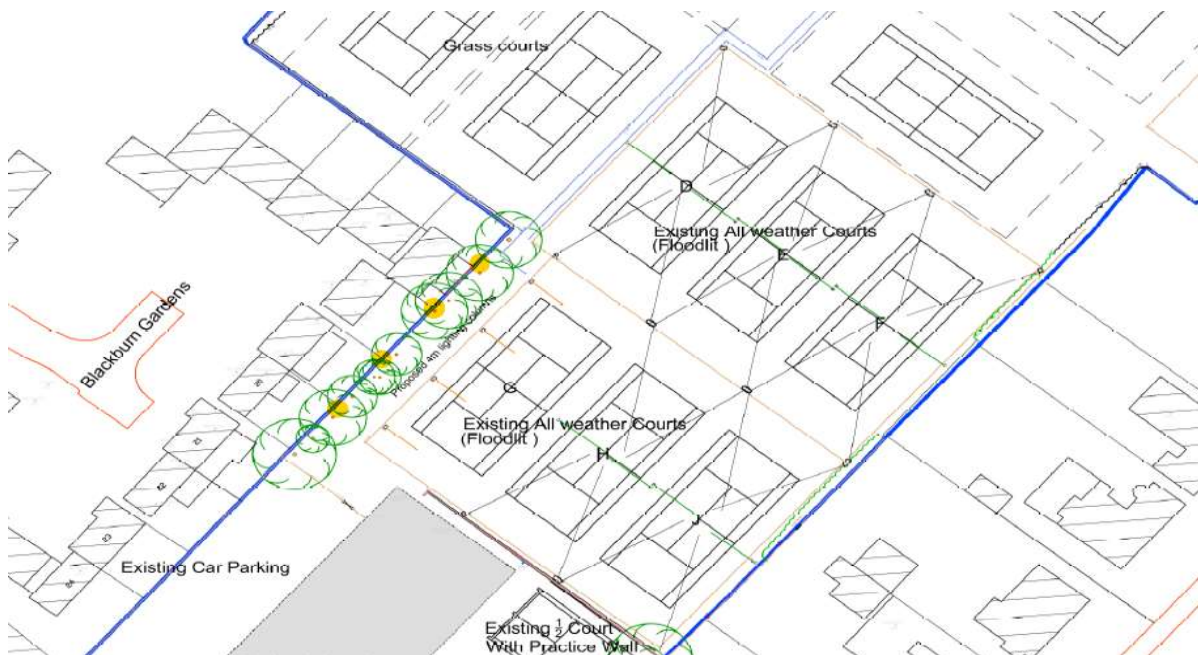
Four points were checked along the fence line in design and real life, with all real life results lower than the designed values. The testing points are indicated below (yellow circles) :

I can therefore confirm that the installation is operating within the design parameters with max readings at 21 lux in the tennis facility, expected window lux level < 9lux.

As the installation is operating within the design criteria no further measures are required.
