# Arboricultural Method Statement

**MSP Greenheys  
26th April 2023**

TG Report No. 15264\_R05\_WS

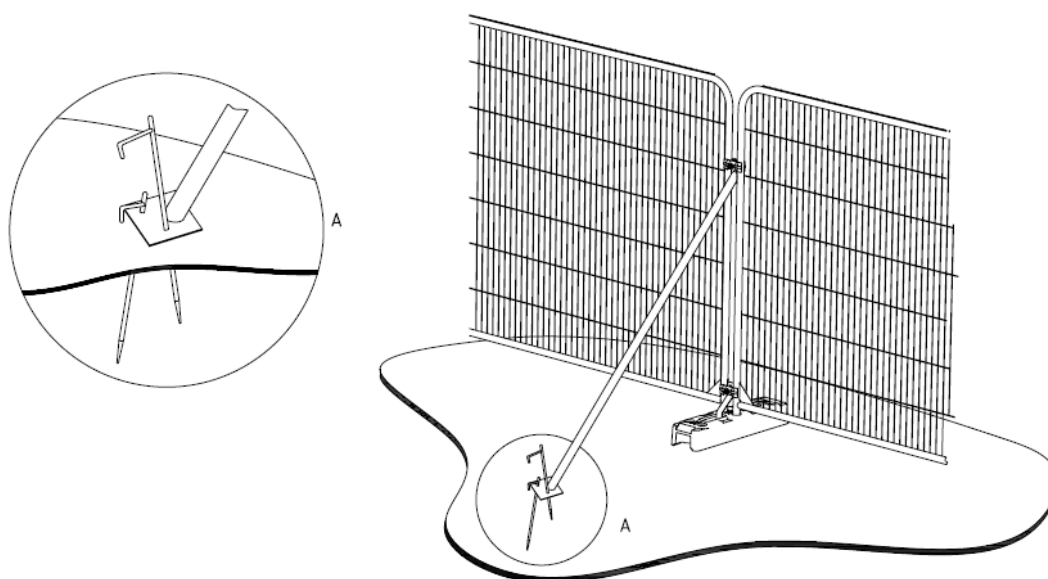
- 2.20. The fencing will comprise a scaffold framework, well braced to resist impacts, with vertical tubes spaced at a maximum of 3m to add further stability. Onto this, weldmesh panels will be securely fixed with wire or scaffold clamps.

a) Stabilizer strut with base plate secured with ground pins

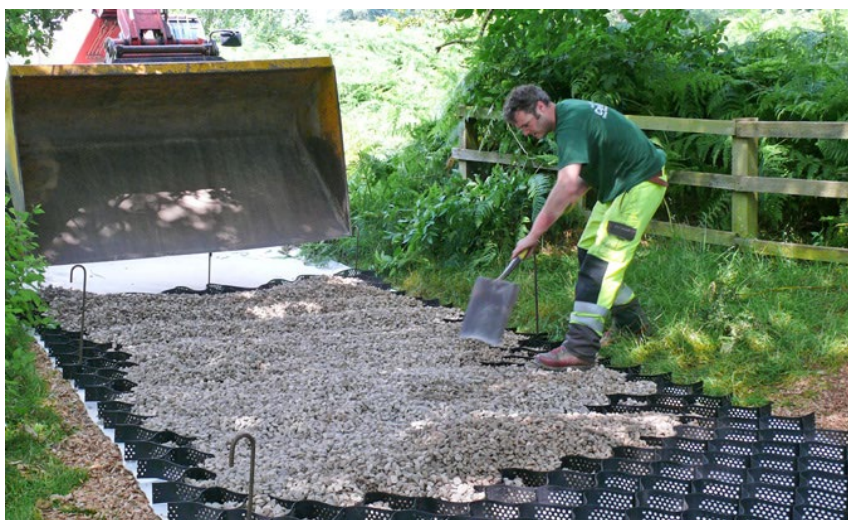
- 2.33. The **TPP (See Plan 3)** identifies where a no-dig construction method is required for surfacing within the RPAs of trees G3. Typically, this will adopt a cellular confinement system (example below), however, site conditions and circumstances may require the use of alternative products.

- 2.34. The design will take account of the bearing capacity of the soil and loading requirements. The detail of product and specification are technical engineering matters to be provided by the project engineer and product specialists. Design advice and detailed specifications can be provided by the following suppliers:

- 9) Install membrane, system and surface in accordance with manufacturers specification:
  - a. Lay the cellular system over the Geotextile, which is secured open under tension during the infill process with steel staples or pegs;

- c. Fill the cellular system ensuring any machinery works only on already filled areas. Typical infill consists of no fines angular granular material 20-40mm, which will remain uncompacted; and

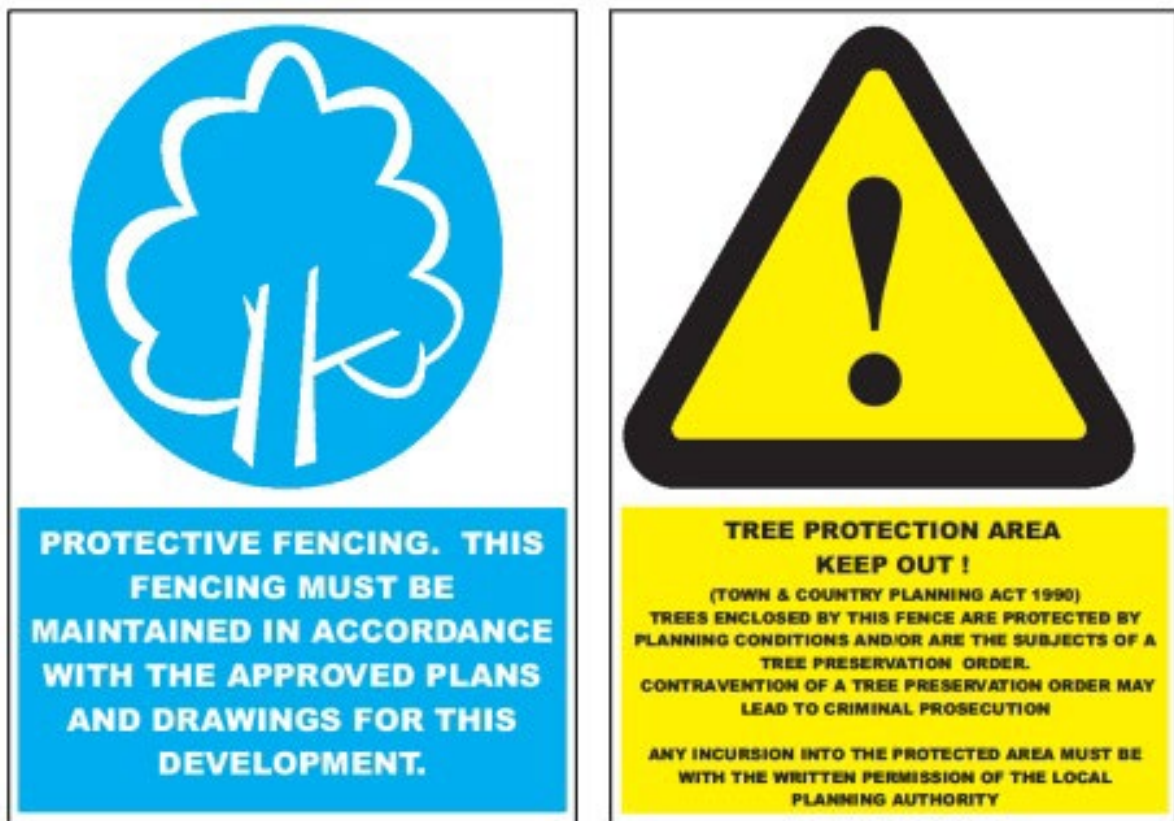
## Appendix 2: Signage Example

- 2.24. All-weather notices will be attached to the barriers with words such as 'Construction Exclusion Zone – No Access' (See signage example at **Appendix 2**).

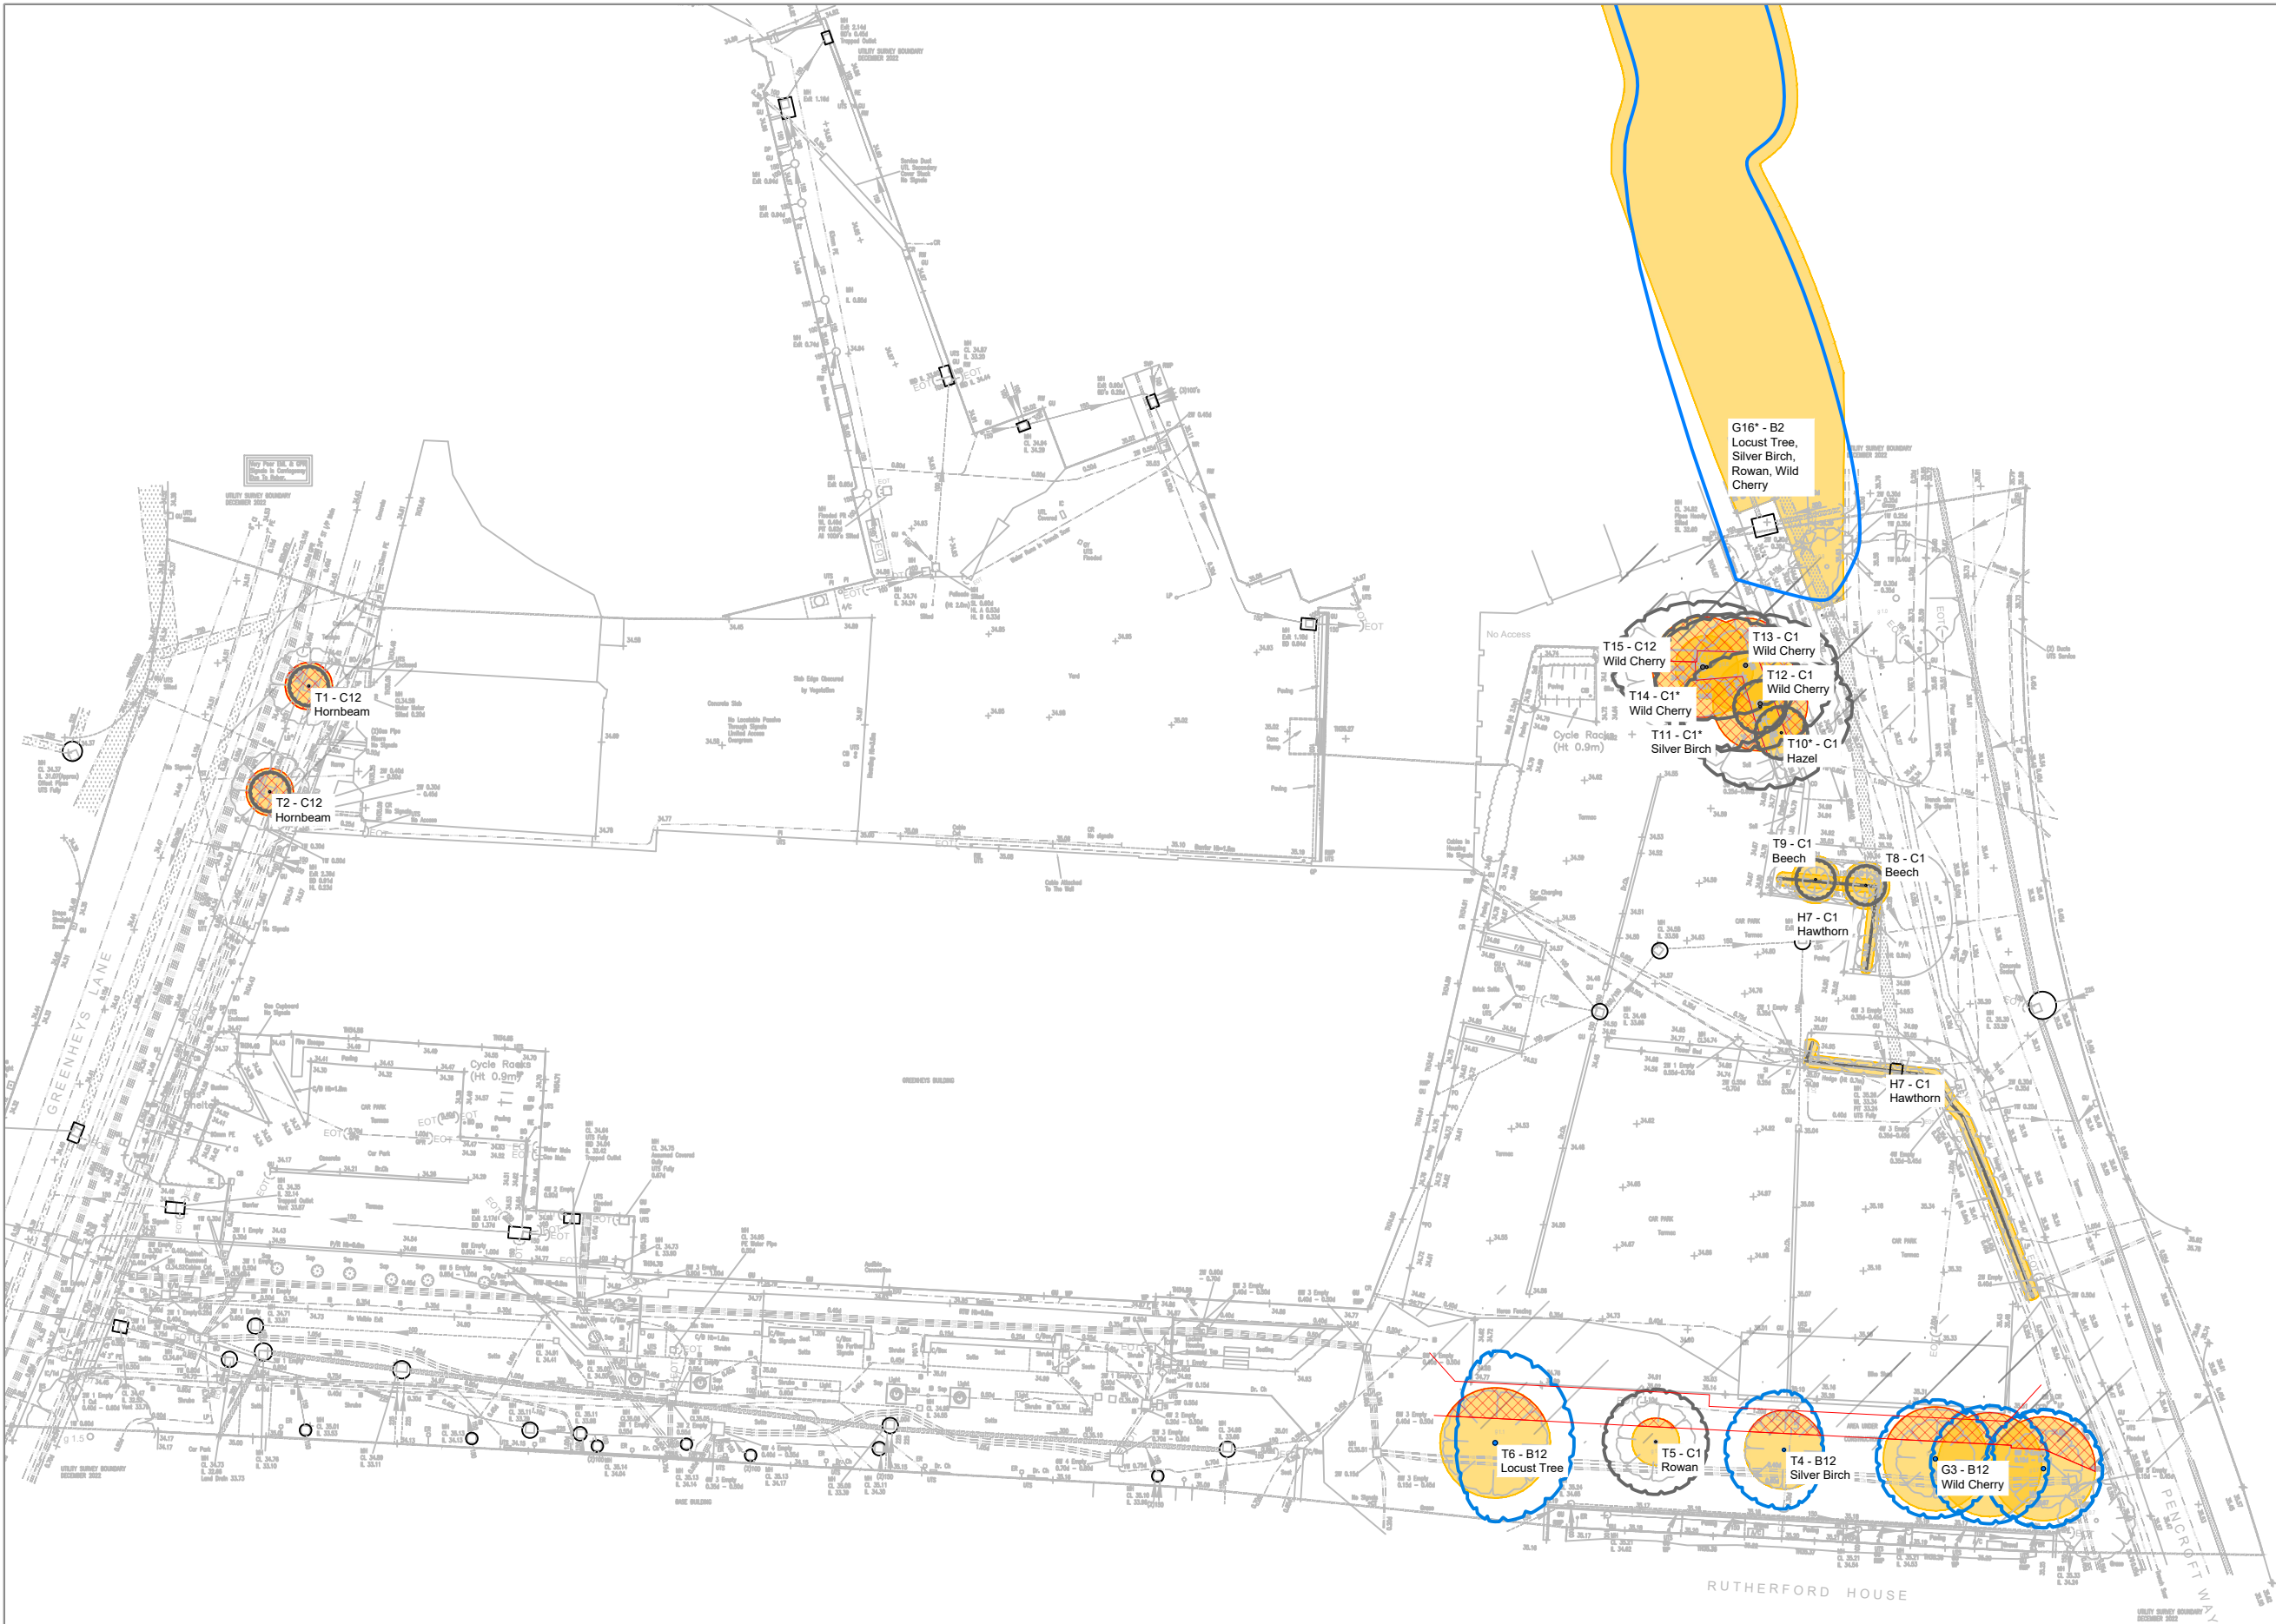
Plan 3: Tree Protection Plan (TPP), (15264/P04)

- 2.3. The **TPP (See Plan 3)** shows the Root Protection Areas (RPAs) and branches spread of retained trees. The RPA signifies the area that must be protected during the demolition and construction works to avoid harm to the rooting environments of trees. Where development and site works occur within RPAs or close the tree branches, there are mitigative measures and protocols that must be adhered to as detailed within this document. Unless otherwise stated within this document, within the areas protected by tree protection barriers the following shall apply:

- 2.19. The **TPP (See Plan 3)** identifies the location of the tree protective fencing. To ensure accurate positioning and to avoid costly adjustments, the tree protection fence must be set out by a surveyor with all node points being marked clearly on site for the fencing contractor to work to. A geocoordinate AutoCAD file of the **TPP** is available upon request.

- 2.26. The **TPP (See Plan 3)** shows the RPAs of retained trees. This signifies the area that must be protected during the demolition and construction works to avoid harm to the rooting environments of trees. Where development and site works occur in these areas, there are mitigative measures and protocols to adhere to as detailed within the document.
- 2.27. RPAs for G16 have been reshaped to reflect the presence of a either or combination of highways, building foundations and sudden level changes which are considered to act as a barrier towards root growth. Where the shape of an RPA has been altered, the extent of the RPA has not been reduced but compensated to include areas that are considered to be more advantageous to root development.

- 2.28. The TPP (See Plan 3) identifies areas of existing hard surfacing within RPAs that require removal as part of the demolition works. This includes the removal of slab pavement within RPAs of T4, T5, T6 and G3
- 2.29. The removal of surfaces from RPAs will adopt the following protective measures:

- 2.30. The **TPP (See Plan 3)** identifies areas of existing hard surfacing within RPAs that require removal as part of the demolition works. This includes the removal of an existing bike shelter within RPAs of G3.
- 2.31. The removal of built structures and their foundations from RPAs will adopt the following protective measures:
  - 1) Protection fencing will be temporarily removed / repositioned to provide access;
  - 2) Ground boarding will be placed over parts of the exposed RPA that are not surfaced and where access is required. Any machine use must be operated outside from the RPA, or on hard surfaced ground. Machines will only operate within soft-ground RPA as a last resort which is protected by ground protection boards as detailed within this document;

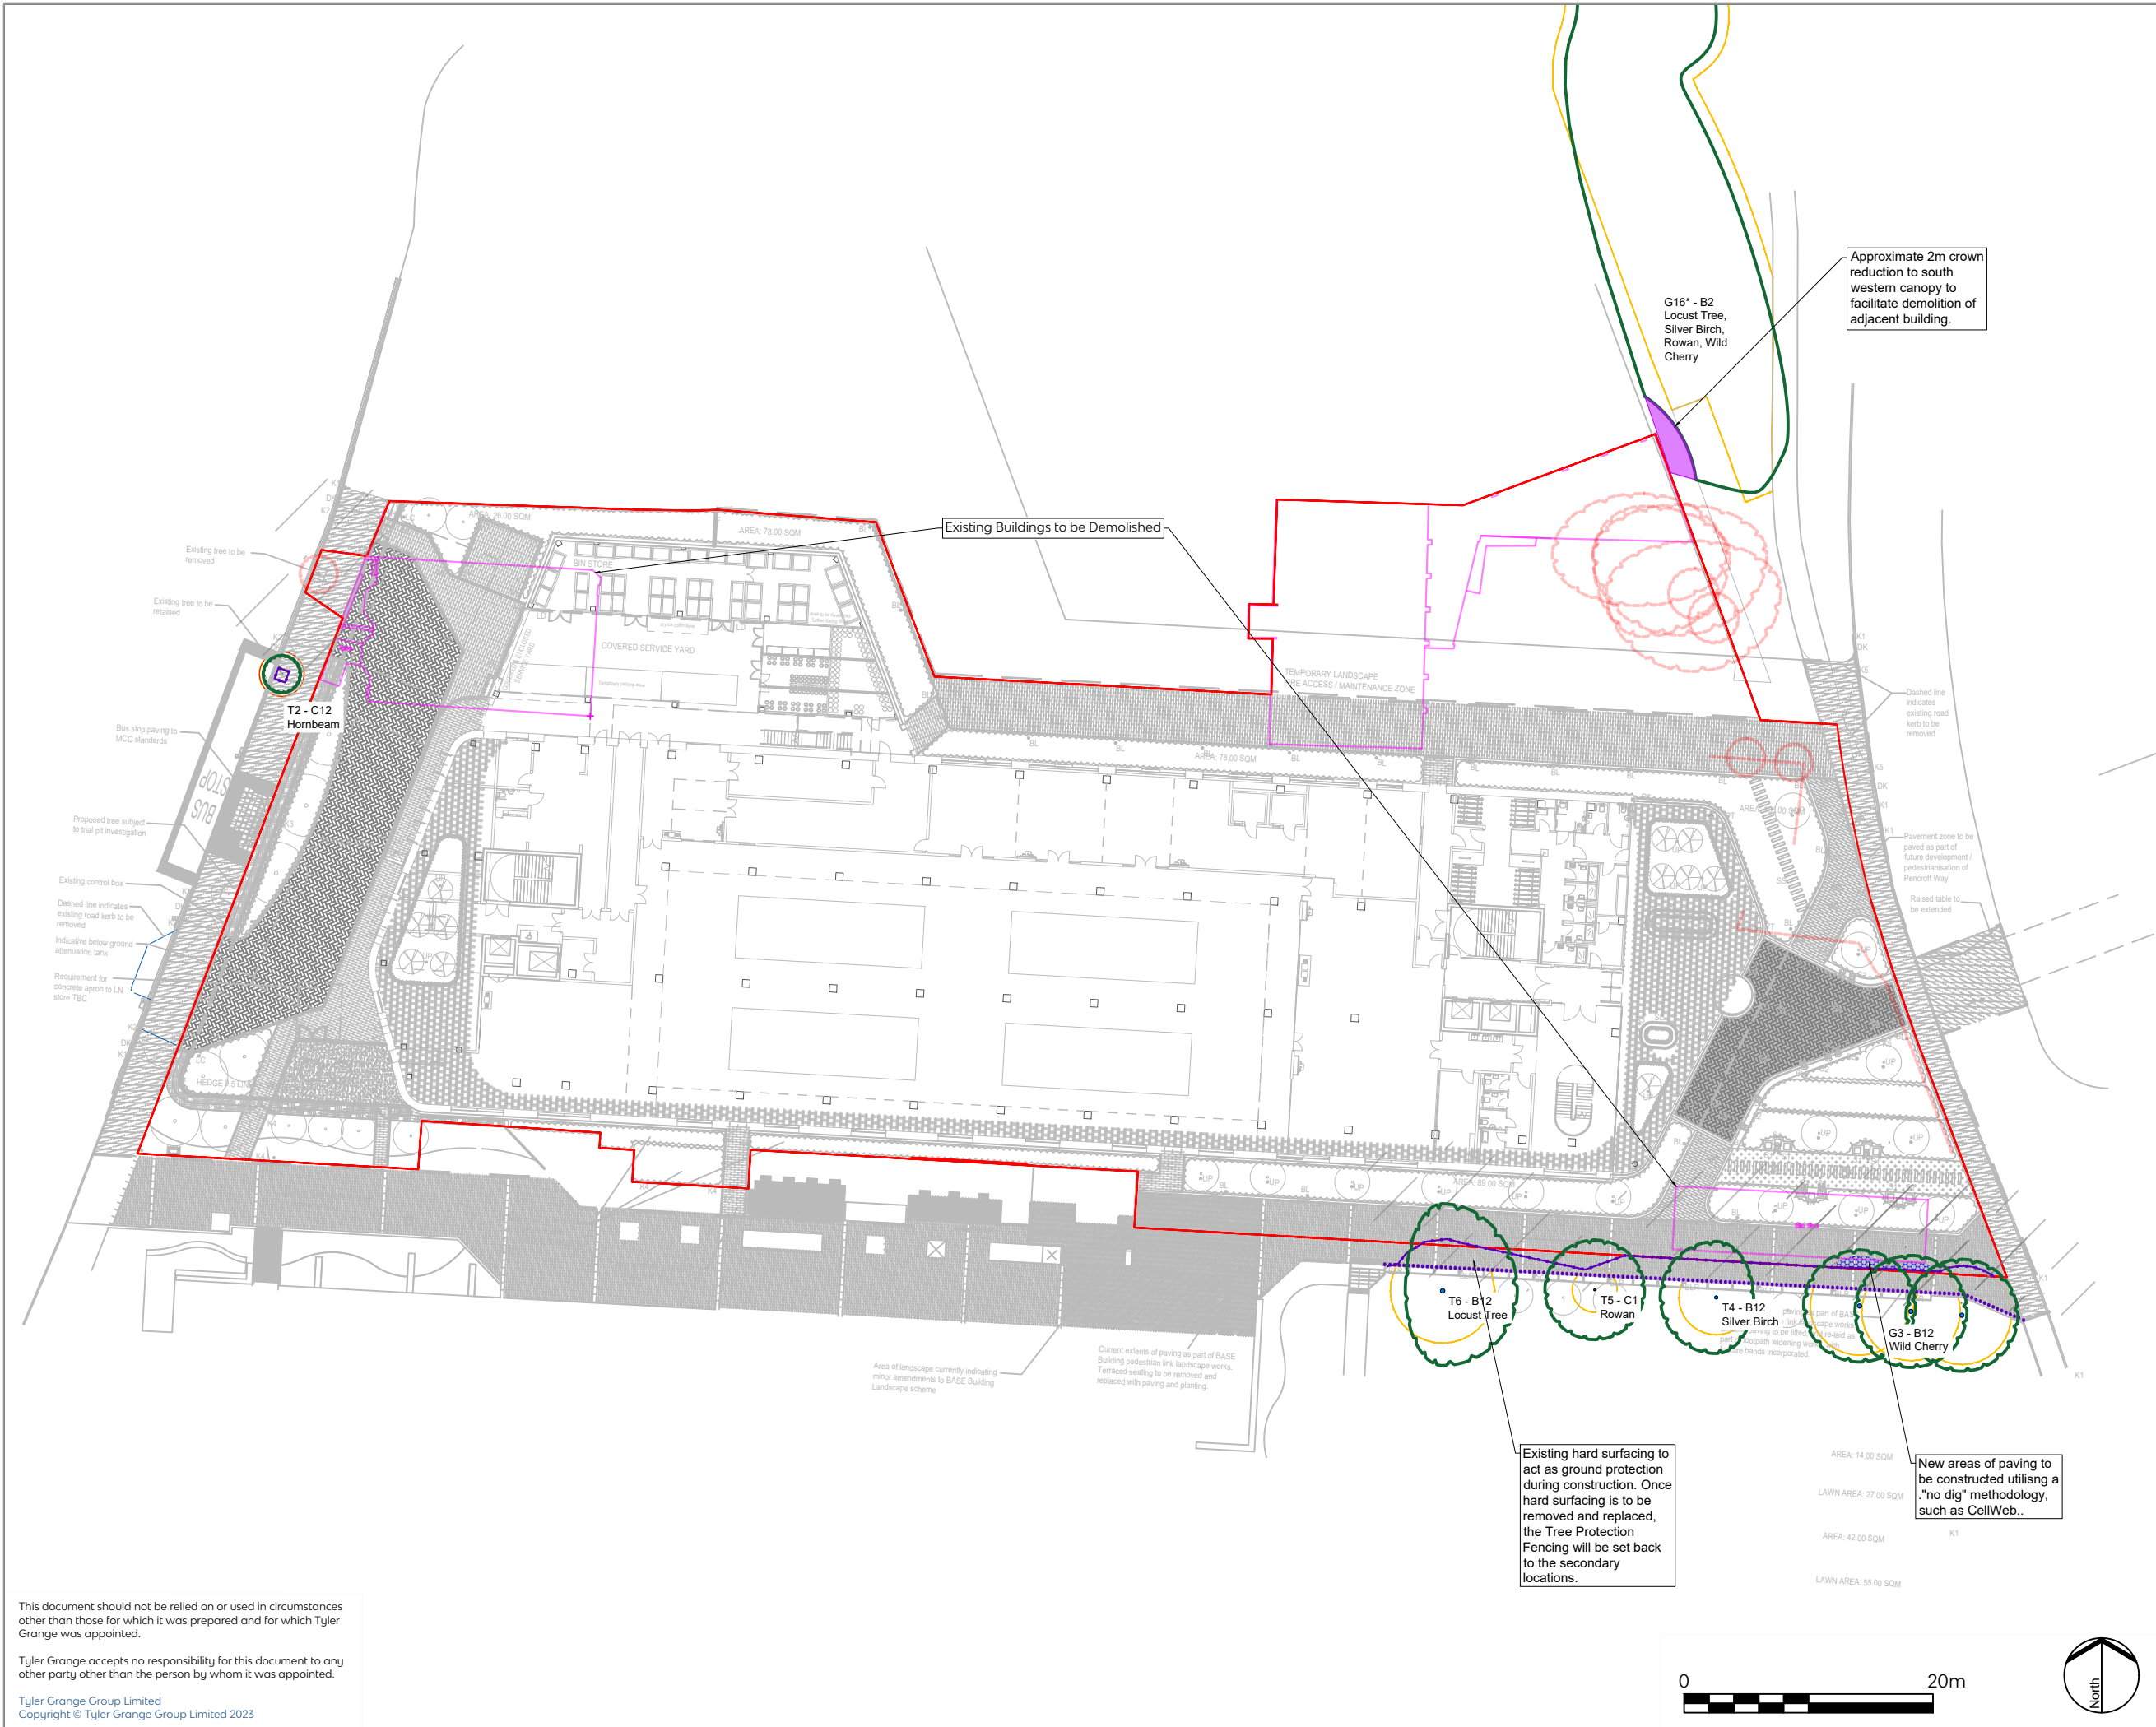
Survey Boundary

Retained Trees

Tree Shading Constraints

*\*Denotes trees and groups not identified on topographical survey. Locations approximated using measurements taken on site.*

- 1.4. A pre-development tree survey of the site has been completed in accordance with BS5837. Findings for each of the trees surveyed are detailed in the **Tree Survey Schedule (See Appendix 1)** and the accompanying **Tree Constraints Plan (See Plan 1)**. The Tree Survey Schedule provides a record of each survey entry, including tree reference numbers, species, tree and root protection area (RPA) dimensions, life stage, physiological and structural condition, and arboricultural value.
