**CSM - College House**  
**Design and Access Statement**  
March 2023

Project name: CSM - College House, Fox's Court and Gatehouse External Works

Client: Chetham's School of Music

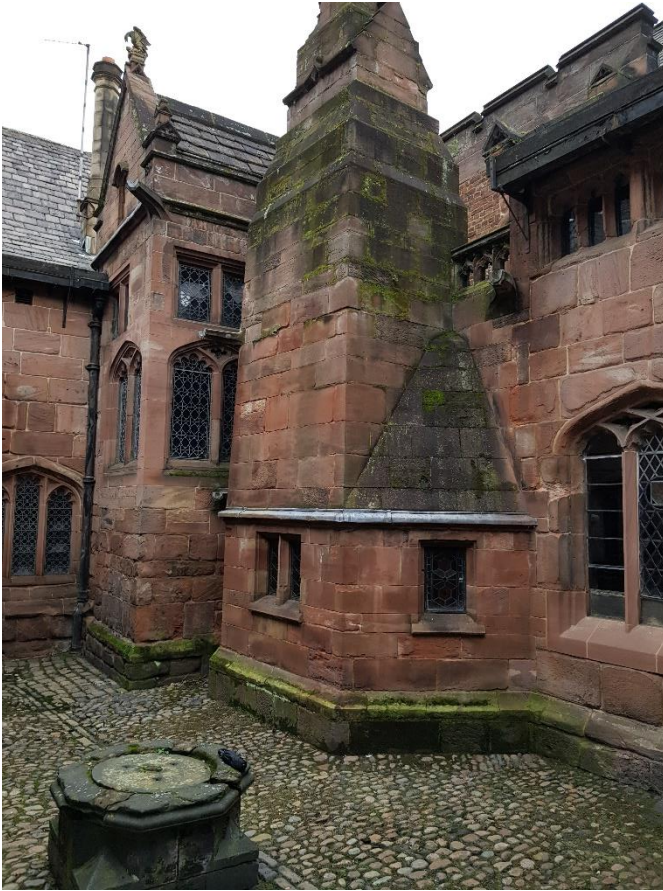
*Fox's Court Well and Chimney.*

Externally in Fox's Court is a medieval well which is progressively deteriorating with open joints and significant surface erosion. The court also has a number of plastic rainwater goods which are inappropriate replacements of former cast iron down pipes.

- 3.2.5.1 The central stone well is in poor condition with indent repairs required to the masonry base. A number of stones are loose and fractures can be seen. In areas inappropriate cement mortar repairs have been introduced.

- 3.2.5.2 The application proposes that the well is carefully dismantled with all stones numbered and recorded. Indent repairs will then be undertaken where required and the stones careful cleaned of vegetation. The well will then be rebuilt using an appropriate lime-based mortar. Samples will be produced to ensure the lime mix is appropriate to the stone composition. Masonry mortar repairs will also be undertaken at this time using a lime-based mortar mixed with stone dust to exactly match the composition and visual character of the stone. Samples will be produced to ensure an appropriate mix is specified.

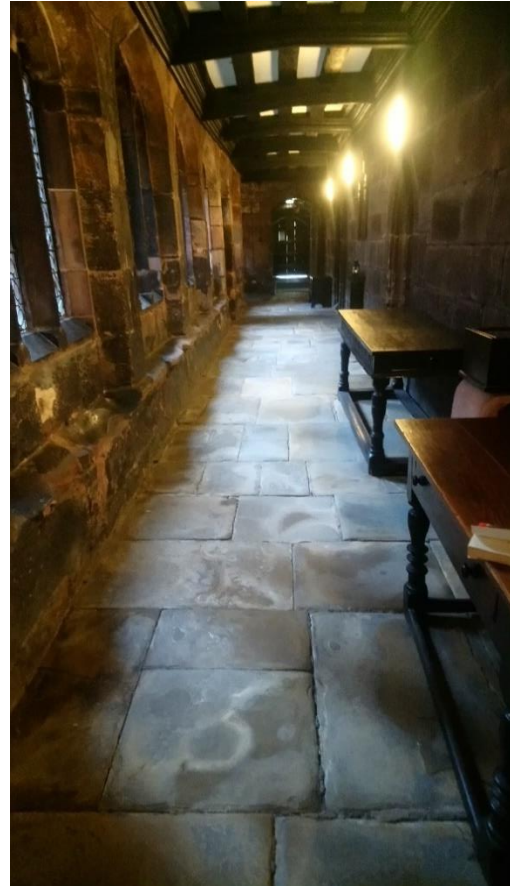
*College House Baronial Hall Corridor – Stone floor condition.*

The internal floor is composed of stone flags which have undergone several phases of repair. Some of the repairs are cementitious and inappropriate. The flags are progressively deteriorating with some large fractures and loose stones.

3.2.6.1 The existing stone flags have undergone several phases of repair and some areas have been repaired with cementitious mortar. Large fractures are visible in several places and are progressively deteriorating. Several raised stones have led to trip hazards across the floor area.
