**Project Title** CSM - College House  
**Client** Chetham's School of Music  
**Location** Manchester

**Drawing Title** Baronial Hall & Access Corridors  
College House Ground Floor 1 of 2  
As Proposed

#### Status PLANNING

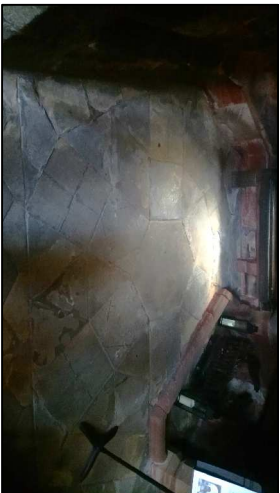
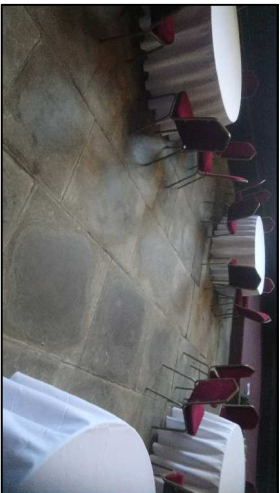
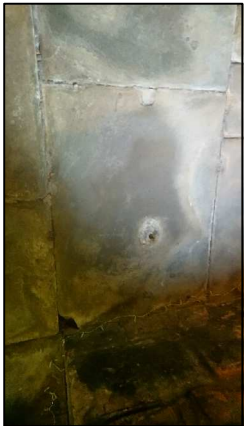
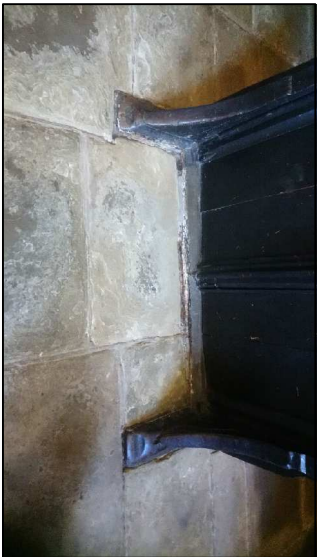
| KEY | |
|---|---|
| 1 | Fractures |
| 2 | Loose Stone |
| 3 | Broken / Missing Stone |
| 4 | Raised Stone |
| 5 | Surface Erosion |
| 6 | Open Joints |
| 7 | Cement Mortar |
| 8 | Assess for full replacement |

| For isolated fractures carefully use an epoxy resin to re-seal the stone to the wider flag. For multiple fractures allow for stainless steel dowels to stabilise the flag alongside an epoxy resin to seal the fractures. | |
| Carefully lift stone & re-bed in lime based mortar level | |
| Small area - masonry mortar repair in lime based mortar mixed with stone dust to exactly match and sit flush with the existing & adjacent (provide sample). | |
| Larger area, where repair is not possible - inset new stone to match existing & adjacent and bed in a lime based mortar, level with surrounding stones (provide sample) . | |
| Carefully chisel the edge of the raised stone to remove the tip hazard but retain the historic form and position of the flag. | |
| Surface erosion - where erosion has caused an edge or tip hazard allow to chamfer the edge as described above. | |
| Carefully rake out with hand tools and re-point in a lime based mortar to exactly match historic mortars everywhere in the hall. | |
| Carefully rake out cement mortars with hand tools, lifting stones if required. Re-bed stones in a lime based mortar | |
| Assess on site at time of works for full replacement. Any replacement to be sampled for an exact match with existing & adjacent and to be agreed with The Architect | |

Vapour permeability tests should be used to determine an appropriate lime mix for the existing stone composition. Samples of the lime based mortar are to be agreed before installation

Allow to make good any impact on surrounding stones following work to match existing & adjacent in every respect. Samples of all lime & masonry mortar repairs and stone replacements are to be agreed before installation
