# **GTech Surveys Limited**

## **Planning Condition 27 - Television Signal Reception Impact Assessment**

### **NOMA 4 Angel Square**

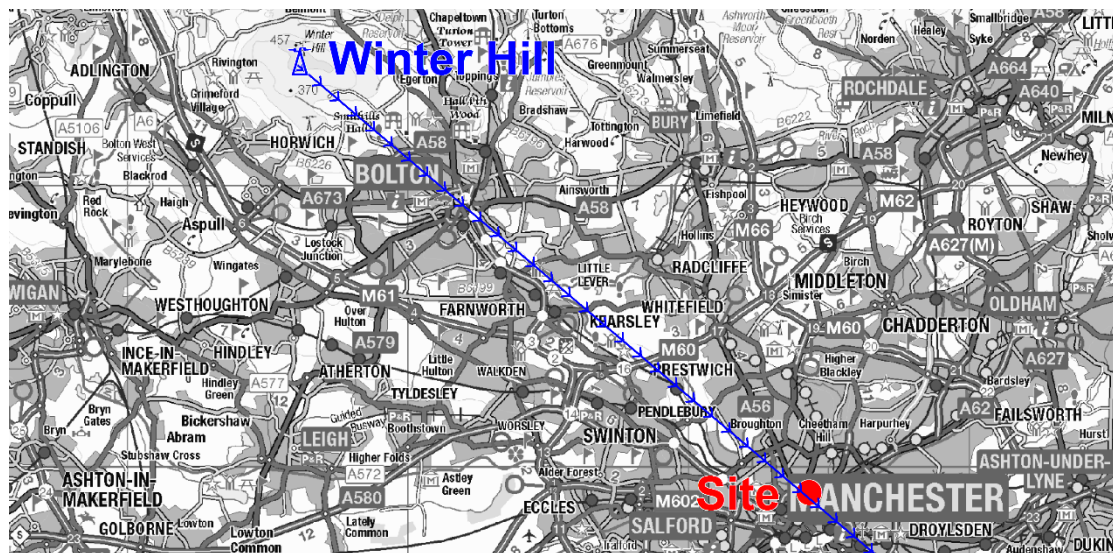
Figure 1 - The Location of the Winter Hill Transmitter, the Site and the direction of the incoming DTT signals at the Site (shown by the blue arrow)

The survey area was served by DTT services (Granada TV region) from the Winter Hill transmitter (grid reference SD 66053 14463), on a bearing of  $310^\circ$  (with respect to true north) and 24km away from the Site. The transmitter is shown with respect to the Site in Figure 1.

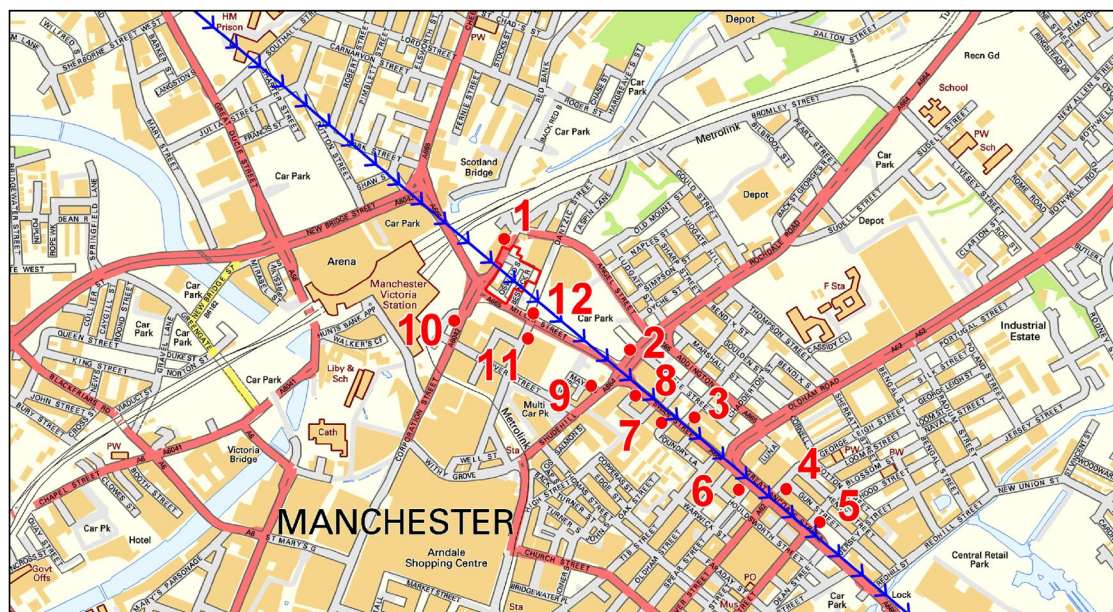
Figure 2 - Surveyed Locations. The blue arrows indicate the direction of the incoming DTT signals from Winter Hill transmitter

The survey was undertaken during February 2023. 12 locations were visited in similar areas as identified in Figure 2 and signal measurements were undertaken to assess the quality and availability of terrestrial television services. the measurements are detailed in Appendix - *Signal Measurements*. The following data was recorded:
