Phase II Geoenvironmental Site Assessment  
Ancoats Green, Jersey Green and Prussia Street  
Arm Greenway Public Realm Improvements

Reference:15-798-R2-1  
Date: January 2023

## PHASE II GEOENVIRONMENTAL SITE ASSESSMENT

Ancoats Green, Jersey Green and Prussia Street Arm Greenway Public  
Realm Improvements

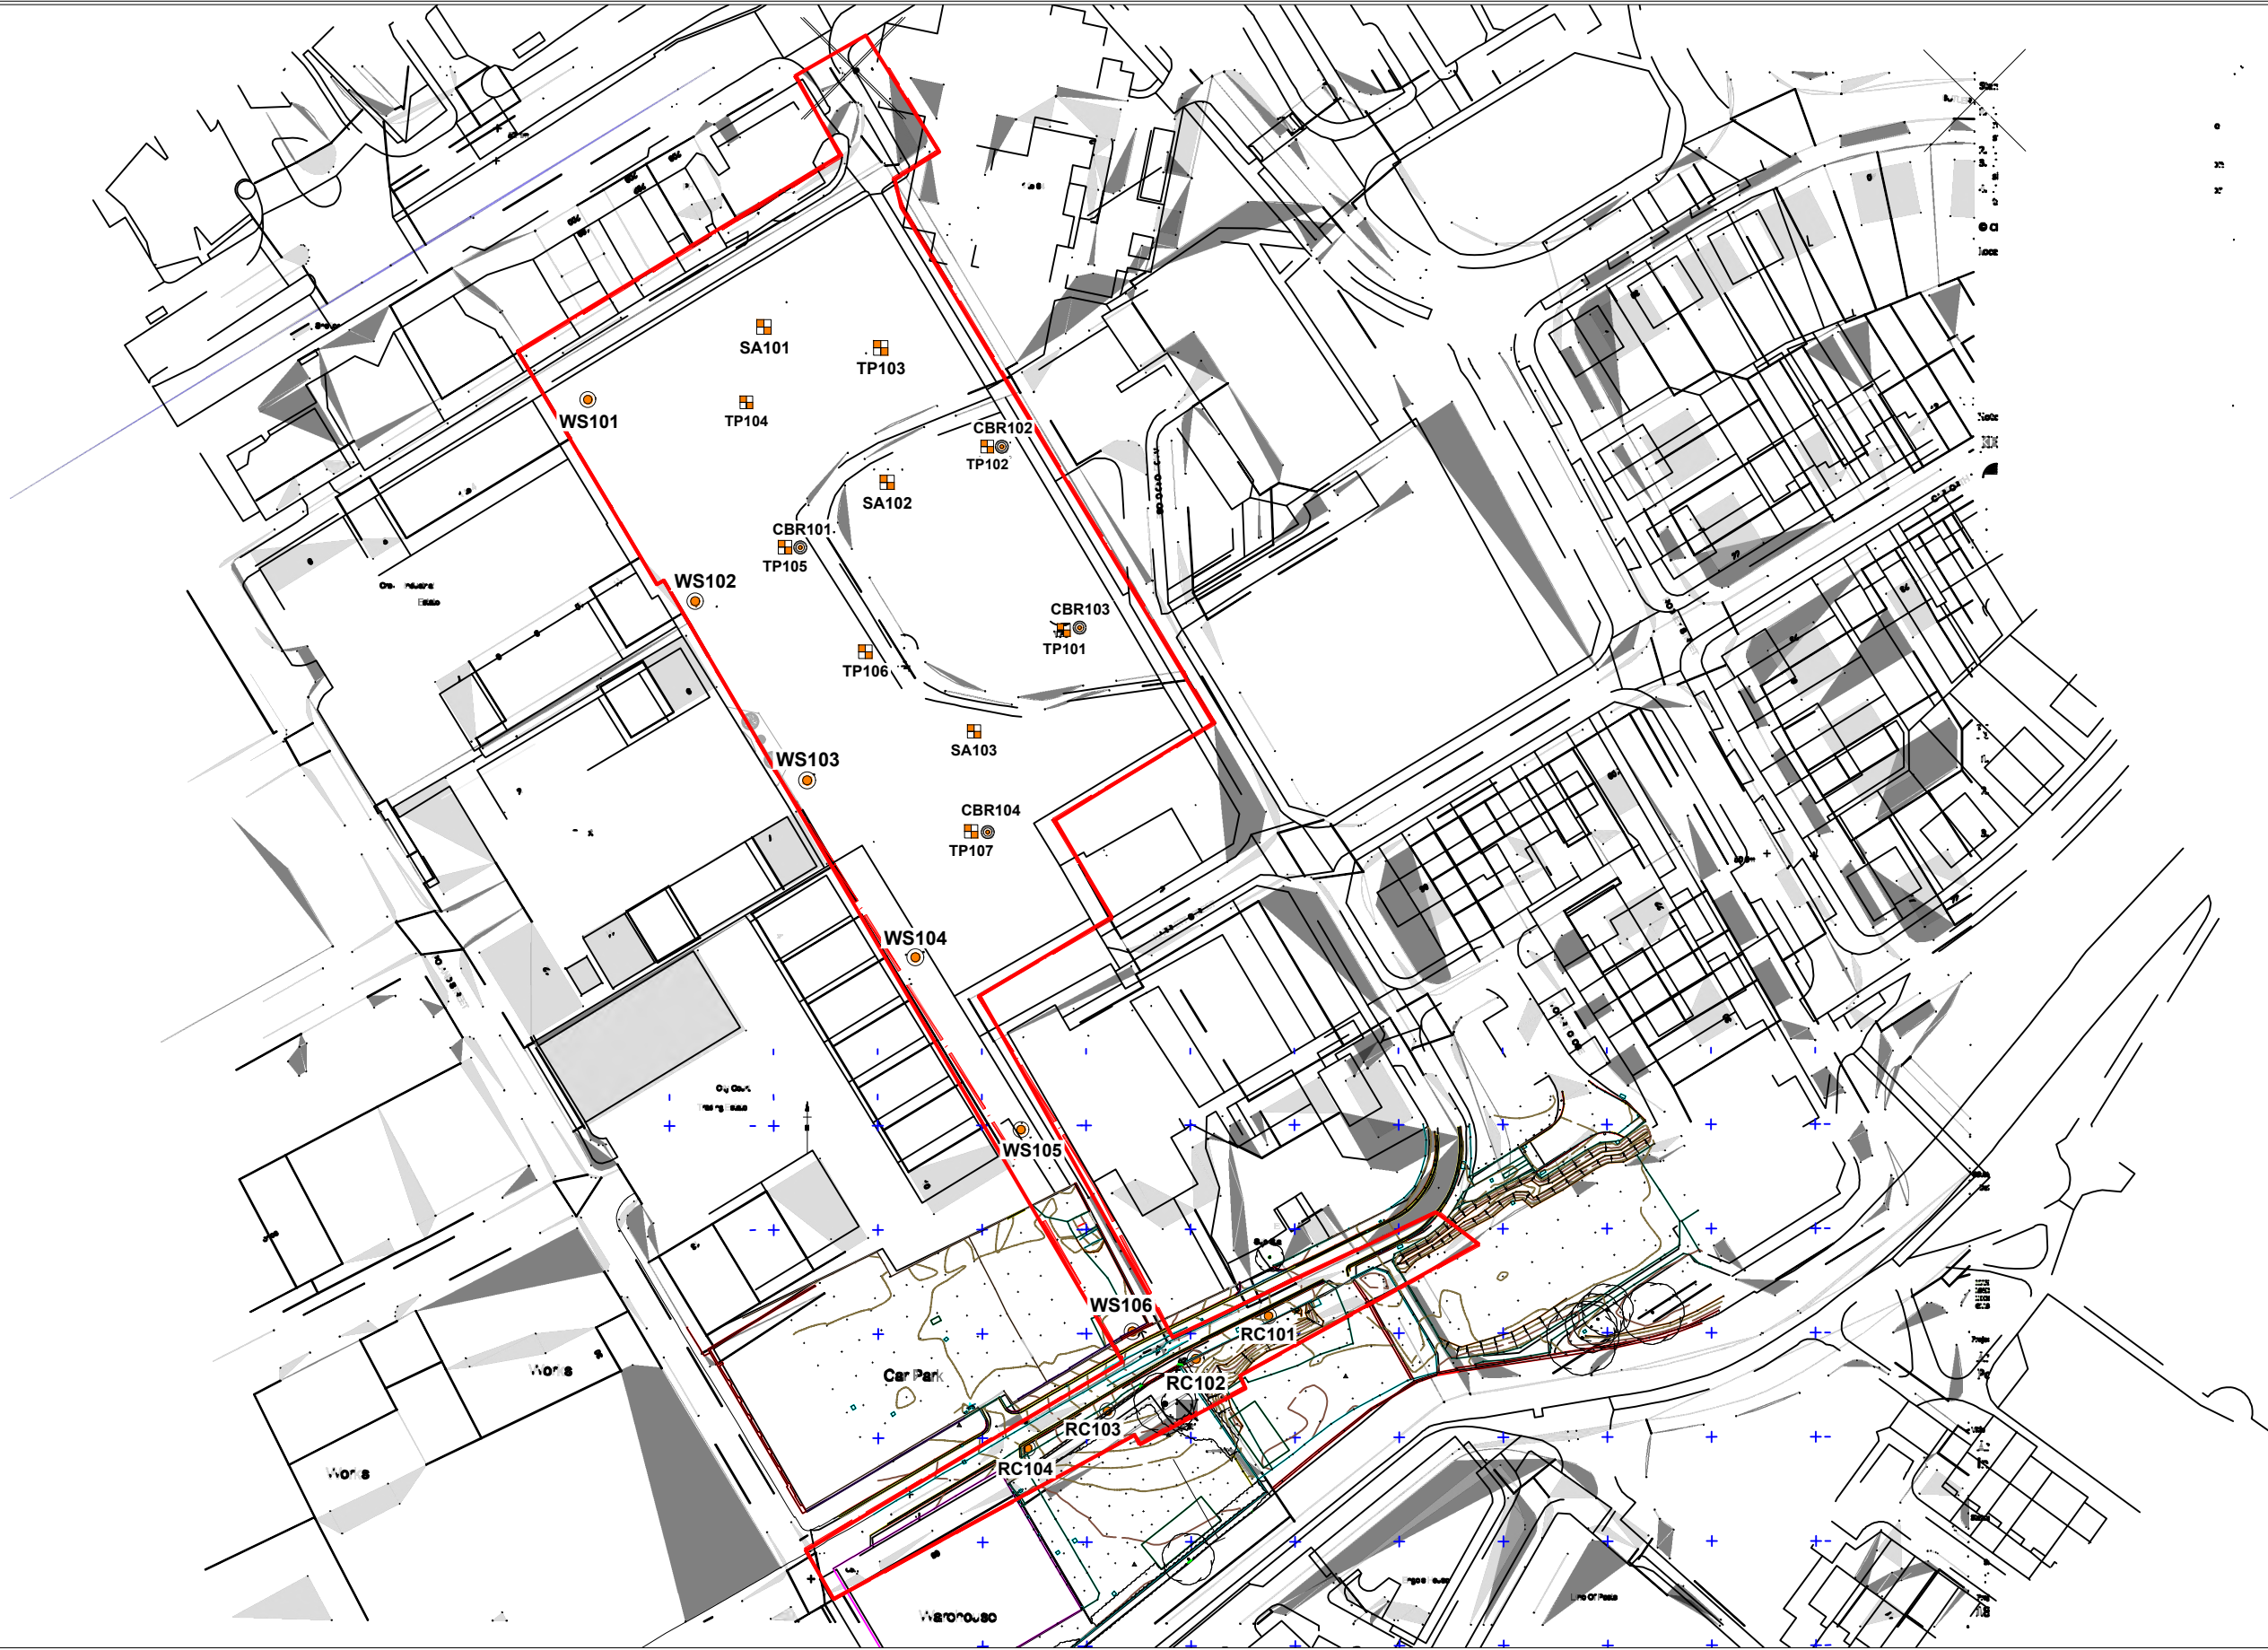
- Location Symbols
- Approximate Window Sample Probehole Location
  - Approximate Trial Pit Location
  - Approximate Soakaway Test Location
  - Approximate Rotary Borehole Location
  - Approximate California Bearing Ratio Test Location

The sampling locations are illustrated in Drawing 15-798-004 (Appendix III). The ground conditions encountered are indicated on the logs, which are provided in Appendix V.

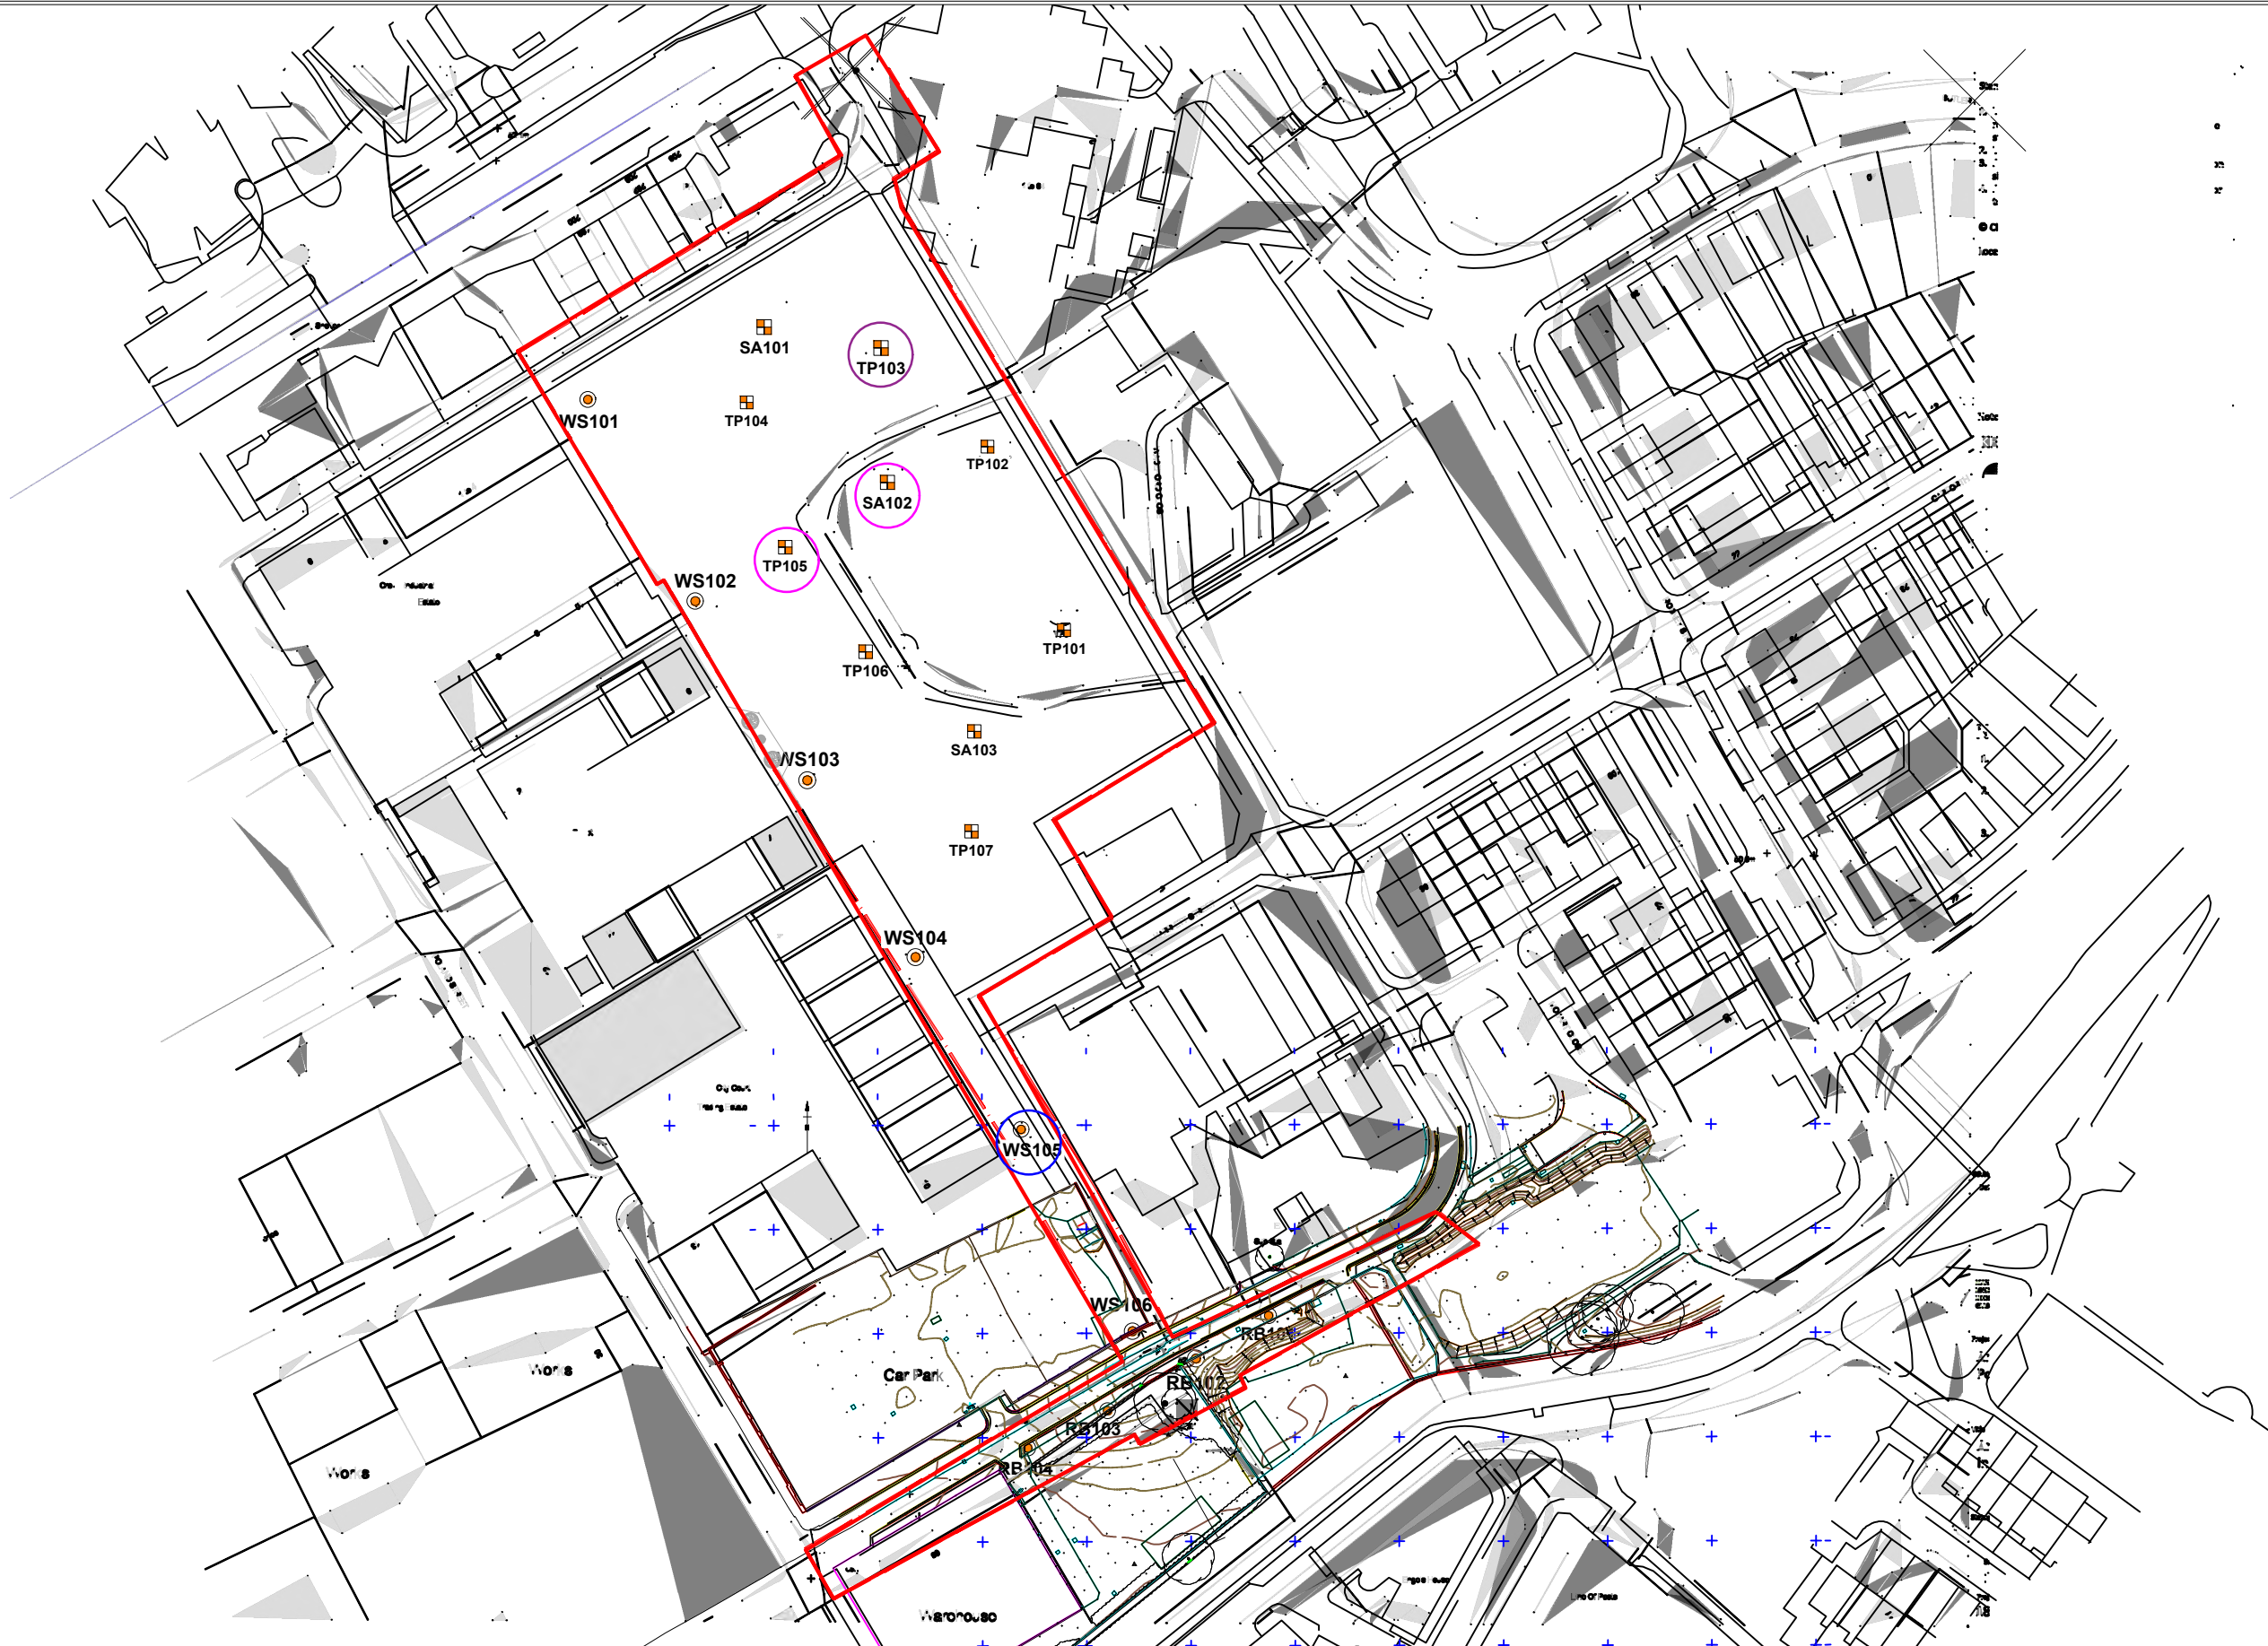
Development  
Constraints Plan

- Development Constraints**
- Concrete Obstruction
  - Soft Clay
  - Made Ground Refusal

| <b>Underground Obstructions &amp; Hazards</b> | <p>Significant concrete and brick obstructions have been encountered within the Made Ground, indicative of relic foundations from the former buildings.</p> <p>The infilled canal will comprise deleterious materials which are likely to be geotechnically and chemically unsuitable. It is also understood that relict drainage infrastructure allows a flow of water into the infilled canal.</p> <p>Further detailed site investigation is required comprising a series of trial trenching to further understand the ground conditions and nature of infilled material within the infilled canal.</p> <p>During a phase of cut-and-fill enabling works to create a developable platform, all below-ground obstructions will require grubbing out to the base of the Made Ground to enable the construction of proposed plots.</p> |

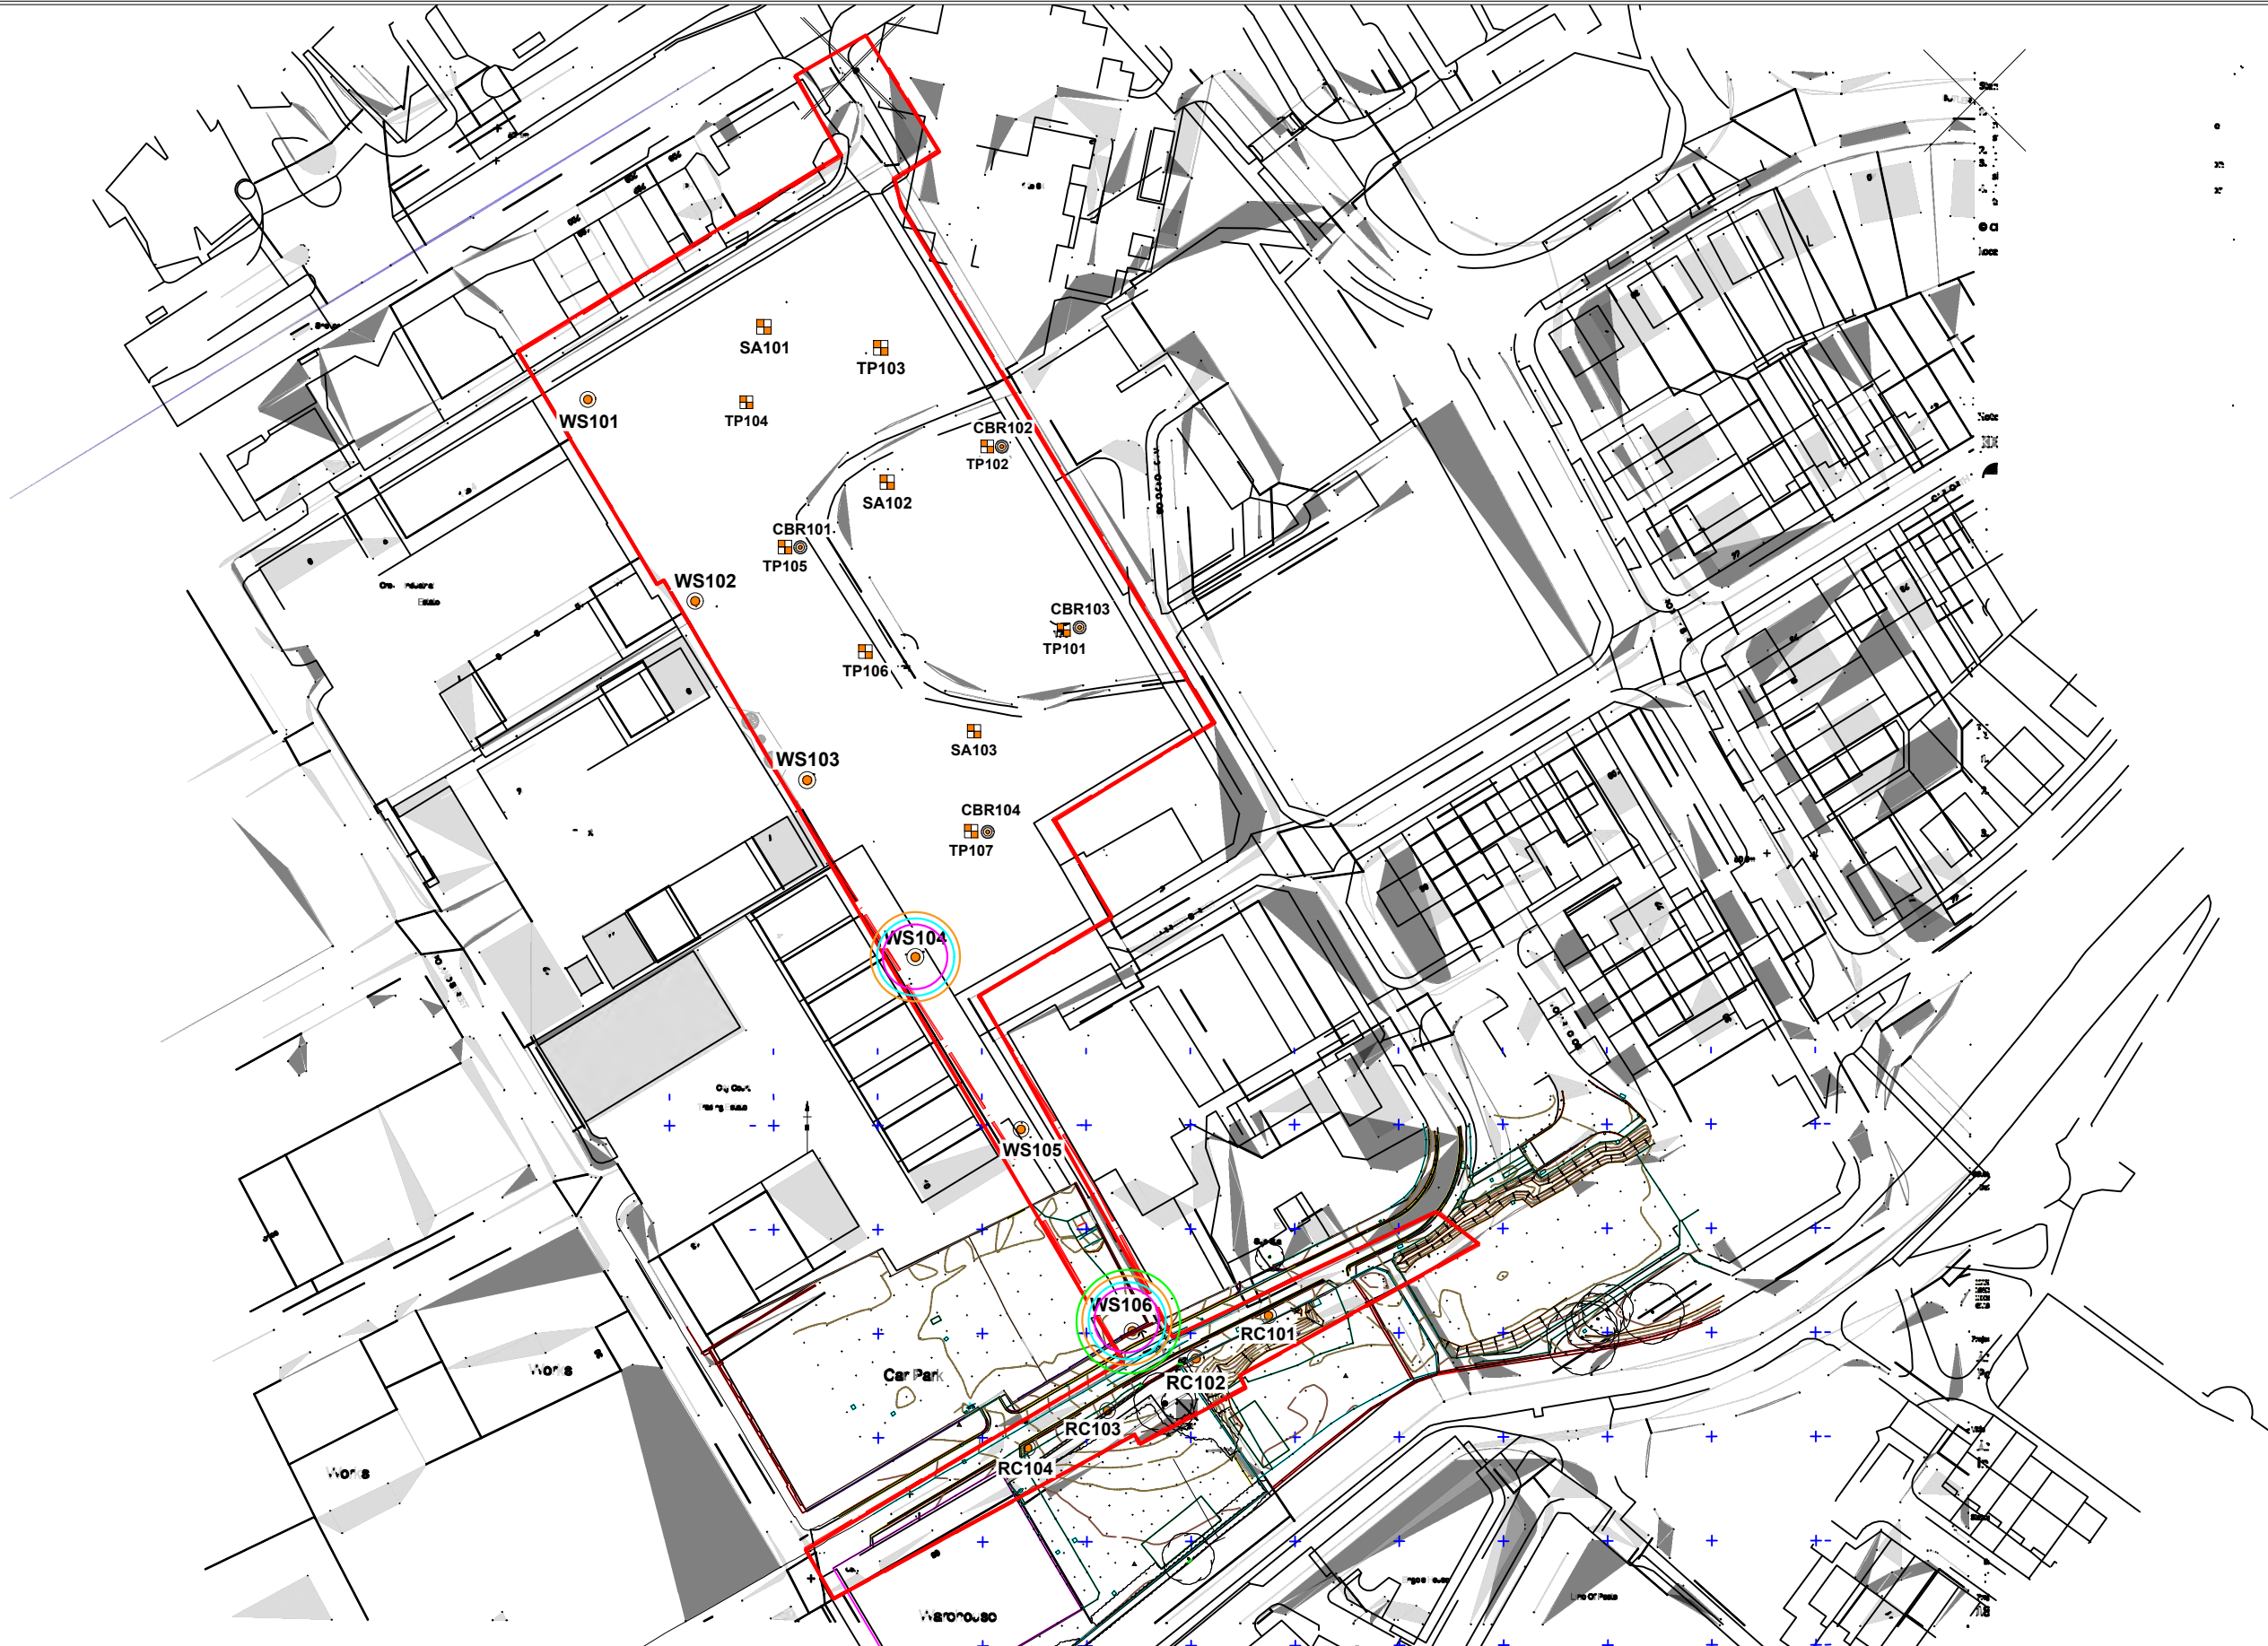
Contamination Issues  
Plan - Controlled  
Waters

- Contamination Issues - Controlled Waters
- Heavy Metals
  - PAH
  - TPH (Aromatic)
  - TPH (Aliphatic)

- ✳ Due to the exceedances of hydrocarbons noted in the soil, leachate and water samples, the risk to controlled waters is considered to be moderate. It is recommended that further investigation including trial trenching along the infilled canal to inform a detailed controlled waters risk assessment to further assess the risk. Further water sampling is likely required.

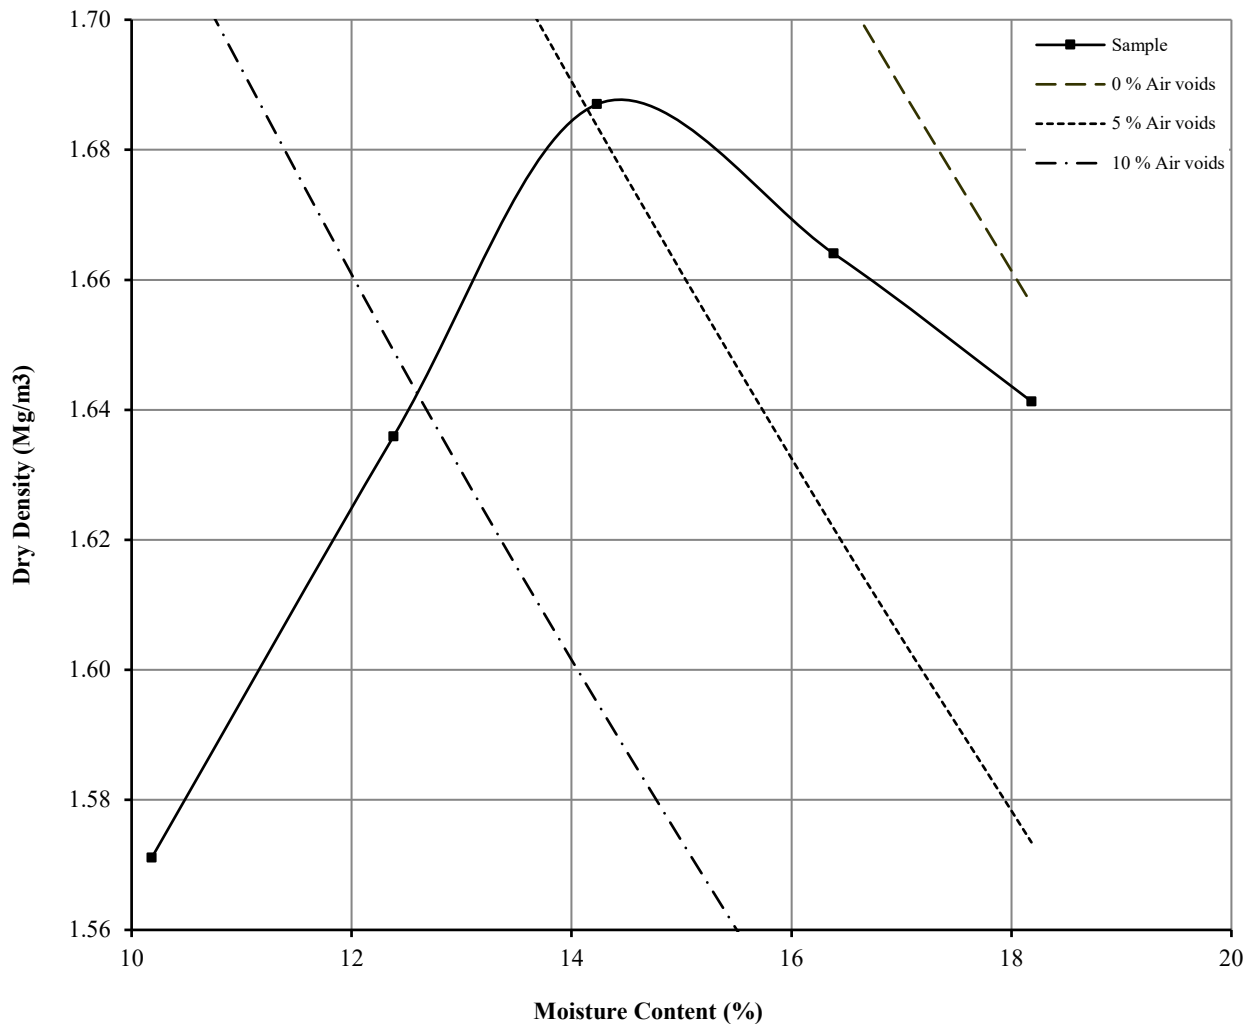
| Initial Moisture Content: | 14 | Method of Compaction: | 2.5kg | Separate Samples |
| Particle Density (Mg/m <sup>3</sup> ): | 2.37 | Assumed | Material Retained on 37.5 mm Test Sieve (%): | 16 |

The proctor compaction tests have indicated that the materials on site are wet of the optimum. It should be noted that if this material is excavated for use in a cut/fill operation careful consideration should be taken in the stabilisation of this material.

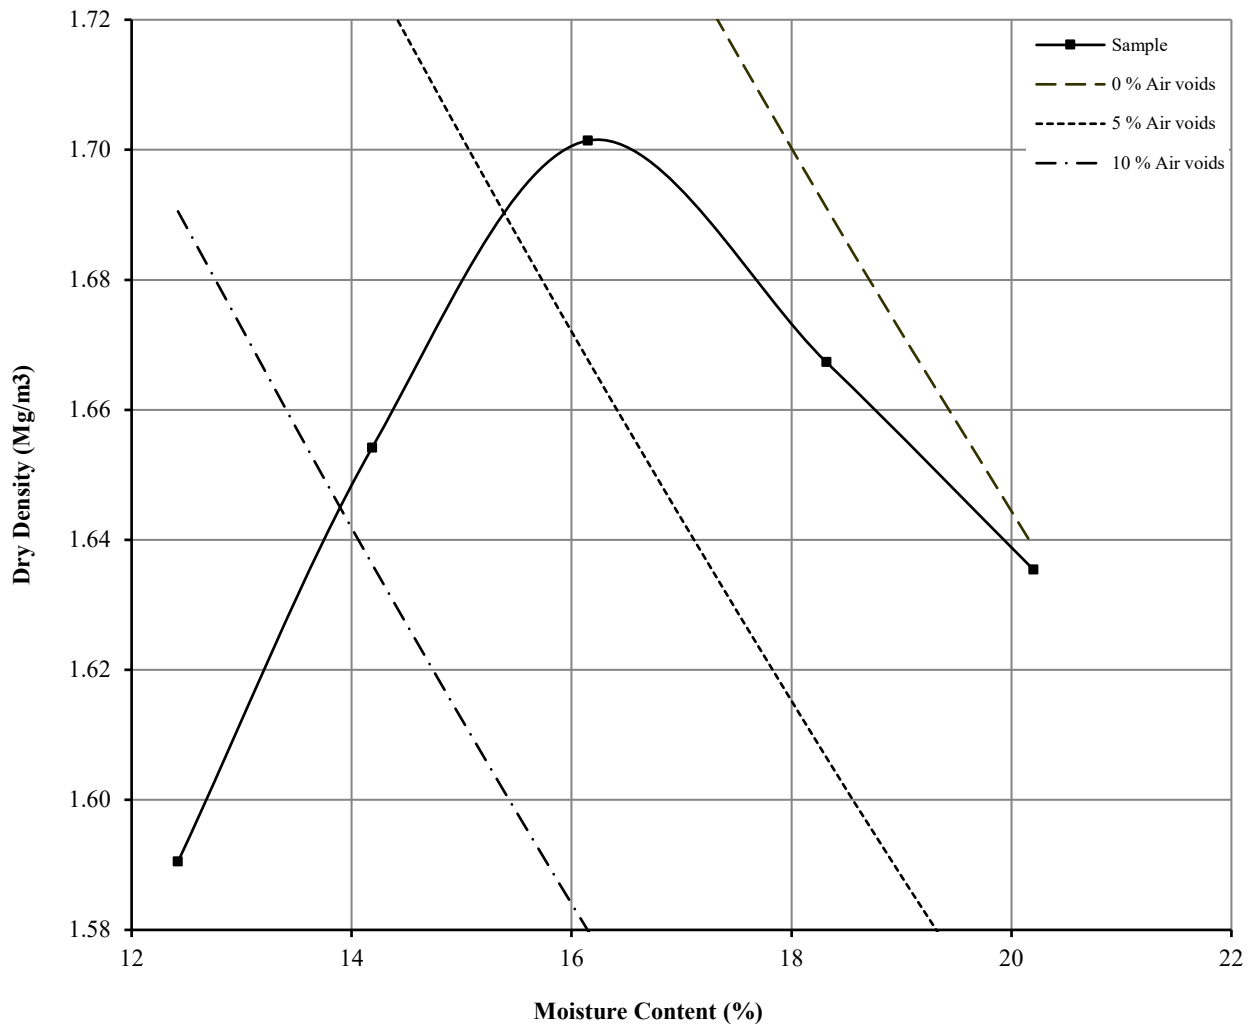
| Initial Moisture Content: | 16 | Method of Compaction: | 2.5kg | Separate Samples |
| Particle Density (Mg/m <sup>3</sup> ): | 2.45 | Assumed | Material Retained on 37.5 mm Test Sieve (%): | 21 |

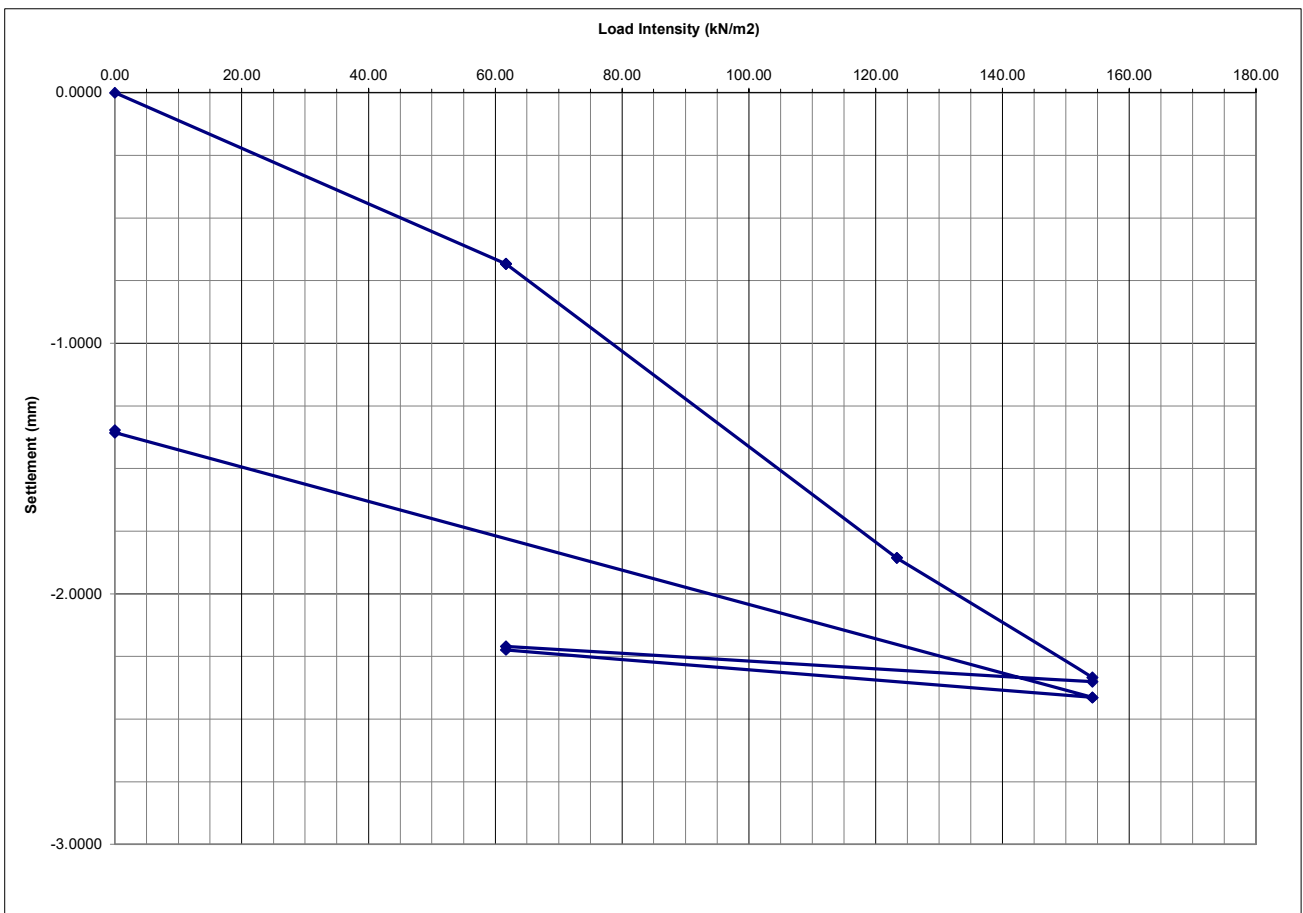
| Strata Description: | Made Ground | | |

**Equivalent CBR Value of 8%**

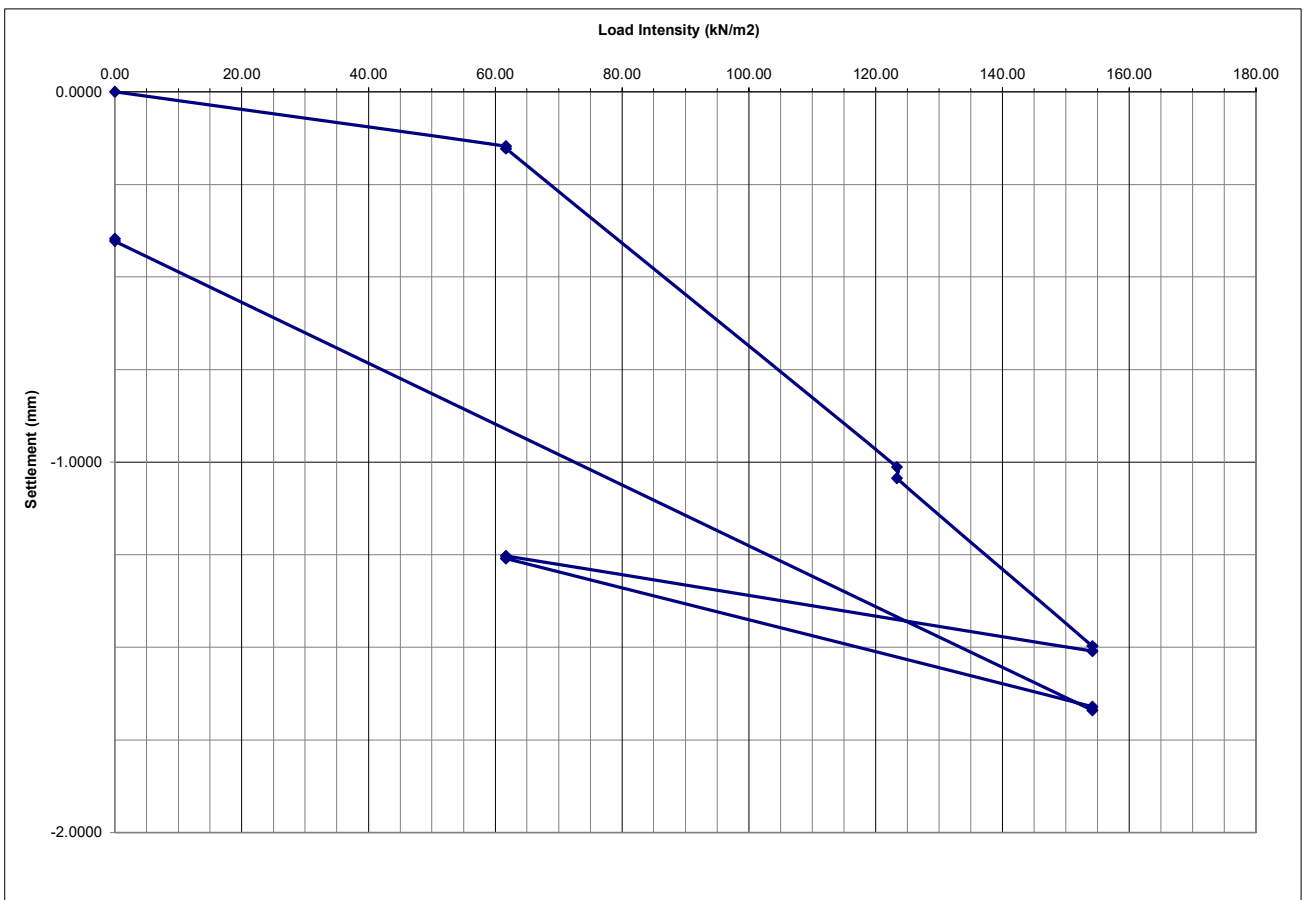
| Strata Description: | Made Ground | | |

### Equivalent CBR Value of 15%

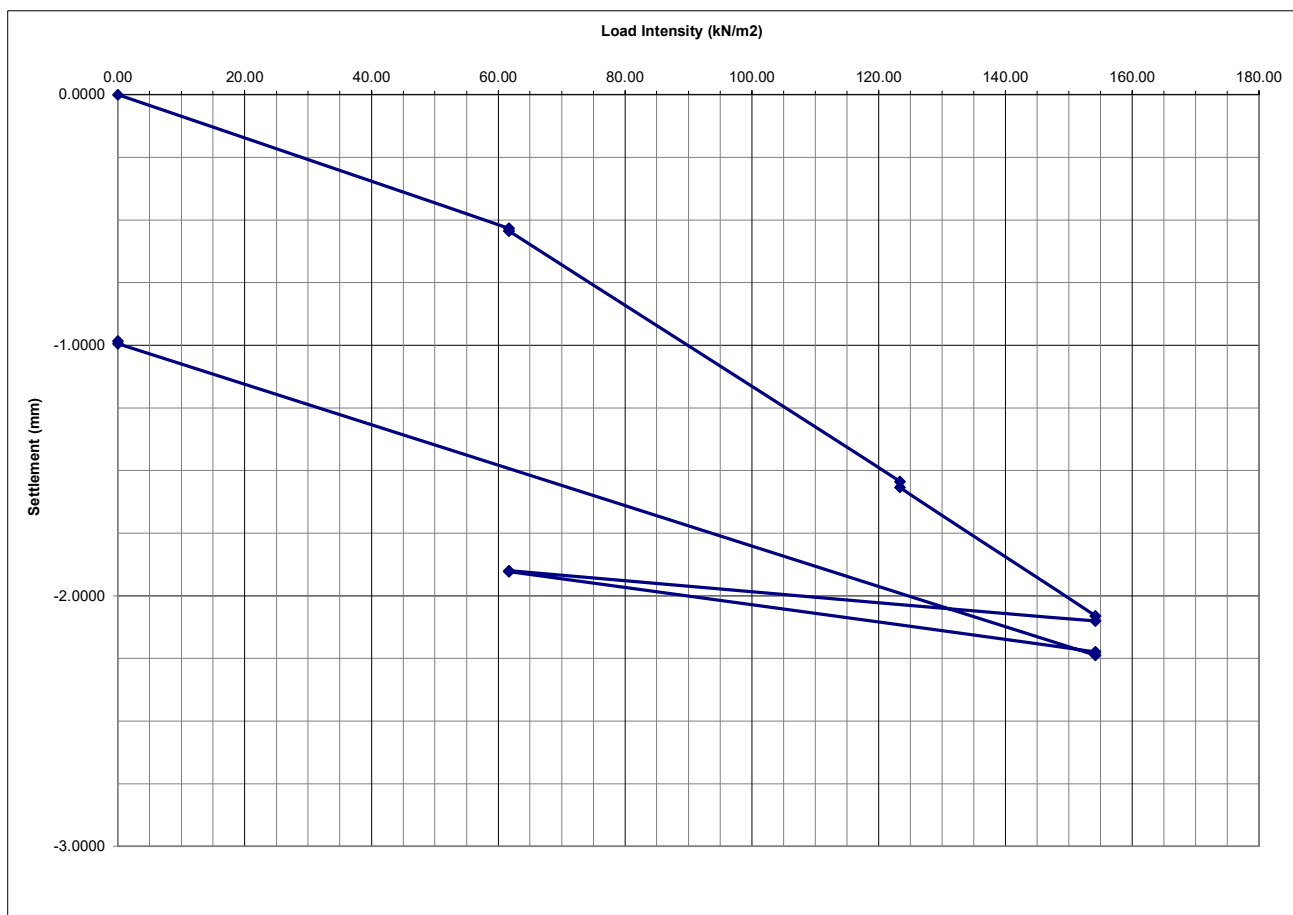
Site Name: Jersey Street  
Site Ref: 15-798  
Test No.: CBR103-TP101  
Plate Diameter (mm): 450  
Maximum Applied Pressure (kN/m<sup>2</sup>): 154.20  
Maximum Deformation (mm): -2.24  
Strata Description: Made Ground

### Equivalent CBR Value of 10%

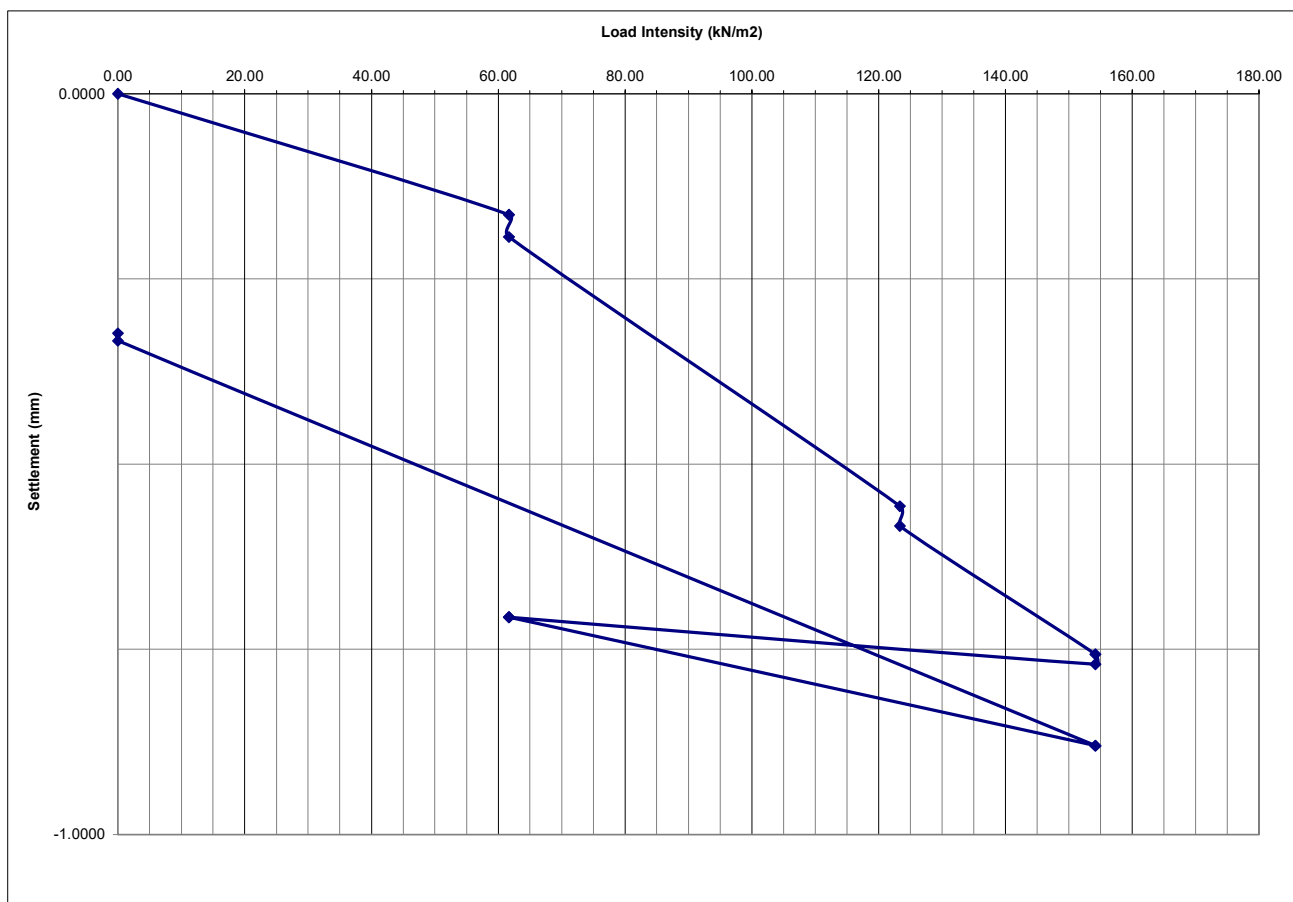
Site Name: Jersey Street  
Site Ref: 15-798  
Test No.: CBR104-TP107  
Plate Diameter (mm): 450  
Maximum Applied Pressure (kN/m<sup>2</sup>): 154.20  
Maximum Deformation (mm): -0.88  
Strata Description: Made Ground

**Equivalent CBR Value in excess of 19%**
