Remediation Strategy

Liberty Northern Moor

Wythenshawe

**Report A4701/22/RMS**

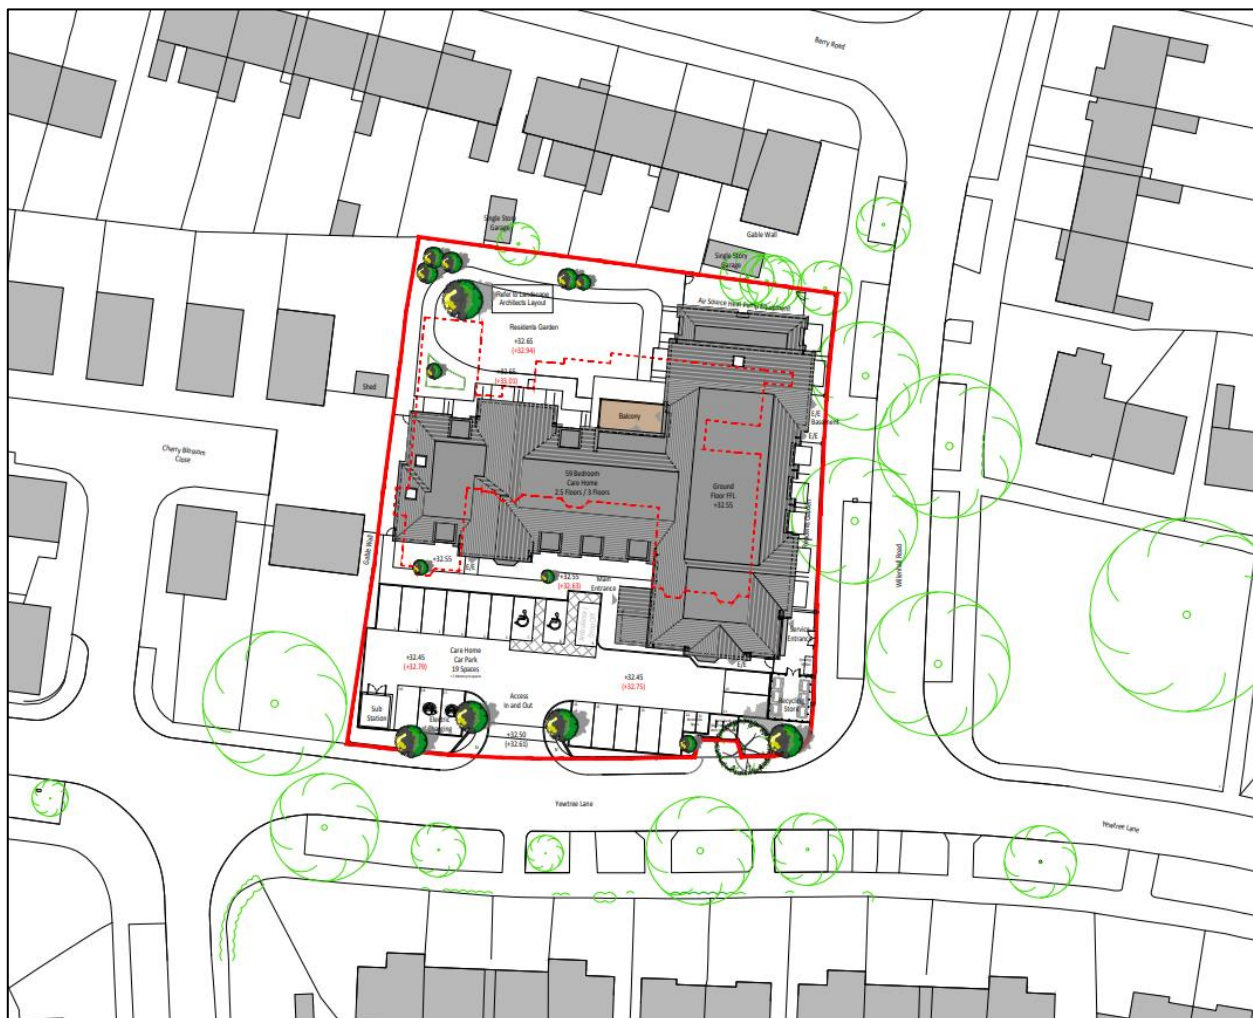
**Figure 1 Proposed Development Layout Plan**

It is understood that the client wishes to demolish Yew Tree Manor Care Home to construct a new Care Home with a larger building footprint. The existing access route from Yew Tree Lane will be retained but utilised as a vehicle exit only. Another access route will be developed along Yew Tree Lane to be utilised as a vehicle entrance.

A new vehicular parking area as well as a new substation in the southwest corner of the site, are also proposed as part of the development.

Figure 1 below shows the proposed development layout plan.

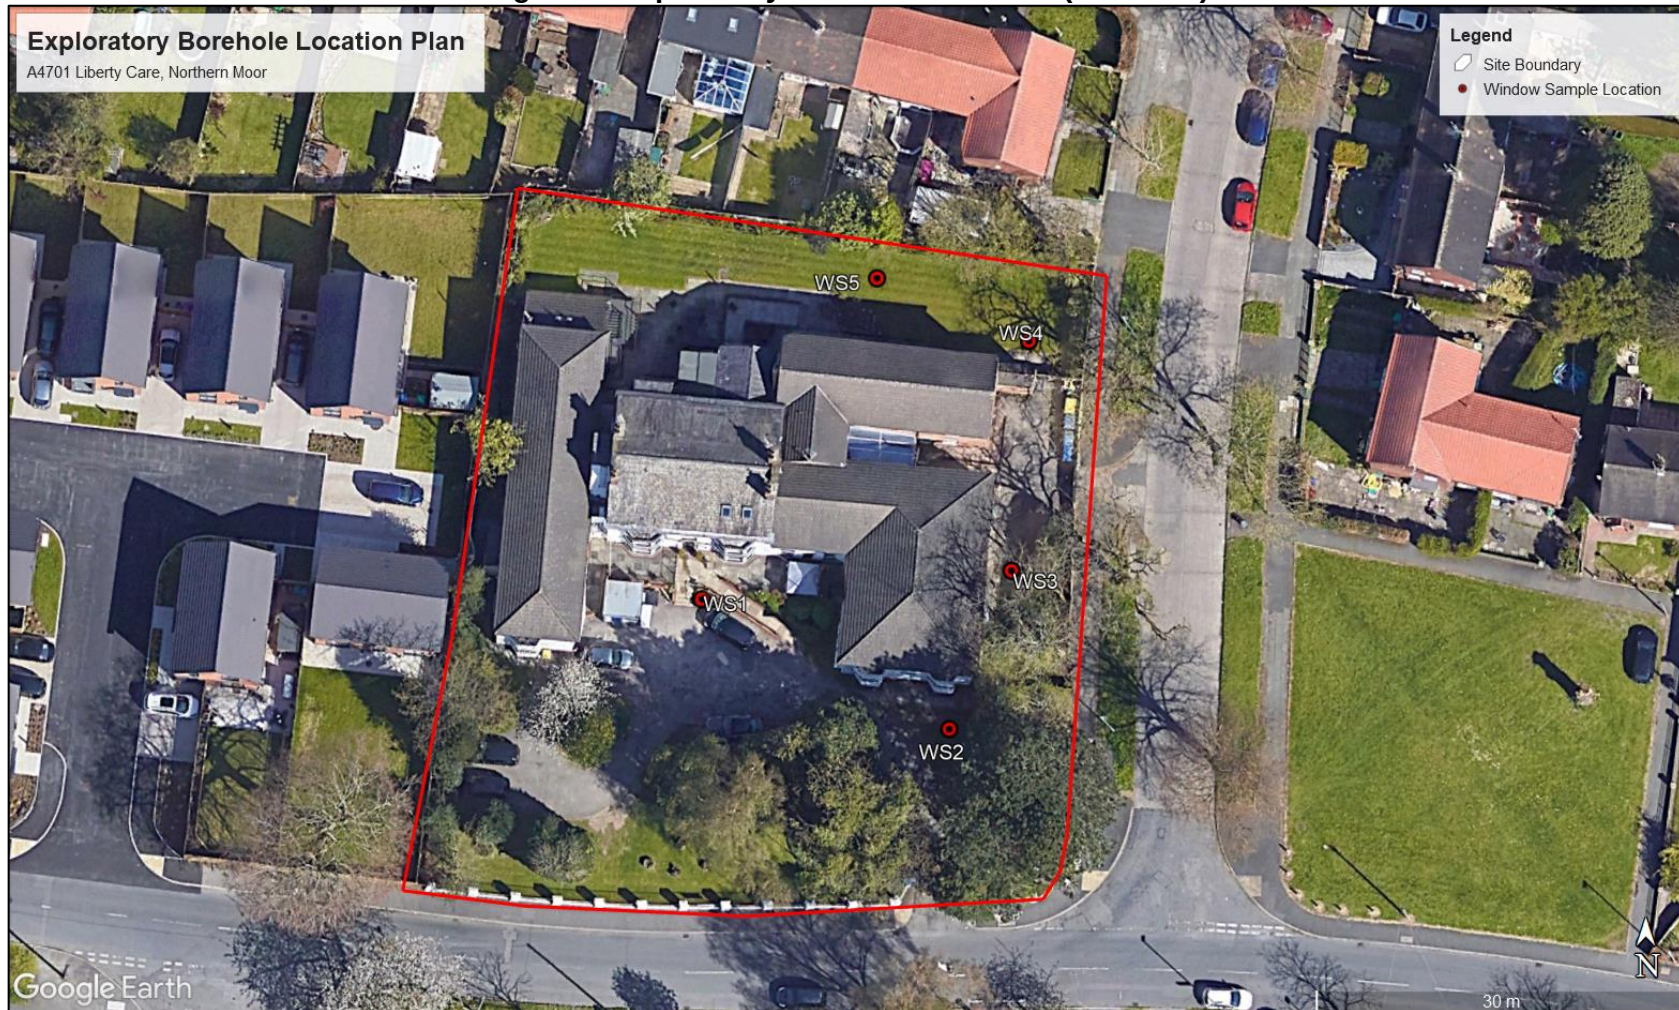
**Figure 3: Exploratory Hole Location Plan (A4701/22)**

- 5 window sample boreholes (WS1 - WS5) to a maximum depth of 5.00m bgl;

Standard Penetration Tests (SPTs) were conducted in the window sampler boreholes, and soil samples were retrieved from the exploratory holes at regular intervals for geotechnical and chemical analysis. Soils were logged by an on-site engineer.

An exploratory hole location plan is presented as Figure 3, overleaf.
