| Project | | | | PN 8443 BROOMCROFT HALL CONSERVATORY REPLACEMENT | | | |

| BROOMCROFT HALL GROUND FLOOR PLAN<br>SHOWING EXISTING CONSERVATORY<br>DRAINAGE | | | | | | | |
| 071AA-8443-A102 | | | | - | | | |

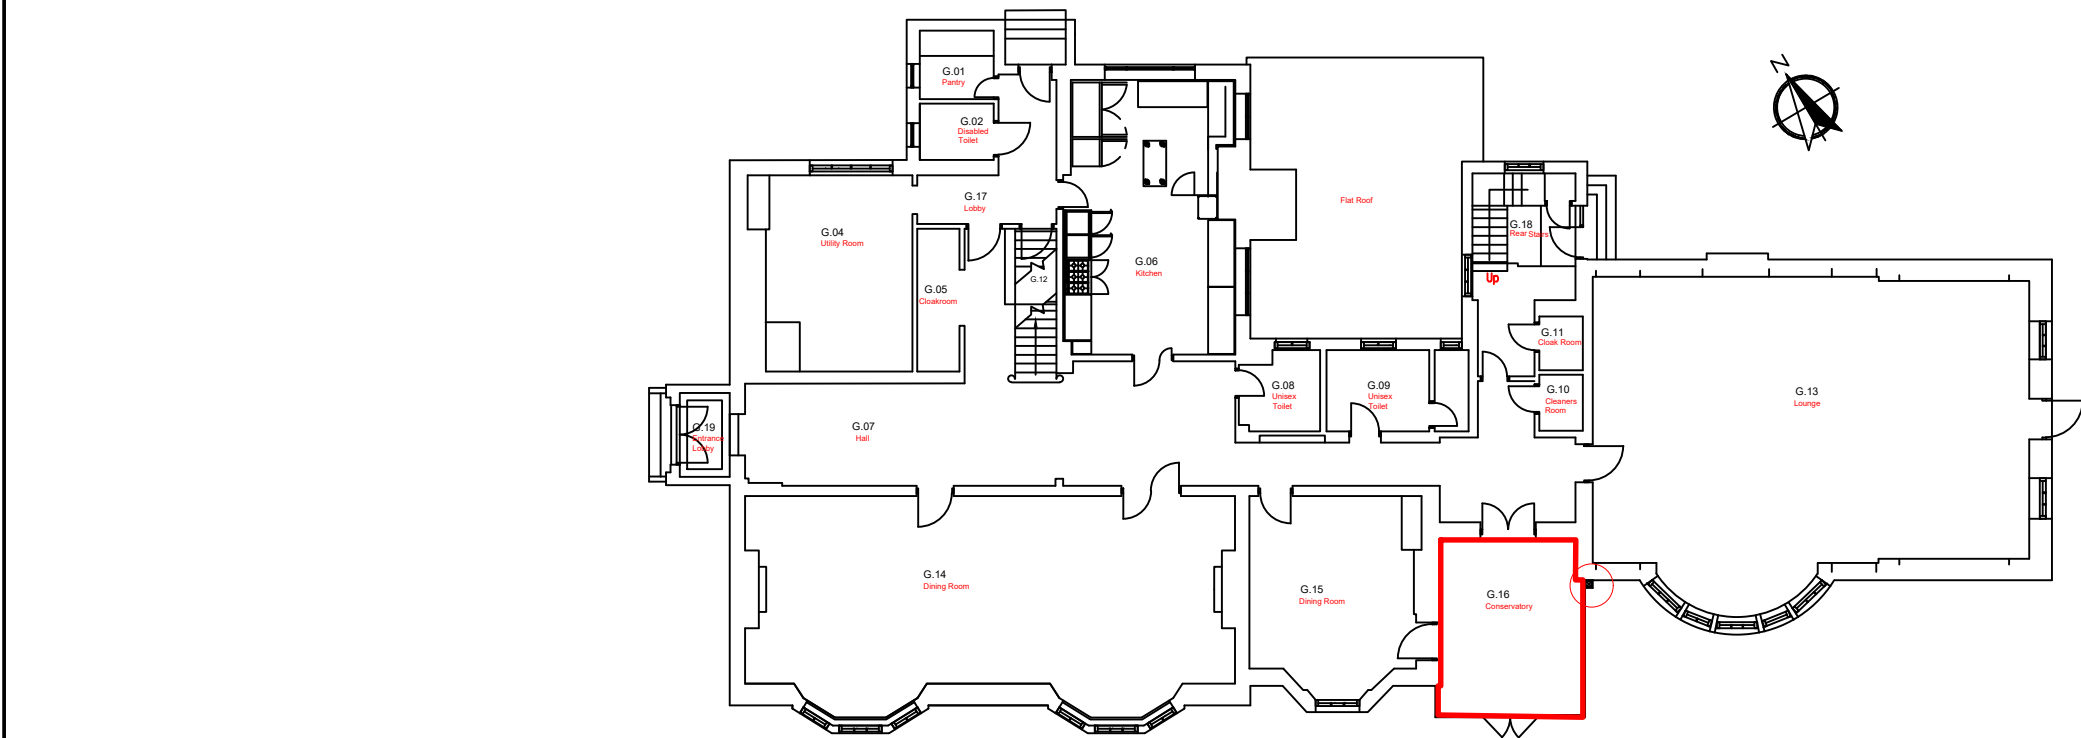
LOCATION OF EXISTING CONSERVATORY DRAINAGE

Showing location of rainwater outlet and downpipe for existing conservatory. New conservatory to use existing downpipe for drainage.
