# DESIGN, ACCESS & HERITAGE STATEMENT

**Project:** RBS Manchester St Ann Street - ATM replacement  
**Address:** 25 St Ann Street, Manchester, Greater Manchester, M2 7PW  
**Date:** 23 November 2022 – Revision B

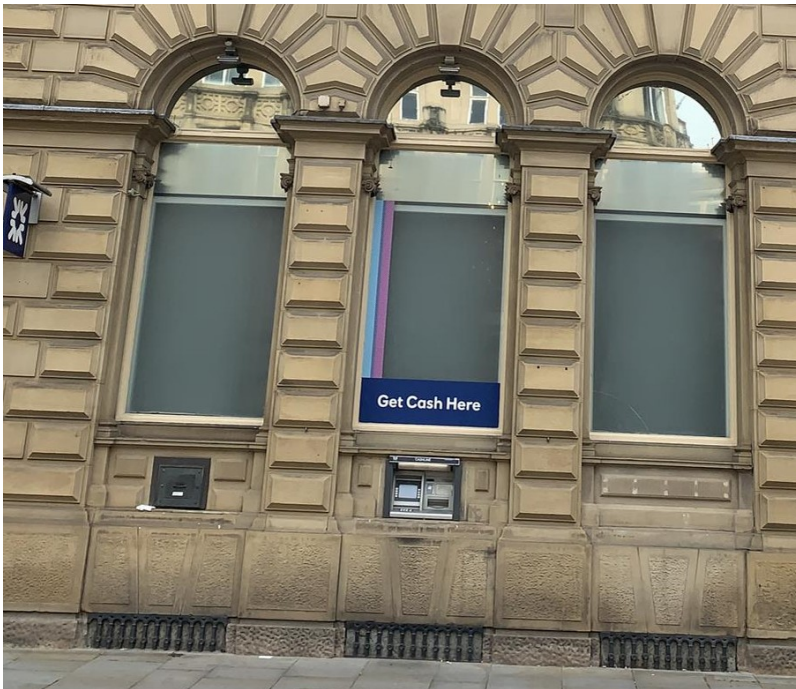
Photographs taken 10 August 2020 of St Ann's Square

More recently, two external automated teller machines (ATMs) have been installed into the external stonework. With larger replacements installed in 1980 & 1987. There is currently one external ATM and night safe on the St Ann's Square elevation and one ATM on the St Ann Street elevation.

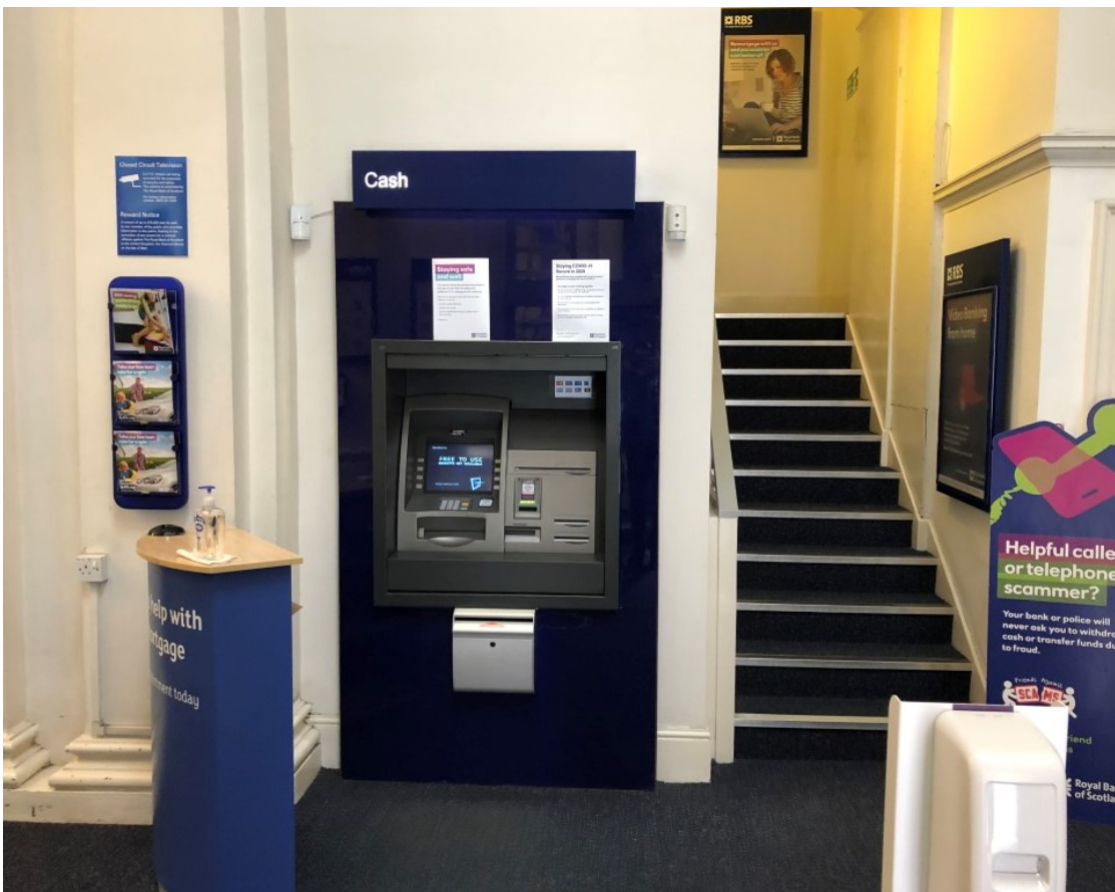
Photograph taken 10 August 2020 of the internal ATM for removal.

The removal of the internal ATM and all internal non-original fixtures, fittings and furniture will not affect any original internal walls or features.
