**Project Title** CSM - Whiteley Hall  
**Client** Chetham's School of Music  
**Location** Manchester

Drawing Title Proposed Coving Detail

9357 BA ZZ 1F DR A (27)002 P2

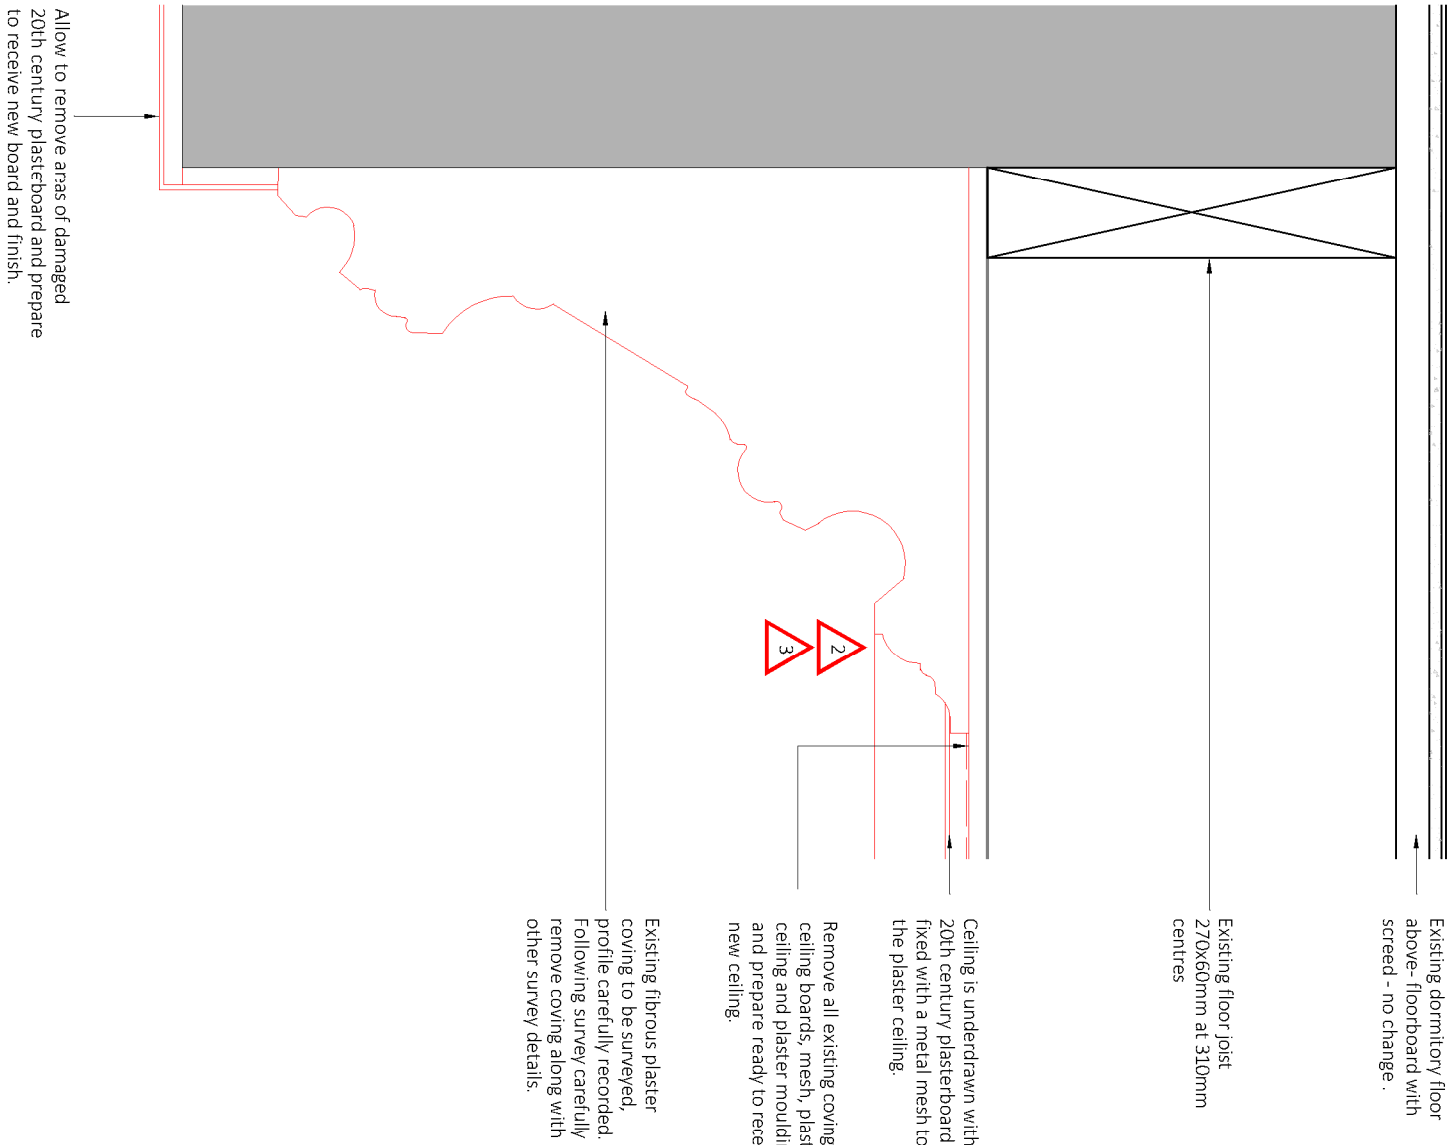
Existing Detail F - Coving Detail 1:5

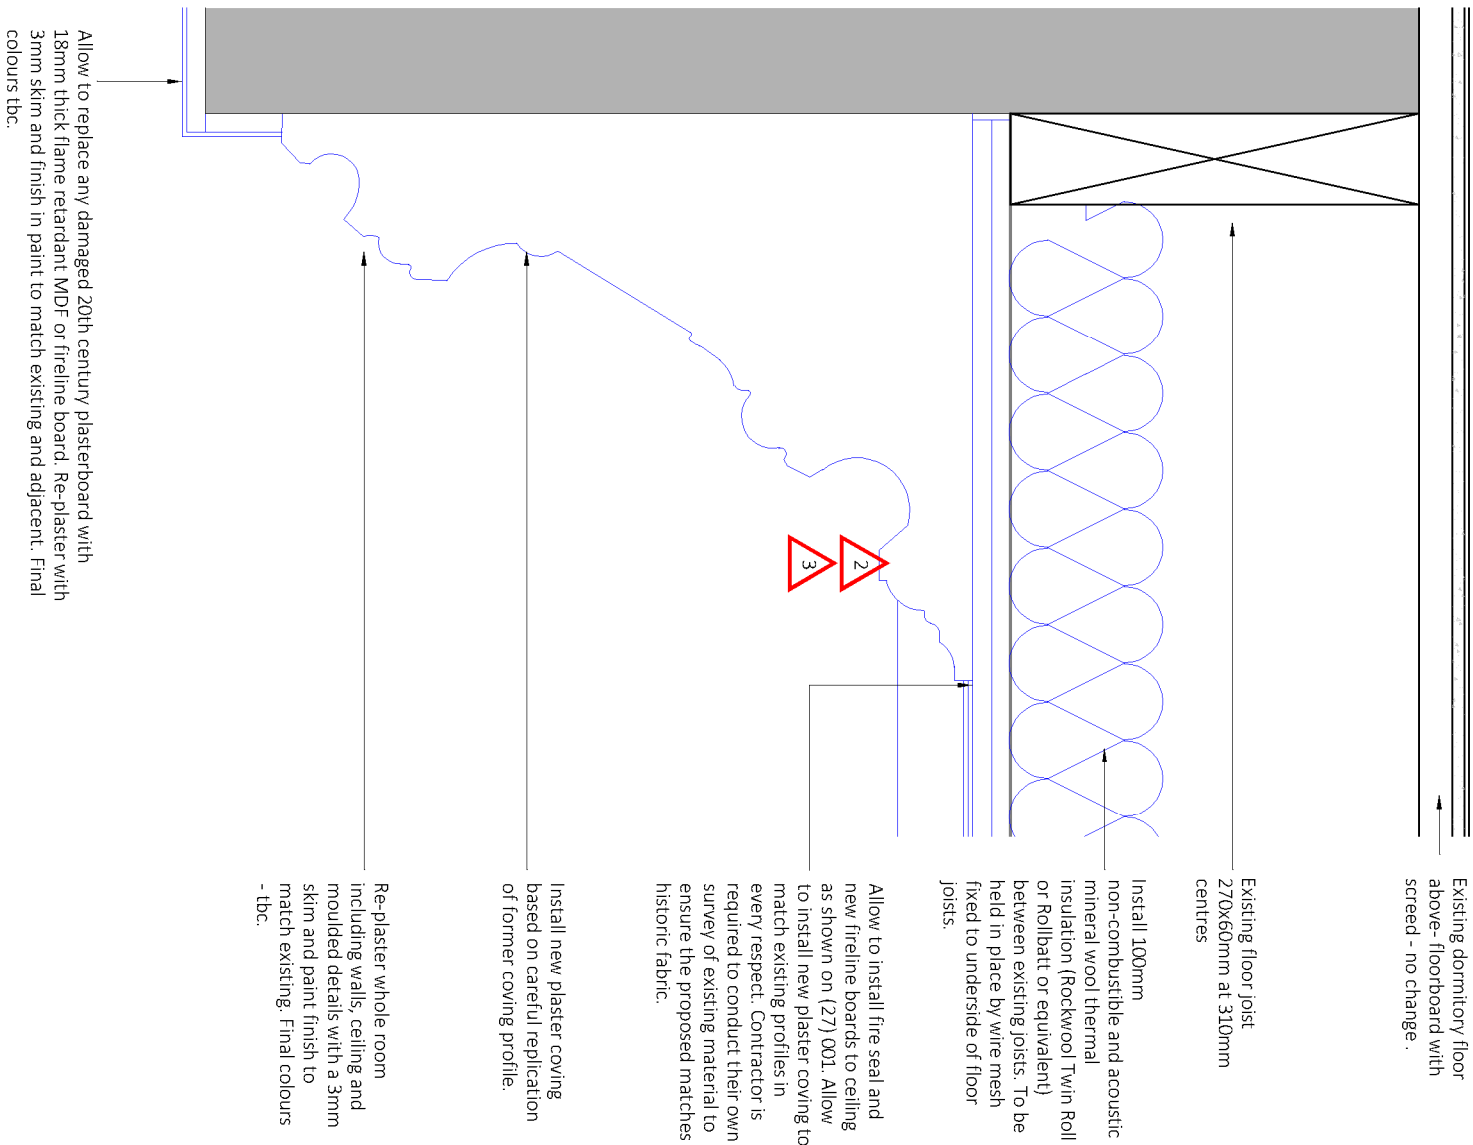
Proposed Detail F - Coving Detail 1:5

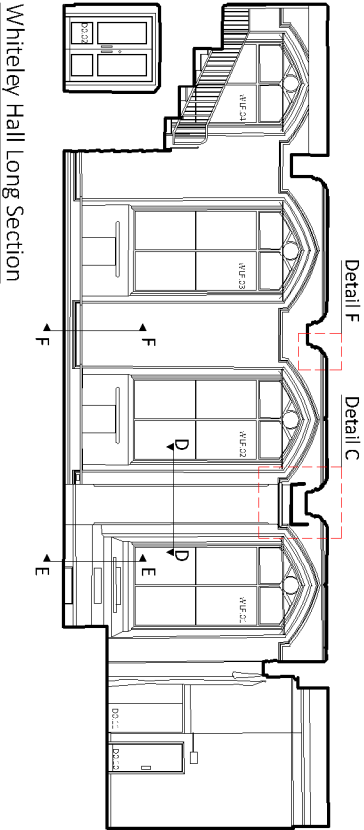
Location of details - Key:
