## **DESIGN AND ACCESS STATEMENT**

### Broomcroft Hall, Ford Lane, Didsbury, M20 2RU

PN 8443 PROPOSED REPLACEMENT OF CONSERVATORY AT BROOMCROFT HALL, FORD LANE, DIDSBURY, M20 2RU.

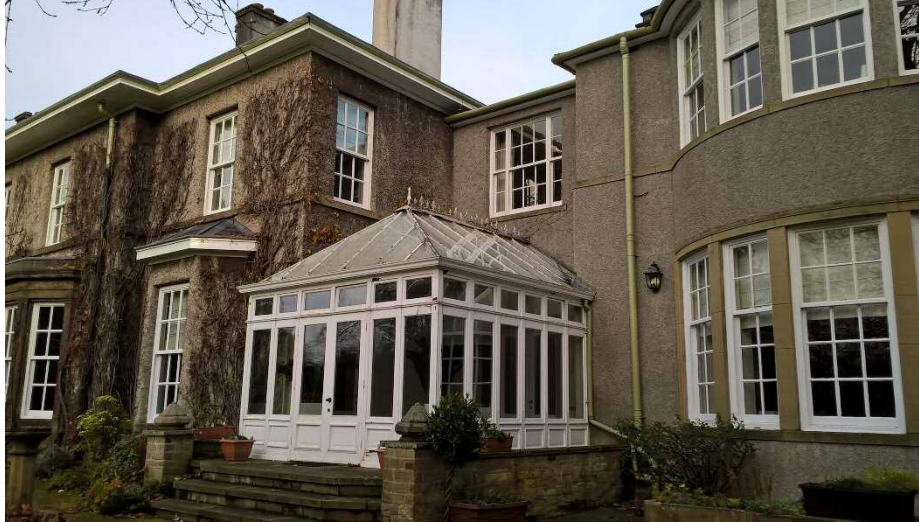
**Photo 1.** Existing conservatory.

2.1 Planning permission is sought to replace the timber frame conservatory on the south elevation of Broomcroft Hall, facing the gardens. (Photo 1 and Photo 2, Appendix 1) Substantial repair work has been carried out previously to the existing conservatory, but the timber frame is now rotten in numerous areas and the conservatory has reached the end of its serviceable life.

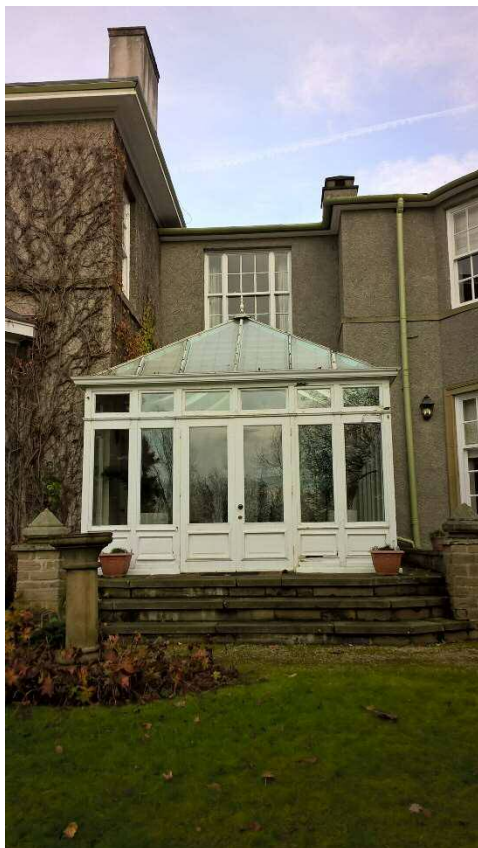
**Photo 2.** Existing conservatory.

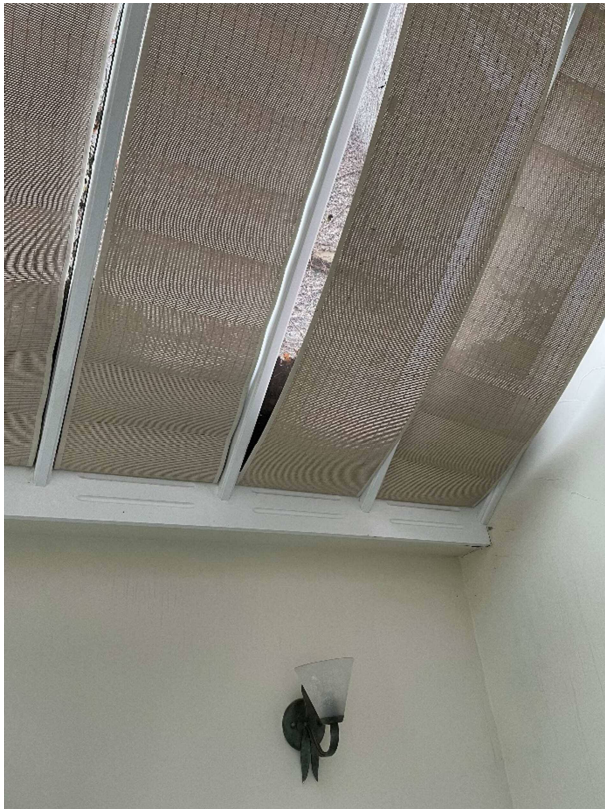
**Photo 3.** Internal photo showing build-up of leaves and debris in side gutter

The proposed roof arrangement will allow easy access for maintenance of the conservatory gutters. With the existing conservatory safe access to the side gutter is difficult, causing the gutter to become heavily blocked with leaves and debris. (Photo 3)

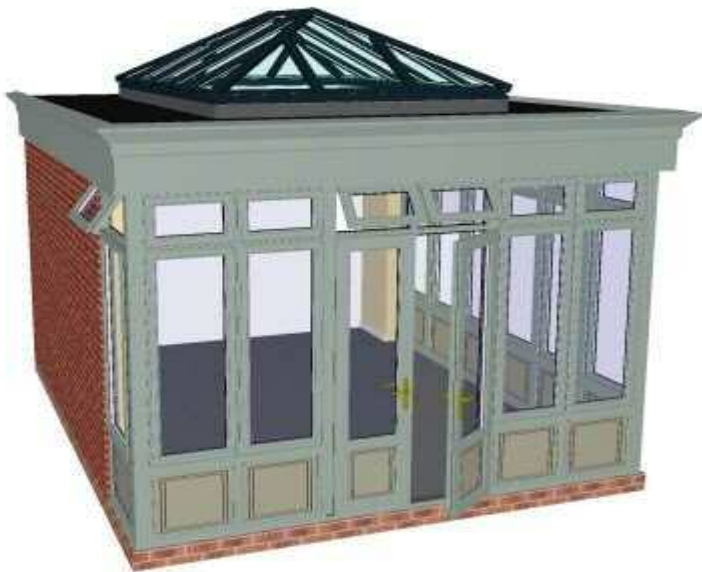
**Image 4.** Image showing arrangement of proposed replacement conservatory.

2.2 The proposed replacement conservatory will have the same footprint as the existing conservatory. The new frame will be constructed from Accoya timber so will match the existing timber frame. The arrangement of the window fixed lights, opening lights and the doors will match the existing. (Images 4 and 5)

The roof of the existing conservatory is double glazed units with timber frame and aluminium cappings, forming a pitched roof with a decorative cresting. The roof of the proposed conservatory will incorporate a perimeter flat roof detail with an EPDM membrane covering, and a central lantern feature formed from double glazed units and timber frame with aluminium cappings. (Images 4 and 5)

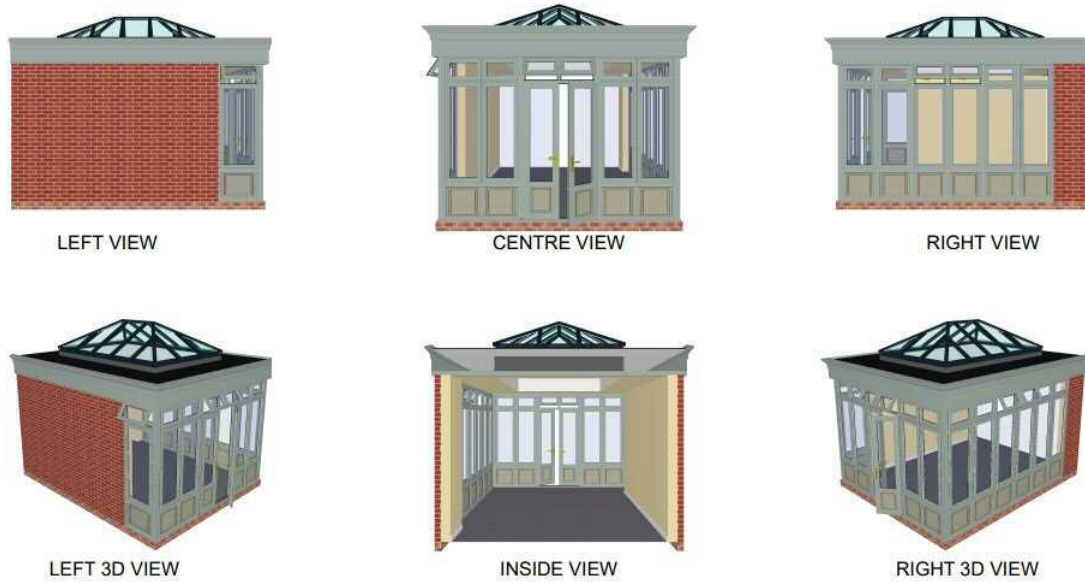
**Image 5.** Images showing proposed conservatory
