Client  
MANCHESTER CITY COUNCIL

Project Title  
CHORLTON LIBRARY

Drawing Title  
PROPOSED REMEDIAL WORKS TO  
CONCRETE DOME

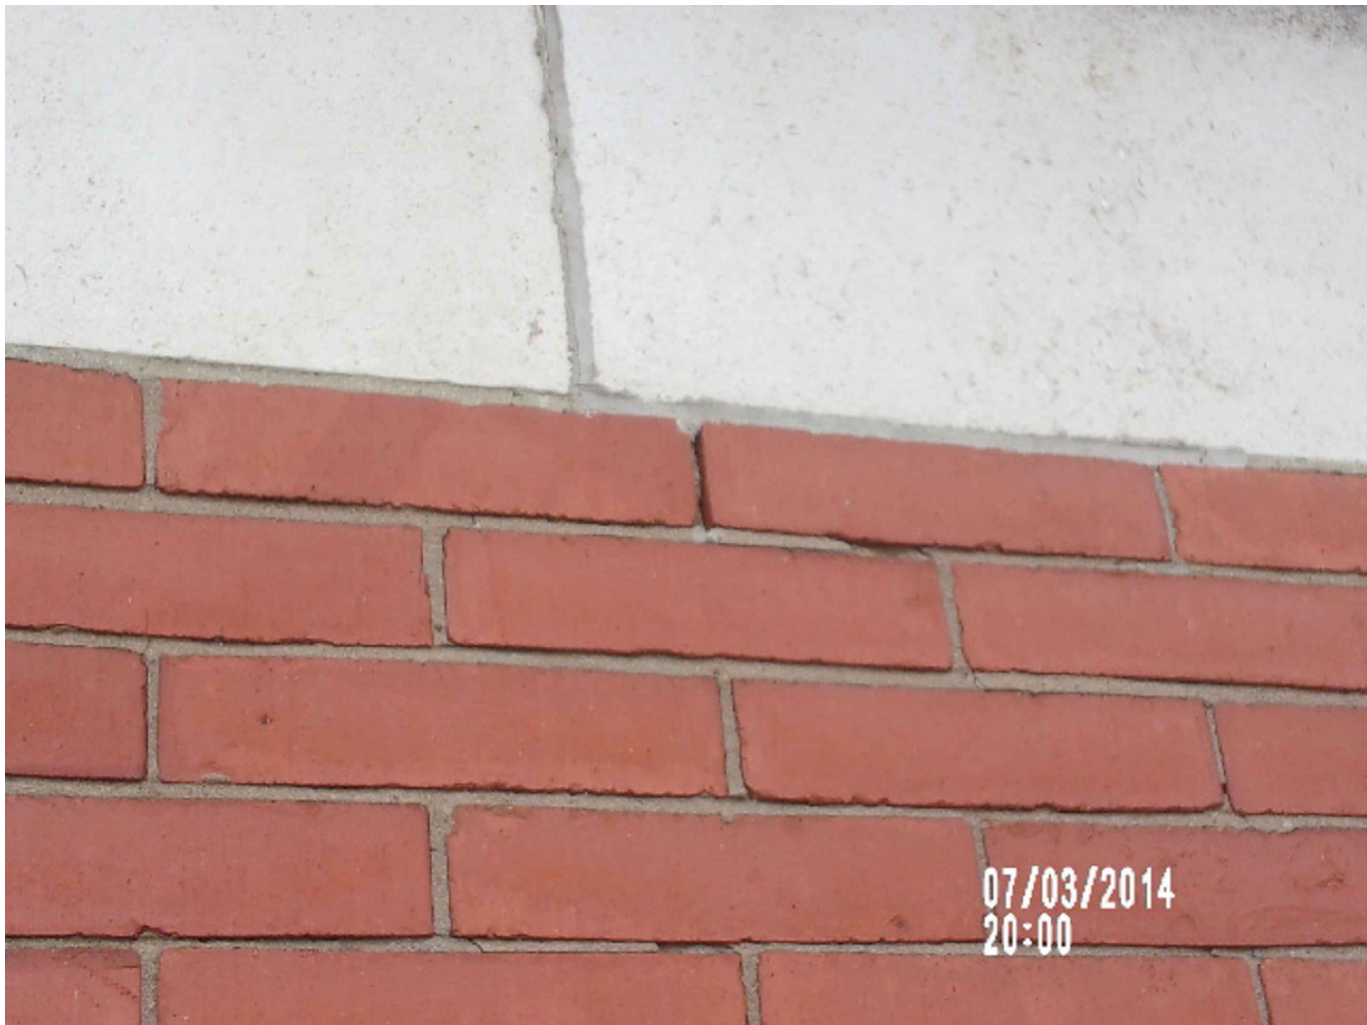
REPOINTING OF BRICKWORK REQUIRED  
(NTS)

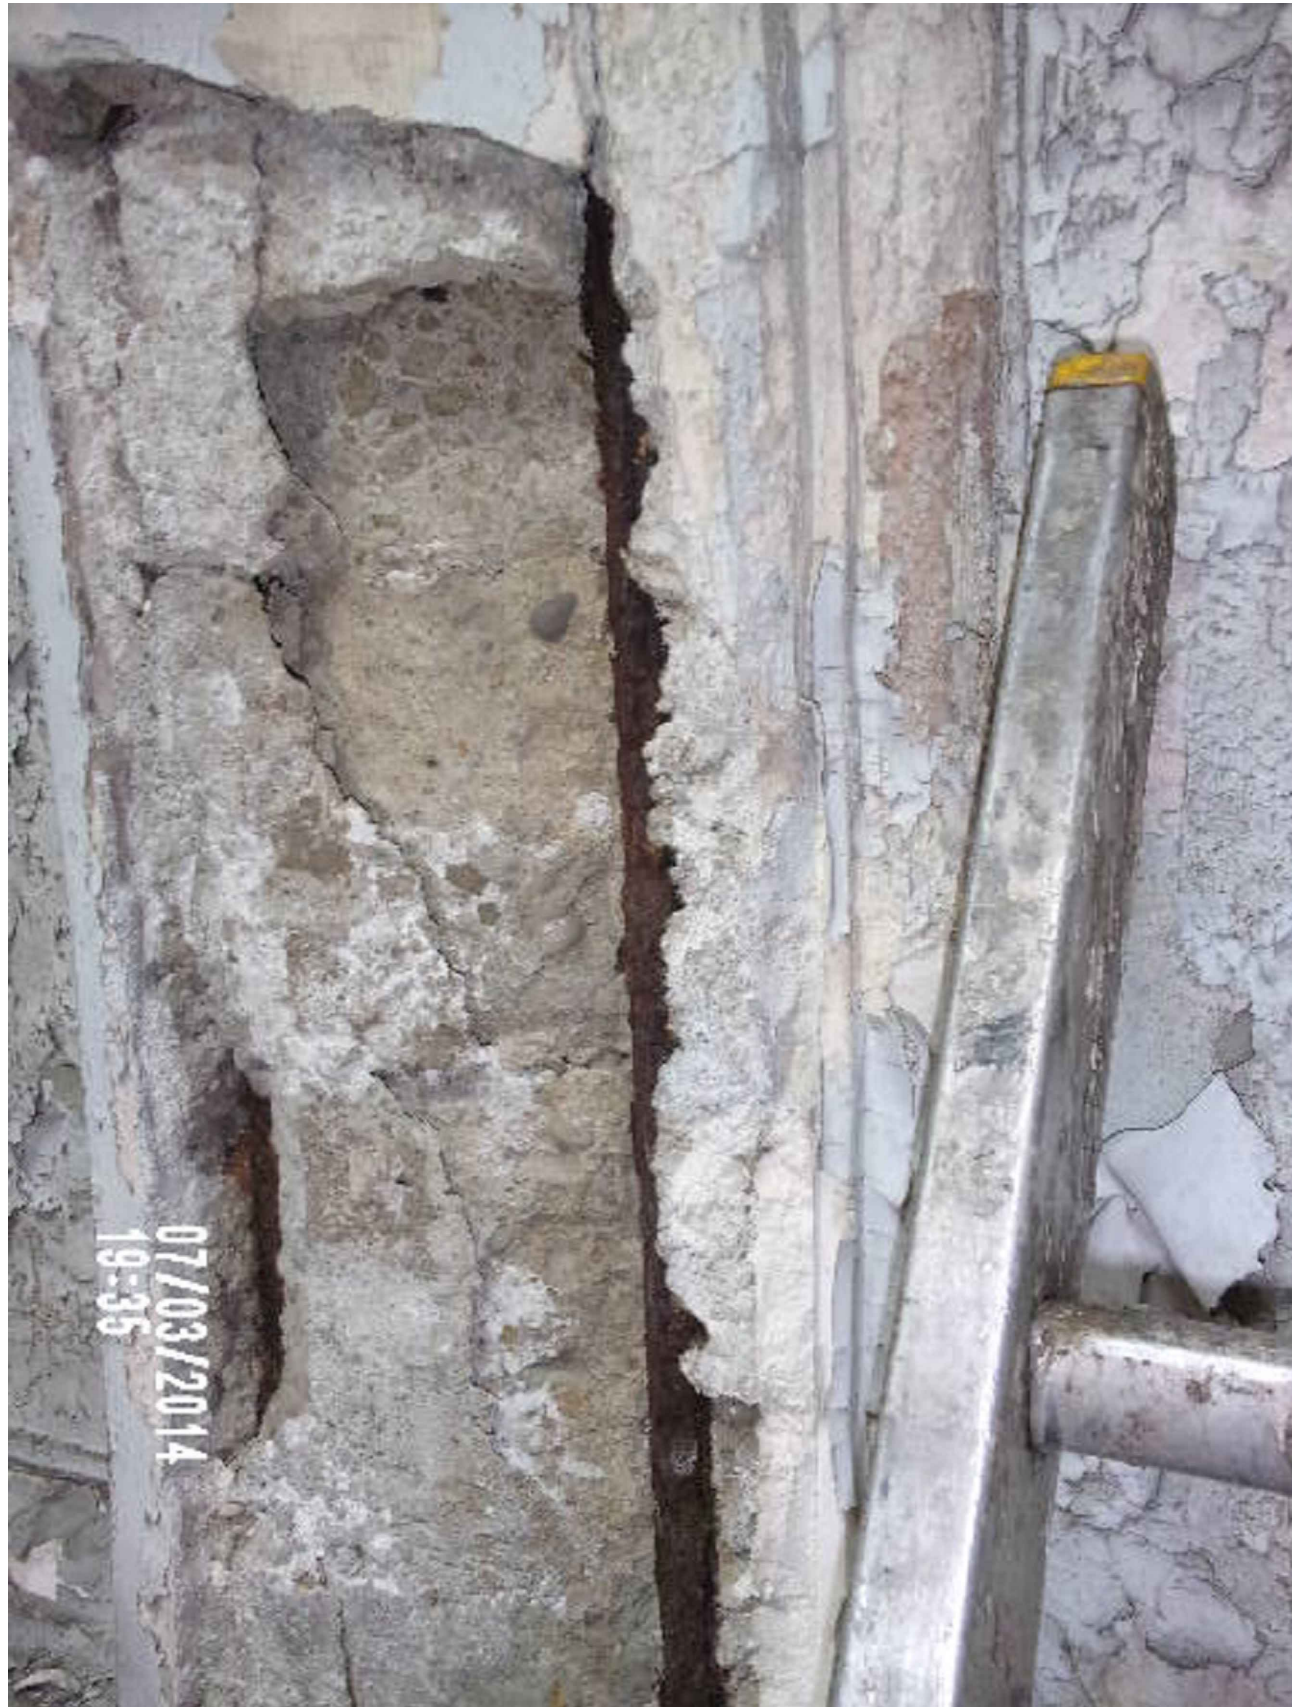
DAMAGED CONCRETE PHOTO  
(NTS)

1. BREAK OFF ALL CRACKED CONCRETE AND CHASE BACK BEYOND BY 20mm TO EXPOSED STEEL.
2. NEEDLE GUN EXPOSED REINFORCEMENT.
3. PRIME WITH NITOPRIME ZINC-RICH PRIMER OR SIMILAR APPROVED BY ENGINEER.
4. BUILD UP CONCRETE SECTION WITH FIVE STAR NON-SHRINK REPAIR OR SIMILAR APPROVED BY ENGINEER.

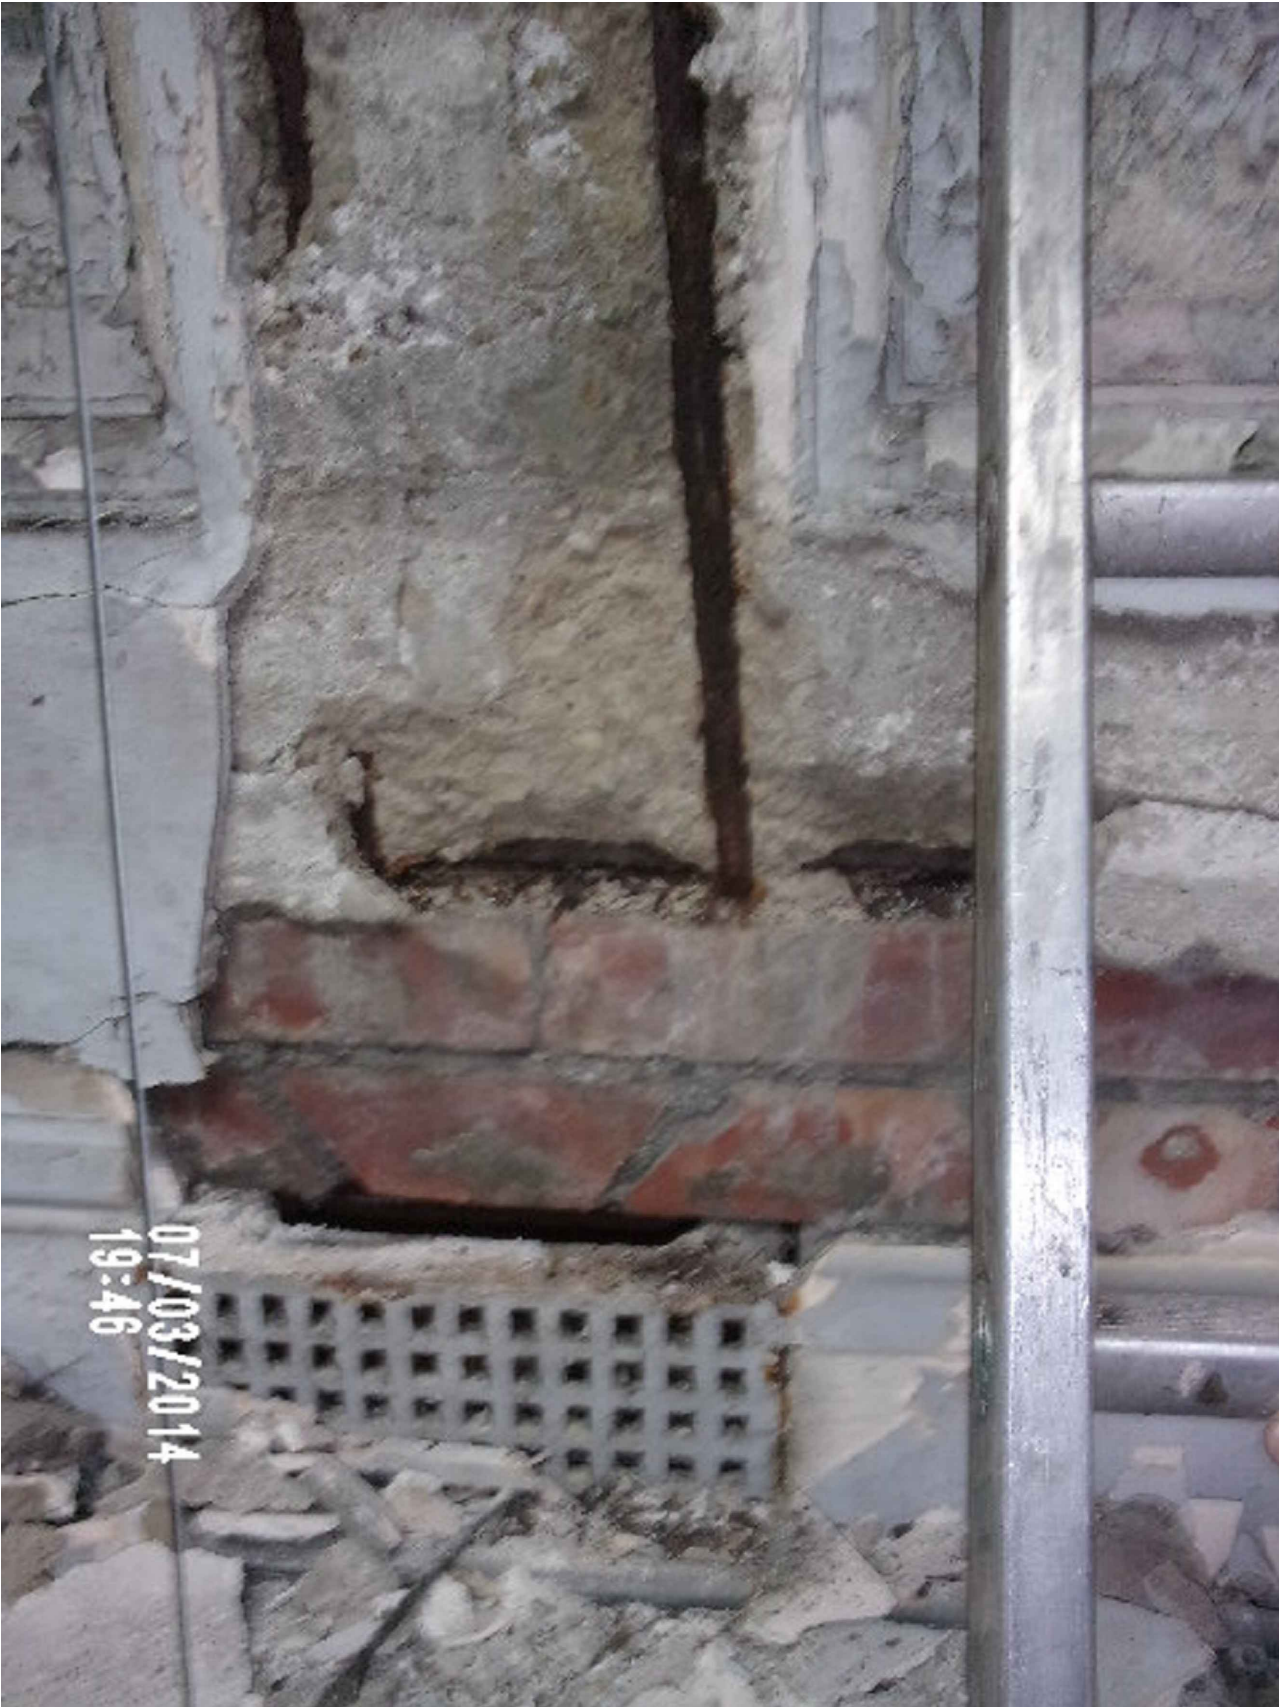
DAMAGED CONCRETE PHOTO  
(NTS)
