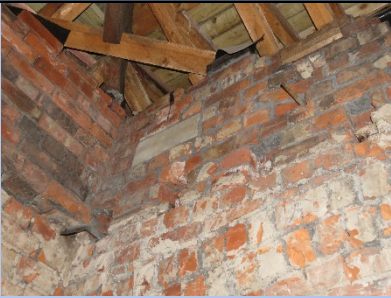
| Room Ref. | Element | Description / Item | Condition | Action | Photographs | | | |
|---|---|---|---|---|---|---|--|---|
| S02 | Walls | Holes to red brick walls. Misc. screws and M&E fixings. | Fair | <ul style="list-style-type: none"> <li>Fix salvaged red brick to holes.</li> <li>Remove all screws and fixings from walls.</li> </ul> <hr/> Proposed works <ul style="list-style-type: none"> <li>Existing walls to be stripped back to masonry, and all loose material removed.</li> </ul> | | | | 010 |

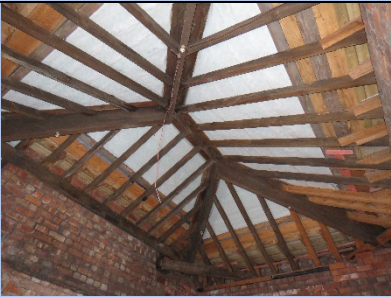
| Room Ref. | Element | Description / Item | Condition | Action | Photographs | | | |
|---|---|---|---|---|---|---|--|---|
| | Ceiling | Exposed timber roof structure. | Good | <ul style="list-style-type: none"> <li>Remove redundant fixings and clean roof truss.</li> </ul> <hr/> Proposed works <ul style="list-style-type: none"> <li>All existing ceilings to be removed</li> <li>Provide new insulated plasterboard ceiling below rafters (to be read in conjunction with roof type drawing 3501)</li> <li>Prepare and decorate existing trusses (colour tbc by architect).</li> </ul> | | | | |

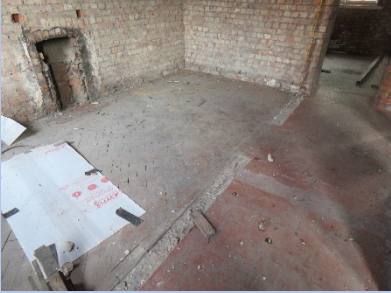
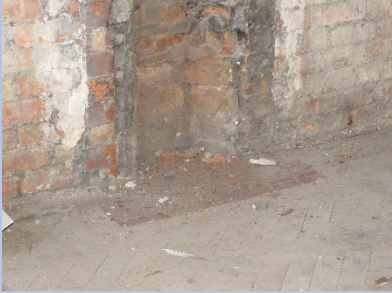
| Room Ref. | Element | Description / Item | Condition | Action | Photographs | | | |
|---|---|---|---|---|---|---|--|---|
| | Floor | Red quarry tile, wood block and glazed tile to hearth. | Good / fair | <ul style="list-style-type: none"> <li>Clean red quarry tile and protect.</li> <li>Record quantity of wood block, lift and store on pallet in room.</li> <li>Carefully remove glazed tile and store in box on pallet in room.</li> <li>Remove all debris.</li> </ul> <hr/> Proposed works <ul style="list-style-type: none"> <li>Floor to be levelled and prepared throughout with latex levelling screed or similar NBS:M10/120.</li> </ul> | | | | |

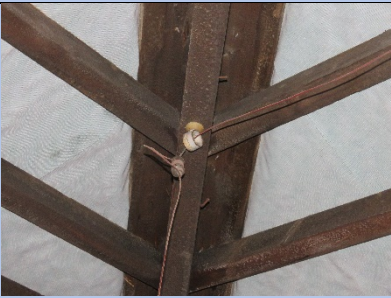
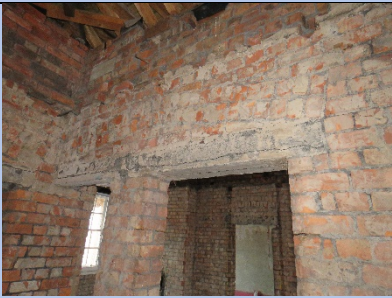
| Room Ref. | Element | Description / Item | Condition | Action | Photographs | | | |
|---|---|---|---|---|---|---|--|---|
| | Misc. | Failed concrete lintels. Conduit to walls. Misc. fixing and cable to roof truss. | | <ul style="list-style-type: none"> <li>CURTINS COMMENT: Doorways are proposed to be infilled. We recommend infilling in load bearing masonry to avoid repairs to two suspect lintels.</li> <li>Remove redundant conduit.</li> <li>Retain misc. fixing and cable to roof truss.</li> <li>Clean fire place.</li> </ul> | | | | |

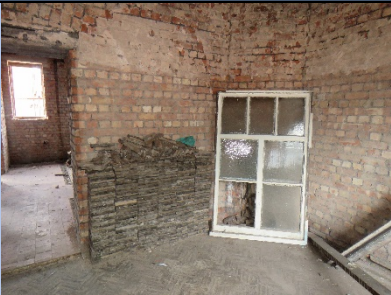
| Room Ref. | Element | Description / Item | Condition | Action | Photographs | | | |
|---|---|---|---|---|---|---|--|---|
| S11 | Walls | Holes to red brick walls. Misc. screws and M&E fixings. | Fair | <ul style="list-style-type: none"> <li>Fix salvaged red brick to holes.</li> <li>Remove all screws and fixings from walls.</li> </ul> <hr/> Proposed works <ul style="list-style-type: none"> <li>Existing walls to be stripped back to masonry, and all loose material removed.</li> </ul> | | | | 010 |

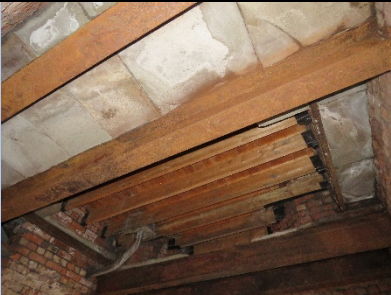
| Room Ref. | Element | Description / Item | Condition | Action | Photographs | | | |
|---|---|---|---|---|---|---|--|---|
| | Ceiling | Exposed timber and steel structure with stone slabs. | Good | <ul style="list-style-type: none"> <li>De-rust all beams ready for re-decoration.</li> </ul> <hr/> Proposed works <ul style="list-style-type: none"> <li>All existing ceilings to be removed</li> <li>Steel beams to be de-rusted and treated with intumescent paint NBS:M61/120.</li> <li>Provide new suspended plasterboard ceiling consisting of MF grid with 2 layers fireboard and skim in preparation for decoration.</li> </ul> <i>Provisional to pricing purposes – further inspection required.</i> | | | | |

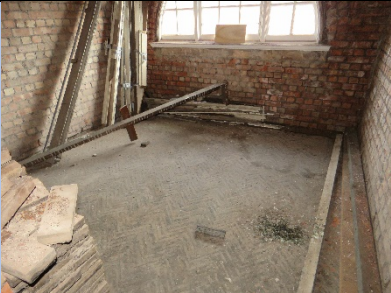
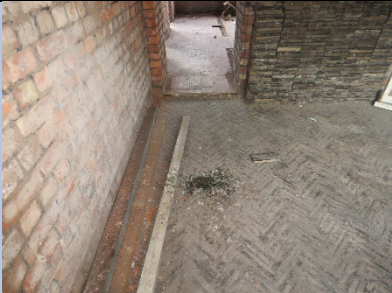
| Room Ref. | Element | Description / Item | Condition | Action | Photographs | | | |
|---|---|---|---|---|---|---|--|---|
| | Floor | Wood block already lifted. | Good / fair | <ul style="list-style-type: none"> <li>Record quantity of wood block and store on pallet in room.</li> <li>Remove all debris and pigeon guano.</li> </ul> <hr/> Proposed works <ul style="list-style-type: none"> <li>Floor to be levelled and prepared throughout with latex levelling screed or similar NBS:M10/120.</li> </ul> | | | | |

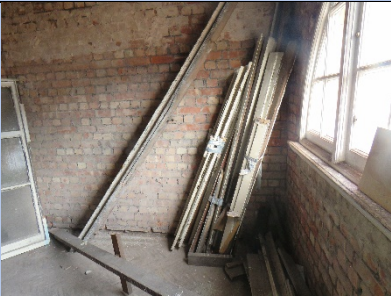
| Room Ref. | Element | Description / Item | Condition | Action | Photographs | | | |
|---|---|---|---|---|---|---|--|---|
| | Joinery | Window and pile of joinery piled in room. | | Proposed work <ul style="list-style-type: none"> <li>Loose window to be set aside for reuse</li> <li>Misc joinery to be reused where possible, otherwise, scrapped.</li> </ul> | | | | |

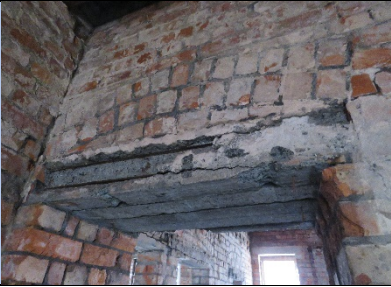
| Room Ref. | Element | Description / Item | Condition | Action | Photographs | | | |
|---|---|---|---|---|---|---|--|---|
| | Misc. | Failed concrete lintels. Conduit to walls. Misc. fixing and cable to roof truss. | | <ul style="list-style-type: none"> <li>CURTINS COMMENT: Patch repair lintel with patch repair mortar e.g. Sika monotop615. Repoint cracked mortar joints (lintel expansion rust jacking).</li> <li>Remove redundant conduit (and fill holes)</li> <li>Retain misc. fixing and cable to roof truss (fill holes).</li> </ul> | | | | |

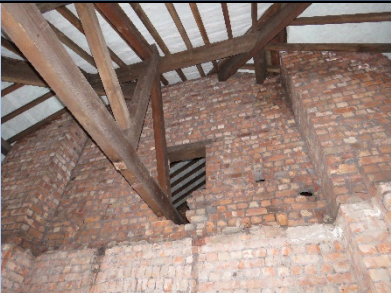
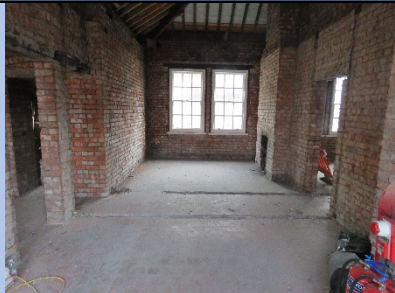
| Room Ref. | Element | Description / Item | Condition | Action | Photographs | | | |
|---|---|---|---|---|---|---|---|---|
| 313a, 313B, 313G | Walls | Holes to red brick walls. Misc. screws and M&E fixings. | Fair | <ul style="list-style-type: none"> <li>Fix salvaged red brick to holes.</li> <li>Remove all screws and fixings from walls.</li> </ul> <hr/> Proposed works <ul style="list-style-type: none"> <li>Strip all walls back to masonry</li> <li>Provide insulated plasterboard (refer to wall type drawing) and secondary glazing (NBS:L10/580A) to east wall (LR).</li> <li>Provide stud partitions to form internal bathroom (313B) and Lobby (313g) as per drawing 2418.</li> <li>Provide acoustic plaster board to north and south party wall of 313a as per drawing 2418.</li> <li>North (party) wall of Lobby 313g to remain as bare masonry.</li> </ul> | | | | 001 |

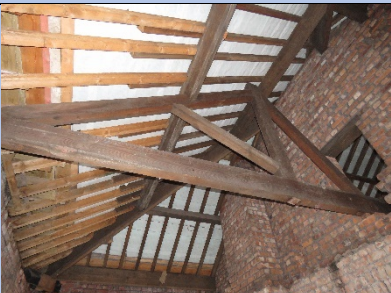
| Room Ref. | Element | Description / Item | Condition | Action | Photographs | | | |
|---|---|---|---|---|---|---|---|---|
| | Ceiling | Exposed timber roof structure. | Good | <ul style="list-style-type: none"> <li>Remove redundant fixings and clean roof truss.</li> </ul> <hr/> Proposed works <ul style="list-style-type: none"> <li>All existing ceilings to be removed</li> <li>Provide new insulated plasterboard ceiling below rafters (to be read in conjunction with roof type drawing 3501)</li> <li>Prepare and decorate existing trusses (colour tbc by architect)</li> </ul> | | | | |

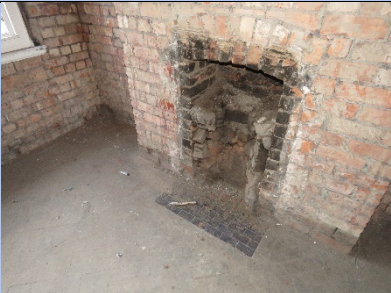
| Room Ref. | Element | Description / Item | Condition | Action | Photographs | | | |
|---|---|---|---|---|---|---|---|---|
| | Floor | Red quarry tile, wood block and glazed tile to hearth. | Good / fair | <ul style="list-style-type: none"> <li>Clean red quarry tile and protect.</li> <li>Record quantity of wood block, lift and store on pallet in room.</li> <li>Remove all debris.</li> </ul> <hr/> Proposed works <ul style="list-style-type: none"> <li>Floor to be levelled and prepared throughout with latex levelling screed or similar NBS:M10/120.</li> </ul> | | | | |

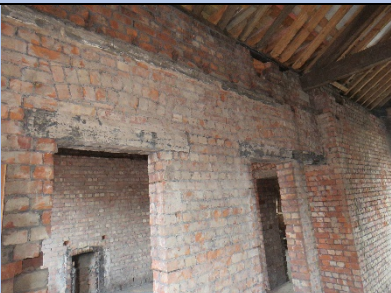
| Room Ref. | Element | Description / Item | Condition | Action | Photographs | | | |
|---|---|---|---|---|---|---|---|---|
| | Misc. | Failed concrete lintels. Conduit to walls. Misc. fixing and cable to roof truss. | | <ul style="list-style-type: none"> <li>CURTINS COMMENT: Walls proposed to be infilled. Partition infill should be load bearing masonry to support wall over.</li> <li>ALLIED COMMENT: Quadriga to confirm with Curtins if existing lintel is to be removed and replaced with the brickwork or to remain in place.</li> <li>Remove redundant conduit (and fill holes).</li> <li>Retain misc. fixing and cable to roof truss (check with Project Manager if this item should instead be removed).</li> </ul> | | | | |

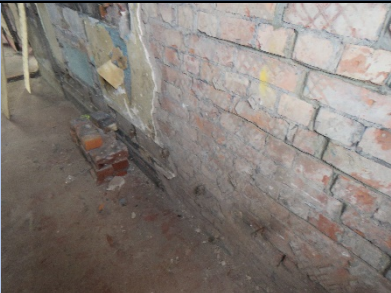
| Room Ref. | Element | Description / Item | Condition | Action | Photographs | | | |
|---|---|---|---|---|---|---|--|---|
| 315a, 315b | Walls | Plaster on brickwork with paint and wallpaper finish.<br>Minor no. of nails to walls. | Fair | <ul style="list-style-type: none"> <li>Remove redundant fixings.</li> </ul> <hr/> Proposed works <ul style="list-style-type: none"> <li>Strip all walls back to masonry</li> <li>Provide insulated plasterboard (refer to wall type drawing) and secondary glazing (NBS:L10/580A) to east wall (LR).</li> <li>Provide stud partitions to form internal bathroom (315B) as per drawing 2418.</li> <li>Provide acoustic plaster board to south party wall of 315a as per drawing 2418.</li> <li>North (party) wall to remain as bare masonry.</li> </ul> | | | | 00<br>1 |

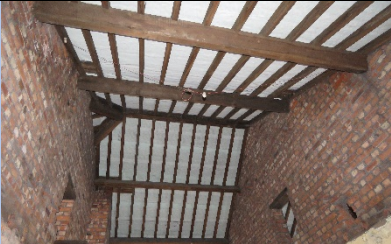
| Room Ref. | Element | Description / Item | Condition | Action | Photographs | | | |
|---|---|---|---|---|---|---|--|---|
| | Ceiling | Exposed timber roof structure. | Good | <ul style="list-style-type: none"> <li>Remove redundant fixings and clean roof truss.</li> </ul> <hr/> Proposed works <ul style="list-style-type: none"> <li>All existing ceilings to be removed</li> <li>Provide new insulated plasterboard ceiling below rafters (to be read in conjunction with roof type drawing 3501)</li> <li>Prepare and decorate existing trusses (colour tbc by architect)</li> </ul> | | | | |

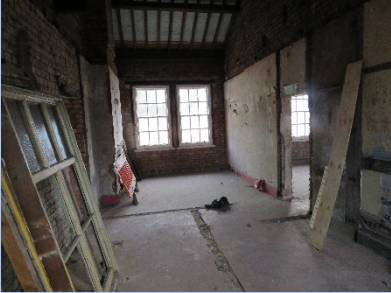
| Room Ref. | Element | Description / Item | Condition | Action | Photographs | | | |
|---|---|---|---|---|---|---|--|---|
| | Floor | Red quarry tile, wood block and glazed tile to hearth. | Good / fair | <ul style="list-style-type: none"> <li>Clean red quarry tile and protect.</li> <li>Record quantity of wood block, lift and store on pallet in room.</li> <li>Remove all debris.</li> </ul> <hr/> Proposed works <ul style="list-style-type: none"> <li>Floor to be levelled and prepared throughout with latex levelling screed or similar NBS:M10/120.</li> </ul> | | | | |

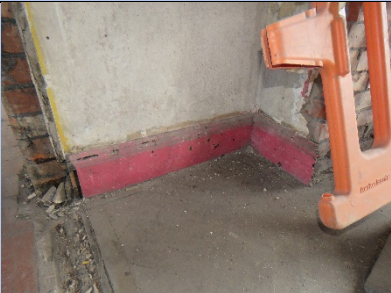
| Room Ref. | Element | Description / Item | Condition | Action | Photographs | | | |
|---|---|---|---|---|---|---|--|---|
| | Joinery | Minor area of skirting in-situ.<br>Window and pile of joinery piled in room. | | Proposed works <ul style="list-style-type: none"> <li>Reinstate skirting boards to new plastered walls, leave masonry walls bare.</li> <li>Standalone window to be set aside for reuse</li> <li>Misc. joinery to be reused where possible, otherwise scrapped.</li> </ul> | | | | |

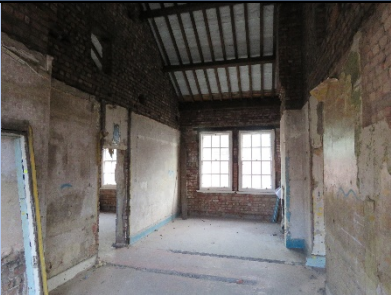
| Room Ref. | Element | Description / Item | Condition | Action | Photographs | | | | |
|---|---|---|---|---|---|---|--|--|---|
| 316a, 316b, 316c | Walls | Plaster on brickwork with paint and wallpaper finish.<br>Minor no. of nails to walls. | Fair | <ul style="list-style-type: none"> <li>Remove redundant fixings.</li> </ul> <hr/> Proposed works <ul style="list-style-type: none"> <li>Strip all walls back to masonry</li> <li>Provide insulated plasterboard (refer to wall type drawing) and secondary glazing (NBS:L10/580A) to east wall (LR).</li> <li>Provide stud partitions to form internal bathroom (316B) and lobby 316c as per drawing 2418.</li> <li>Provide acoustic plaster board to north party wall of 316a as per drawing 2418.</li> <li>South (party) wall to remain as bare masonry.</li> </ul> | | | | | 001 |

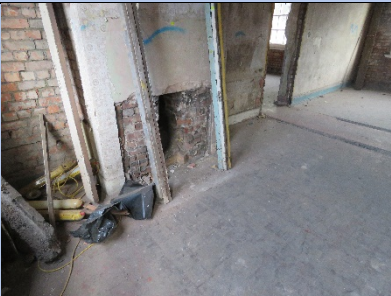
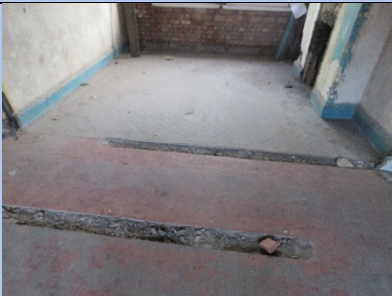
| Room Ref. | Element | Description / Item | Condition | Action | Photographs | | | | |
|---|---|---|---|---|---|---|--|--|---|
| | Floor | Red quarry tile, wood block and glazed tile to hearth. | Good / fair | <ul style="list-style-type: none"> <li>Clean red quarry tile and protect.</li> <li>Record quantity of wood block, lift and store on pallet in room.</li> <li>Remove all debris.</li> </ul> <hr/> Proposed works <ul style="list-style-type: none"> <li>Floor to be levelled and prepared throughout with latex levelling screed or similar NBS:M10/120.</li> </ul> | | | | | |

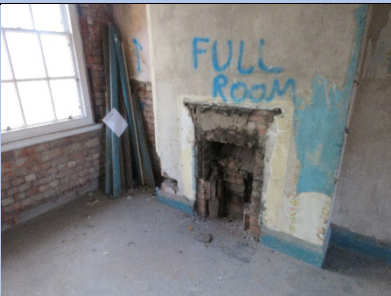
| Room Ref. | Element | Description / Item | Condition | Action | Photographs | | | | |
|---|---|---|---|---|---|---|--|--|---|
| | Joinery | Minor area of skirting in-situ.<br>Door frame and pile of joinery piled in room. | | Proposed works <ul style="list-style-type: none"> <li>Reinstate skirting boards/picture rails to new plastered walls, leave masonry walls bare.</li> <li>Doors and frames to be set aside for reuse</li> <li>Misc. joinery to be reused where possible, otherwise scrapped.</li> </ul> | | | | | |

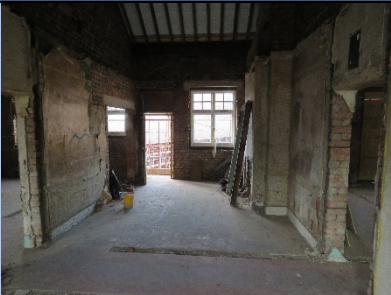
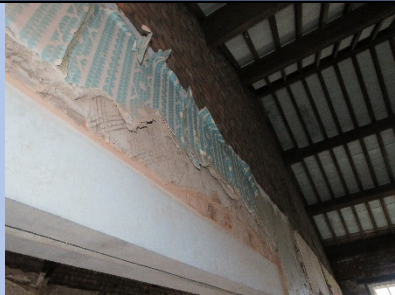
| Room Ref. | Element | Description / Item | Condition | Action | Photographs | | | |
|---|---|---|---|---|---|---|---|---|
| 318 | Walls | Plaster on brickwork with paint and wallpaper finish.<br>Minor no. of nails to walls. | Fair | <ul style="list-style-type: none"> <li>Remove redundant fixings.</li> </ul> <hr/> Proposed works <ul style="list-style-type: none"> <li>Strip all walls back to masonry</li> <li>Provide insulated plasterboard (refer to wall type drawing) and secondary glazing (NBS:L10/580A) to east wall (LR).</li> <li>Provide stud partitions to form internal bathroom as per drawing 2418.</li> <li>Provide acoustic plaster board to north &amp; west party walls, along with recesses in south party wall, all as per drawing 2418.</li> <li>South (party) wall chimney breasts to remain as bare masonry.</li> </ul> | | | | 00<br>1 |

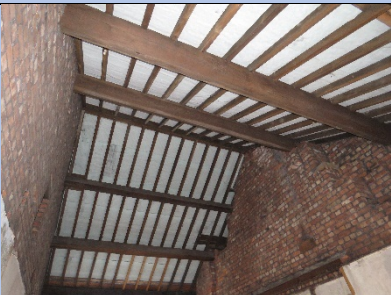
| Room Ref. | Element | Description / Item | Condition | Action | Photographs | | | |
|---|---|---|---|---|---|---|---|---|
| | Ceiling | Exposed timber roof structure. | Good | <ul style="list-style-type: none"> <li>Remove redundant fixings and clean roof truss.</li> </ul> <hr/> Proposed works <ul style="list-style-type: none"> <li>All existing ceilings to be removed</li> <li>Provide new insulated plasterboard ceiling below rafters (to be read in conjunction with roof type drawing 3501)</li> <li>Prepare and decorate existing trusses (colour tbc by architect).</li> </ul> | | | | |

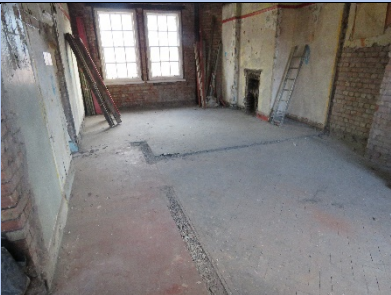
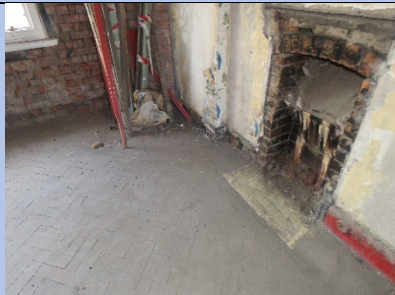
| Room Ref. | Element | Description / Item | Condition | Action | Photographs | | | |
|---|---|---|---|---|---|---|---|---|
| | Floor | Red quarry tile, wood block and glazed tile to hearth. | Good / fair | <ul style="list-style-type: none"> <li>Clean red quarry tile and protect.</li> <li>Record quantity of wood block, lift and store on pallet in room.</li> <li>Carefully remove glazed tile and store in box on pallet in room.</li> <li>Remove all debris.</li> </ul> <hr/> Proposed works <ul style="list-style-type: none"> <li>Floor to be levelled and prepared throughout with latex levelling screed or similar NBS:M10/120.</li> </ul> | | | | |

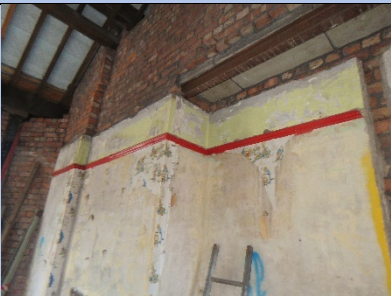
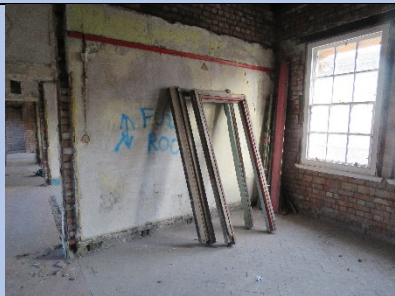
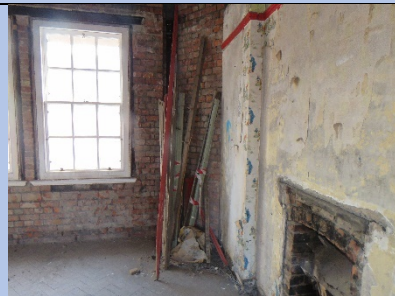
| Room Ref. | Element | Description / Item | Condition | Action | Photographs | | | |
|---|---|---|---|---|---|---|---|---|
| | Joinery | Minor area of skirting and picture rail in-situ.<br>Door frames and pile of joinery piled in room. | | Proposed works <ul style="list-style-type: none"> <li>Reinstate skirting boards/picture rails to new plastered walls, leave masonry walls bare.</li> <li>Doors and frames to be set aside for reuse</li> <li>Misc. joinery to be reused where possible, otherwise scrapped.</li> </ul> | | | | |

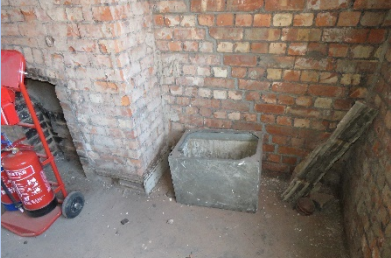
| Room Ref. | Element | Description / Item | Condition | Action | Photographs | | | |
|---|---|---|---|---|---|---|---|---|
| | Misc. | Misc. fixing and cable to roof truss.<br>Lead water tank stored in room. | | <ul style="list-style-type: none"> <li>Retain misc. fixing and cable to roof truss. (check with Project Manager as to whether these should instead be removed).</li> <li>Record lead tank and move to heritage store room.</li> <li>Remove all other waste.</li> </ul> | | | | |

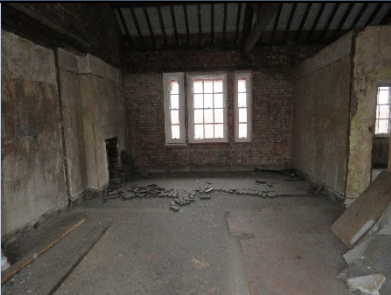
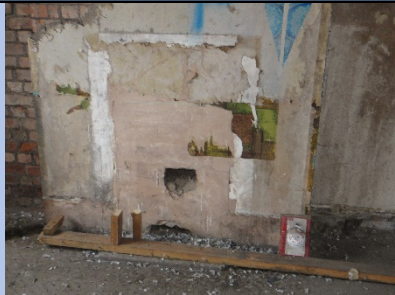
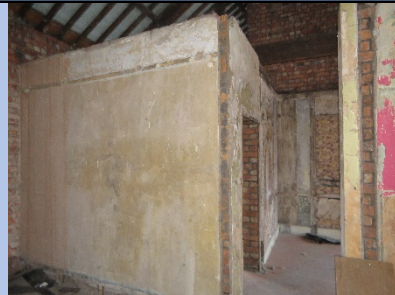
| Room Ref. | Element | Description / Item | Condition | Action | Photographs | | | |
|---|---|---|---|---|---|---|---|---|
| 320a, 320b | Walls | Plasterboard to fireplace.<br>Plaster on brickwork with paint and wallpaper finish.<br>Minor no. of nails and embedded timbers to walls. | Fair | <ul style="list-style-type: none"> <li>Remove plaster to fireplace.</li> <li>Remove redundant fixings and embedded timbers.</li> </ul> <hr/> Proposed works <ul style="list-style-type: none"> <li>Strip all walls back to masonry</li> <li>Provide insulated plasterboard (refer to wall type drawing) and secondary glazing (NBS:L10/580A) to east wall (LR).</li> <li>Provide stud partitions to form internal bathroom (320b) as per drawing 2416.</li> <li>Provide acoustic plaster board to south party wall &amp; west (corridor) party walls all as per drawing 2416.</li> <li>North (party) wall to remain as bare masonry.</li> </ul> | | | | 00<br>1 |

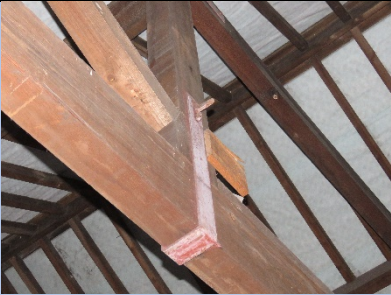
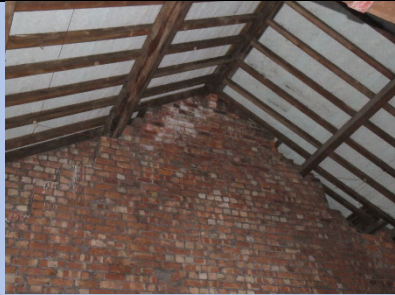
| Room Ref. | Element | Description / Item | Condition | Action | Photographs | | | |
|---|---|---|---|---|---|---|---|---|
| | Ceiling | Exposed timber roof structure. | Good | <ul style="list-style-type: none"> <li>Remove redundant fixings and timber fixed to truss.</li> <li>Clean roof truss.</li> </ul> <hr/> Proposed works <ul style="list-style-type: none"> <li>All existing ceilings to be removed</li> <li>Provide new insulated plasterboard ceiling below rafters (to be read in conjunction with roof type drawing 3501)</li> <li>Prepare and decorate existing trusses (colour tbc by architect).</li> </ul> | | | | |

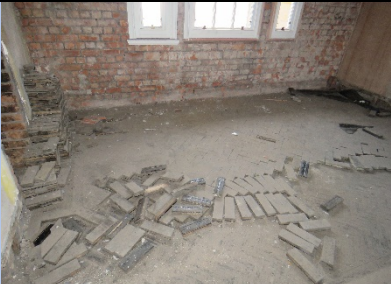
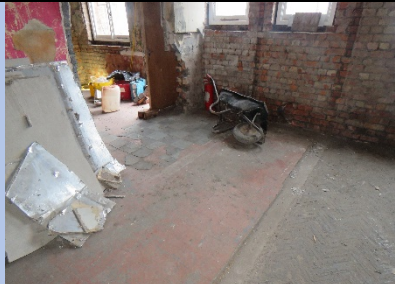
| Room Ref. | Element | Description / Item | Condition | Action | Photographs | | | |
|---|---|---|---|---|---|---|---|---|
| | Floor | Red quarry tile, wood block and glazed tile to hearth.<br>Small area of vinyl tile over red quarry tile. | Good / fair | <ul style="list-style-type: none"> <li>Remove vinyl and adhesive.</li> <li>Clean red quarry tile and protect.</li> <li>Record quantity of wood block, lift and store on pallet in room.</li> <li>Remove all debris.</li> </ul> <hr/> Proposed works <ul style="list-style-type: none"> <li>Floor to be levelled and prepared throughout with latex levelling screed or similar NBS:M10/120.</li> </ul> | | | | |

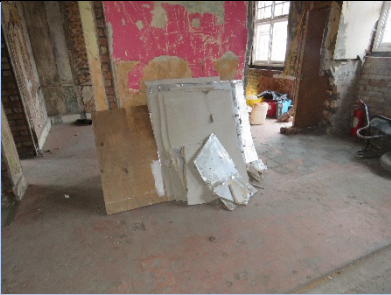
| Room Ref. | Element | Description / Item | Condition | Action | Photographs | | | |
|---|---|---|---|---|---|---|---|---|
| | Misc. | Misc. fixing and cable to roof truss.<br>Section of plaster cornice.<br>Pile of waste plasterboard in room. | | <ul style="list-style-type: none"> <li>Retain misc. fixing and cable to roof truss (check with Project Manager as to whether these should instead be removed).</li> <li>Retain plaster cornice.</li> <li>Remove all other waste.</li> </ul> | | | | |

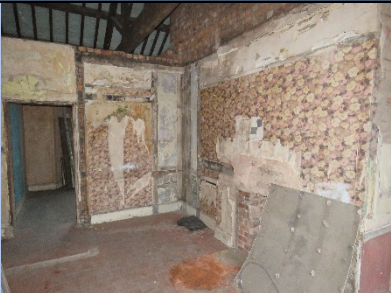
| Room Ref. | Element | Description / Item | Condition | Action | Photographs | | | |
|---|---|---|---|---|---|---|---|---|
| 323a, 323b, 323c | Walls | Plasterboard to fireplace. Plaster on brickwork with wallpaper finish. Minor no. of nails and embedded timbers to walls. | Fair | <ul style="list-style-type: none"> <li>Remove redundant fixings and embedded timbers (and fill holes)</li> </ul> <hr/> Proposed works <ul style="list-style-type: none"> <li>Strip all walls back to masonry</li> <li>Provide insulated plasterboard (refer to wall type drawing) and secondary glazing (NBS:L10/580A) to east wall of 323a (LR).</li> <li>Provide stud partitions to form internal bathroom (323b) and lobby (232c) as per drawing 2416.</li> <li>Provide acoustic plaster board to south party wall (323a) as per drawing 2416.</li> <li>North (party) wall to remain as bare masonry.</li> </ul> | | | | 001 |

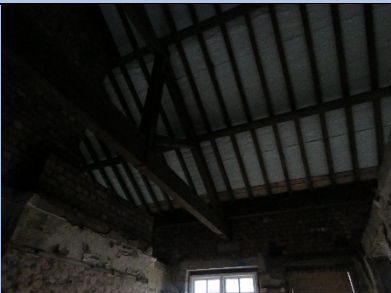
| Room Ref. | Element | Description / Item | Condition | Action | Photographs | | | |
|---|---|---|---|---|---|---|---|---|
| | Ceiling | Exposed timber roof structure. | Good | <ul style="list-style-type: none"> <li>Remove redundant fixings and timber fixed to truss.</li> <li>Clean roof truss.</li> </ul> <hr/> Proposed works <ul style="list-style-type: none"> <li>All existing ceilings to be removed</li> <li>Provide new insulated plasterboard ceiling below rafters (to be read in conjunction with roof type drawing 3501)</li> <li>Prepare and decorate existing trusses (colour tbc by architect).</li> </ul> | | | | |

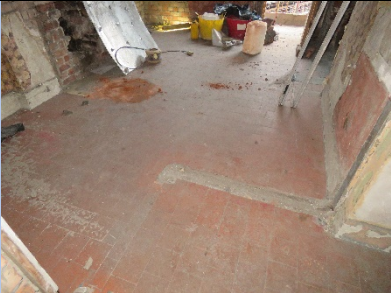
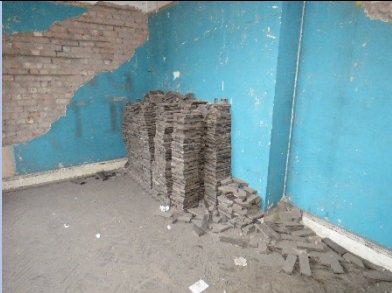
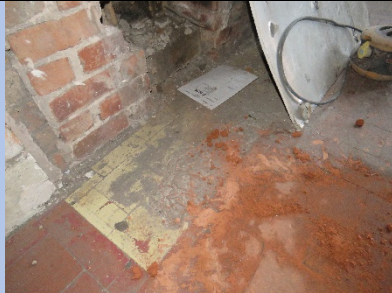
| Room Ref. | Element | Description / Item | Condition | Action | Photographs | | | |
|---|---|---|---|---|---|---|---|---|
| | Floor | Red quarry tile and white tile, wood block and glazed tile to hearth. Small area of vinyl tile over red quarry tile. | Good / fair | <ul style="list-style-type: none"> <li>Remove debris, vinyl and adhesive.</li> <li>Clean red quarry tile, white tile and protect.</li> <li>Record quantity of wood block, lift remaining and store on pallet in room.</li> <li>Carefully remove glazed tile and store in box on pallet in room.</li> </ul> <hr/> Proposed works <ul style="list-style-type: none"> <li>Floor to be levelled and prepared throughout with latex levelling screed or similar NBS:M10/120.</li> </ul> | | | | |

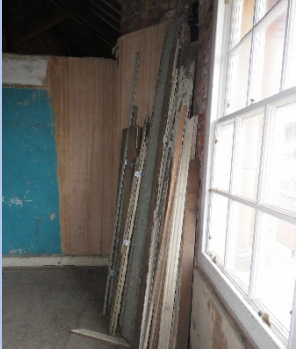
| Room Ref. | Element | Description / Item | Condition | Action | Photographs | | | |
|---|---|---|---|---|---|---|---|---|
| | Joinery | Minor area of skirting in-situ. Pile of misc. joinery. | | Proposed works <ul style="list-style-type: none"> <li>Reinstate skirting boards/picture rails to new plastered walls, leave masonry walls bare.</li> <li>Misc. joinery to be reused where possible, otherwise scrapped.</li> </ul> | | | | |

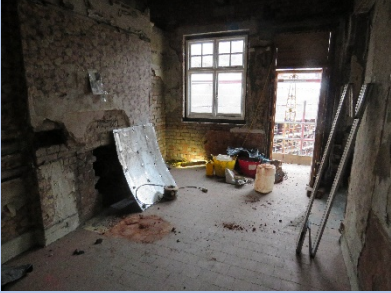
| Room Ref. | Element | Description / Item | Condition | Action | Photographs | | | |
|---|---|---|---|---|---|---|---|---|
| | Misc. | Misc. fixing and cable to roof truss. Pile of general building waste in room. | | <ul style="list-style-type: none"> <li>Retain misc. fixing and cable to roof truss.</li> <li>Remove all other waste.</li> </ul> | | | | |

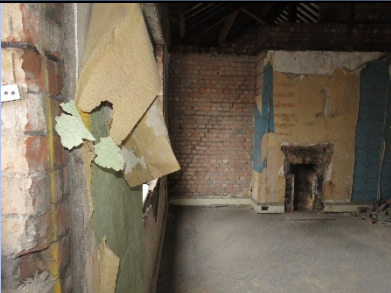
| Room Ref. | Element | Description / Item | Condition | Action | Photographs | | | |
|---|---|---|---|---|---|---|---|---|
| 325a, 325b | Walls | Plaster on brickwork with wallpaper finish.<br>Minor no. of nails to walls. | Fair | <ul style="list-style-type: none"> <li>Remove redundant fixings (and fill holes).</li> </ul> <hr/> Proposed works <ul style="list-style-type: none"> <li>Strip all walls back to masonry</li> <li>Provide insulated plasterboard (refer to wall type drawing) and secondary glazing (NBS:L10/580A) to east wall of 325a (LR).</li> <li>Provide stud partitions to form internal bathroom (3253b) as per drawing 2416.</li> <li>Provide acoustic plaster board to north and south party wall of 325a and to west (corridor) party wall (325a) as per drawing 2416.</li> <li>North (party) wall 325b to remain as bare masonry.</li> </ul> | | | | 00<br>1 |

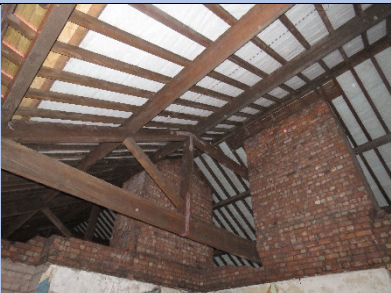
| Room Ref. | Element | Description / Item | Condition | Action | Photographs | | | |
|---|---|---|---|---|---|---|---|---|
| | Ceiling | Exposed timber roof structure. | Good | <ul style="list-style-type: none"> <li>Remove redundant fixings to roof timbers..</li> <li>Clean roof truss.</li> </ul> <hr/> Proposed works <ul style="list-style-type: none"> <li>All existing ceilings to be removed</li> <li>Provide new insulated plasterboard ceiling below rafters (to be read in conjunction with roof type drawing 3501</li> <li>Prepare and decorate existing trusses (colour tbc by architect).</li> </ul> | | | | |

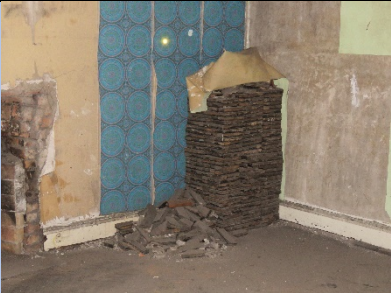
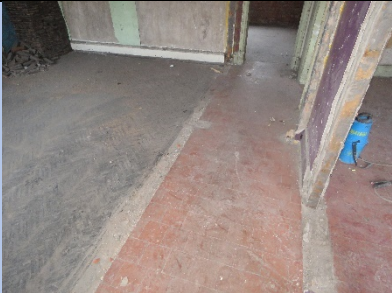
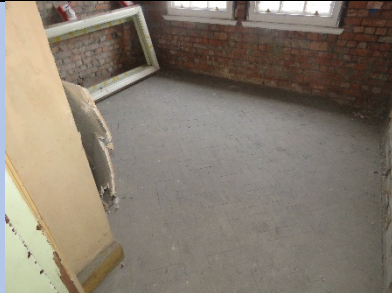
| Room Ref. | Element | Description / Item | Condition | Action | Photographs | | | |
|---|---|---|---|---|---|---|---|---|
| | Floor | Red quarry tile, wood block (1no. room already lifted) and glazed tile to hearth. | Good / fair | <ul style="list-style-type: none"> <li>Clean red quarry tile and protect.</li> <li>Record quantity of wood block, lift and store on pallet in room.</li> <li>Carefully remove glazed tile and store in box on pallet in room.</li> <li>Remove all debris.</li> </ul> <hr/> Proposed works <ul style="list-style-type: none"> <li>Floor to be levelled and prepared throughout with latex levelling screed or similar NBS:M10/120.</li> </ul> | | | | |

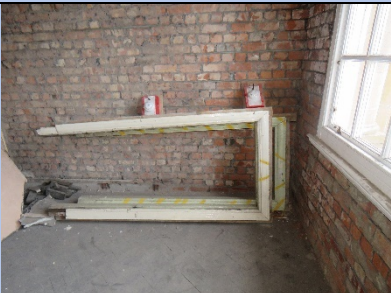
| Room Ref. | Element | Description / Item | Condition | Action | Photographs | | | |
|---|---|---|---|---|---|---|---|---|
| | Joinery | Minor area of skirting, picture rail and door architrave in-situ.<br>2no. door frames stacked in room. | | Proposed works <ul style="list-style-type: none"> <li>Reinstate skirting boards/picture rails to new plastered walls, leave masonry walls bare.</li> <li>Doors and architraves to be set aside for reuse elsewhere</li> <li>Misc. joinery to be reused where possible, otherwise scrapped.</li> </ul> | | | | |

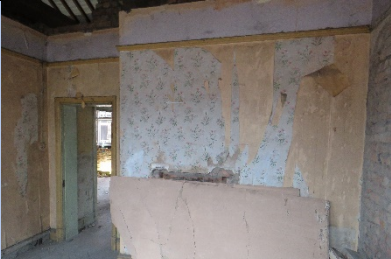
| Room Ref. | Element | Description / Item | Condition | Action | Photographs | | | |
|---|---|---|---|---|---|---|---|---|
| | Misc. | Misc. fixing and cable to roof truss.<br>Section of plaster cornice.<br>Pile of waste plasterboard in room. | | <ul style="list-style-type: none"> <li>Retain misc. fixing and cable to roof truss (check with Project Manager as to whether these should instead be removed).</li> <li>Retain plaster cornice &amp; clean.</li> <li>Remove all other waste.</li> </ul> | | | | |

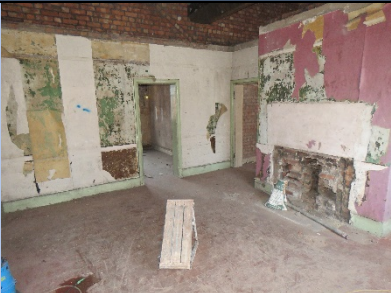
| Room Ref. | Element | Description / Item | Condition | Action | Photographs | | | | |
|---|---|---|---|---|---|---|--|--|---|
| 327a, 237b, 237c | Walls | Plaster on brickwork with paint and wallpaper finish.<br>Minor no. of nails to walls. | Fair | <ul style="list-style-type: none"> <li>Remove redundant fixings and fill holes)</li> </ul> <hr/> Proposed works <ul style="list-style-type: none"> <li>Strip all walls back to masonry</li> <li>Provide insulated plasterboard (refer to wall type drawing) and secondary glazing (NBS:L10/580A) to east wall of 327a (LR).</li> <li>Provide stud partitions to form internal bathroom (327b) and lobby (327c) as per drawing 2416.</li> <li>Provide acoustic plaster board to north and south party walls of 327a where noted on drawing 2416, otherwise leave as bare masonry.</li> </ul> | | | | | 001 |

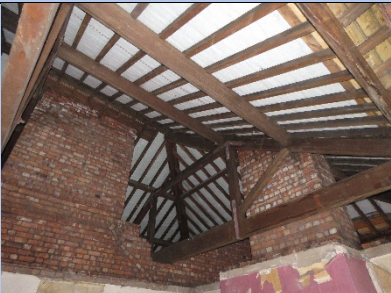
| Room Ref. | Element | Description / Item | Condition | Action | Photographs | | | | |
|---|---|---|---|---|---|---|--|--|---|
| | Ceiling | Exposed timber roof structure. | Good | <ul style="list-style-type: none"> <li>Remove redundant fixings to roof timbers.</li> <li>Clean roof truss.</li> <li>Retain hanging bracket and cable to roof trusses.</li> </ul> <hr/> Proposed works <ul style="list-style-type: none"> <li>All existing ceilings to be removed</li> <li>Provide new insulated plasterboard ceiling below rafters (to be read in conjunction with roof type drawing 3501</li> <li>Prepare and decorate existing trusses (colour tbc by architect).</li> </ul> | | | | | |

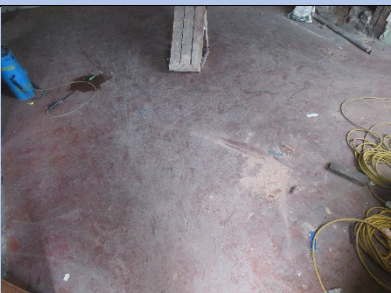
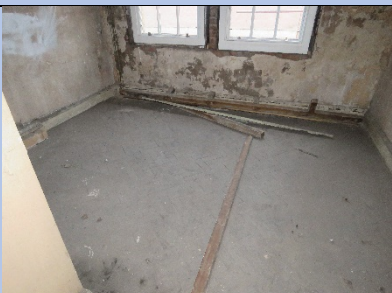
| Room Ref. | Element | Description / Item | Condition | Action | Photographs | | | | |
|---|---|---|---|---|---|---|--|--|---|
| | Floor | Red quarry tile, white tile and wood block, | Good / fair | <ul style="list-style-type: none"> <li>Clean red quarry tile, white tile and protect.</li> <li>Record quantity of wood block, lift and store on pallet in room.</li> <li>Remove all debris.</li> </ul> <hr/> Proposed works <ul style="list-style-type: none"> <li>Floor to be levelled and prepared throughout with latex levelling screed or similar NBS:M10/120.</li> </ul> | | | | | |

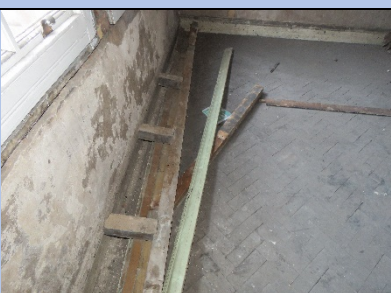
| Room Ref. | Element | Description / Item | Condition | Action | Photographs | | | | |
|---|---|---|---|---|---|---|--|--|---|
| | Joinery | Minor area of skirting, and door architrave in-situ.<br>Misc. joinery stacked in room. | | Proposed works <ul style="list-style-type: none"> <li>Reinstate skirting boards/picture rails to new plastered walls, leave masonry walls bare.</li> <li>Doors and architraves to be set aside for reuse elsewhere</li> <li>Misc. joinery to be reused where possible, otherwise scrapped.</li> </ul> | | | | | |

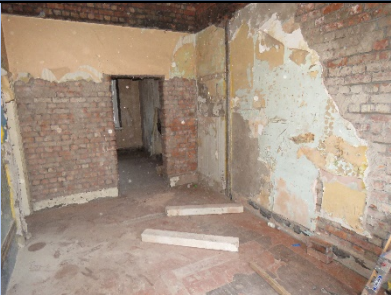
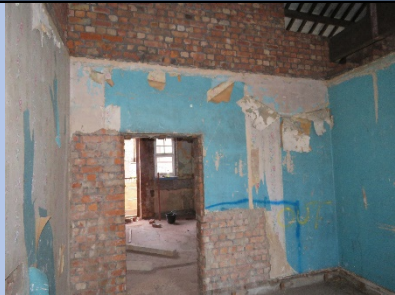
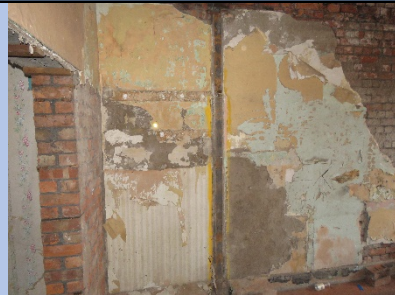
| Room Ref. | Element | Description / Item | Condition | Action | Photographs | | | |
|---|---|---|---|---|---|---|---|---|
| 329a, 329b | Walls | Plaster on brickwork with paint and wallpaper finish.<br>Minor no. of nails and embedded timber to walls.<br>Small holes to brickwork. | Fair | <ul style="list-style-type: none"> <li>Remove redundant fixings and embedded timber (and fill holes).</li> <li>Fill holes to brickwork with salvaged red brick.</li> </ul> <hr/> Proposed works <ul style="list-style-type: none"> <li>Strip all walls back to masonry</li> <li>Provide insulated plasterboard (refer to wall type drawing) and secondary glazing (NBS:L10/580A) to east wall of 329a (LR).</li> <li>Provide stud partitions to form internal bathroom (329b) as per drawing 2416.</li> <li>Provide acoustic plaster board to north and south party walls of 329a where noted on drawing 2416, otherwise leave as bare masonry.</li> </ul> | | | | 00<br>1 |

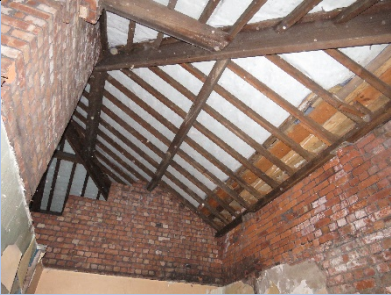
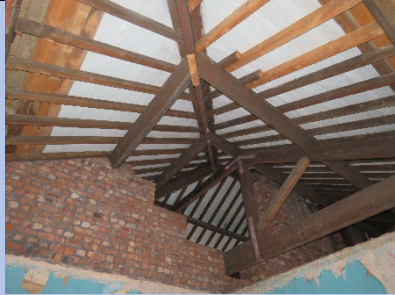
| Room Ref. | Element | Description / Item | Condition | Action | Photographs | | | |
|---|---|---|---|---|---|---|---|---|
| | Ceiling | Exposed timber roof structure. | Good | <ul style="list-style-type: none"> <li>Remove redundant fixings to roof timbers.</li> <li>Clean roof truss.</li> <li>Retain hanging bracket and cable to roof trusses (check fixings and replace with new if required)</li> </ul> <hr/> Proposed works <ul style="list-style-type: none"> <li>All existing ceilings to be removed</li> <li>Provide new insulated plasterboard ceiling below rafters (to be read in conjunction with roof type drawing 3501)</li> <li>Prepare and decorate existing trusses (colour tbc by architect).</li> </ul> | | | | |

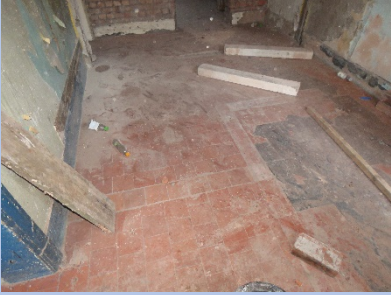
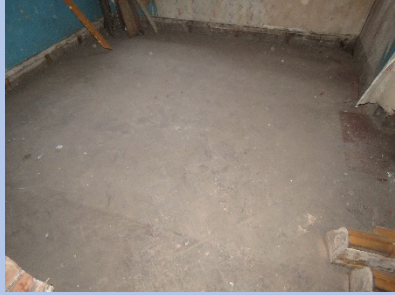
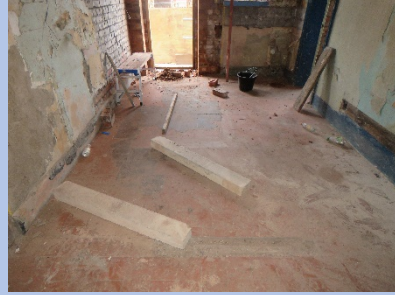
| Room Ref. | Element | Description / Item | Condition | Action | Photographs | | | |
|---|---|---|---|---|---|---|---|---|
| | Floor | Minor area of vinyl tile over red quarry tile.<br>Red quarry tile, white tile and wood block, | Good / fair | <ul style="list-style-type: none"> <li>Remove vinyl and adhesive.</li> <li>Clean red quarry tile, white tile and protect.</li> <li>Record quantity of wood block, lift and store on pallet in room.</li> <li>Remove all debris.</li> </ul> <hr/> Proposed works <ul style="list-style-type: none"> <li>Floor to be levelled and prepared throughout with latex levelling screed or similar NBS:M10/120.</li> </ul> | | | | |

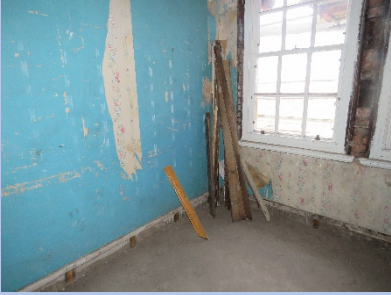
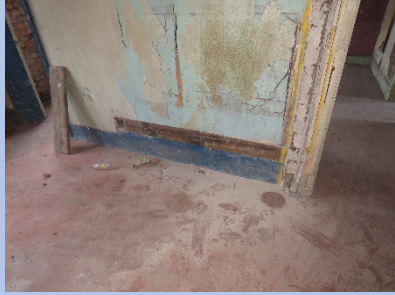
| Room Ref. | Element | Description / Item | Condition | Action | Photographs | | | |
|---|---|---|---|---|---|---|---|---|
| | Joinery | Minor area of skirting, and door architrave in-situ.<br>Misc. joinery stacked in room. | | Proposed works <ul style="list-style-type: none"> <li>Reinstate skirting boards/picture rails to new plastered walls, leave masonry walls bare.</li> <li>Doors and architraves to be set aside for reuse elsewhere</li> <li>Misc. joinery to be reused where possible, otherwise scrapped.</li> </ul> | | | | |

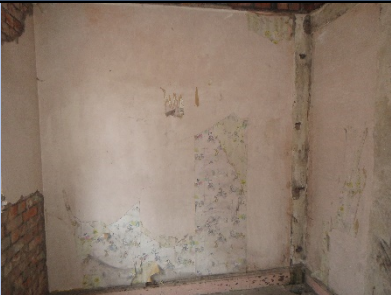
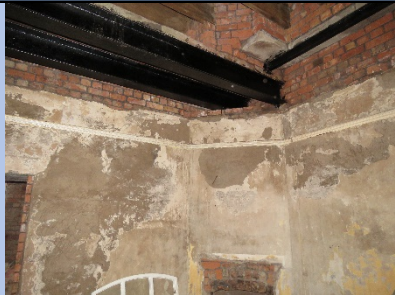
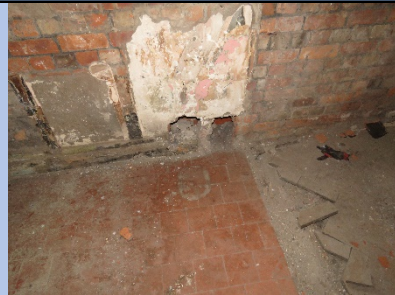
| Room Ref. | Element | Description / Item | Condition | Action | Photographs | | | |
|---|---|---|---|---|---|---|---|---|
| 330, 330a, 330b | Walls | Plaster on brickwork with paint and wallpaper finish.<br>Minor no. of nails to walls.<br>Small holes to brickwork. | Fair | <ul style="list-style-type: none"> <li>Remove redundant fixings (and fill holes).</li> <li>Fill holes to brickwork with salvaged red brick.</li> </ul> <hr/> Proposed works <ul style="list-style-type: none"> <li>Strip all walls back to masonry</li> <li>Provide insulated plasterboard (refer to wall type drawing) and secondary glazing (NBS:L10/580A) to east wall of 330a (LR).</li> <li>Provide stud partitions to form internal bathroom (330b) and lobby (330) as per drawing 2404.</li> <li>Provide acoustic plaster board to west (corridor) party wall of 330, otherwise leave as bare masonry.</li> </ul> | | | | 00<br>1 |

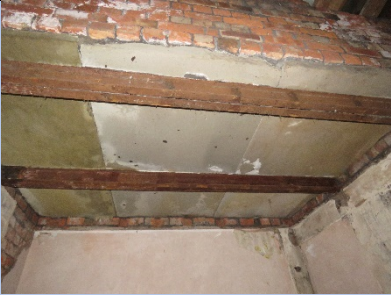
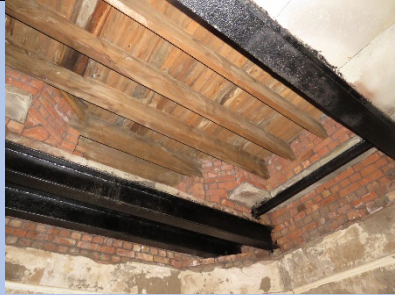
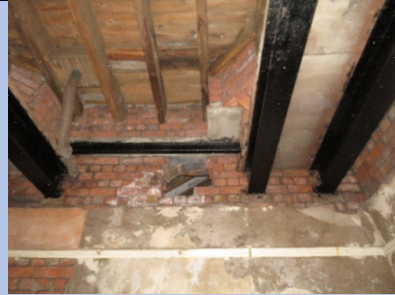
| Room Ref. | Element | Description / Item | Condition | Action | Photographs | | | |
|---|---|---|---|---|---|---|---|---|
| | Ceiling | Exposed timber ceiling structure.<br>Steel beams with stone slabs. | Good | <ul style="list-style-type: none"> <li>Remove redundant fixings to roof timbers.</li> <li>Clean timbers.</li> <li>De-rust beams ready for decoration.</li> </ul> <hr/> Proposed works <ul style="list-style-type: none"> <li>All existing ceilings to be removed</li> <li>Provide new insulated plasterboard ceiling below rafters (to be read in conjunction with roof type drawing 3501)</li> <li>Prepare and decorate existing trusses (colour tbc by architect).</li> </ul> | | | | |

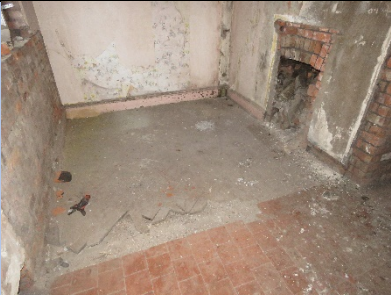
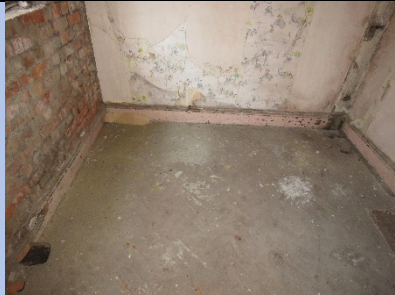
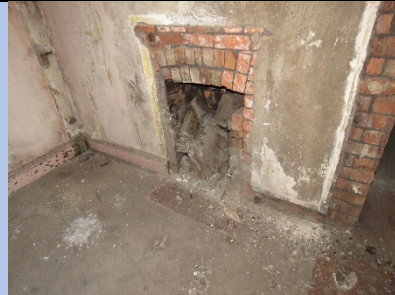
| Room Ref. | Element | Description / Item | Condition | Action | Photographs | | | |
|---|---|---|---|---|---|---|---|---|
| | Floor | Red quarry tile, glazed tile to hearths and wood block, | Good / fair | <ul style="list-style-type: none"> <li>Clean red quarry tile and protect.</li> <li>Record quantity of wood block, lift and store on pallet in room.</li> <li>Remove all debris.</li> </ul> <hr/> Proposed works <ul style="list-style-type: none"> <li>Floor to be levelled and prepared throughout with latex levelling screed or similar NBS:M10/120.</li> </ul> | | | | |

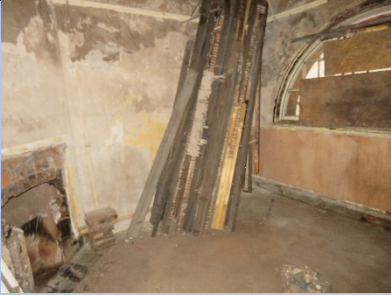
| Room Ref. | Element | Description / Item | Condition | Action | Photographs | | | |
|---|---|---|---|---|---|---|---|---|
| | Joinery | Minor area of skirting, and picture rail in-situ.<br>Misc. joinery and window stacked in room. | | Proposed works <ul style="list-style-type: none"> <li>Reinstate skirting boards/picture rails to new plastered walls, leave masonry walls bare.</li> <li>Standalone window to be set aside for reuse elsewhere</li> <li>Misc. joinery to be reused where possible, otherwise scrapped.</li> </ul> | | | | |

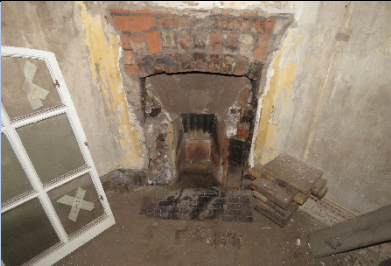
| Room Ref. | Element | Description / Item | Condition | Action | Photographs | | | |
|---|---|---|---|---|---|---|---|---|
| | Misc. | Misc. building waste and fire insert. | | <ul style="list-style-type: none"> <li>Remove mortar and brick from fireplace and clean area.</li> </ul> <hr/> Proposed works <ul style="list-style-type: none"> <li>Overboard fireplace</li> </ul> | | | | |

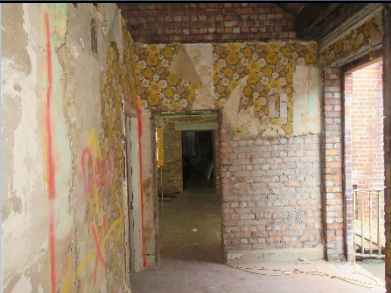
| Room Ref. | Element | Description / Item | Condition | Action | Photographs | | | |
|---|---|---|---|---|---|---|---|---|
| 331e<br>(Lobby rotunda) | Walls | Plaster on brickwork with wallpaper finish.<br>Minor no. of nails and embedded timber to walls.<br>Area of heavily eroded brickwork. | Fair | <ul style="list-style-type: none"> <li>Remove redundant fixings and embedded timber.</li> <li>Make repairs/replacements to eroded brickwork</li> </ul> <hr/> Proposed works <ul style="list-style-type: none"> <li>Strip all walls back to masonry</li> <li>Provide insulated plasterboard (refer to wall type drawing) and secondary glazing (NBS:L10/580A) to rotunda room (LR/FFS).</li> <li>Provide stud partitions to form internal lobby as per drawing 2404.</li> <li>Provide acoustic plaster board to west (corridor) party wall backing onto riser, otherwise leave as bare masonry.</li> </ul> | | | | 00<br>1 |

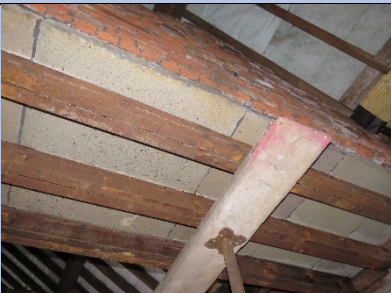
| Room Ref. | Element | Description / Item | Condition | Action | Photographs | | | |
|---|---|---|---|---|---|---|---|---|
| | Ceiling | Exposed timber ceiling structure.<br>Steel beams with stone slabs. | Good | <ul style="list-style-type: none"> <li>Remove nails and redundant M&amp;E fixings only (and fill holes).</li> <li>Clean timbers.</li> <li>De-rust beams ready for decoration.</li> </ul> <hr/> Proposed works <ul style="list-style-type: none"> <li>All existing ceilings to be removed</li> <li>Provide new insulated plasterboard ceiling below rafters (to be read in conjunction with roof type drawing 3501)</li> <li>Prepare and decorate existing trusses (colour tbc by architect).</li> </ul> | | | | |

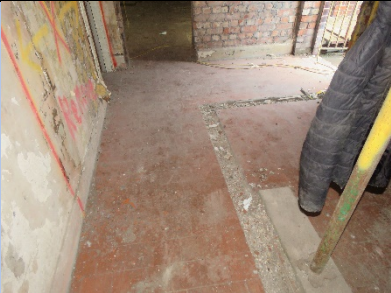
| Room Ref. | Element | Description / Item | Condition | Action | Photographs | | | |
|---|---|---|---|---|---|---|---|---|
| | Floor | Red quarry tile. | Good / fair | <ul style="list-style-type: none"> <li>Clean red quarry tile and protect.</li> <li>Remove all debris.</li> </ul> <hr/> Proposed works <ul style="list-style-type: none"> <li>Floor to be levelled and prepared throughout with latex levelling screed or similar NBS:M10/120.</li> </ul> | | | | |

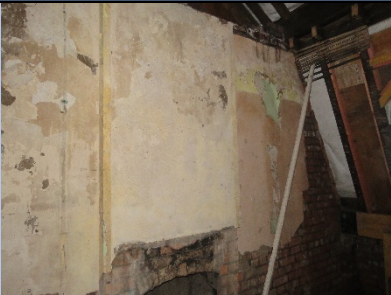
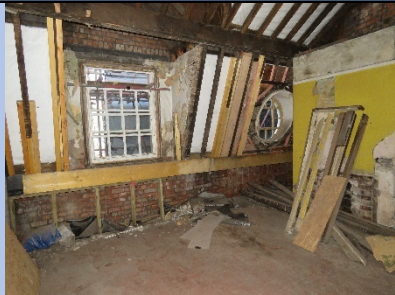
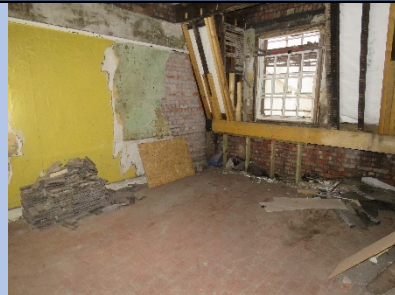
| Room Ref. | Element | Description / Item | Condition | Action | Photographs | | | |
|---|---|---|---|---|---|---|---|---|
| 331c, 331d | Walls | Plaster on brickwork with wallpaper finish.<br>Minor no. of nails to walls. | Fair | <ul style="list-style-type: none"> <li>Remove redundant fixings (and fill holes).</li> </ul> <hr/> Proposed works <ul style="list-style-type: none"> <li>Strip all walls back to masonry</li> <li>Provide insulated plasterboard (refer to wall type drawing) and secondary glazing (NBS:L10/580A) to east wall (LR).</li> <li>Provide stud partitions to form bedroom, bathroom, lobby as per drawing 2404.</li> <li>North and south walls to remain as bare masonry.</li> </ul> | | | | 00<br>1 |

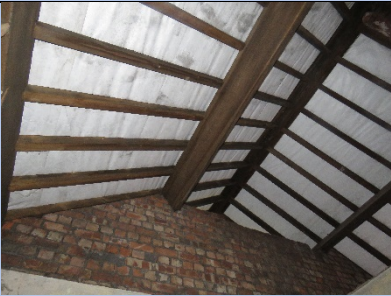
| Room Ref. | Element | Description / Item | Condition | Action | Photographs | | | |
|---|---|---|---|---|---|---|---|---|
| | Ceiling | Exposed timber ceiling structure. | Good | <ul style="list-style-type: none"> <li>Remove nails only (and fill holes).</li> <li>Clean timbers.</li> </ul> <hr/> Proposed works <ul style="list-style-type: none"> <li>All existing ceilings to be removed</li> <li>Provide new insulated plasterboard ceiling below rafters (to be read in conjunction with roof type drawing 3501)</li> <li>Prepare and decorate existing trusses (colour tbc by architect).</li> </ul> | | | | |

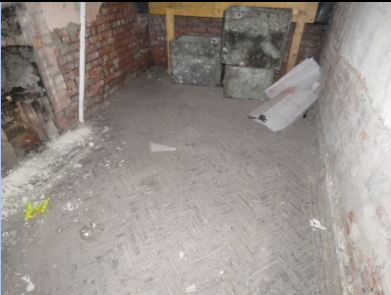
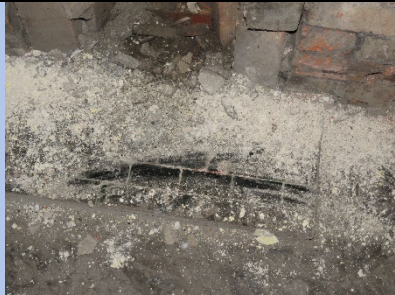
| Room Ref. | Element | Description / Item | Condition | Action | Photographs | | | |
|---|---|---|---|---|---|---|---|---|
| | Floor | Red quarry tile, wood block (already lifted) and tiled hearth. | Good / fair | <ul style="list-style-type: none"> <li>Clean red quarry tile and protect.</li> <li>Remove all debris.</li> <li>Quantity wood block and stack on pallet in room.</li> </ul> <hr/> Proposed works <ul style="list-style-type: none"> <li>Floor to be levelled and prepared throughout with latex levelling screed or similar NBS:M10/120.</li> </ul> | | | | |

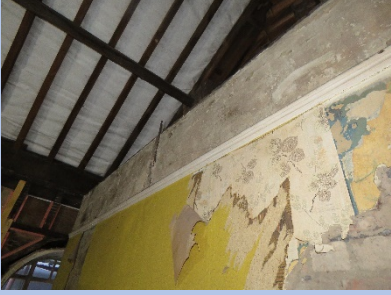
| Room Ref. | Element | Description / Item | Condition | Action | Photographs | | | |
|---|---|---|---|---|---|---|---|---|
| | Joinery | Picture rail in-situ. | | Proposed works <ul style="list-style-type: none"> <li>Reinstate skirting boards/picture rails to new plastered walls, leave masonry walls bare.</li> </ul> | | | | |

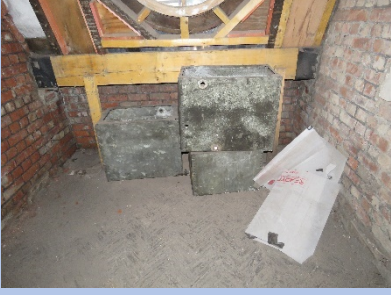
| Room Ref. | Element | Description / Item | Condition | Action | Photographs | | | |
|---|---|---|---|---|---|---|---|---|
| | Misc. | 3no lead water tanks.<br>General building waste. | | <ul style="list-style-type: none"> <li>Record tanks and retain in heritage store room.</li> <li>Remove all other waste.</li> </ul> | | | | |

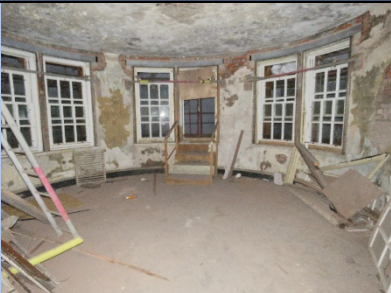
| Room Ref. | Element | Description / Item | Condition | Action | Photographs | | | |
|---|---|---|---|---|---|---|---|---|
| 331, 331a | Walls | Plaster on brickwork with wallpaper finish.<br>Minor no. of nails to walls. | Fair | <ul style="list-style-type: none"> <li>Remove redundant fixings (and fill holes)</li> </ul> Proposed works <ul style="list-style-type: none"> <li>Strip all walls back to masonry</li> <li>Provide insulated plasterboard (refer to wall type drawing) and secondary glazing (NBS:L10/580A) to south wall of 331 (FFS).</li> <li>Provide stud partitions to form internal bathroom (331a) as per drawing 2404.</li> <li>Provide acoustic plaster board to west party wall of 331, otherwise leave as bare masonry.</li> </ul> | | | | 001 |

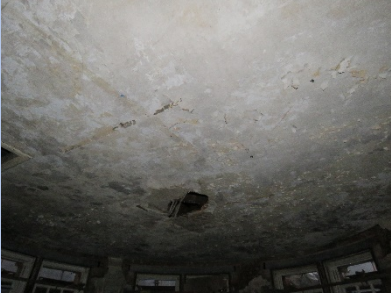
| Room Ref. | Element | Description / Item | Condition | Action | Photographs | | | |
|---|---|---|---|---|---|---|---|---|
| | Ceiling | Lath and Plaster ceiling with paint finish.<br>Exposed timber roof structure. | Good | <ul style="list-style-type: none"> <li>Remove redundant fixings and clean roof timbers.</li> </ul> Proposed works <ul style="list-style-type: none"> <li>All existing ceilings to be removed</li> <li>Provide new insulated plasterboard ceiling below rafters (to be read in conjunction with roof type drawing 3501)</li> <li>Prepare and decorate existing trusses (colour tbc by architect).</li> </ul> | | | | |
