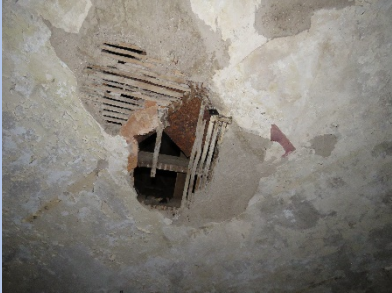
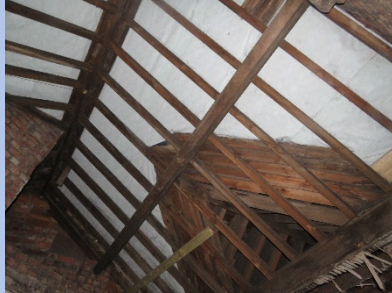
| Room Ref. | Element | Description / Item | Condition | Action | Photographs | | | |
|---|---|---|---|---|---|---|---|---|
| | Ceiling | Lath and Plaster ceiling with paint finish.<br>Exposed timber roof structure. | Good | <ul style="list-style-type: none"> <li>Remove redundant fixings and clean roof timbers.</li> </ul> Proposed works <ul style="list-style-type: none"> <li>All existing ceilings to be removed</li> <li>Provide new insulated plasterboard ceiling below rafters (to be read in conjunction with roof type drawing 3501)</li> <li>Prepare and decorate existing trusses (colour tbc by architect).</li> </ul> | | | | |

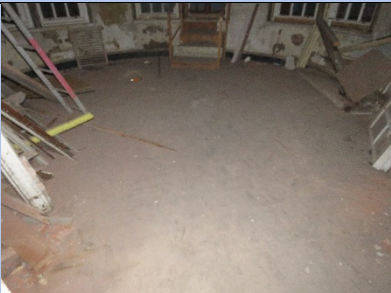
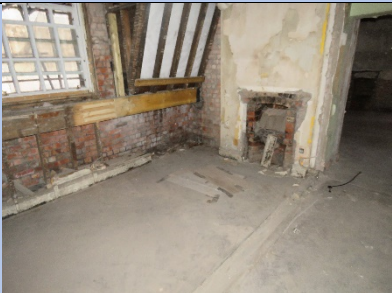
| Room Ref. | Element | Description / Item | Condition | Action | Photographs | | | |
|---|---|---|---|---|---|---|---|---|
| | Floor | Wood block | Good / fair | <ul style="list-style-type: none"> <li>Quantity wood block, lift and stack on pallet in room.</li> </ul> Proposed works <ul style="list-style-type: none"> <li>Floor to be levelled and prepared throughout with latex levelling screed or similar NBS:M10/120.</li> </ul> | | | | |

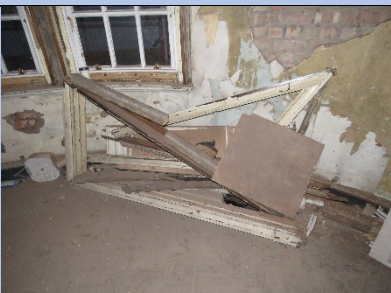
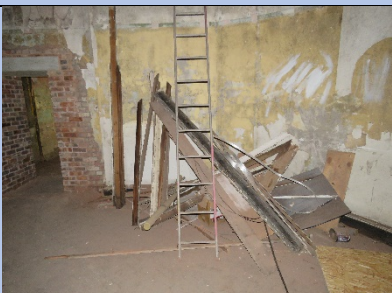
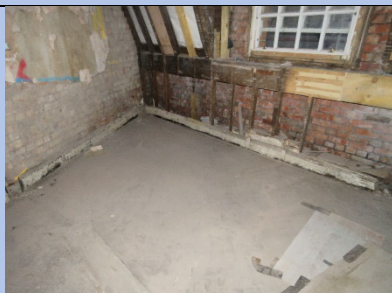
| Room Ref. | Element | Description / Item | Condition | Action | Photographs | | | |
|---|---|---|---|---|---|---|---|---|
| | Joinery | Skirting board in-situ 100%.<br>Misc. door frames and joinery stacked in room. | | Proposed works <ul style="list-style-type: none"> <li>Reinstate skirting boards/picture rails to new plastered walls, leave masonry walls bare.</li> <li>Doors, frames, architraves to be removed and set aside for reuse elsewhere</li> </ul> | | | | |

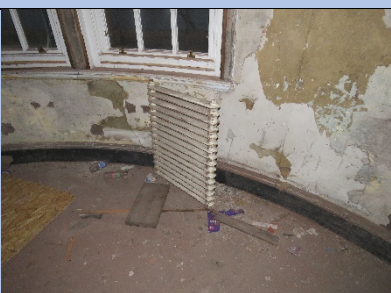
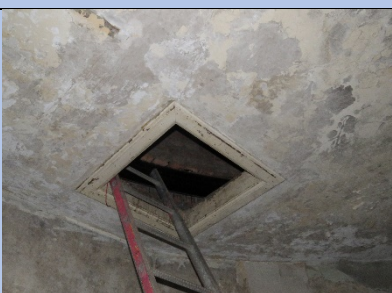
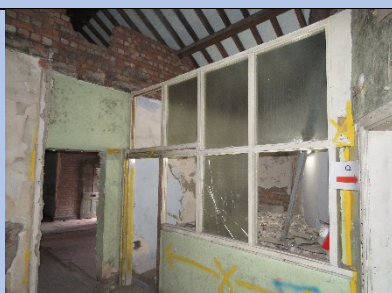
| Room Ref. | Element | Description / Item | Condition | Action | Photographs | | | |
|---|---|---|---|---|---|---|---|---|
| | Misc. | 1no. radiator.<br>Miscellaneous waste.<br>Ceiling hatch.<br>Glazed screen. | | <ul style="list-style-type: none"> <li>Record radiator and store in heritage storeroom.</li> <li>Remove all other waste.</li> <li>Remove glazed screen.</li> </ul> | | | | |
