## Asbestos Management Plan

Claremont Road

Manchester

**Report Ref: A2212/19/AMP**

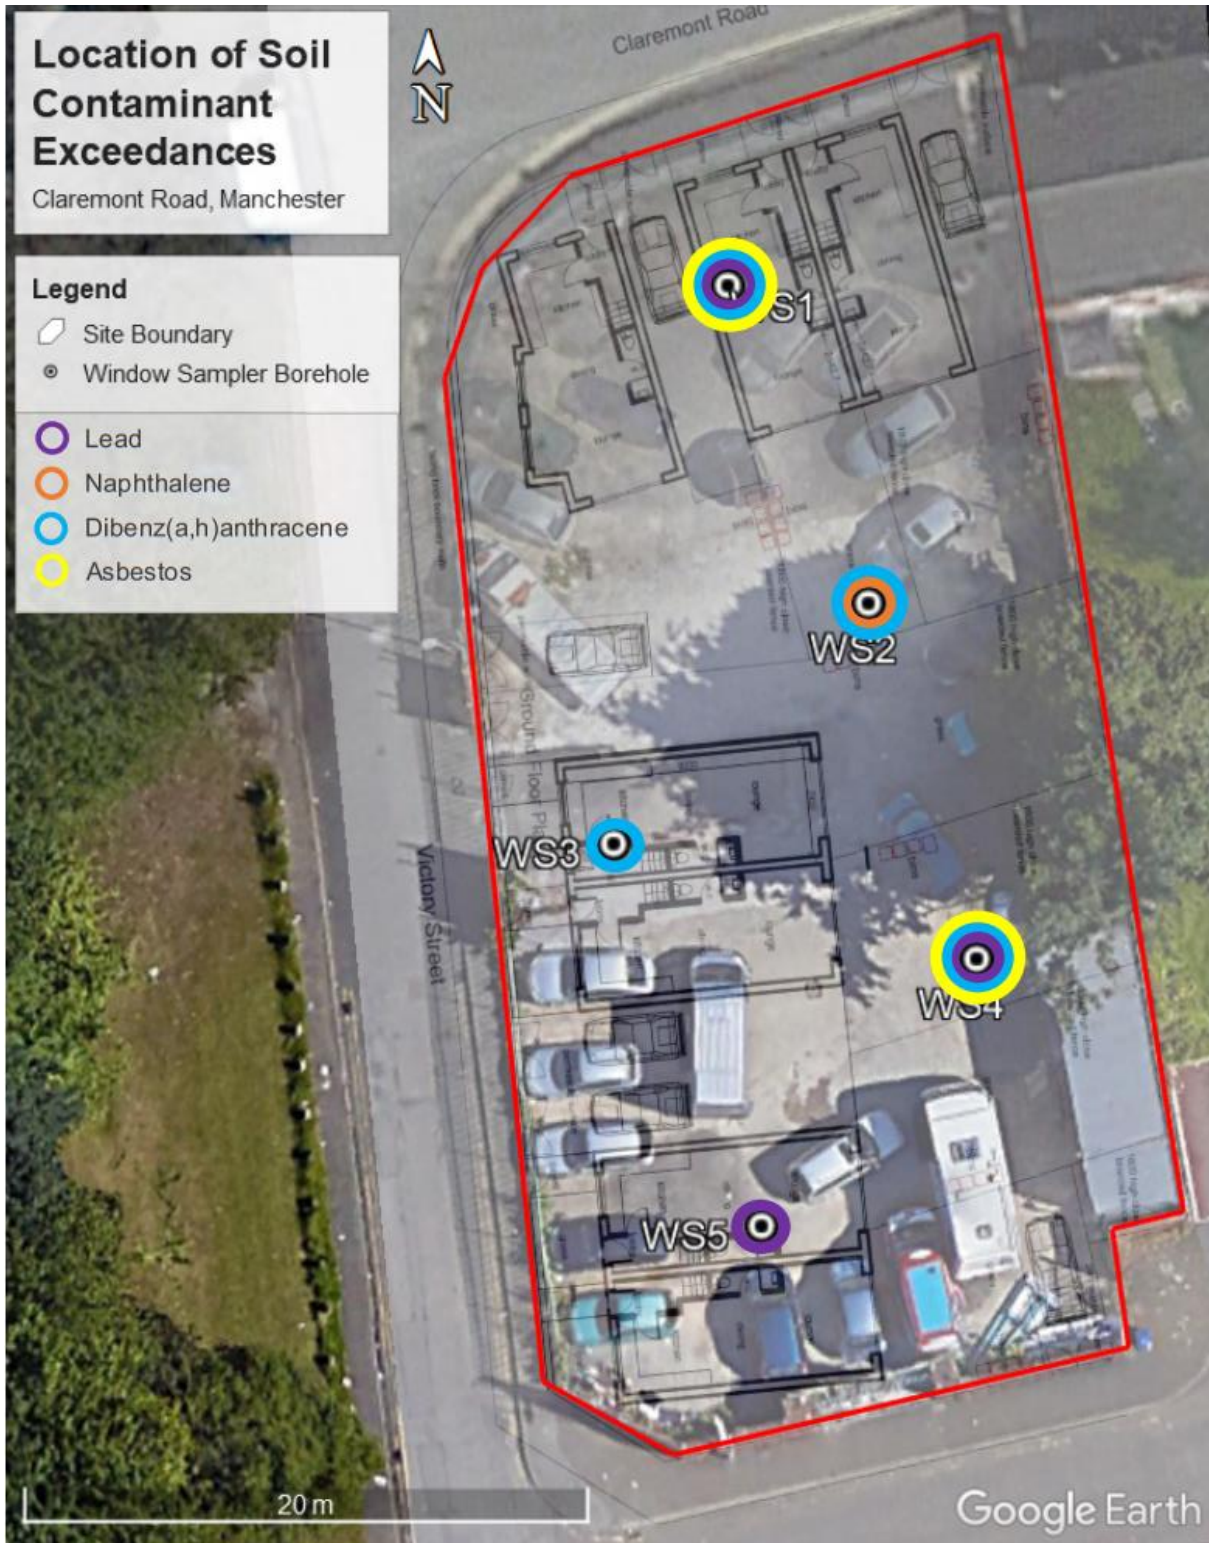
Figure 3 Location of Soil Contaminant Exceedances

Asbestos was also detected at two locations; WS1 at 0.30m as microscopic loose fibres of Chrysotile (0.055% by mass) and WS4 at 0.40m as a Chrysotile fibre bundle (<0.001% by mass).

Loose fibres and fibre bundles have been detected in the Made Ground at two locations at the site, at concentrations of up to 0.055%, as such, the possibility of asbestos containing materials (ACM) existing away from and in between sampling locations cannot be ruled out. The risk from release of free fibres during the construction phase is therefore considered high, particularly in the vicinity WS1 and the former public house on site.

A plan showing the location of the identified Asbestos contamination is presented in the Remediation Strategy as Figure 3 and also as Figure 1 overleaf.

It should be noted that the extent of the asbestos impacted soils has not been delineated, and as such, the whole site area is considered to be potentially contaminated with low level Asbestos. The guidance within this Management Plan should therefore be followed during **all** works on site.
