PROPOSED GROUND FLOOR LAYOUT.

REF - 004

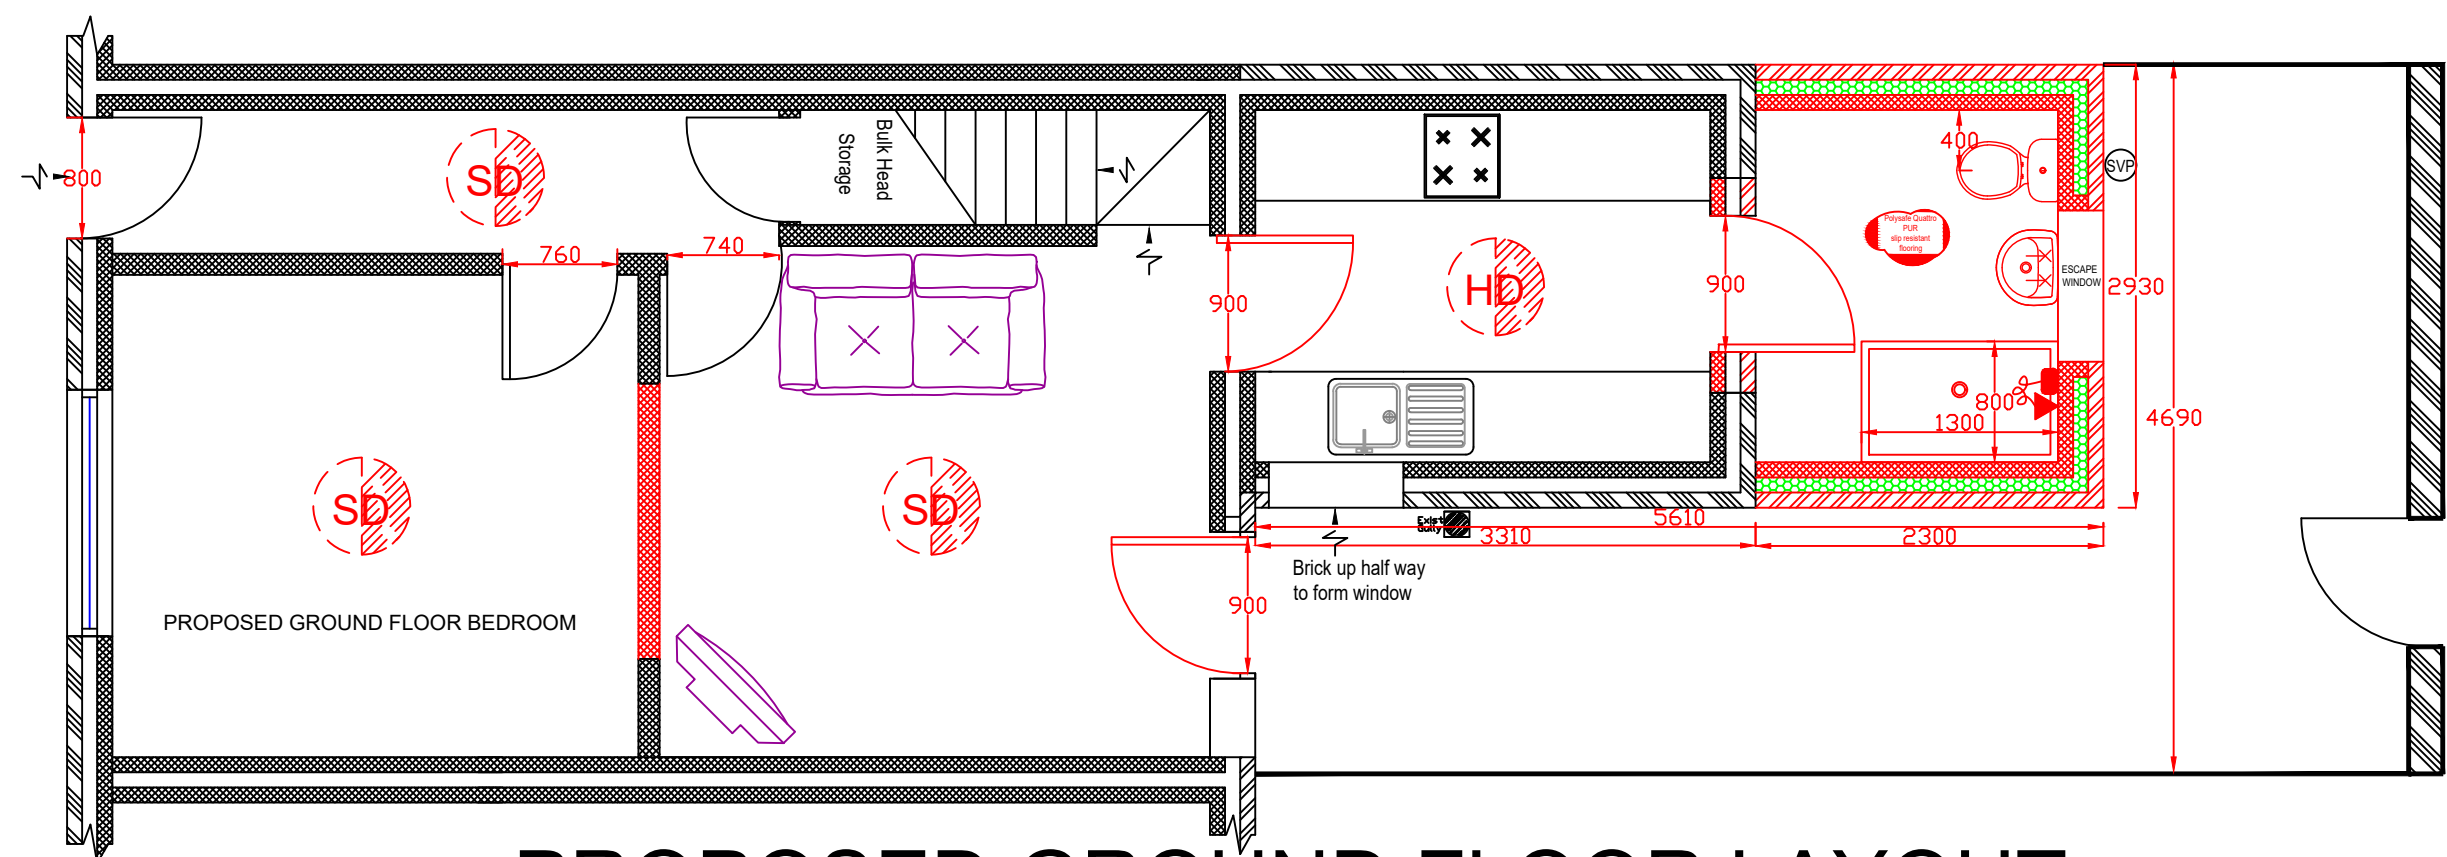
Mains operated interconnected smoke detector with battery backup to be installed in the newly formed bedroom, ground floor lounge, hall and 1st floor landing. (SD)

Mains operated interconnceted heat detector with battery backup to be installed in the kitchen. (HD)
