Phase I Geoenvironmental Site Assessment  
Renaissance, Manchester

Reference: 14-261-R1-1  
Date: September 2020

# PHASE I GEOENVIRONMENTAL SITE ASSESSMENT

Renaissance,  
Deansgate  
Manchester  
M3 2FE

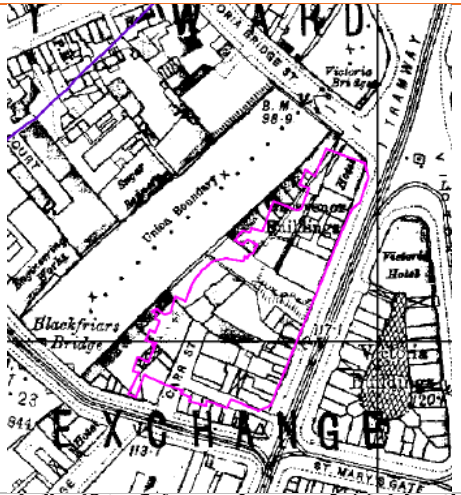
| MAP EDITION | HISTORICAL LAND USE | HISTORICAL MAP EXCERPT |
|---|---|---|
| <b>1892</b><br><br><b>1:2,500</b> | <p>The site has been developed since Pre 1892. A hotel is recorded in the north of the site, with numerous other buildings present across the site.</p> <p>A section of Carr Street is present in the south western corner of the site.</p> | |

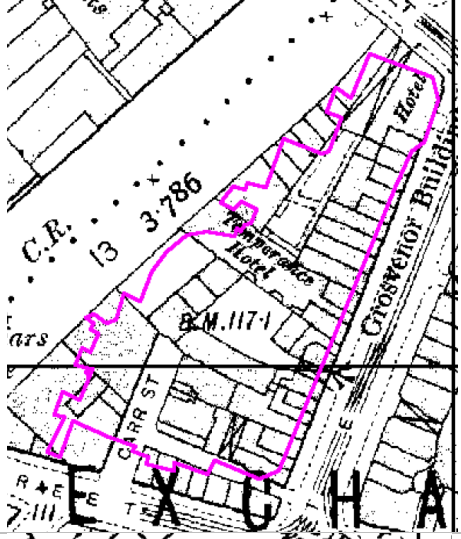
| MAP EDITION | HISTORICAL LAND USE | HISTORICAL MAP EXCERPT |
|---|---|---|
| <b>1908</b><br><br><b>1:2,500</b> | <p>A building in the centre of the site is named as the Temperance Hotel.</p> <p>The rest of the site remains relatively unchanged.</p> | |

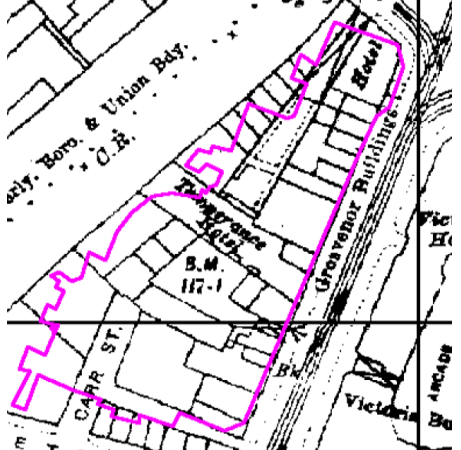
| MAP EDITION | HISTORICAL LAND USE | HISTORICAL MAP EXCERPT |
|---|---|---|
| <b>1932-1933</b><br><br><b>1:2,500</b> | <p>The site remains relatively unchanged.</p> | |

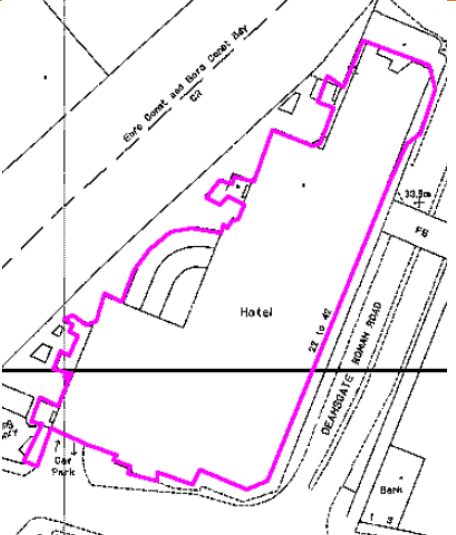
| MAP EDITION | HISTORICAL LAND USE | HISTORICAL MAP EXCERPT |
|---|---|---|
| <p>1992<br/>1:1,250</p> | <p>There are no significant changes recorded at the subject site.</p> | |

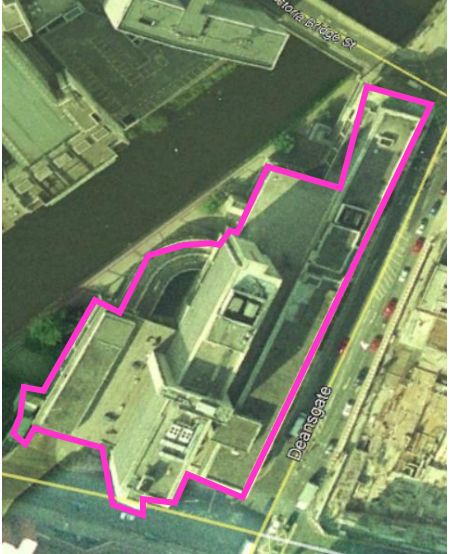
| MAP EDITION | HISTORICAL LAND USE | HISTORICAL MAP EXCERPT |
|---|---|---|
| <p>Google Earth<br/>2000</p> | <p>There are no significant changes recorded at the subject site.</p> | |

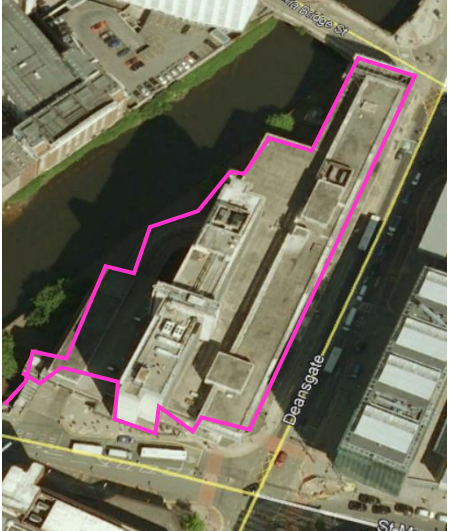
| MAP EDITION | HISTORICAL LAND USE | HISTORICAL MAP EXCERPT |
|---|---|---|
| <p>Google Earth<br/>2009</p> | <p>There are no significant changes recorded at the subject site.</p> | |

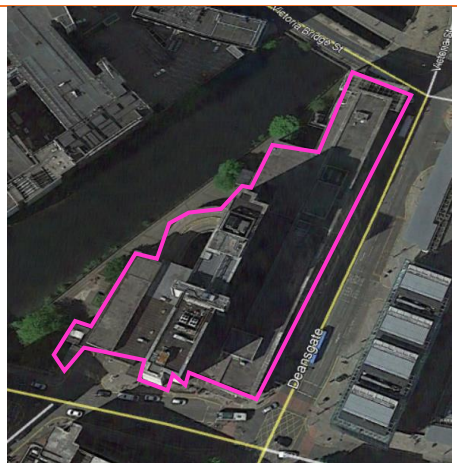
| MAP EDITION | HISTORICAL LAND USE | HISTORICAL MAP EXCERPT |
|---|---|---|
| Google Earth<br>2019 | There are no significant changes recorded at the subject site. | |

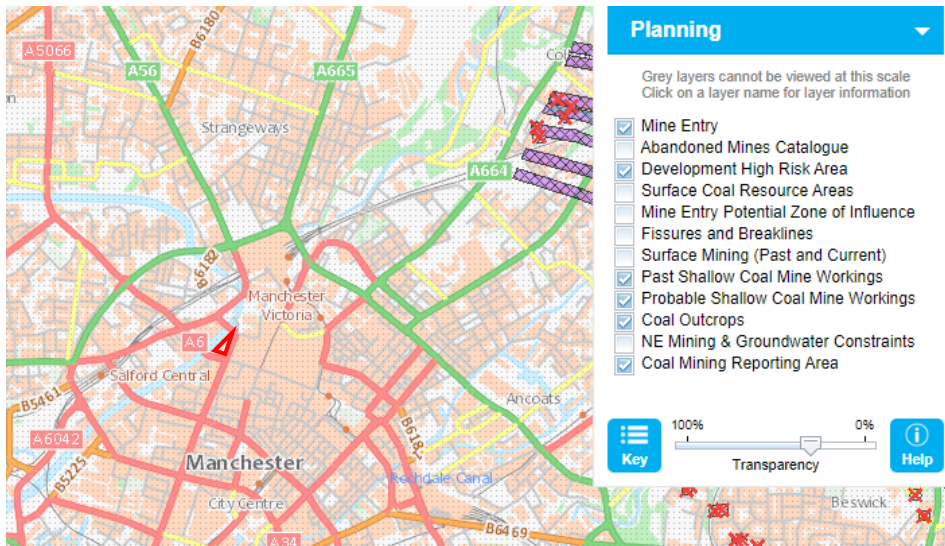
| SOURCES OF INFORMATION | SUMMARY |
|---|---|
| Coal Authority Interactive Map | <p>The site is not situated within a development high risk area. There are no mine entries recorded within 500m of the site boundary. There are also no past shallow coal mine workings or probable shallow coal mine workings or coal outcrops within 500m of the site boundary.</p> |

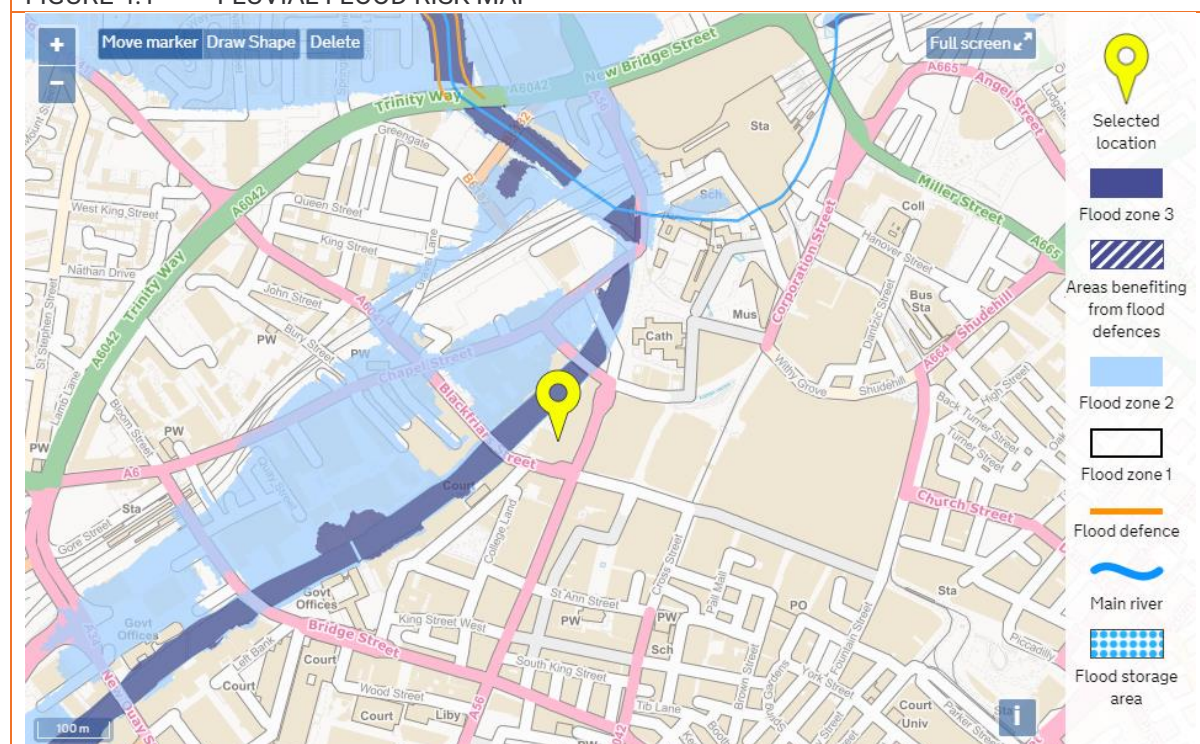
FIGURE 4.1 FLUVIAL FLOOD RISK MAP

The Fluvial Flood Risk Map is presented in Figure 4.1.

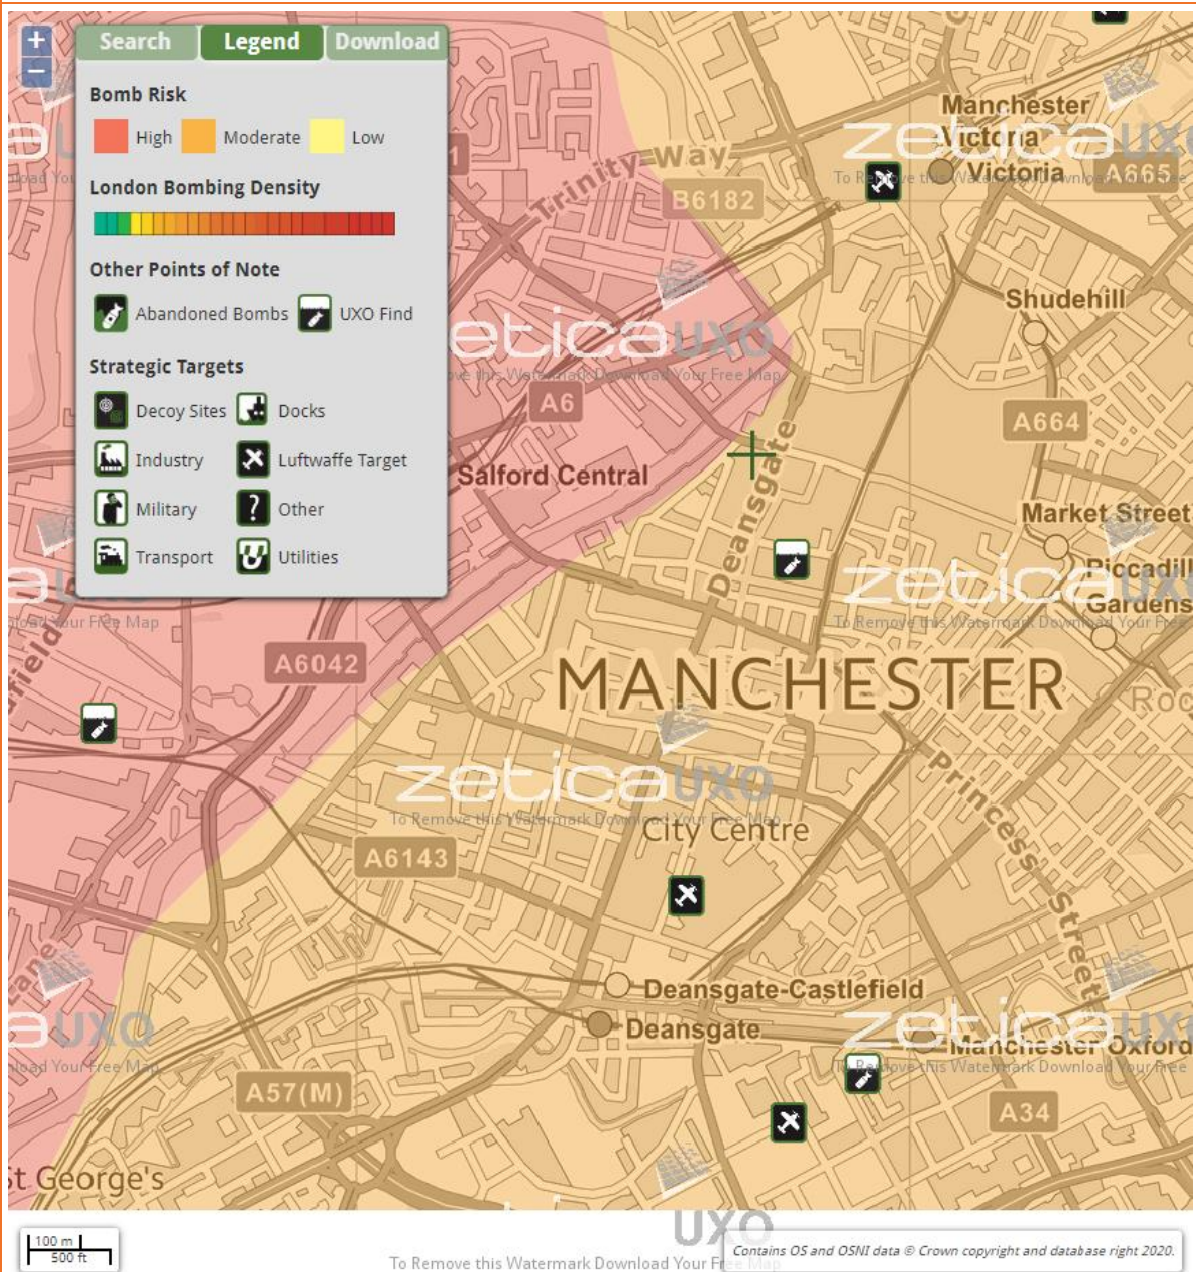
FIGURE 4.2 ZETICA UXO RISKS MAP

As the western boundary of the site is within the high-risk area, it is recommended that further detailed assessments are carried out to establish the level of risk and the potential need for mitigation.

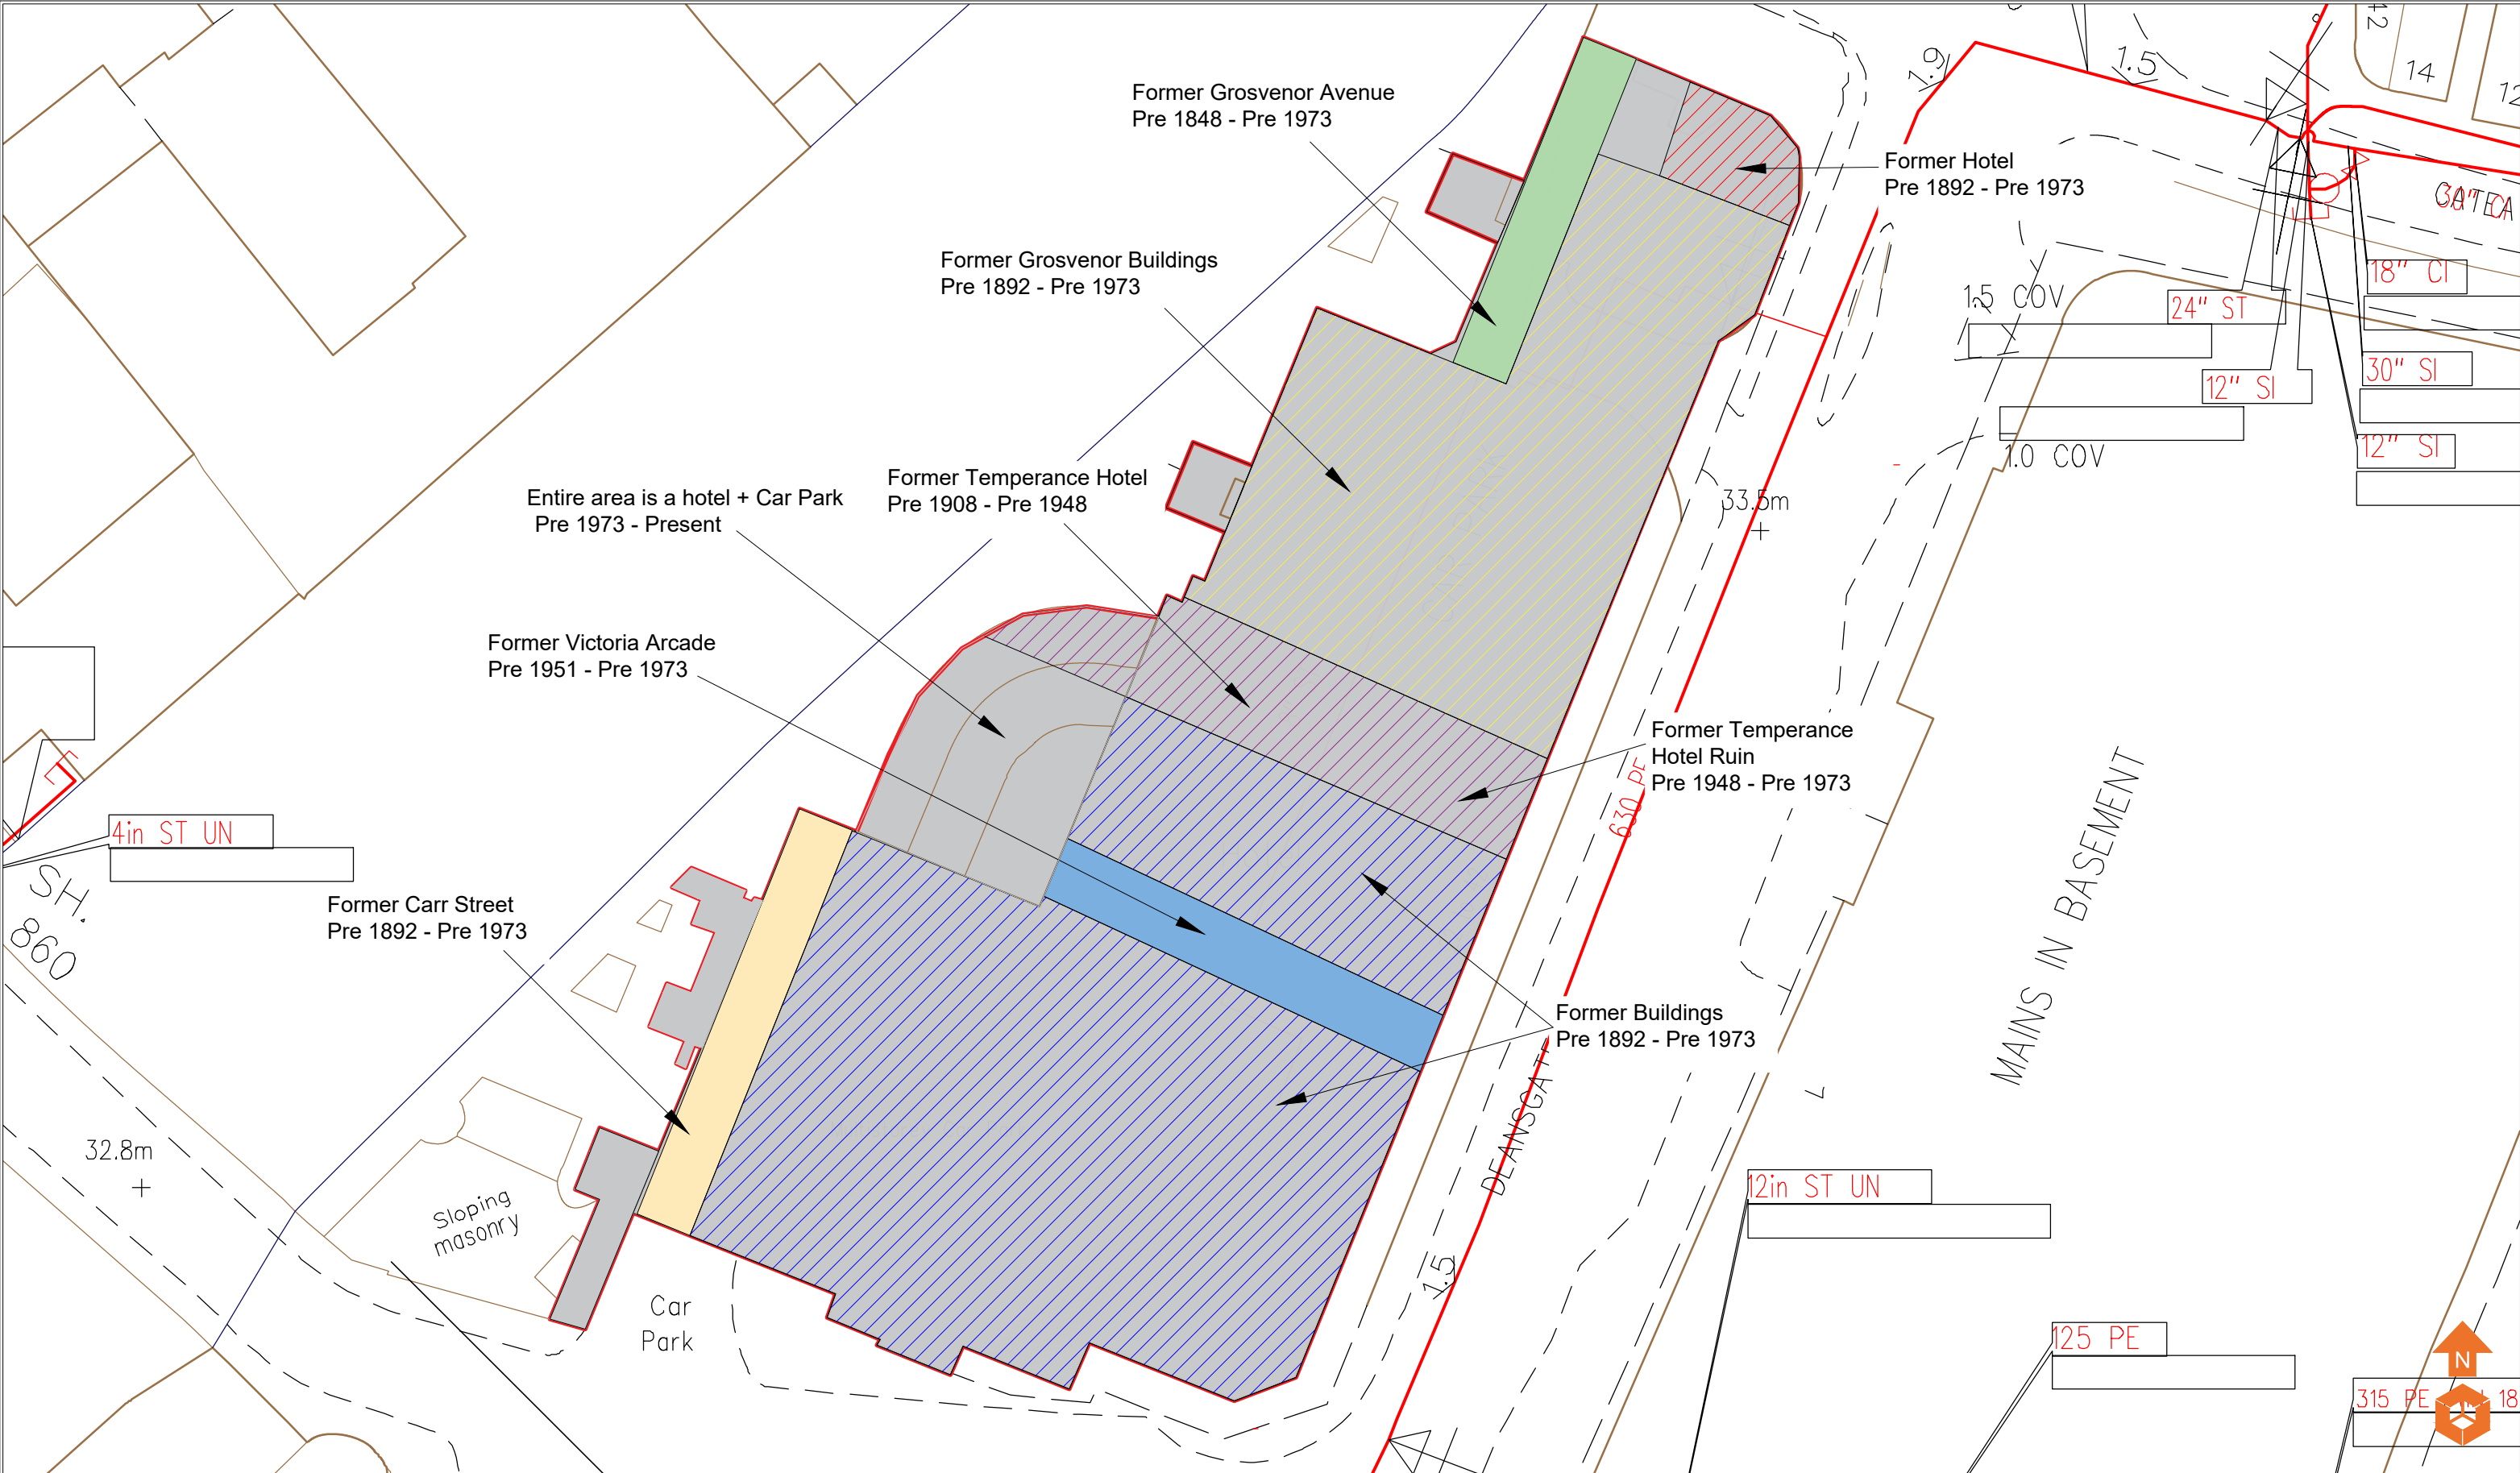
| <div>Historical Features</div> <div><div></div>Former Buildings</div> <div><div></div>Former Carr Street</div> <div><div></div>Former Victoria Arcade</div> <div><div></div>Former Temperance Hotel</div> <div><div></div>Former Grosvenor Building</div> <div><div></div>Former Grosvenor Avenue</div> <div><div></div>Former Hotel</div> <div><div></div>Current Hotel and Car Park</div> |
