Arboricultural  
Impact Assessment  
with  
Arboricultural Method Statement

**Land at Sherborne Street  
Cheetham Hill  
Manchester**

Project No. AIA.13473.01

4<sup>th</sup> June 2022

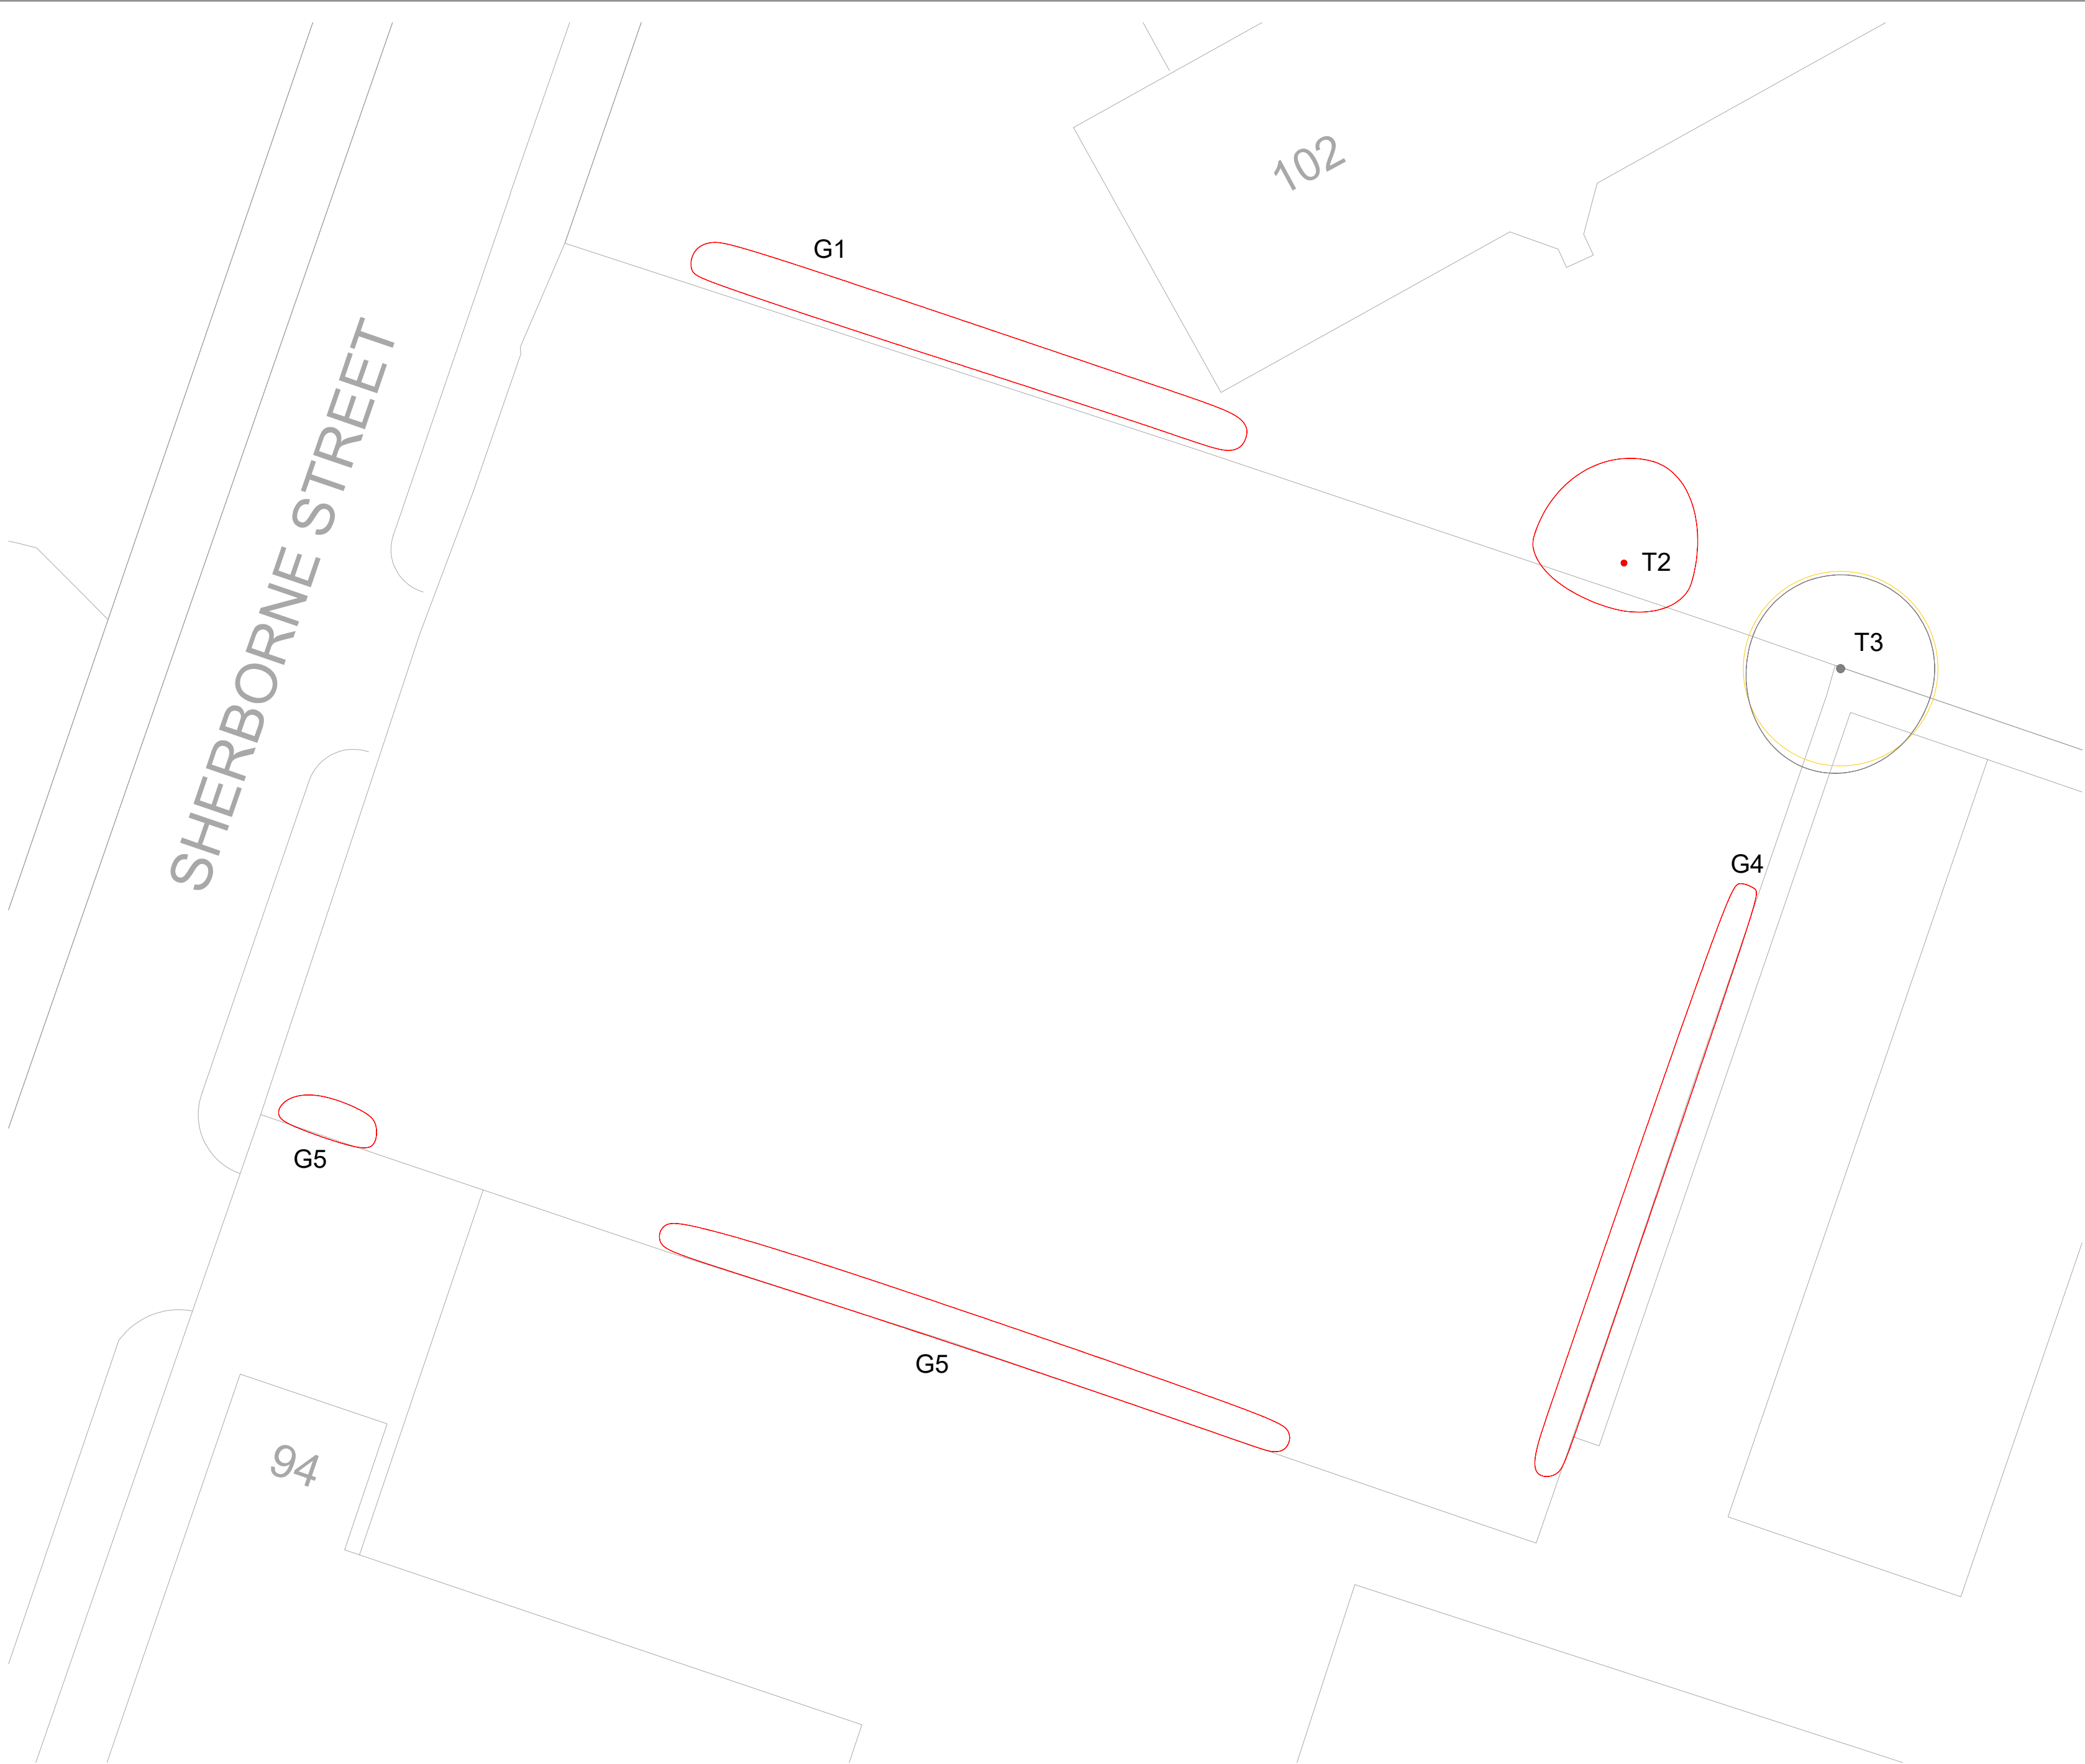
## Drawing 1. Tree Constraints Plan

- 2.2.1. Please see *Appendix 1* for the detailed list on existing species, age class, dimensions and condition of trees within the site, and *Appendix 2* for an explanation of retention category criteria. Tree locations can be seen on the *Tree Constraints Plan* at the rear of this report (*Drawing 1*).
- 2.2.2. The inspection of several trees was restricted as detailed at *Appendix 1*. The inspection of these trees was limited to a cursory observation of the parts of the trees that could be clearly observed, without obstruction, from the available vantage point. However, sufficient tree related data was collected to fulfil the requirements detailed within the scope of this report.

- 2.3.1. The tree Root Protection Area (RPA) is a layout design tool indicating the area around a tree that, along with the tree stem and branches, must be considered during development. The protection of the roots and soil structure within the RPA should be treated as a priority. The RPA of each tree or group is marked on the *Tree Constraints Plan* at the rear of this report.

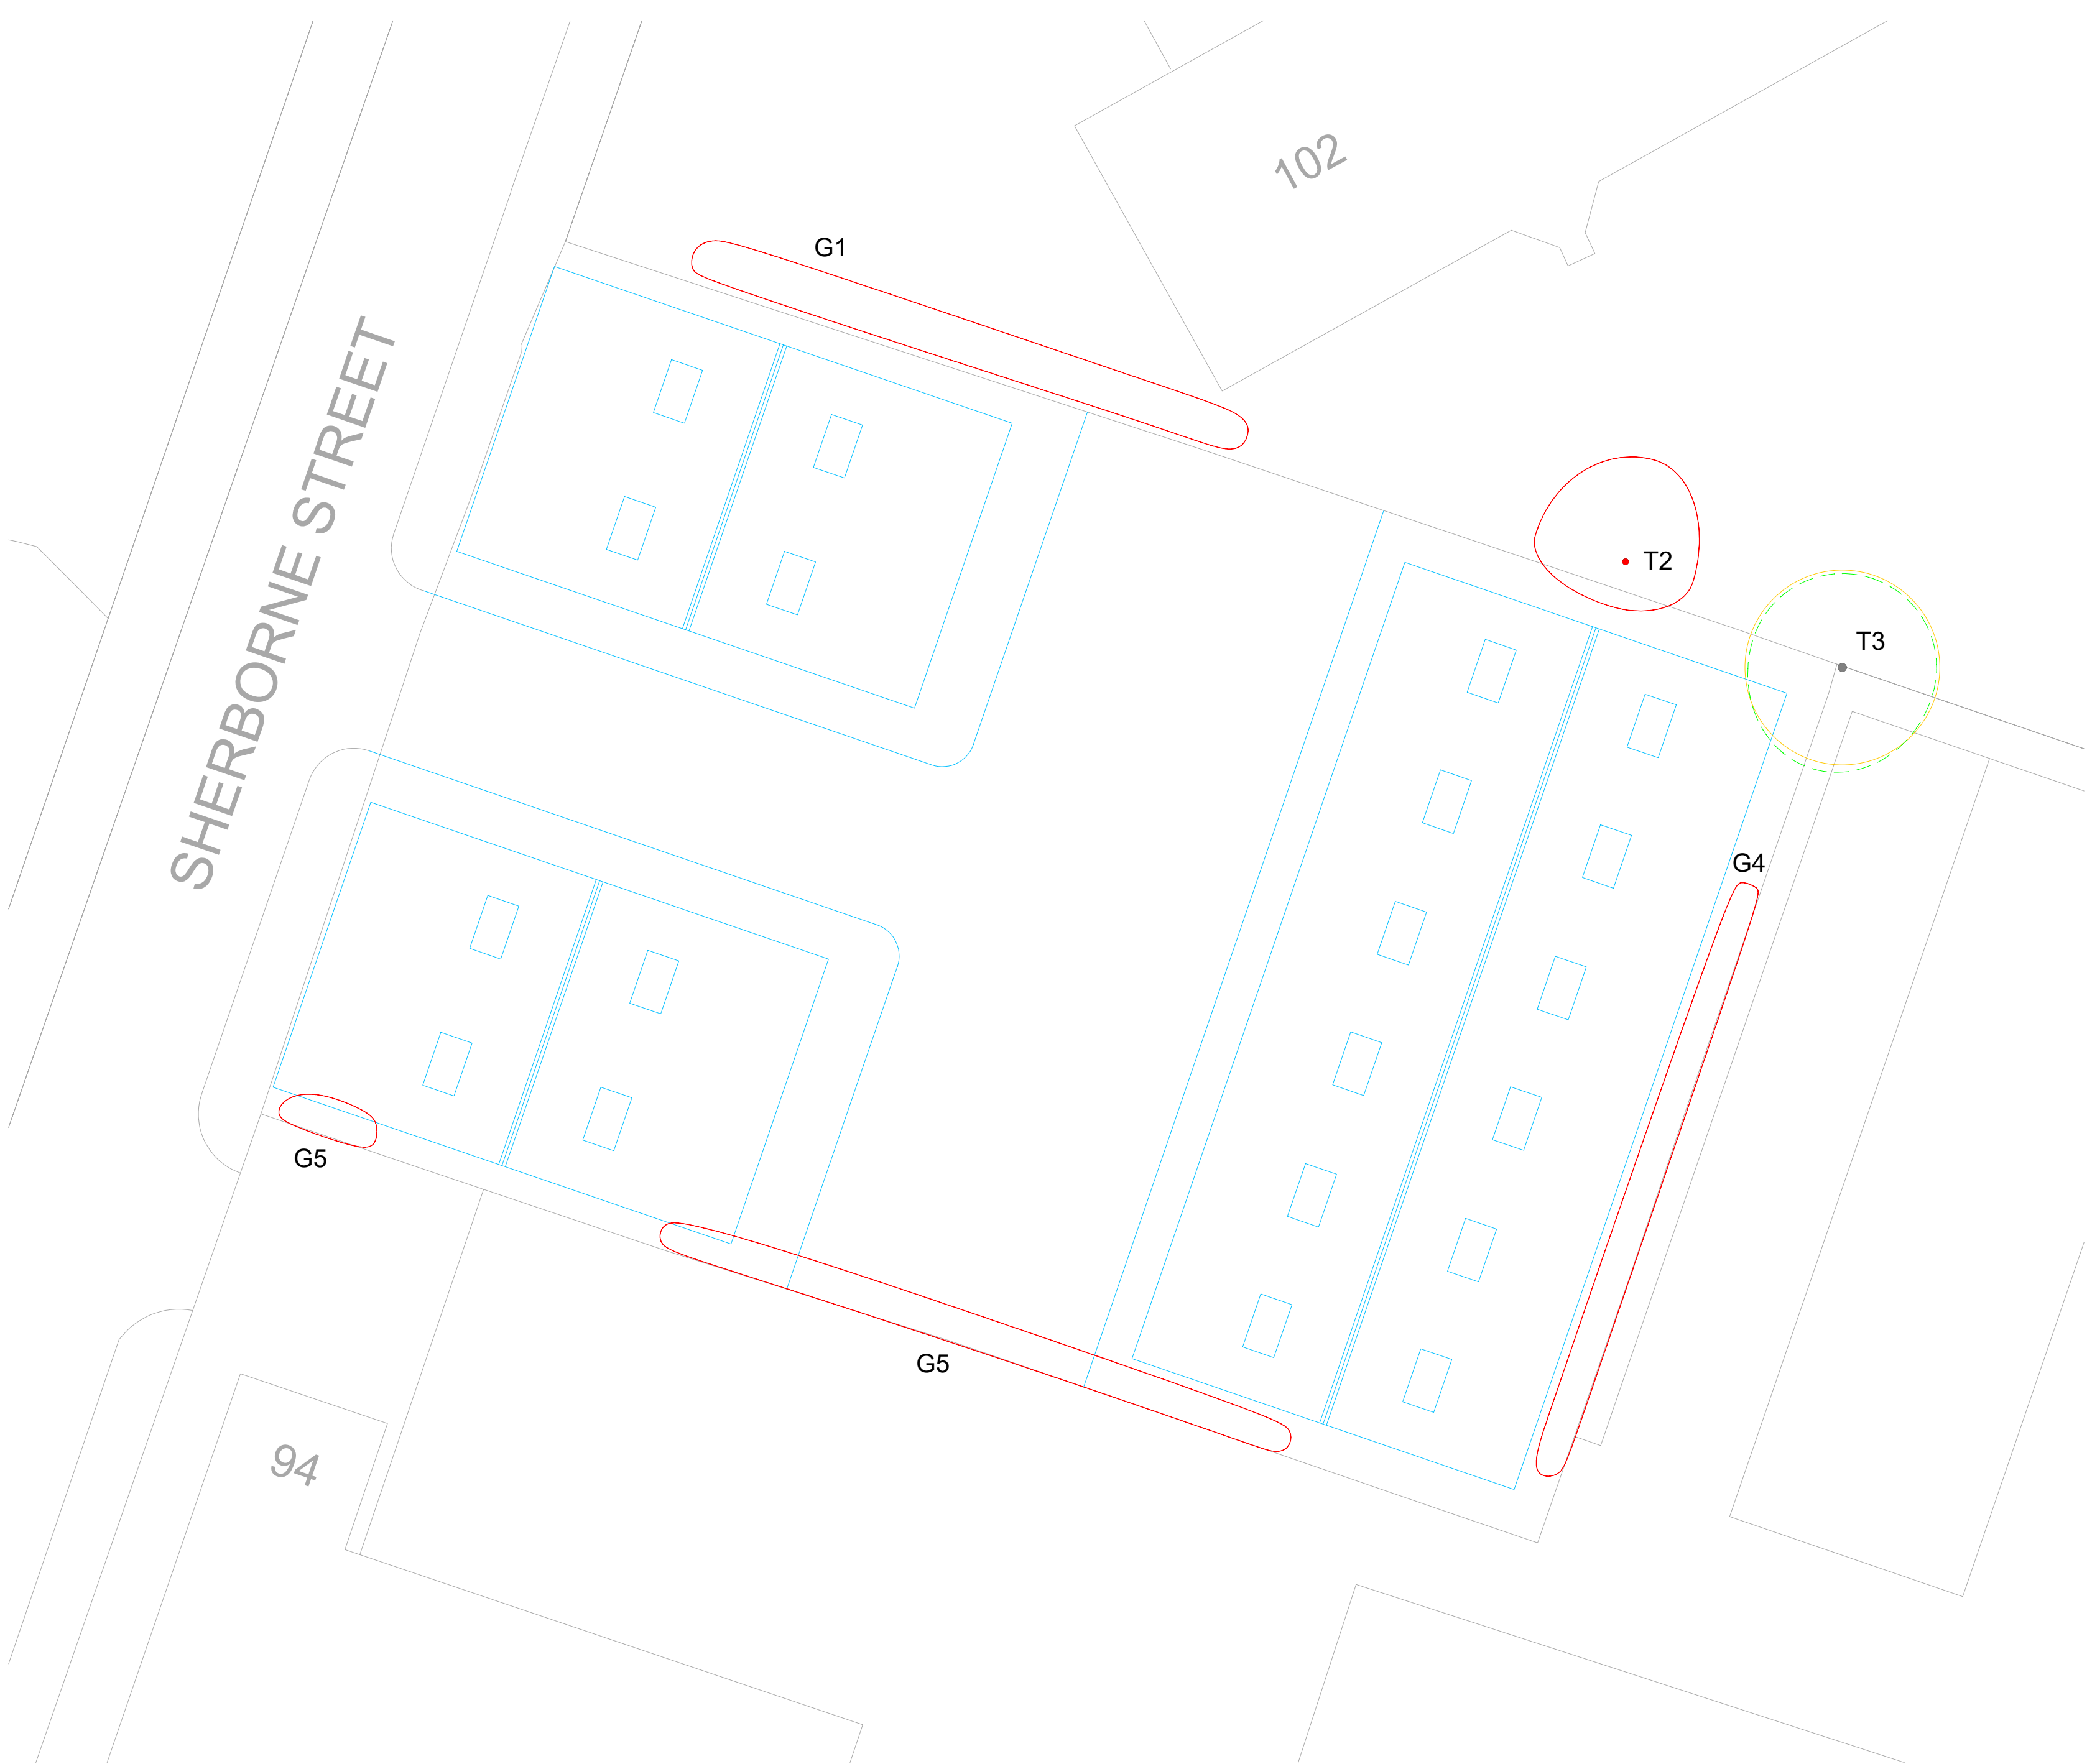
## Drawing 2. Tree Protection Plan

- 3.1.1. A new industrial warehouse development with associated car parking and access road is proposed. The proposed layout drawing can be seen within the *Tree Protection Plan* to the rear of this report. This drawing has been used to assess the potential direct and indirect arboricultural impacts.

- 3.3.1. The retained tree (**T3**) is located beyond an existing boundary fence, and away from the proposed development area. As such, this tree shall not require protection via a temporary protective barrier as it is already provided protection due to its inaccessible location.

- 3.4.1. A section of RPA from tree **T3** extends beyond the existing boundary fence and into an area proposed for hard surface. It should be noted that the RPA of **T3** is currently located within an existing hard surface area, and as such the proposed development should not put the tree under any increased pressure during construction. However, as a precautionary measure, it is recommended that the removal of the existing hard surface, and the construction of the proposed hard surface are undertaken using a *No-Dig* technique that is sympathetic to tree roots.

The retained trees will be protected to British Standard *BS5837:2012 Trees in relation to design, demolition and construction* to ensure that they remain in a healthy condition during and post development. The *Tree Protection Plan* to the rear of this report highlights the recommended tree protection measures.

- 4.3.1. The removal of the existing hard surface within the RPA of **T3** must only be undertaken by hand. The underlying existing soil sub-base ground level must be retained, avoiding the use of heavy machinery within the exposed RPA. Once existing ground level has been reached, the exposed ground level must be protected by temporary ground protection until the proposed hard surface has been constructed.

- 4.5.1. It is recommended that the proposed hard surface within the RPA of **T3** is constructed in a manner that would not cause the hedge any long-term harm. In this instance, it is recommended that a '*No-Dig*' technique is used to prevent damage to the underlying RPA.
