**National Football Museum- Application number: 131037/VO/2021**

**Planning Condition 3 -Discharge Information**

**Condition 3**

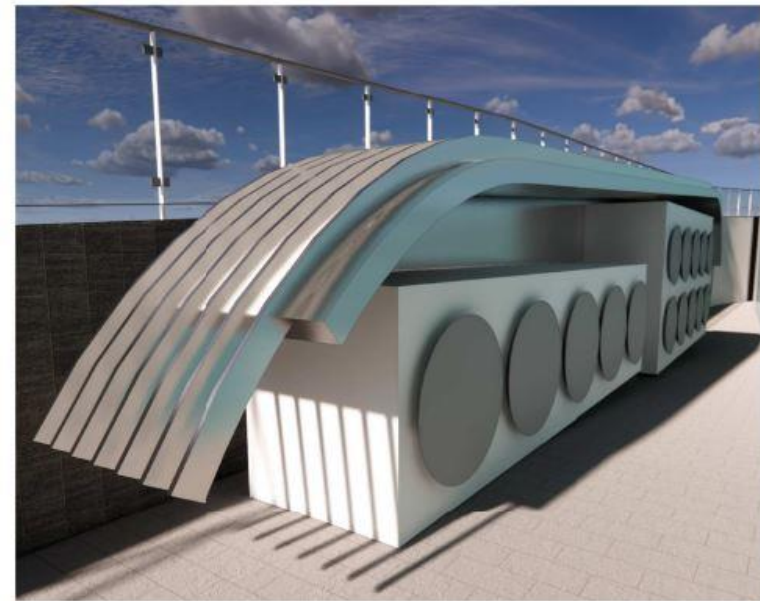
Figure 2-Planning Application Intent perspective image

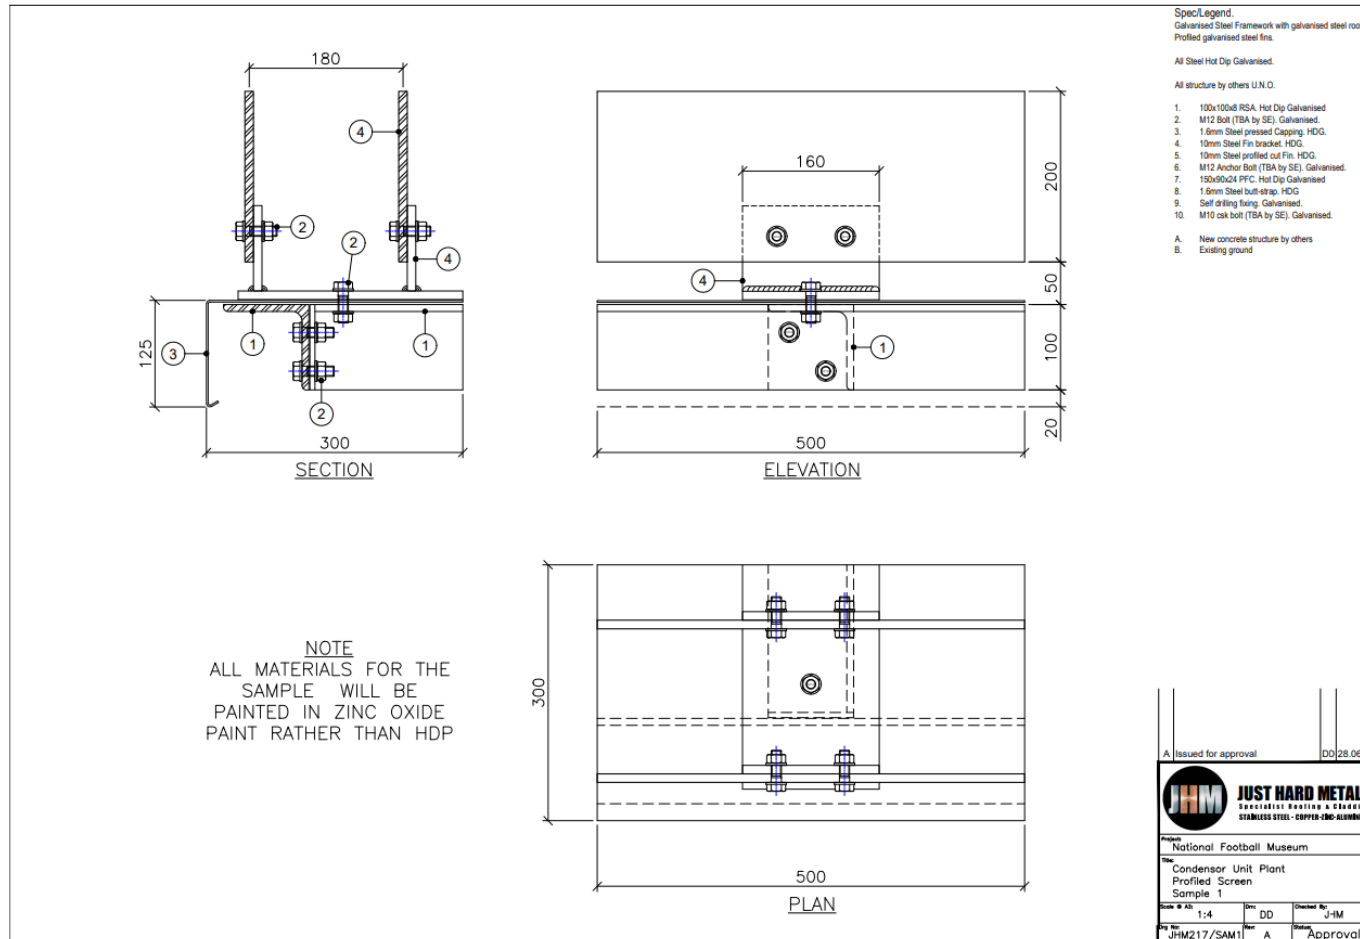
*Figure 4- Structure material specification.*

Galvanised Steel Framework with galvanised steel roof.  
Profiled galvanised steel fins.

All Steel Hot Dip Galvanised.

1. 100x100x8 RSA. Hot Dip Galvanised
2. M12 Bolt (TBA by SE). Galvanised.
3. 1.6mm Steel pressed Capping. HDG.
4. 10mm Steel Fin bracket. HDG.
5. 10mm Steel profiled cut Fin. HDG.
6. M12 Anchor Bolt (TBA by SE). Galvanised.
7. 150x90x24 PFC. Hot Dip Galvanised
8. 1.6mm Steel butt-strap. HDG.
9. Self drilling fixing. Galvanised.
10. M10 csk bolt (TBA by SE). Galvanised.

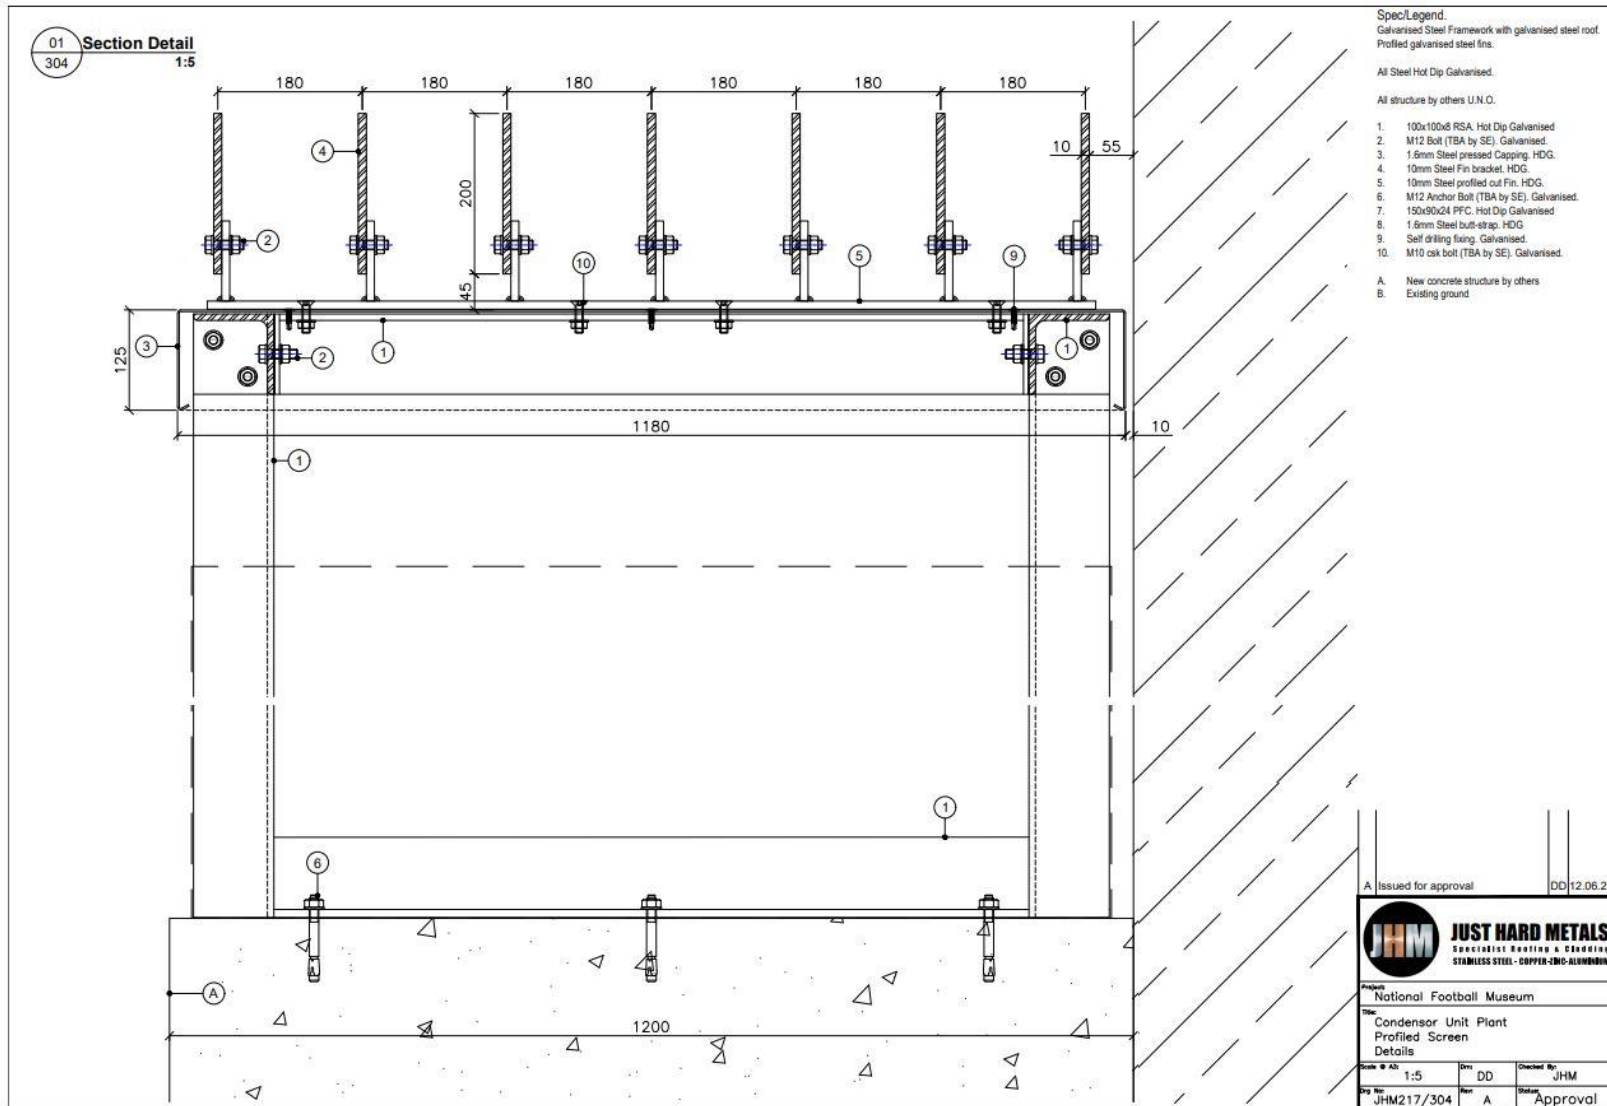
Figure 5- Fabrication drawing cross section of structure
