# **NOMA 2&3 Angel Square**

## **Ground Engineering Desk Study Report**

**050930-BHE-GE-RP-XX-X-0001**

Revision P02

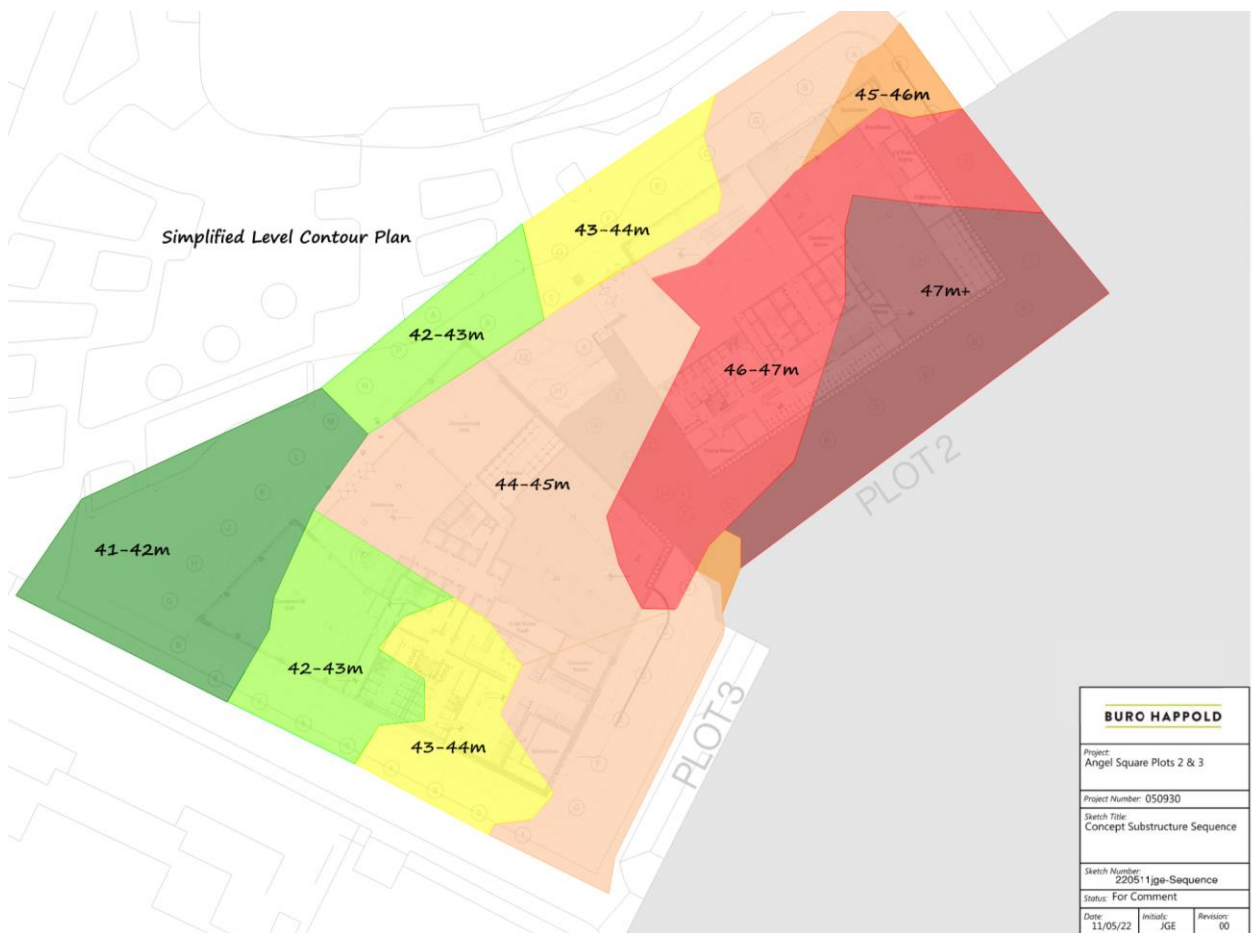
Figure 3-1 Site levels (simplified)

- The eastern area predominantly comprises the former archaeological excavation for Arkwrights Mill. The majority of the platform is between 46 – 47 m AOD, however, the maximum elevation (to the nearest metre) is ~48 m AOD in the far eastern corner of the platform, with a minimum elevation of ~45 m AOD in the northern corner.
- The western area currently comprises existing car parking, however, during the construction of 1 Angel Square this area of site was utilised as a site compound with two temporary buildings. The area slopes to the southwest from a maximum elevation of ~44.5 m AOD in the northern corner, with a minimum elevation of ~41 m AOD in the western corner.

There is thus currently a ~7 m difference in height across the Site separated by slopes with localised or potentially buried retaining structures.

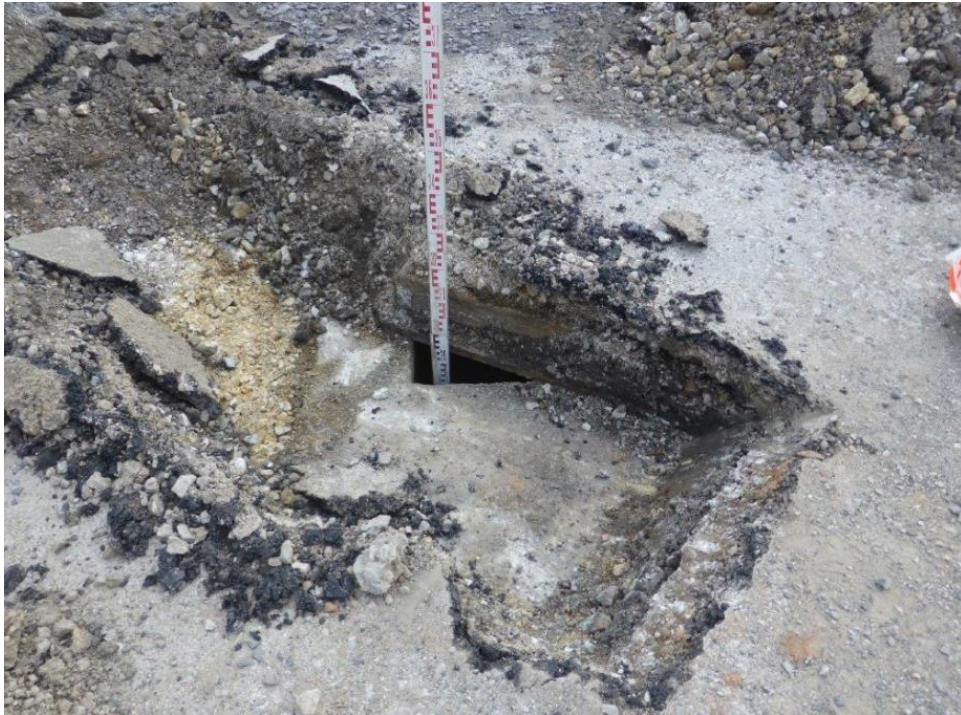
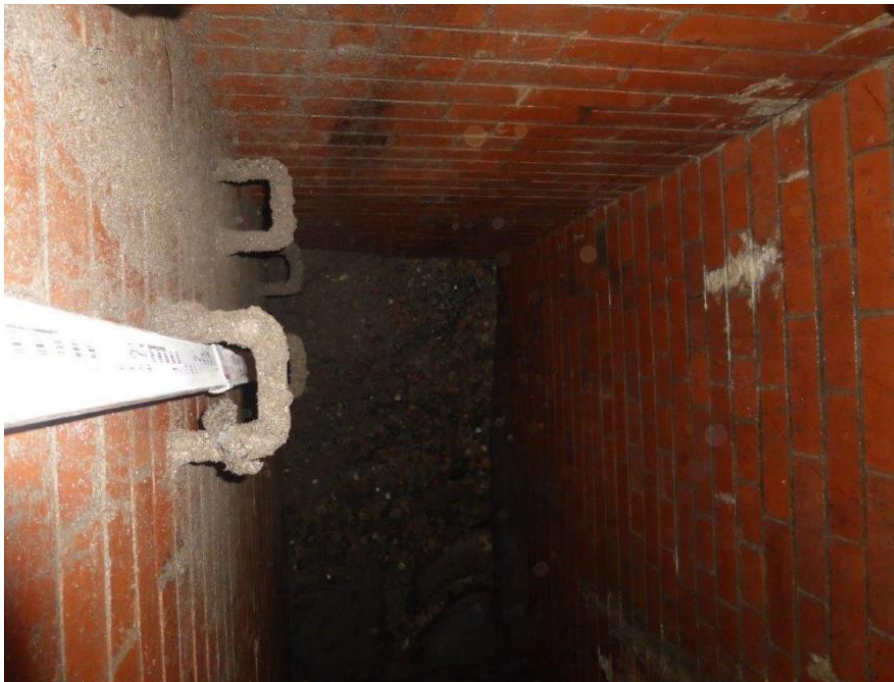
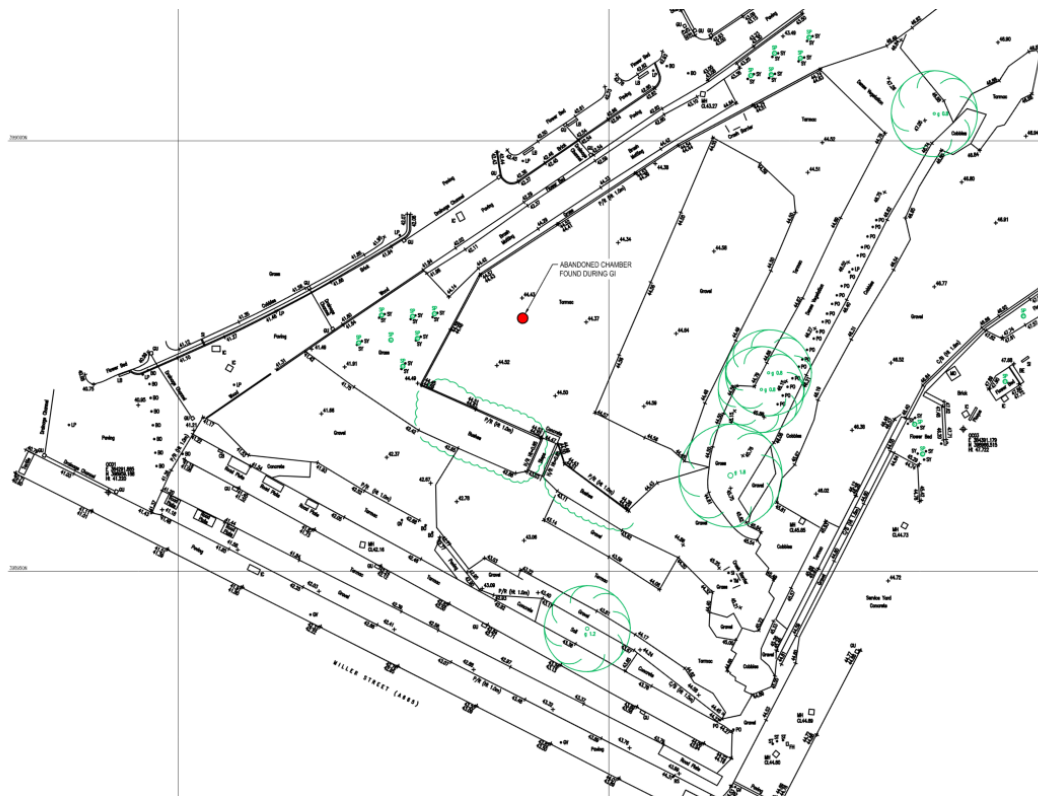
**Figure 3-2-Abandoned chamber found during GI**

It should also be noted that during the SSL 2021 GI a ~3.2 m below ground chamber was encountered in TP110a. This is not recorded on any previous surveys, therefore it is recommended that further investigation is undertaken to understand if the existing chamber / infrastructure is still in use and requires diverting, or if it is part of an abandoned system to be grubbed up/ grouted up.

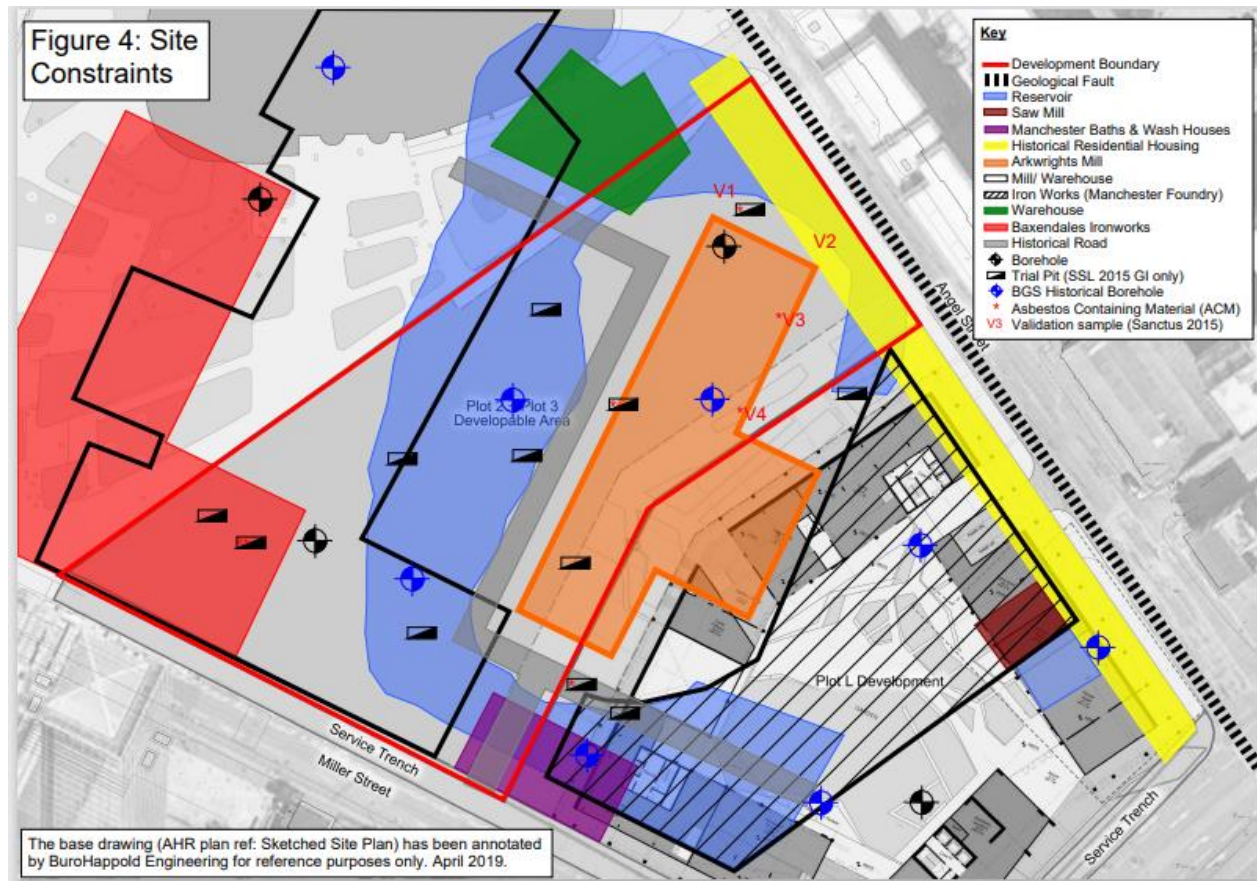
**Figure 3-5 Site Constraints**

For ease of reference, the key points of site history likely to affect the proposed development are summarised as site constraints in Figure 3-5.

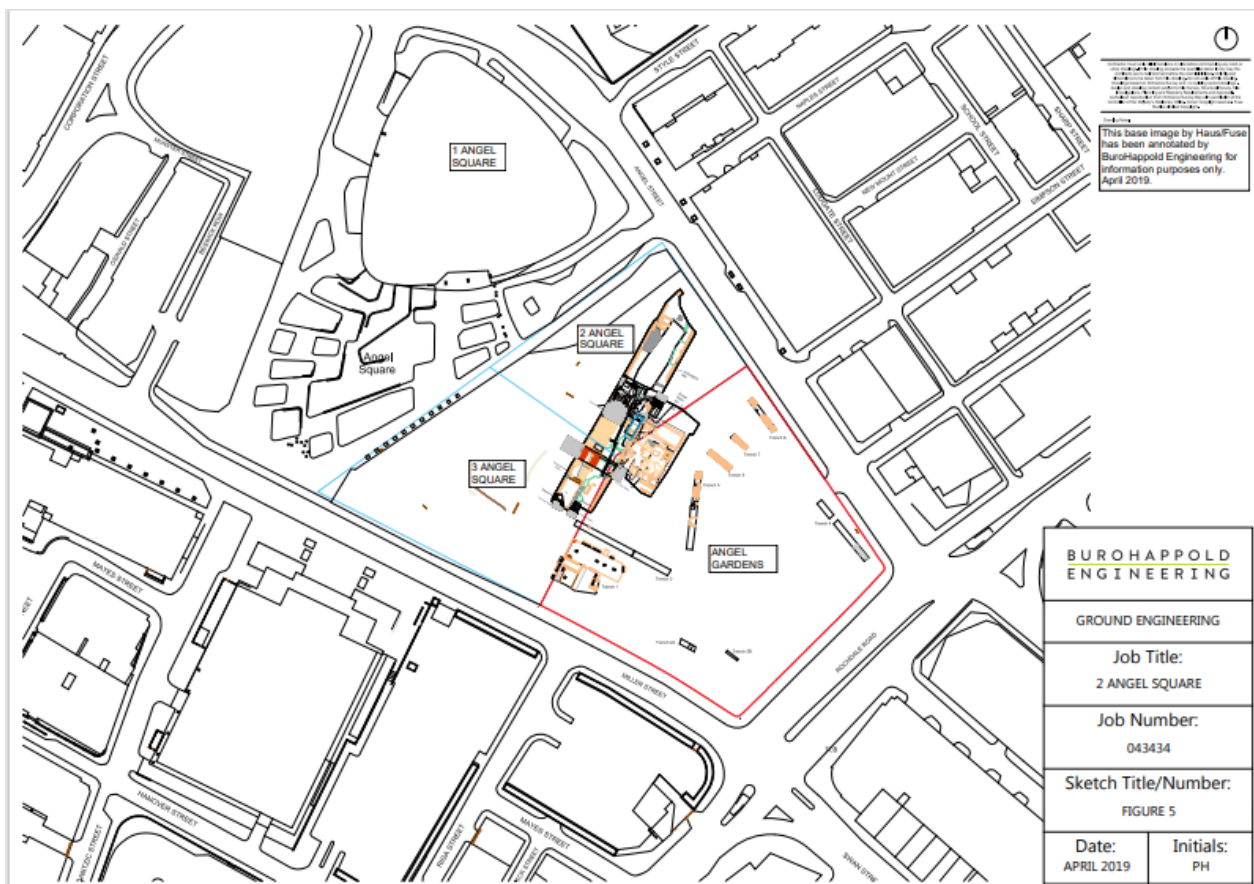
Figure 3-6 Archaeological Trenches (2014)

During 2014, Arkwright's Mill was subject to an intrusive archaeological excavation by Oxford Archaeology North which comprised an evaluated excavation of the majority of the main footprint of the building as well as the Engine House. Full and detailed photographic records were taken as well as surveying to Ordnance Datum with the remains left in situ. The study concluded that the site is 'of considerable archaeological and historical significance on a regional level', however the 'overall group value is reduced by extensive loss of the component buildings and infrastructure' over the years that followed its use. In addition, Salford Archaeology completed further trenching across the site during 2021. Reference to the findings of this study should be made in conjunction with these reports.

The potential archaeological remains that exist on or adjacent to the Site may include the remains of cotton mills and associated reservoirs, an iron foundry, a saw mill and timber yard, a brewery, a public baths and wash house, public houses, shops and housing of various types. Although some evidence of features along Miller Street are likely to have been destroyed either during the Manchester Blitz or during road widening works in the early 1990s, the Time Team investigation and Oxford Archaeology North's recent works shows that evidence of Arkwright's Mill both on site and to the west of the proposed development site is well preserved and close to the surface (Figure 3-6 refers). The mill was

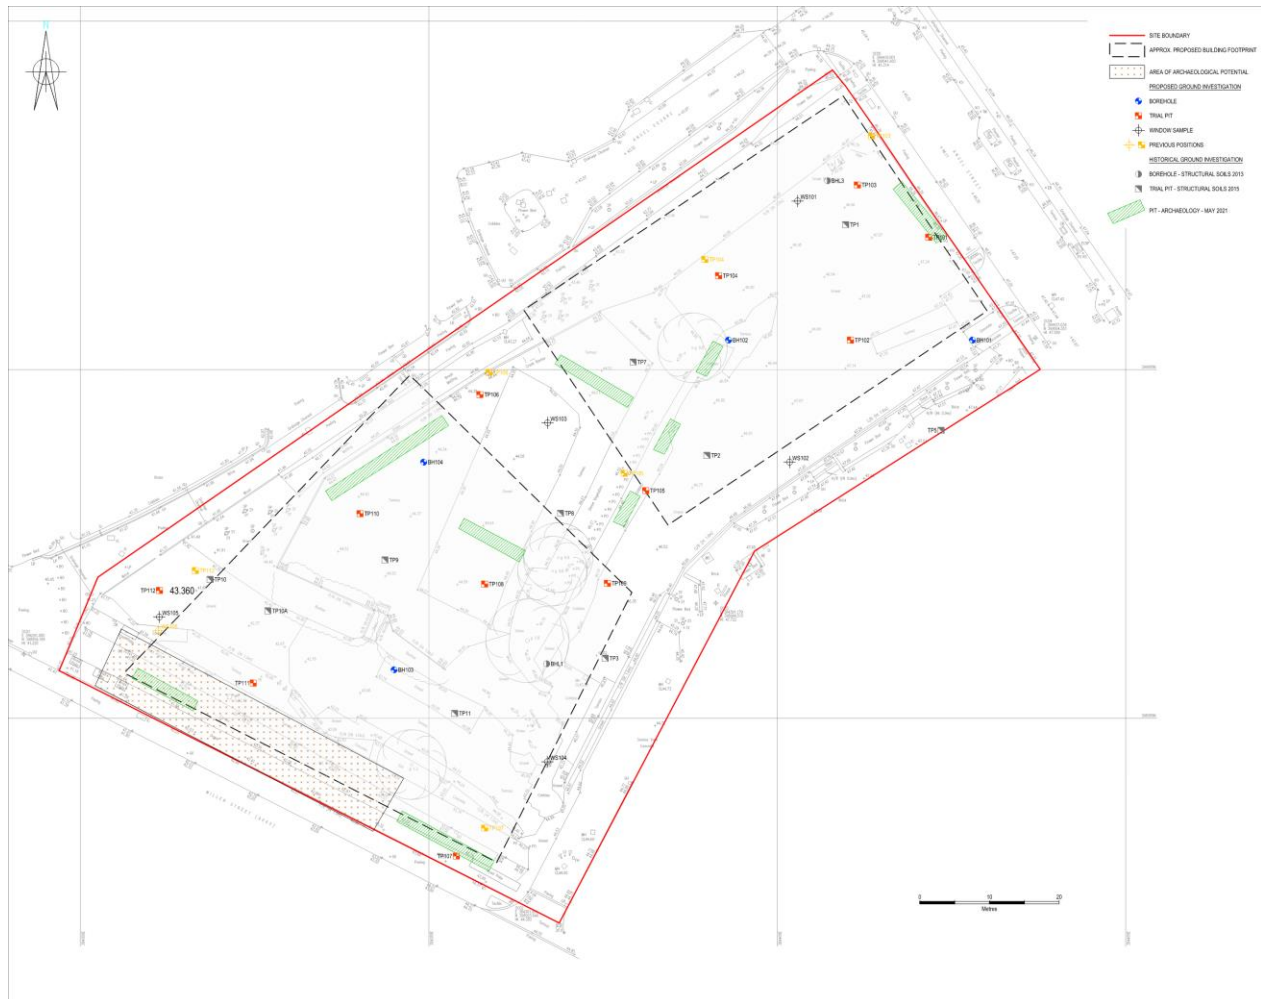
Figure 4-1 Historical and Recent GI Locations

Two site specific GI's have been undertaken by Structural Soils Limited (SSL), both under the supervision of Buro Happold. Historical GI's for the adjacent sites have also been taken into consideration to inform the ground model - SSL 2009 GI at 1 Angel Square to the northwest and SSL 2013 GI at Angel Gardens to the southeast. Please note, BHL01 and BHL03 from the SSL 2013 GI for Angel Gardens were located on the 2&3 Angel Square site.

The SSL 2015 GI was undertaken during January 2015 and comprised 13 No. machine excavated trial pits (TP1 - TP4, TP4A, TP5 – TP10, TP10A and TP11) across the Site and its surrounds, along with associated chemical testing including asbestos identification and quantification. Groundwater and ground gas monitoring was also carried out in historical borehole BHL01 on the Angel Gardens site. All other historical borehole installations could not be found.

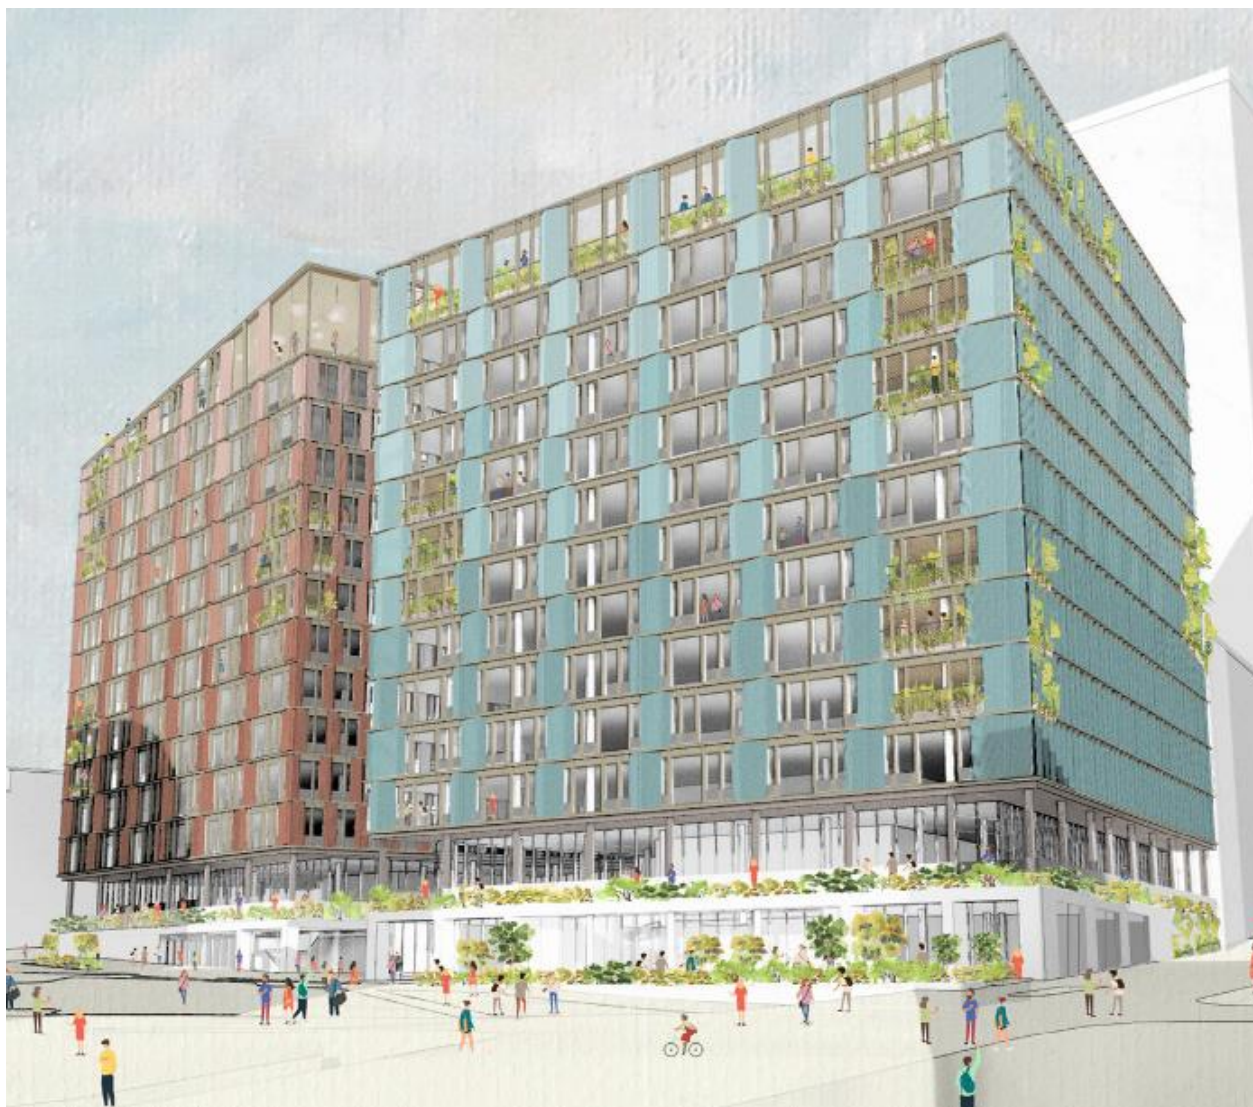
**Figure 6-1 Architects visuals of the two buildings**

The Proposed Development comprises the erection of two high quality commercial office buildings of 13 and 14 storeys, alongside public realm, car parking, extensive cycle parking facilities, and associated highways and access arrangements. At this stage the phasing and delivery strategy is not fixed. It is possible that either 2 Angel Square or 3 Angel Square could be delivered first as a standalone building, or the delivery could be concurrent. In advance of works starting on 2 & 3 Angel Square, the Noma Marketing Suite is under construction on the Site as a temporary building in the southwestern corner of the Site and will consist of a single storey temporary building with associated car parking and public realm. This is proposed to be relocated for the construction of 3 Angel Square.
