# Television and Radio Baseline Survey and Report

Alberton House

June 2022

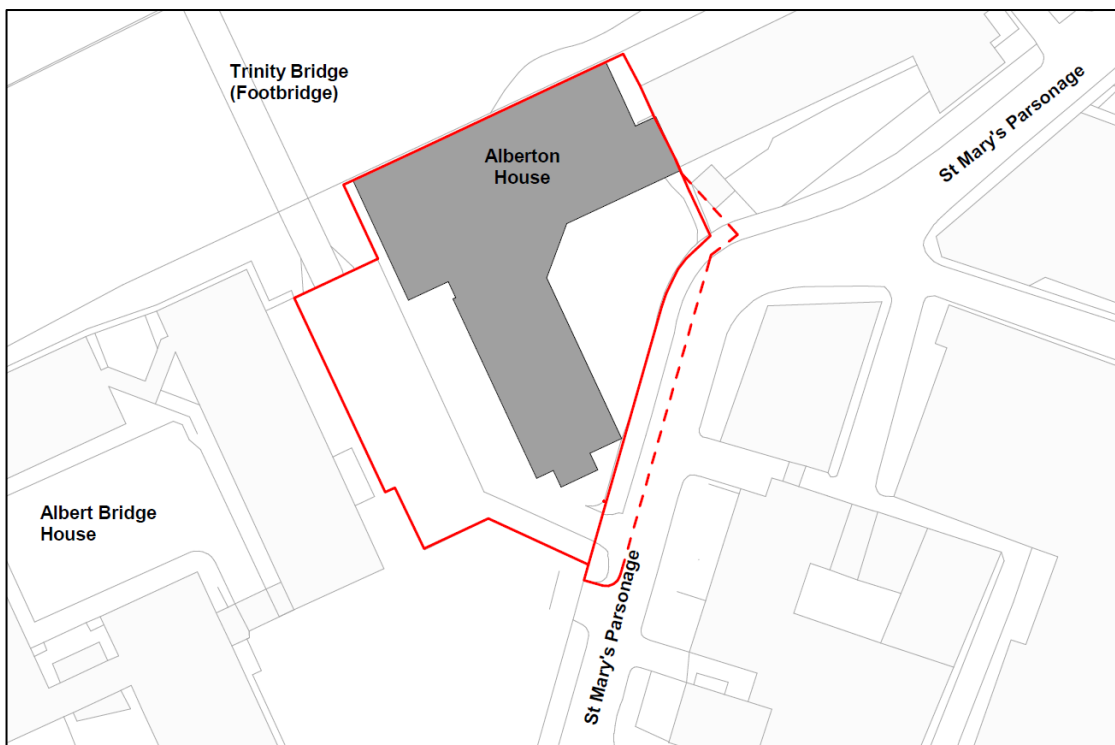
Figure 1 Proposed development redline boundary

The proposed development redline boundary is shown in Figure 1<sup>1</sup> below.

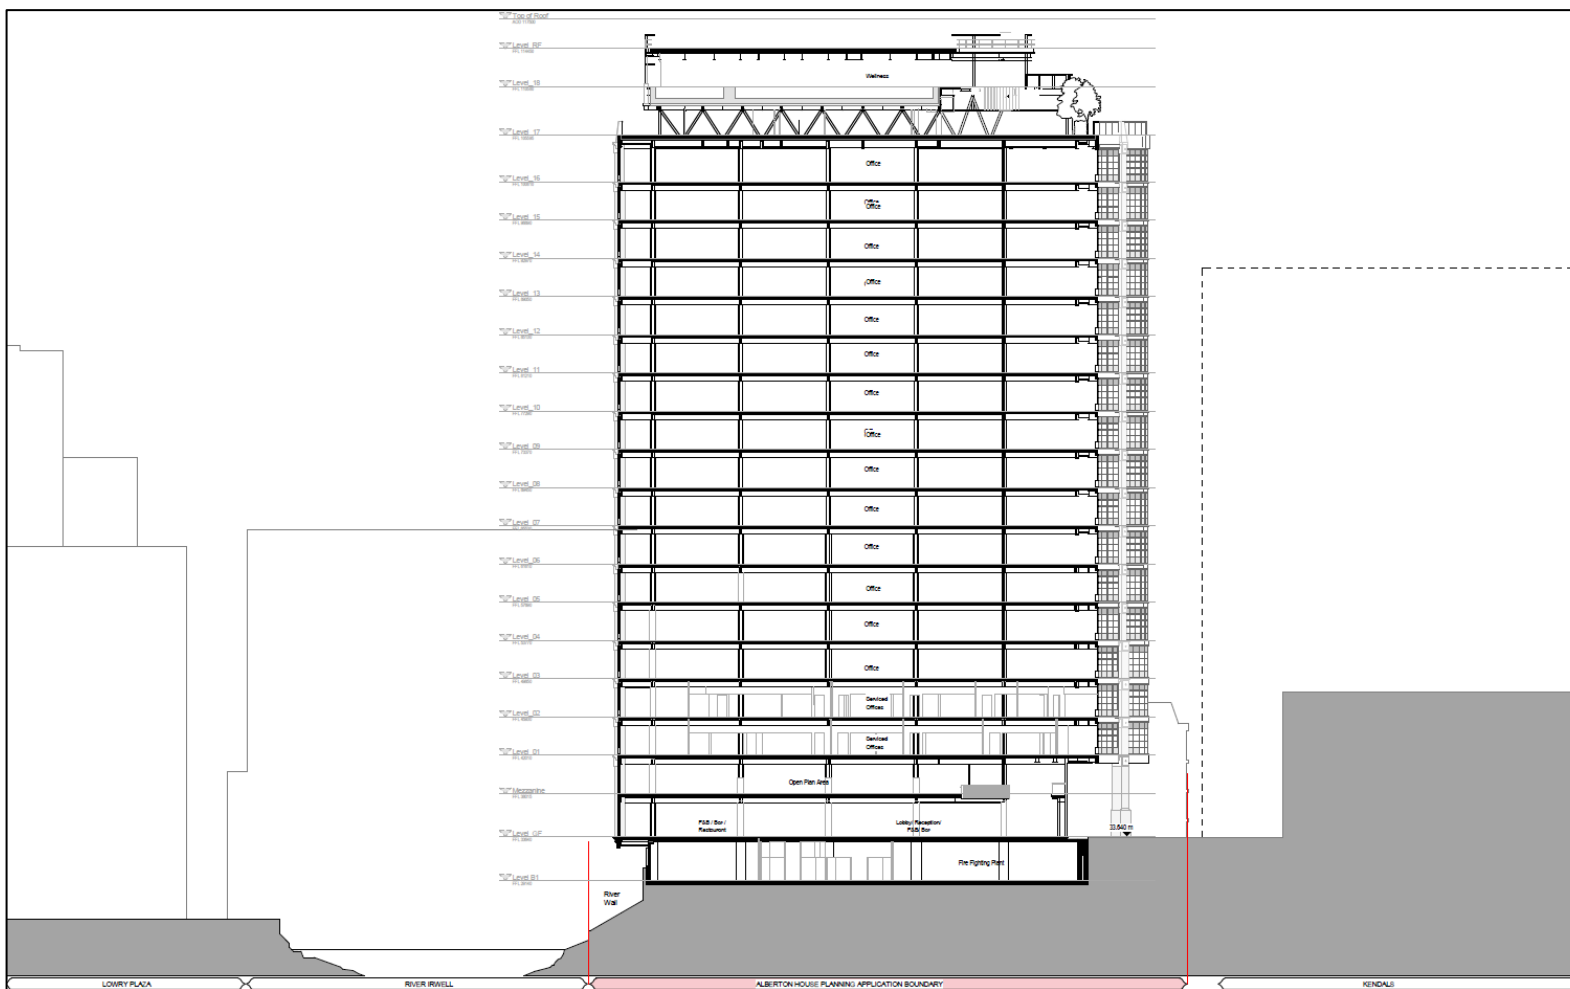
Figure 2 West elevation

Figure 2<sup>2</sup> on the following page shows the west elevation of the proposed development.

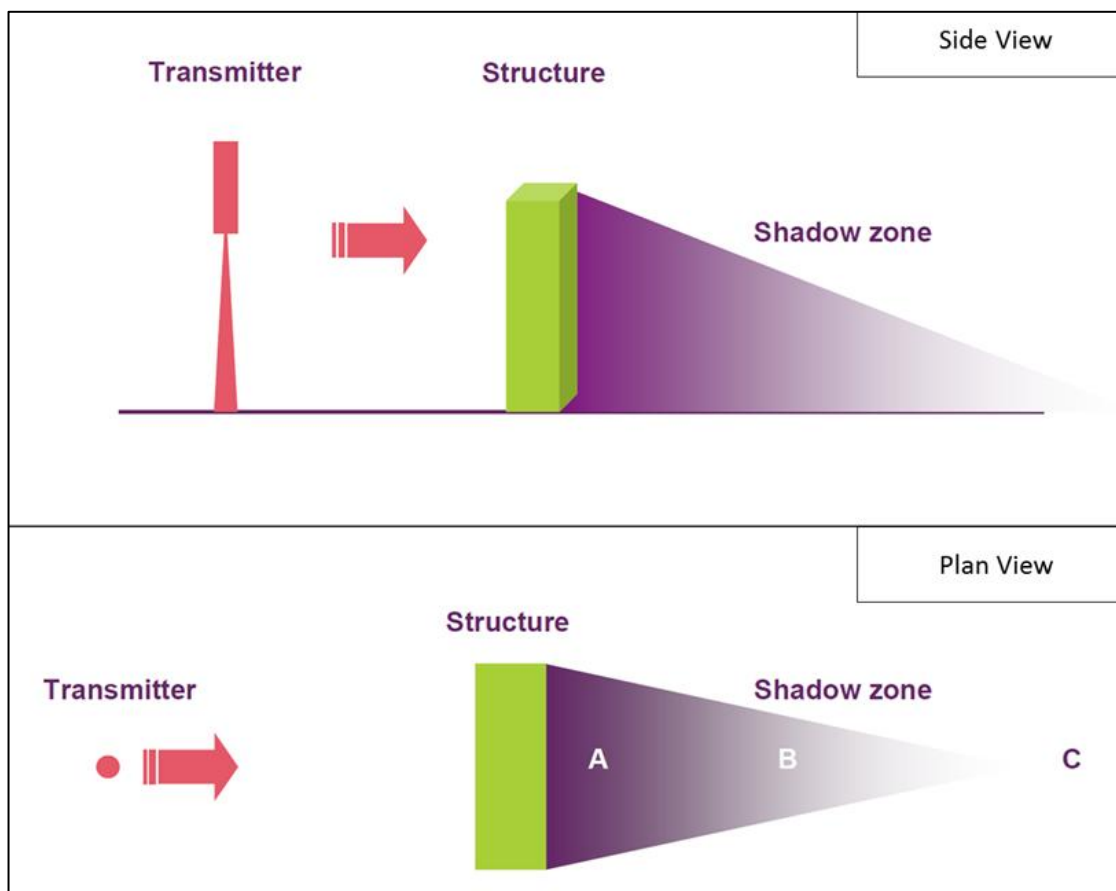
Figure 3 Diffraction loss zones

*"In general, there will be three 'zones' behind the structure:*

*Zone A - close behind the structure (typically a few tens of metres) there may be a large reduction in signal level with a possible complete loss of reception*

Zone B - further away (typically a few hundred metres) the signal reduction is less severe and the shadow will be smaller as diffraction effects partially fill in the shadow. Depending on the size of the structure, some locations could still lose reception completely

Zone C - some distance away (1-5km) the shadow will effectively have disappeared.”

The zones mentioned are illustrated in Figure 3 below<sup>4</sup>, taken from Section 3.2 of an Ofcom paper<sup>5</sup> regarding the impact of buildings on broadcast signals.

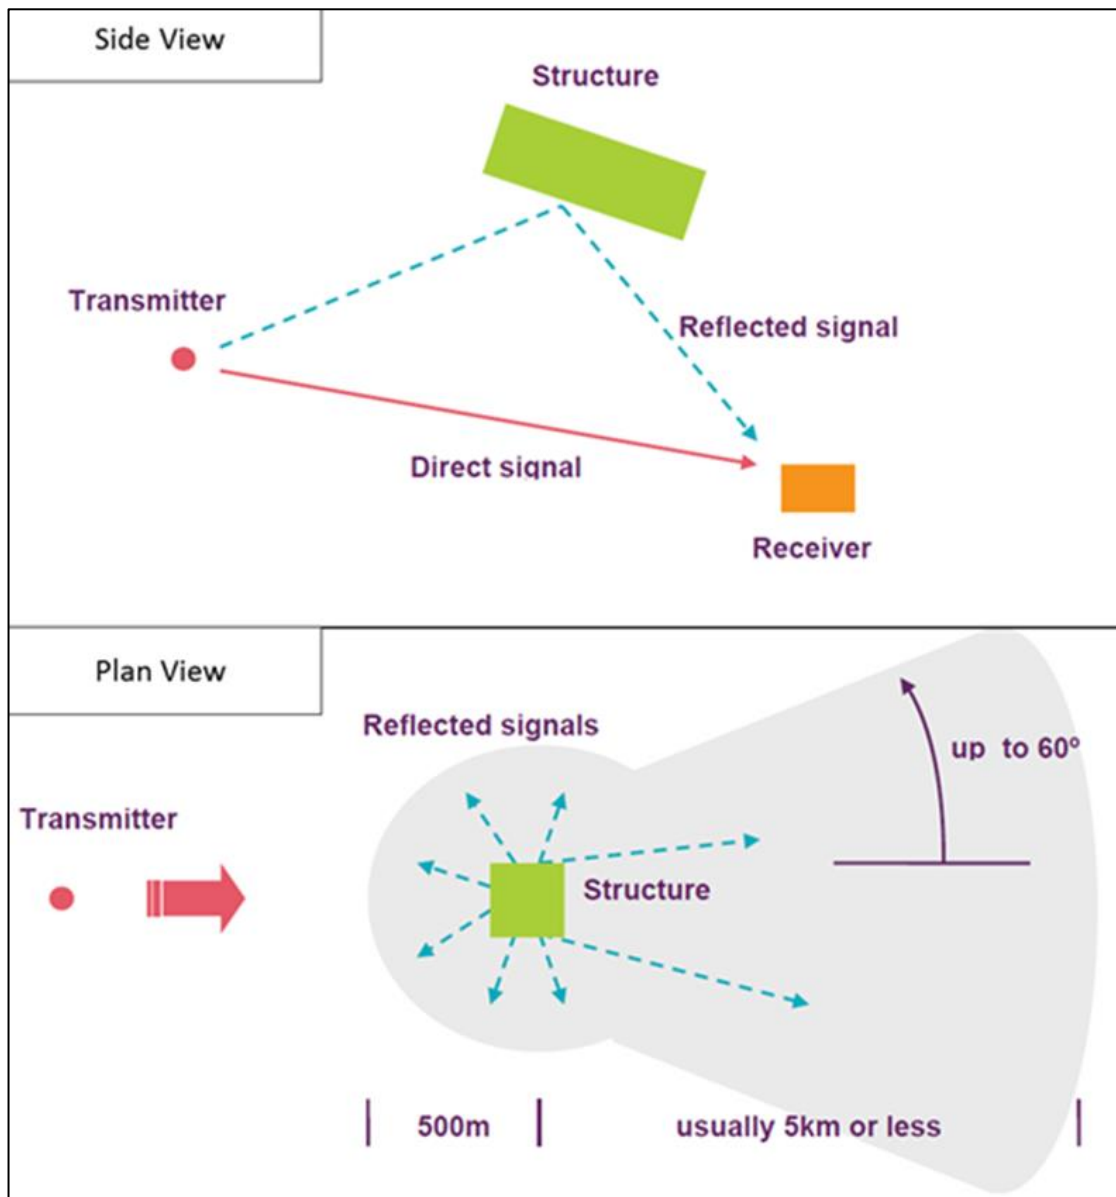
Figure 4 Reflection zones

For large developments with straight edges, the transmitted signal can be reflected by the building itself. This causes an effect known as ‘multipath interference’ whereby the signal is received twice by an aerial at different times. The direct signal arrives first because it has a shorter distance to travel.

Figure 4 on the following page (taken from Section 3.3 of the Ofcom document referenced above) illustrates this effect.

In practice, it is considered highly unlikely that reflections will have an effect for receivers in front of the building or on either side when viewed from the location of the transmitter. For digital transmissions in particular, it is unlikely that issues will occur if the angle between the direct signal and the reflected signal is more than 30 degrees<sup>6</sup>.

The reflection zone has been constructed in accordance with the Ofcom approach, however the angle considered is 30 degrees rather than 60 degrees. This is in order to represent a more realistic scenario for digital transmissions.

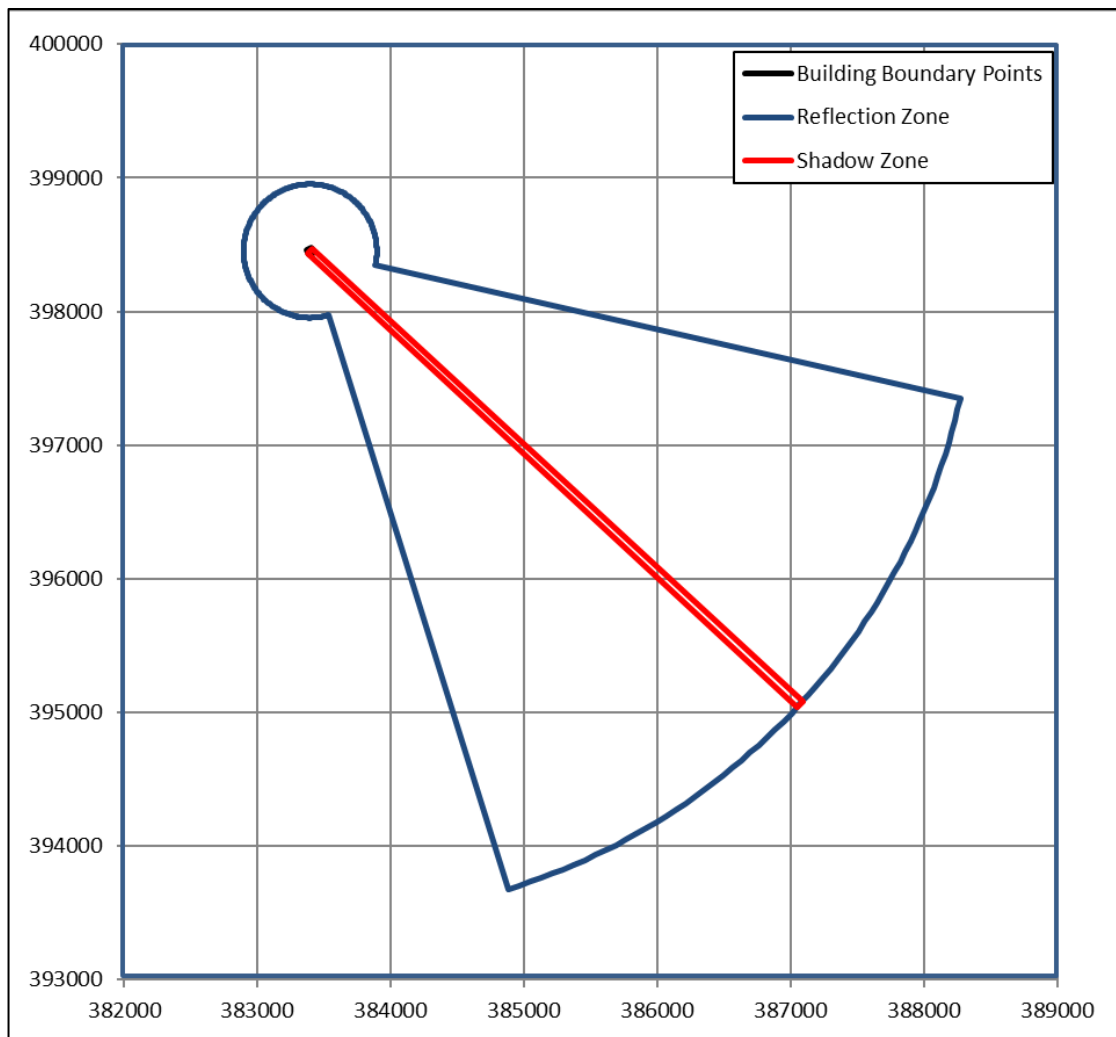
Figure 5 Interference areas

The shadow and reflection zones have been defined based on the geometry as set out in the previous section. Both zones extend to a distance of 5km beyond the proposed development location in accordance with the Ofcom guidance.

In the case of the shadow zone, this has been modelled as having straight sides in order to be conservative. In actuality, due to diffraction effects, the zone would have a more triangular shape as shown in Figure 3 in the previous section. Figure 5 below shows the potential interference areas associated with the proposed development.

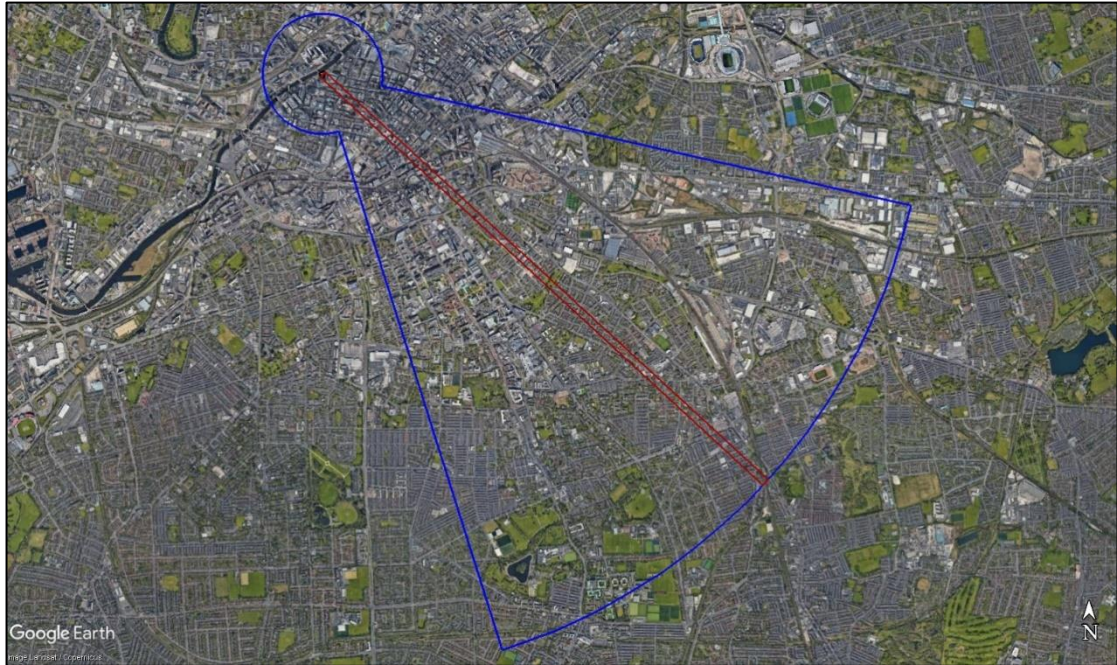
Figure 6 Interference zones map

Figure 6 below shows the interference zones overlaid onto an aerial image of the area.

Urban areas closest to the proposed development are at the highest risk of experiencing television interference. However, based on a review of the aerial imagery, the shadow zone passes over the city centre which contains shops and non-residential buildings.

The closest urban areas with high- and low-rise residential properties within the shadow zone are located approximately 1.5km from the proposed development.

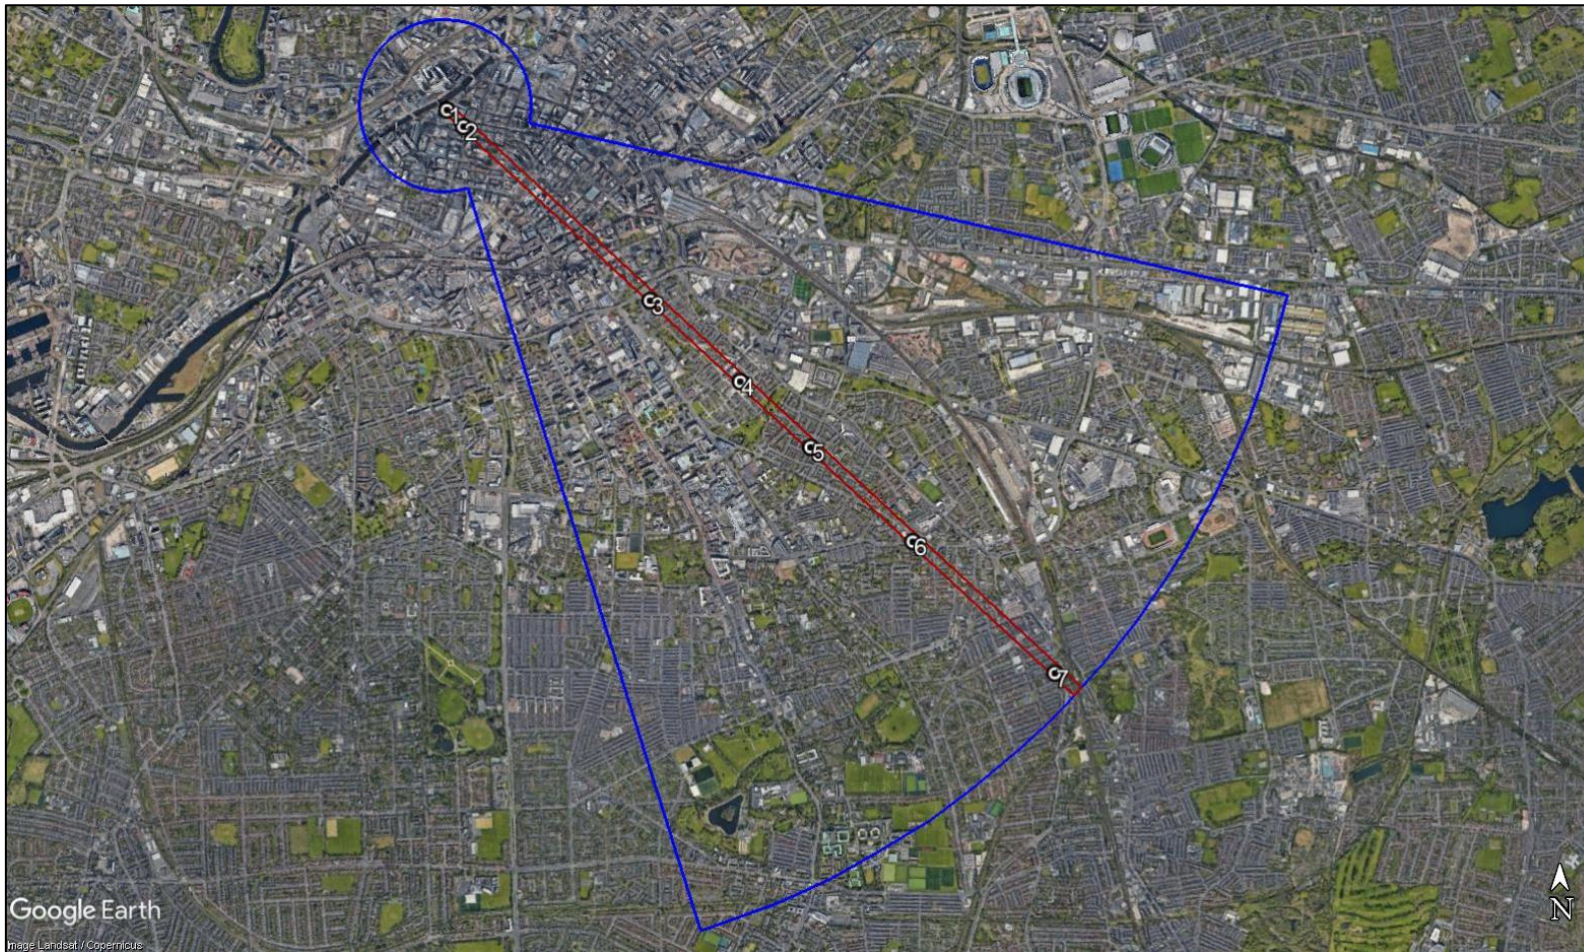
Figure 7 Survey locations

Locations were selected considering potential residential areas within the building's shadow zone. The locations are deliberately spaced close together nearest the proposed development, as this is the area where effects would generally be the most likely and multiple measurements within a relatively short distance could be the most relevant.

Survey locations were chosen pre-survey (within the shadow zone); however, safe and available access influenced the specific position on the day.

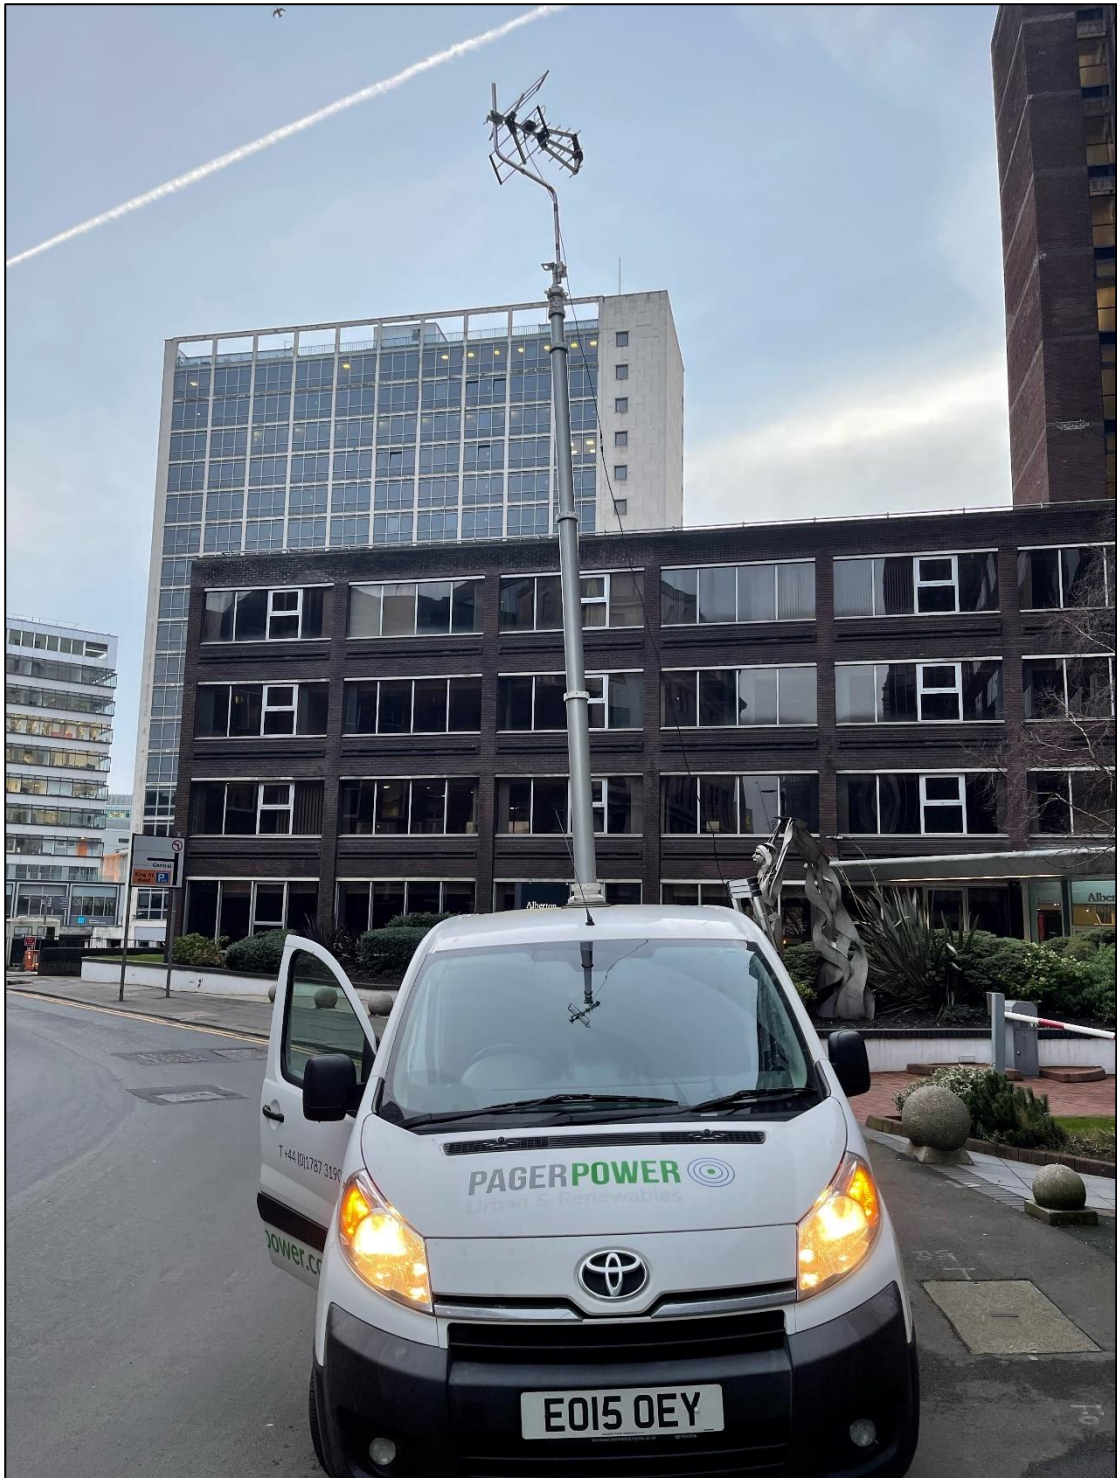
### Location 1

Notes: No aerials or satellite dishes observed at this survey location.

| Location | Average Measured Signal Strength (dB) | Remarks | High-Level Conclusion |
|---|---|---|---|
| 1 | <p>Main TV MUX:<br/>45.0<br/>(Moderate/Good)</p> <p>Local TV MUX:<br/>34.8 (Low)</p> | <p>No aerials observed at this location. It is likely none of the surrounding buildings are residential properties or the aerials are higher than 10m agl.</p> <p>All main multiplexes displayed fine picture and audio quality with no signs of interference.</p> <p>Two local multiplexes did not decode.</p> | <p>The survey location is within 10m of the proposed development and within its shadow zone.</p> <p>Considering the distance from the proposed development, a reduction in signal strength is likely.</p> <p>Noticeable effects are not predicted in practice due to the lack of residential properties or height of any aerials in the area.</p> |

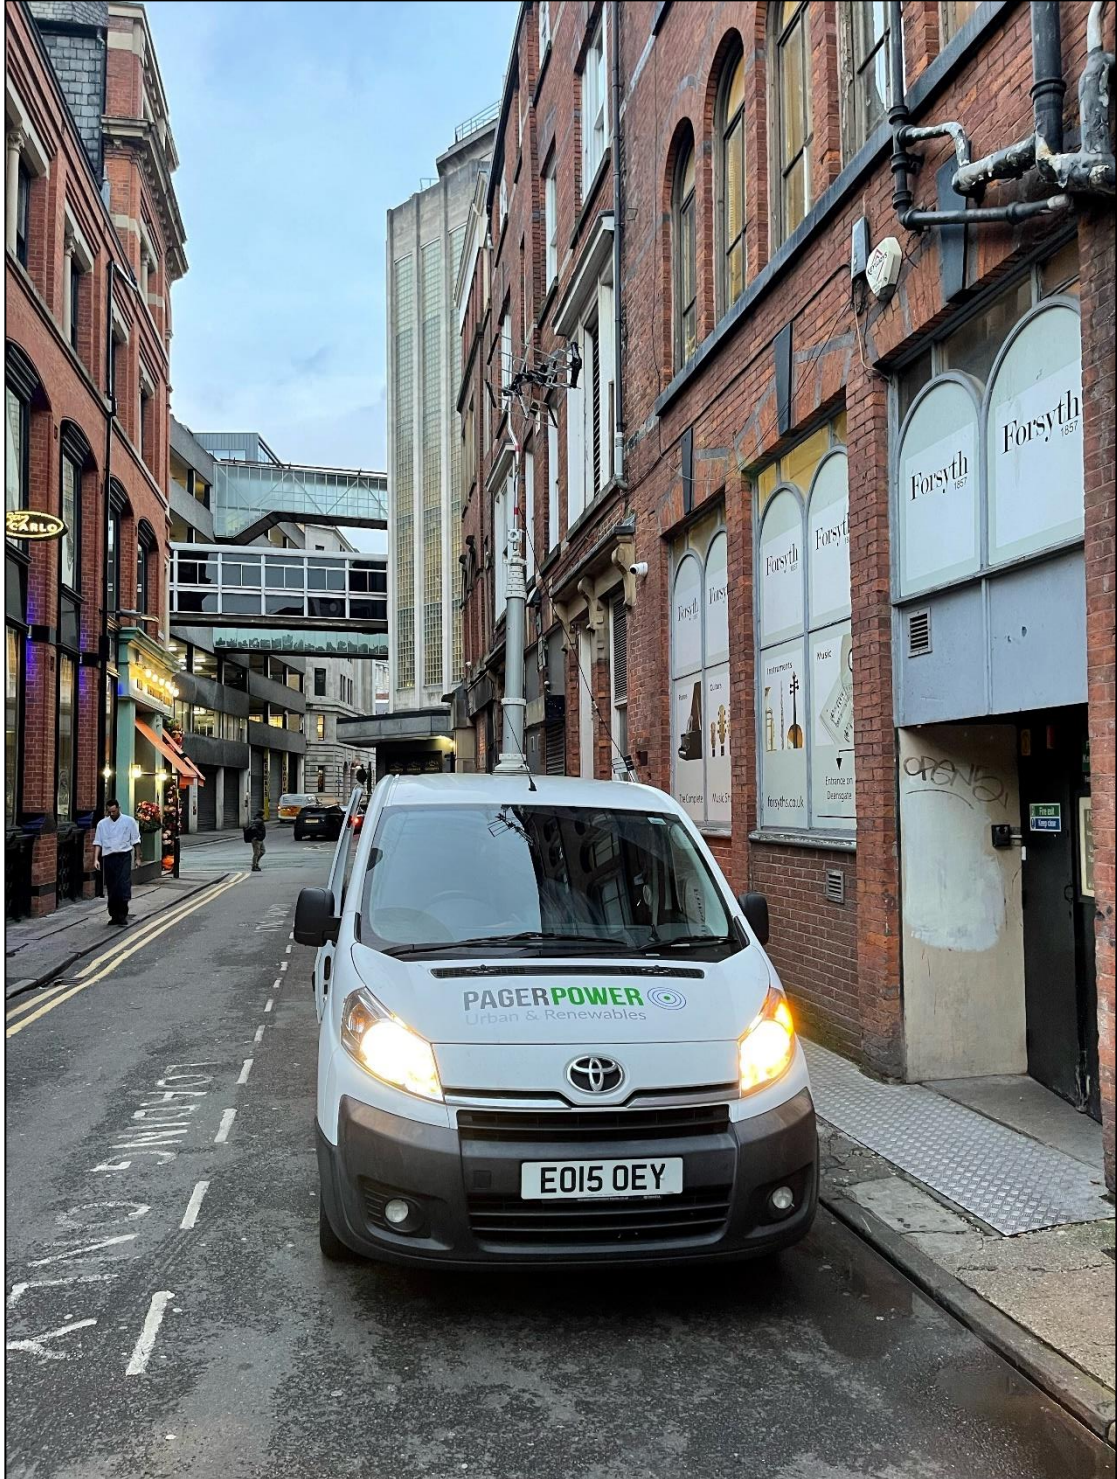
Location 2

Notes: No aerials or satellite dishes observed at this survey location.

| Location | Average Measured Signal Strength (dB) | Remarks | High-Level Conclusion |
|---|---|---|---|
| 2 | <p>Main TV MUX:<br/>38.5 (Moderate)</p> <p>Local TV MUX:<br/>33.2 (Low)</p> | <p>No aerials observed at this location. It is likely none of the surrounding buildings are residential properties or the aerials are higher than 10m agl.</p> <p>Three main multiplexes displayed fine picture and audio quality with no signs of interference. The other three main multiplexes experienced heavy interference or did not decode.</p> <p>No local multiplexes decoded.</p> | <p>The survey location is within 140m of the proposed development and within its shadow zone.</p> <p>Considering the distance from the proposed development, a reduction in signal strength is likely.</p> <p>Noticeable effects are not predicted in practice due to the lack of residential properties or height of any aerials in the area.</p> |

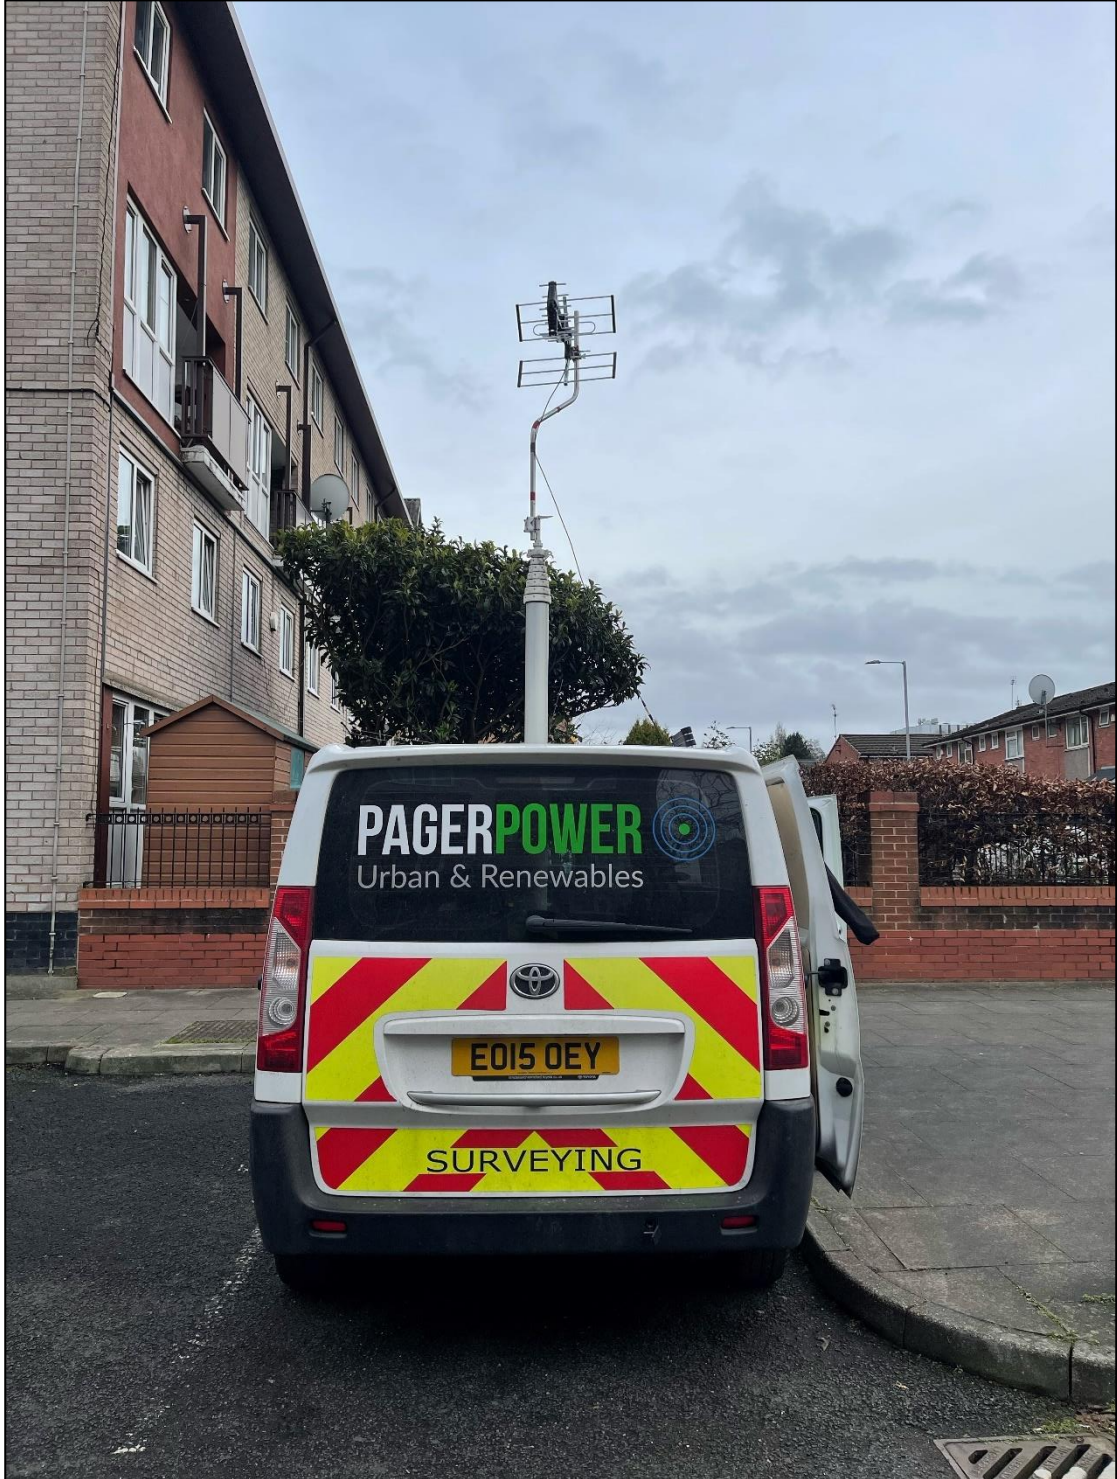
Location 3

Notes: Multiple HP<sup>7</sup> UHF<sup>8</sup> aerials directed towards the Winter Hill transmitter and satellites were observed.

| Location | Average Measured Signal Strength (dB) | Remarks | High-Level Conclusion |
|---|---|---|---|
| 3 | <p>Main TV MUX:<br/>42.8 (Moderate)</p> <p>Local TV MUX:<br/>33.5 (Low)</p> | <p>Multiple aerials directed towards Winter Hill and satellite dishes observed.</p> <p>All main multiplexes and one local multiplex displayed fine picture and audio quality with no signs of interference.</p> <p>Two local multiplexes did not decode.</p> | <p>The survey location is approximately 1.6km from the proposed development and within its shadow zone.</p> <p>Considering the distance from the proposed development, further interference is not anticipated; however, it cannot be entirely ruled out due to the current signal strength.</p> |

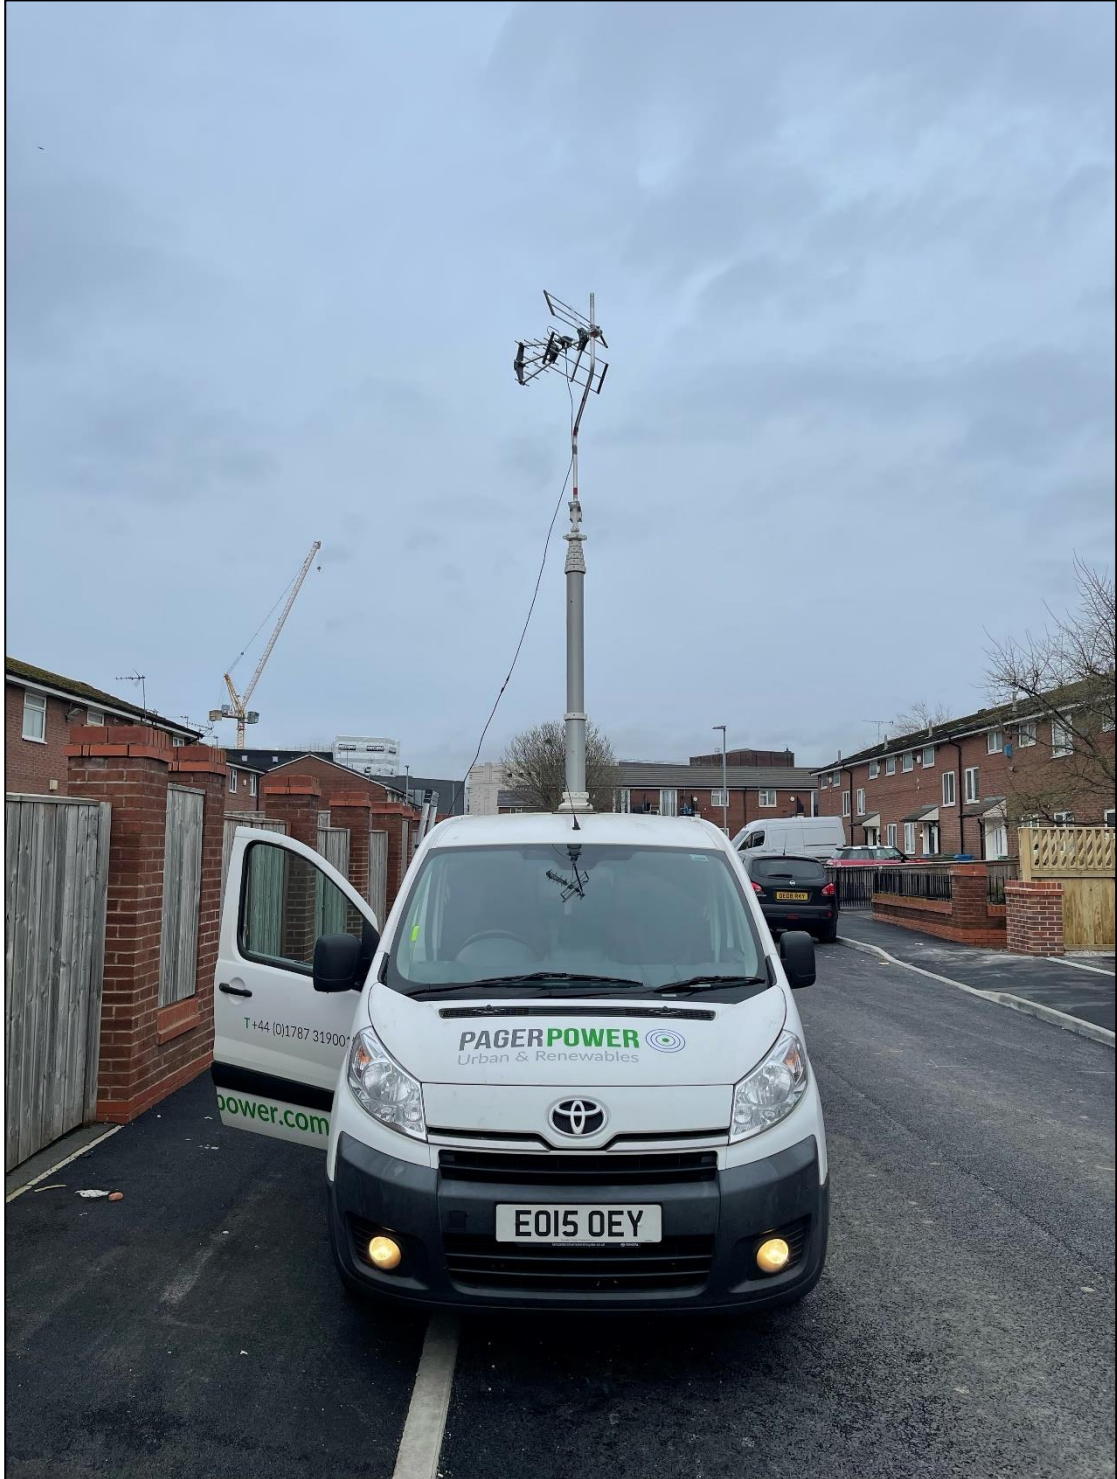
Location 4

Notes: Multiple HP UHF aerials directed towards the Winter Hill transmitter and satellites were observed.

| Location | Average Measured Signal Strength (dB) | Remarks | High-Level Conclusion |
|---|---|---|---|
| 4 | <p>Main TV MUX:<br/>56.3 (Very good)</p> <p>Local TV MUX:<br/>39.5 (Moderate)</p> | <p>Multiple aerials directed towards Winter Hill and satellite dishes observed.</p> <p>All main and local multiplexes displayed fine picture and audio quality with no signs of interference.</p> | <p>The survey location is approximately 2.3km from the proposed development and within its shadow zone.</p> <p>Considering the distance from the proposed development and current signal strength, interference is not anticipated.</p> |

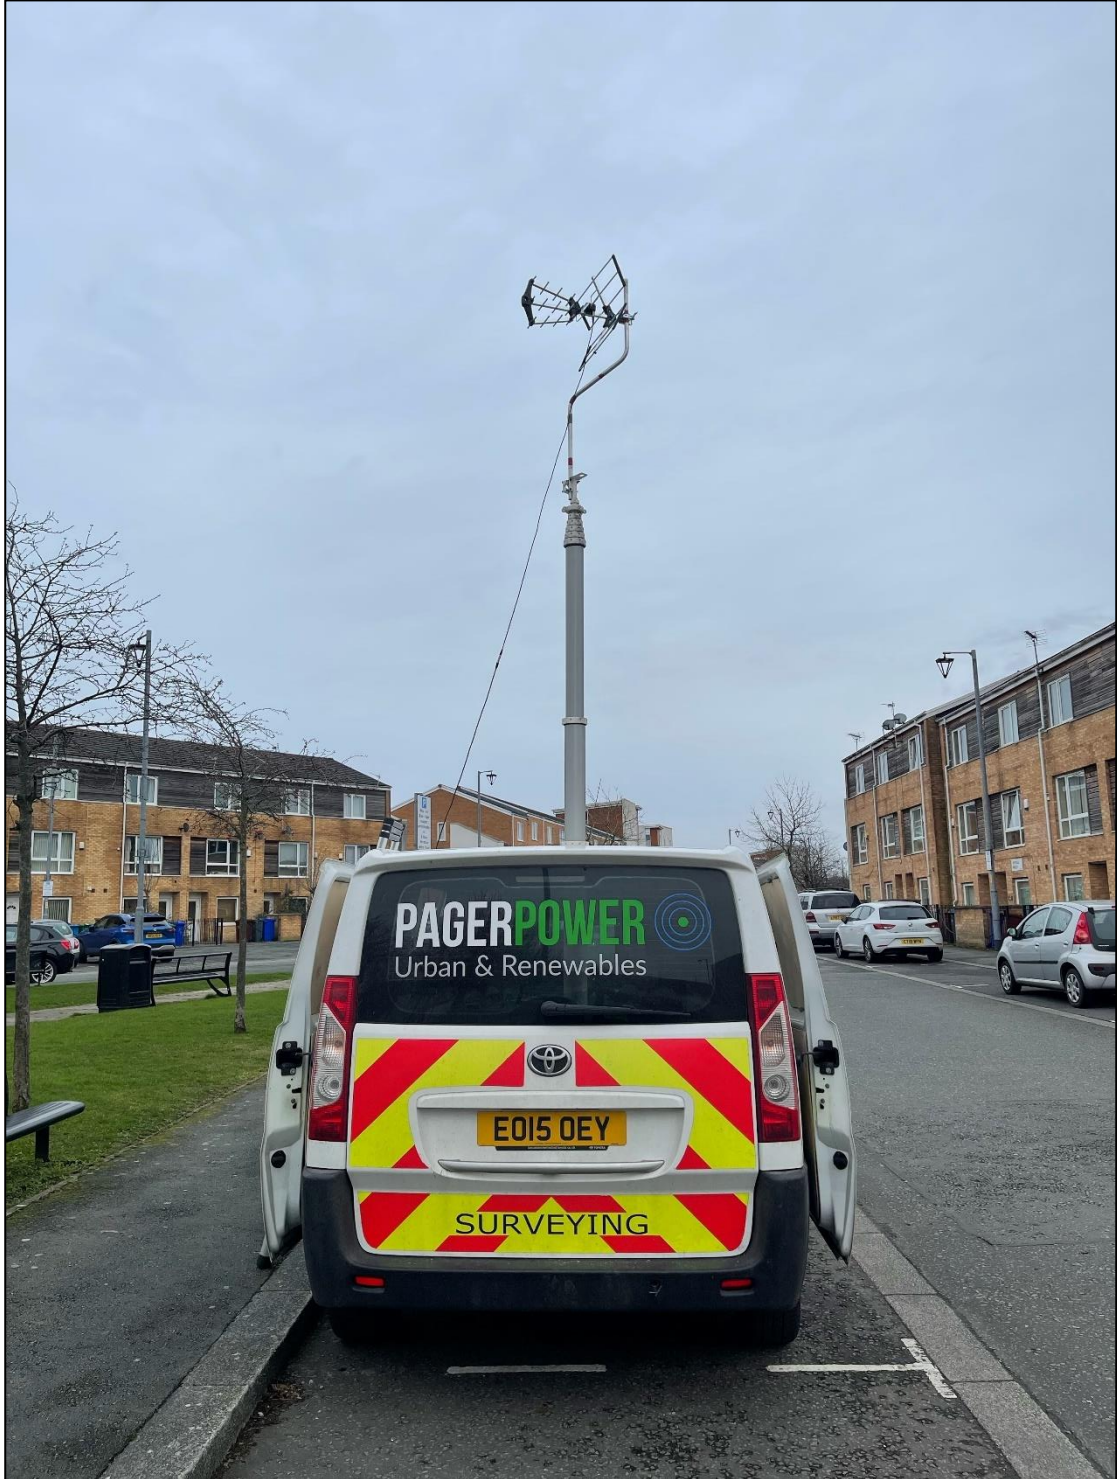
Location 5

Notes: Multiple HP UHF aerials directed towards the Winter Hill transmitter and satellites were observed.

| Location | Average Measured Signal Strength (dB) | Remarks | High-Level Conclusion |
|---|---|---|---|
| 5 | <p>Main TV MUX:<br/>58.0 (Very good)</p> <p>Local TV MUX:<br/>39.5 (Moderate)</p> | <p>Multiple aerials directed towards Winter Hill and satellite dishes observed.</p> <p>All main and local multiplexes displayed fine picture and audio quality with no signs of interference.</p> | <p>The survey location is approximately 2.9km from the proposed development and within its shadow zone.</p> <p>Considering the distance from the proposed development and current signal strength, interference is not anticipated.</p> |

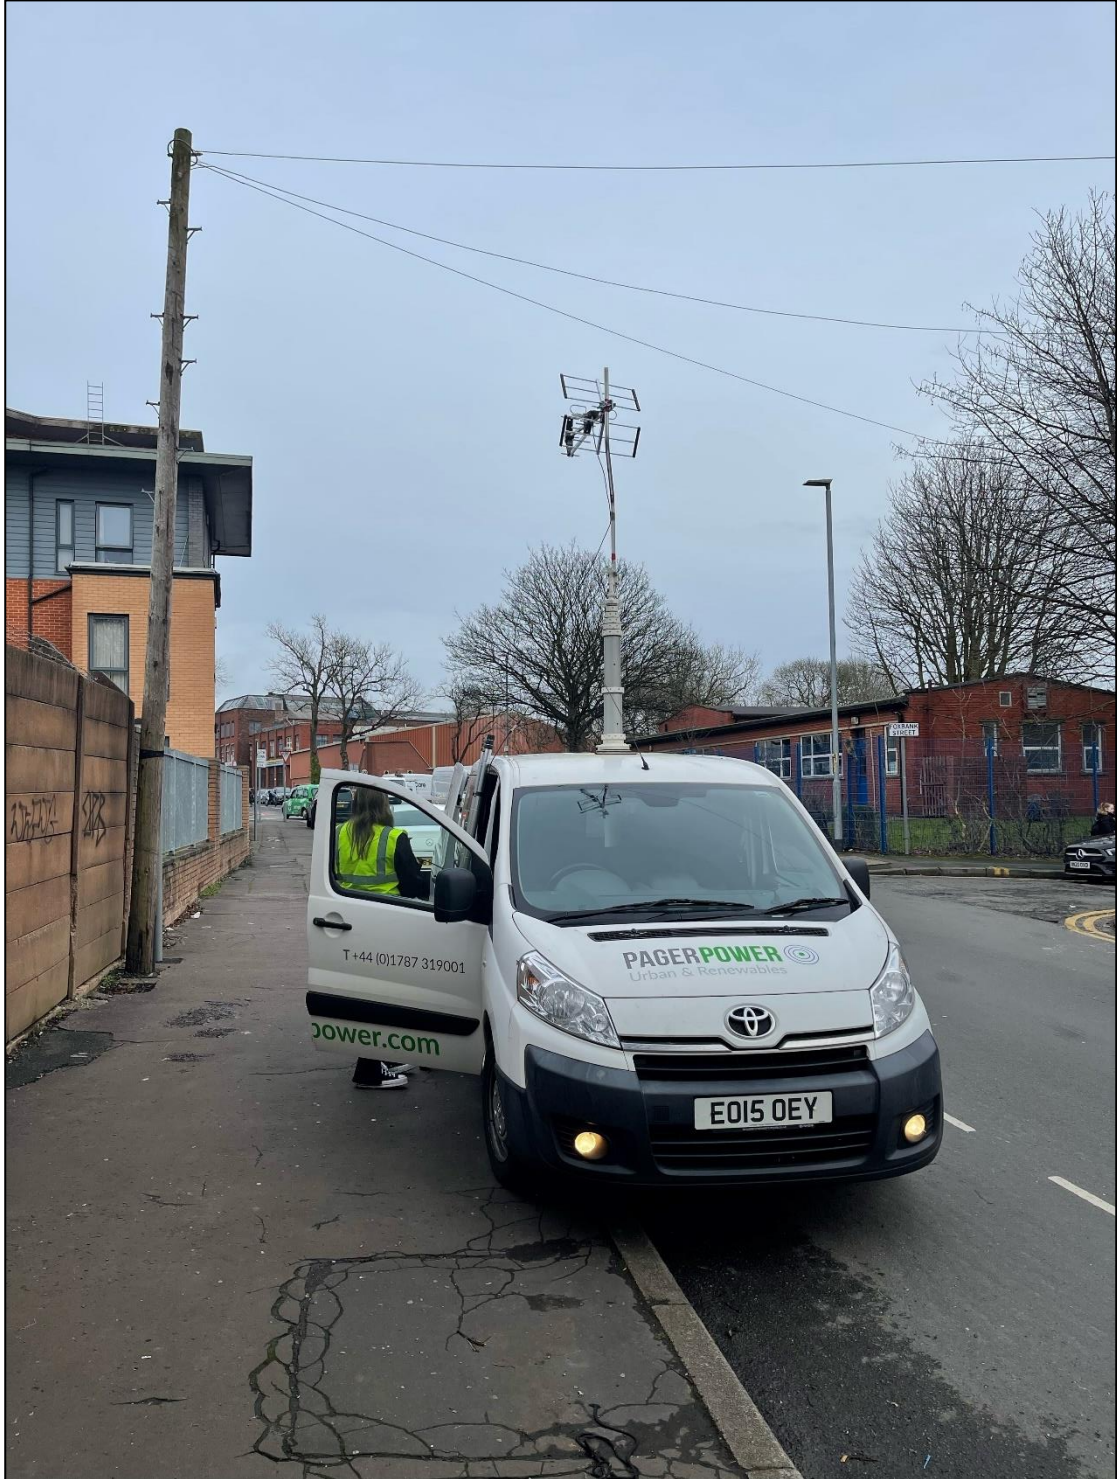
Location 6

Notes: Multiple HP UHF aerials directed towards the Winter Hill transmitter and satellites were observed.

| Location | Average Measured Signal Strength (dB) | Remarks | High-Level Conclusion |
|---|---|---|---|
| 6 | Main TV MUX:<br>62.0 (Very good)<br><br>Local TV MUX:<br>43.9 (Moderate) | Multiple aerials directed towards Winter Hill and satellite dishes observed.<br><br>All main and local multiplexes displayed fine picture and audio quality with no signs of interference. | The survey location is approximately 3.6km from the proposed development and within its shadow zone.<br><br>Considering the distance from the proposed development and current signal strength, interference is not anticipated. |

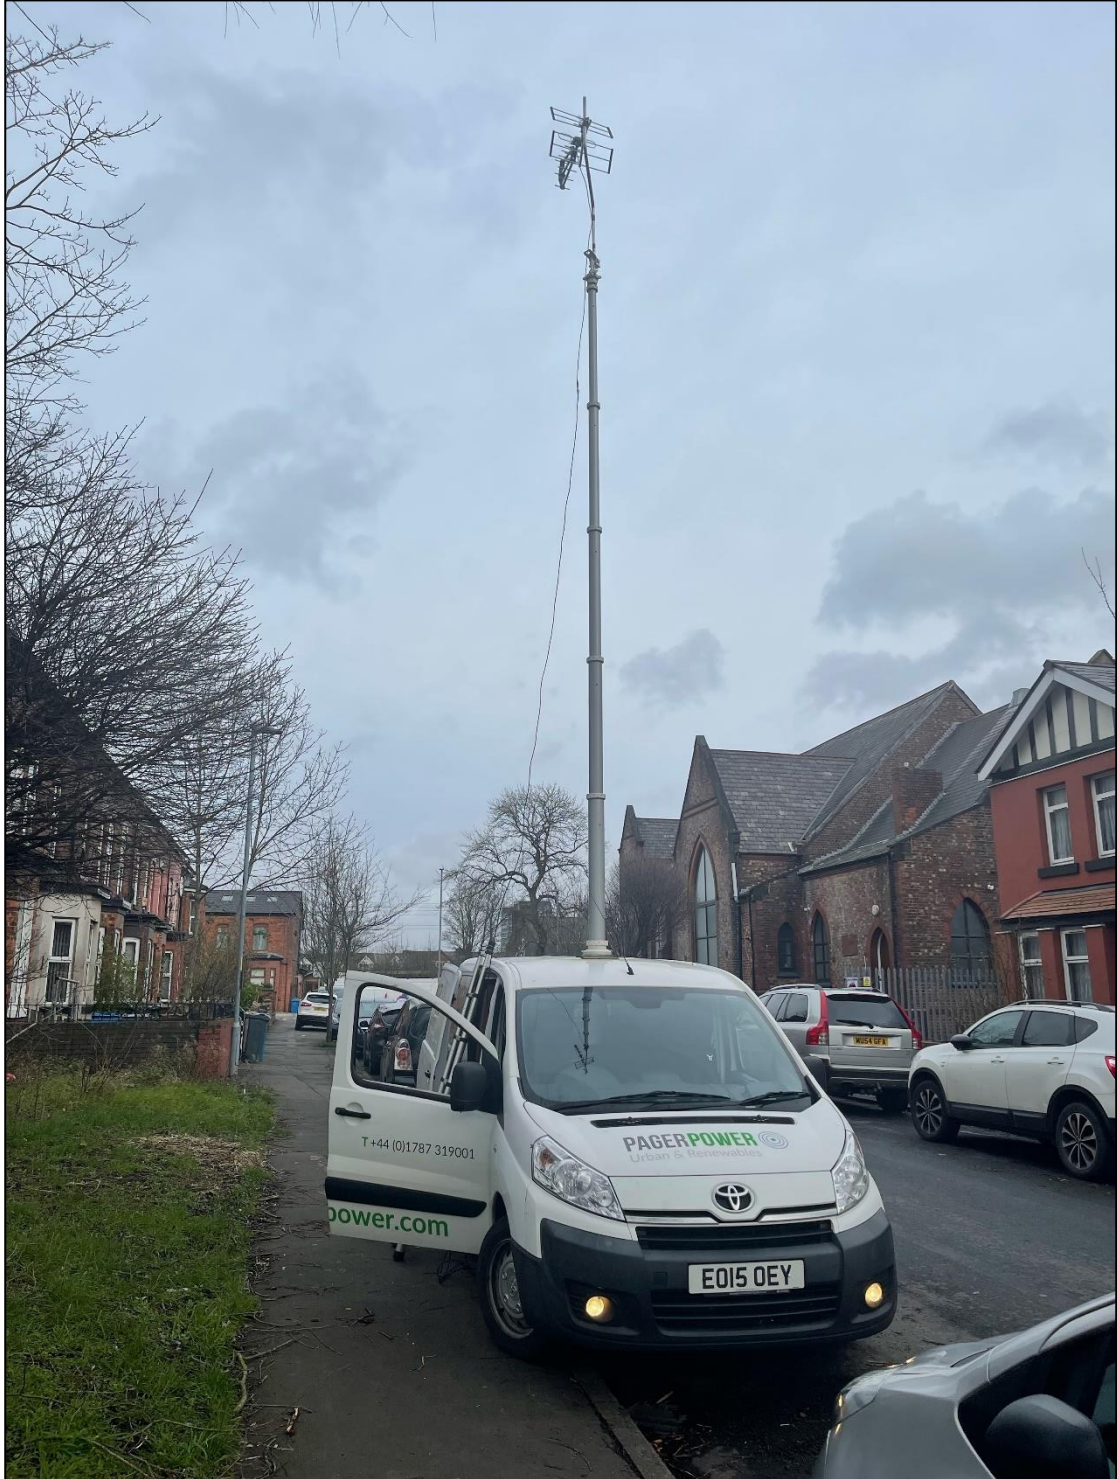
Location 7

Notes: Multiple HP UHF aerials directed towards the Winter Hill transmitter and satellites were observed.

| Location | Average Measured Signal Strength (dB) | Remarks | High-Level Conclusion |
|---|---|---|---|
| 7 | Main TV MUX:<br>65.5 (Very good)<br><br>Local TV MUX:<br>49.3 (Good) | Multiple aerials directed towards Winter Hill and satellite dishes observed.<br><br>All main and local multiplexes displayed fine picture and audio quality with no signs of interference. | The survey location is approximately 4.7km from the proposed development and within its shadow zone.<br><br>Considering the distance from the proposed development and current signal strength, interference is not anticipated. |
