Coal Mining Risk Assessment &  
Specification for the Consolidation of  
Abandoned Mine Workings

Manox, Miles Platting

# COAL MINING RISK ASSESSMENT & PERFORMANCE SPECIFICATION FOR CONSOLIDATION OF ABANDONED MINE WORKINGS

**Report Ref: 13-887-R7-revA**  
**Date Issued: January 2021**

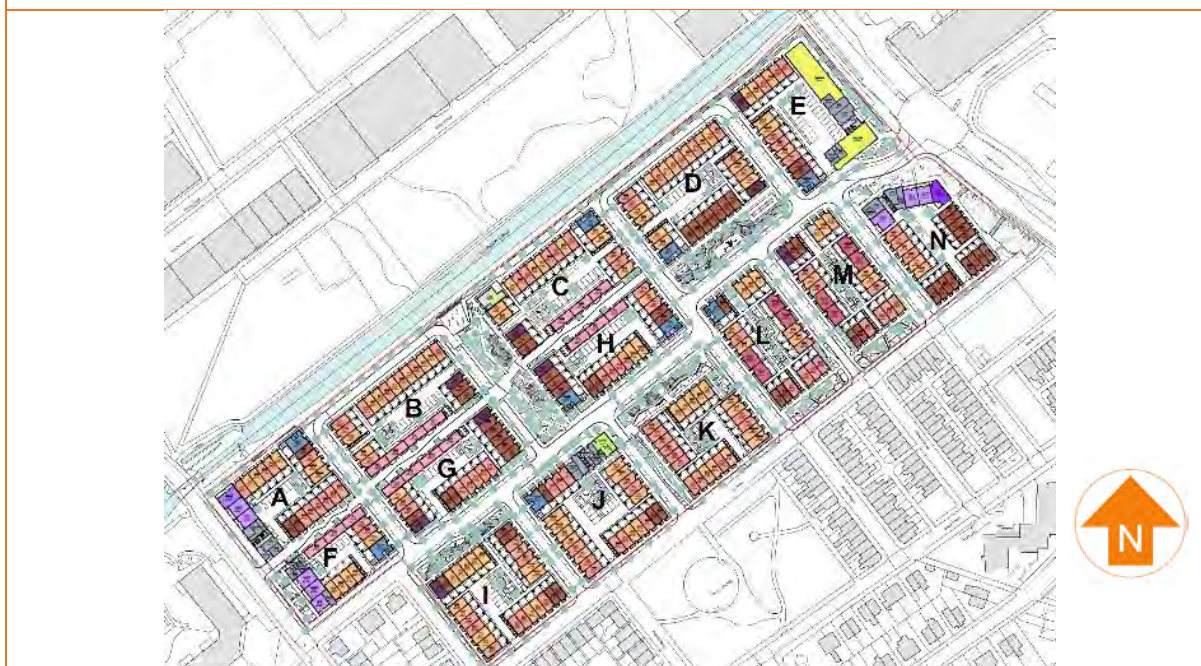
**FIGURE 1.1**      **SNAPSHOT OF PROPOSED DEVELOPMENT**

Engie intend to construct a residential development comprising 410 low rise residential dwellings with associated gardens, public open space, estate roads and infrastructure. Drawing 13-887-002 (Appendix III) identifies the proposed development layout and Figure 1.1 provides a snapshot of this.

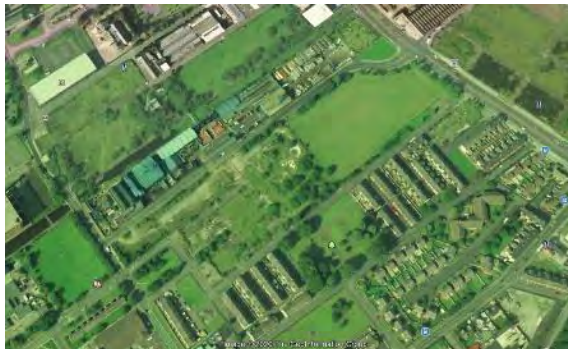
| Occupancy/Use | <p>Figure 1.1 Vegetation in West</p> <p>An aerial photograph from ~2000 shows the former Manox industrial facility in the northern sector and formal playing fields to the east.</p> <p>Figure 1.2 Aerial Photograph ~2000</p> | |

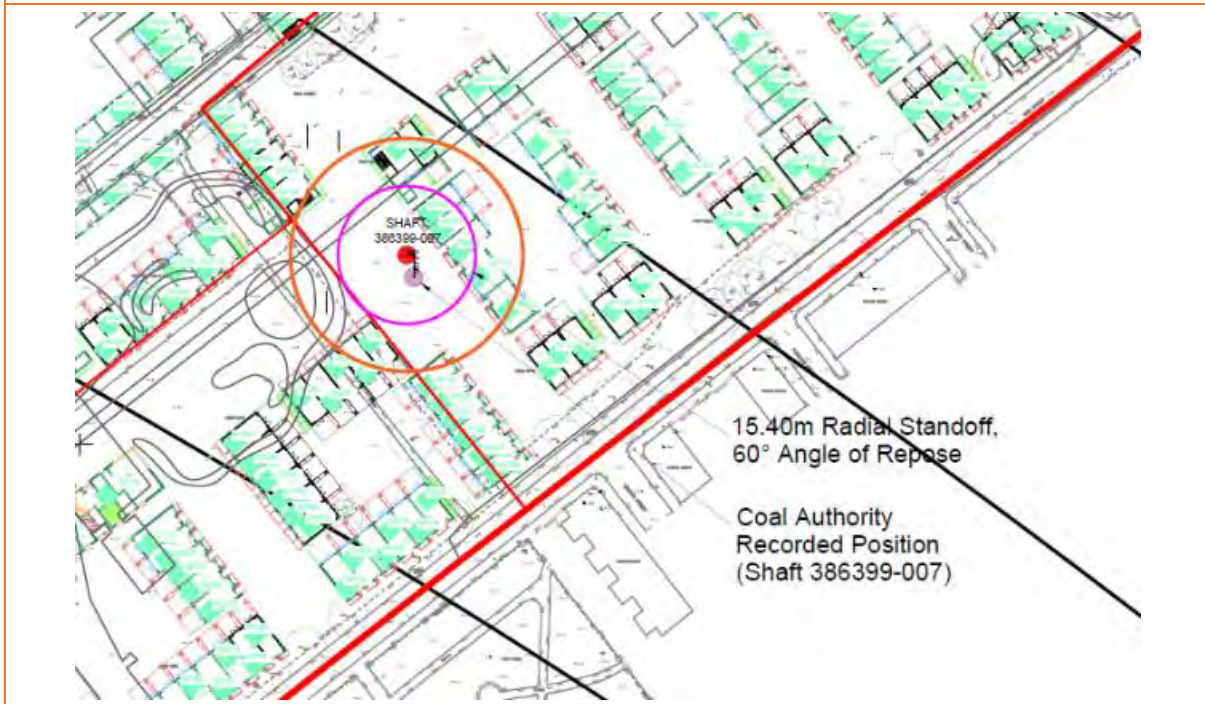
FIGURE 2.1 – MAXIMUM EXTENT OF RADIAL INFLUENCE – SHAFT COLLAPSE.

*In due consideration of the proven ground conditions, it has been determined that a 60° safe angle of repose can applied in this situation, therefore in the event of total shaft collapse the maximum extent of radial influence would be 15.4m.*

*It is therefore recommended that all structures within the 15.4m zone of potential influence in the event of total collapse (which is not considered possible) be constructed using a raft semi-stiffened raft foundation capable of spanning a 3.0m area of ground subsidence.*

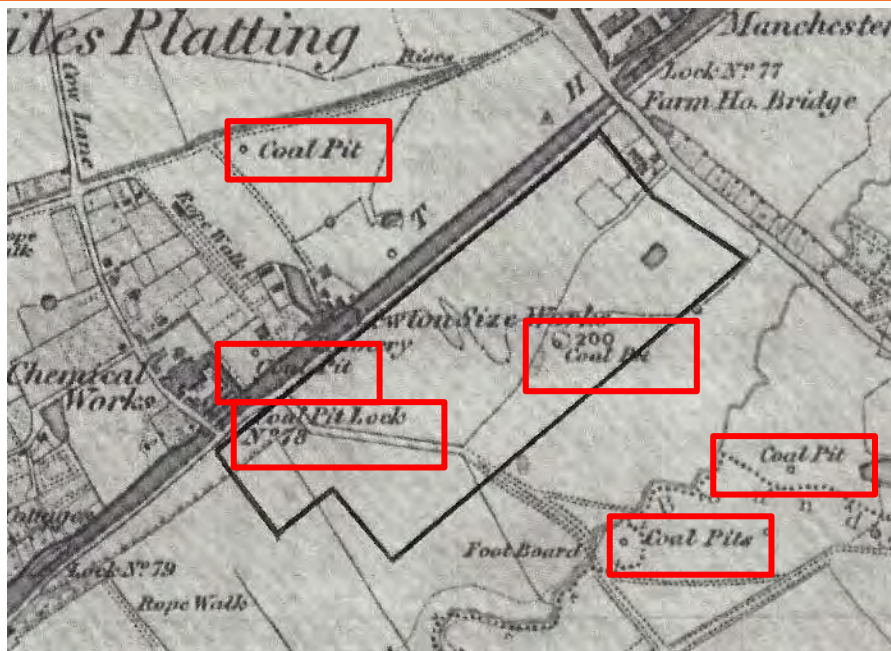
FIGURE 2.3 1848 ORDNANCE SURVEY MAP

- ✧ Coal Pit in the central / east sector;
- ✧ Coal Pit Locks indicated adjacent to the southwest boundary confirming the presence of mining in the area;
- ✧ Coal pit ~30m to the north of the western boundary;
- ✧ Coal Pit ~200m north of the site; and,
- ✧ 2 No. Coal Pits to the South / South East.

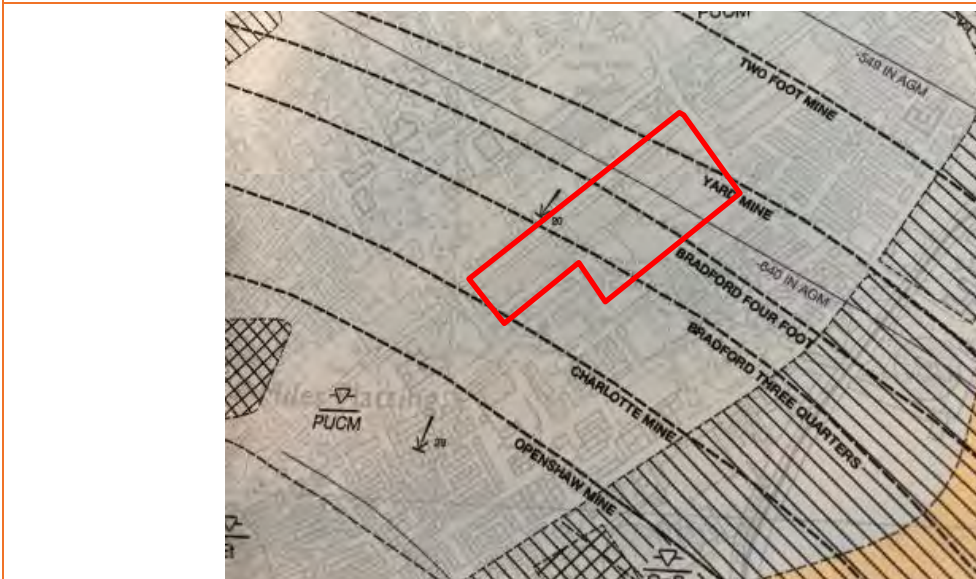
FIGURE 2.4 – EXTRACT OF 1:10,000 BGS MAPPING

The British Geological Survey (BGS) map for the site, (1:50,000, Solid and Drift edition) and online records indicate that the site is underlain by the geological sequence presented in Table 2.1 and BGS boreholes in Table 2.2.

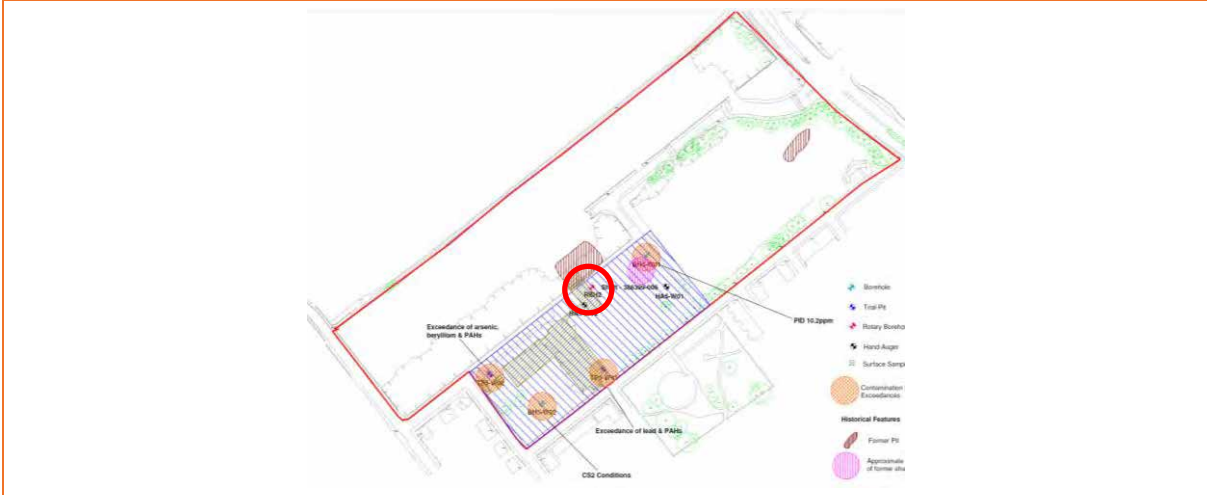
FIGURE 2.5 – RBH2

Figure 2.5 and 2.6 indicate the location of the historical Parsons Brinkerhoff rotary boreholes.

The report confirms that the boreholes did not encounter any coal seams or evidence of potential mine workings to their completion depth.

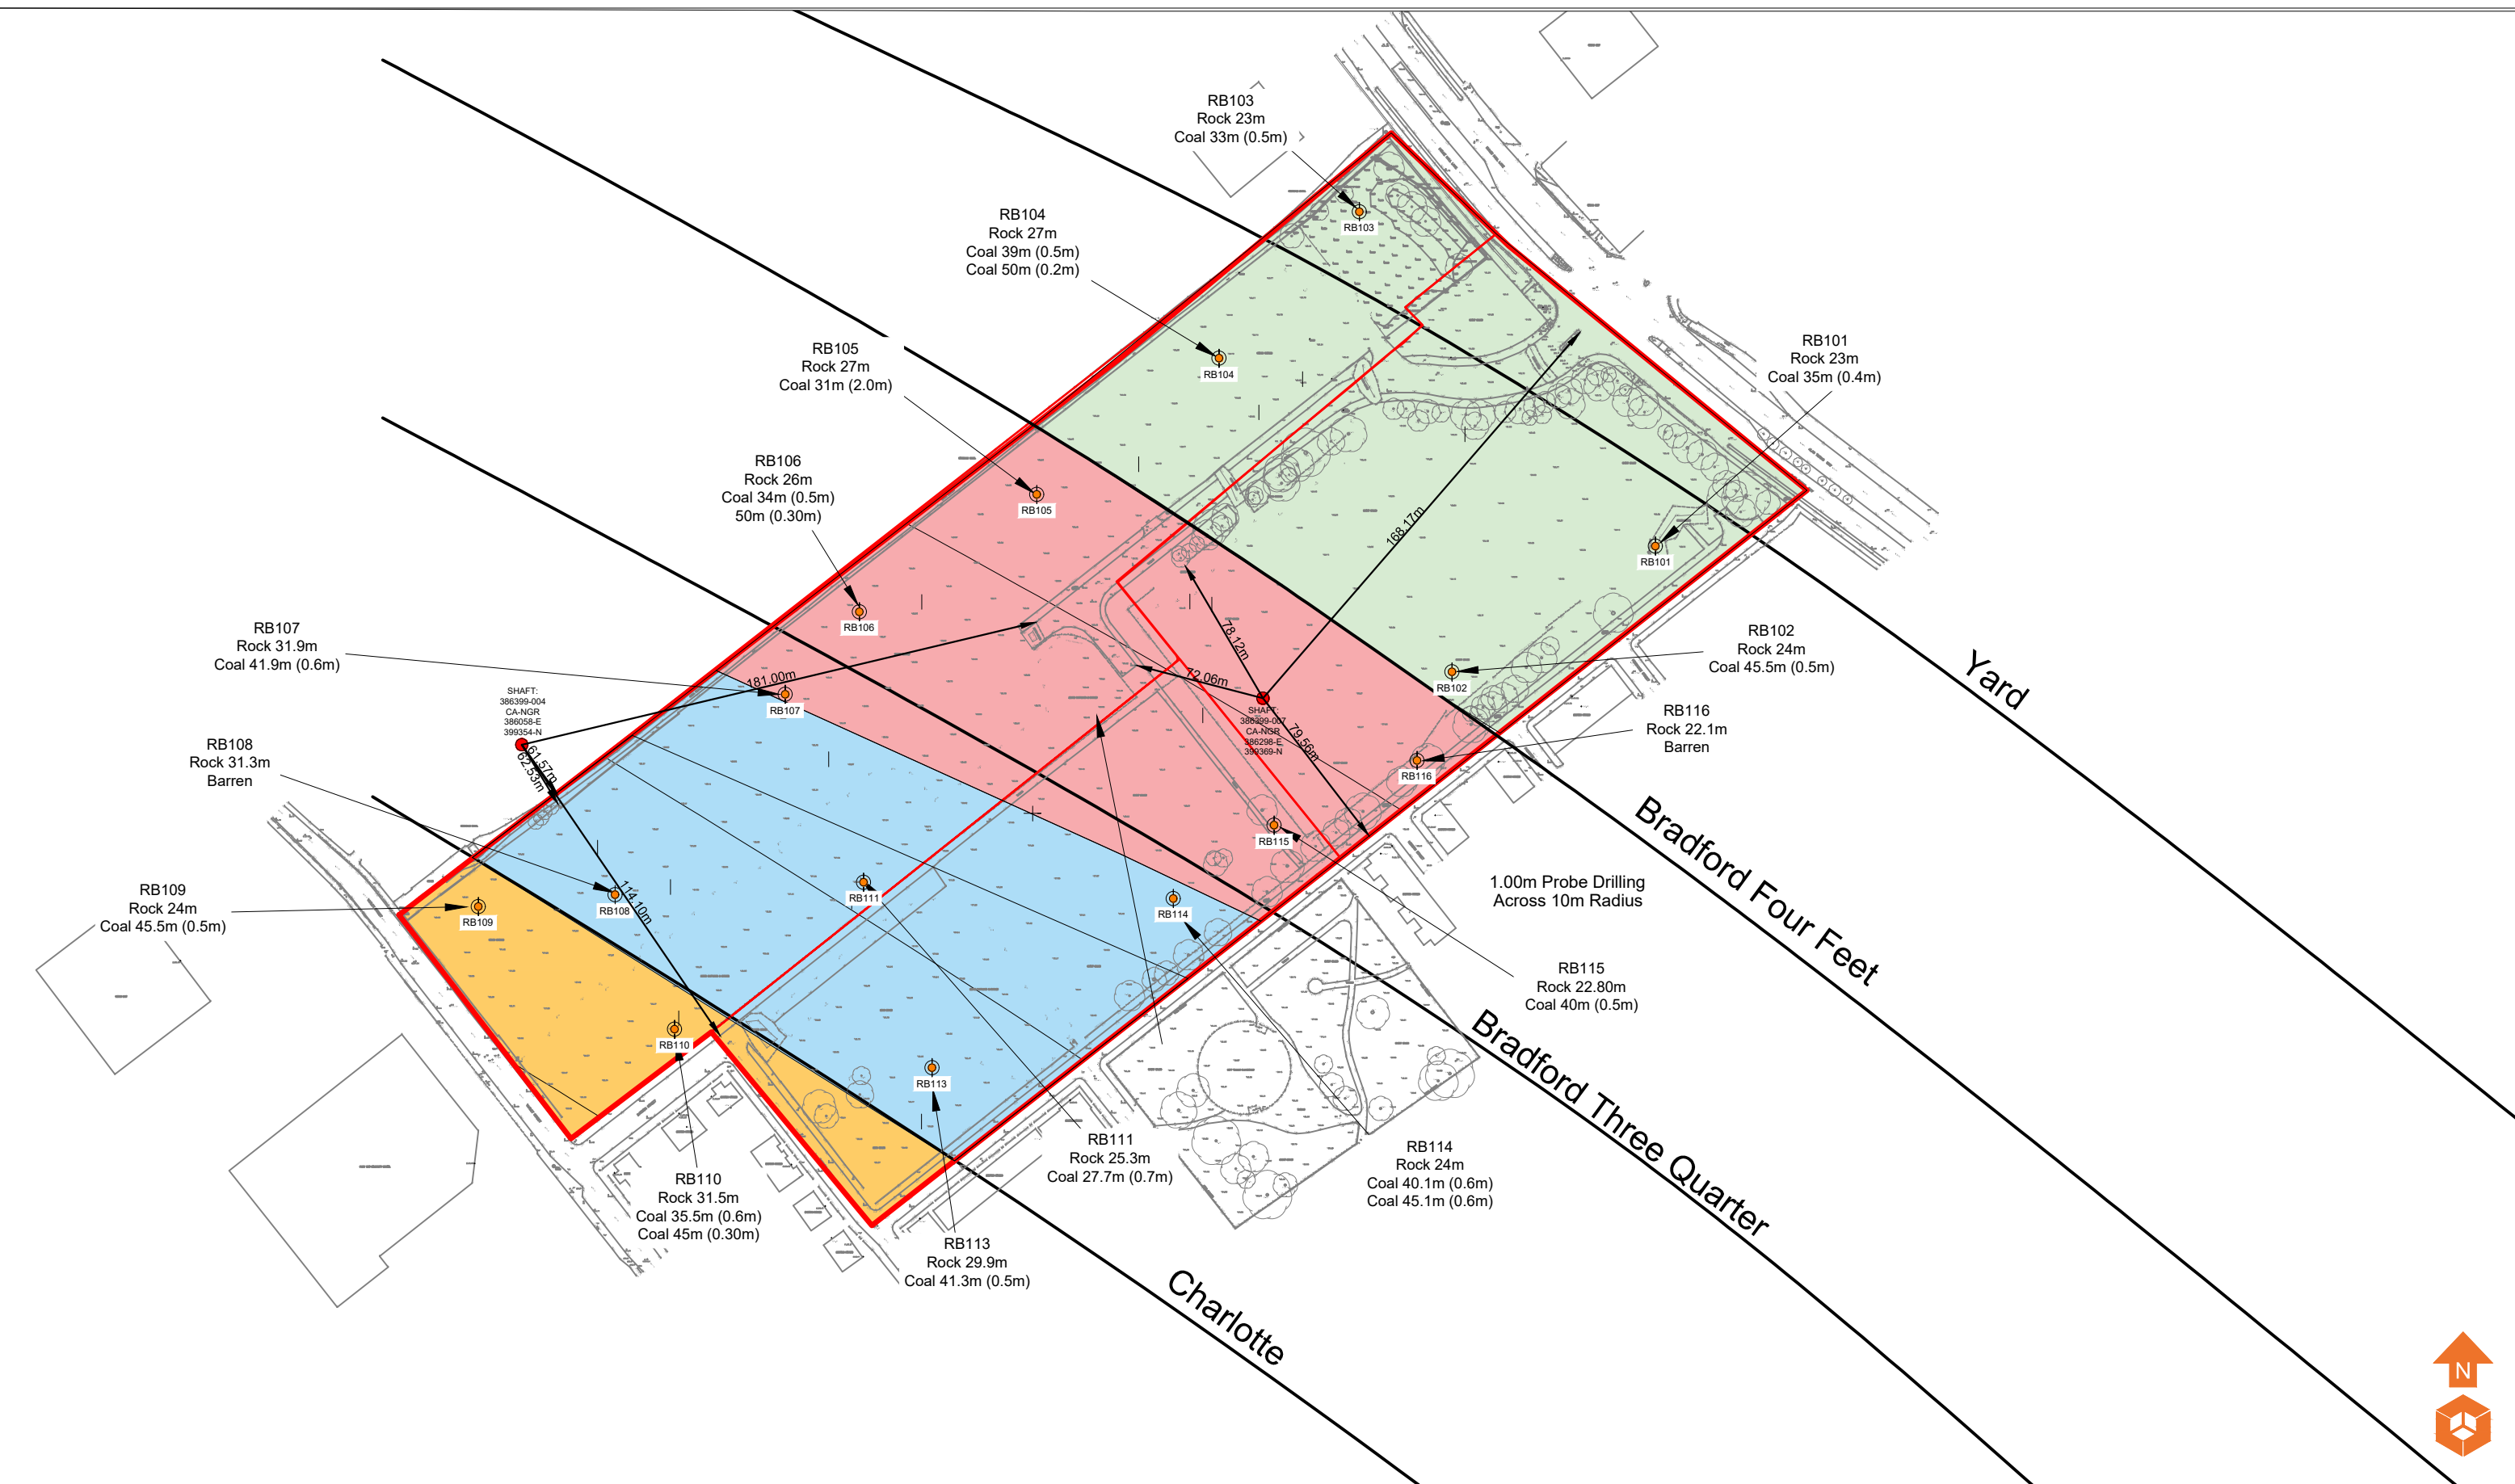
Location Symbols

Approximate Rotary Borehole Location

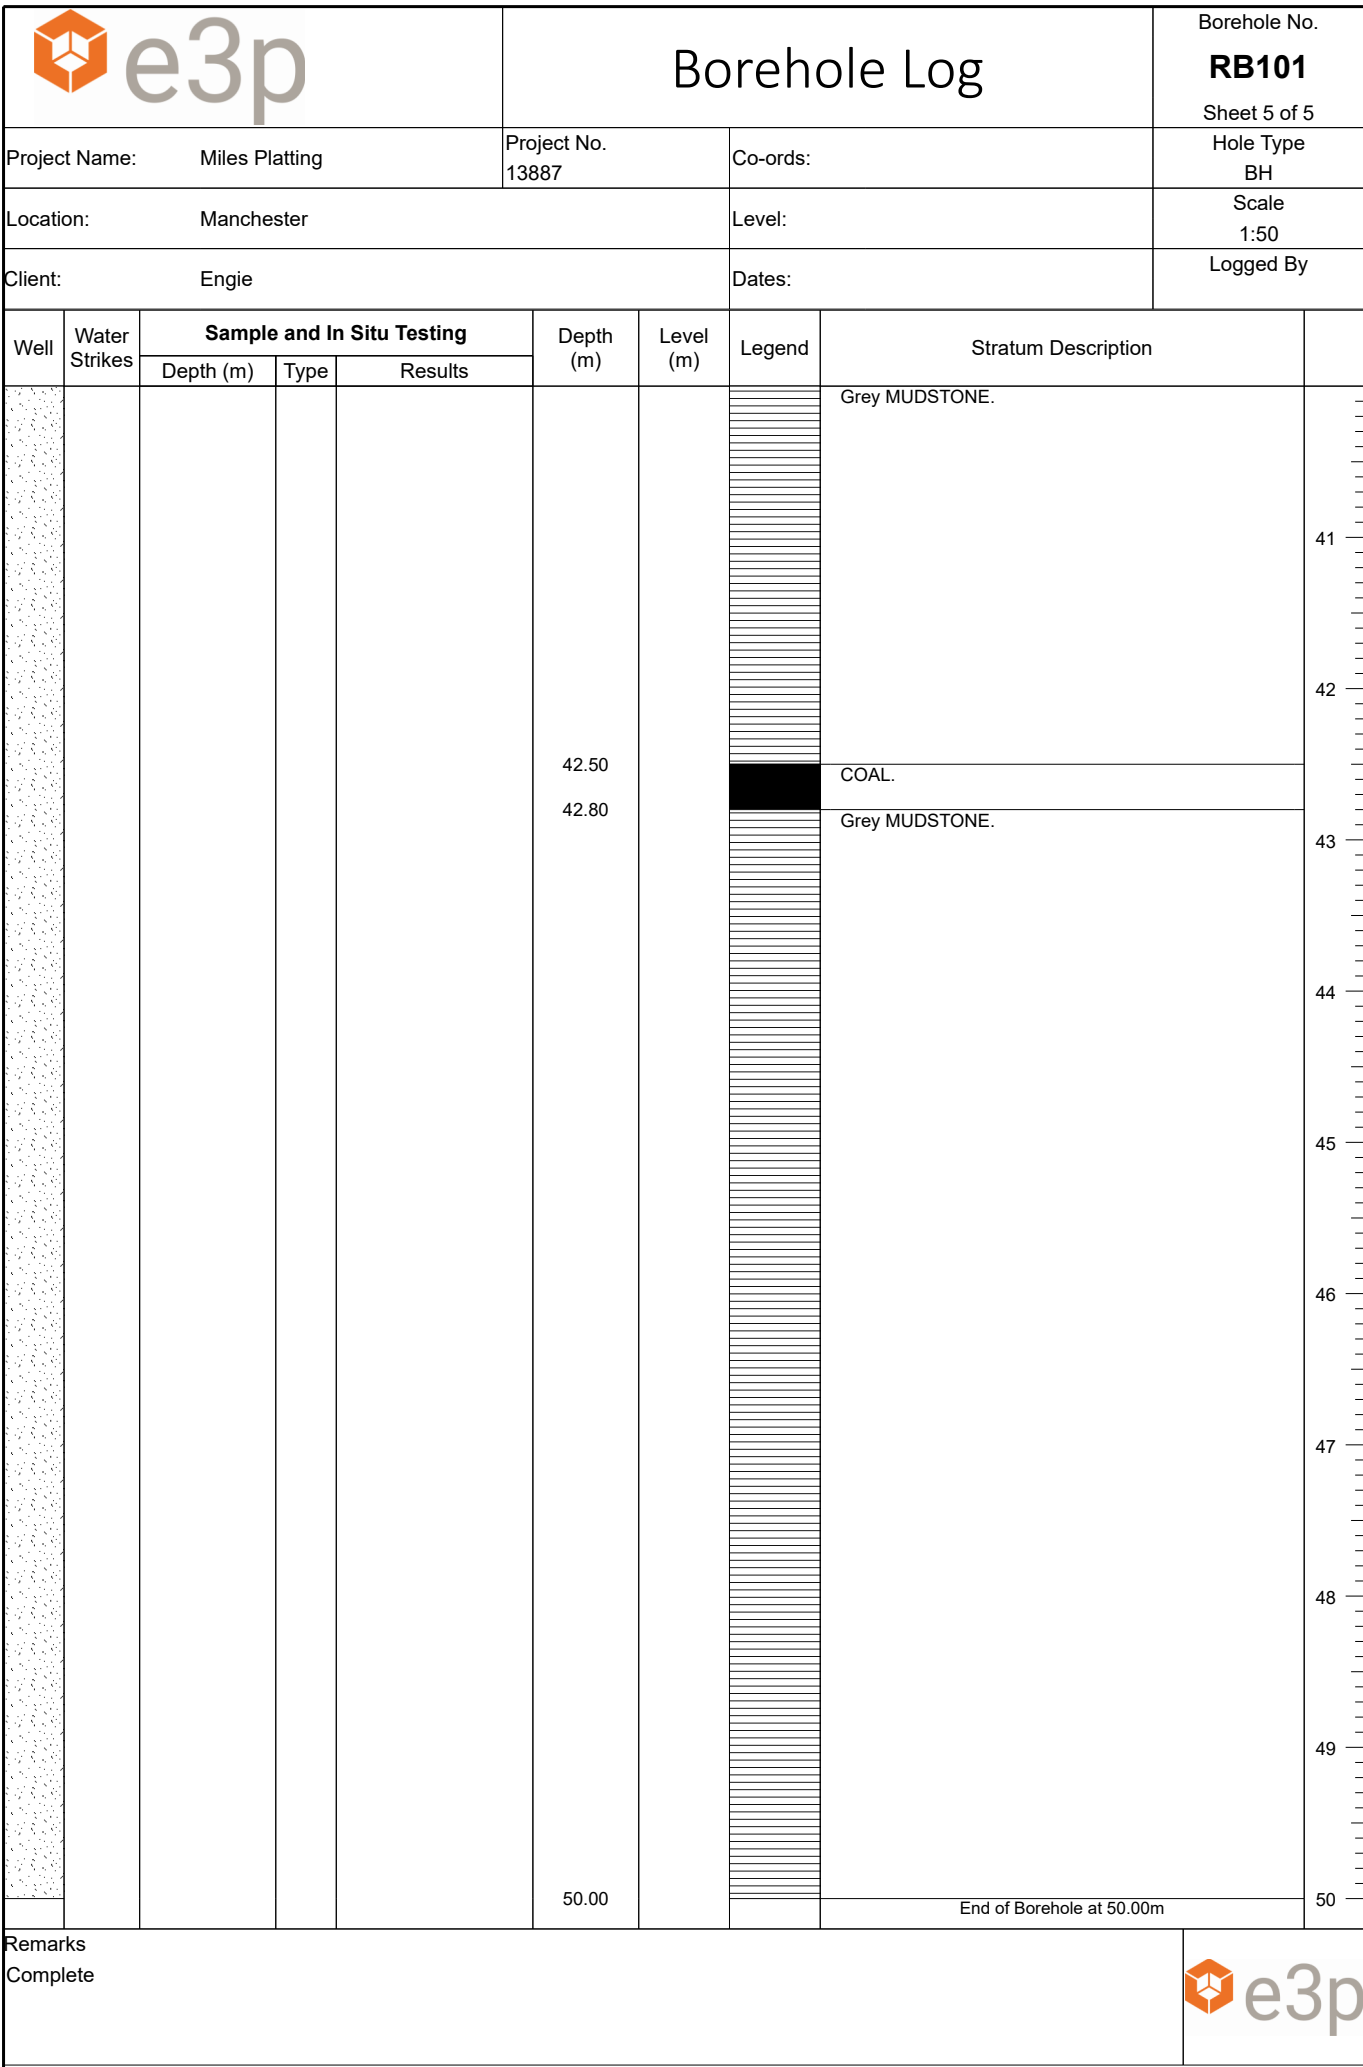
| Project Name: Miles Platting | | | | | Project No.<br>13887 | | Co-ords: | | Hole Type<br>BH |

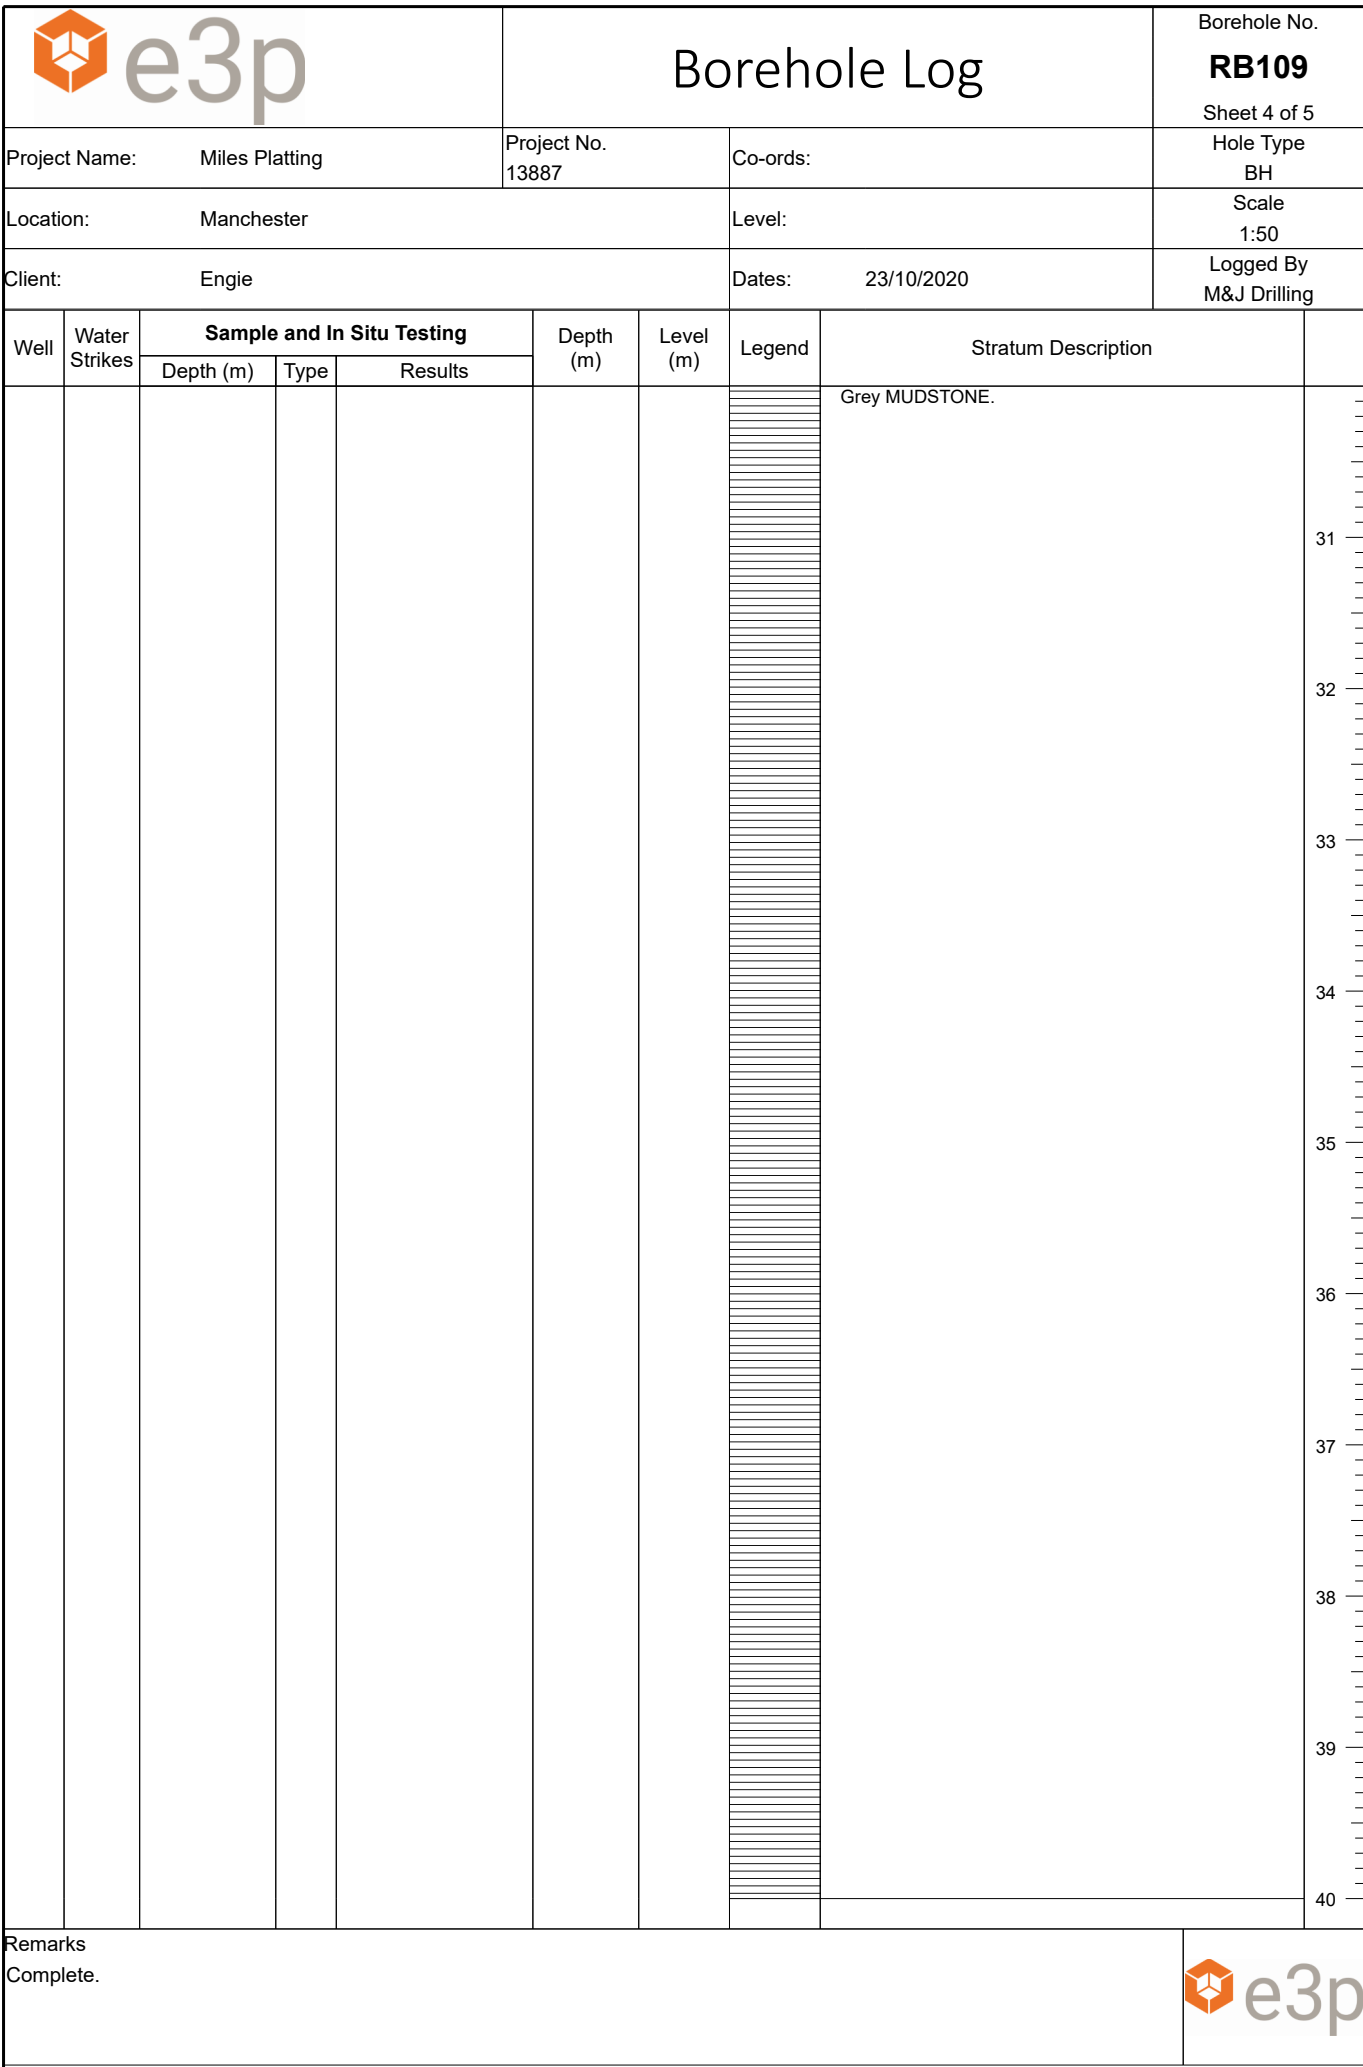
| | | | | <h1>Borehole Log</h1> | | | | Borehole No.<br><b>RB109</b><br>Sheet 5 of 5 | |

| | | | | <h1>Borehole Log</h1> | | | | Borehole No.<br><b>RB109</b><br>Sheet 5 of 5 | |
|---|---|---|---|---|---|---|---|---|---|
| Project Name: Miles Platting | | | | Project No.<br>13887 | | Co-ords: | | Hole Type<br>BH | |

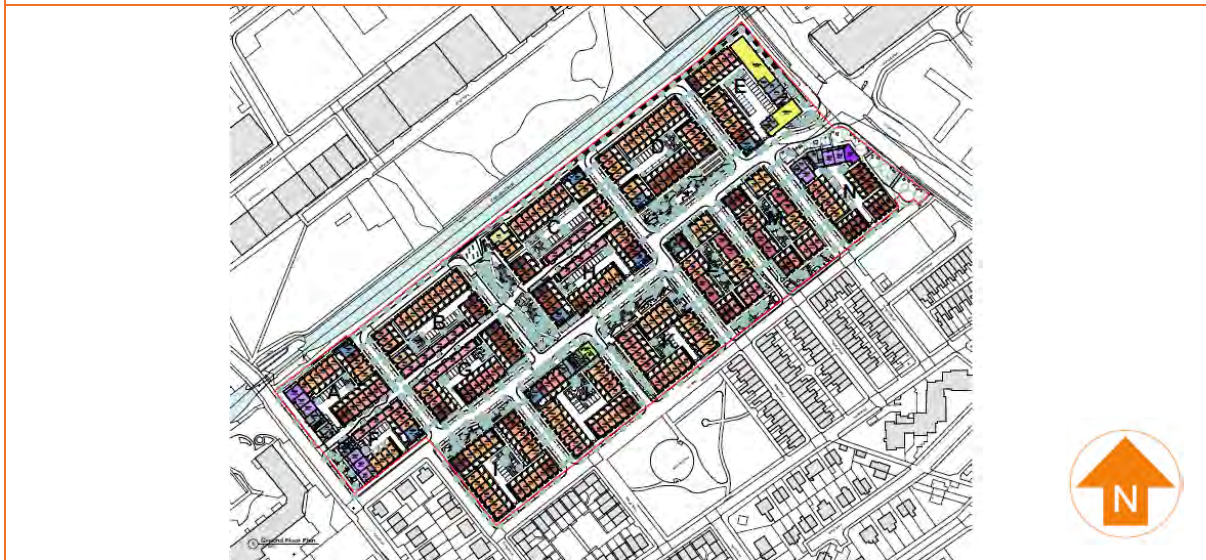
FIGURE 1.1 SNAPSHOT OF PROPOSED DEVELOPMENT

Engie intend to construct a residential development comprising 4100 low rise residential dwellings with associated gardens, public open space, estate roads and infrastructure. An extract of the proposed development layout is indicated in Figure 1.1 (overleaf) and enclosed as Drawing 13-882-002.

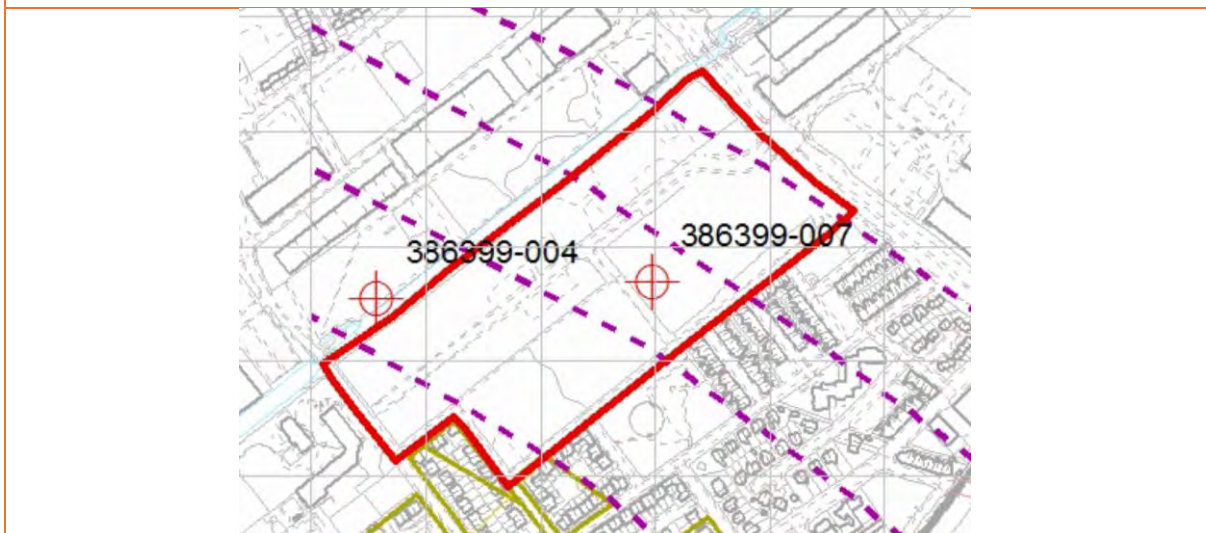
FIGURE 1.1 EXTRACT OF COAL AUTHORITY SEARCH RECORDS

The Coal Authority record one mine entry on-site, this could potentially have been used to access shallow workings in the Arley, Bradford Four Feet & Bradford Three Quarter Coal seams that are present beneath the site. A second mine entry is located to the west of the site. An extract of the Coal Authority search (ref: 51002224407001) dated January 2020 detailing the recorded position of abandoned mine entries is included in Figure 2.1 below.

The on-site recorded mine entry 386399-007 is located in the central sector of the site with a reported maximum extent of radial departure of 8m (mispositioning from CA co-ordinates).

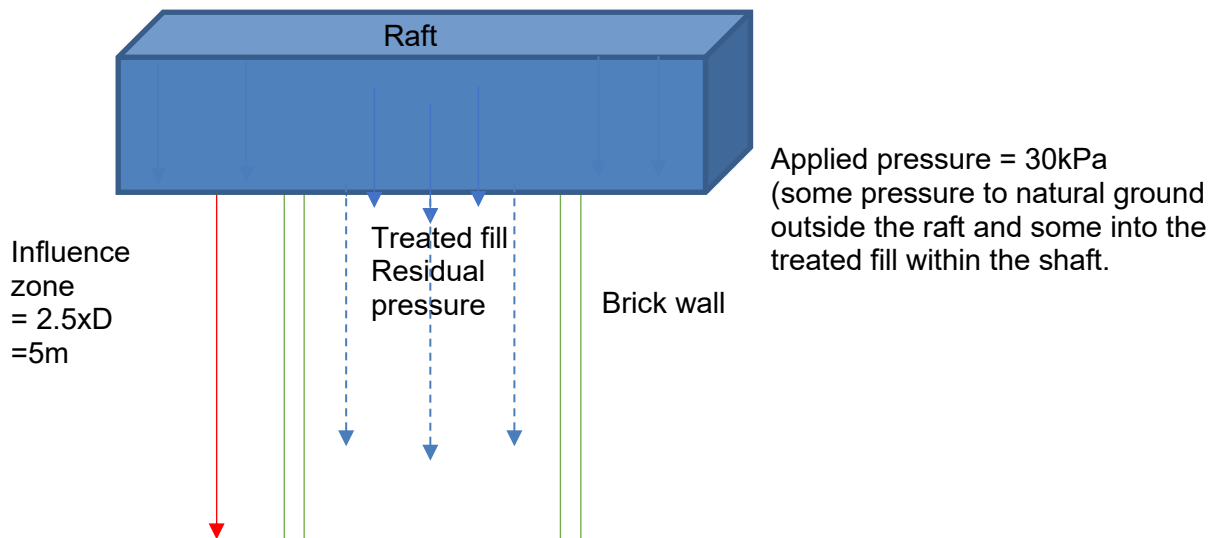
Accordingly, the pressure will be in line with one dimensional consolidation extended to an influence zone of  $2.5 \times$  shaft diameter (see sketch below). The contribution from the perimeter brick wall and its shaft resistance is ignored.

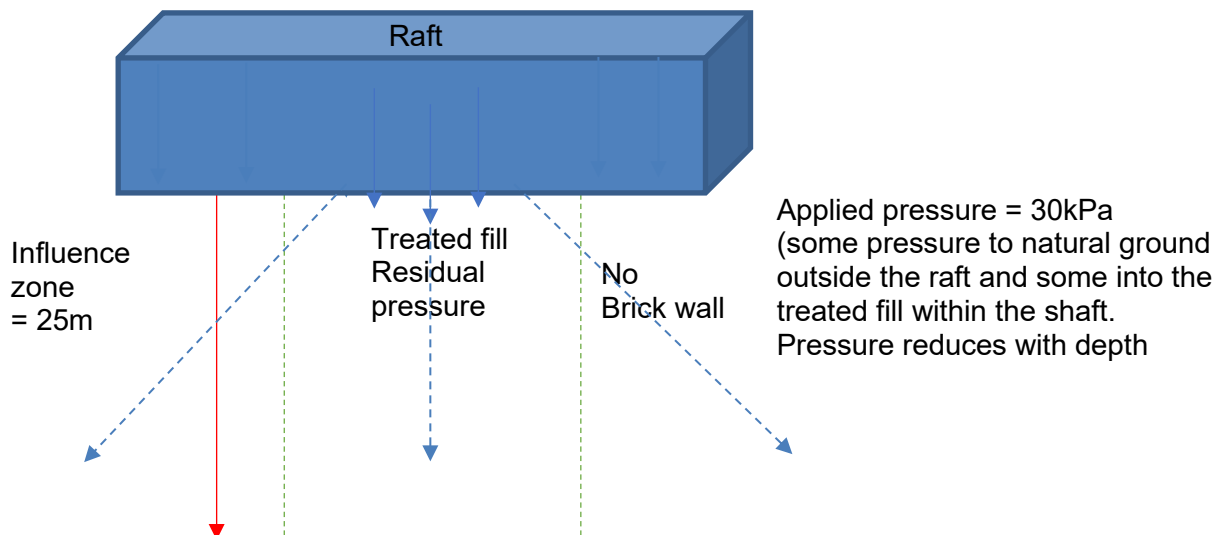
## Model 2

This model is adopted for sensitivity check. Unlike Model 1, the perimeter brick wall is being ignored based on the worst case assumption of severe damage of the perimeter brick wall. Based on the above scenario, the applied pressure will be able to transfer deeper into the treated fill. If based on a 15m x 15m raft (assumed), the stress influence zone will be anticipated to be the full depth of superficial deposits above the bedrock (i.e.  $2.5 \times B = 2.5 \times 15 = 37.5 > 25\text{m}$ ).
