## **Phase 1 & Preliminary Phase 2 Geoenvironmental Assessment for Proposed Premier Inn Annex Extension Premier Inn West Didsbury, Christie Fields Business Park, Derwent Ave, Manchester M21 7QS,**

**EAT SLEEP & DRINK  
WHITBREAD**

**Project No: NX601**

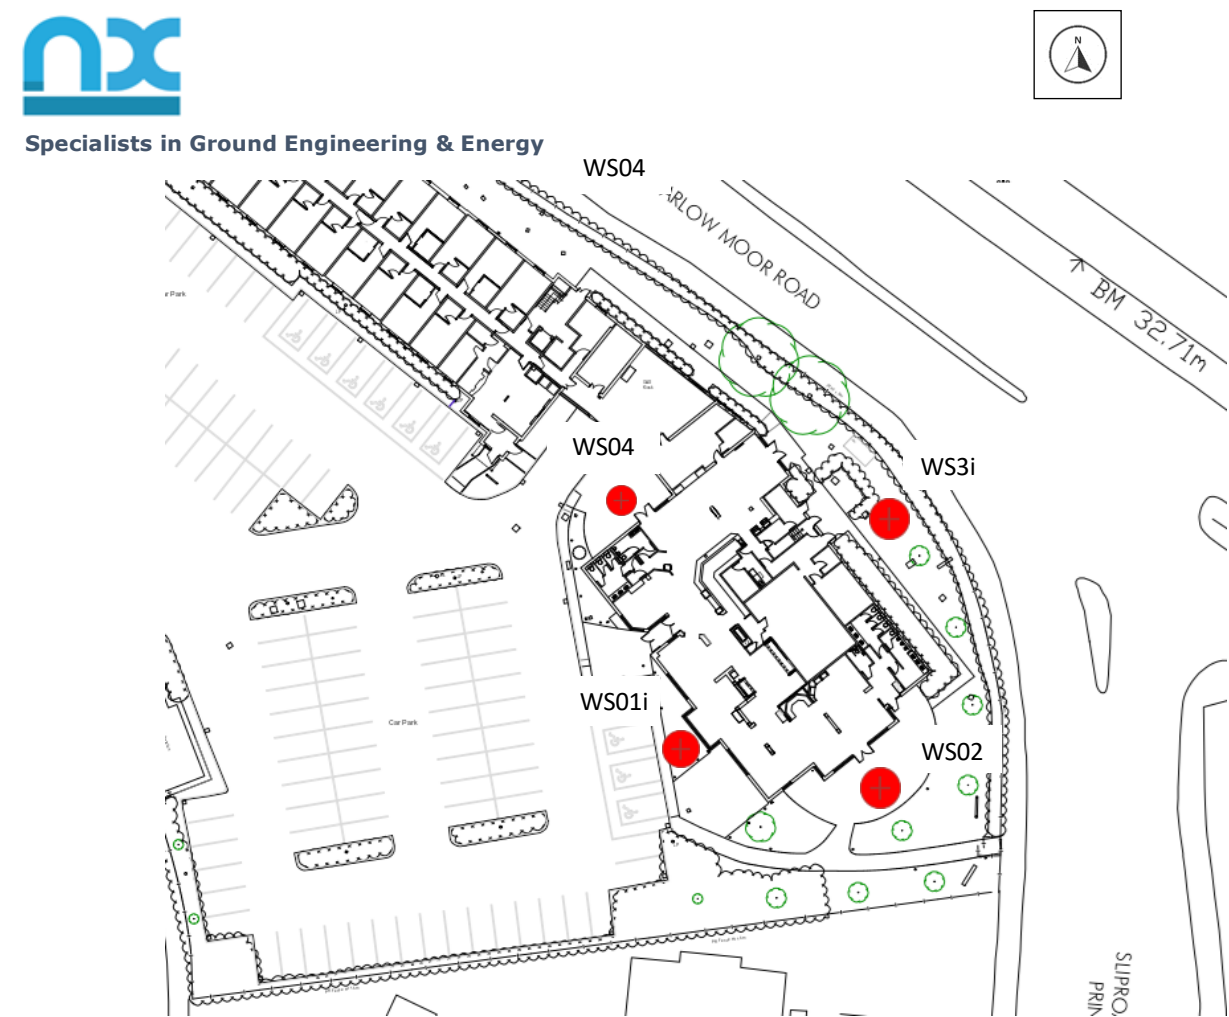
| | Title:<br>Exploratory Hole Location Plan |

Denotes NX groundwater/  
gas installation

In 2015, NX Carried out a Phase 1 and Phase 2 intrusive investigation for a proposed extension for a Premier Inn. The works comprised of the formation 5no window sampler boreholes were undertaken across the site to a maximum depth of 5.45mbgl. 1no hand excavated trial pits (HP1) were formed to confirm the dimensions of existing foundations.

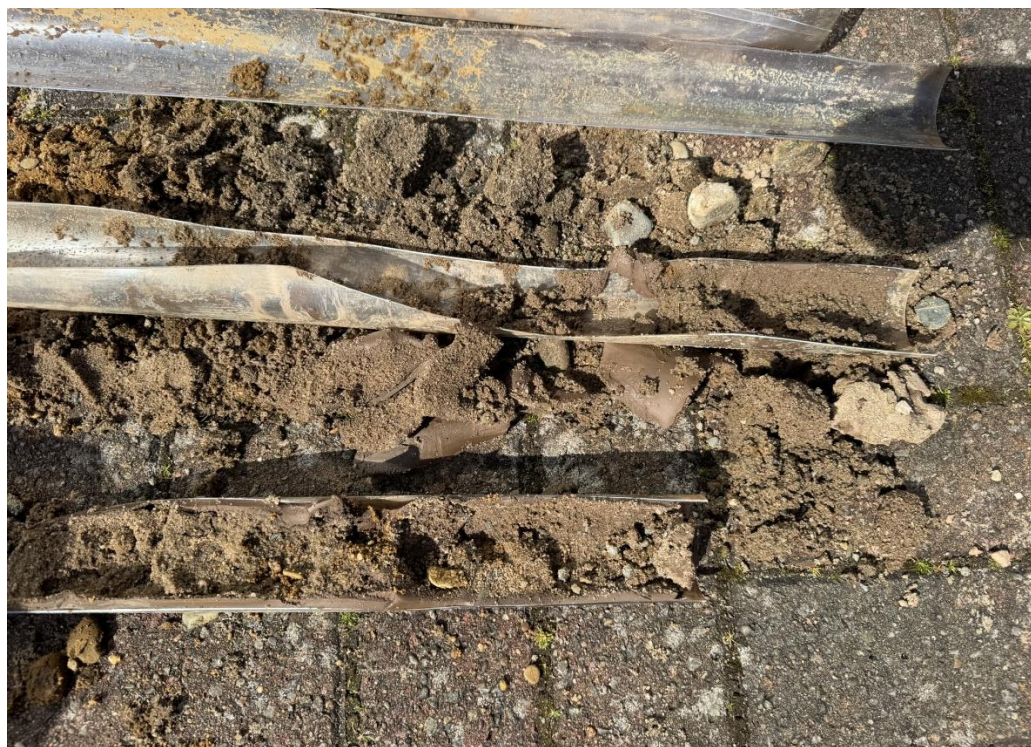
**Plate 1 – Window Sampler borehole (WS01) 1.0m bgl to 5.00m below ground level (bgl)**

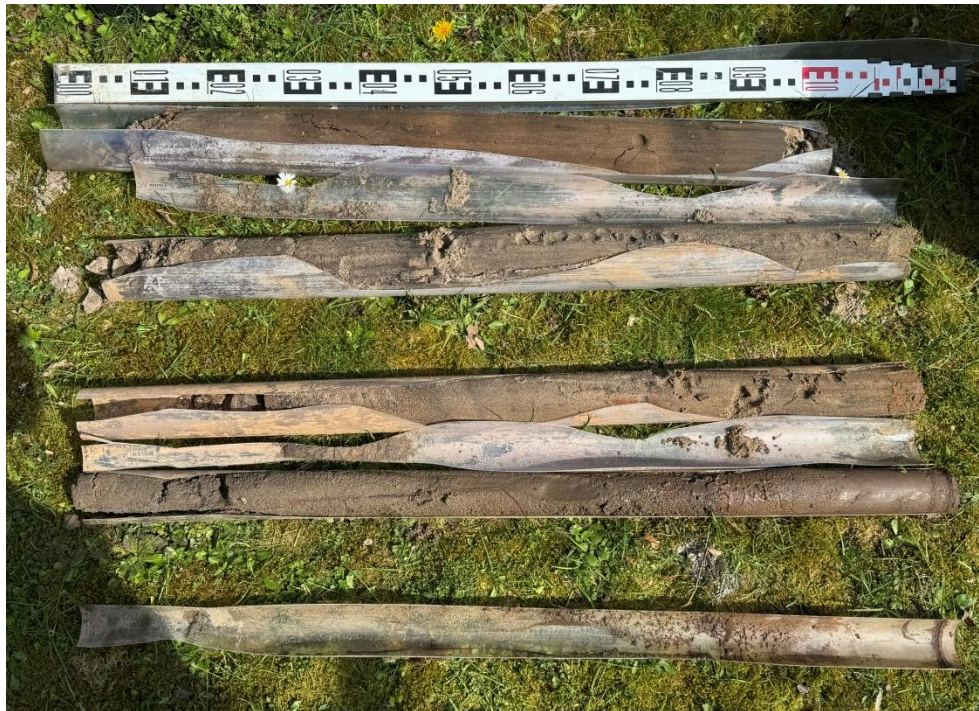
**Plate 2 – WS02, 1.00m bgl and 5.45m bgl.**

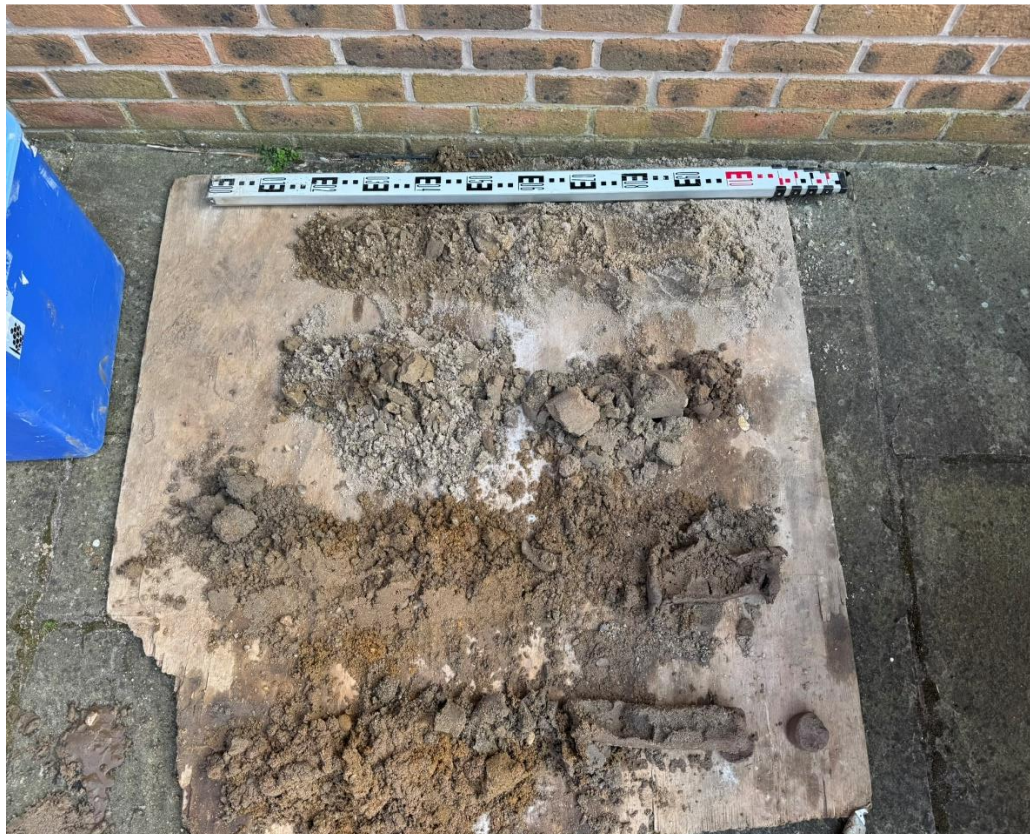
**Plate 3 – WS03, 1.0m bgl to 5.00m bgl**

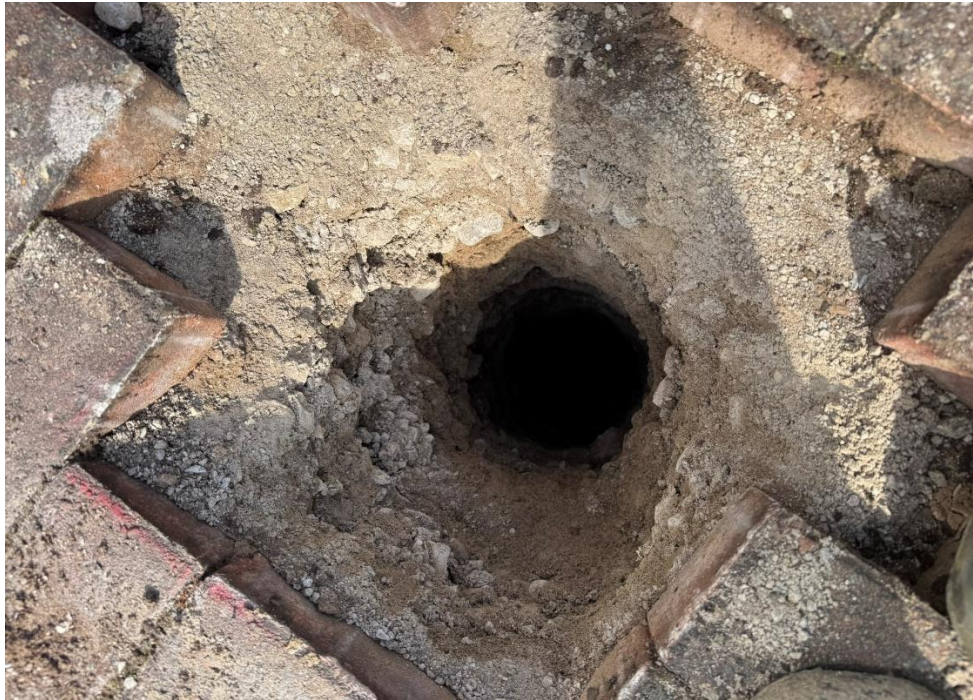
**Plate 4 - WS04, 1.00m bgl and 3.00m bgl.**

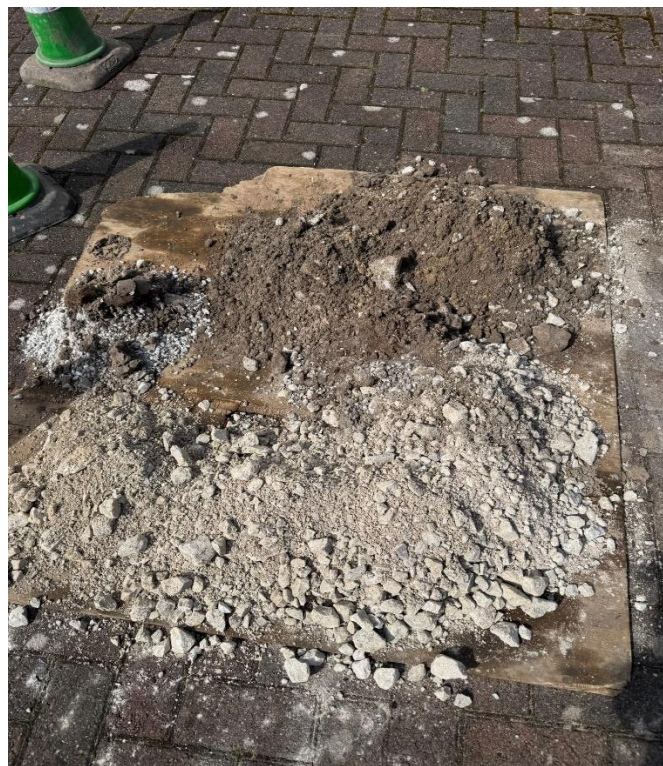
**Plate 5 – WS02, GL to 0.60m bgl Pavement.**

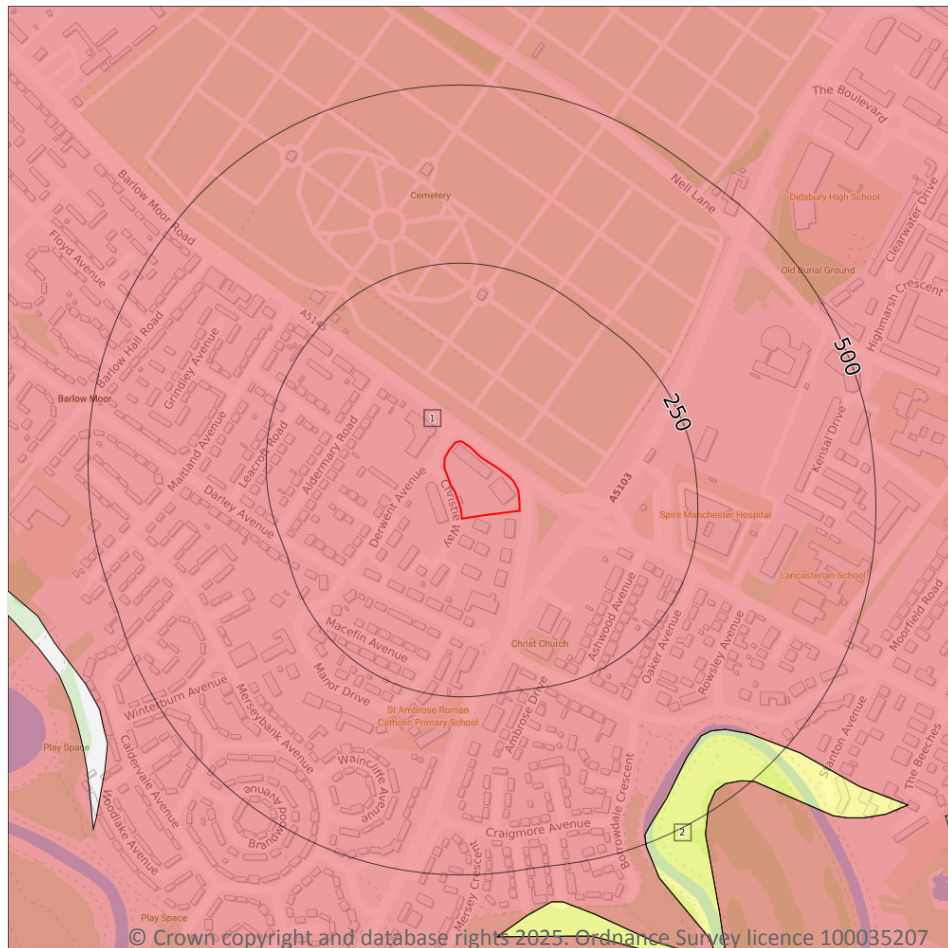
## 5 Hydrogeology - Superficial aquifer

- Site Outline
- Search buffers in metres (m)
- Principal
  - Secondary A
  - Secondary B
  - Secondary Undifferentiated
  - Unproductive
  - Unknown

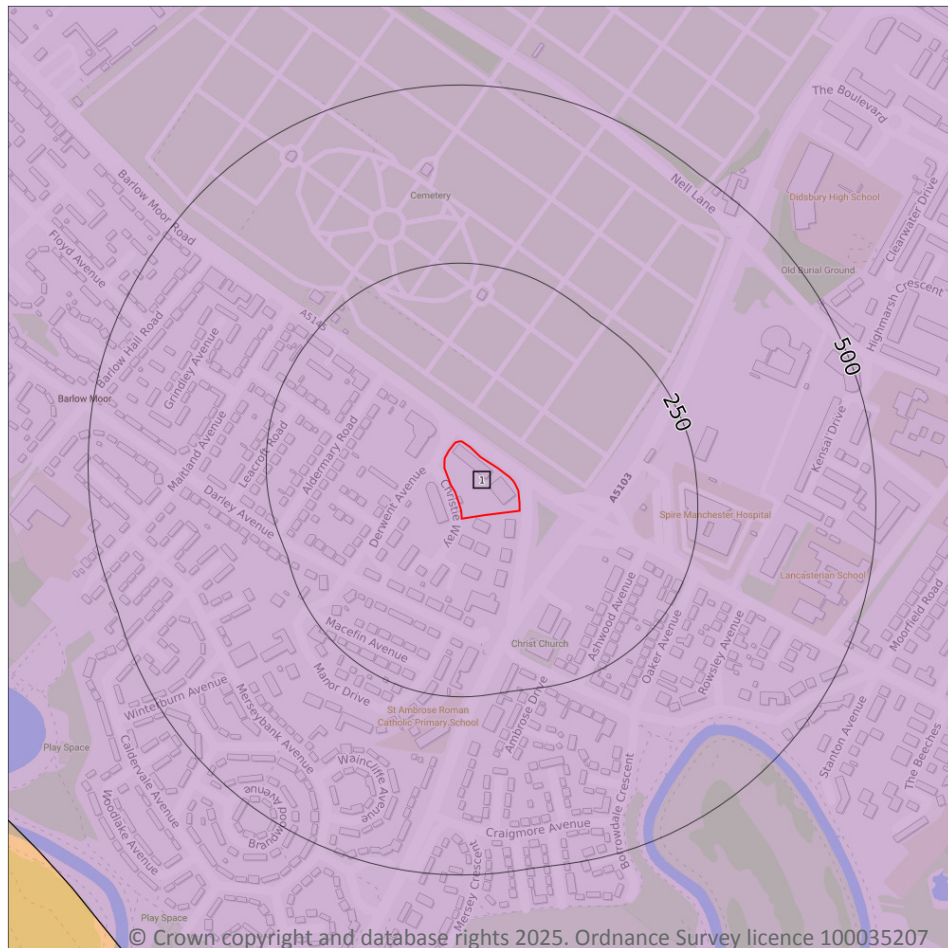
## Bedrock aquifer

- Site Outline
- Search buffers in metres (m)
- Principal
  - Secondary A
  - Secondary B
  - Secondary Undifferentiated
  - Unproductive

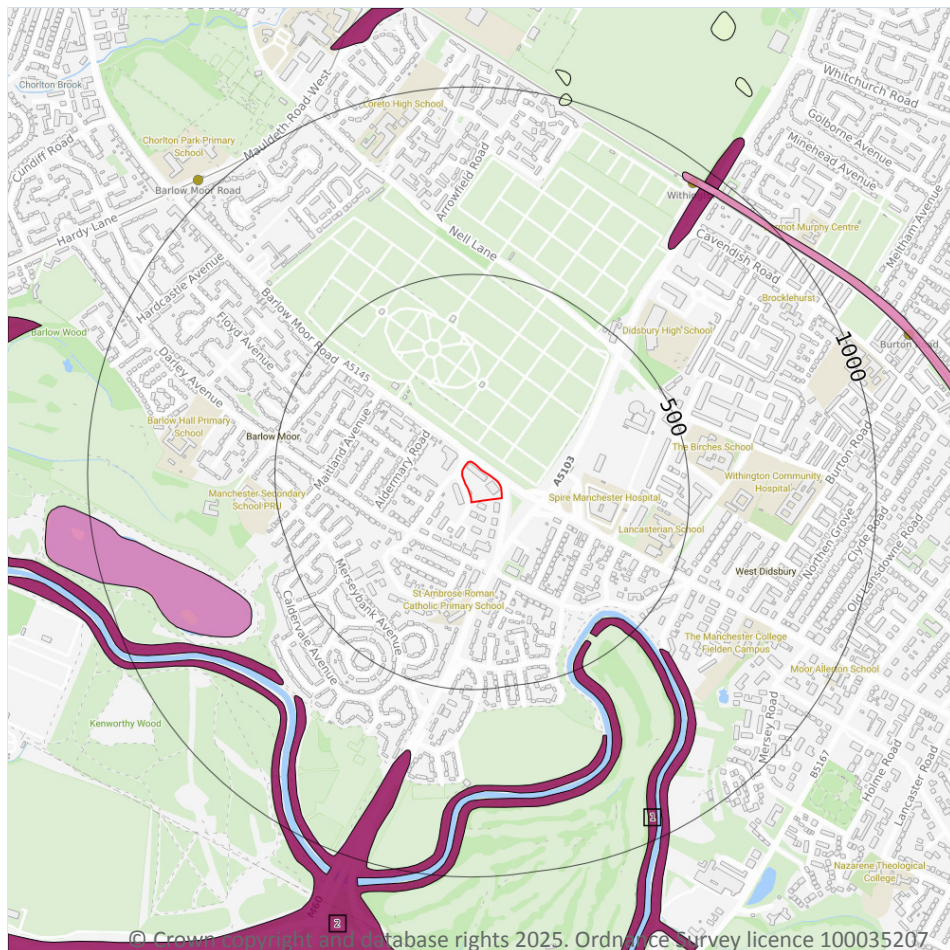
## Geology 1:10,000 scale - Artificial and made ground

- Site Outline**
- Search buffers in metres (m)**
- Reclaimed ground
  - Made ground
  - Worked ground
  - Infilled ground
  - Disturbed ground
  - Landscaped ground

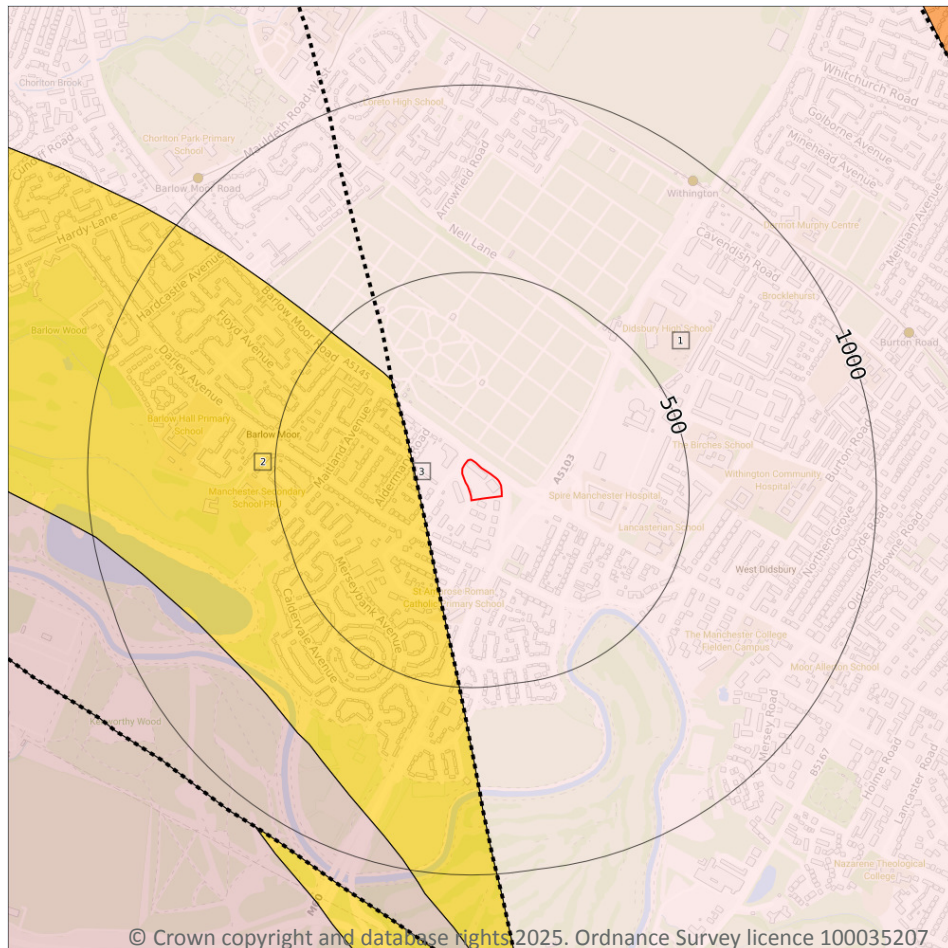
## Geology 1:50,000 scale - Bedrock

Linear features at the ground or bedrock surface at 1:50,000 scale of six main types; rock, fault, fold axis, mineral vein, alteration area or landform. Features are either observed or inferred, and relate primarily to bedrock.

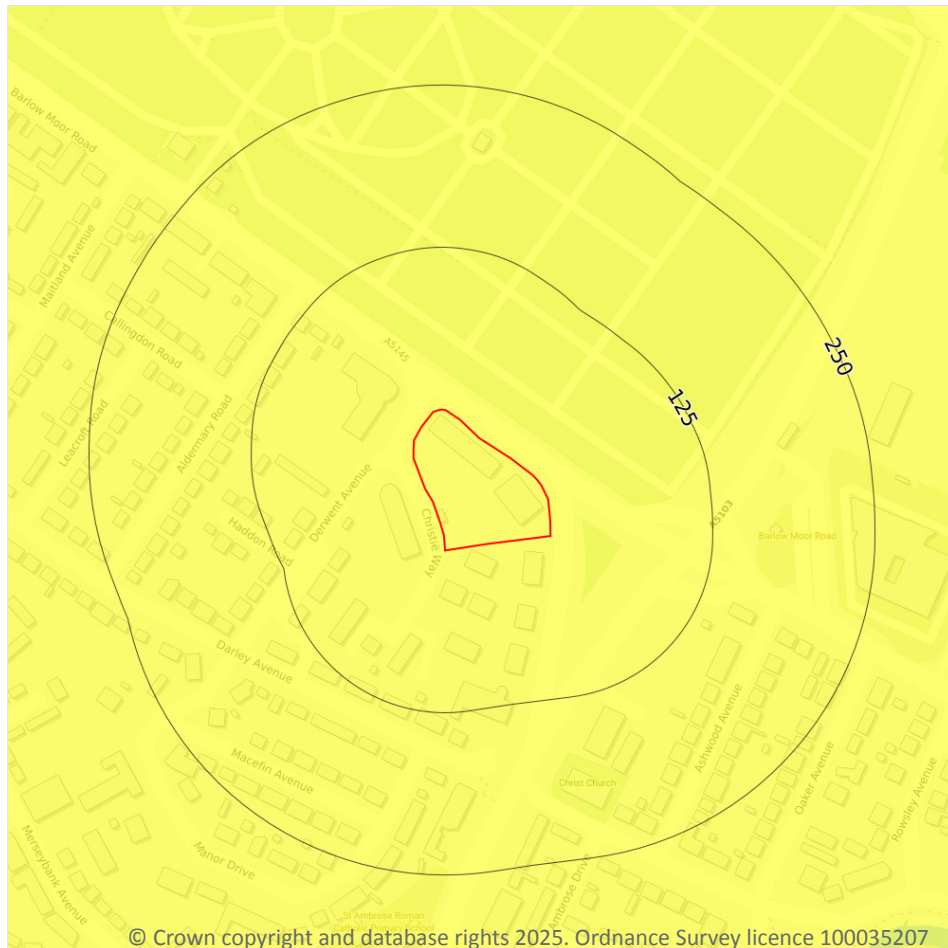
## Natural ground subsidence - Running sands

The potential hazard presented by rocks that can contain loosely-packed sandy layers that can become fluidised by water flowing through them. Such sands can 'run', removing support from overlying buildings and causing potential damage.

| Location | Hazard rating | Details |
|---|---|---|
| On site | Very low | Running sand conditions are unlikely. No identified constraints on land use due to running conditions unless water table rises rapidly. |

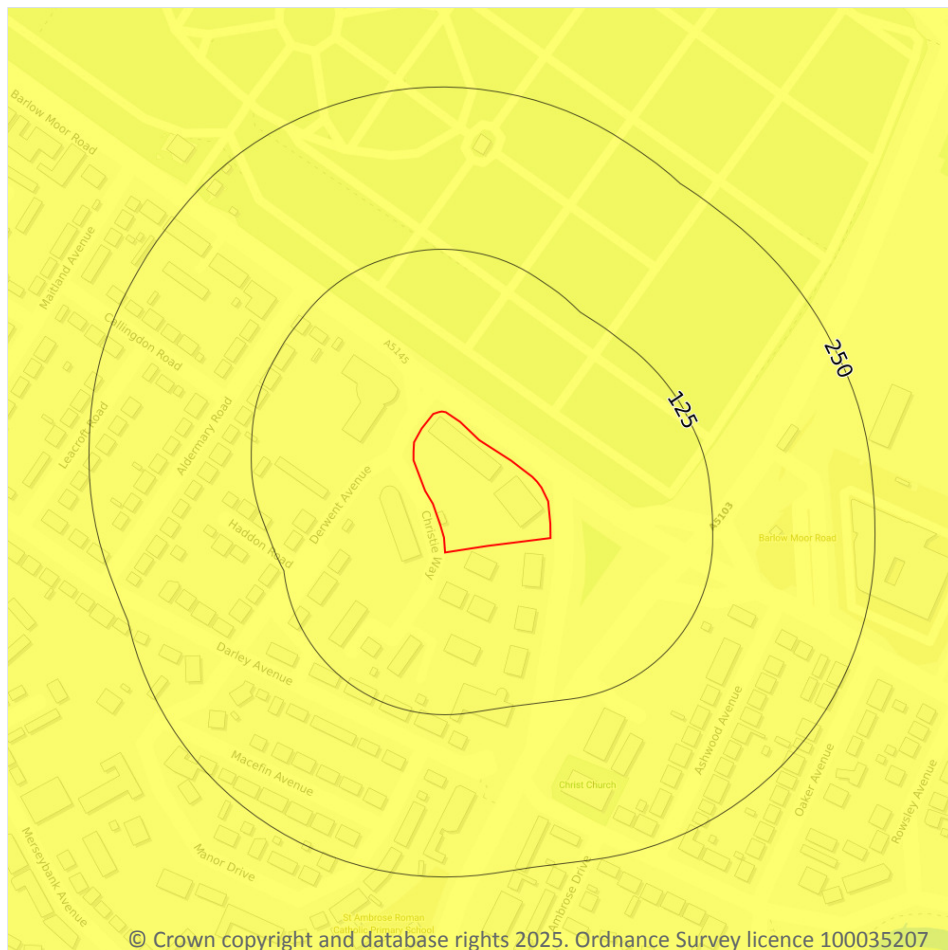
## Natural ground subsidence - Landslides

The potential for landsliding (slope instability) to be a hazard assessed using 1:50,000 scale digital maps of superficial and bedrock deposits, combined with information from the BGS National Landslide Database and scientific and engineering reports.
