# Sharston Road, Sharston Industrial Estate

## *Remediation Strategy and Verification Plan (including management of asbestos in soils)*

| Title | Remediation Strategy and Verification Plan (including management of asbestos in soils) | |
| Doc ref | 333800048-STN-XX-XX-RP-GE-0002 | |

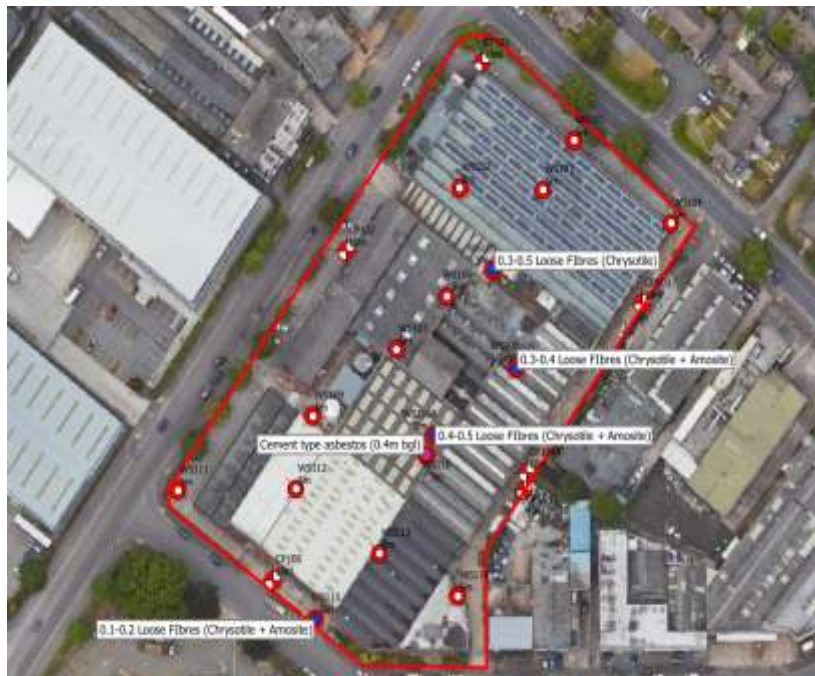
Figure 2.2: Location of laboratory confirmed cement type asbestos

The overarching strategy is to break contaminant linkages associated with construction workers and exposure to asbestos containing materials, notably the known occasional occurrence of cement type asbestos at 0.4m bgl within WS110 and import Topsoil/Subsoil for cover systems. The location of the known cement type asbestos in WS110 and trace asbestos loose fibres is shown below Figure 2.2.

- Occasional laboratory confirmed cement type asbestos is present in WS110 in the Made Ground at 0.4m bgl – *the cement type asbestos at this location could pose a risk to construction workers either during the earthworks, service or foundation installation and therefore mitigation is required.*

The cement type asbestos present at the location of exploratory hole WS110 at 0.4m bgl and if present elsewhere underlying the slab/ following strip should be recorded/ handpicked and removed as far as reasonably practicable. To ensure a briefing note can be provided to the LPA it's recommended that a suitably qualified geo-environmental engineer (with suitable asbestos in soil training) is present during the hand picking to take photographic evidence of the works and compile a site visit letter.

- Locally at the location of WS110 soils should be excavated to 0.4m bgl to hand pick the known cement type asbestos, it is recommended that soils are dampened down as a precaution to minimise fibre release (a jet wash bowser could be deployed);

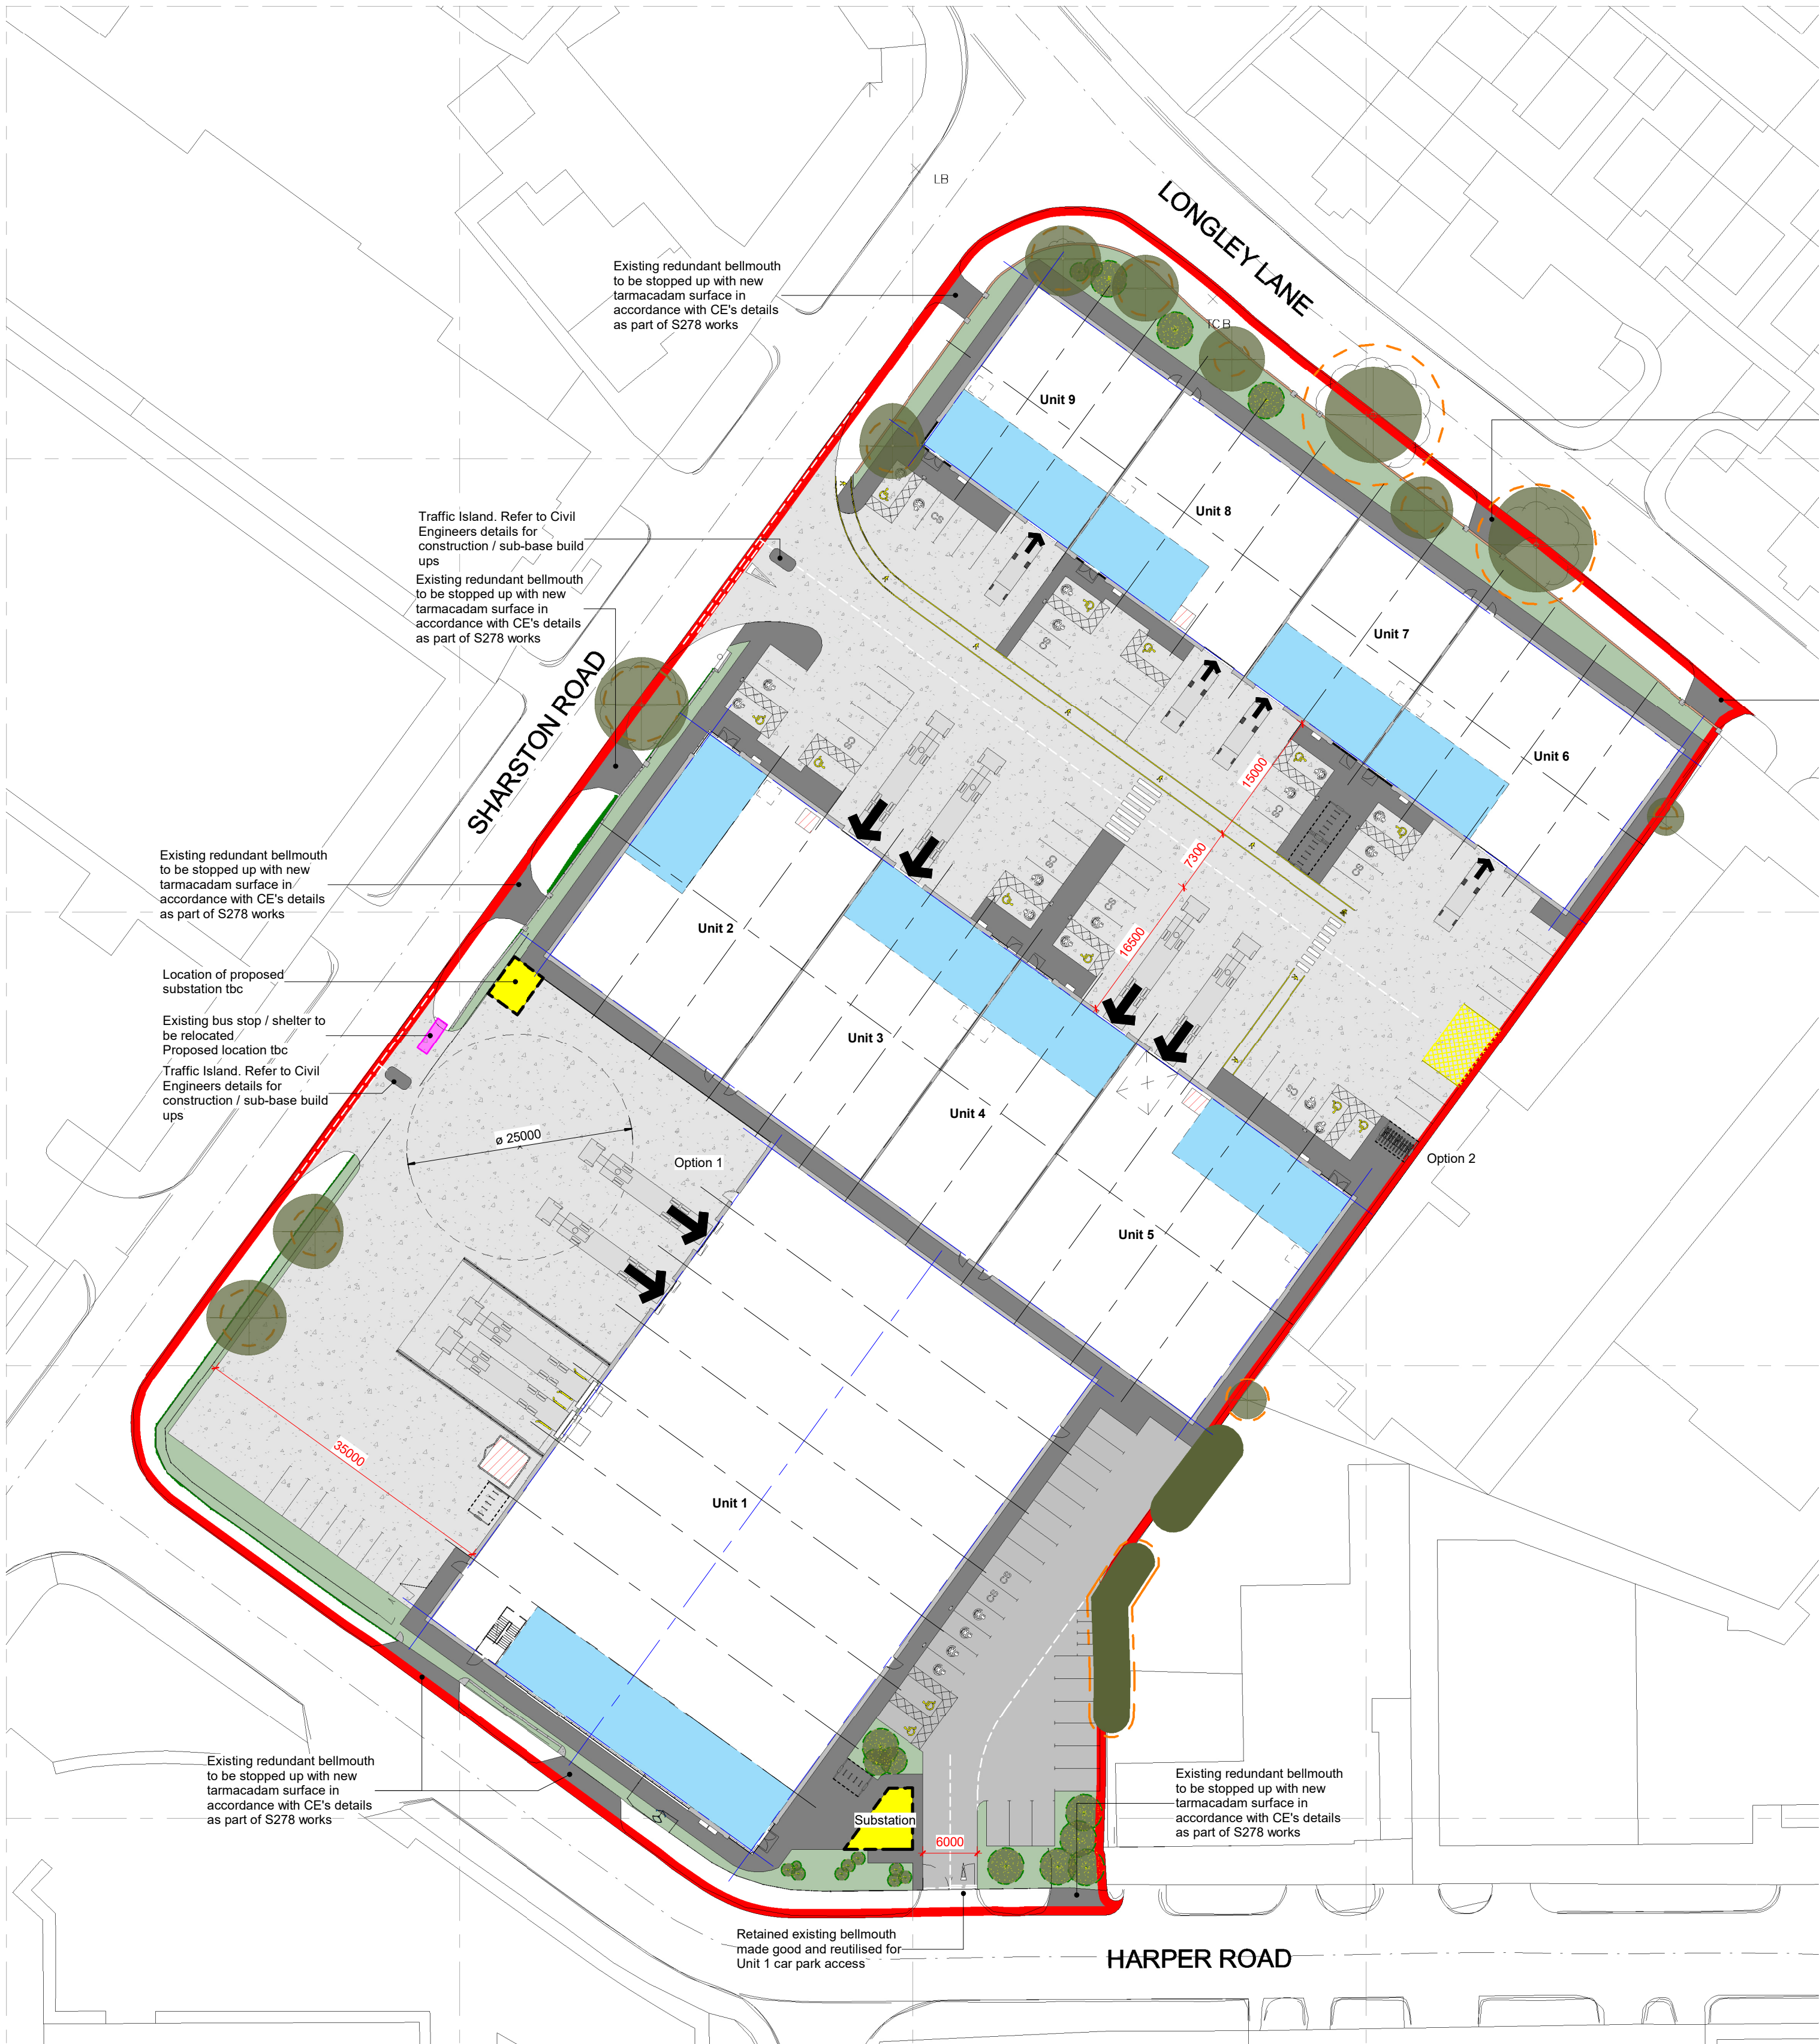
1 05-ZZ\_Site Plan as Proposed

- Proposed Planning boundary
- Reinforced concrete service yard inc. dock ramp. Refer to Civil Engineers details for construction / sub-base build ups
- Tarmacadam surface to vehicular access road. Refer to Civil Engineers details for construction / sub-base build ups
- Traffic Island. Refer to Civil Engineers details for construction / sub-base build ups
- Proposed areas of soft landscaping (Trees / planting) in accordance with Landscape Architect details
- Approximate area of existing vegetation (Trees, bushes, hedgerows) taken from topographical survey
- Root protection area of existing trees in accordance with BS 5837:2012. Refer to Arboriculturist details for confirmation
- Extent of first floor accommodation space to each unit (office & core)

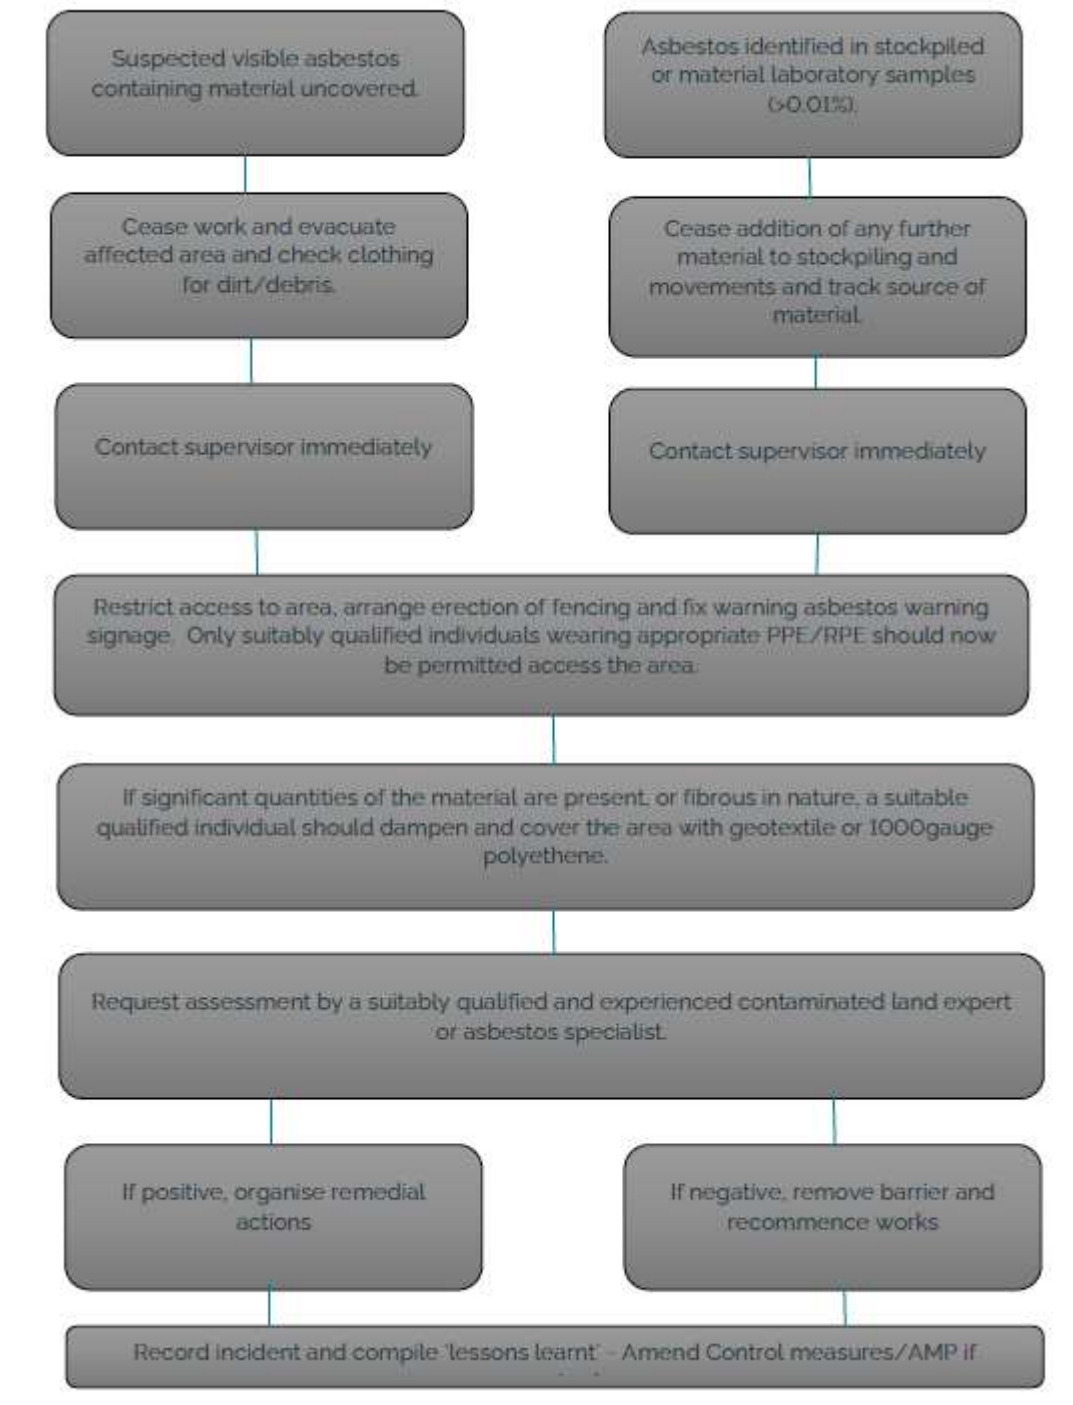
## Emergency Procedures (Asbestos)

The procedure to be followed in the event of suspected ACM being uncovered can be found in **below**.
