**Mayfield, Phase 1**  
EIA Volume 2

September 2019

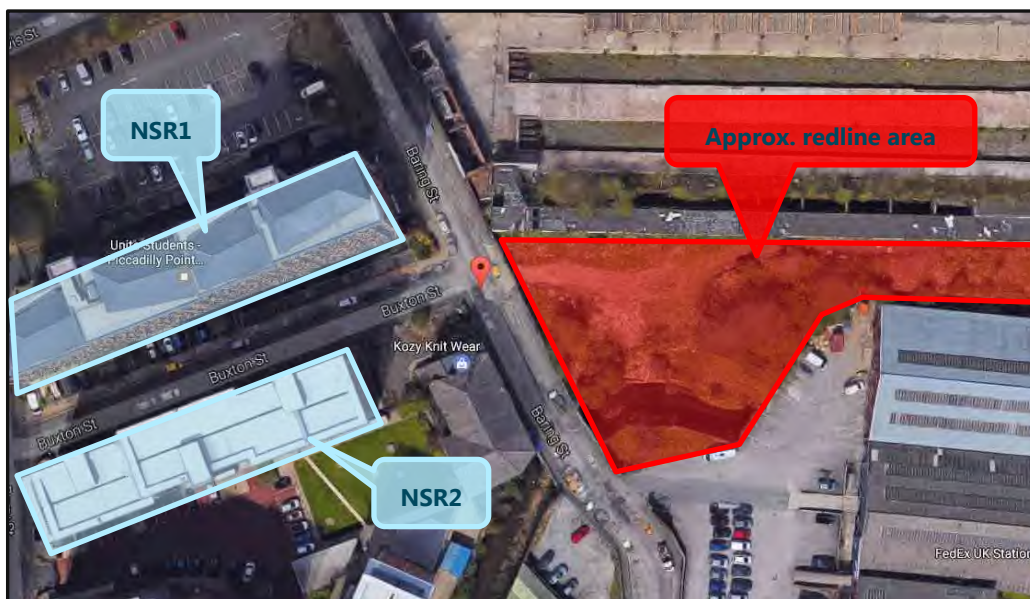
**Figure 1-1 - Site and nearest noise-sensitive receivers**

The figure below shows the approximate location for the proposed development. As can be seen from the figure, there are nearby existing student residences to the immediate west of the site, and these are considered to be the nearest noise-sensitive receptors (*NSRs*).

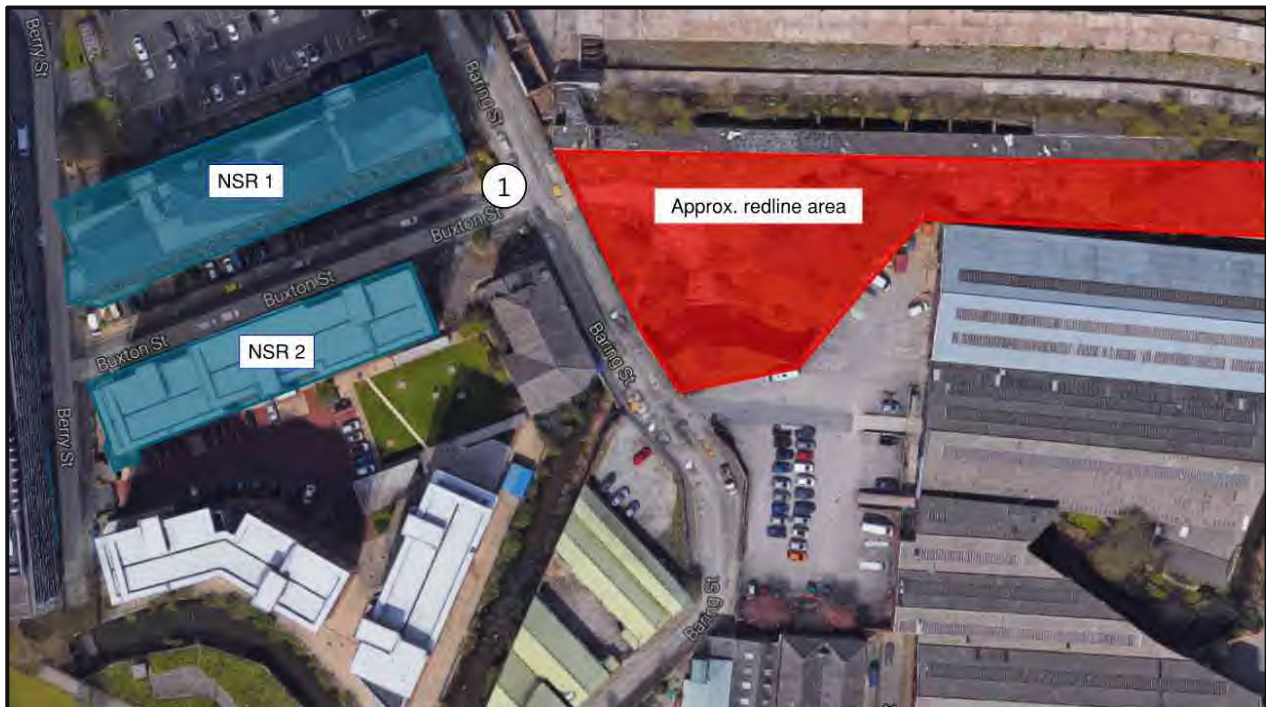
Figure 1-2 Location of the site (red), NSRs (blue) and location of the noise survey measurements

Figure 1-2 presents the site and the location of the short term noise survey (position 1).

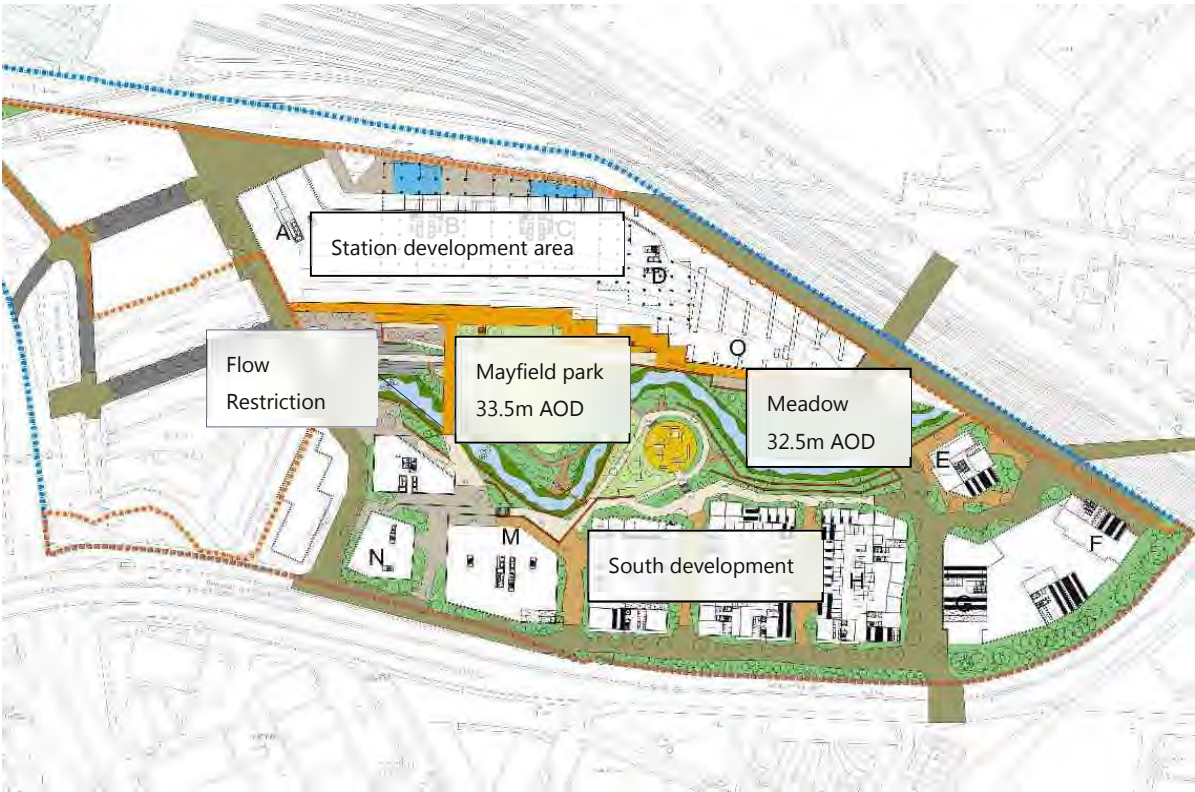
Figure 1-1 - SRF Scheme park levels

| Hydraulic modelling | Landscape design and flow restriction | Several schemes were tested through hydraulic modelling; the SRF Scheme park levels are shown in Figure 1-1 below. A flow restriction at the proposed bridge location replicates the effect of the 'day-lighted' culvert. |

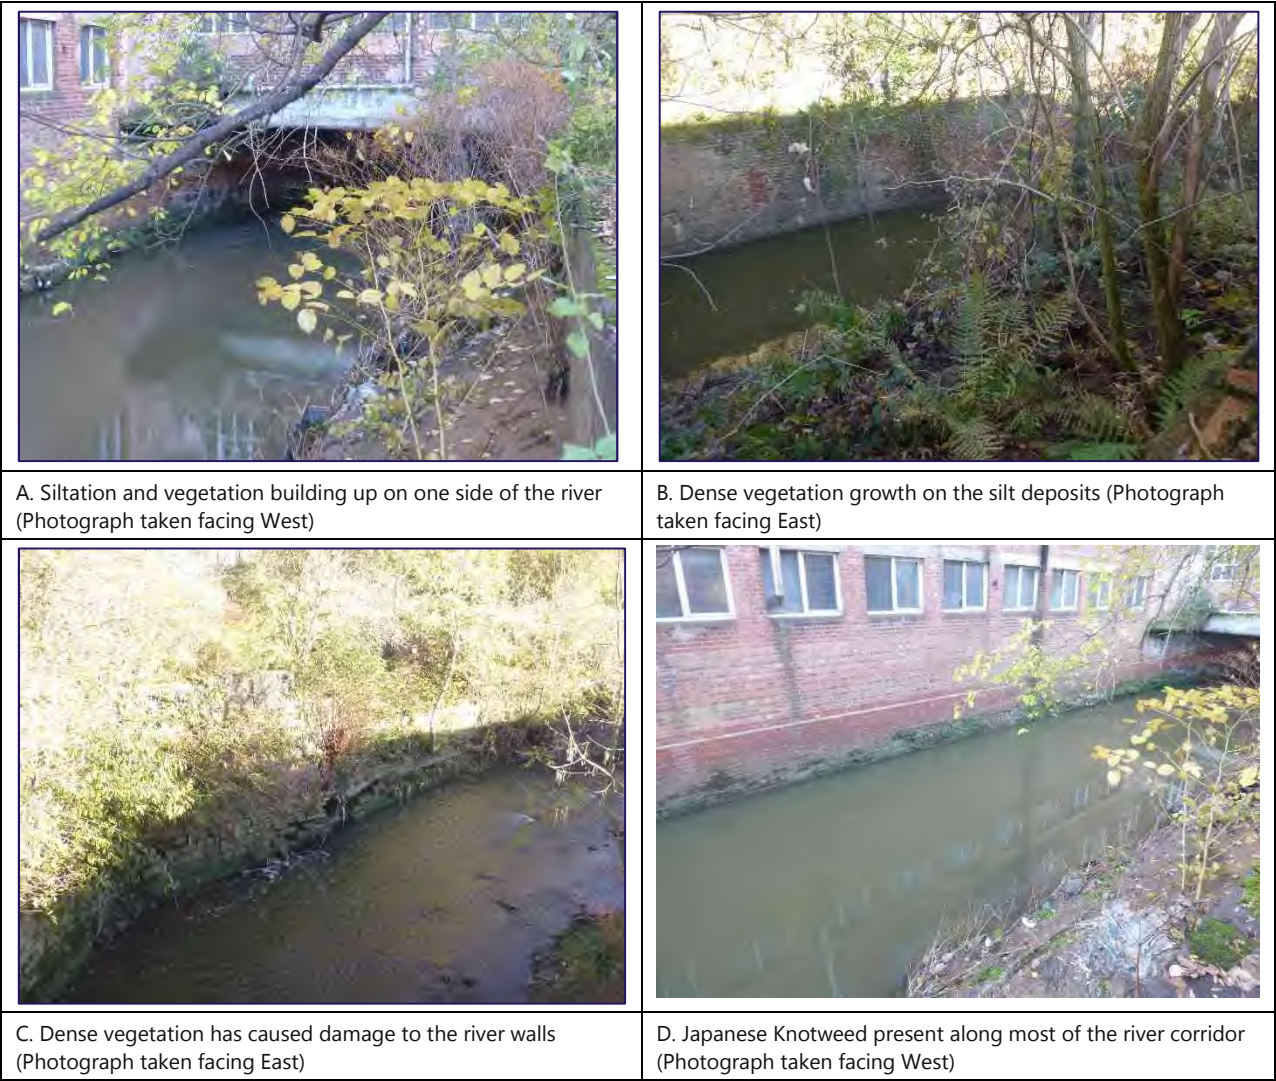
Figure 3-1 Site visit photographs

A number of visits have been made to site by BuroHappold at various times of the year (between October 2016 and November 2017) during which different river conditions were observed. The river through the site is difficult to view due to the existing industrial development and the extent of vegetation, particularly during the summer months; refer to Figure 3-1.

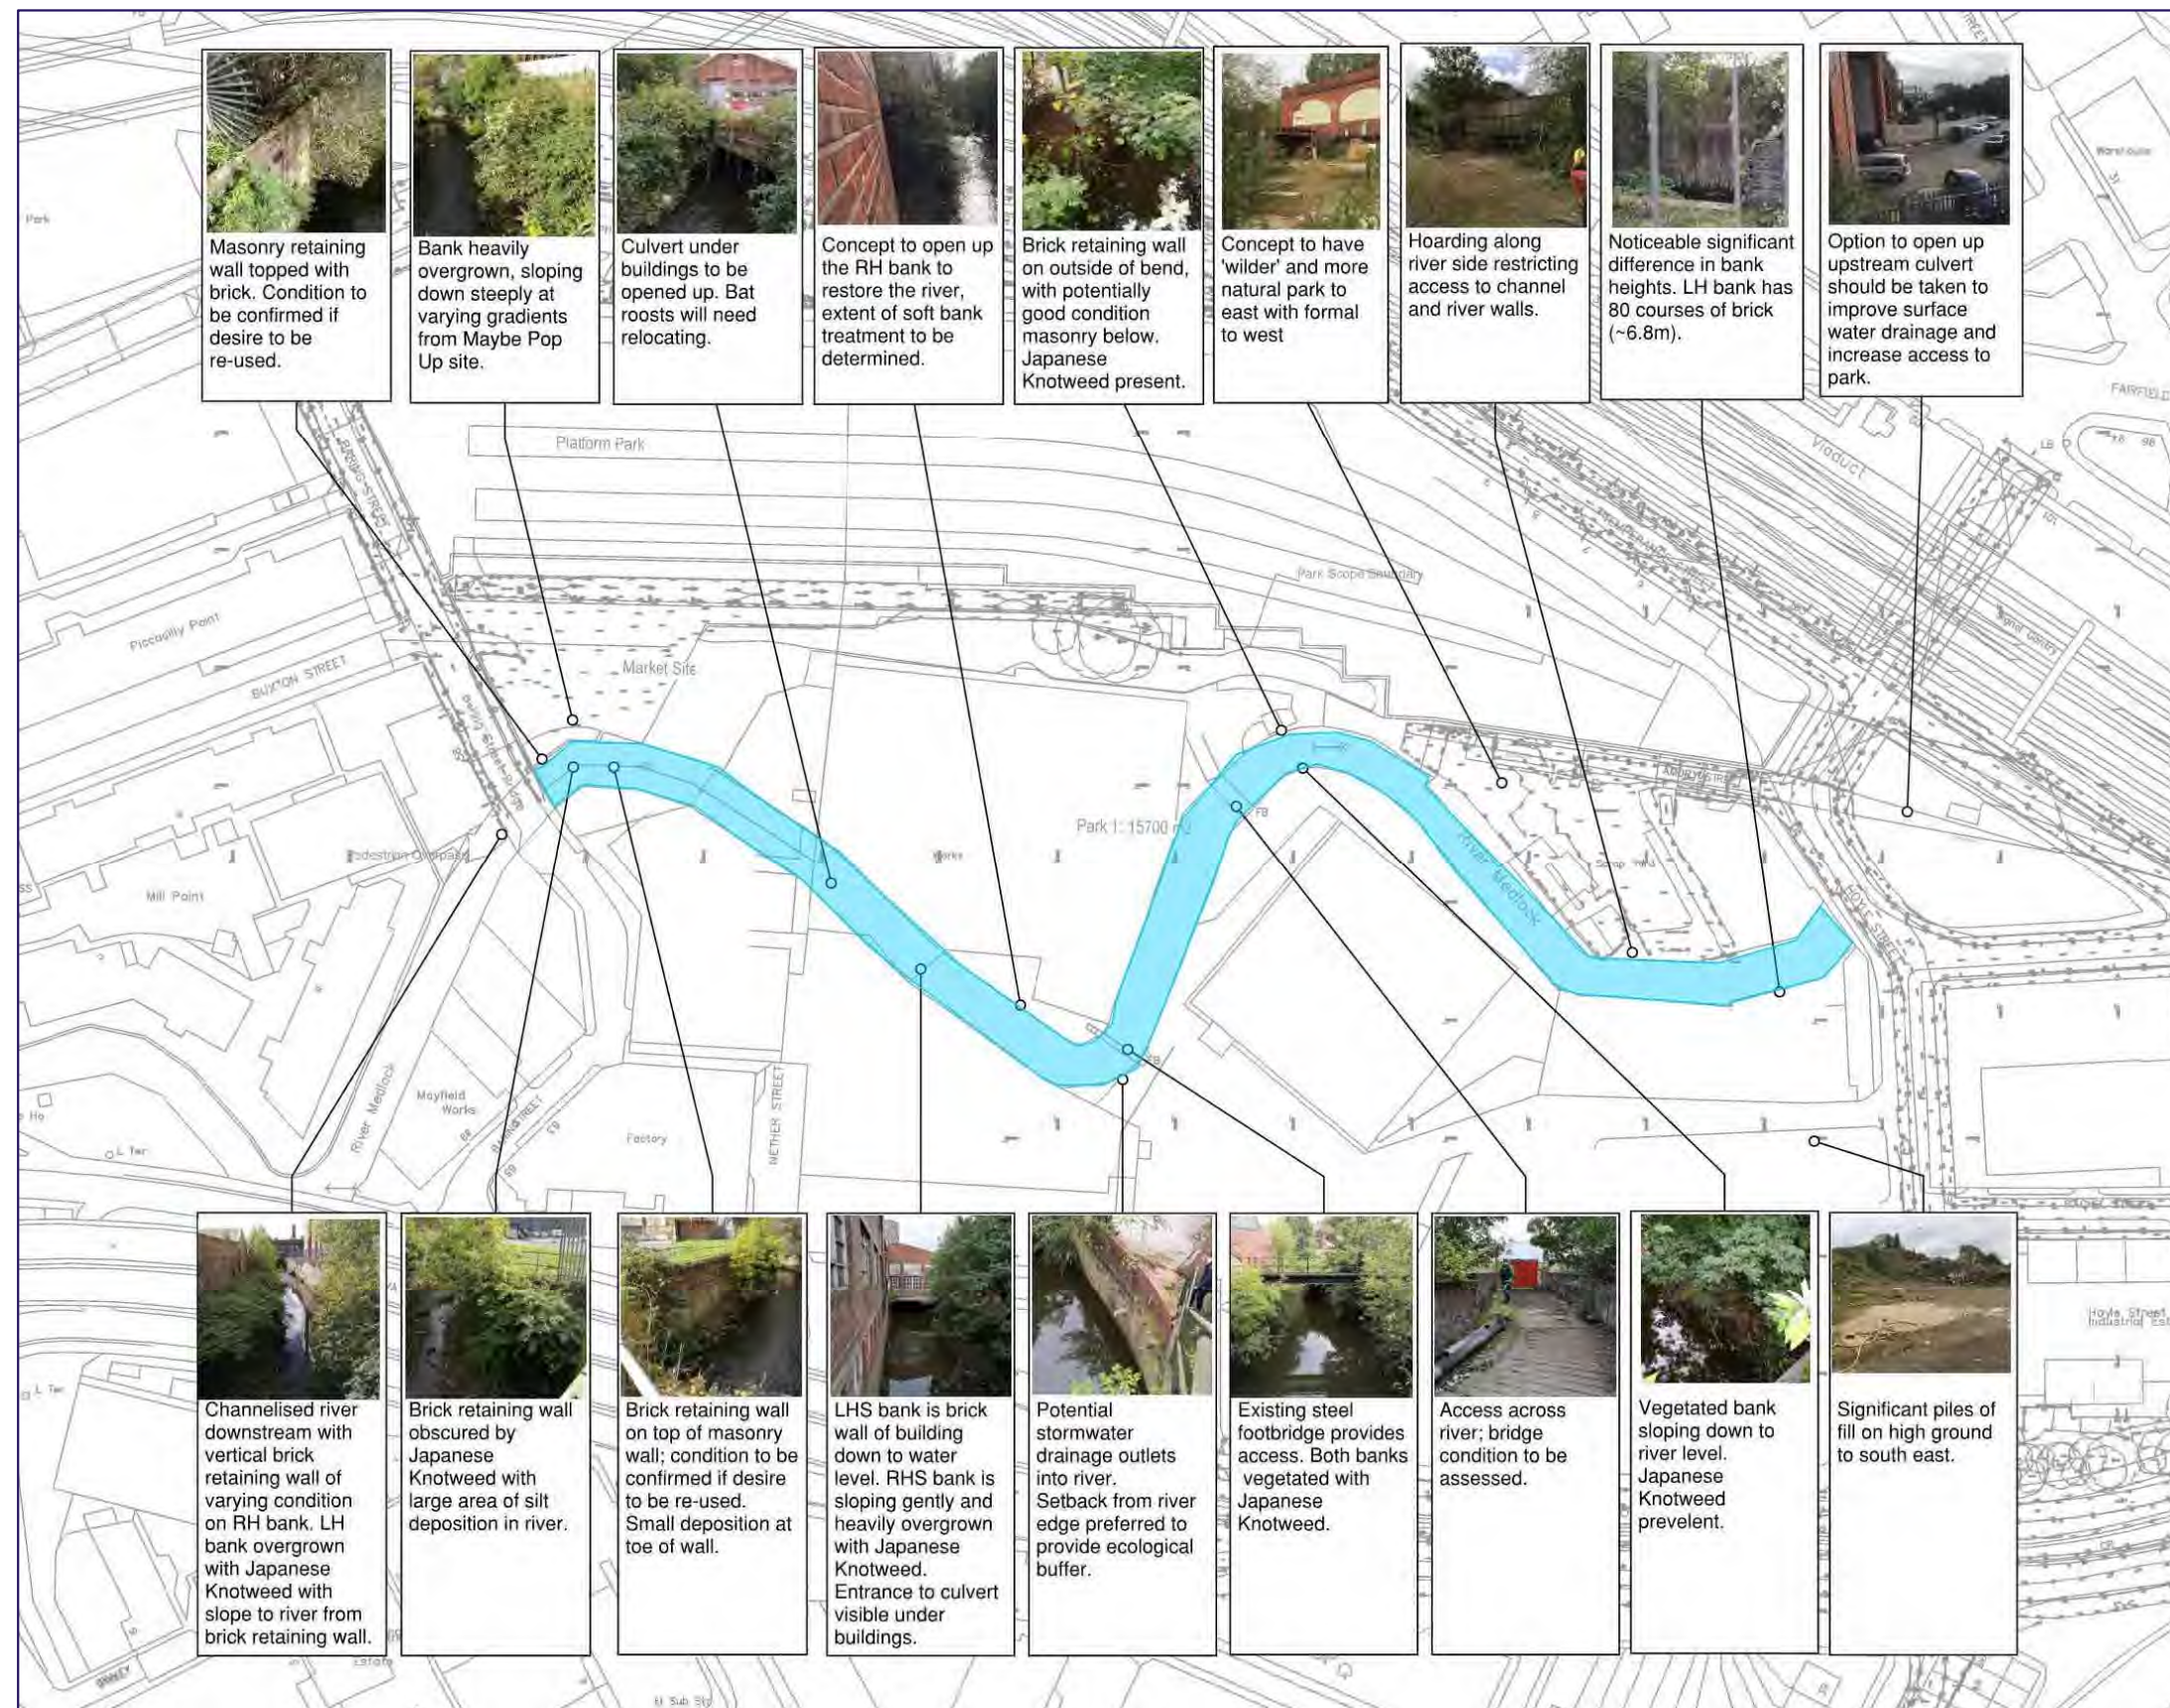
Figure 3-2 Site walkover observations

The BuroHappold visited site on 03/10/2017 together with F+G to investigate the Mayfield site in relation to the proposed riverside landscape park. The joint site walkover was useful in order to fully understand the various drivers for flood risk management set against the desired outcomes for the supporting landscape. Figure 3-2 summarises the main observations of the walkover.

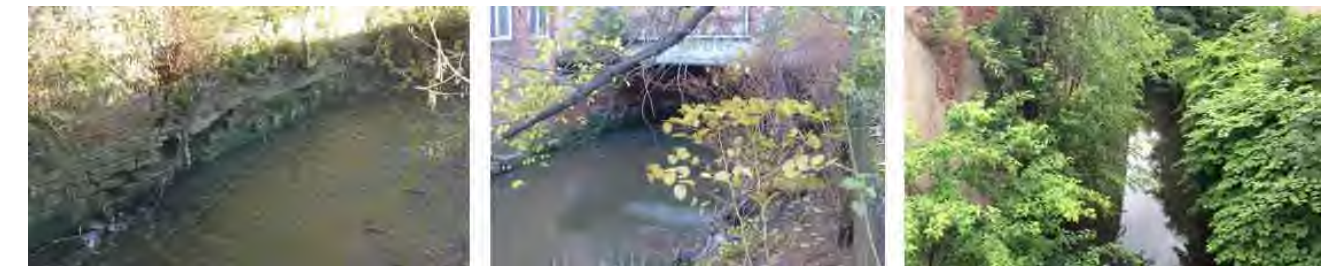
Figure 4-1 Existing river walls

Within the site the River Medlock is highly constrained by vertical masonry and brick river walls between the existing industrial plots from 2m to over 7m in height. With the redevelopment of the area and the formation of a meaningful park, the intention is to open up these walls and culverts to allow the river to influence the area in a very much more positive way. The design intent is to encourage people to get closer proximity to the water's edge in order to improve the interaction for users and improve biodiversity.

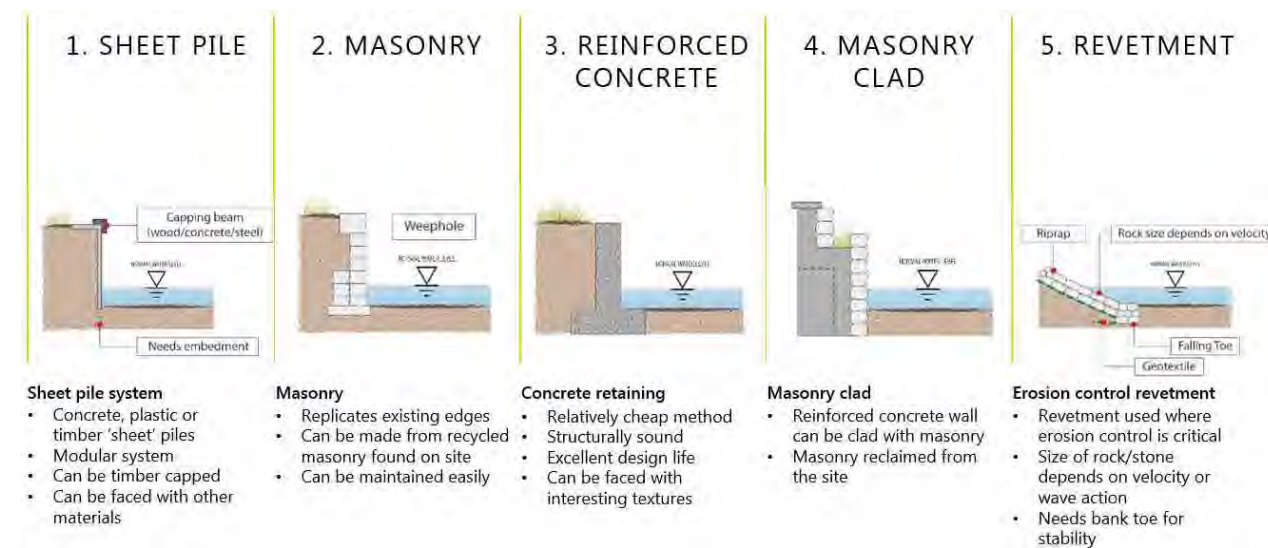
Figure 4-2 Hard Riverbank Options

Hard, soft and hybrid options for the treatment of river edges, marginal fringes and changes in elevation at the edge of the River Medlock have been developed to demonstrate to the Design Team that there are many different approaches that can be used even on a relatively short section of restored river park (see Figures 4-2, 4-3 and 4-4 below). The applicability of each treatment depends on the floodplain, landscape design, degree of contamination of adjacent ground and proposed topography. A coordinated concept design for the river edge treatment is shown in Figure 4-5.

The edge treatments outlined above can be used alone or in combination to create particular effects for use by park visitors, or more natural solutions for the improvement of biodiversity. Some of these treatments have been used in the concept design.

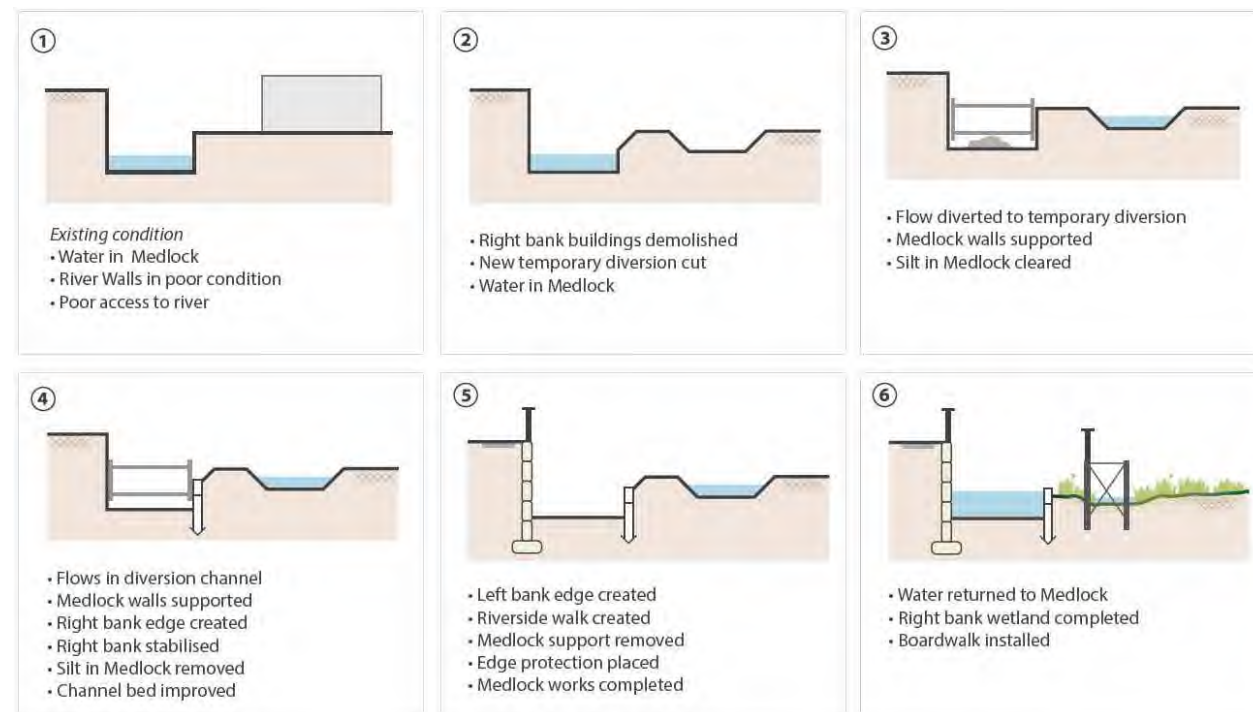
Figure 4-6 Construction methodology for soft edges

With soft edges a temporary diversion channel on one bank can be excavated to deal with the river flow as shown in Figure 4-6 below. The works can be eventually utilised in the permanent works, therefore saving duplicate excavation.

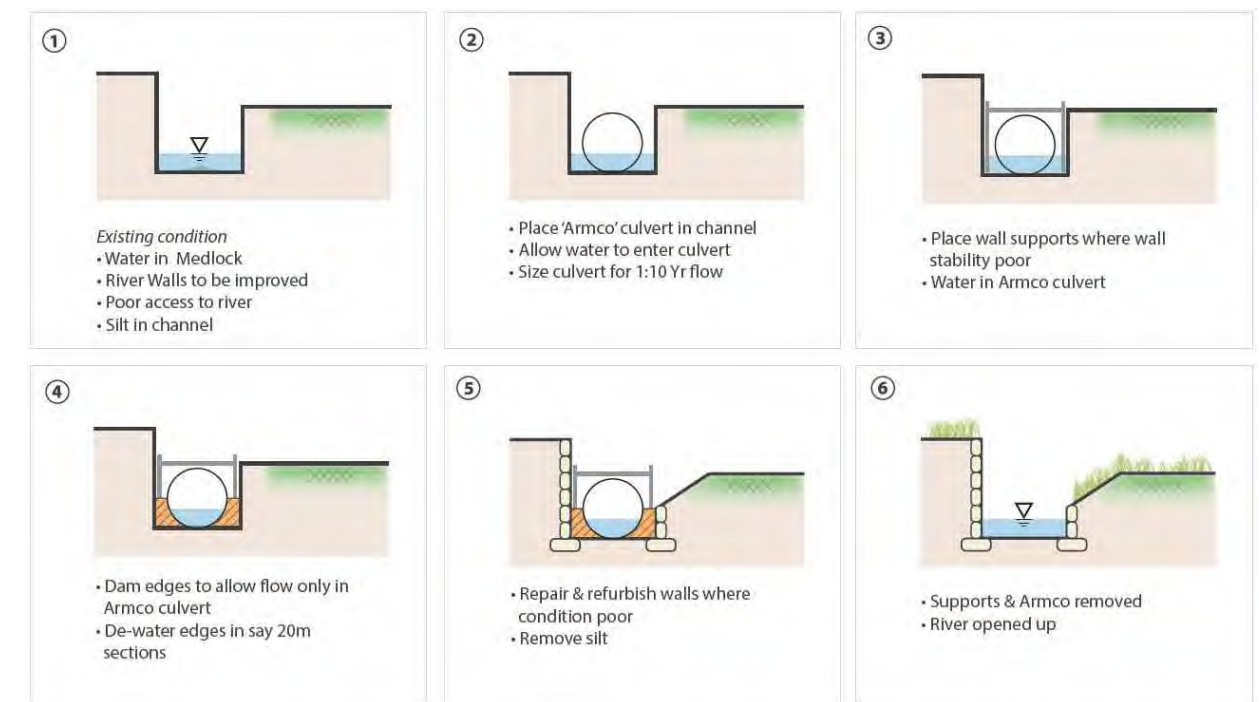
Figure 4-7 Construction methodology for hard edges

With hard edges a temporary flume or culvert can be used to deal with the river flow as shown in Figure 4-7 below. The works would usually be carried out in short (say, 20m) sections to ensure the banks/river walls remain stable.

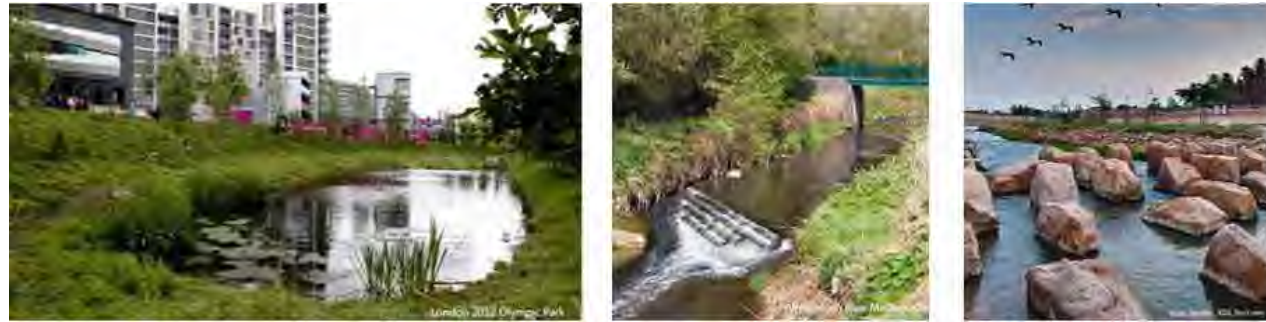
Figure 4-8 Flow control examples

These features will be included and represented in the hydraulic modelling during the detailed design stages.

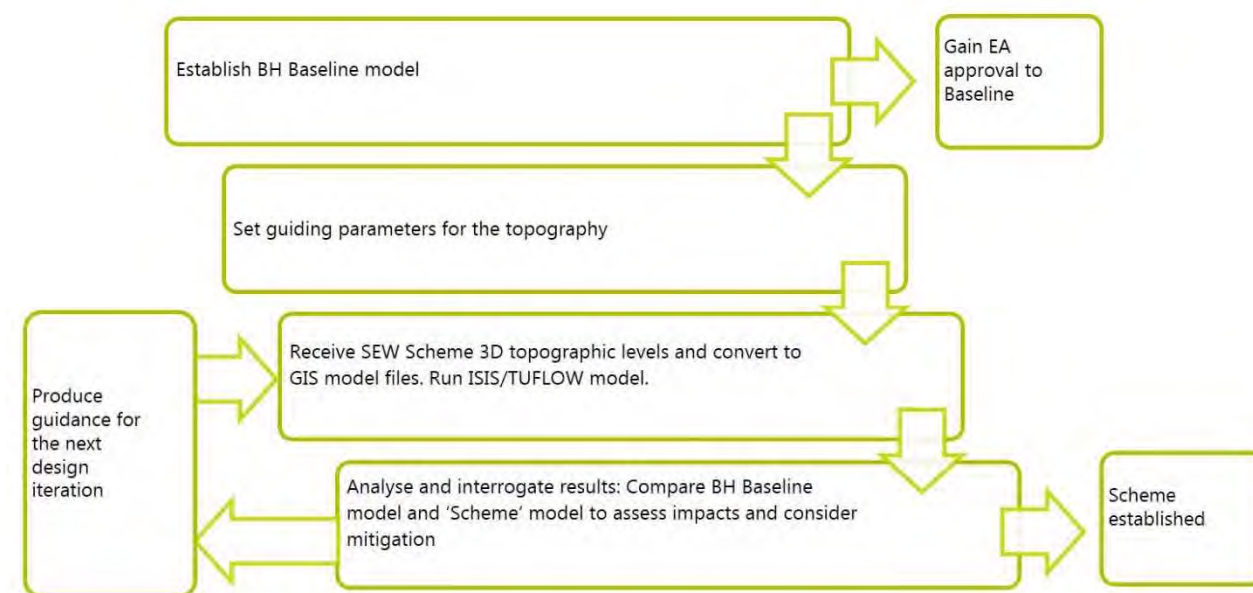
Figure 5-1 Modelling process for the concept

For each iteration the following work has to be undertaken as shown in Figure 5-1.

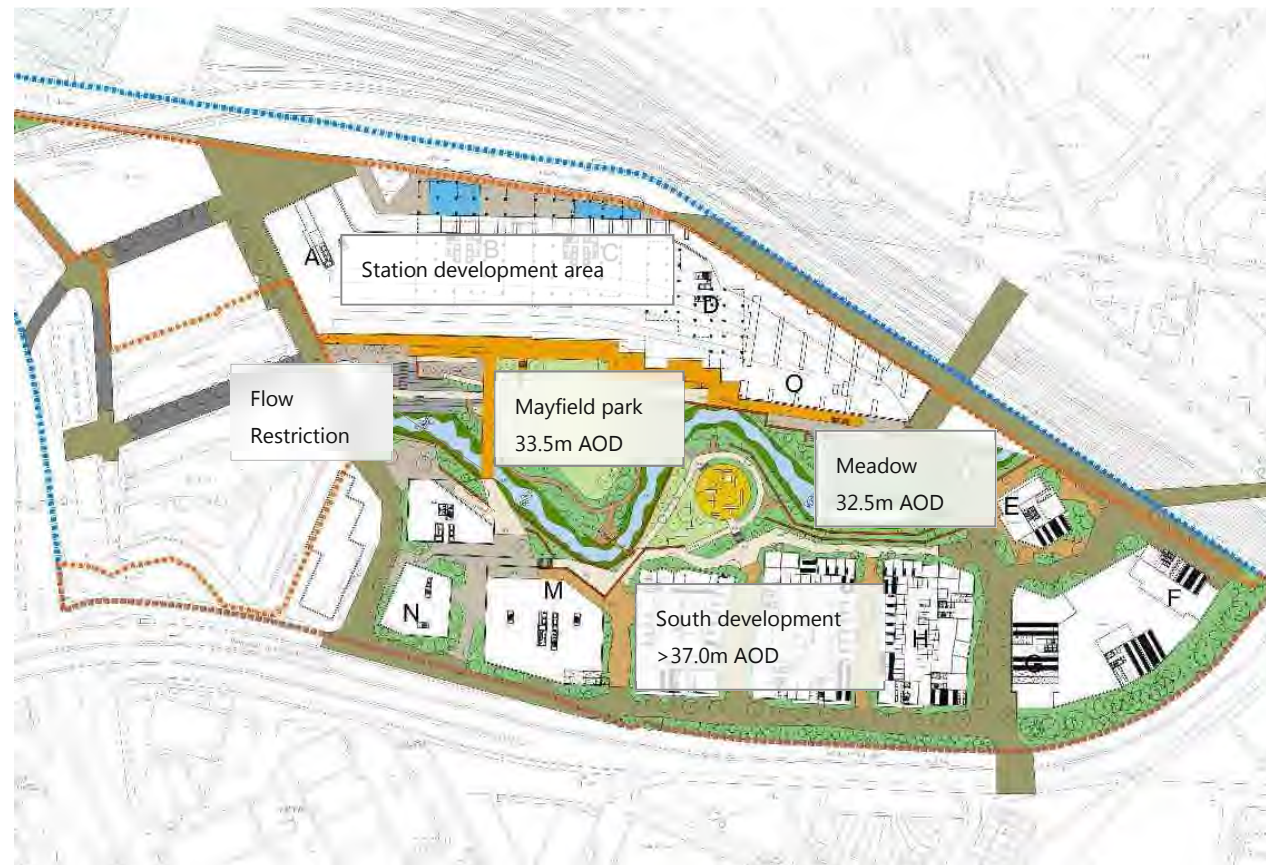
**Figure 5-2 SRF Scheme**

Model run BH\_024 (referred to in this section as the SRF Scheme) was compiled based on the SEW masterplan (drg nr 0292-SEW-ZZ-00-DR-T-001000, issued to BHE on 16/10/2017). The main park level was set at 33.50m AOD with the upstream meadow area generally set at 32.50m AOD, lower than the SEW masterplan proposals. Both culverts are shown 'daylighted' or opened-up, and the buildings to the south in plots M,N, J, I and H are set back at least 5m from the river. The masterplan is shown in Figure 5-2. SEW have further refined the park design and made minor adjustments to the levels. These are not considered to be significant in hydraulic modelling terms.

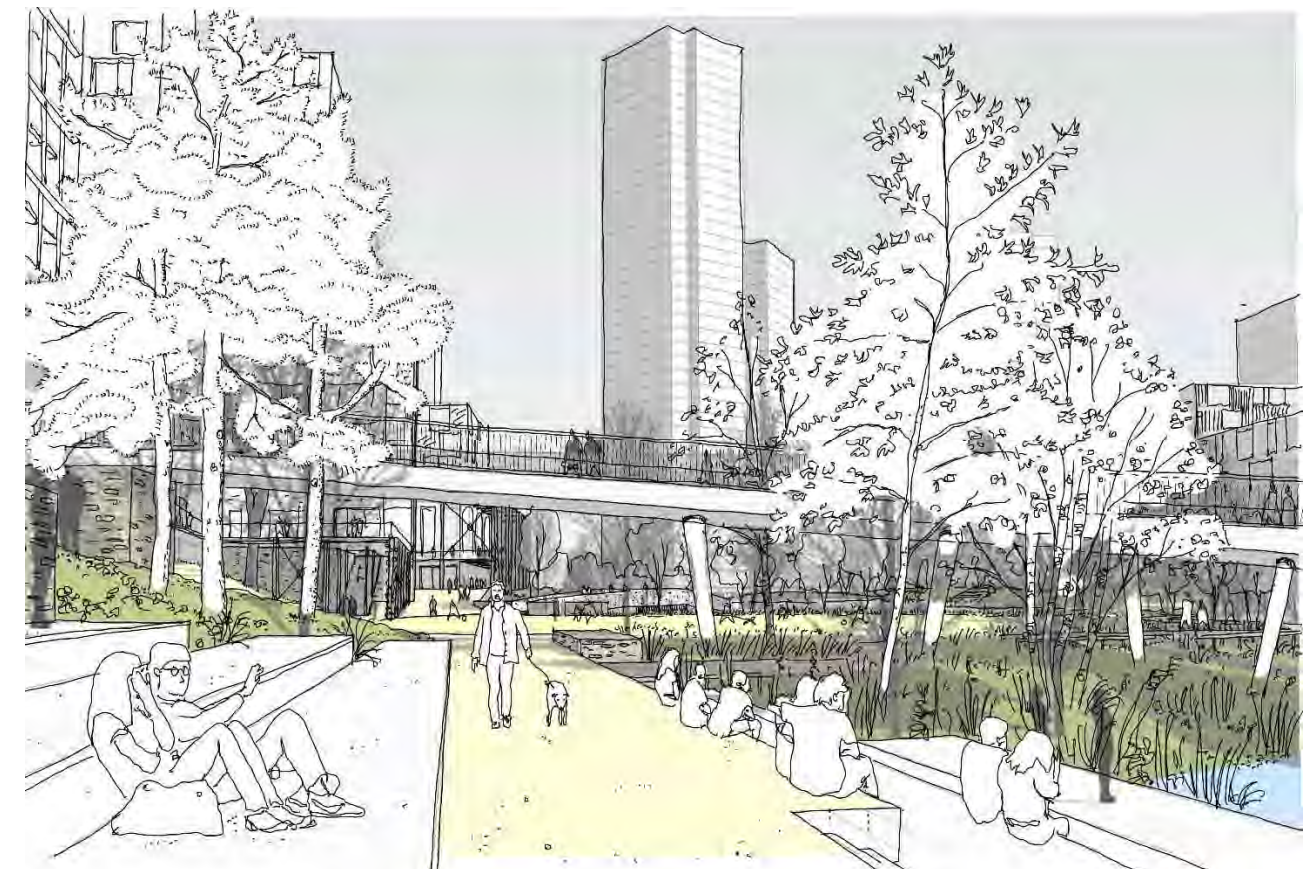
**Figure 5-3 Typical view of park looking east (Sketch by SEW)**

However, as shown in the preliminary sketches in Figure 5-3 it was SEW's design intent that the views across the park should also include the view beneath the bridge. A number of model iterations have been run to investigate whether moving the restriction would provide an adequate restriction to flow, in order to replicate downstream levels as found in the baseline model. Initial attempts to run alternative solutions have been on-going. These model runs have been inconclusive, but can be investigated further during design development. Please refer to Section 8 – Next Steps.

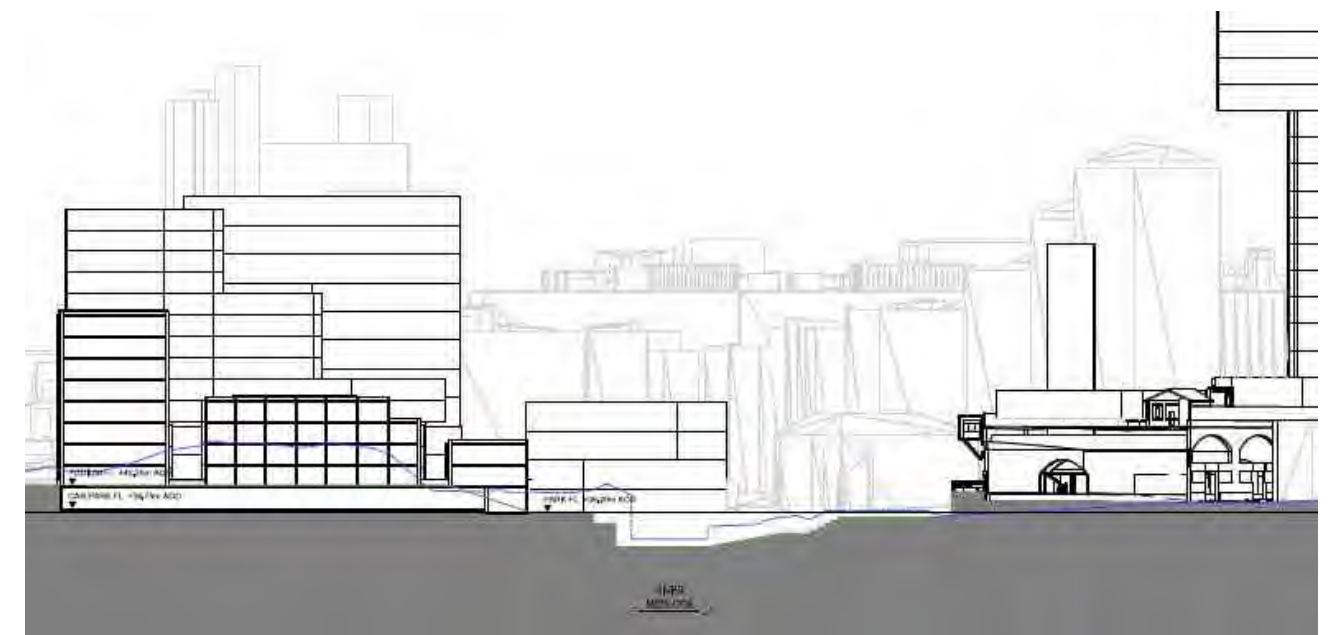
**Figure 5-4 Typical section across the park**

Currently, a restriction across the floodplain beneath the pedestrian bridge is required to a (relatively high) level of 34.8m AOD. Further investigation of the location for the restriction will be investigated during the following stages of design development.

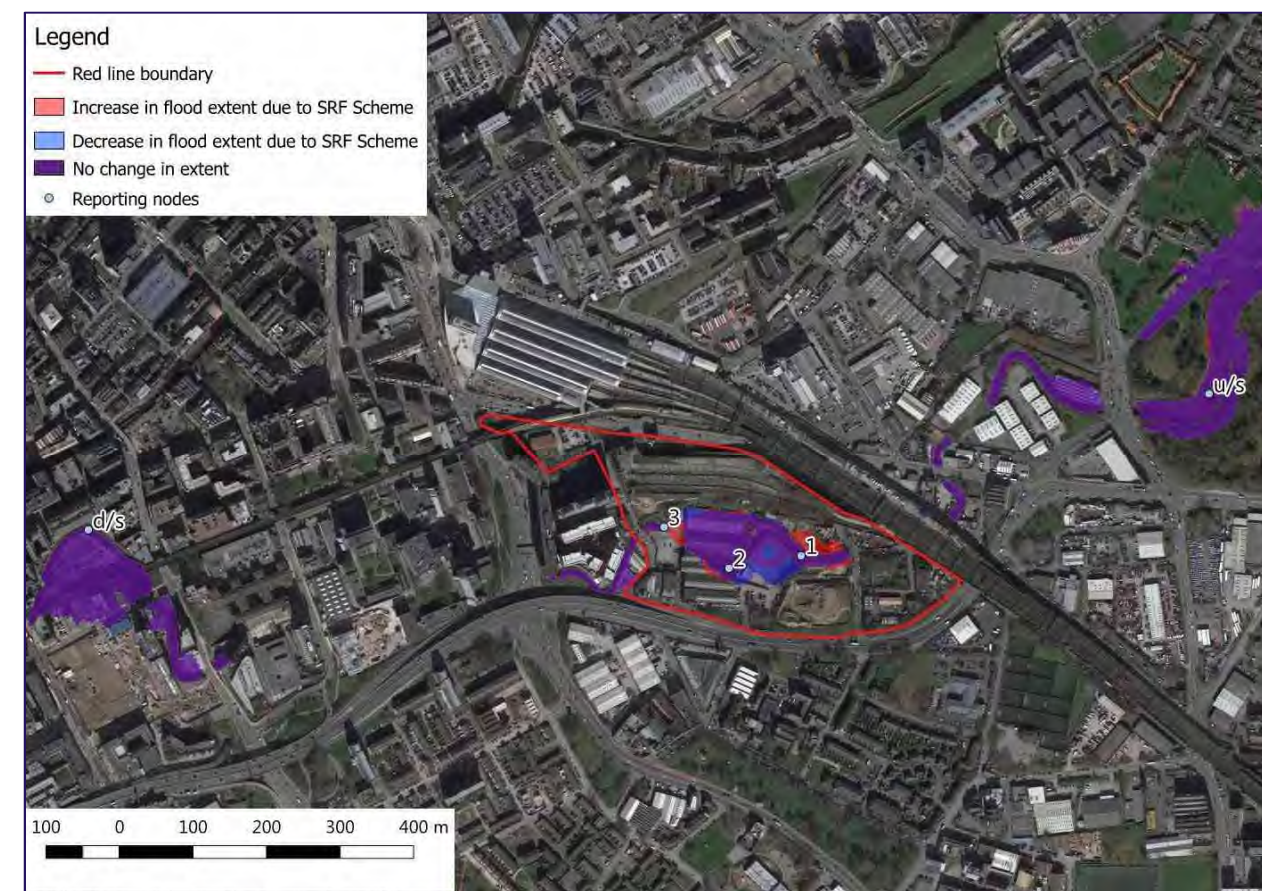
Figure 5-5 Flood extent changes due to SRF Scheme (BH\_024)

The hydraulic modelling results show that there are marginal increases in the extent of flooding in the post-development scenario when compared to the baseline scenario. Upstream and downstream of the site there is only a very minor increase in flood extent and significantly less than for previous schemes tested. The flood extent within the park varies from that of the baseline, as per intended landscape design; to create a park that can flood at the north of the river and replace the floodplain on the south where park-side development is proposed. Refer to Figures below.

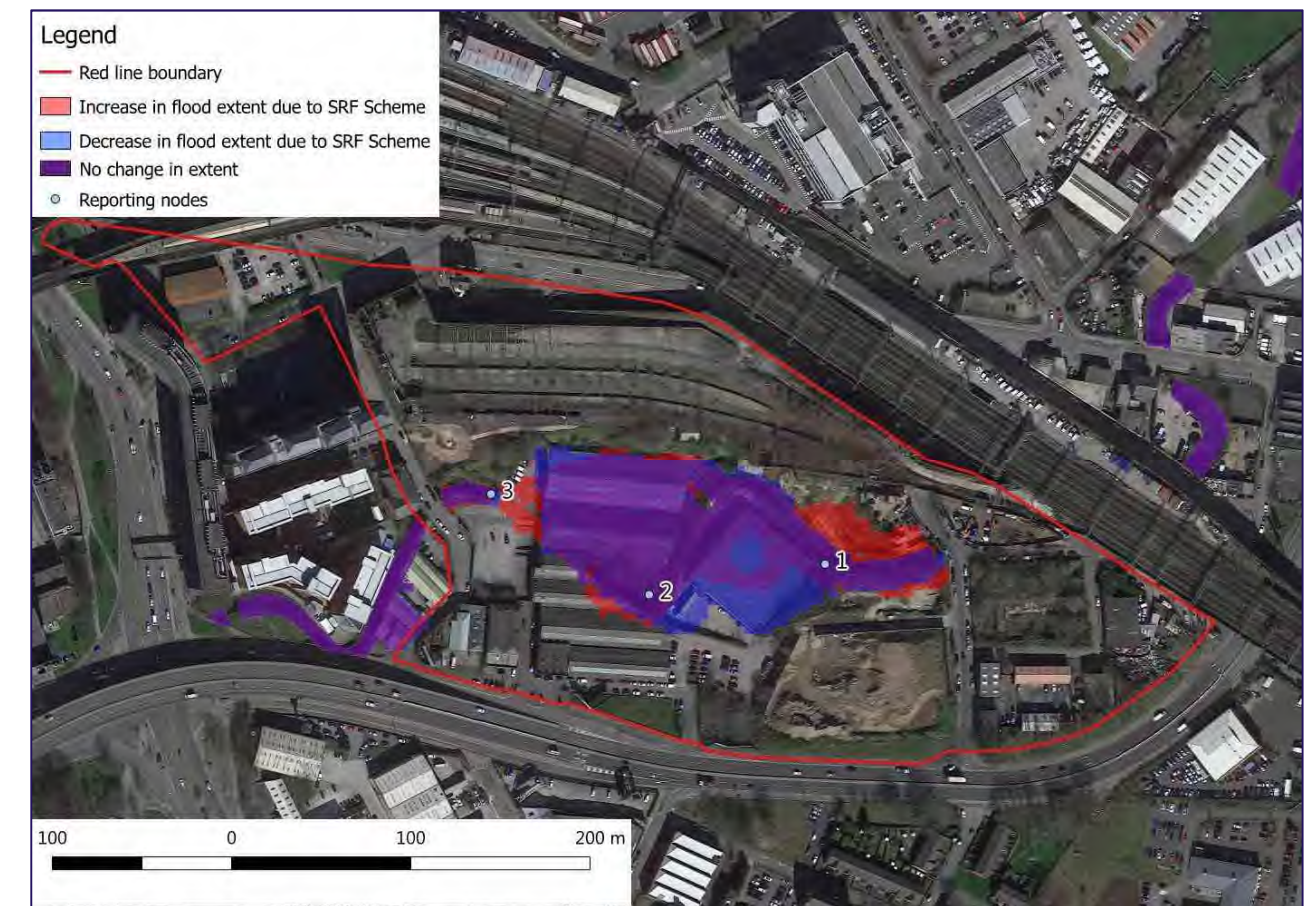
Figure 5-6 - Flood extent changes due to SRF Scheme on site

The hydraulic modelling results indicate that there is a general increase in flood levels across the park, and therefore corresponding flood depth, in the post-development scenario when compared to the baseline scenario. This is the desired effect of producing useable flood storage.

Upstream of the site, the general increase in flood depth is approximately 25mm in the worst affected areas. At this stage it is not clear what the hydraulic mechanism is for these increased levels, however, it is proposed to address this in future iterations of the scheme. Downstream, there are very minor increases in flood level of 2mm. This increase in flood level is considered to be well within the tolerances of the hydraulic modelling software used and it is anticipated that this will be acceptable to the EA at the SRF stage. Please refer to Figure 5-6 and Table 5-1.

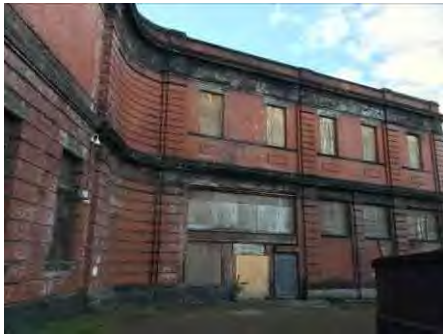
| Reference | Picture | Description | Potential Bat Roost Features and Evidence of Roosting | Assessed Roost Status |
|---|---|---|---|---|
| B1 | | <p>Former Mayfield Station.<br/>Brick façade with stone parapet and stone lintels to windows.</p> <p>Large decoratively tiled stairwell and offices/warehouse at ground floor, offices and station concourse at second floor.<br/>No roof structure remaining.</p> <p>All windows and doors boarded up.</p> <p><b>No access to interior due to presence of asbestos &amp; lead paint.</b></p> | <p>Damaged wooden fascia boards on external façade providing access to cavity behind.<br/>Small crevices in brickwork and around stone lintels on external façade.<br/>Unglazed window into stairwell providing potential bat access to internal rooms.</p> | High Potential |

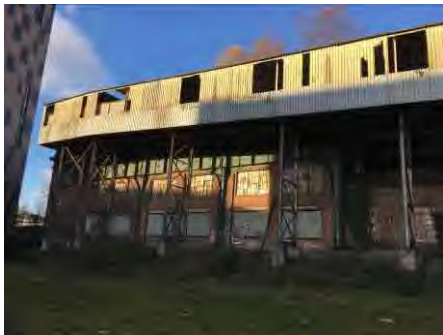
| Reference | Picture | Description | Potential Bat Roost Features and Evidence of Roosting | Assessed Roost Status |
|---|---|---|---|---|
| B2a | | <p>Former station platforms and warehouses.<br/>Brick façade with two large internal warehouses.<br/>Concrete floor, flat roof supported by concrete pillars.</p> <p>Narrow enclosed ramp from ground level to platforms on southern elevation, supported by metal framework and covered with corrugated sheets. Open ramp on northern elevation.</p> <p>Series of large brick arches beneath platforms at eastern end, each enclosed with wooden boarding and used as warehouse/industrial units.</p> | <p>Crevices on the external façade.<br/>Broken windows and gaps around roller shutter doors providing access to internal warehouses. Very limited roost potential within these rooms but considered likely to be used as sheltered foraging site during poor weather conditions.</p> <p>Existing record of pipistrelle roost on northern side, potentially on external façade or at platform level.</p> | Confirmed Roost<br><br>High Potential on rest of structure |

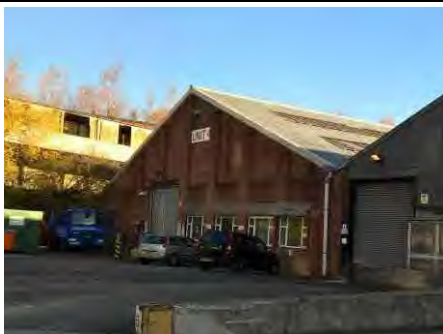
| B3 | | <p>Industrial unit occupied as warehouse.</p> <p>Brick walls with pitched roof covered with corrugated asbestos cement sheets and numerous plastic skylights.</p> <p>Roof supported by metal framework, open to ridge with no roof voids.</p> <p>Concrete floor.</p> | None | Negligible Potential |

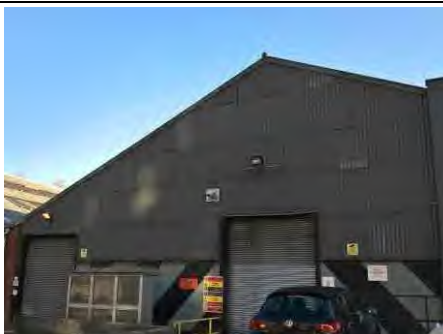
| B4 | | <p>Industrial unit occupied by Fedex as warehouse and distribution centre.</p> <p>Brick walls with corrugated metal sheets on front elevation. Pitched roof of corrugated asbestos sheets with numerous plastic skylights.</p> <p>Open to ridge with no roof void.</p> | None | Negligible Potential |

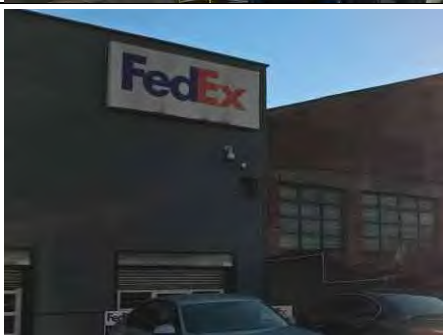
| B5 | | <p>Office unit of warehouse complex occupied by Fedex.</p> <p>Metal sheet walls to front elevation, brick walls with pitched roof of corrugated sheets to rest of building.</p> <p>No roof voids.</p> | None | Negligible Potential |

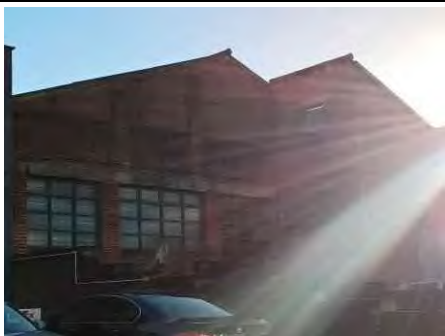
| B6 | | <p>Industrial unit used as storage warehouse together with B9 and B10b.</p> <p>Brick with pitched roof covered with asbestos cement sheets.</p> <p>Roof supported by metal framework, open to ridge with no roof voids.</p> <p>Concrete floor.</p> <p>Large basement, also used for storage.</p> | <p>Crevices on brickwork on northern elevation above River Medlock.</p> <p>Basement provided no obvious crevice features and was too light and disturbed for potential hibernation use.</p> | High Potential |

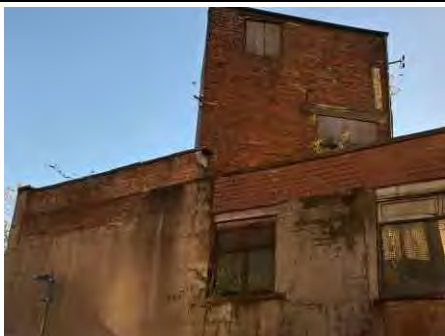
| B7a | | <p>Disused industrial units, part of former Towbar and Trailer Centre.</p> <p>Two-storey section, brick with pitched slate roof, clay ridge tiles and wooden bargeboards at gable ends. Underside visible from interior - open to ridge and appeared to be lined with wooden or metal boards.</p> <p>Two-storey section at SE corner, brick with pitched roof covered with bitumen felt. <b>No access for internal inspection on this section, potentially a roof void present.</b></p> <p>Single storey section with flat bitumen felt roof.</p> <p>Concrete floors throughout and single glazed windows boarded up or secured with wire mesh.</p> | <p>Numerous crevices in brickwork.</p> <p>Crevices around windows providing bat access to interior of two storey sections.</p> <p>Crevices beneath barge boards, potentially providing access to space between slates and lining beneath.</p> <p>Dilapidated fascia boards at eaves on single storey section.</p> | Moderate Potential |

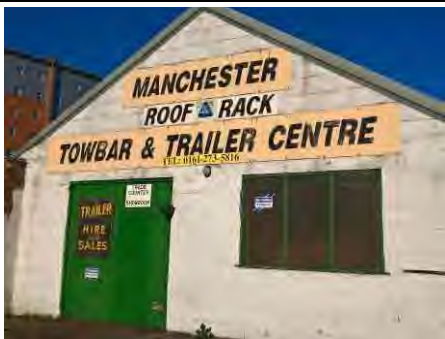
| B7b | | <p>Disused industrial units, part of former Towbar and Trailer Centre.</p> <p>Brick walls with pitched roof covered with metal sheets.</p> <p>Wooden ceiling with roof void above – no obvious hatches to provide access for inspection.</p> <p>Underside of roof partially visible at rear of building (adjacent to two-storey section visible in photo for B7a), supported by wooden rafters and fully lined with membrane.</p> <p>Underground basement.</p> | <p>Basement provided no obvious crevice features but was dark and likely to provide relatively stable temperature conditions.</p> <p>In use until relatively recently and therefore likely to have been too disturbed for hibernation use; however, could potentially be used in future now that the building is disused.</p> | Negligible Potential |

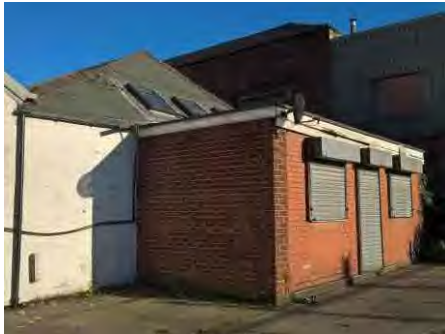
| B7c | | <p>Industrial unit, occupied as religious premises.</p> <p>Brick walls with pitched roof covered with bitumen felt and clay ridge and hip tiles. Skylights on roof suggesting no roof void present.</p> <p>Small section at front with flat roof covered with bitumen felt and narrow wooden fascia boards at eaves.</p> <p><b>No access permission for inspection.</b></p> | <p>None apparent from areas visible.</p> | Full inspection required. |

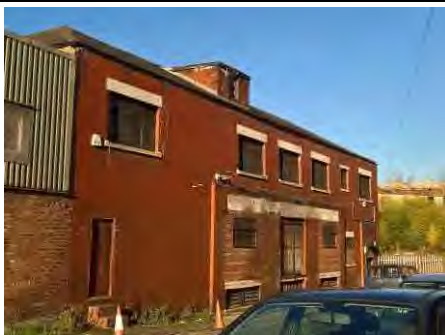
| B8a | | <p>Industrial/office units.</p> <p>Two-storey brick building, two separate pitched slate roofs with hipped gables.</p> <p><b>No access permission for internal inspection.</b></p> | <p>Potentially two roof voids.</p> <p>Crevice on external brickwork.</p> | <p>Moderate Potential</p> <p>Full inspection required</p> |

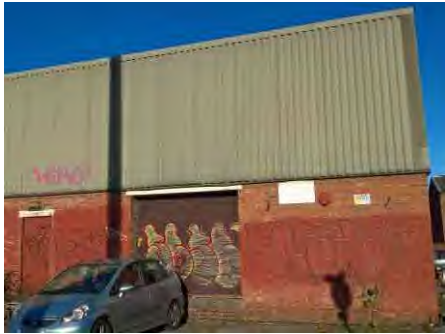
| B8b | | <p>Industrial units.</p> <p>Two-storey flat roofed building with brick walls with metal sheeting at upper level.</p> <p><b>No access permission for internal inspection.</b></p> | <p>Unlikely to be any roof void.</p> <p>No obvious crevices on external façade.</p> | Negligible Potential |

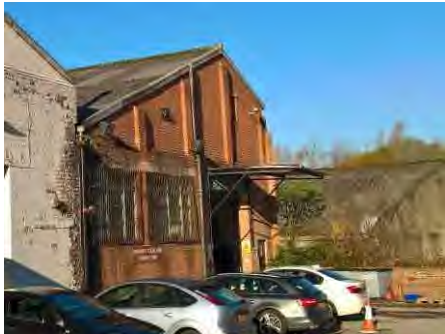
| B9 | | <p>Industrial unit occupied as factory and storage warehouse, together with B10b and B6.</p> <p>Brick with pitched roof of asbestos cement sheets.</p> <p>Roof supported by metal framework, open to ridge with no roof voids.</p> <p>Concrete floor.</p> <p>Large basement beneath, used for storage.</p> | <p>No roof void.</p> <p>Basement provided no obvious crevice features and was too light and disturbed for potential hibernation use.</p> | Negligible Potential |

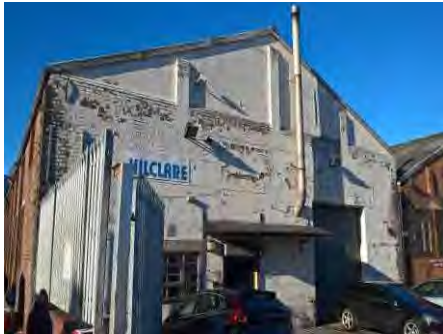
| B10b | | <p>Industrial unit occupied as factory and storage warehouse, together with B9 and B6.</p> <p>Brick with pitched roof of asbestos cement sheets.</p> <p>Open to ridge with no roof void.</p> | None | Negligible Potential |

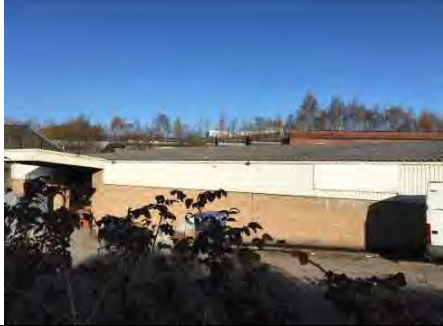
| B12 | | <p>Industrial unit used as a storage/distribution warehouse.</p> <p>Brick walls with corrugated metal sheeting towards roof level.</p> <p>Shallow pitched roof covered with corrugated sheets, open to ridge with no roof void.</p> | None | Negligible Potential |
