**Mayfield, Phase 1**  
EIA Volume 2

September 2019

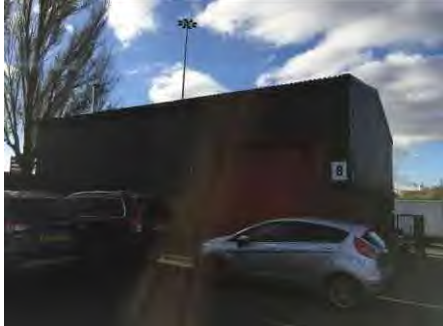
| B13 | | <p>Industrial unit.</p> <p>Two-storey building with brick walls at ground level and metal sheeting at first floor level.</p> <p>Shallow pitched roof covered with metal sheets.</p> | None | Negligible Potential |

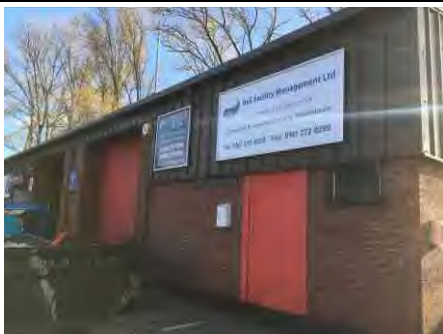
| B14 | A two-storey industrial building with brick walls at ground level and metal sheeting at first floor level. It has a shallow pitched roof covered with metal sheets. A sign for 'Bat Facility Management Ltd' is visible on the wall. | Industrial unit.<br><br>Two-storey building with brick walls at ground level and metal sheeting at first floor level.<br><br>Shallow pitched roof covered with metal sheets. | None | Negligible Potential |

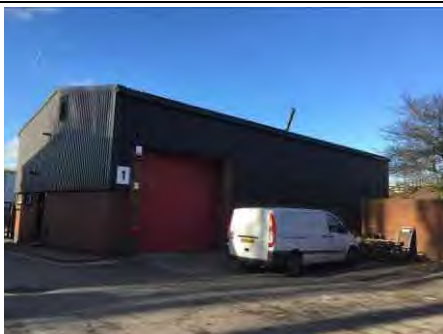
| B15 | A two-storey industrial building with brick walls at ground level and metal sheeting at first floor level. It has a shallow pitched roof covered with metal sheets. A white van is parked in front. | Industrial unit.<br><br>Two-storey building with brick walls at ground level and metal sheeting at first floor level.<br><br>Shallow pitched roof covered with metal sheets. | None | Negligible Potential |

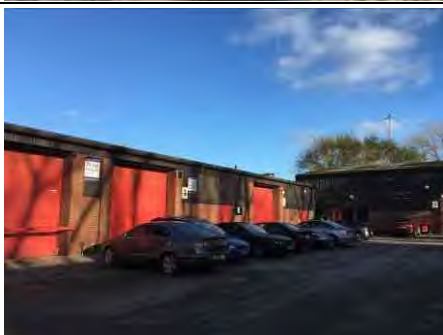
| B16 | A single-storey industrial building with brick walls at ground level and metal sheeting towards roof level. It has a shallow pitched roof covered with metal sheets. Several cars are parked in front. | Industrial units.<br><br>Single-storey building with brick walls at ground level and metal sheeting towards roof level.<br><br>Shallow pitched roof covered with metal sheets. | None | Negligible Potential |

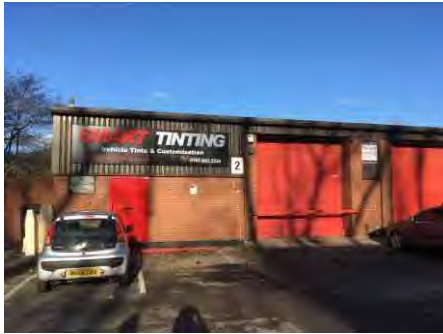
| B17 | | <p>Industrial unit.</p> <p>Brick walls at ground level and metal sheeting towards roof level.</p> <p>Shallow pitched roof covered with metal sheets.</p> | None | Negligible Potential |

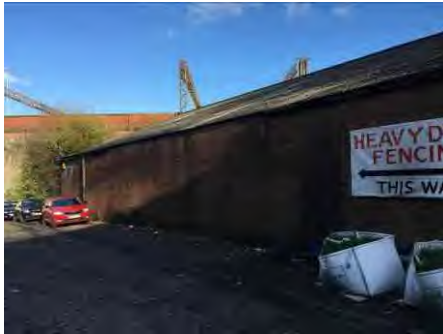
| B18 | | <p>Warehouse/industrial unit, used as storage and recycling facility.</p> <p>Brick walls with pitched roof of asbestos cement sheets, open to the ridge with no roof void.</p> <p>Interior very cluttered.</p> | None | Negligible Potential |

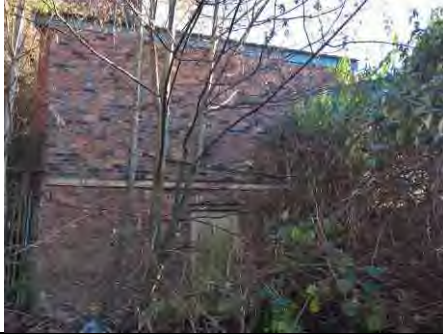
| B20 | | <p>Two-storey brick structure with sloping roof covered with corrugated sheets.</p> <p>Unlikely to have roof void.</p> <p>Narrow wooden fascia board at eaves.</p> <p><b>No access permission for inspection.</b></p> | None apparent from visible areas | Negligible potential |

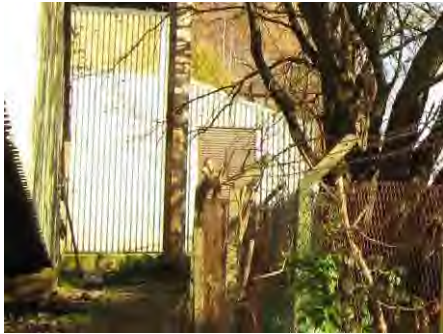
| B21 | | Small lean-to structure adjoined to B2.<br>Corrugated metal walls with roller shutter door and sloping metal roof. | None | Negligible Potential |

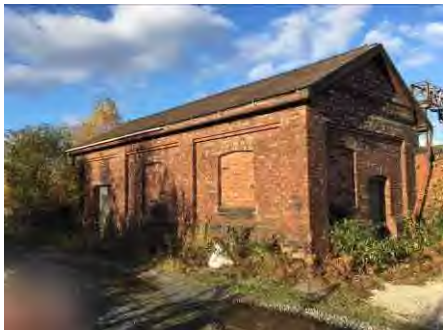
| B23 | | Single-storey brick building. Pitched slate roof with clay ridge tiles and overhanging eaves with wooden soffit and bargeboards at gable ends.<br>Metal roller shutter door (locked) on southern elevation, door and window on eastern gable end boarded up.<br><br>No access permission for internal inspection. | Gaps between brickwork and soffit providing potential access to cavity within soffit and/or interior of building.<br><br>Gap beneath end ridge tile at eastern gable end.<br><br>Gap above roller shutter door. | High Potential |

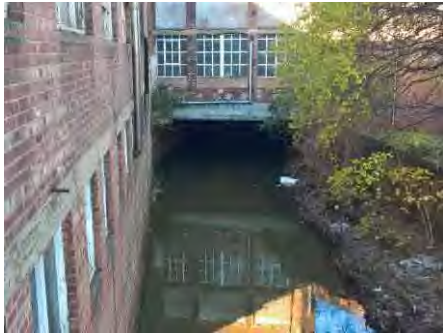
| B24 | | <p>Culverted section of River Medlock.</p> <p>Length approx. 60m, width approx. 4m, height approx. 2.5-3m above water level.</p> <p>No access for internal inspection.</p> | Bats known to roost in a similar culvert on another nearby site in Manchester. | High Potential |

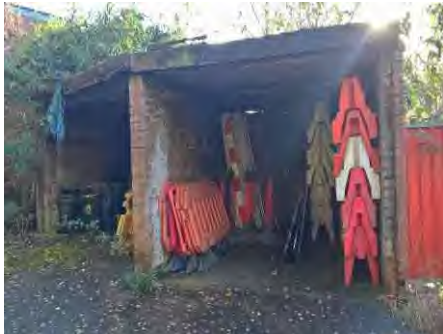
| B25 | | <p>Pair of open fronted garages with brick walls and flat concrete roof.</p> <p>Used for storage but appeared relatively undisturbed.</p> | None | Negligible Potential |

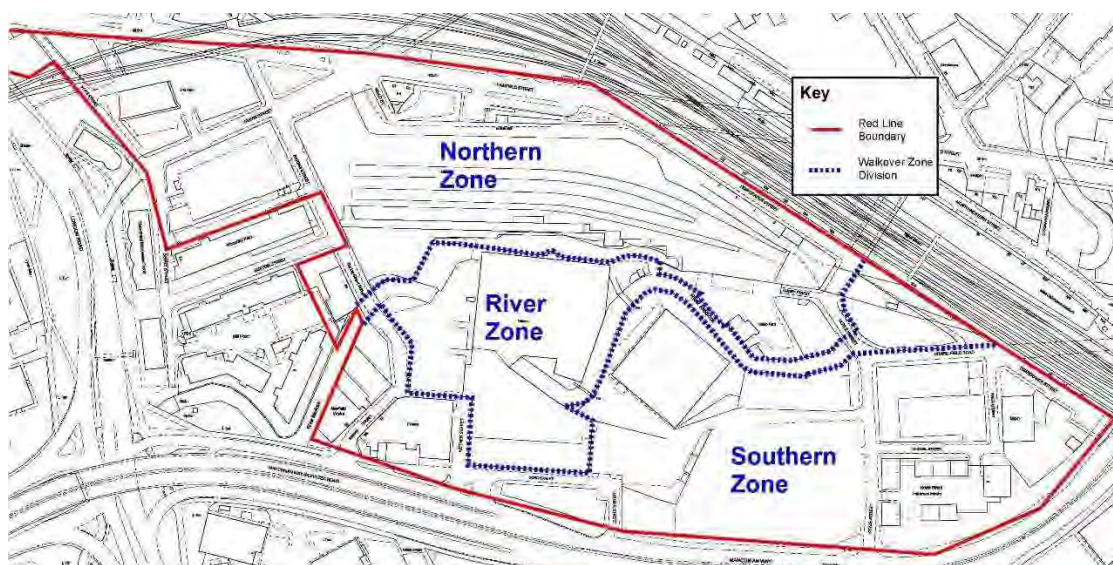
**Figure 2-1** Division of the Site into zones.

The Site walkover survey was carried out on 4<sup>th</sup> July 2017, in mild and overcast weather conditions and was generally limited to external areas, though all external areas were accessible. Philippa Hunsworth and George Mitchell from Buro Happold attended, and were escorted around Site by Jonathan Such (JS) of U+I. An annotated plan showing points of interest identified during the survey is included as Appendix E. To describe its variable nature, the Site has been divided into three zones: northern, southern, and the river zone, for ease of reference (Figure 2-1 refers).

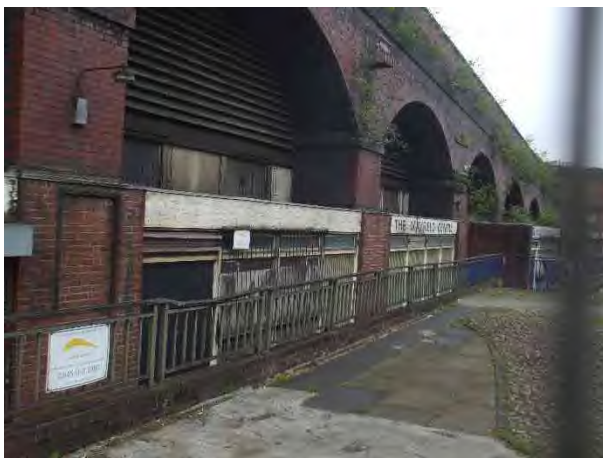
Photograph 5

- Row of 1 storey units present against the Mayfield Station building. Uses include a garage, storage, substation. (Photograph 5)
- Temperance Street: Series of arches on both sides of the road, however only the southern set are onSite.

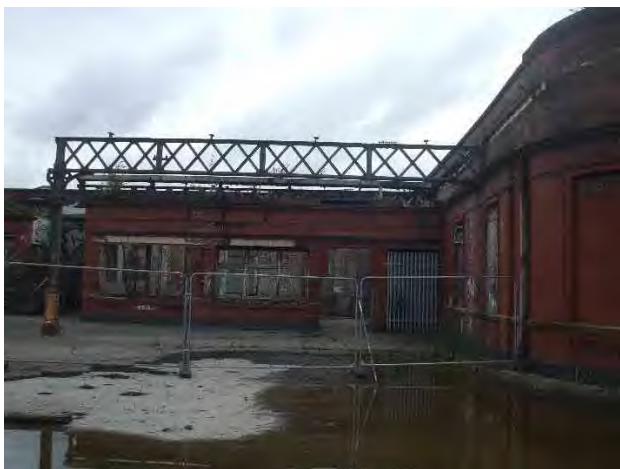
Photograph 7

- Dilapidated old station buildings in western corner of platform. Heras fenced off. (Photograph 7)
  - 2 No. tracks with stoppers at western end. Overgrown.

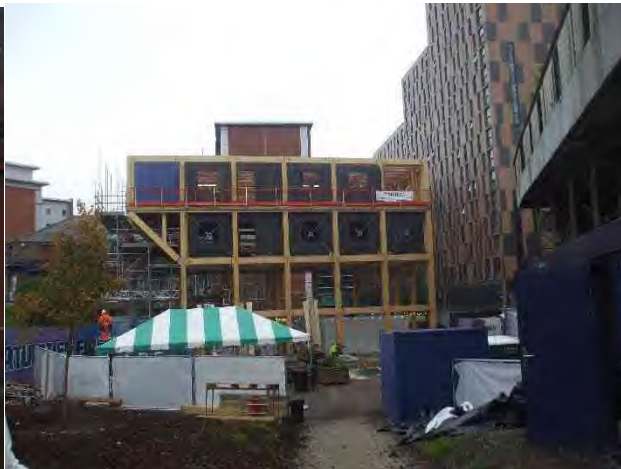
Photograph 8

- Compound where U+I temporary offices are currently under construction (wooden frame up at time of walkover). (Photograph 8)
- Temporary landscaped area in southern portion of compound, surfaced with wood chips directly on top of Made Ground. 2 No. trees in poor health (brown leaves). (Photograph 9)

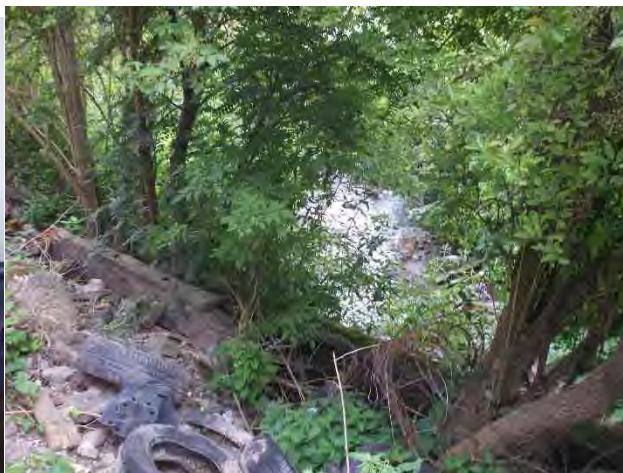
Photograph 10

- Through a gate to the south of the compound: Heavily overgrown area adjacent to the River Medlock, which is at a lower level. Fly tipping (old tyres, brick and concrete rubble) present. River wall in poor state of disrepair. Knotweed present on riverbank but not noted on upper level. (Photograph 10)

Large quantities of Japanese Knotweed were identified on the banks of the River Medlock within the channel during the Site walkover. There was no visual evidence that knotweed had migrated out of the channel onto surrounding areas of the Site, however it is quite possible this has occurred. It is understood that a full survey of the river will be undertaken in the near future, which will fully characterise the extent of knotweed present. It is recommended that a Japanese Knotweed specialist is consulted with regards to identifying the extent of the infestation and recommending appropriate measures for Site management and/or removal of Japanese Knotweed impacted material.

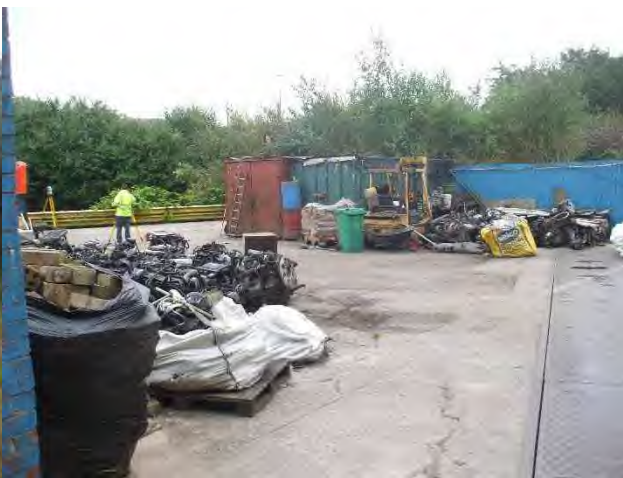
Photograph 11

- Western area: Former scrapyards, now vacated. Metal structures, ~2 m high, present around the edge of the Site, filled with Made Ground/fly tipping. (Photograph 11) Vacant industrial building in west of yard, joined onto Mayfield Station.

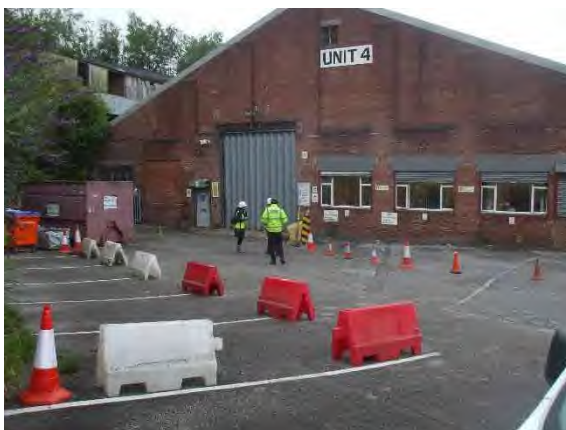
Photograph 13

- Transport for Greater Manchester (TFGM) building area
  - River Medlock is culverted under the car park area.
  - 1 storey brick/steel industrial building (Photograph 13). River Medlock is culverted under the building (Photograph 14). Multiple units:

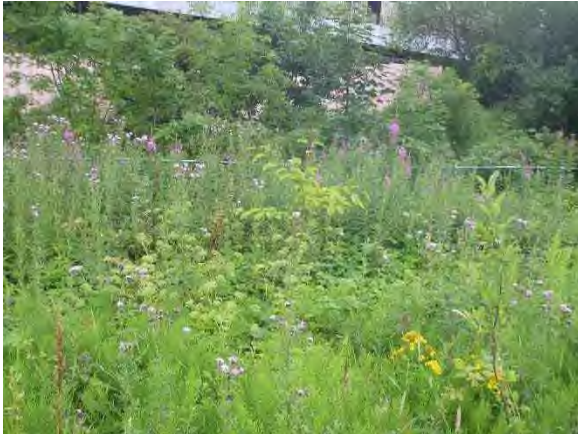
Photograph 15

- TFGM car park (east of Baring Street)
  - Very overgrown in northern portion of car park adjacent to River Medlock. (Photograph 15)
  - Car park surfaced with tarmac.

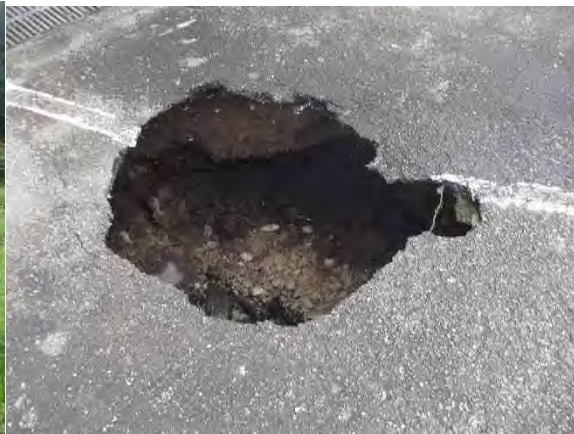
Photograph 16

- Void recently opened up in car park outside Unit 4 (Section 3.5 refers). Cordoned off by barriers at time of walkover. (Photograph 16)
- Area north of Chapelfield Road and east/south of Hoyle Street: Yard with vehicles parked (including tracked excavators). Sign outside advertising 'Free tipping of clean hardcore'. River culverted under this yard. (Photograph 17)

In June 2017, a void (~1.50 m diameter x ~5.00 m deep) appeared in the car park of the Transport for Greater Manchester (TFGM) building (Unit 4), close to the culverted River Medlock. The cause is currently unknown and is under investigation. The void appears to be connected to existing drainage, and there may have historically been a chamber in the locality. Further assessment, including a CCTV survey, is currently being undertaken, and appropriate repair/remediation measures will be undertaken once better understood. Bulging and cracking to the nearby car park retaining wall was also noted, with a depression to the tarmac adjacent to the wall. A Design Note has been prepared by BuroHappold and is included as Appendix C.

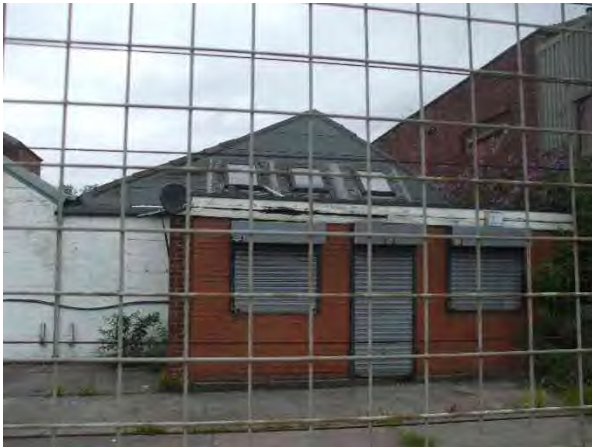
Photograph 18

- West of Baring Street: Row of buildings and concrete yards (not currently owned by U+I) (Photograph 18)
  - Southernmost building = Mayfield Works (disused); formerly clothing works. Yard/car park area to north of building.

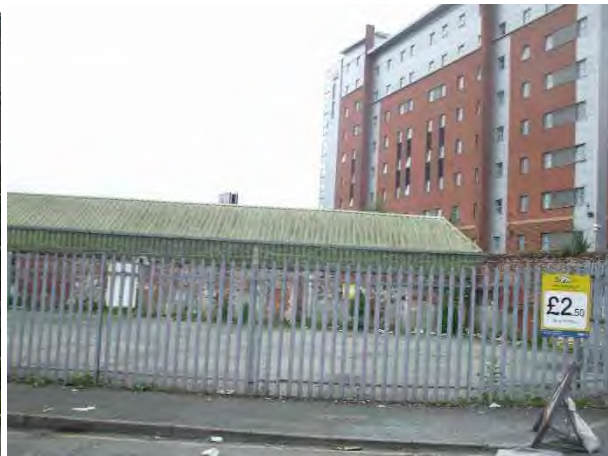
Photograph 19

- Area between Baring Street and Nether Street:
  - 3 No. conjoined buildings (west to east): Tow bar and trailer shop; Historic church (with basement – advised by JS); sock factory (still in use; JS advised that it has been there for >20 years). Concrete yard present to south of buildings. (Photograph 19)

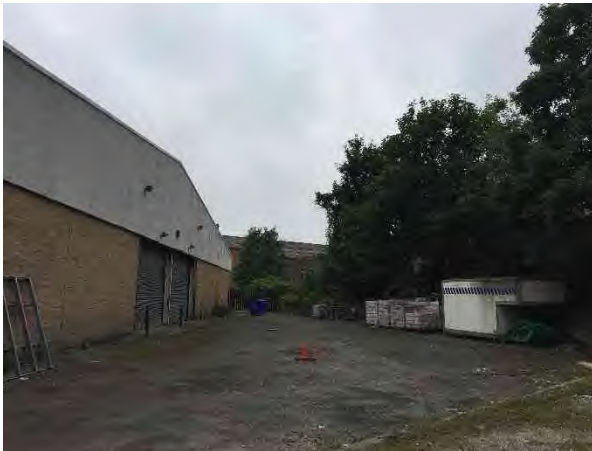
Photograph 20

- Square warehouse building, north of Hilclare car park and surrounded by meandering River Medlock: (Photograph 20)
  - JS advised that the building is to be vacated in mid-July 2017. Mixed boxes stored. Current tenant has occupied the building for ~1 year.

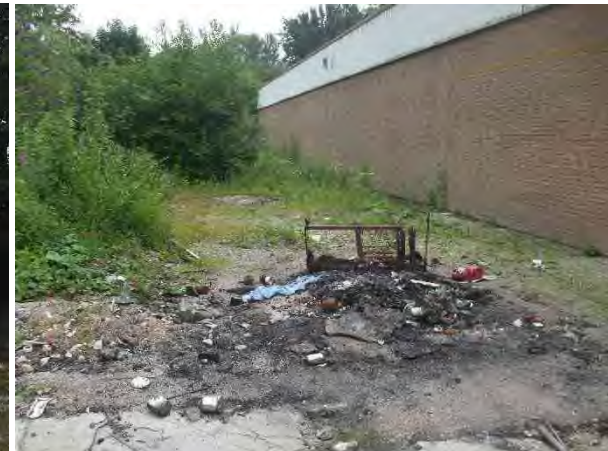
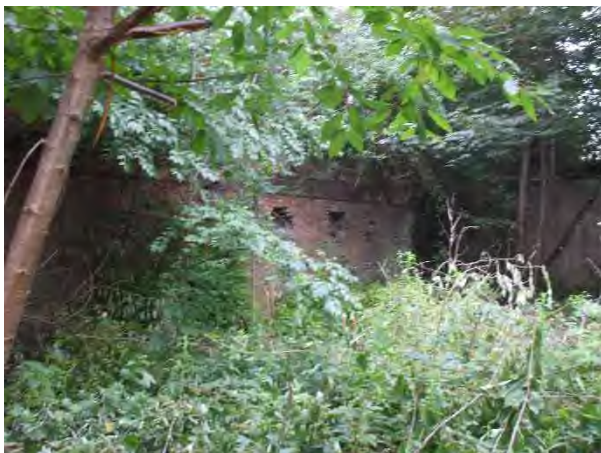
- N and E of building: Overgrown. Fly tipping and evidence of burning (ashes, charred material). Brick/concrete walls border the plot in the eastern area; poor state of disrepair. (Photographs 21 and 22)

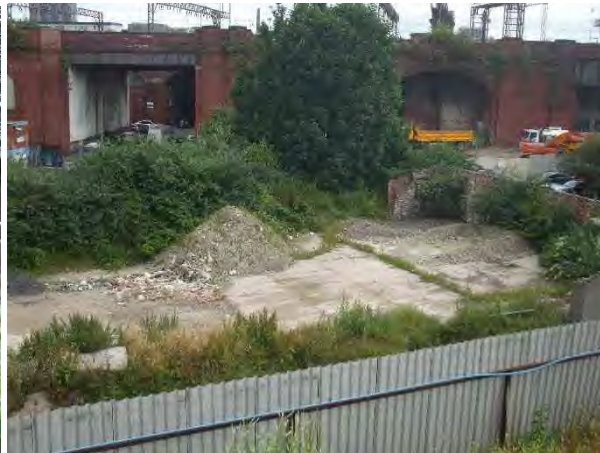
Photograph 23

- East of square warehouse: Unoccupied yard with piles of demolition rubble and brick walls of historic buildings. (Photograph 23)
- South of square warehouse: Concrete retaining wall with Hilclare car park and skips beyond.

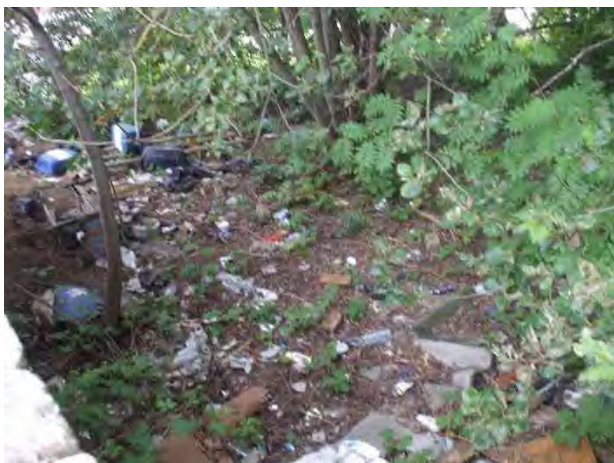
Photograph 24

- East of Manor Street: Wooded area with large amount of fly tipping (Photograph 24)
- East of Hilclare car park and west of Hoyle Street: 'Delaney' Site. Yard area, hoarded off. Material stockpiles ~3 to 5 m high comprising both apparently screened and unscreened material, demolition rubble, piles of whole bricks (Photograph 25)

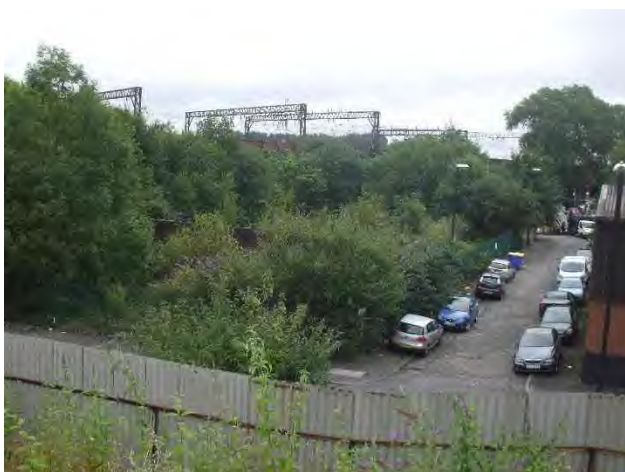
Photograph 26

- Between Hoyle Street, Chapelfield Road, River Street and Rachel Street
  - Former morgue. Extremely overgrown; no access. Fenced off. (Photograph 26)
  - Brick walls of derelict building visible

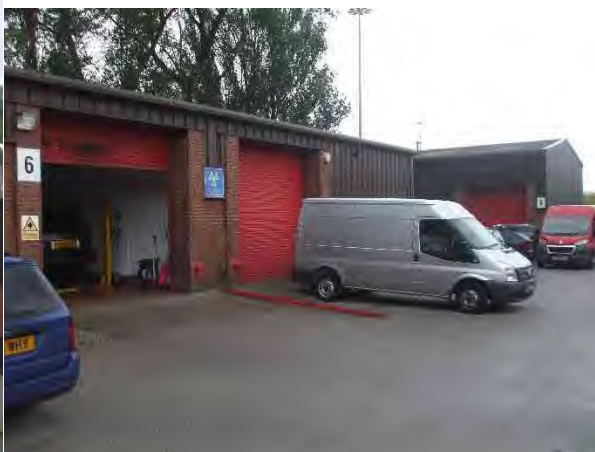
Photograph 27

- JS advised high risk of sharps, needles etc. in the area, and presence of drug users and prostitutes
- Hoyle Street Industrial Estate (Photograph 27)

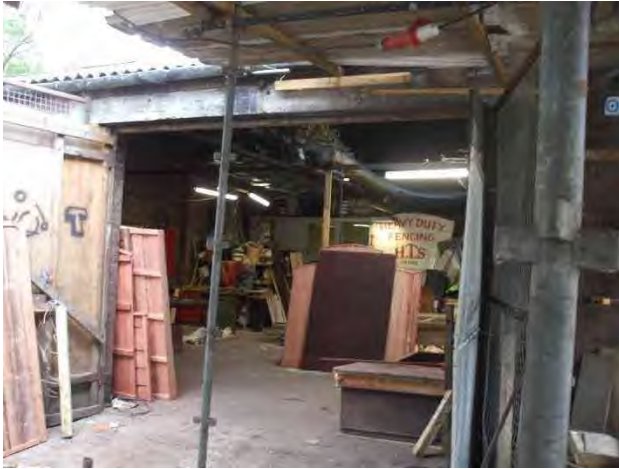
Photograph 28

- Timber yard and car depot
- Western portion of yard full with timber, old vehicles (Photograph 28)
- Eastern portion of yard piled up with doors, oil drums, fridges, rubble, insulation etc. (Photograph 29)

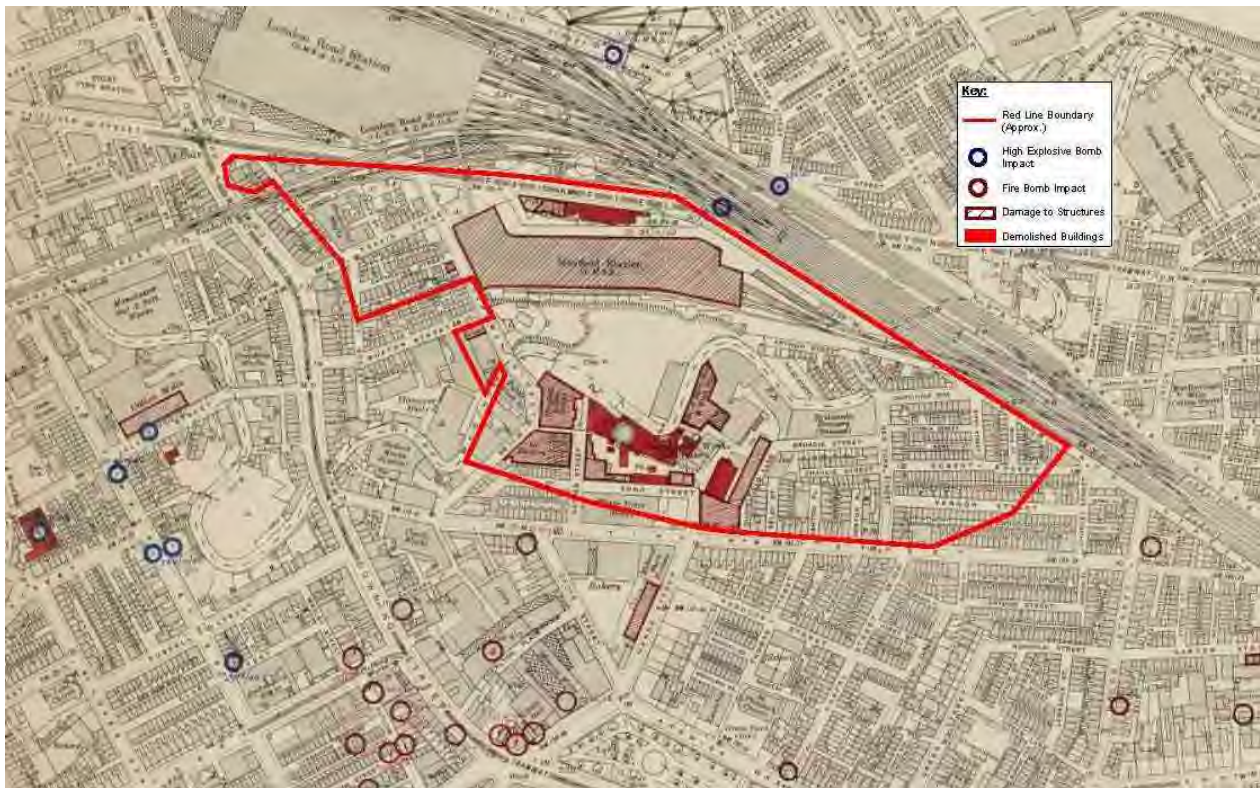
**Figure 3-1** Manchester bomb map

The Manchester bomb map records a number of high explosive and fire bomb impacts in close proximity to the Site, as well as damage to several buildings within the Site (**Error! Reference source not found.** refers). Some buildings, including the Mayfield station building itself, have not been developed since the war and remain on Site.

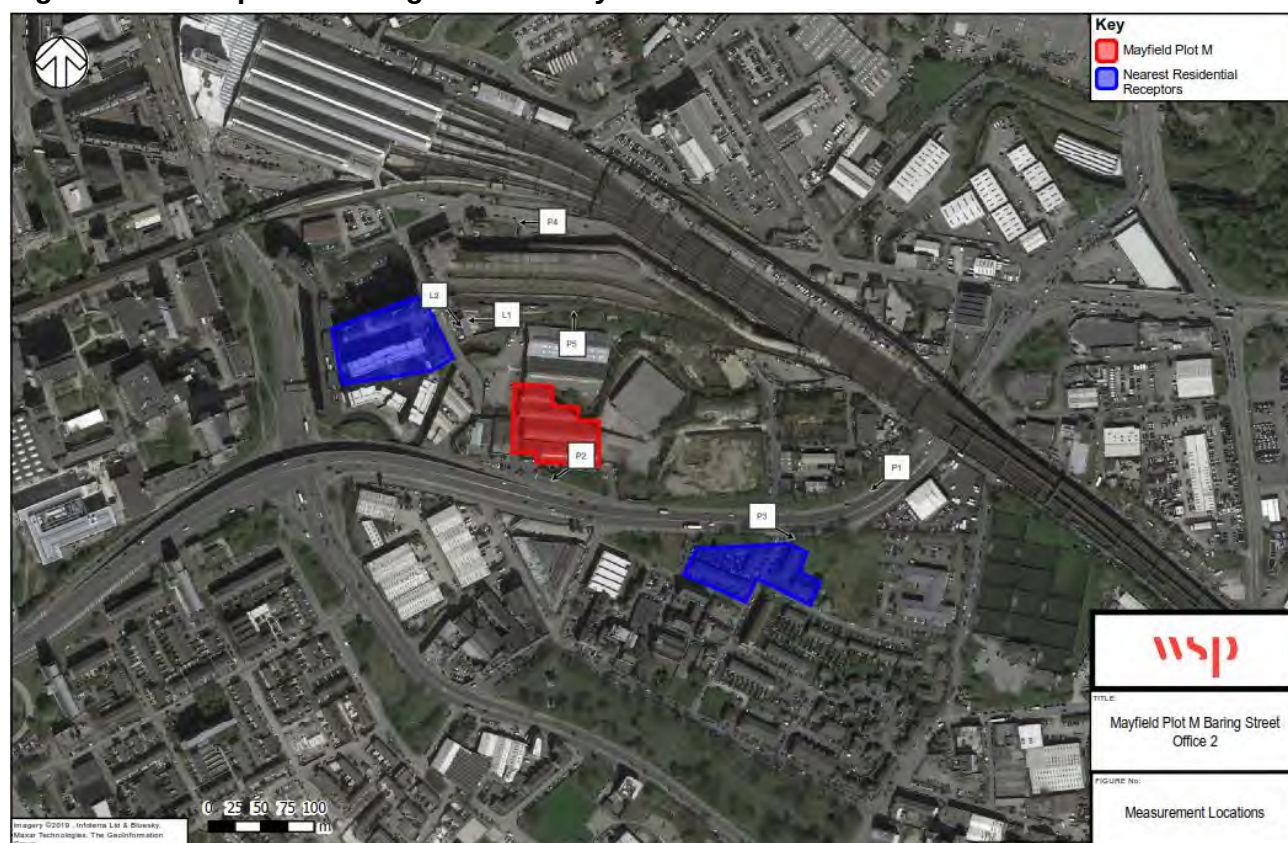
**Figure 2-1 - Site plan showing noise survey measurement locations**

An outdoor food market 'GRUB' operates on the site between 12:00 hrs and 22:00 hrs on Fridays and Saturdays and 12:00 hrs and 18:00 hrs on Sunday to the North of the site, close to the Gatehouse building (Position L1). It is accessed from Baring Street.

The nearest noise sensitive receptors are considered to be the apartments and student accommodation to the west of the site on Baring Street and the houses and apartments on Potter Street and Cotter Street to the south, highlighted in blue in Figure 2-1.

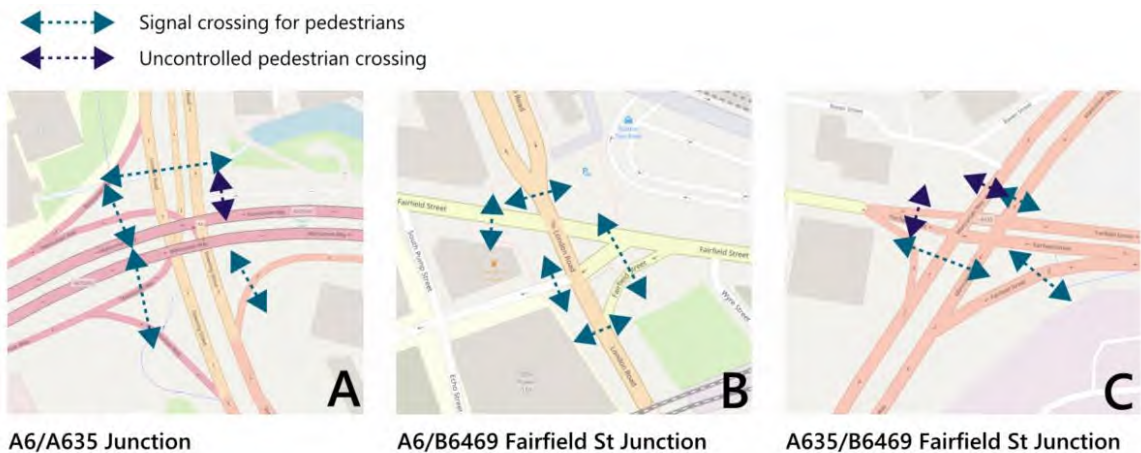
- 3.2.3 There are pedestrian crossing facilities at the A6 London Road/Fairfield Street junction and the junction with A635 Mancunian Way approximately 320m further south. Figure 3.3 illustrates the type of pedestrian signal at each of the three main junctions referenced in Figure 3.2.

**Figure 3.3 Junctions in reference with the pedestrian infrastructure surrounding the Site**

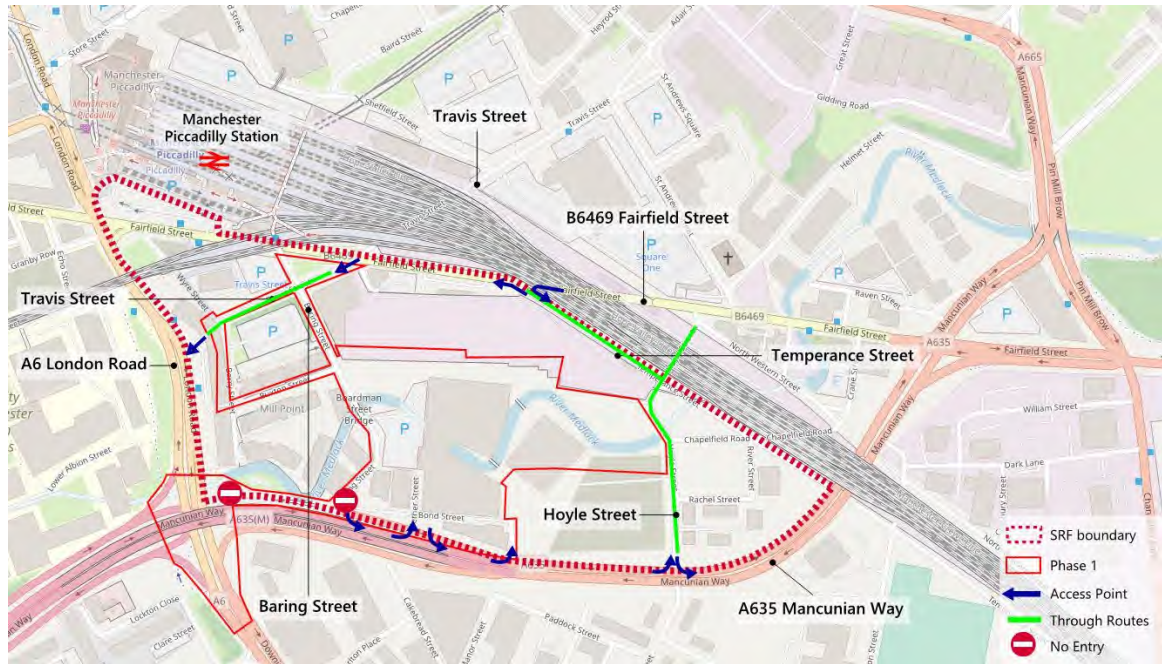
- 3.5.1 The local highway network surrounding the development is shown in Figure 3.11 which also shows the vehicular access points to the Site.

**Figure 3.11 Local Highway Network**

- 3.5.2 Access from the north is from Fairfield Street, which is a single carriageway road subject to a speed limit restriction of 30mph. From Fairfield Street, individual plots within the SRF can be accessed via Travis Street, Temperance Street, North Western Street, and Crane Street. The junction of Travis Street and Fairfield Street is signalised, but all the remaining junctions along Fairfield Street adjacent to the Site are priority junctions.

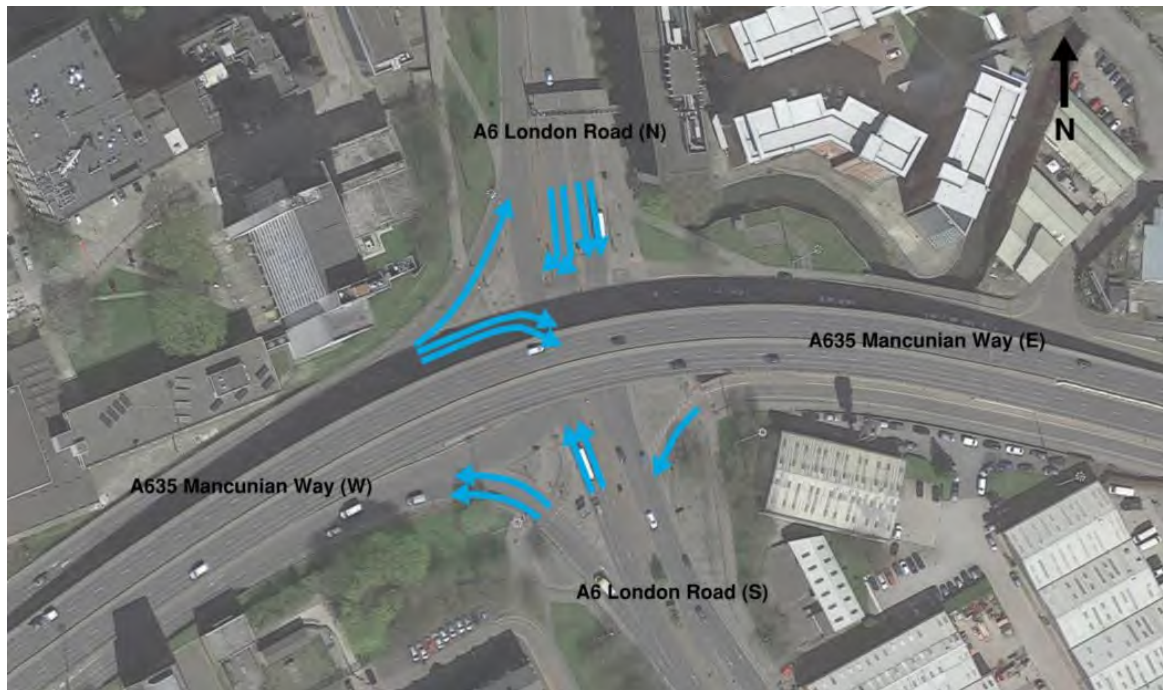
Figure 3.12 London Road – Mancunian Way Existing Junction Layout

- 3.5.14 The southern arm of London Road has four approach lanes; two lanes turning left onto the Mancunian Way westbound slip and two lanes northbound towards London Road north. It is noted that there is currently no right turn onto the Mancunian Way eastbound on-slip. The western arm of the junction is the Mancunian Way eastbound off-slip; this arm has one left turn lane onto London Road north and two right turn lanes towards London Road south. It is noted that all movements onto the Mancunian Way eastbound on-slip are prohibited except for authorised vehicles only.

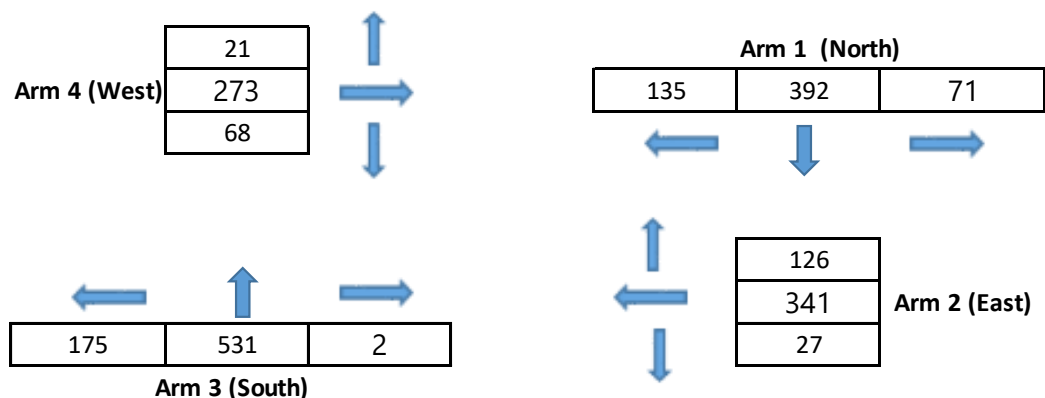
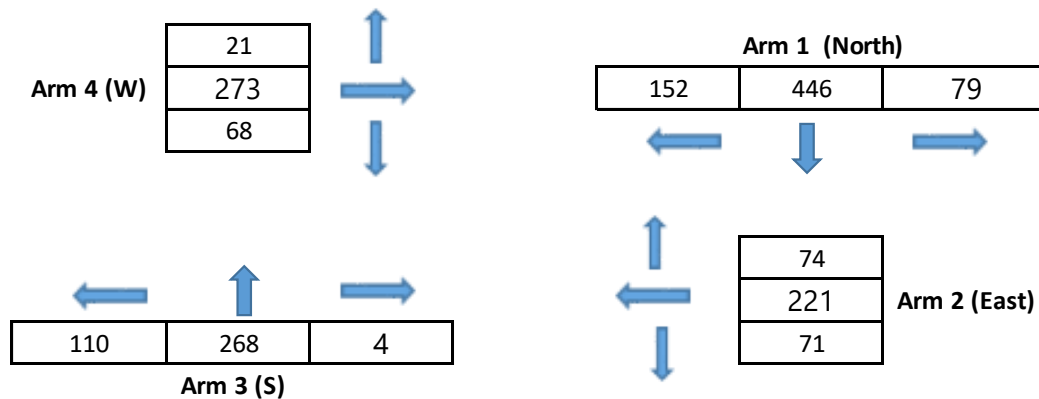
- 3.5.15 Traffic surveys at the junction were undertaken on Wednesday 11 July 2018 and recorded traffic flows, queue lengths and saturation flows. The observed peak hour turning vehicles movements at this junction are shown in Figure 3.13 and Figure 3.14.

Figure 3.13 London Road – Mancunian Way AM Peak Turning Movement (08:00-09:00) - Vehicles

**Figure 3.14 London Road – Mancunian Way PM Peak Turning Movements (17:00-18:00) - Vehicles**

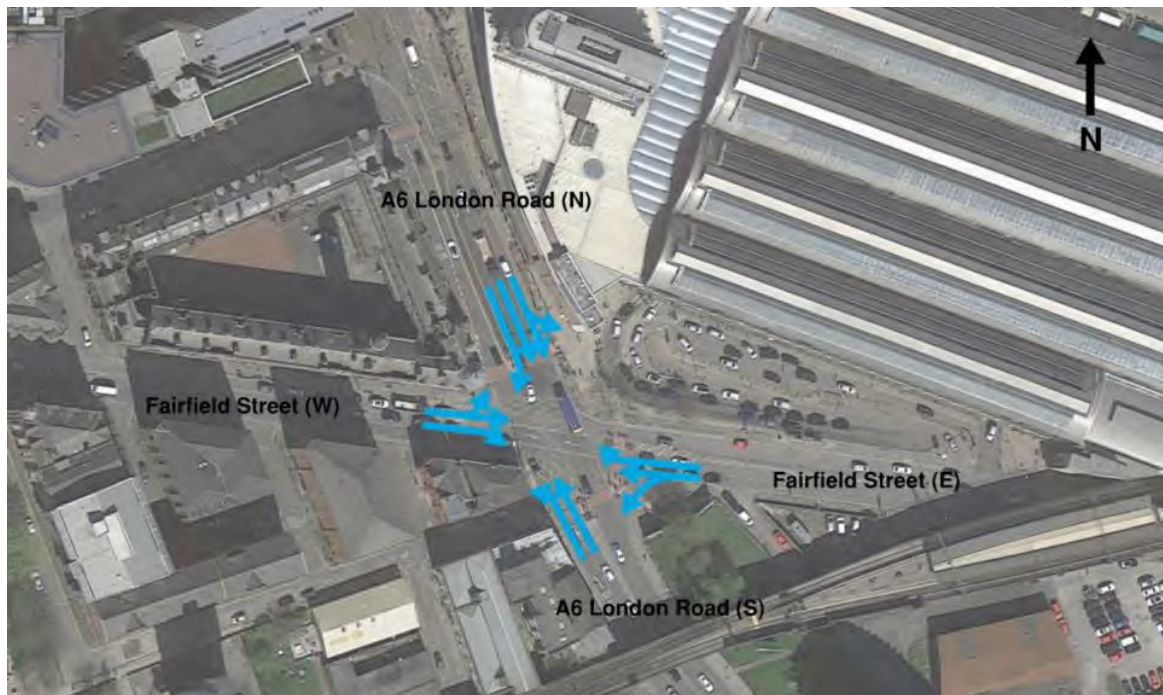
**Figure 3.15 London Road – Fairfield Street Junction Layout**

- 3.5.20 The A6 London Road - Fairfield Street junction is an at-grade signalised junction adjacent to the north-west corner of the Site. The existing layout of the A6 London Road – Fairfield Street junction is shown in Figure 3.15.
- 3.5.21 The northern arm of London Road has three approach lanes giving access to each arm. The eastern arm of the junction is Fairfield Street; this arm has two approach lanes providing access to each arm. The southern arm of London Road has two approach lanes; one lane turning left onto Fairfield Street west and one lane north to London Road north. It is noted that there is no right turn to Fairfield Street east from London Road south. The western arm of the junction is Fairfield Street west, which has two approach lanes and allows movement to each arm of the junction.

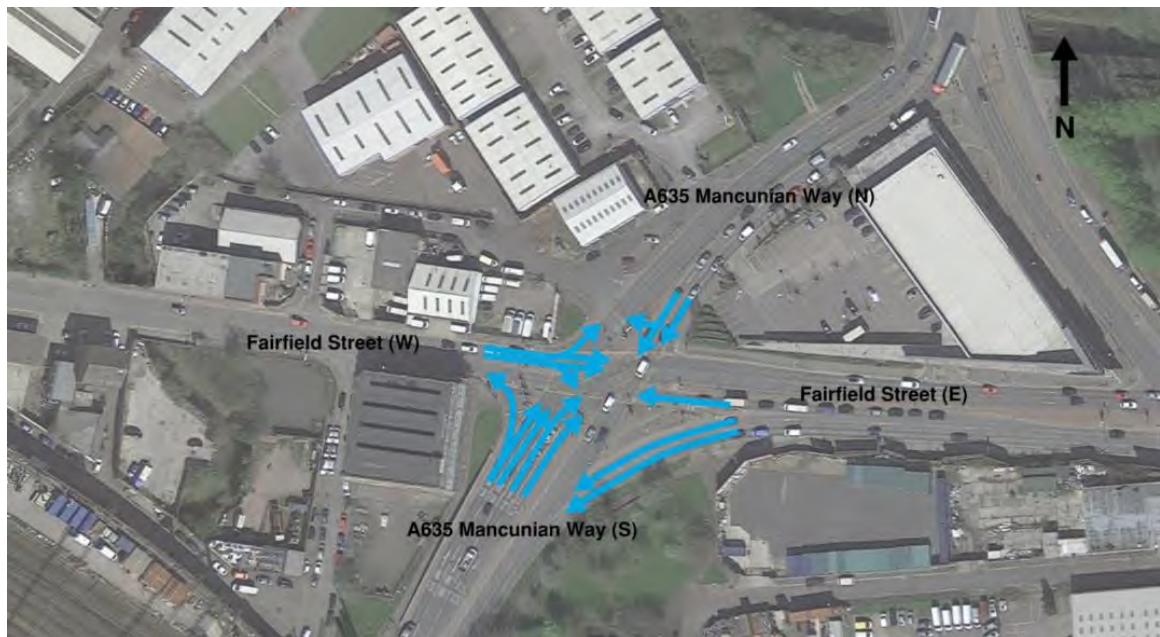
Figure 3.16 Mancunian Way – Fairfield Street Junction Layout

- 3.5.23 The north arm of Mancunian Way has two approach lanes; one providing southbound movement towards Mancunian Way south, and another providing southbound movement and a right turn onto Fairfield Street west. It is noted that there is no left turn on to Fairfield Street east from this arm. The east arm of the junction is Fairfield Street east, which has two left turn lanes onto Mancunian Way south and one lane towards Fairfield Street west; it is noted that a right turn onto Mancunian Way north is prohibited. The Mancunian Way south arm has four approach lanes, with slip road providing access to Fairfield Street west. There are two lanes towards Mancunian Way north and two right turn lanes towards Fairfield Street east. Fairfield Street west arm has one approach lane, and allows movement to all other arms of the junction.

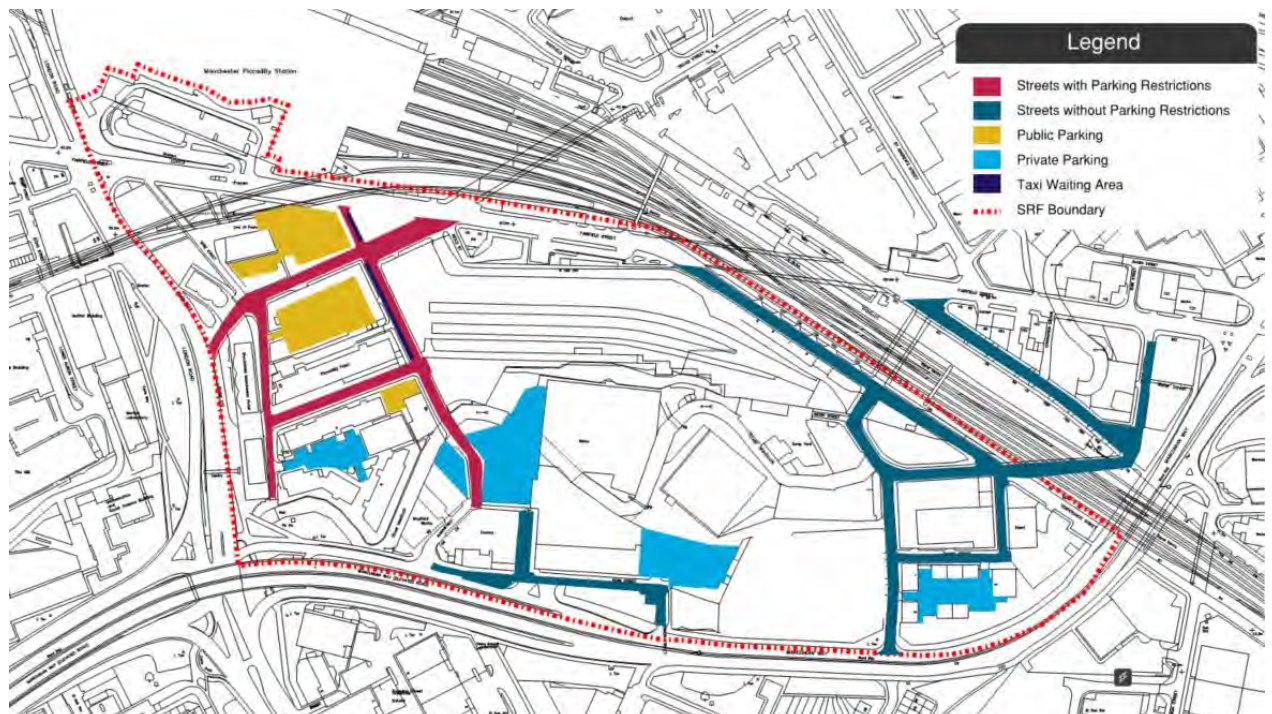
3.6.1 Figure 3.17 shows the existing parking arrangements within the SRF site boundary.

Figure 3.17 Existing Parking Arrangements

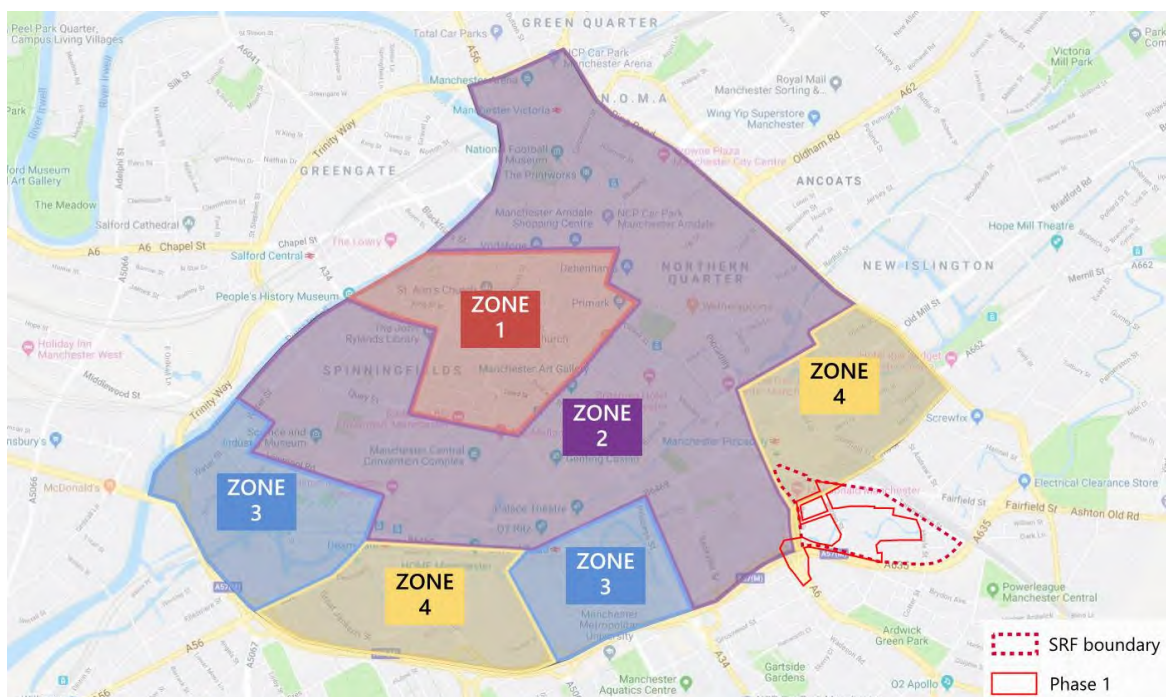
- 3.6.2 A Controlled Parking Zone in Manchester city centre is divided into four zones. Parking Zones 1 and 2 allow parking for up to two hours, whereas Parking Zone 3 allows up to three hours, and Parking Zone 4 up to ten-hours. Figure 3.18 illustrates the location of each parking zones within Manchester city centre, and it can be seen that Parking Zone 4 includes part of the north-west of the Site and incorporates Travis Street and part of Fairfield Street.
- 3.6.3 The parking charges in Zone 4 apply Monday to Sunday between 08:00 and 20:00, with no charge for parking on Bank Holiday. The maximum stay time is 10 hours with charges varying from £0.50 for up to 30 minutes and £7.50 for up to 10 hours.

**Figure 3.18 Controlled Parking Zones in Manchester (Manchester City Council)**

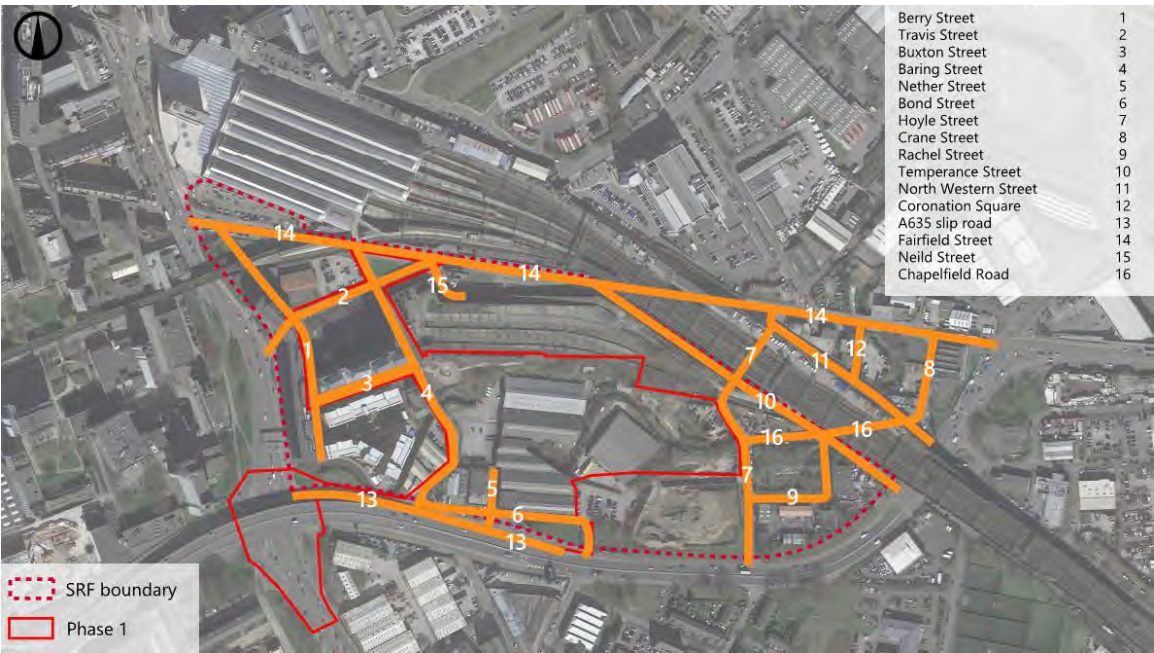
- 3.6.4 A parking occupancy survey for internal local roads in the Mayfield area was undertaken on Tuesday 12 February 2019. The survey observed on-street parking on the roads shown in Figure 3.19 between 07:00 and 22:00 at three-hour intervals.

Figure 3.19 Location of Parking Surveys

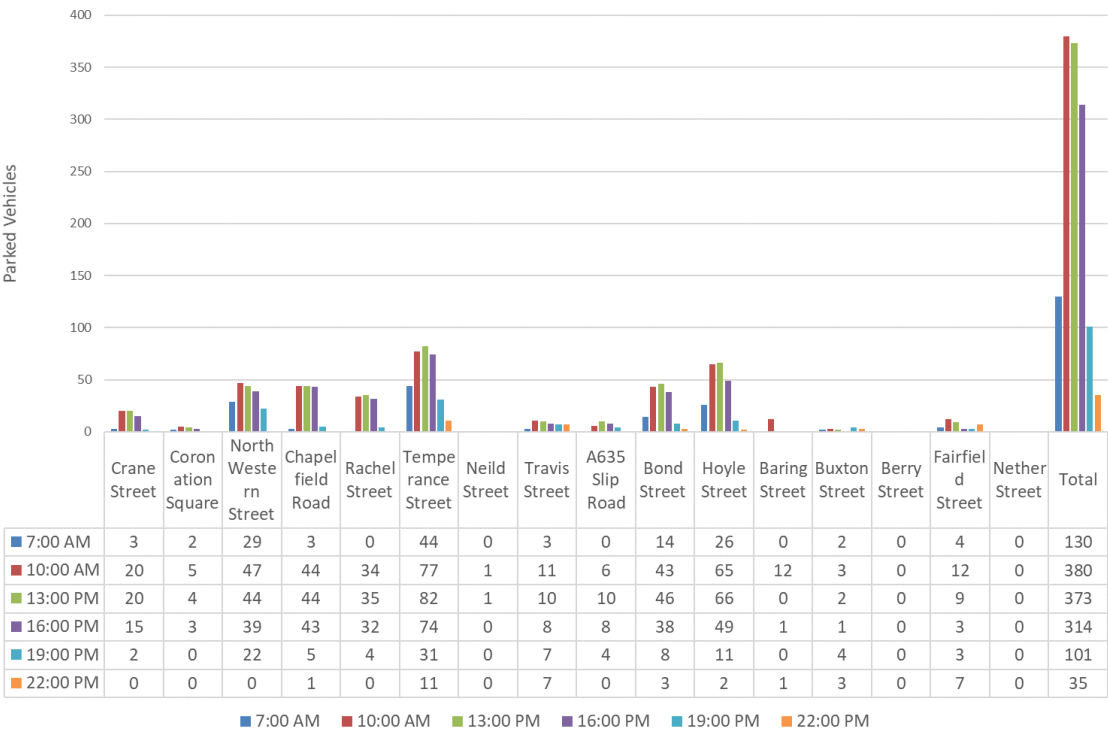
Figure 3.20 Total On-street Parking Occupancy

3.6.5 The on-street parking observed on each road is shown in Figure 3.20.

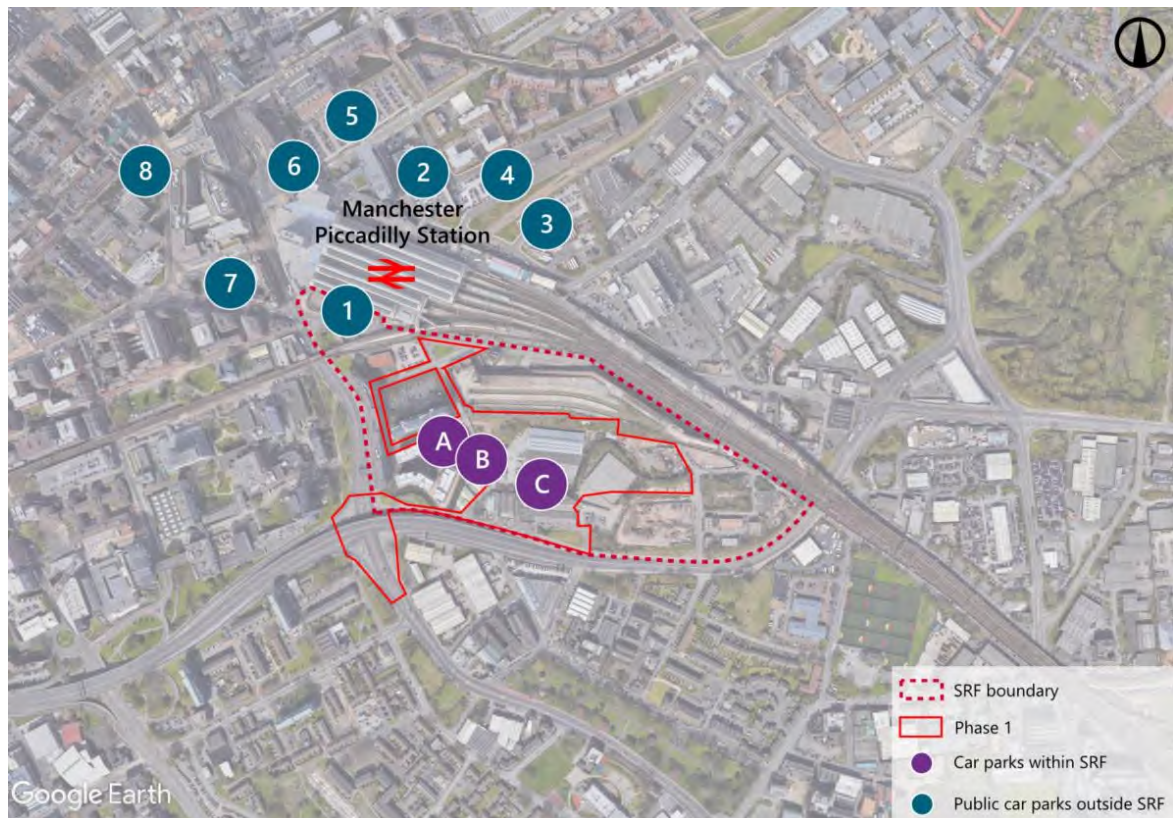
- 3.6.7 In accordance to 'Providing for Journeys on Foot' by the Institution of Highways and Transportation, the desirable walking distance to and from a car park is 400m, Figure 3.21 shows the location of public car parks (off-street parking) available within approximately a 400m radius from the Site. The parking capacity and opening hours are summarised in Table 3.6.
- 3.6.8 There are three public parking areas identified within the Site boundary; these are largely informal parking areas that currently occupy the areas of former industrial buildings and have a capacity of around 200 vehicles. The nearest publicly available car park is the Piccadilly Station short-stay car park which is approximately a 3-minute walk (160m) away. As for long-stay parking, the nearest is Piccadilly Place to the west of the Site, which is approximately a 5-minute walk (482m) away.

**Figure 3.21: Location of Public Car Parks in Proximity to the SRF**
