**Mayfield, Phase 1**  
EIA Volume 2

September 2019

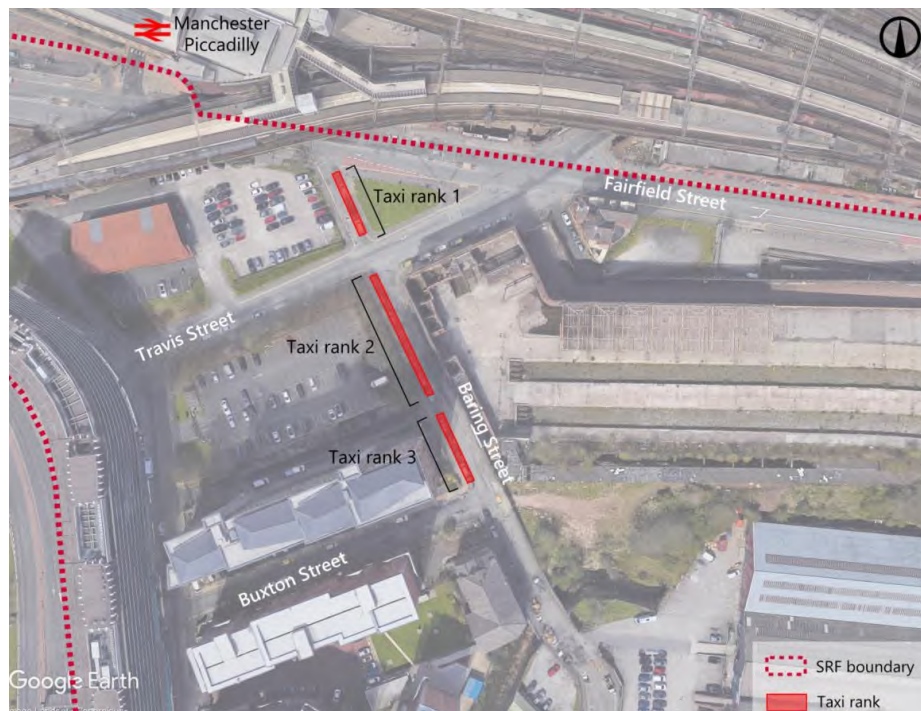
3.6.10 There are marked taxi bays provided on Baring Street within the Site. These taxi ranks act as holding areas for taxis waiting to enter the main Piccadilly Station taxi rank on the north side of Fairfield Street. The location of the taxi ranks south of Fairfield Street are shown in Figure 3.22.

**Figure 3.22 Taxi Rank Location**

3.6.11 The taxi ranks shown in Figure 3.22 can accommodate 14 taxis within the marked bays.

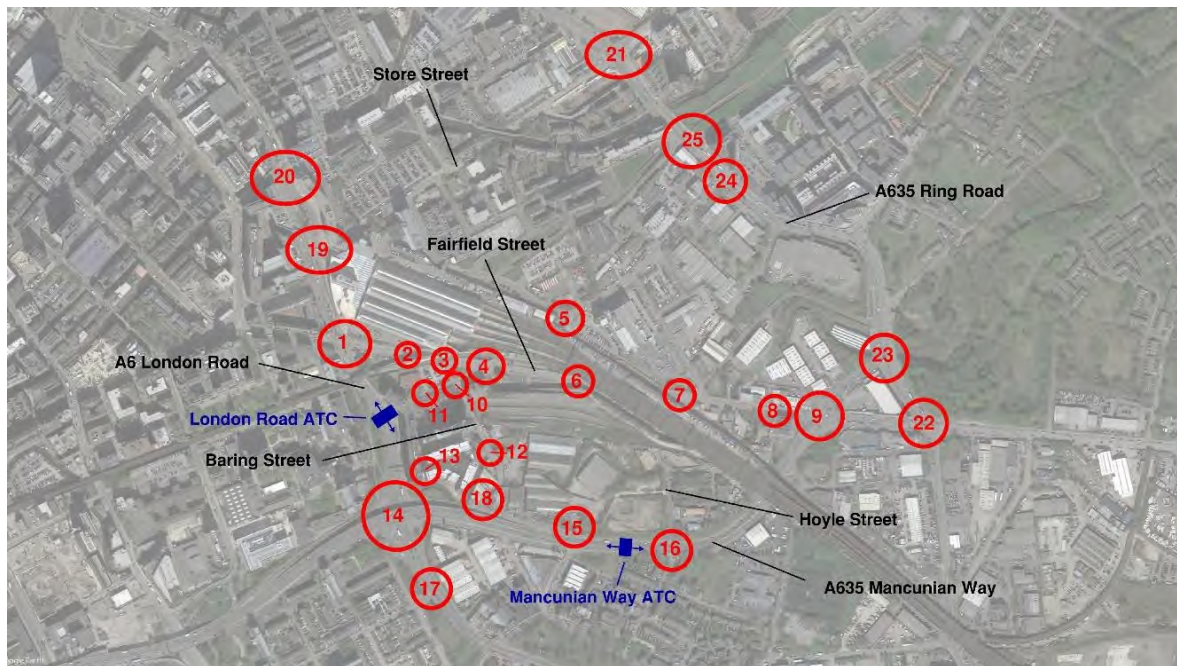
3.7.1 Classified turning count surveys for the junctions shown in Figure 3.23 were undertaken on Tuesday 10 and Wednesday 11 July 2018, with supplementary surveys undertaken on Wednesday 5 June 2019. The surveys recorded queue lengths and saturation flows, where appropriate. In addition to the classified turning counts, automatic traffic counts (ATC) were undertaken on A635 Mancunian Way and A6 London Road for seven days commencing Friday 13 July 2018.

**Figure 3.23 Traffic Survey Locations**

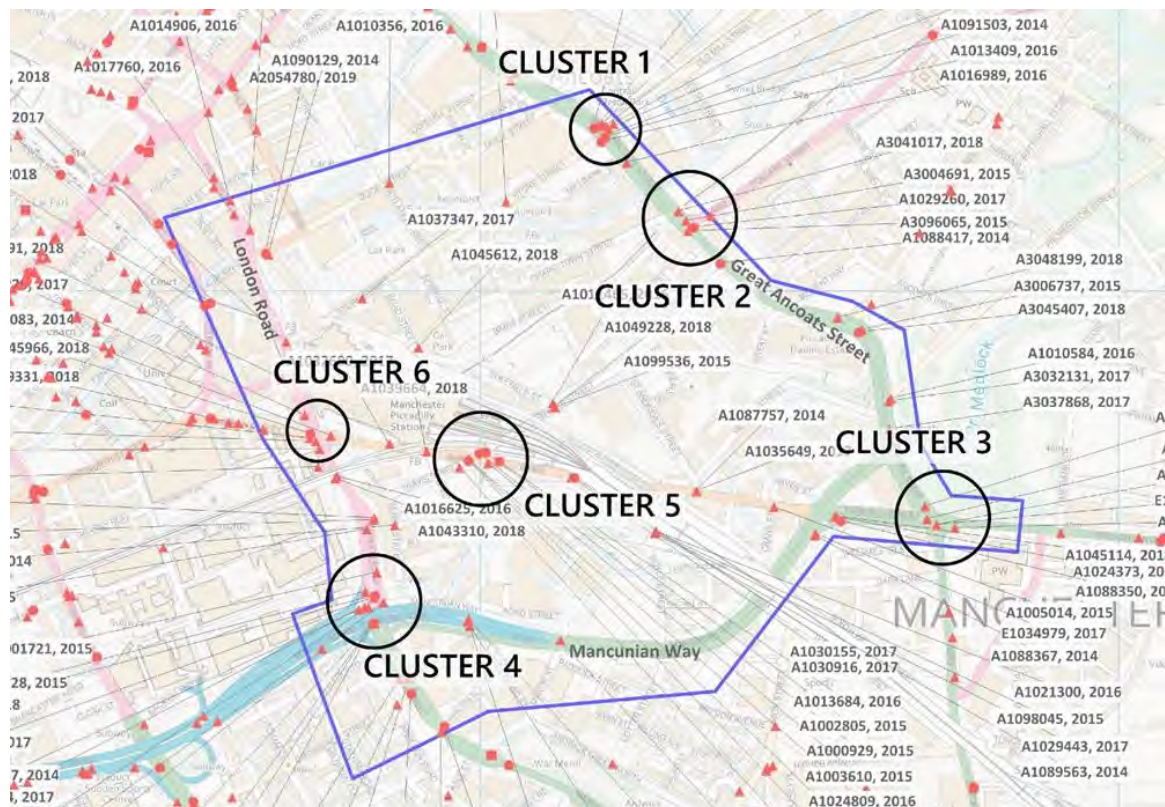
- 3.8.6 Table 3.7 shows that 103 collisions were recorded in the five-year period up to the end of April 2019 and that the majority of the collisions (82) in the study are resulted in slight injury with 21 collisions resulting in serious injury. No fatal collisions were recorded during this period.
- 3.8.7 Pedestrians, cyclists and motorcyclists were involved in 1%, 14%, and 7% of the collisions respectively, while 42% of collisions occurred in dark conditions and 11% for rain and 3% for windy conditions.
- 3.8.8 The data was analysed further by identifying clusters of collisions within the study area. This was done to ascertain whether there were any underlying patterns, trends or factors that may have contributed to the collision. Six key collision clusters were identified as shown in Figure 3.24.

**Figure 3.24 Location of Collision Clusters**

- 3.8.9 There were a total of eight collisions in this location over the study period; six slight injury and two serious. The two serious collisions mainly involve a vehicle colliding with a pedestrian crossing the carriageway. Typical causes in this area include failing to judge other vehicles' path or speed and failing to look properly when changing lanes or turning.

- 3.8.10 Four collisions had occurred at this location over a five-year period of which comprises of three slight and one serious collision – primarily involving a pedestrian believed to be under influence colliding with a vehicle while crossing the junction. The collisions are mainly due to failure in judgment of other vehicles' path or speed and failure of looking properly when manoeuvring or changing lanes.

- 3.8.11 A total of five collisions has been identified over the study period all involving slight injury. The typical causes in this area include sudden braking, failing to judge other vehicles' path or speed and failing to look properly when manoeuvring, turning or changing lanes.

- 3.8.12 Eight collisions had occurred at this location over a five-year period, including one serious and seven slight injury. The serious collision is believed to be a HGV approaching a turn whilst colliding with a pedestrian on a pedestrian crossing. The remaining seven collisions typically involved failure to judge other vehicles' path or speed and failing to look properly when manoeuvring, turning or changing lanes.

- 3.8.13 There were a total of ten collisions over a five year period, four serious and six slight injury. Typical causes involve vehicles colliding with a cyclist when turning, failing to judge other vehicles' path or speed and failing to look properly when manoeuvring, turning or changing lanes.

- 3.8.14 A total of five collisions in this location has been identified over the study period of which comprises of four slight and one serious collisions. The collisions are mainly due to sudden braking, failure in judgment of other vehicles' path or speed and failure of looking properly when manoeuvring, turning or changing lanes.

- 3.8.15 The clusters of collisions identified have been shown to have no prevalent cause, with a variety of contributing factors. However, it is noted that the highway improvements proposed in the surrounding area, including improved accessibility for pedestrians and cyclists, will change how the highway performs in road safety terms and may also change current collision patterns. Further collision analysis would be undertaken as part of the Road Safety Audit procedures for the new and amended highway infrastructure, when it is completed, and by future Reserved Matters Applications for the Mayfield development.

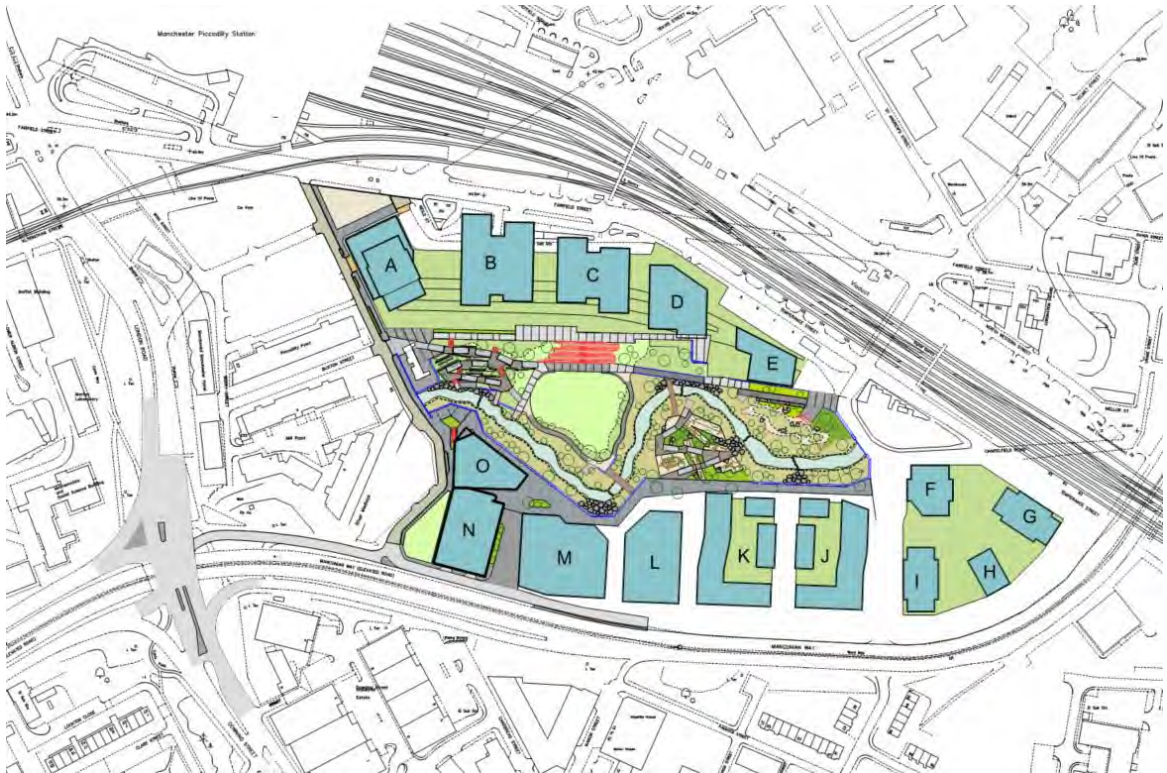
- 4.1.2 The masterplan SRF layout is shown in Figure 4.1. This application focusses on Phase 1 of the SRF which comprises Mayfield Park, Baring Street MSCP (Plot N), Baring Street Office 1 (Plot O) and Baring Street Office 2 (Plot M).

**Figure 4.1 SRF Masterplan**

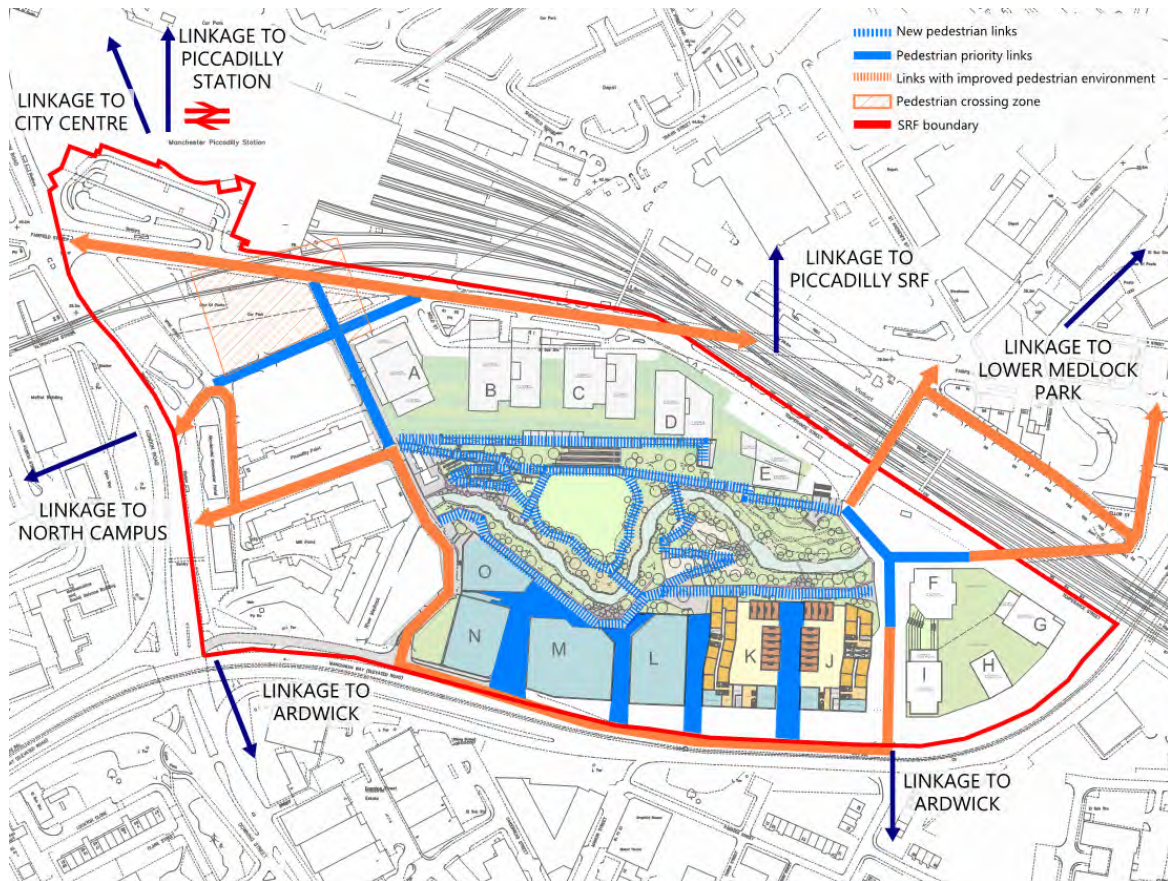
- 4.1.3 The SRF outlines the proposed pedestrian access arrangements for the whole site. The Mayfield Park and improved public realm throughout the masterplan will significantly enhance the east-west and north-south connections through the Site. The pedestrian strategy proposed in the SRF is shown in Figure 4.2.

**Figure 4.2 SRF Pedestrian Strategy**

- 4.1.4 Pedestrian access to the Site from the north will be enhanced through a pedestrian crossing on Fairfield Street directly adjacent to Piccadilly station; this is in parallel to proposed improvements to the pedestrian environment on Fairfield Street in general. These improvements will enhance the Site's connections to Piccadilly Station and the existing pedestrian routes to the city centre.
- 4.1.5 Improvements are proposed to the pedestrian environments on Travis Street, which links to London Road, where a pedestrian crossing zone is proposed across London Road to enhance connectivity to the west towards the University of Manchester Campus. To the east, proposed alterations to the pedestrian environments on Temperance Street, North Western Street and Crane Street will result in improved connectivity and walking environment for pedestrians.

- 4.1.6 The principle of a pedestrian crossing is shown on Mancunian Way adjacent to Hoyle Street, which will improve pedestrian connectivity to Ardwick and amenities to the south. The pedestrian crossing will connect to an internal perimeter road running parallel to Mancunian Way, which provides access to pedestrian links into the Site.
- 4.1.7 Details of the pedestrian access arrangements for the Phase 1 development plots can be found in Section 4.2.

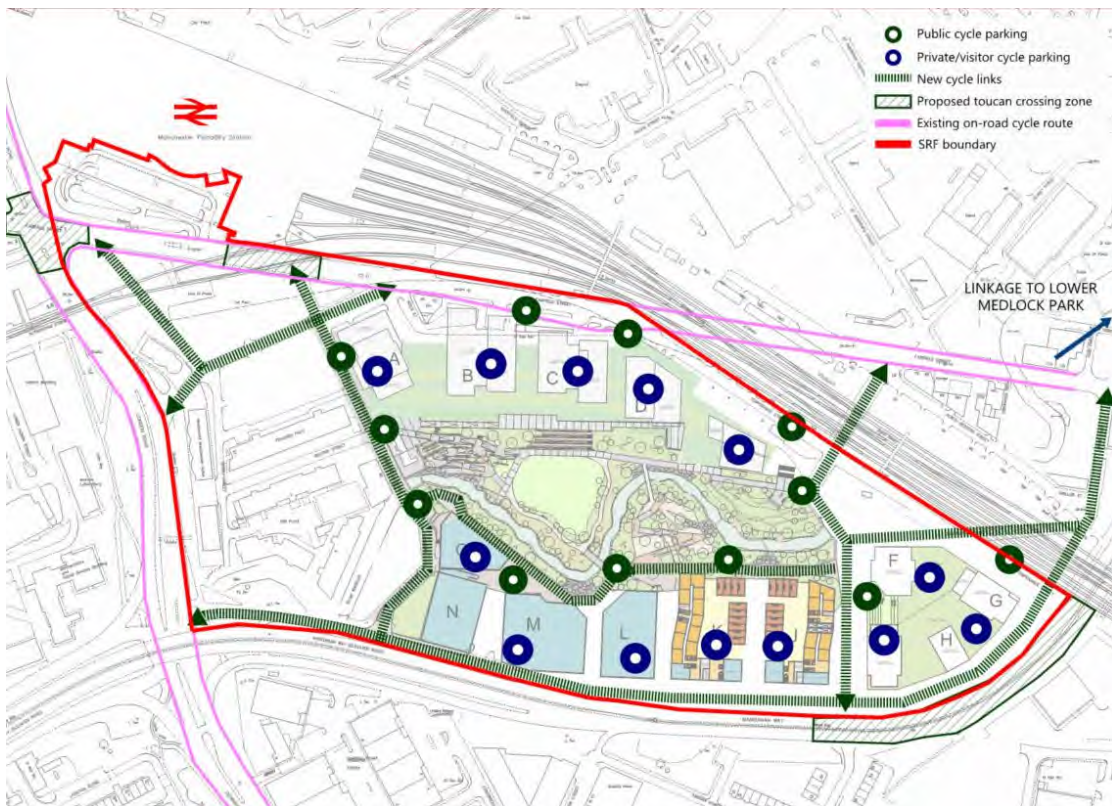
- 4.1.8 The SRF proposes improvements to the cycle connections to, from and through the Mayfield area. Three strategic cycle routes linking into the external network will be created, which it is envisaged will carry the majority of cyclists across Mayfield. These will be along Baring Street connecting the existing cycle routes on Fairfield Street to those on A6 London Road; along Hoyle Street, connecting Fairfield Street to Mancunian Way; and a route on the southern perimeter road parallel to Mancunian Way that will connect Baring Street to Hoyle Street.
- 4.1.9 It is envisaged that a network of internal routes within the Site connecting with the strategic routes will provide local access to the development plots and park, but these routes would be less busy with cyclists and shared with pedestrians.
- 4.1.10 The cycle strategy proposed by the SRF is shown in Figure 4.3.

Figure 4.3 SRF Cycle Strategy

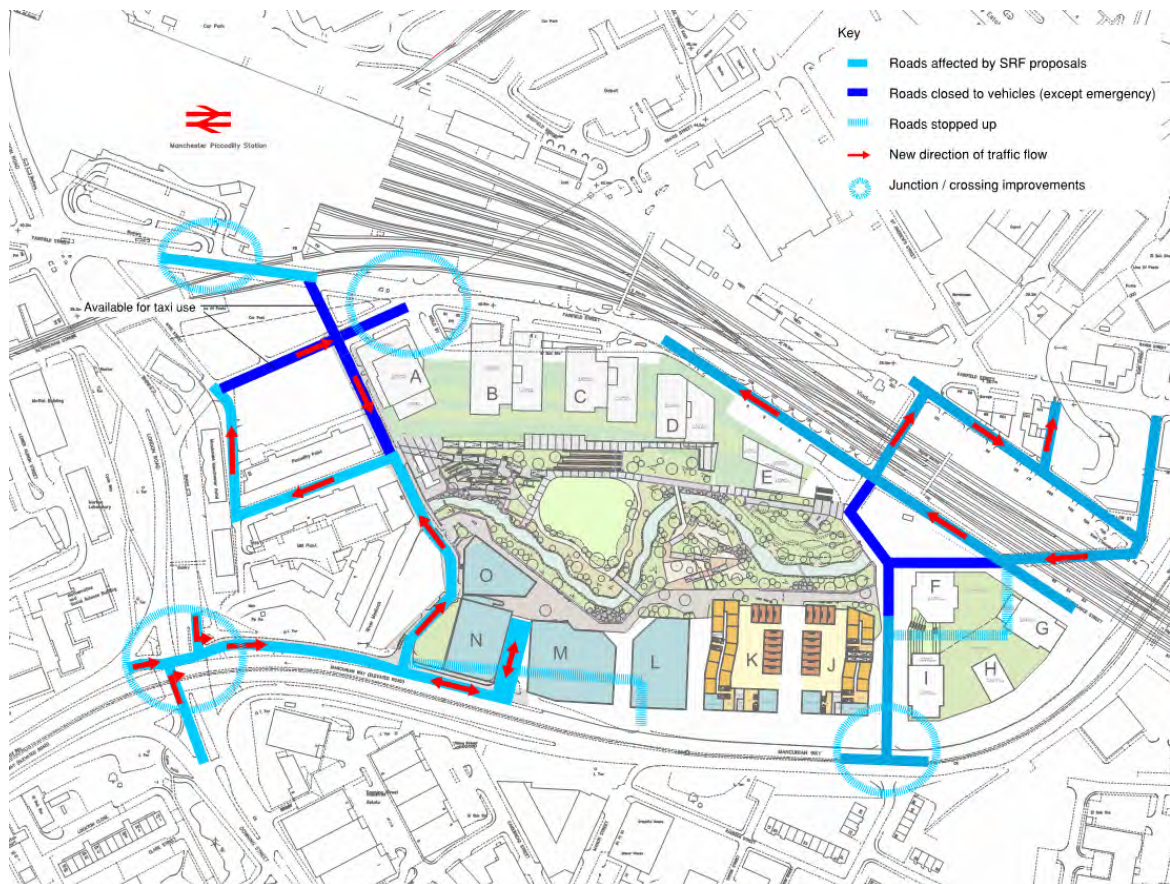
- 4.1.16 The SRF seeks to minimize the impact of vehicular traffic on Mayfield, whilst enhancing connections for non-motorised modes. Measures to achieve this include deliberately restricting vehicle access to the periphery of the Site from off Mancunian Way and Fairfield Street and changing traffic routing within Mayfield to discourage rat-running and through traffic. It is envisaged that a 20mph zone will be introduced across Mayfield and this will be enforced by design measures to reduce vehicle speeds and create quality spaces for pedestrians and cyclists. The site-wide highway access proposals for the SRF are shown in Figure 4.4.

**Figure 4.4 SRF Highway Proposals**

- 4.1.17 These highways proposals have been subsequently developed and current highway access arrangements for Phase 1 can be found in Section 4.2.

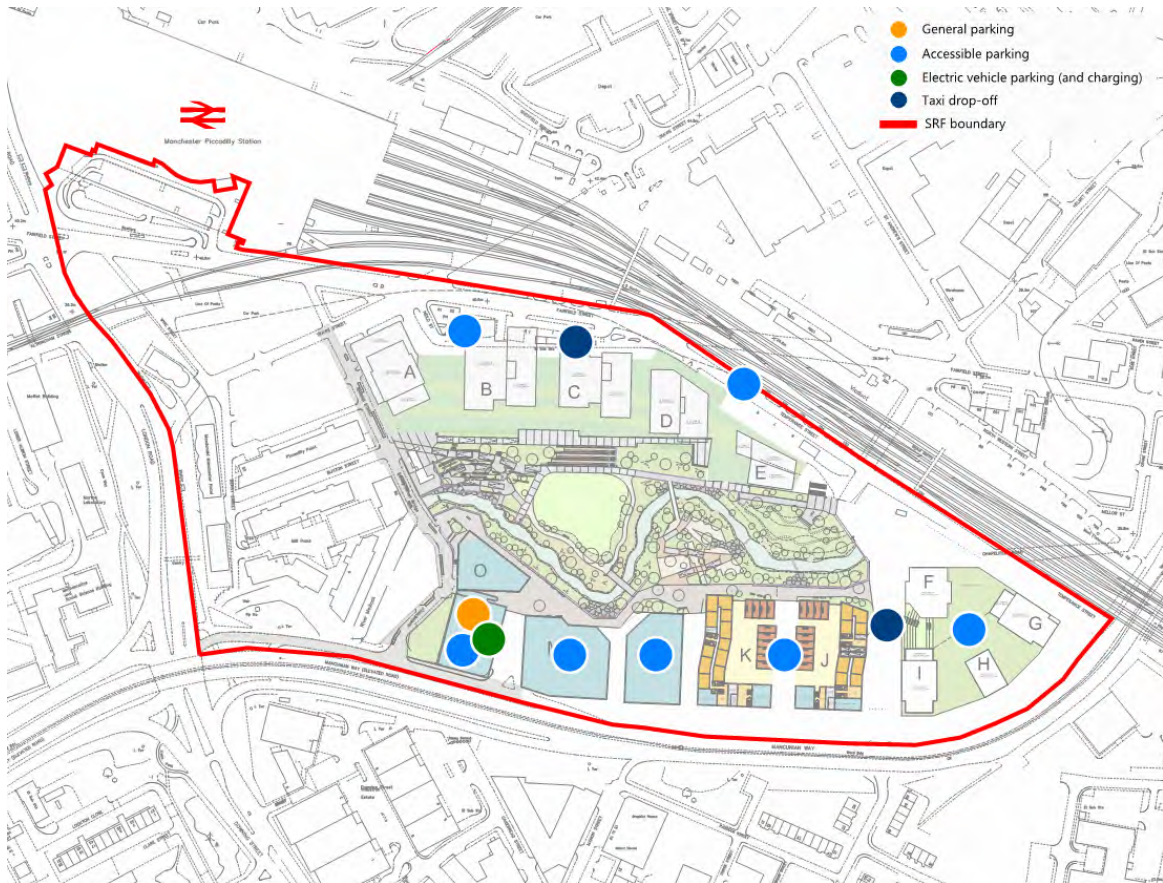
4.1.18 The site-wide car parking strategy for the SRF is shown in Figure 4.5.

**Figure 4.5 SRF Parking Strategy**

- 4.1.19 The SRF proposes up to 700 spaces provided on-site. The majority of parking provision will be provided at a single location in the masterplan to ensure that streets and spaces are as car-free and pedestrian friendly as possible. This will be achieved by the provision of a MSCP in the south western corner of the masterplan area at the southern end of Baring Street.

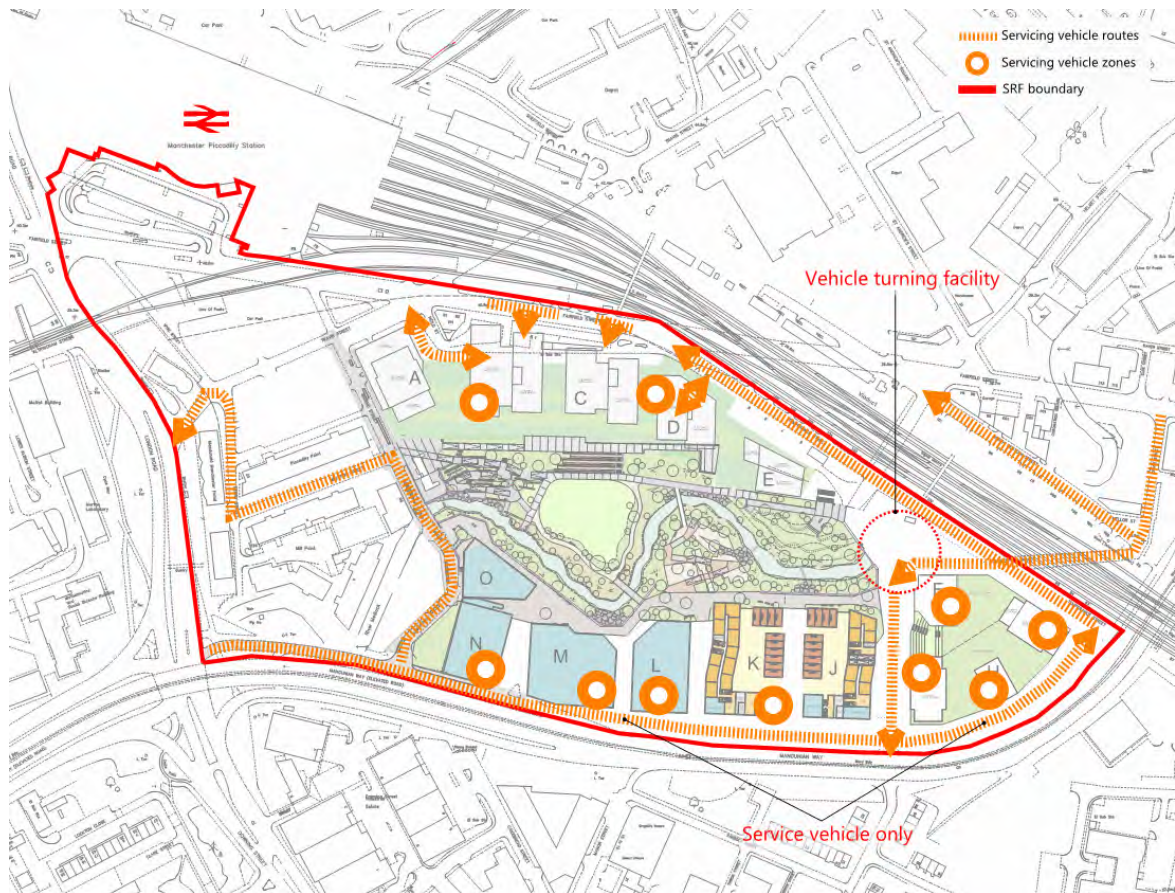
- 4.1.27 It is proposed that servicing and deliveries across the Site will take place on each plot; minimising the interaction between servicing vehicles, pedestrians and cyclists in the public realm. The SRF servicing strategy is shown in Figure 4.6.

**Figure 4.6 SRF Servicing Strategy**

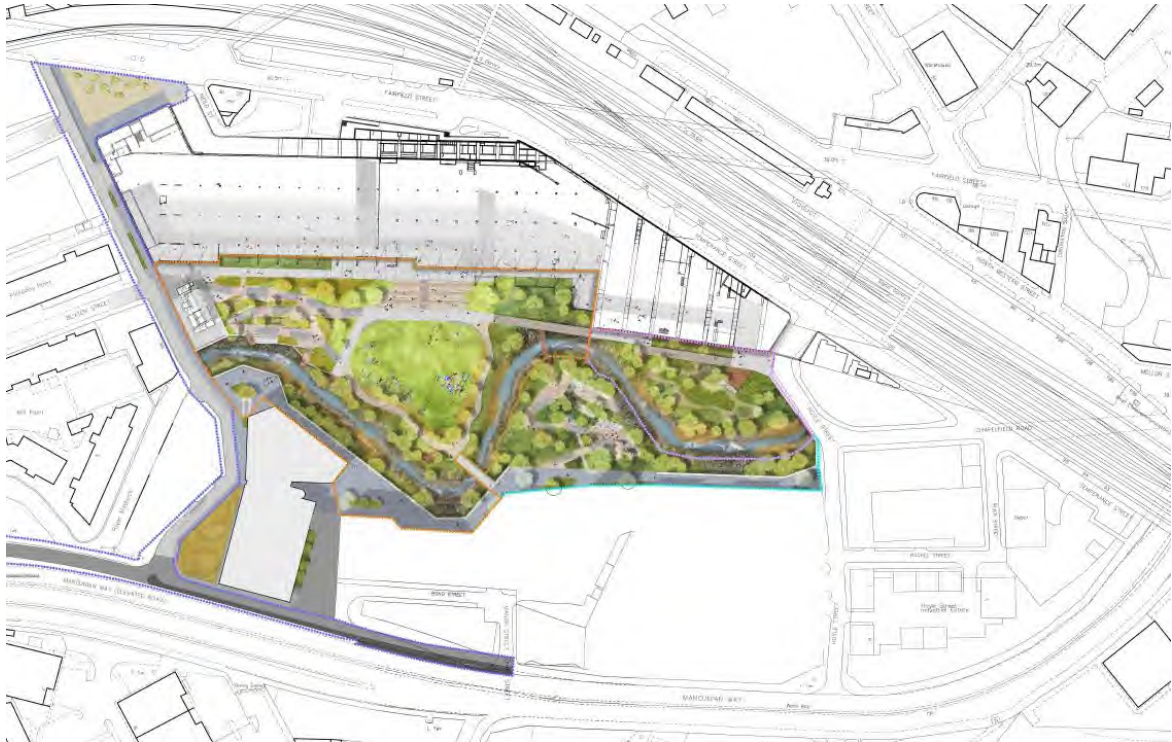
4.2.5 The proposed illustrative plan for Mayfield Park is shown in Figure 4.7.

**Figure 4.7 Mayfield Park Proposals**

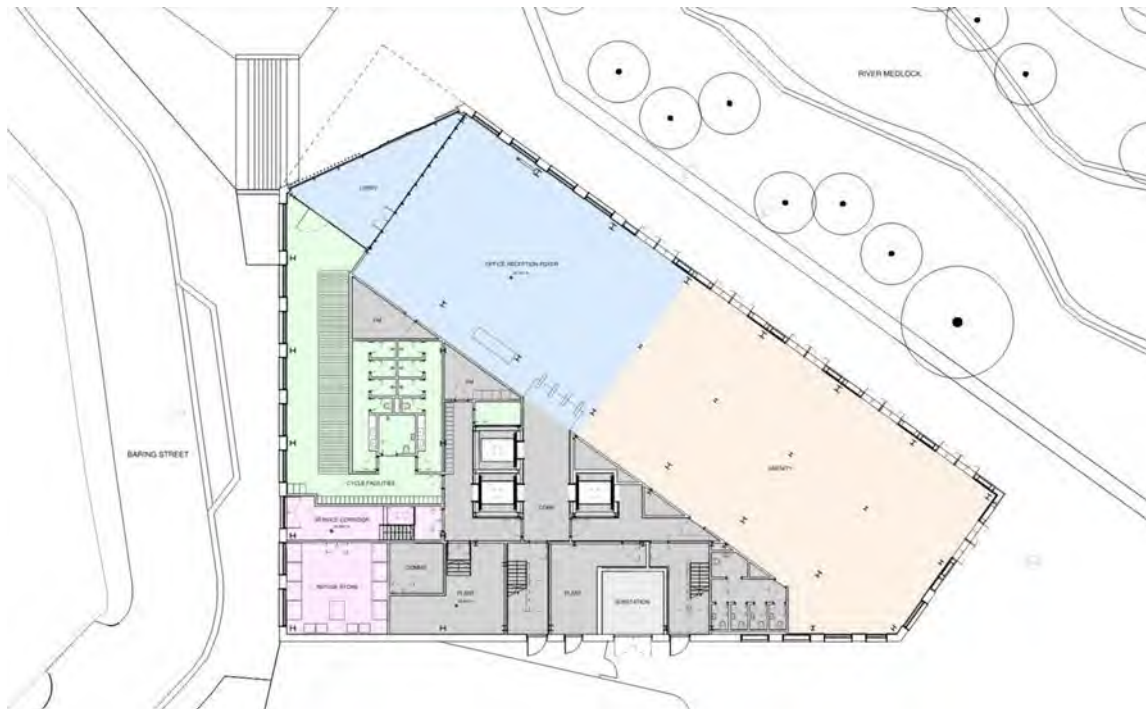
4.2.6 The ground floor plan for Baring Street Office 1 is shown in Figure 4.8.

**Figure 4.8 Baring Street Office 1 – Proposed Ground Floor Plan**

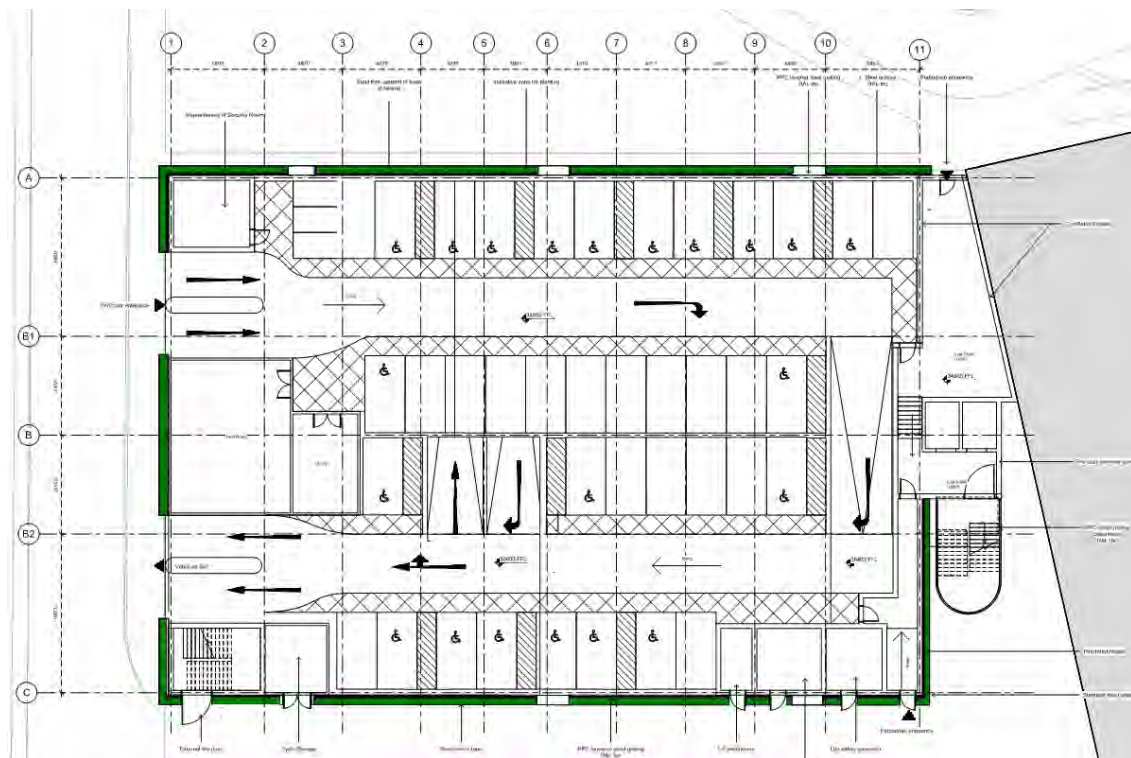
**Figure 4.9 Baring Street MSCP – Proposed Ground Floor Plan**

4.2.7 The proposed ground floor plan for Baring Street MSCP is shown in Figure 4.9.

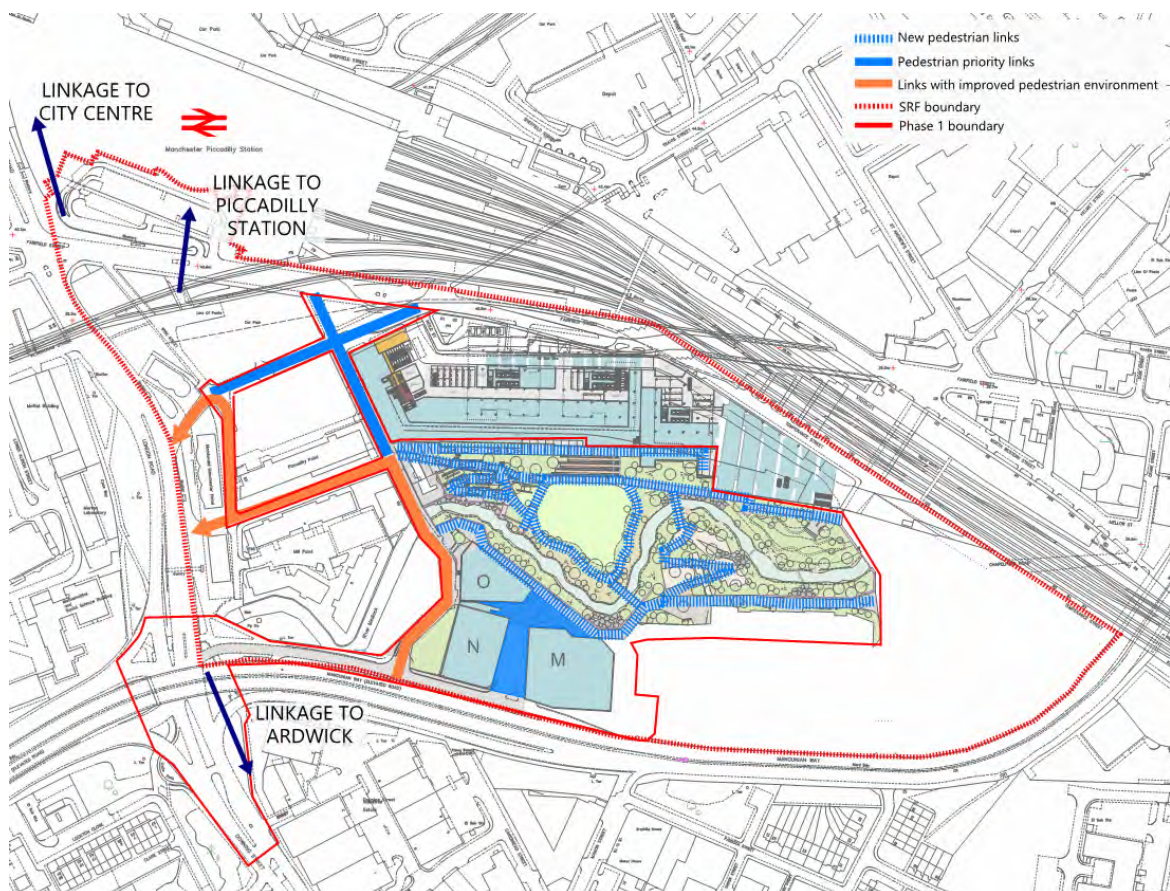
- 4.2.9 The pedestrian access strategy for Phase 1 is shown in Figure 4.10. The strategy includes creating pedestrian priority links with environmental improvements on Travis Street and the northern section of Baring Street to enhance connections between the Site and the city centre. Further environmental improvements will be made to Baring Street (south of Buxton Street), Buxton Street and Berry Street, incorporating measures such as widened footways, improved surfacing materials and new planting.

Figure 4.10 Phase 1 Pedestrian Access

- 4.2.11 The proposed reconfiguration of the London Road / Mancunian Way junction, described in greater detail later, will now include pedestrian facilities on all arms.

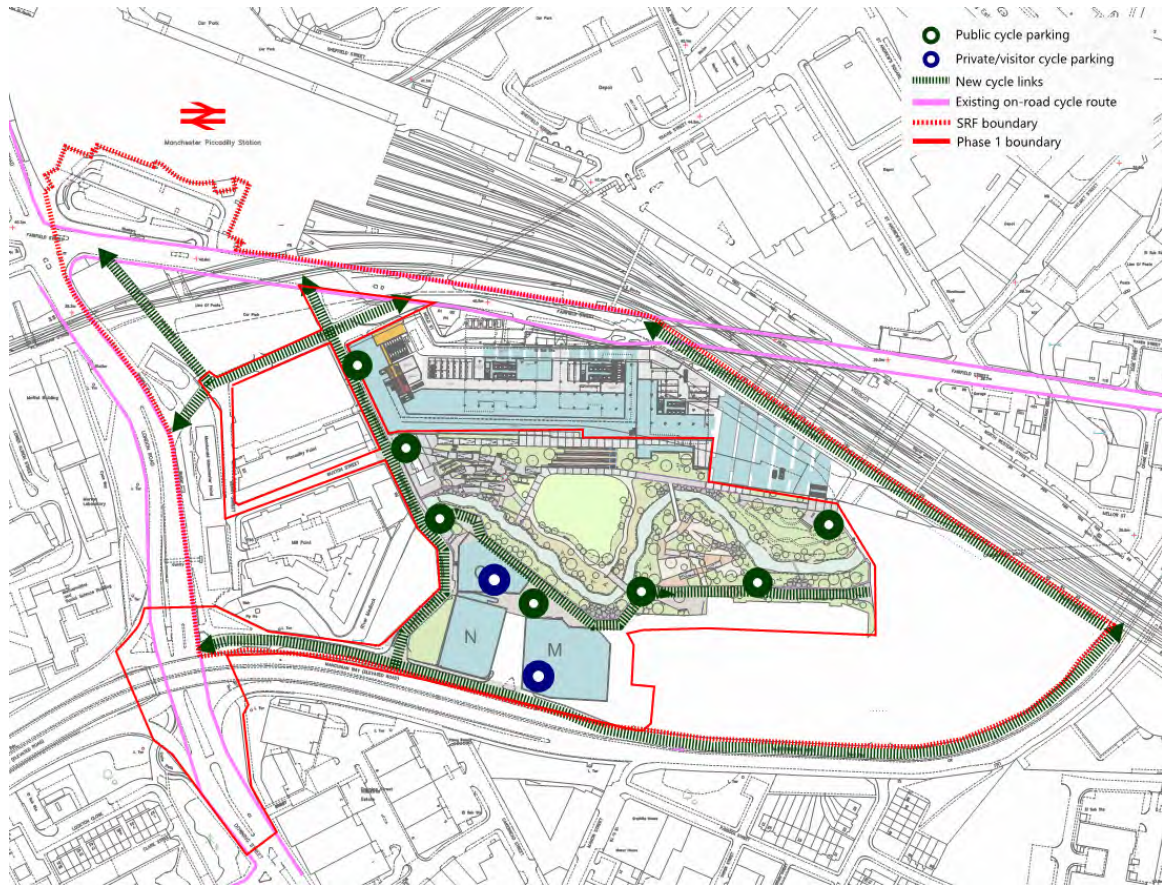
4.2.13 The cycle access strategy for Phase 1 is shown in Figure 4.11.

**Figure 4.11 Phase 1 Cycle Access**

- 4.2.14 As the Phase 1 development only focuses on the western edge of Mayfield, the strategic cycle route to be brought forward for Phase 1 is along Baring Street, linking the existing cycle route on Fairfield Street to London Road, where there are improved cycle crossings proposed. It is envisaged that the route will be a combination of a shared route with pedestrians and a segregated route on the carriageway, but this will be determined through detailed design discussions with MCC.

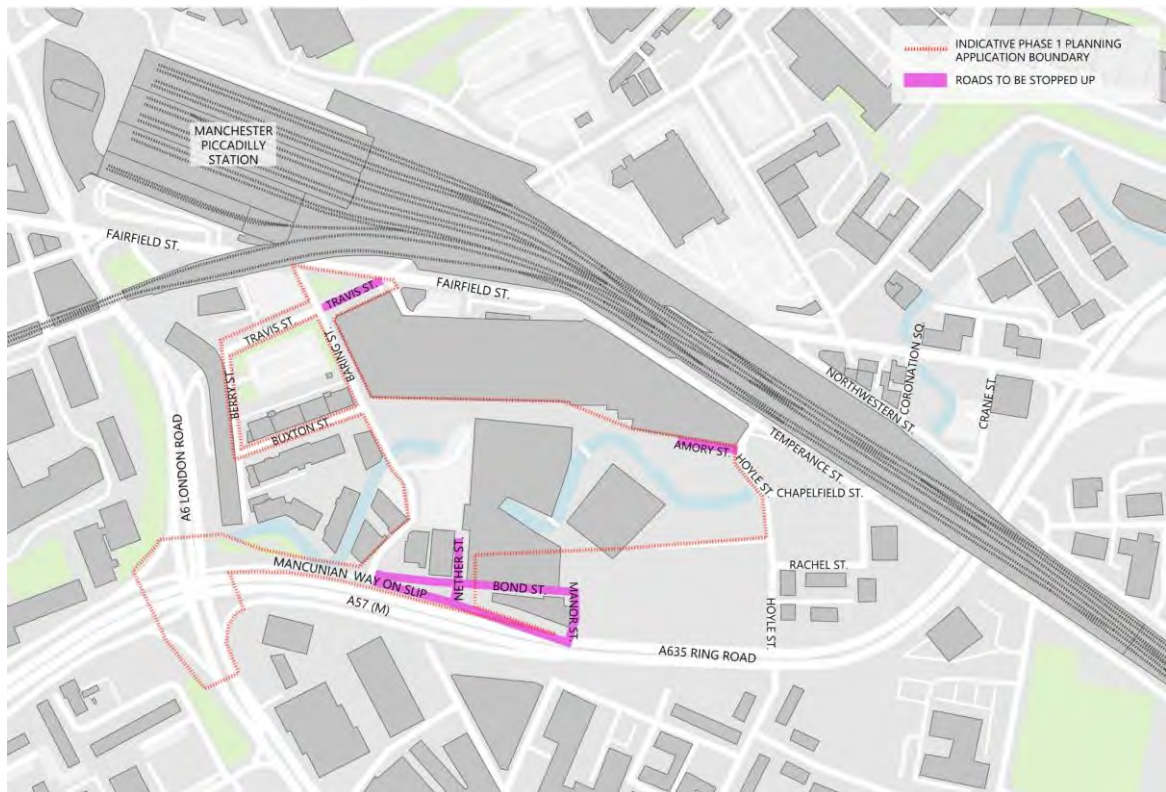
- 4.2.21 The proposed highway access proposals for Phase 1 are summarised in Figure 4.12 and Figure 4.13 with more detailed highways layout plans provided in the Appendix G.
- 4.2.22 As set out in the SRF, various changes are proposed to the highways in and immediately around Mayfield to facilitate the development, and for Phase 1 this will include a new access into Mayfield, new traffic routing, stopping-up of roads, access restrictions and changes to on-street parking. The roads affected by these proposals are shown in the following Figures, which include locations of proposed stopping-up and traffic Regulation Orders (TRO's) and new traffic routing.
- 4.2.23 It is also proposed that a 20mph zone be created throughout the Mayfield area as part of the Phase 1.

Figure 4.12 Phase 1 Highway Proposals – Stopping-Up

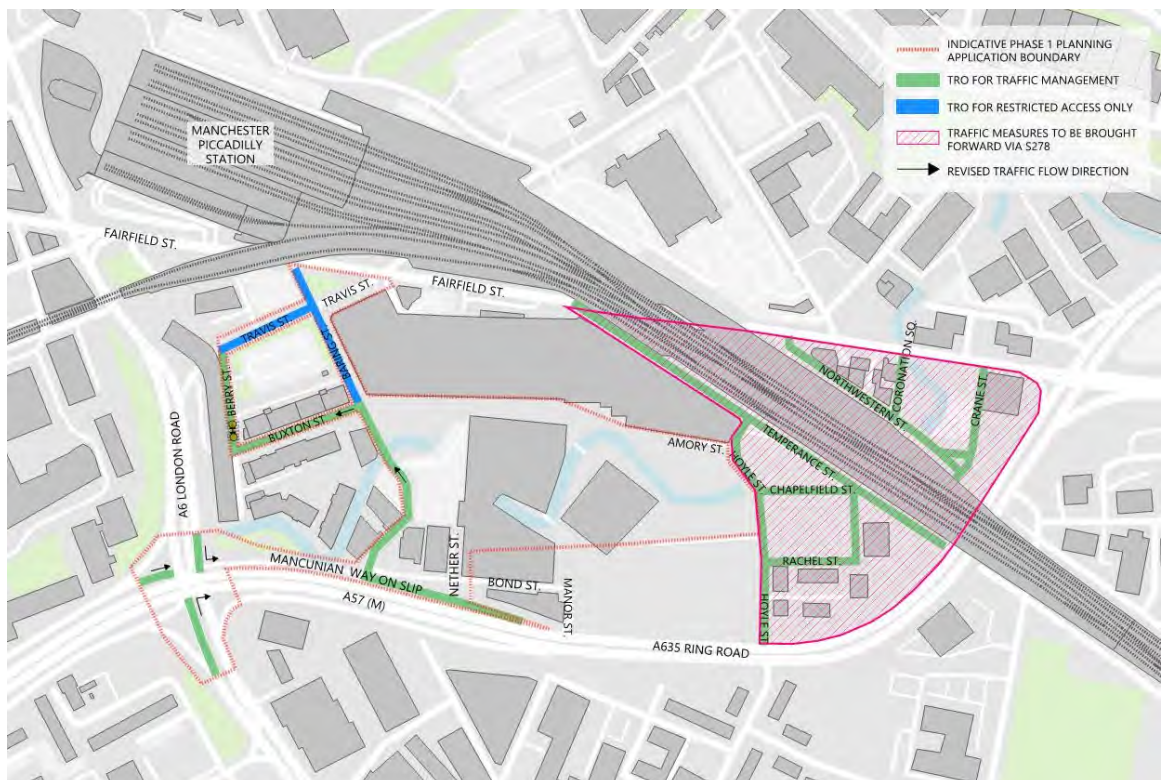
Figure 4.13 Phase 1 Highway Proposals – TRO's and Traffic Routing

- 4.2.34 As shown on Figure 4.13 it is proposed to introduce traffic measures in the streets to the east of Mayfield, in the area between the park and Fairfield Street, both sides of the railway viaduct. The purpose of these measures is as follows:

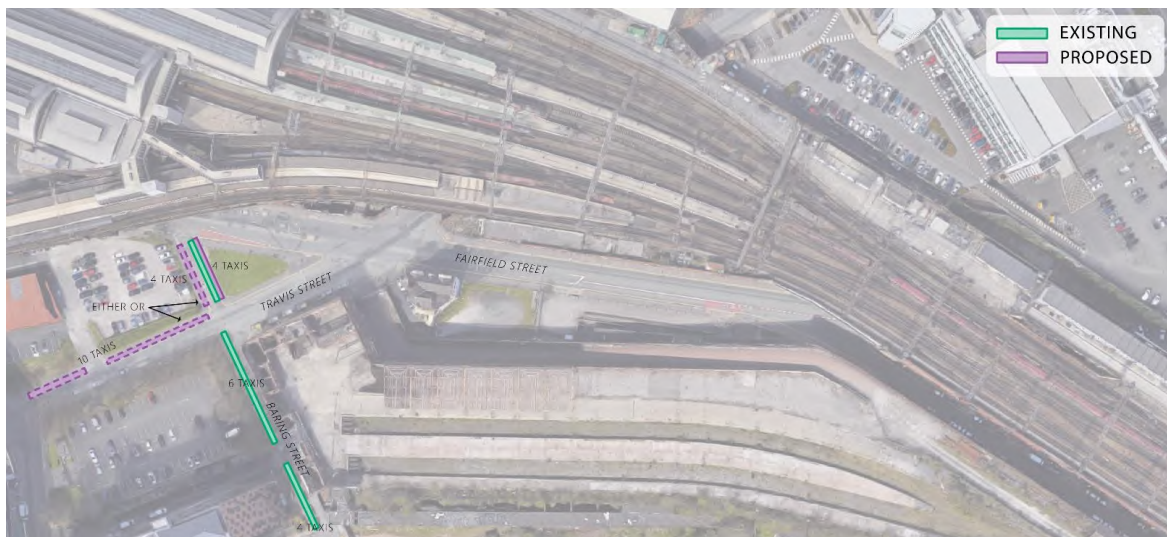
4.2.26 The proposed reconfiguration and operational changes to Travis Street and Baring Street will require the existing taxi ranks on Baring Street south of Travis Street to be removed. A replacement taxi rank for the same number of vehicles as existing is proposed on Travis Street west, between Baring Street and Berry Street. Taxis would approach the relocated rank from London Road. The location of the existing and proposed taxi ranks are shown in Figure 4.14.

**Figure 4.14 Existing and Proposed Taxi Ranks**

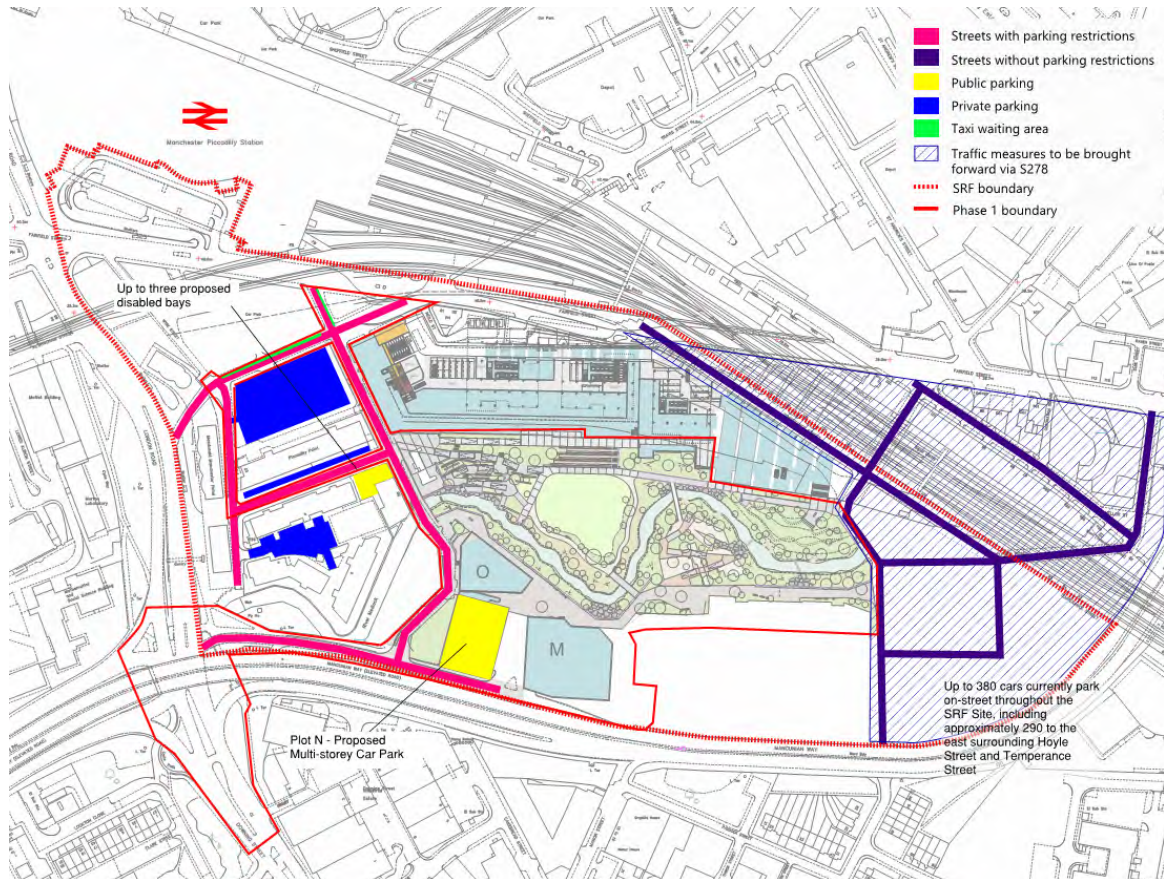
4.2.27 The proposed car parking provision for Phase 1 is shown in Figure 4.15.

**Figure 4.15 Phase 1 Car Parking Provision**

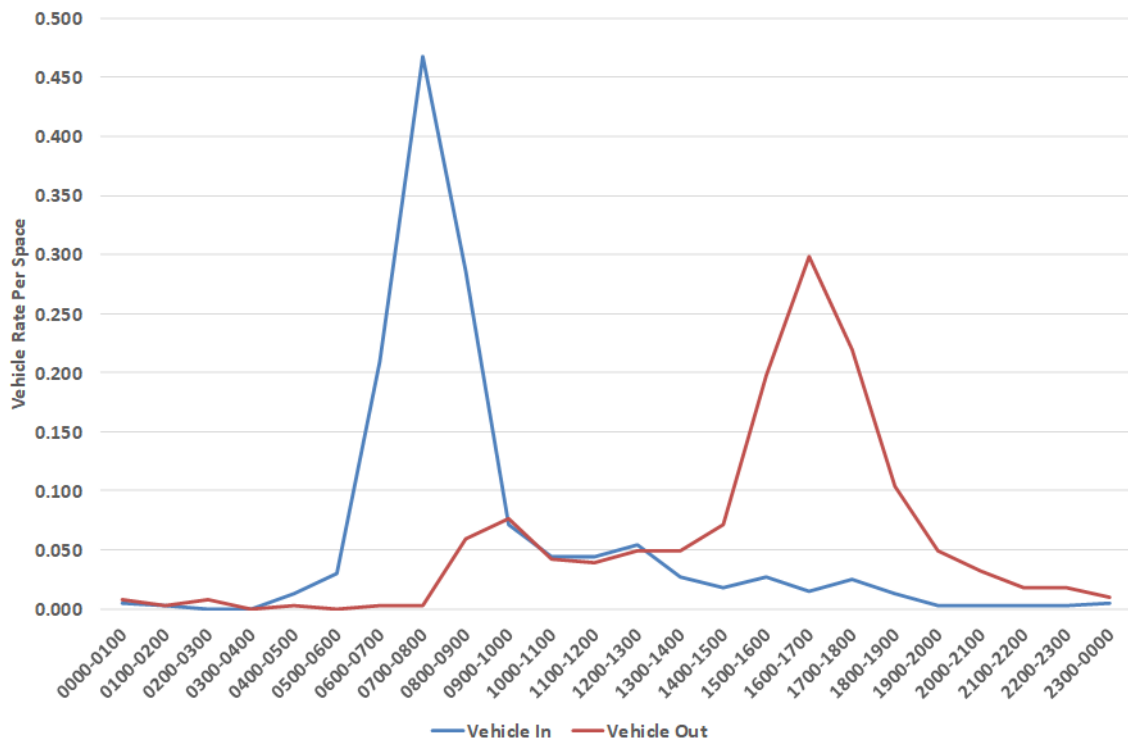
Figure 5.1 MSCP Arrival/Departure Profile

- 5.3.6 Figure 5.1 shows that the peak arrival for the MSCP occurs between 07:00 and 08:00 hours with the peak departure occurring between 16:00 and 17:00 hours. This suggests that commuters travelling to central Manchester tend to travel outside the typical network peak hours of 08:00-09:00 and 17:00-18:00. Anecdotally, this could be to avoid peak hour traffic in central Manchester or to ensure access to parking. This therefore suggests that the car trip generation proposed for commercial-use is conservative and provides a robust estimate because in reality, some commuters have been observed travelling outside network peak hours.

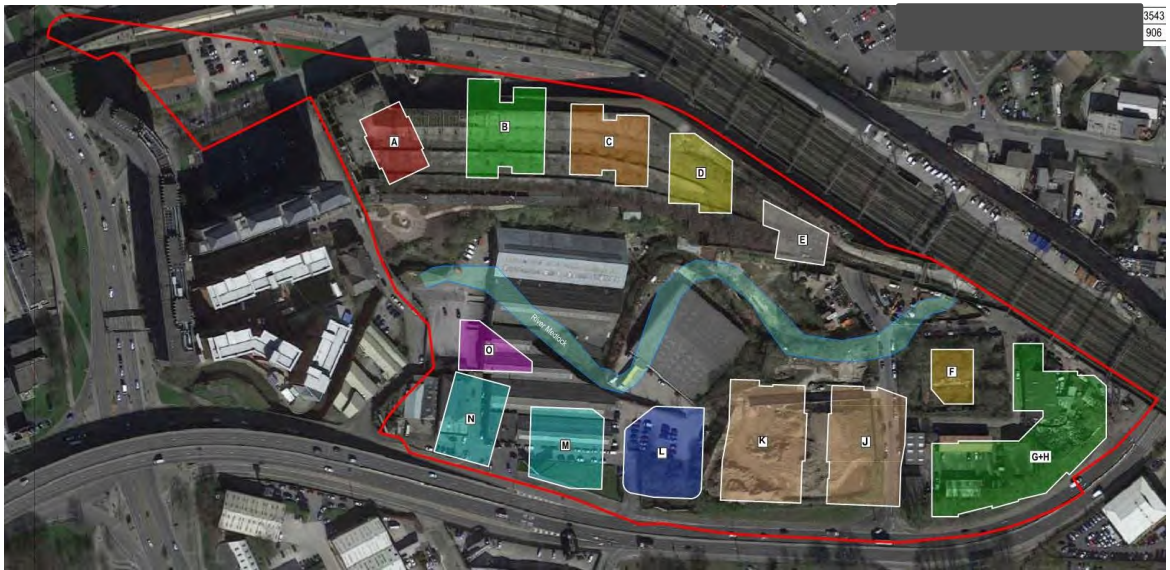
- 1.2.2 The Mayfield SRF has been divided into Plots and these are shown on Figure 1.1.

**Figure 1.1 Mayfield Masterplan Plot Locations with References**

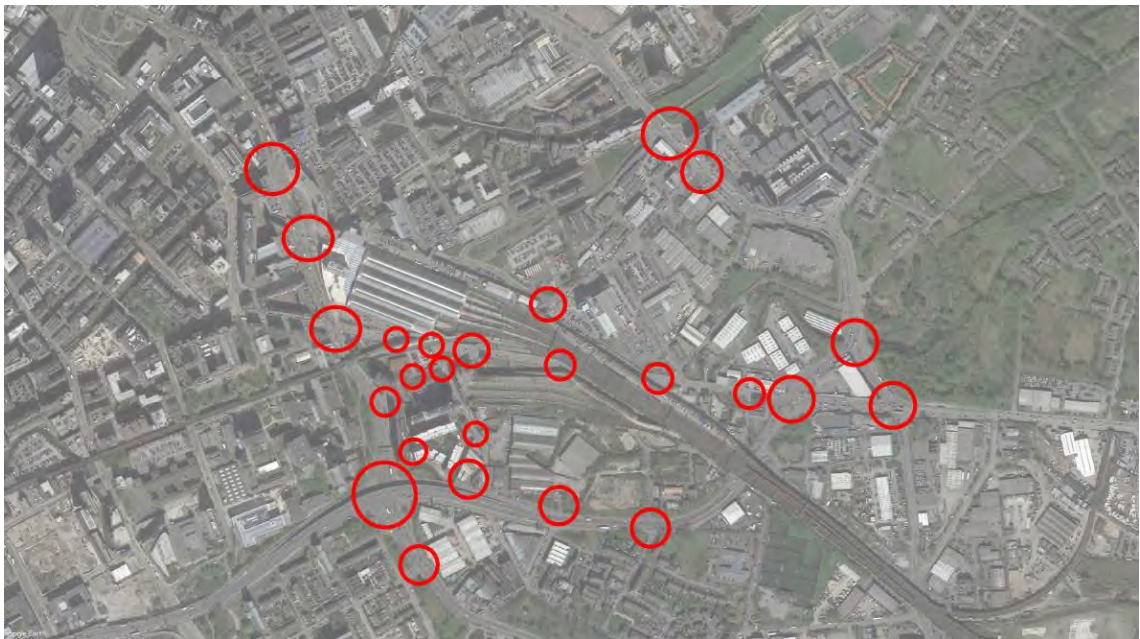
- 3.3.2 The Study Area for the highway impact assessment was agreed with TfGM in June 2018 and includes the junctions shown on Figure 3.1 below.

Figure 3.1 Study Area

- 3.3.3 The TA will include junction capacity assessments for a number of junctions within this Study Area and will be undertaken for the baseline assessment year and the assumed year of opening (discussed in more detail in later sections of this report).
