**Mayfield, Phase 1**  
EIA Volume 2

September 2019

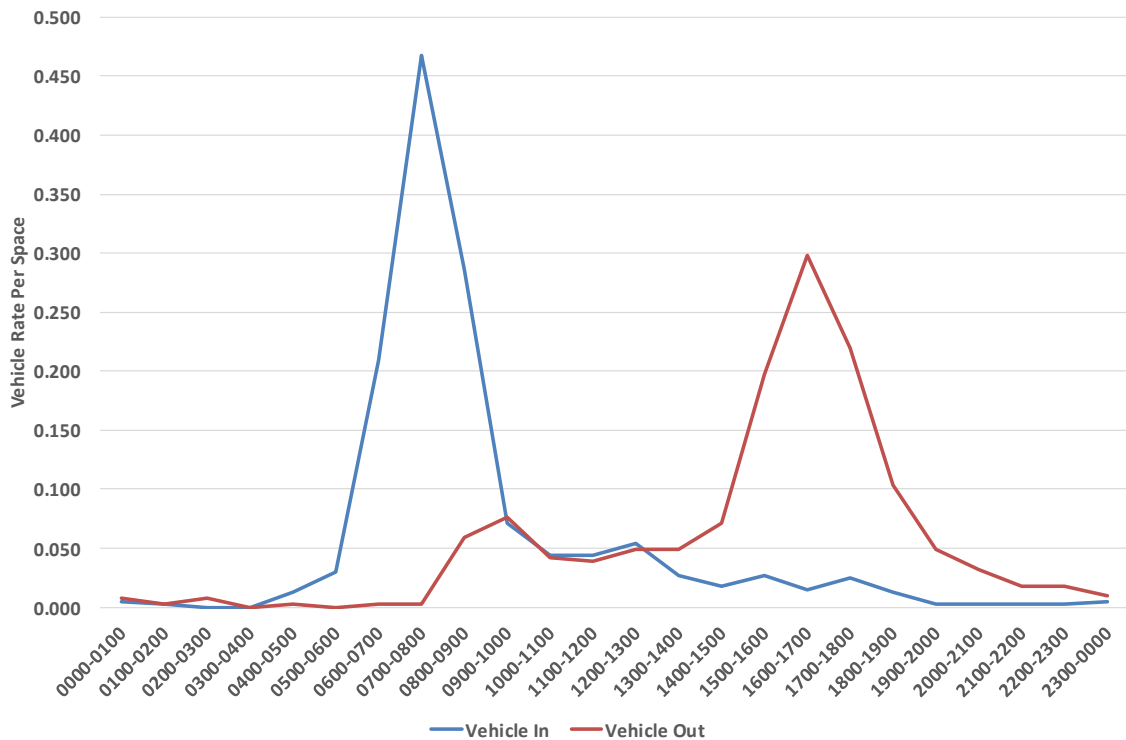
**Figure 5.1 Proposed MSCP Arrival/Departure Profile**

- 5.2.40 Figure 5.1 shows that the peak arrival for the MSCP occurs between 07:00 and 08:00 hours with the peak departure occurs between 16:00 and 17:00 hours. This suggests that commuters travelling to central Manchester tend to travel outside the typical network peak hours of 08:00-09:00 and 17:00-18:00. Anecdotally, this could be to avoid peak hour traffic in central Manchester or to ensure access to parking. This therefore suggests, that the car trip generation proposed for commercial-use is conservative and provides a robust estimate because in reality, some commuters have been observed travelling outside network peak hours.

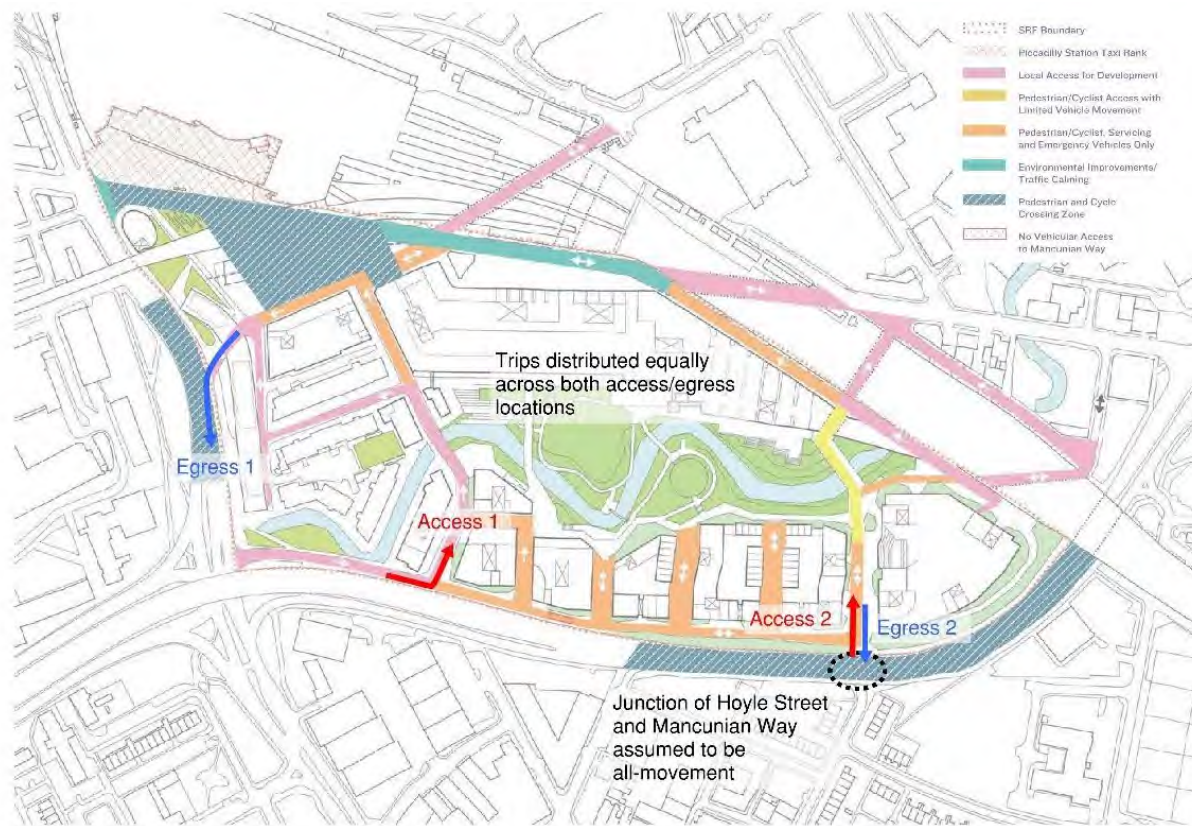
# SITE ACCESS ASSUMPTIONS

Trips have been distributed on the network based on the site access assumptions shown on the diagram, which takes account of the movement strategy presented in the SRF.

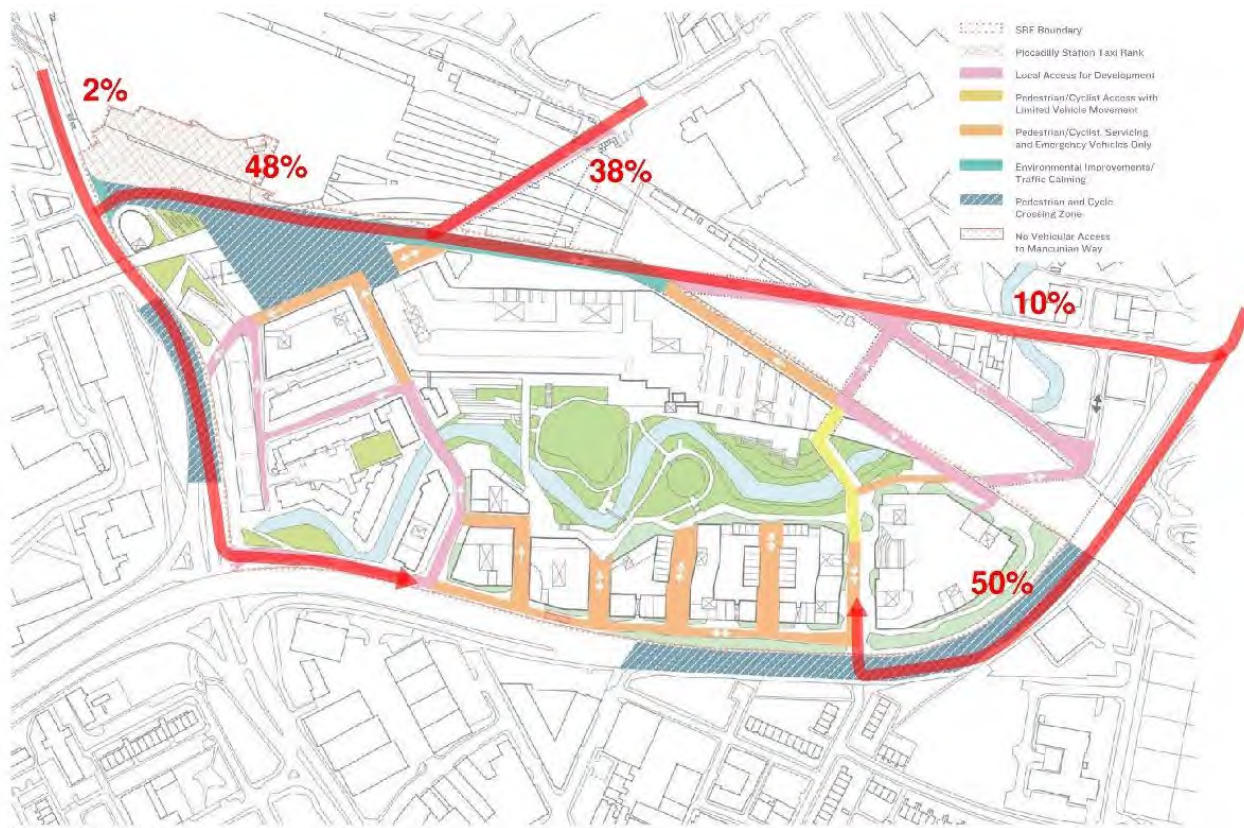
# ROUTING – TRAFFIC ARRIVING FROM THE NORTH

Trips arriving from the north have been assigned a routing to the site access points, shown previously.

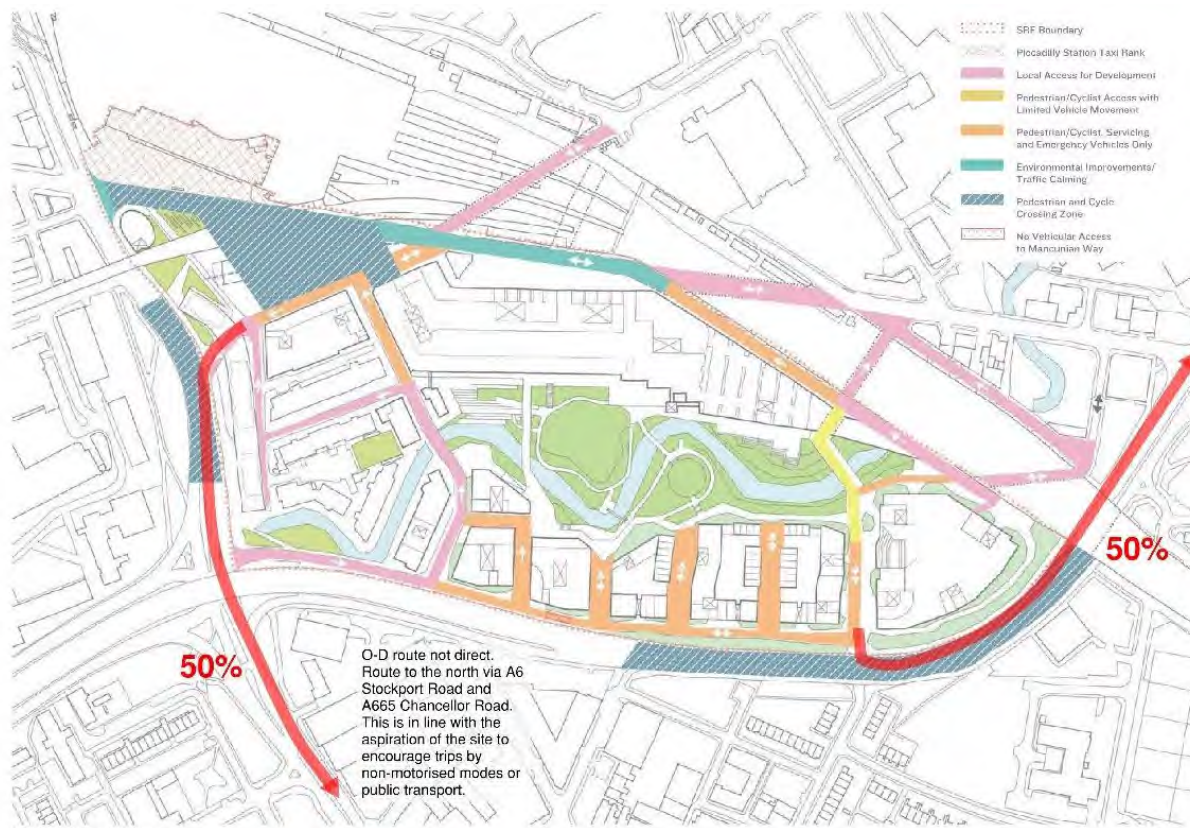
# ROUTING – TRAFFIC DEPARTING TO THE NORTH

Trips departing to the north have been assigned a routing from the site egress points, shown previously.

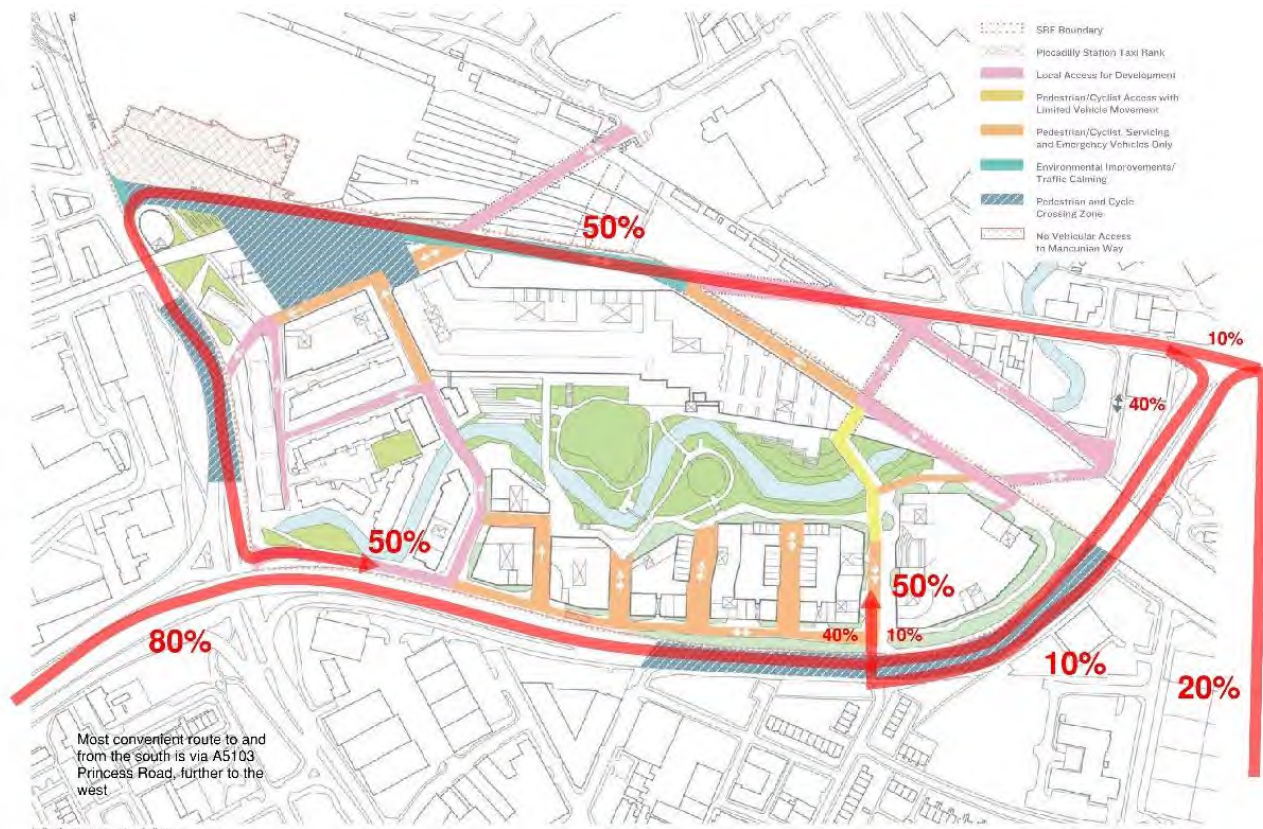
# ROUTING – TRAFFIC ARRIVING FROM THE SOUTH

Trips arriving from the south have been assigned a routing to the site access points, shown previously.

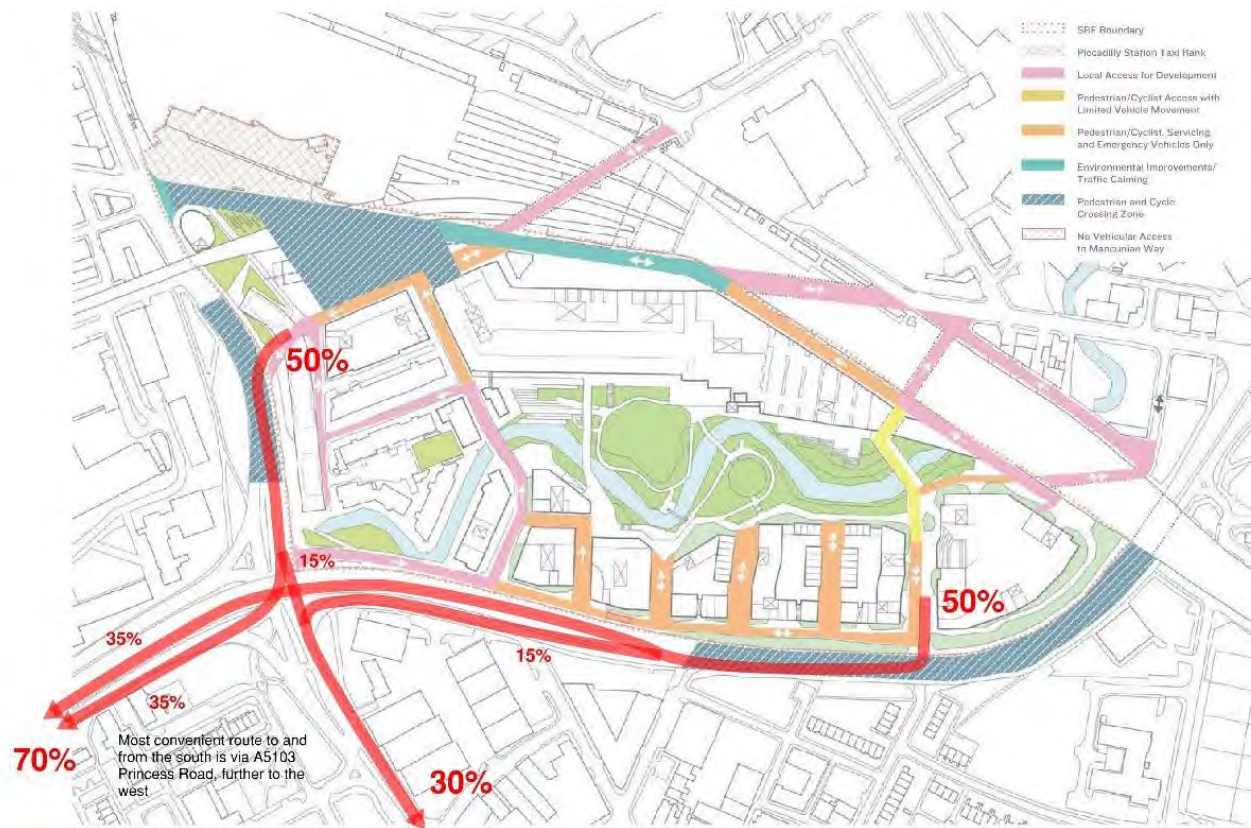
# ROUTING – TRAFFIC DEPARTING TO THE SOUTH

Trips departing to the south have been assigned a routing from the site egress points, shown previously.

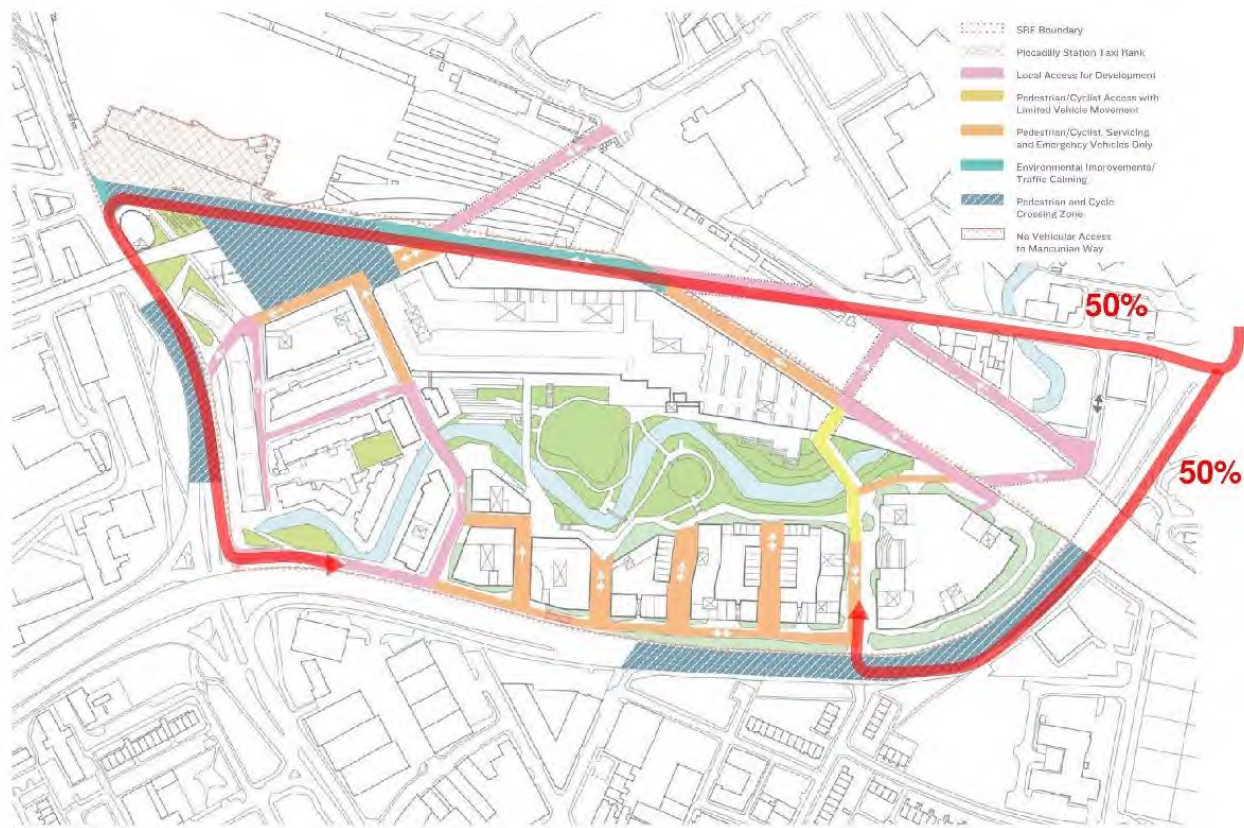
## ROUTING – TRAFFIC ARRIVING FROM THE EAST

Trips arriving from the east have been assigned a routing to the site access points, shown previously.

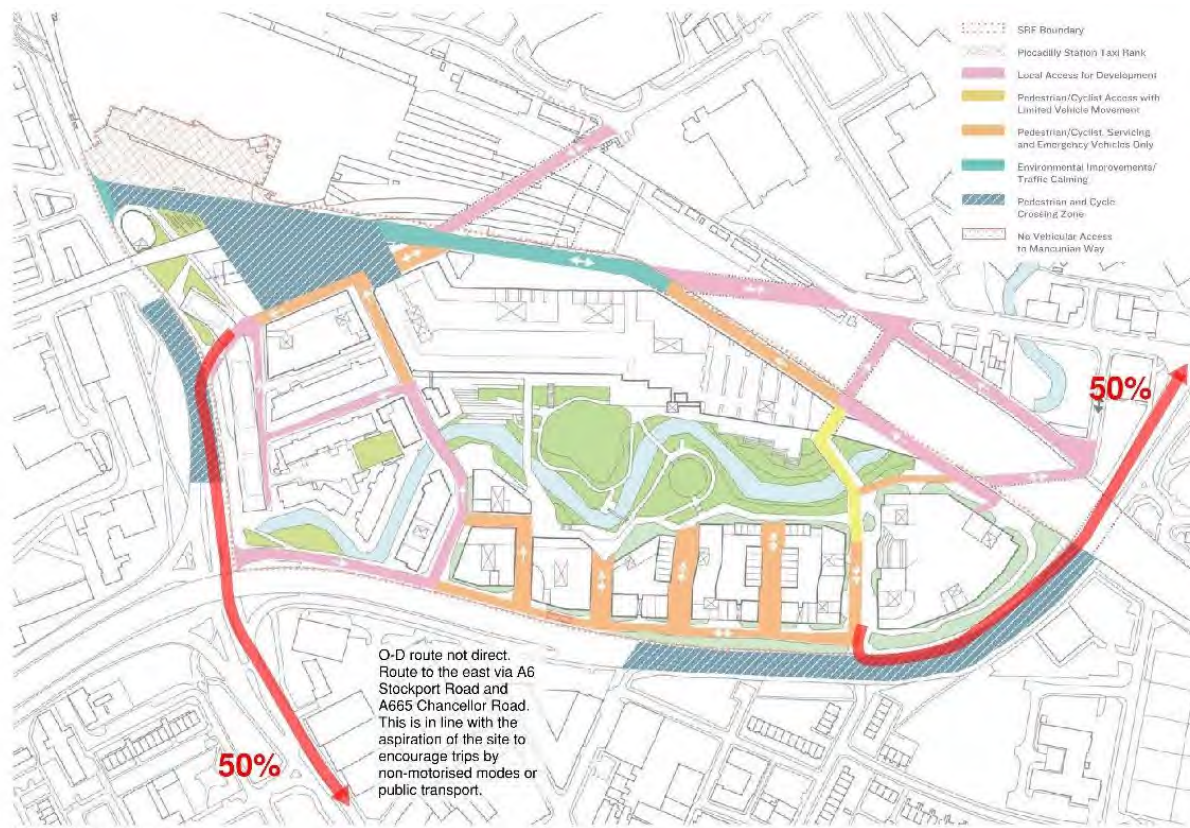
## ROUTING – TRAFFIC DEPARTING TO THE EAST

Trips departing to the east have been assigned a routing from the site egress points, shown previously.

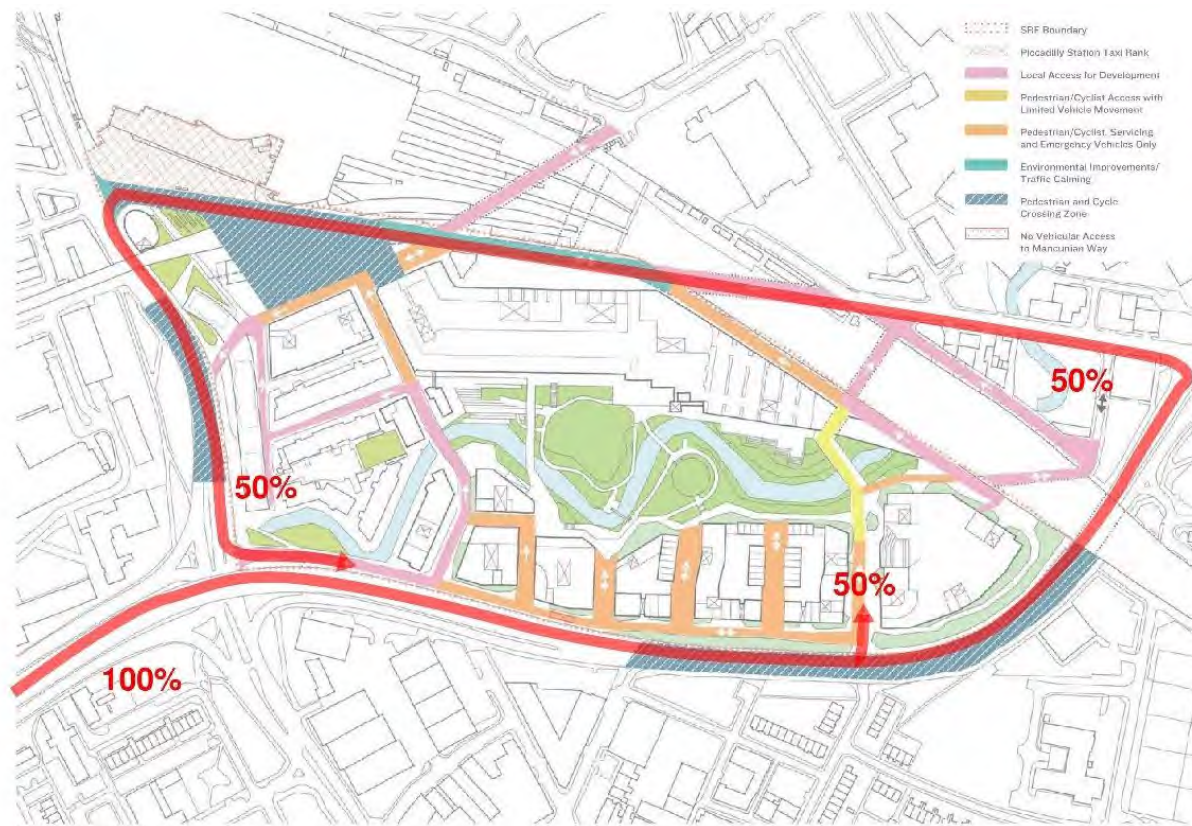
## ROUTING – TRAFFIC ARRIVING FROM THE WEST

Trips arriving from the west have been assigned a routing to the site access points, shown previously.

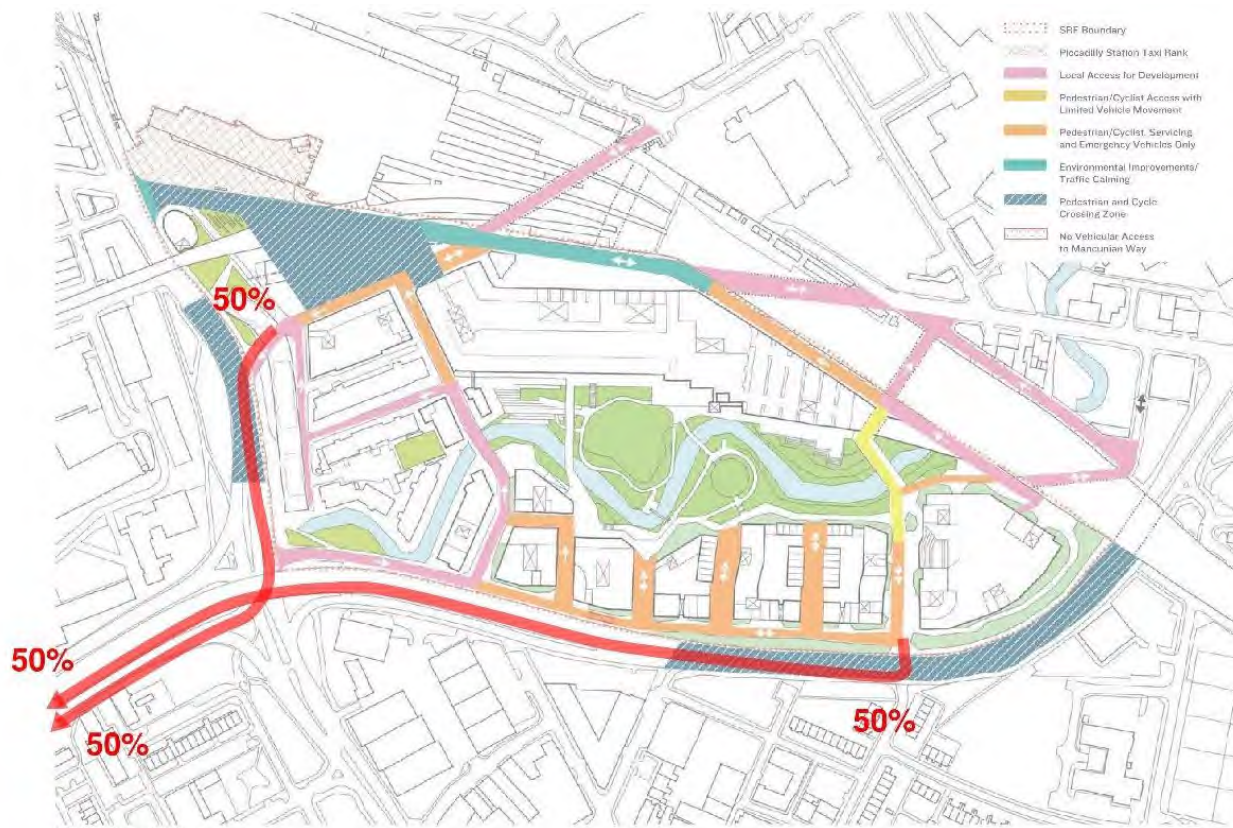
## ROUTING – TRAFFIC DEPARTING TO THE WEST

Trips departing to the west have been assigned a routing from the site egress points, shown previously.

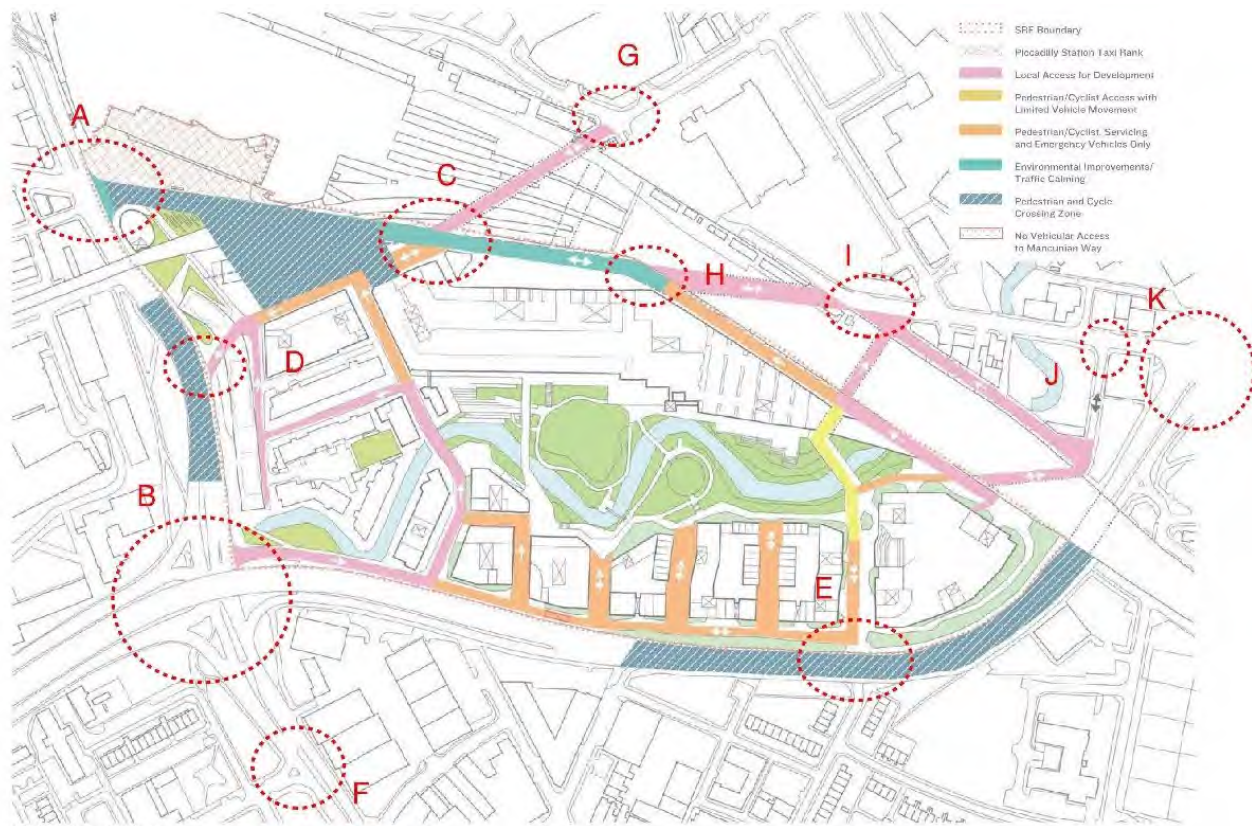
# LOCAL IMPACT JUNCTIONS

Trips generated by the development have been shown at the local junctions around the site, as shown in the figure.

The flow diagrams on the next sheets show the turns at each junction.

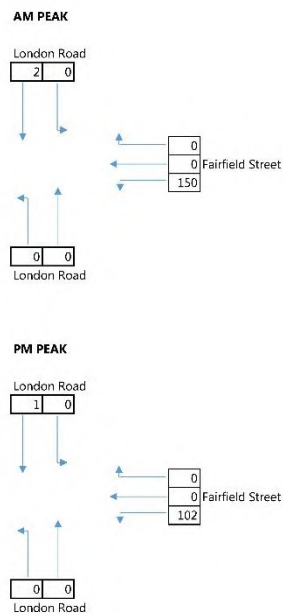
Junction A

# PEAK HOUR TURNING MOVEMENTS BY JUNCTION

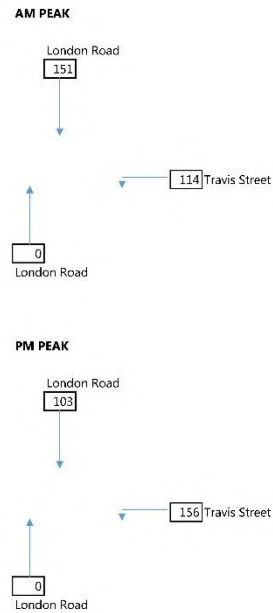
Junction D

# PEAK HOUR TURNING MOVEMENTS BY JUNCTION

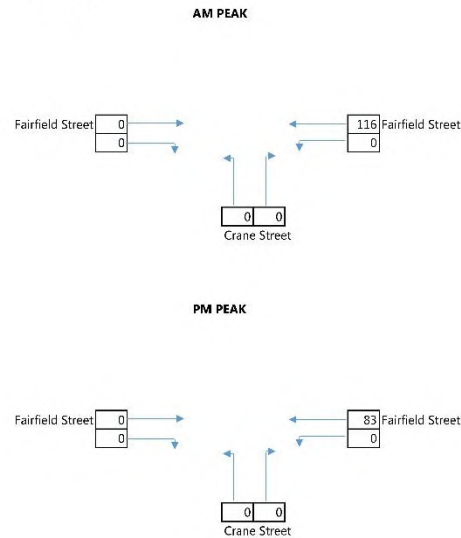
Junction J

# PEAK HOUR TURNING MOVEMENTS BY JUNCTION

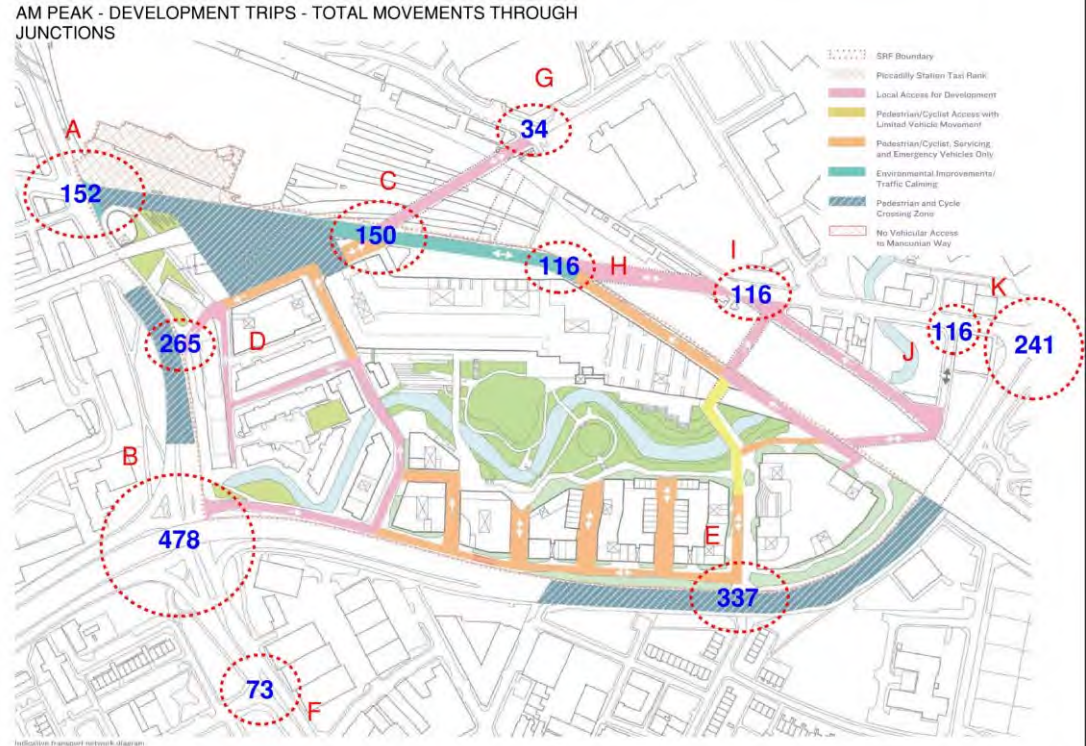
# PROPOSED SURVEY LOCATIONS

This Figure shows the total development trips generated that pass through the local impact junctions in the AM Peak.

This suggests that the proposed survey locations cover the key local impact junctions, reprovided on the next slide.

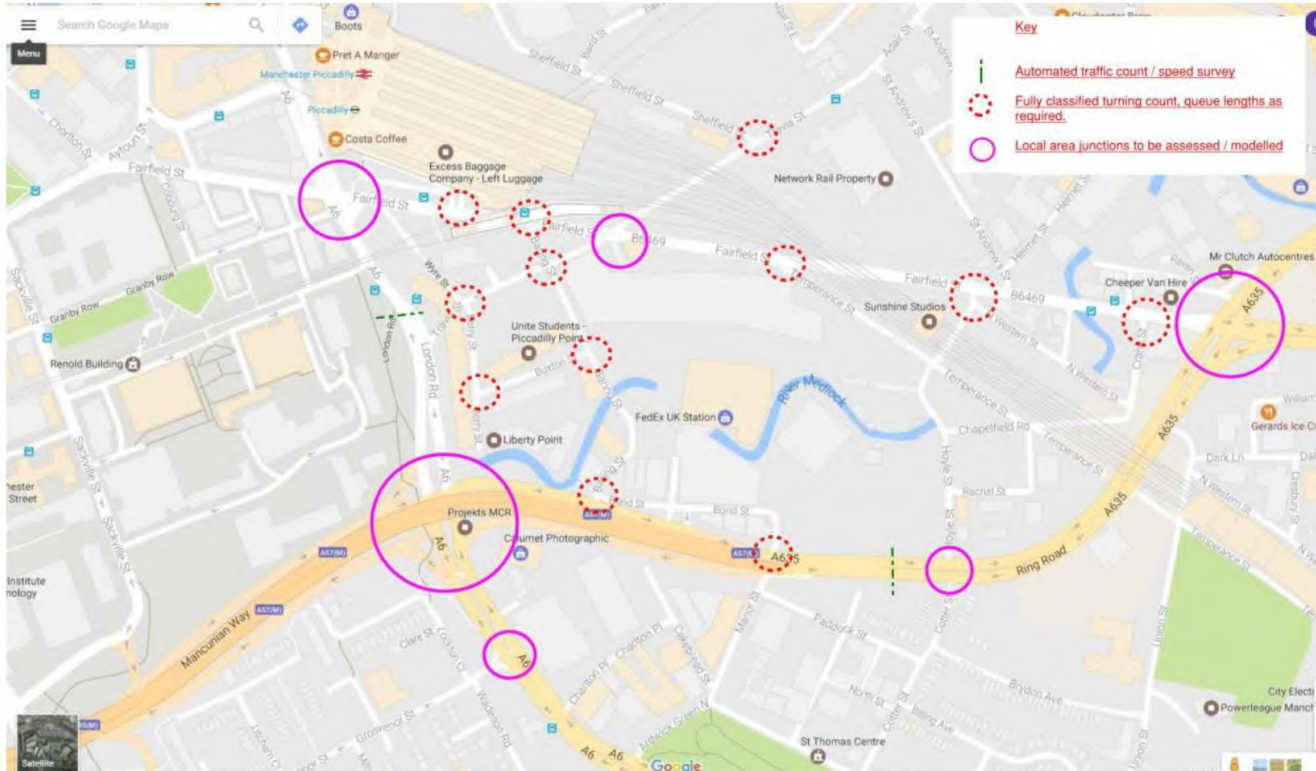
Figure 3 Proposed scope of traffic surveys

# PROPOSED SURVEY LOCATIONS – FROM SCOPING NOTE

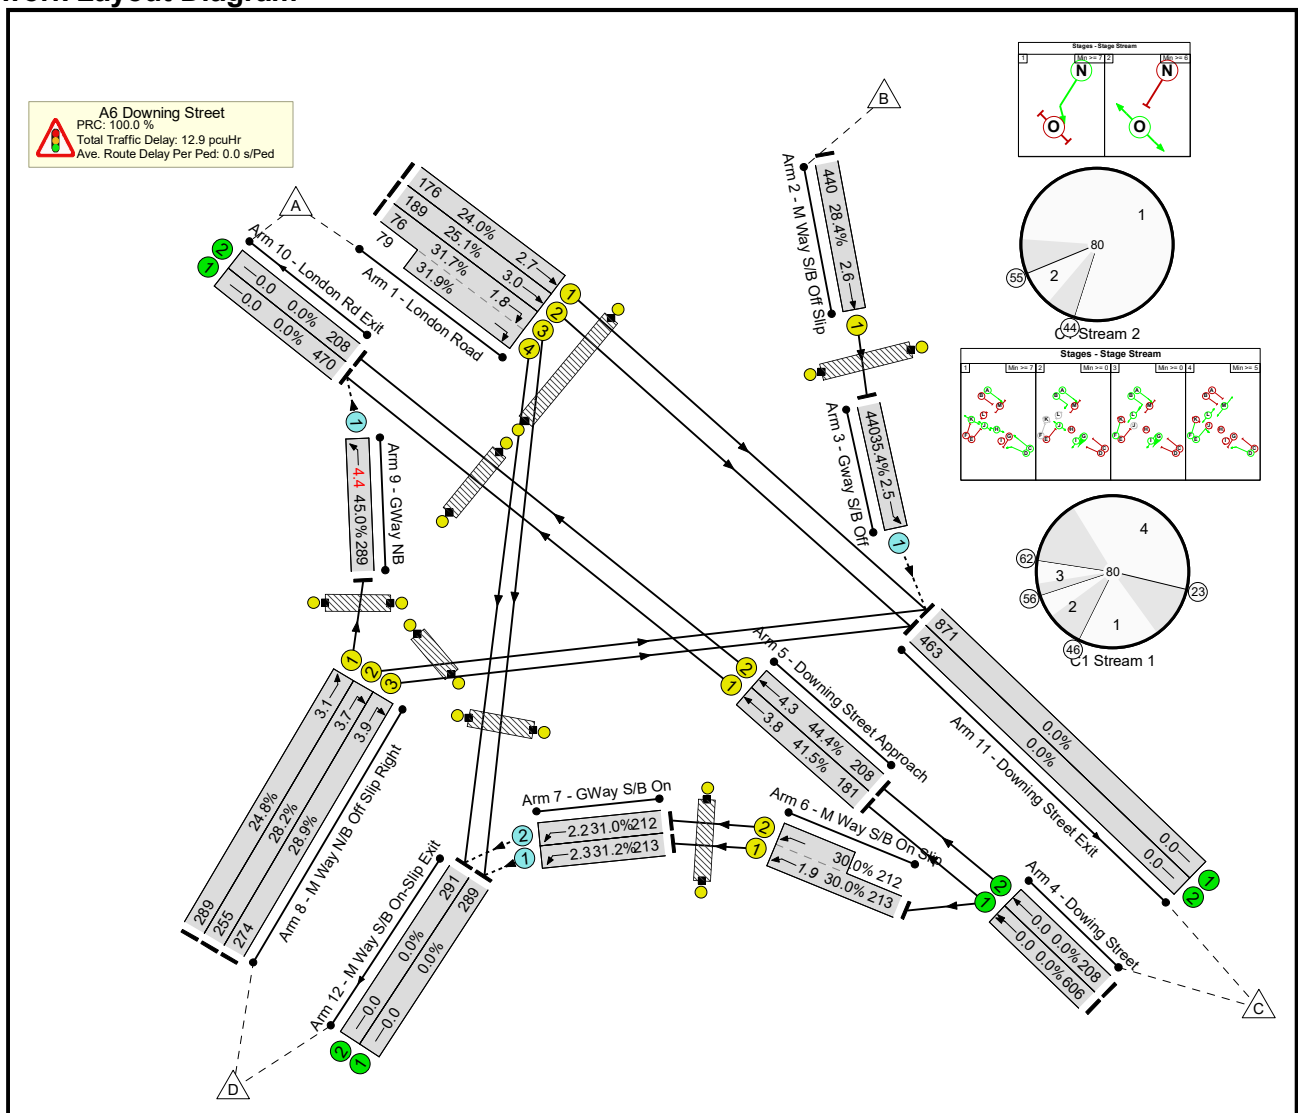
#### Network Layout Diagram

### Scenario 1: 'AM Base' (FG1: 'AM 2018 Baseline', Plan 1: 'Network Control Plan 1')

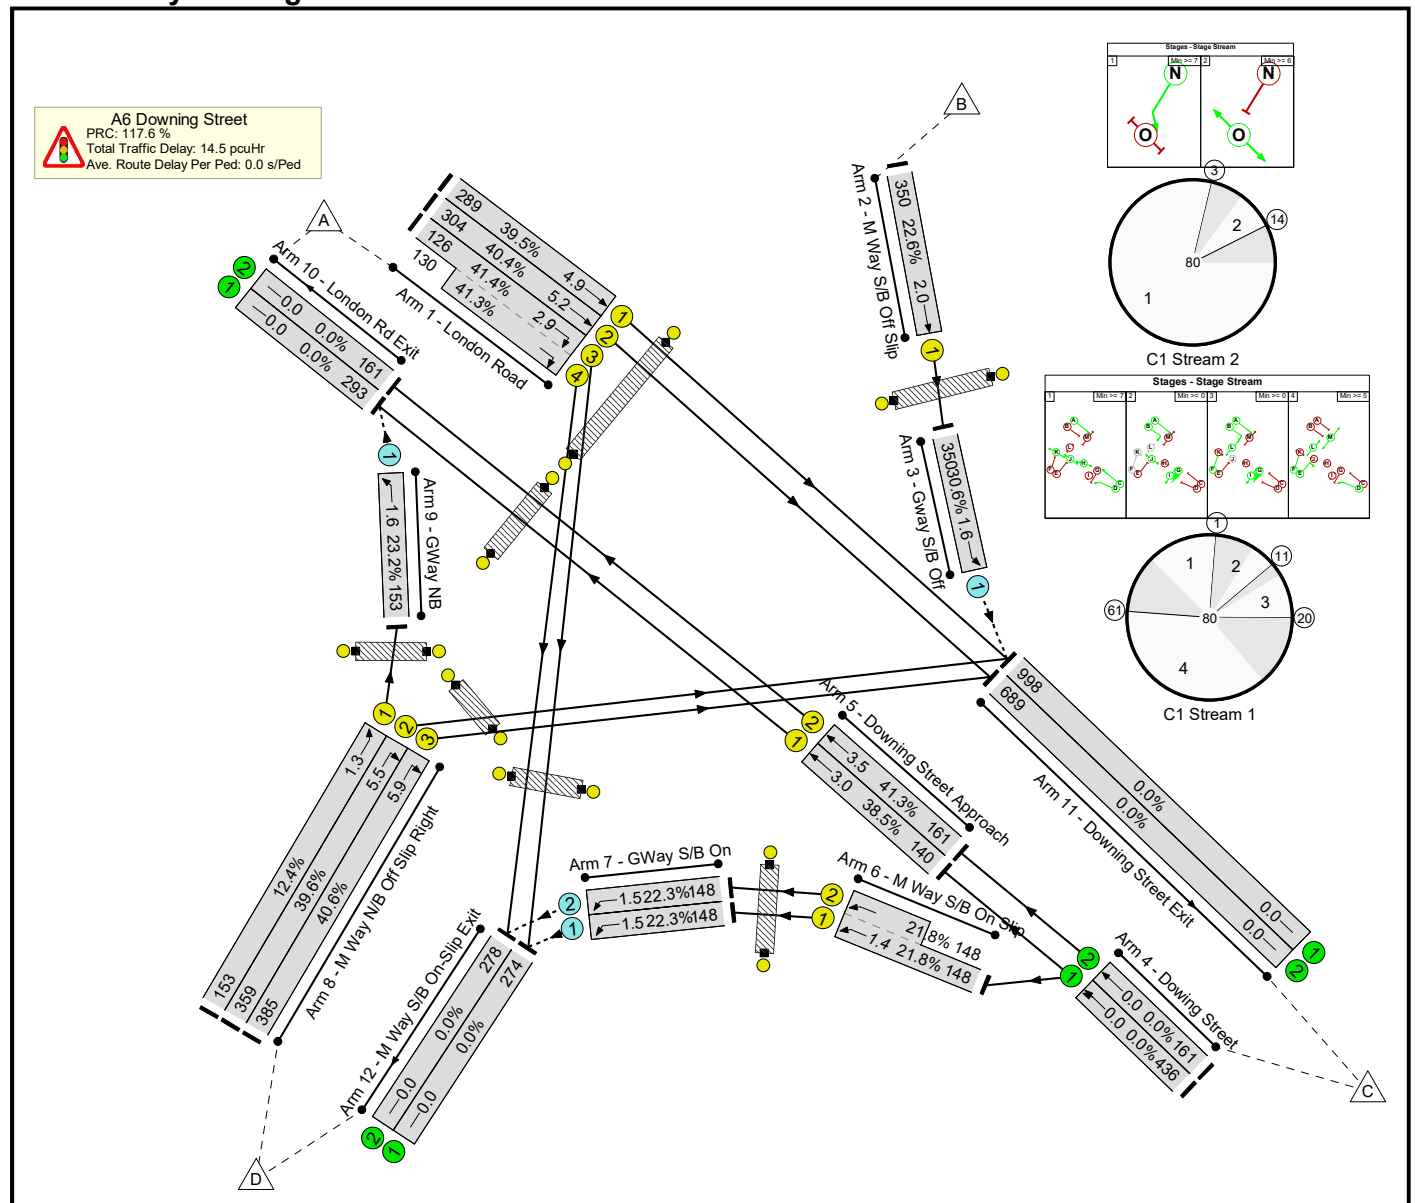
## Network Layout Diagram

**Scenario 2: 'PM Base'** (FG2: 'PM 2018 Baseline', Plan 1: 'Network Control Plan 1')

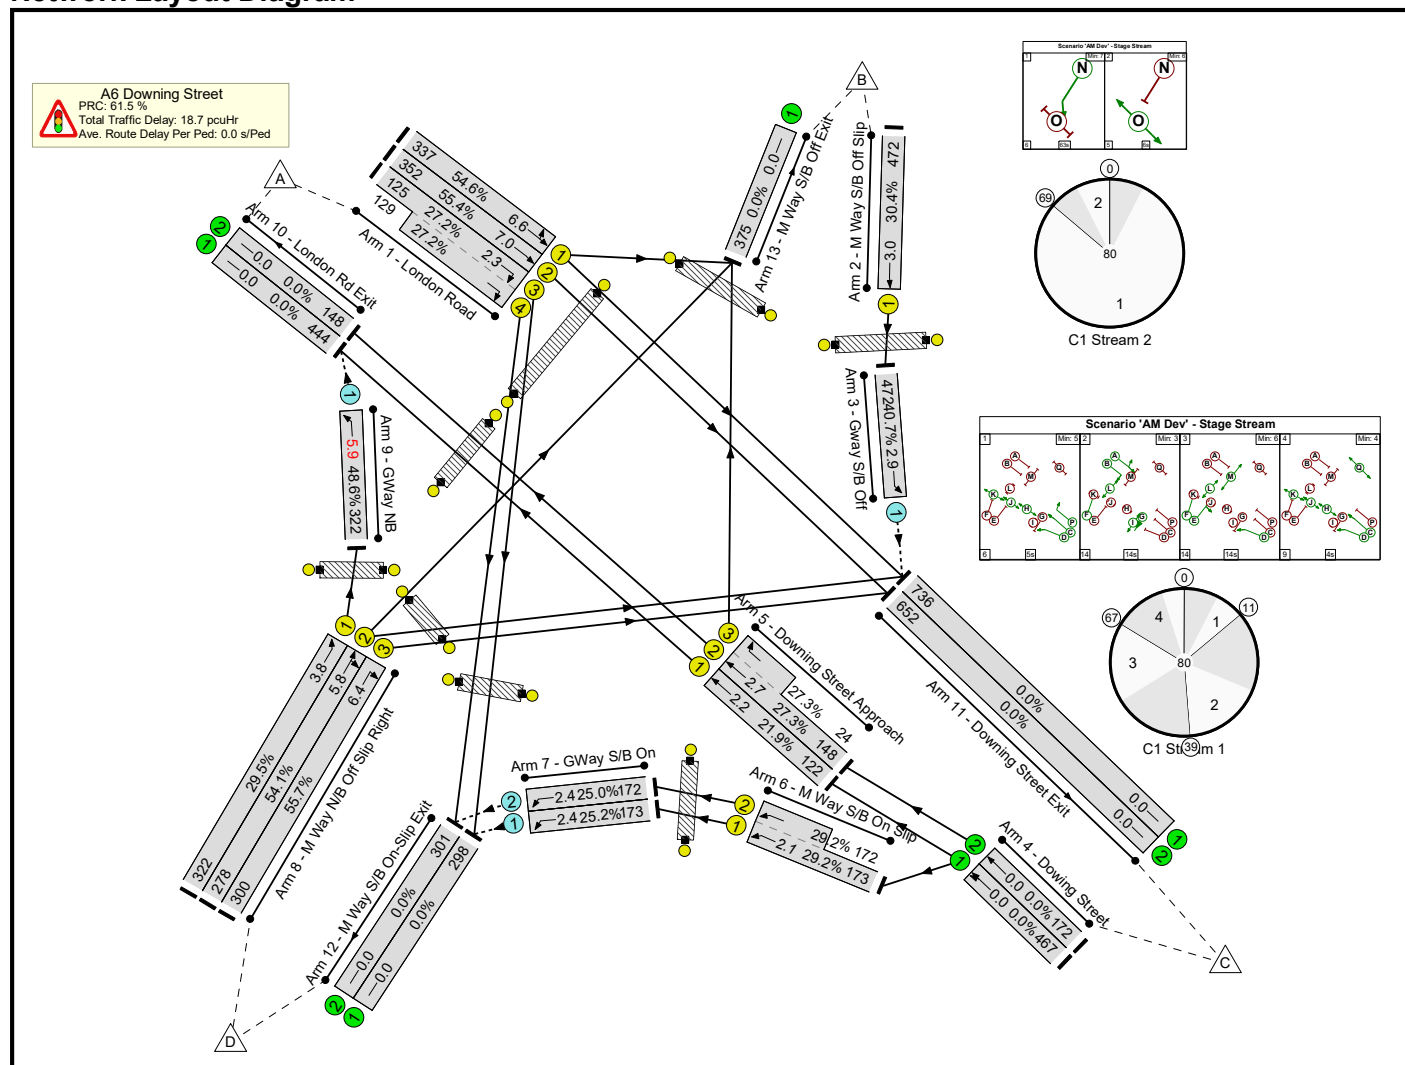
#### Network Layout Diagram

### Scenario 1: 'AM Dev' (FG1: '2030 AM With Dev (TFGM Paramics flow)', Plan 1: 'Network Control Plan 1')

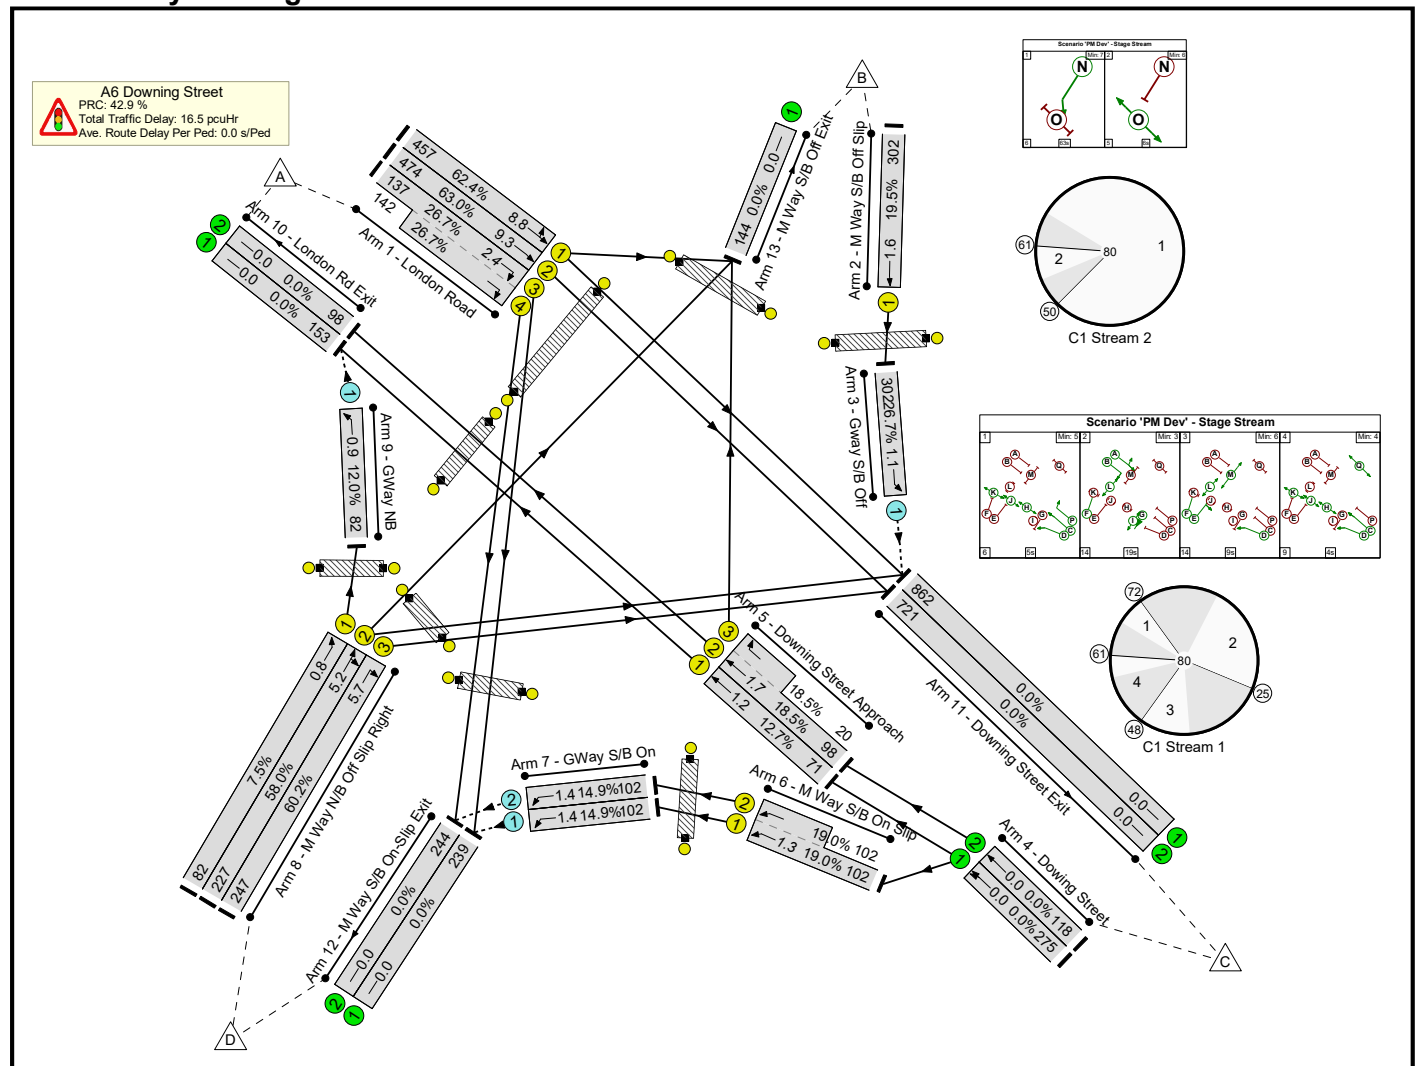
## Network Layout Diagram

**Scenario 2: 'PM Dev'** (FG2: '2030 PM With Dev (TFGM Paramics flows)', Plan 1: 'Network Control Plan 1')
