**Mayfield, Phase 1**  
EIA Volume 2

September 2019

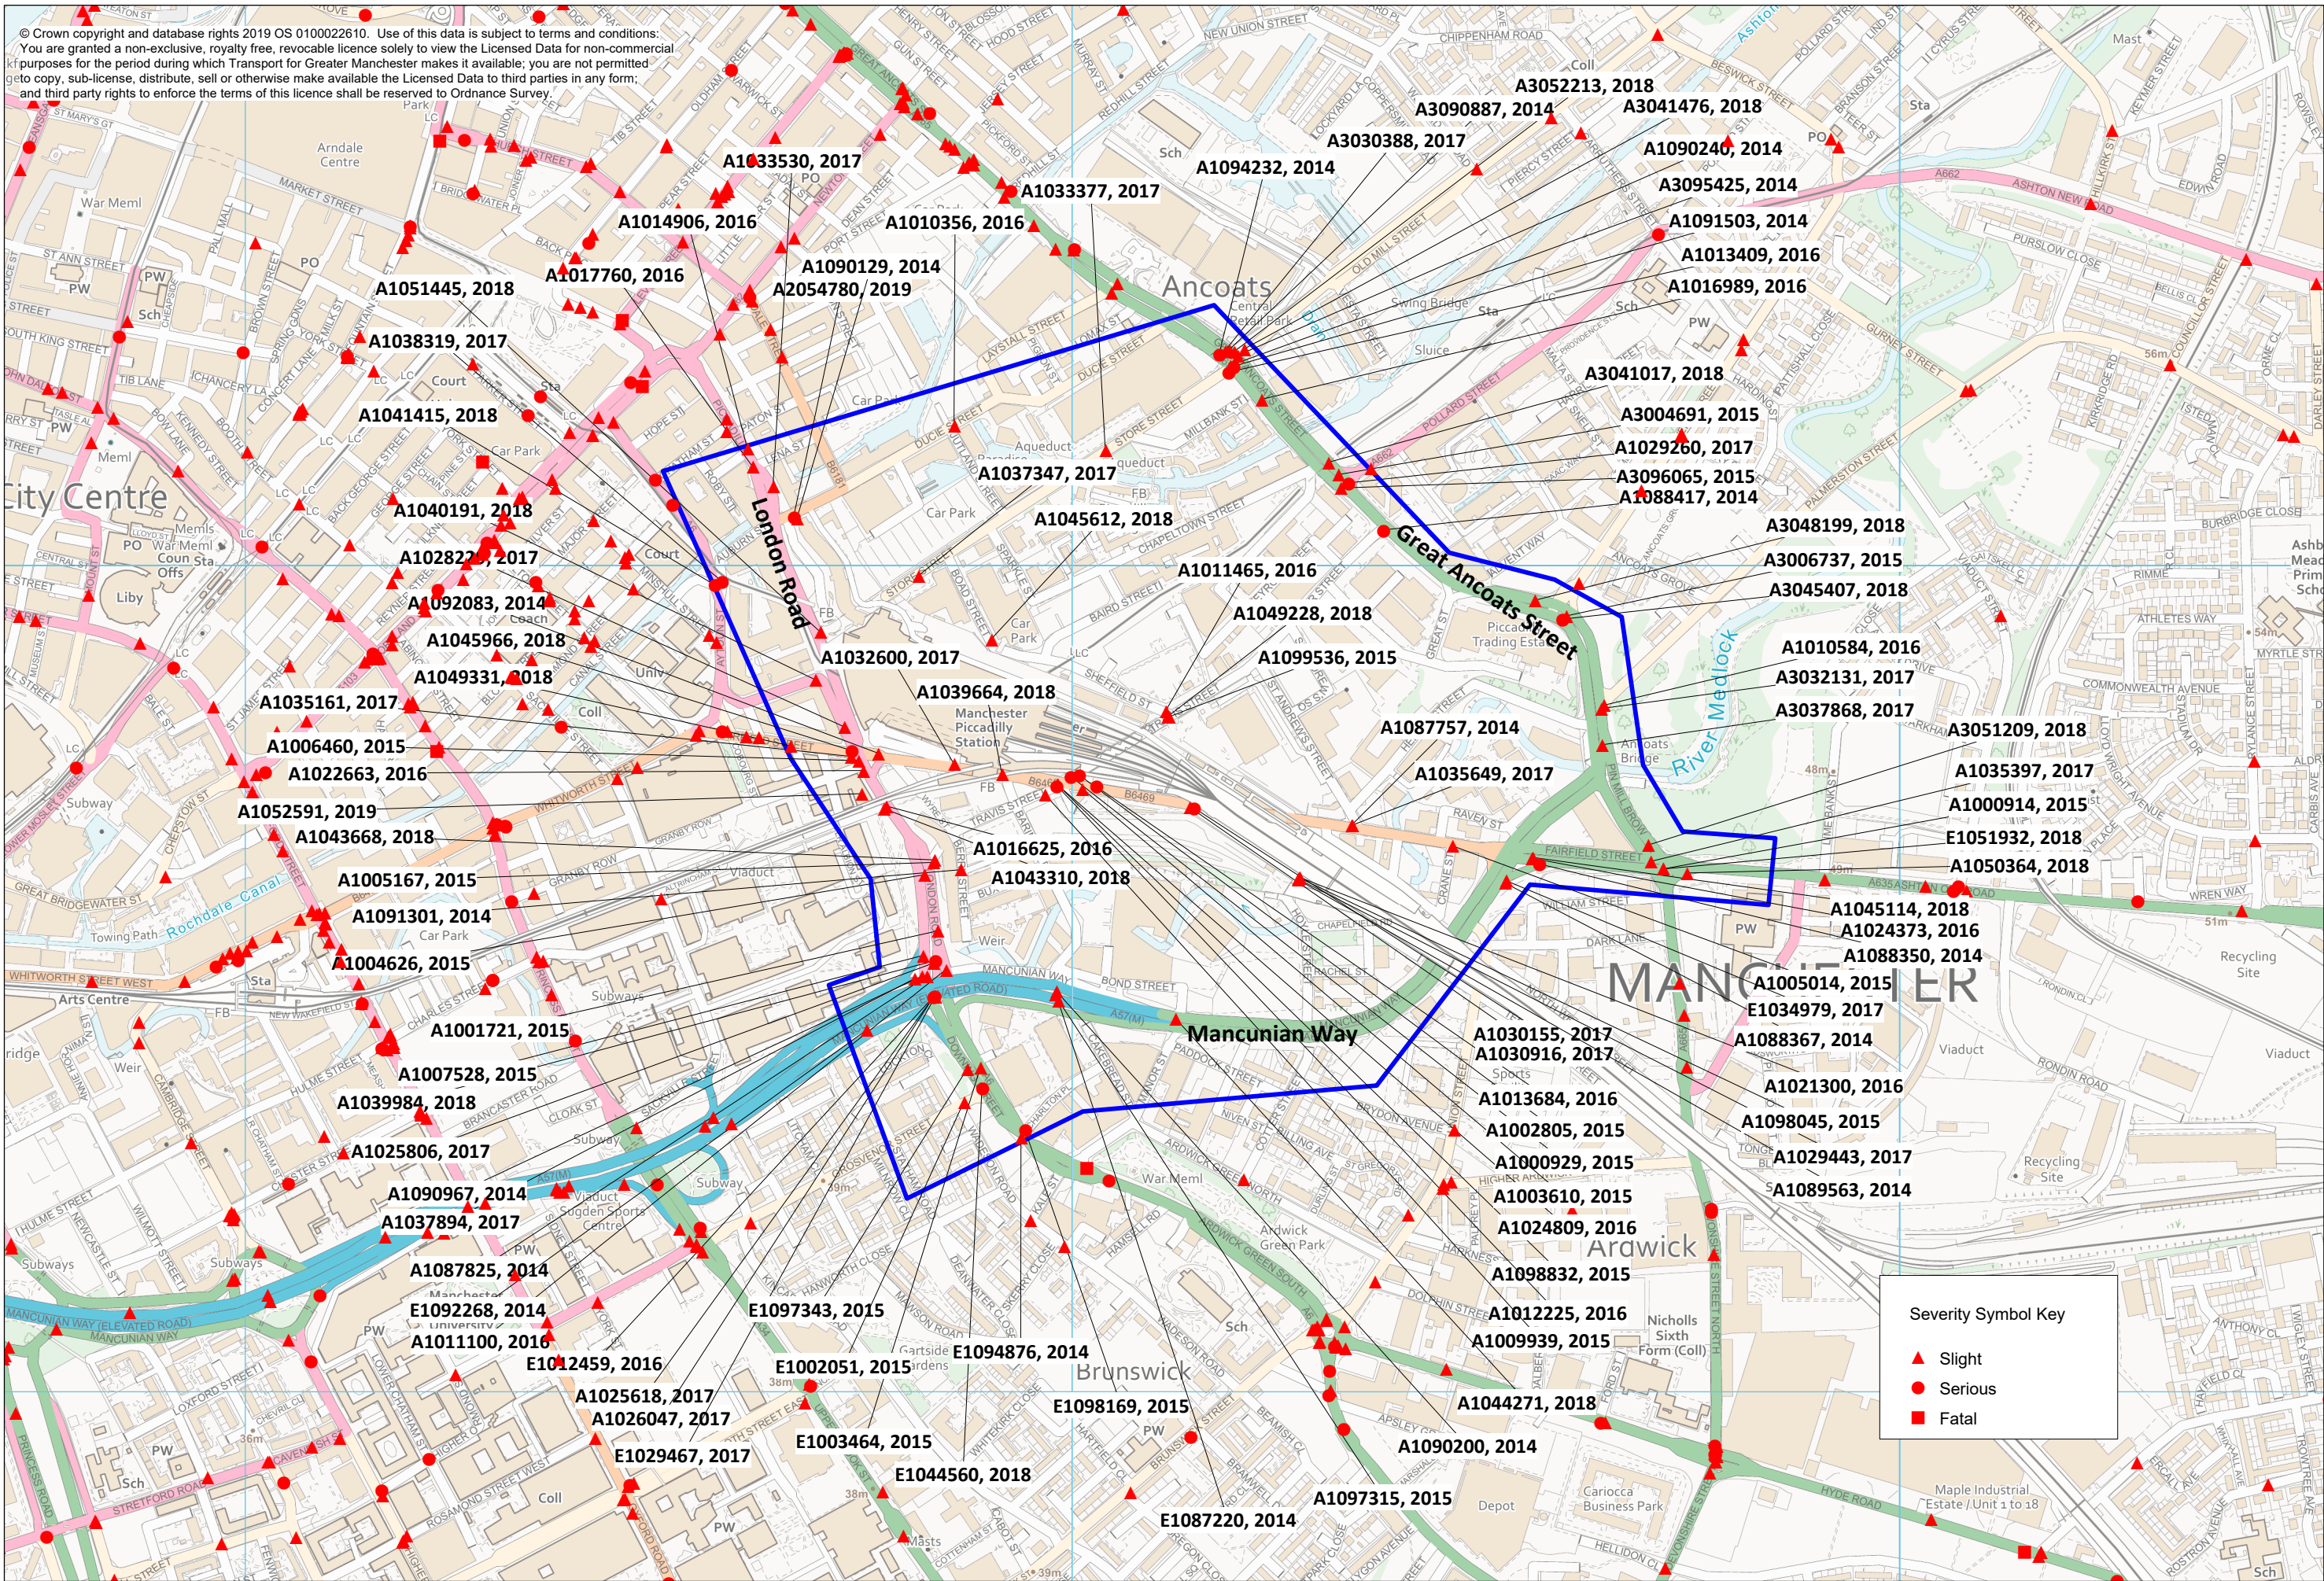
**Reported Road Injury Accidents in Specified Area of Manchester City  
Centre, Manchester.  
01/05/2014 to 30/04/2019**

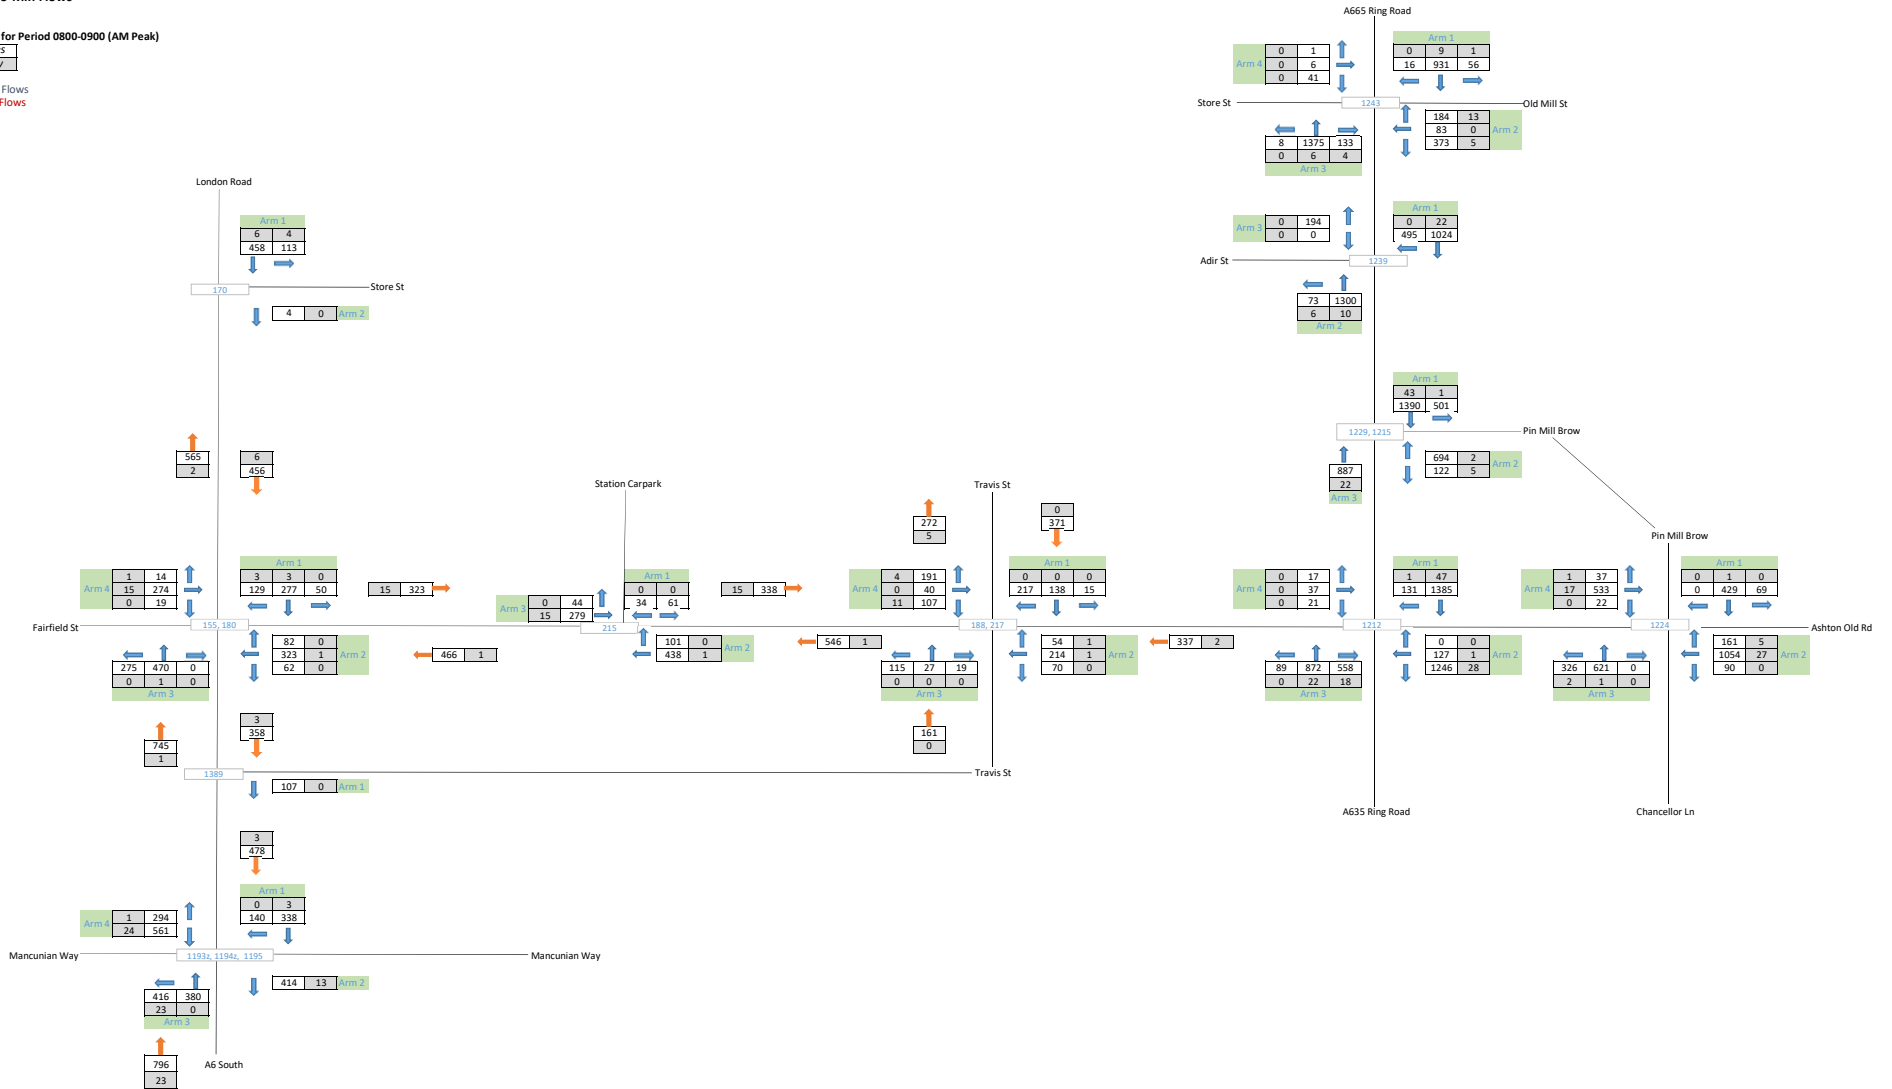
## 2023 AM Do-Min Flows

Key:  
Model Flows for Period 0800-0900 (AM Peak)

1. All Vehicles  
2. HGVs only

→ Turn Flows  
→ Link Flows

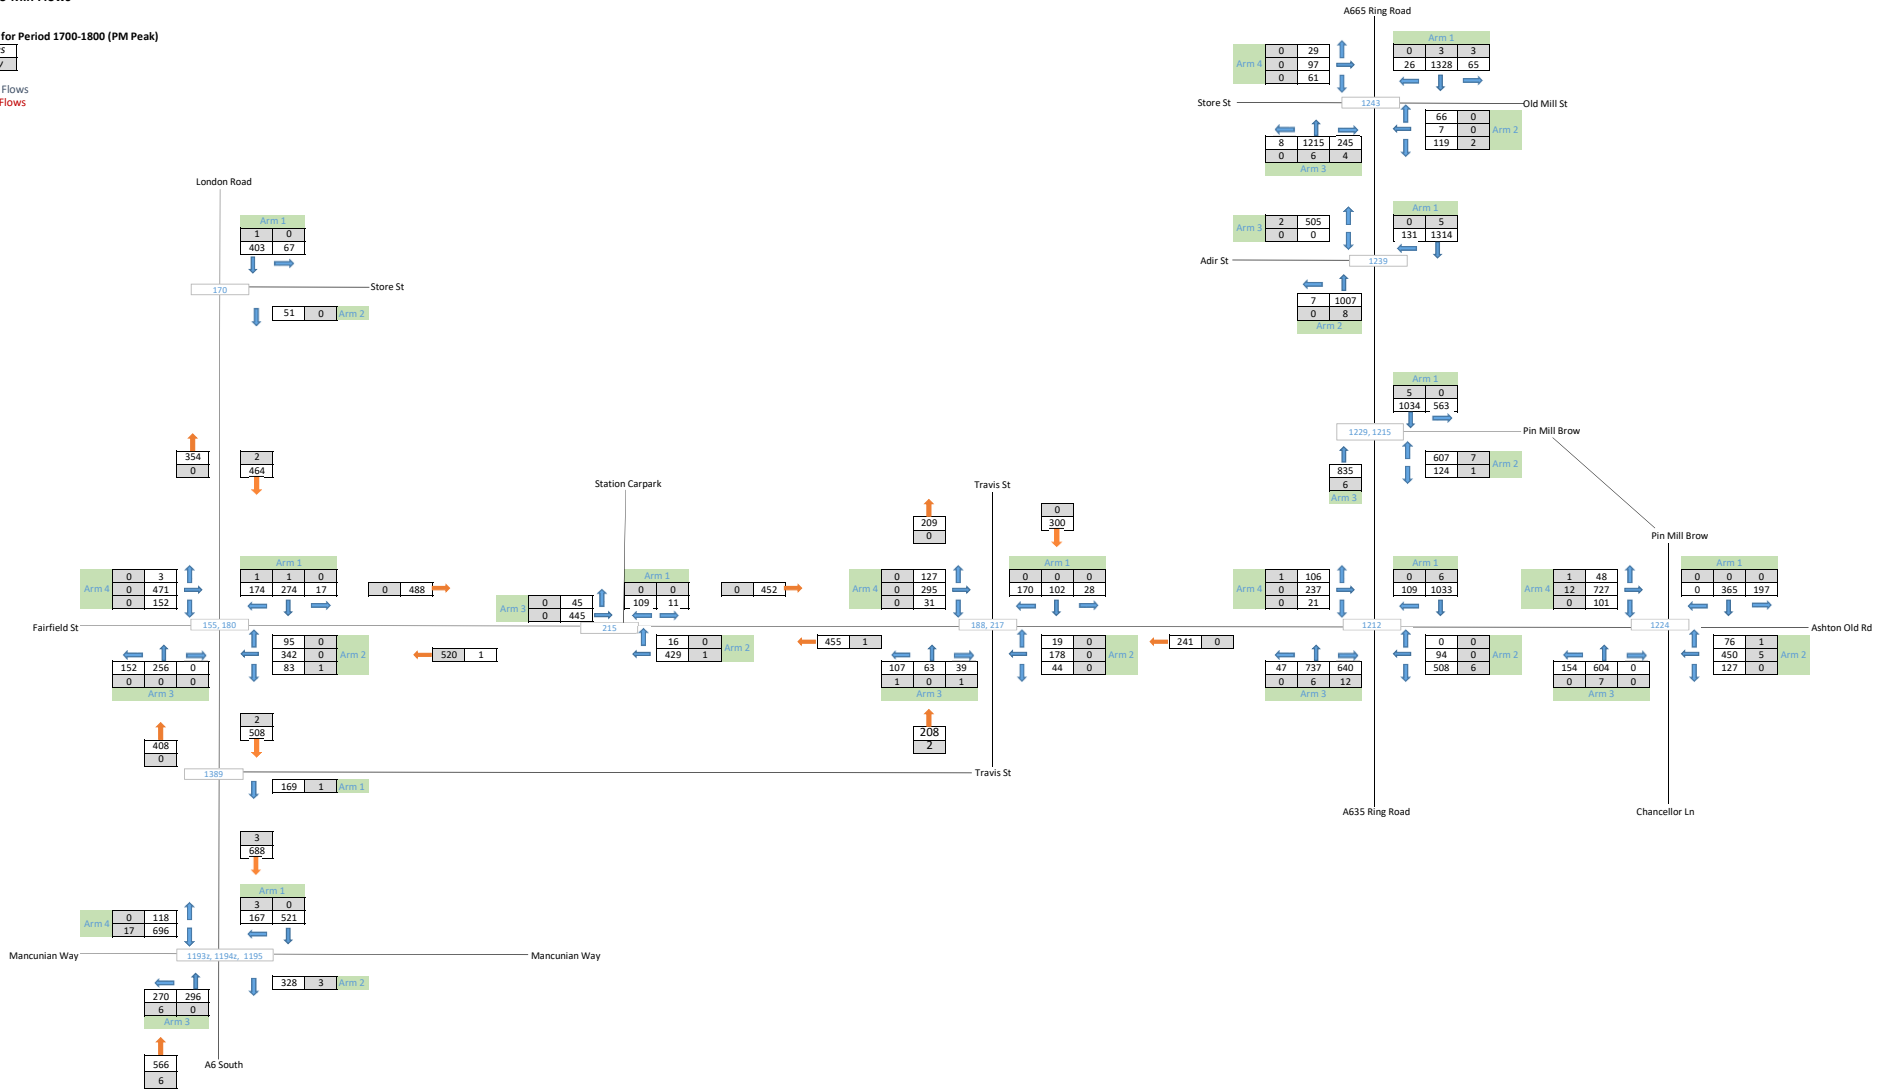
## 2023 PM Do-Min Flows

Key:  
Model Flows for Period 1700-1800 (PM Peak)

1. All Vehicles  
2. HGVs only

→ Turn Flows  
→ Link Flows

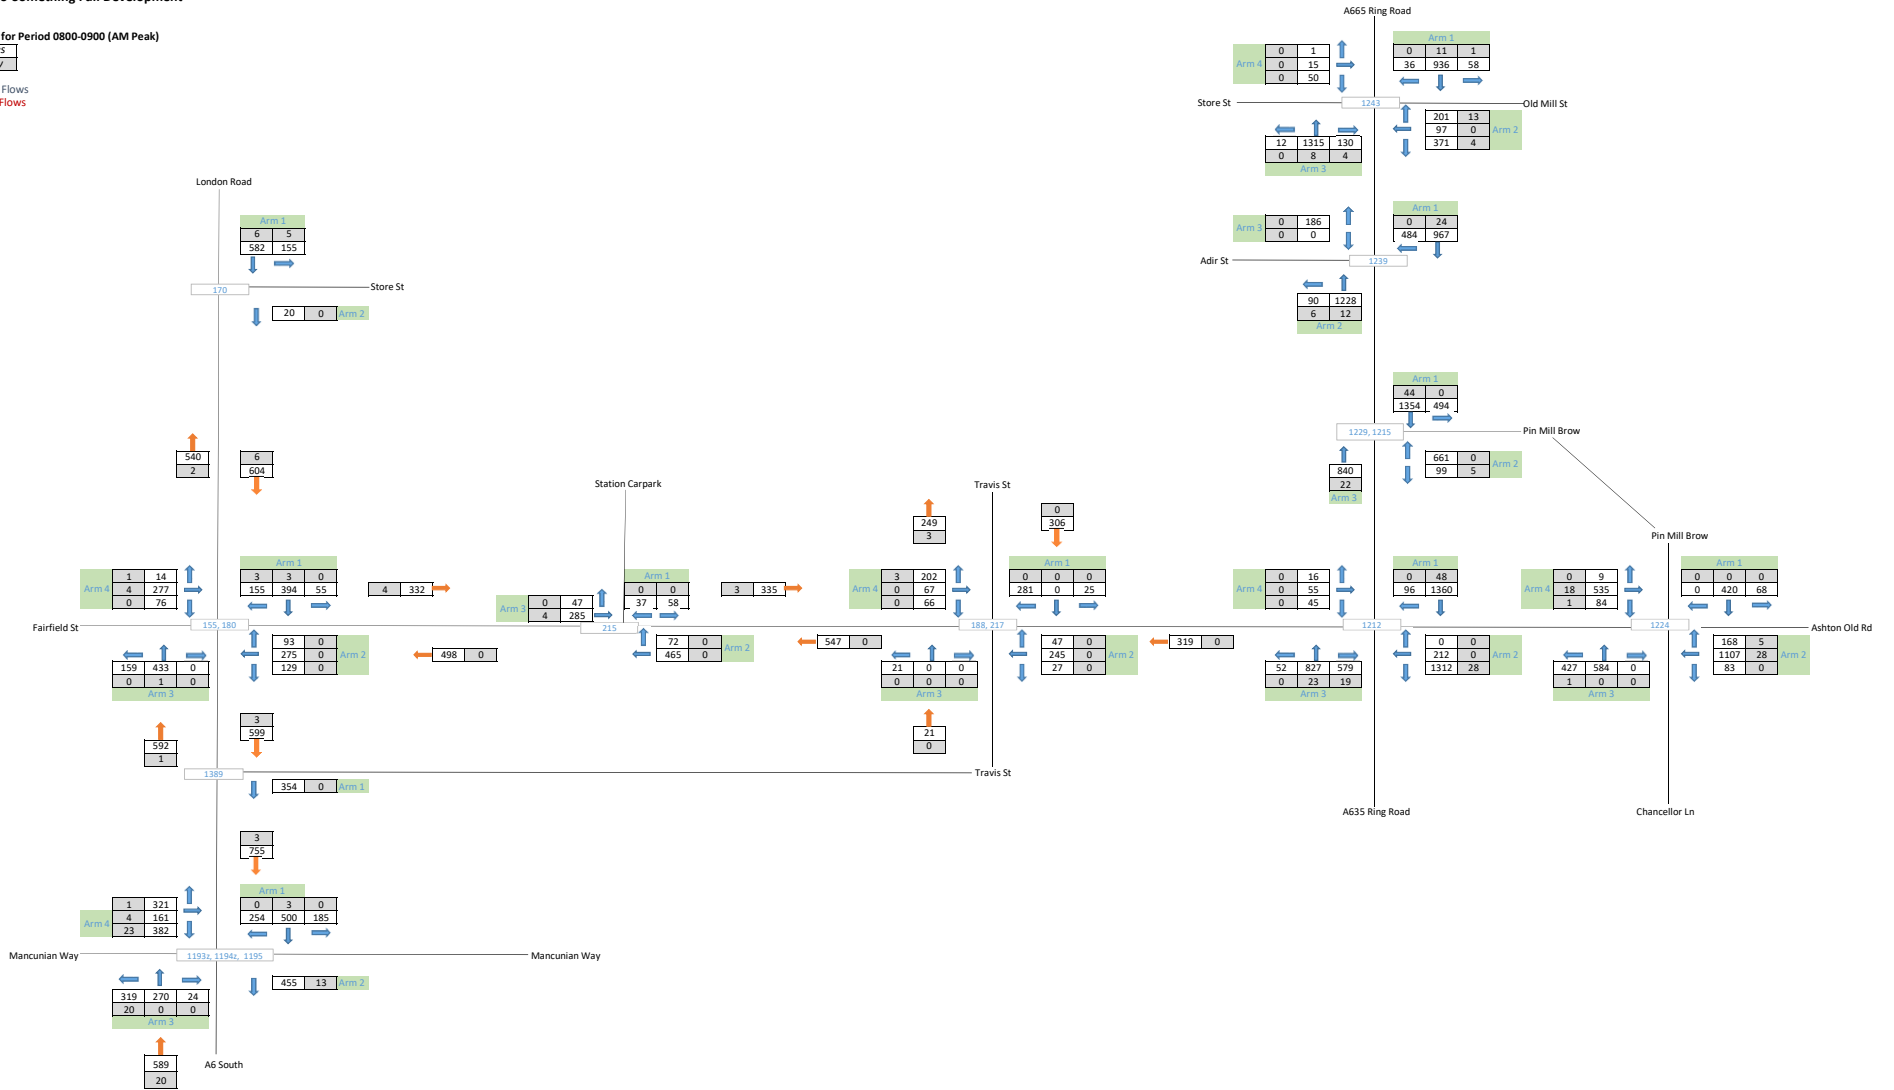
# 2030 AM Do-Something Full Development

Key:  
Model Flows for Period 0800-0900 (AM Peak)  
1. All Vehicles  
2. HGVs only

→ Turn Flows  
→ Link Flows

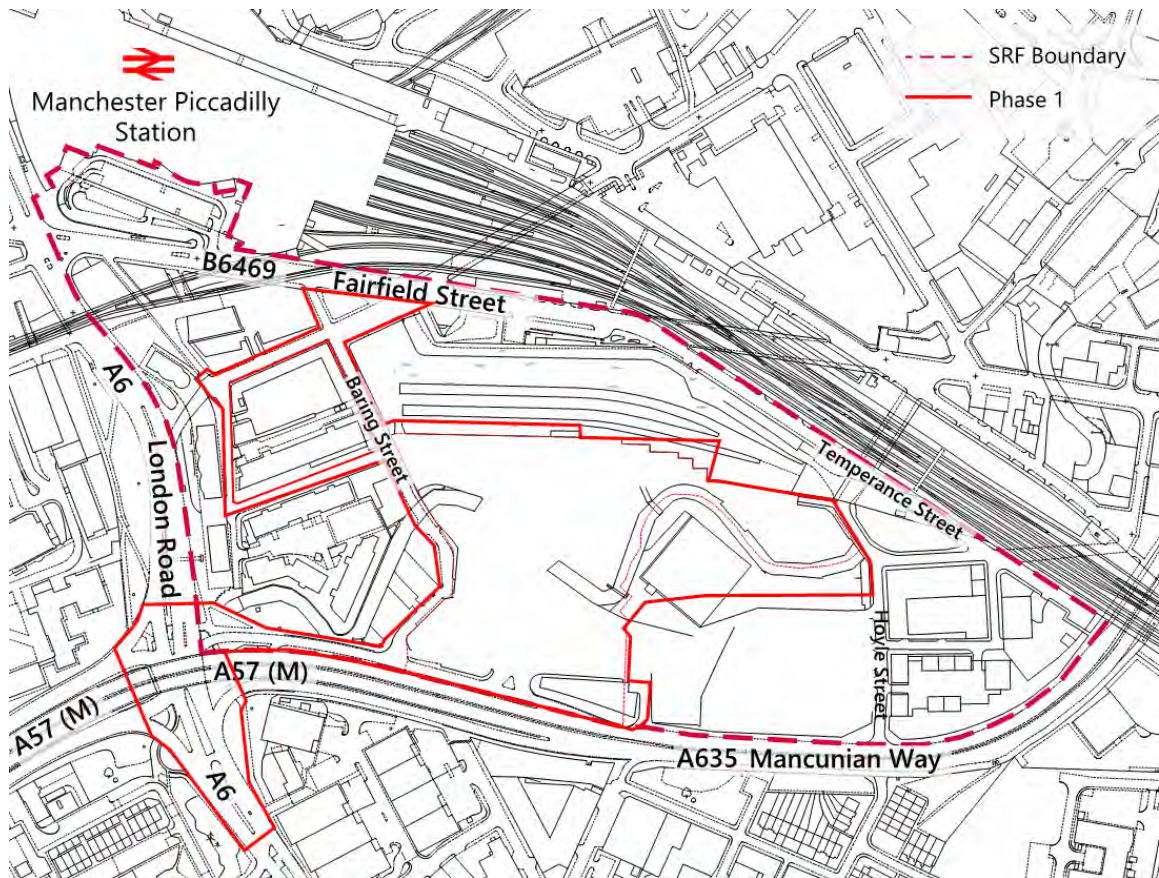
**Figure 1.1 Site Location**

- 1.1.5 Figure 1.1 shows the location of the wider SRF together with Phase 1 within the existing local context.

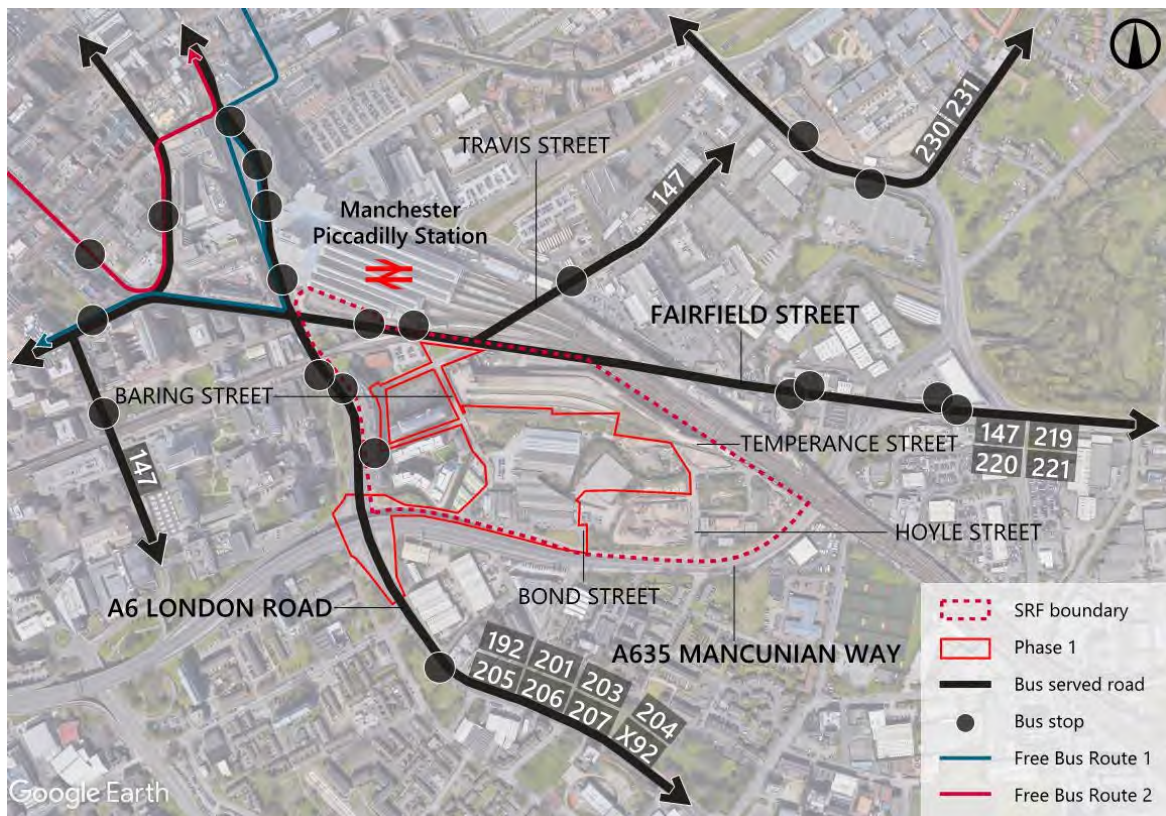
Figure 3.1: Local bus stops and bus routes

3.2.1 The Site is well connected by bus, with 12 bus routes available within a 400m (5-minute) walk from the Site. The location of the existing bus services operating in close proximity to the Site are shown in Figure 3.1.

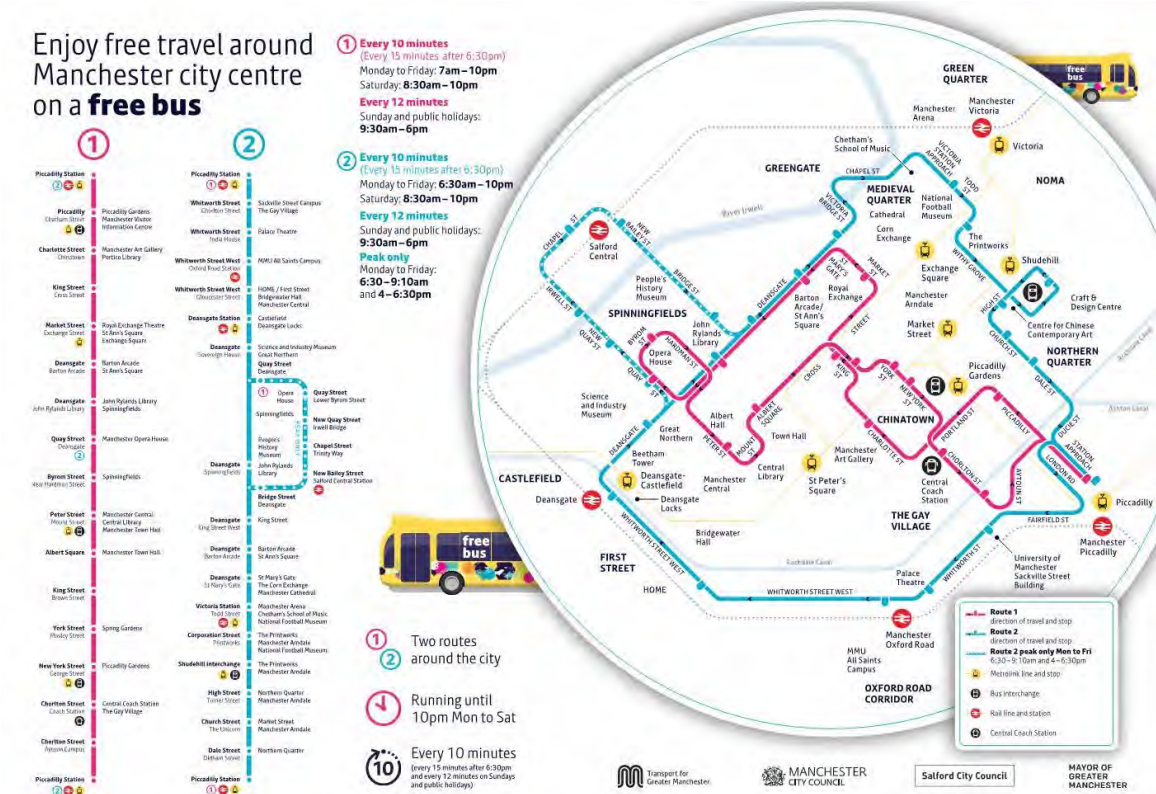
Figure 3.2: Free bus service in Manchester City (Source: TfGM)

3.2.3 There is also a Free Bus service (formerly known as the Metroshuttle), which links the city's train stations, shops and businesses. There are two routes providing a wide-range of connectivity around Manchester city centre as shown on Figure 3.2. The frequency of these two routes is summarised in Table 3.2.

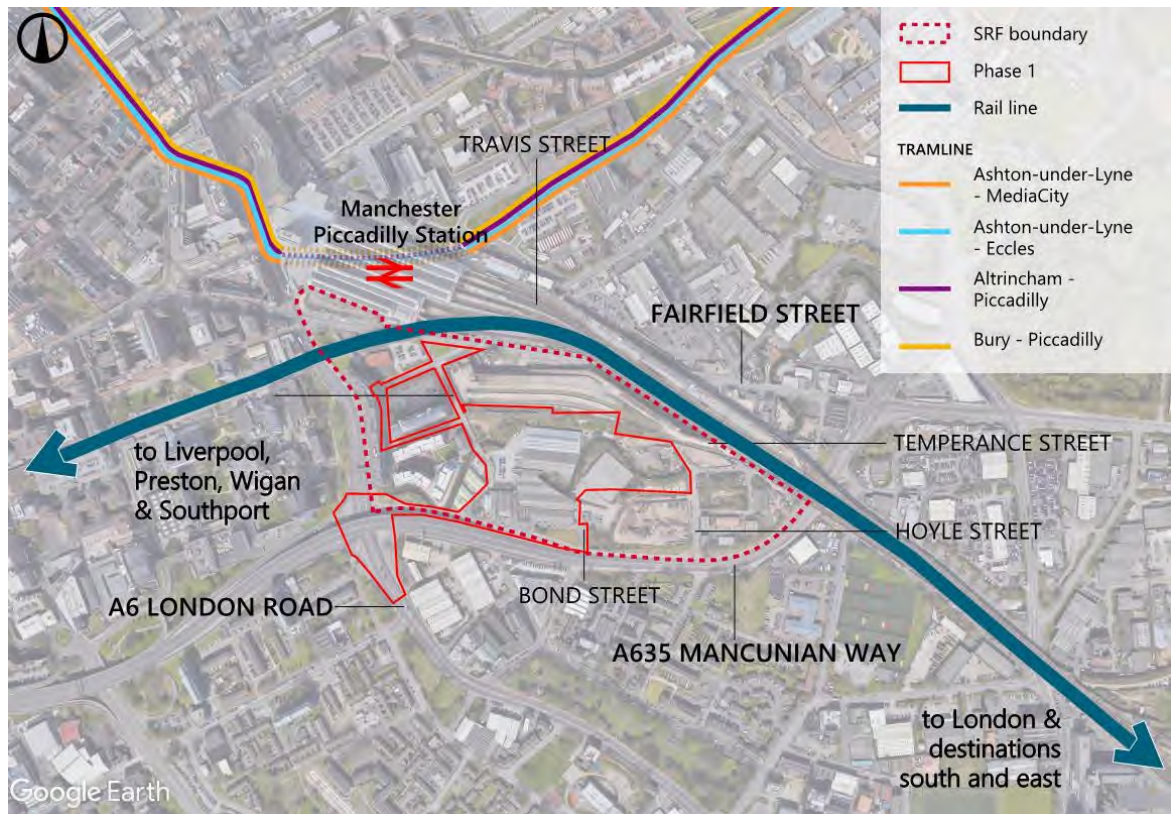
Figure 3.3 Local rail and tram network

3.2.7 The local rail and tramline network is illustrated in Figure 3.3.

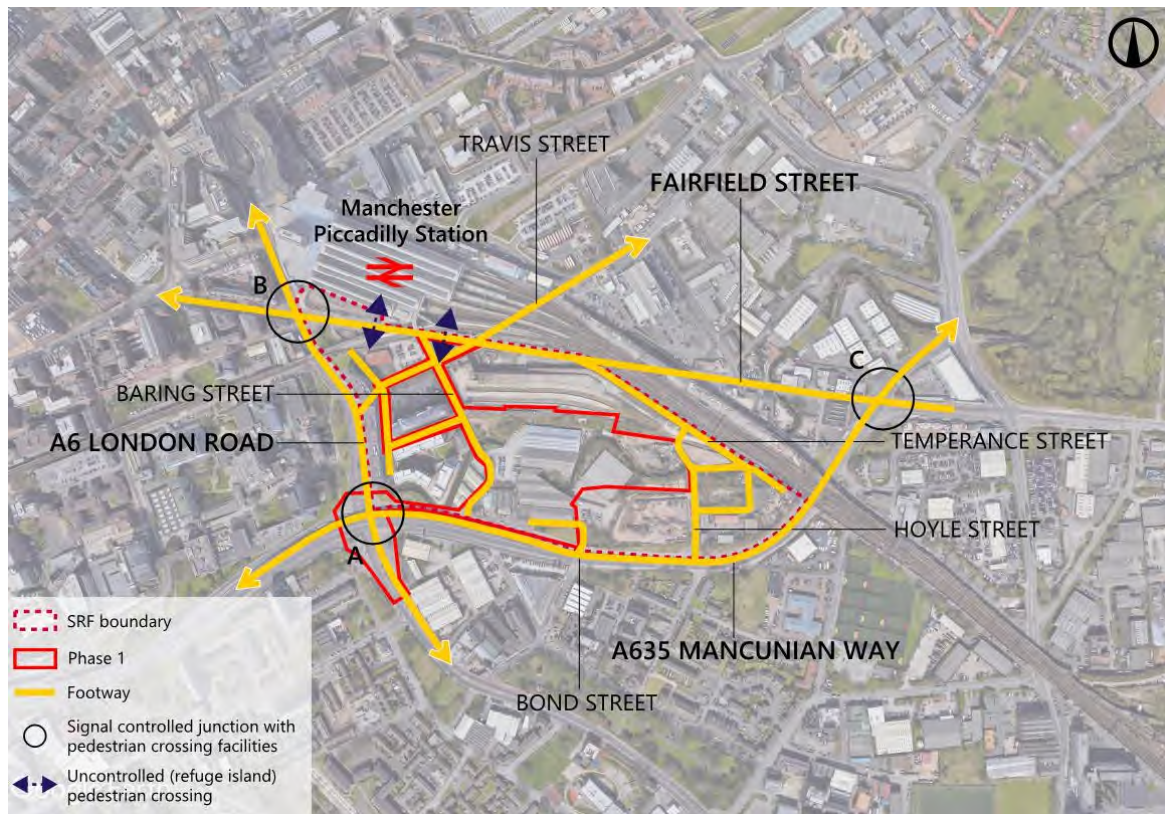
**Figure 3.4 Pedestrian Infrastructure Surrounding the Site**

- 3.3.1 There is extensive provision of pedestrian footways within and around the wider SRF site, as illustrated on Figure 3.4.

- 3.3.3 There are signal controlled pedestrian crossings provided at the A6 London Road/Fairfield Street signal junction and the junction with A635 Mancunian Way approximately 320 metres further south. Figure 3.5 illustrates the type of pedestrian signal crossings available for each of the three main junctions referenced in Figure 3.4.

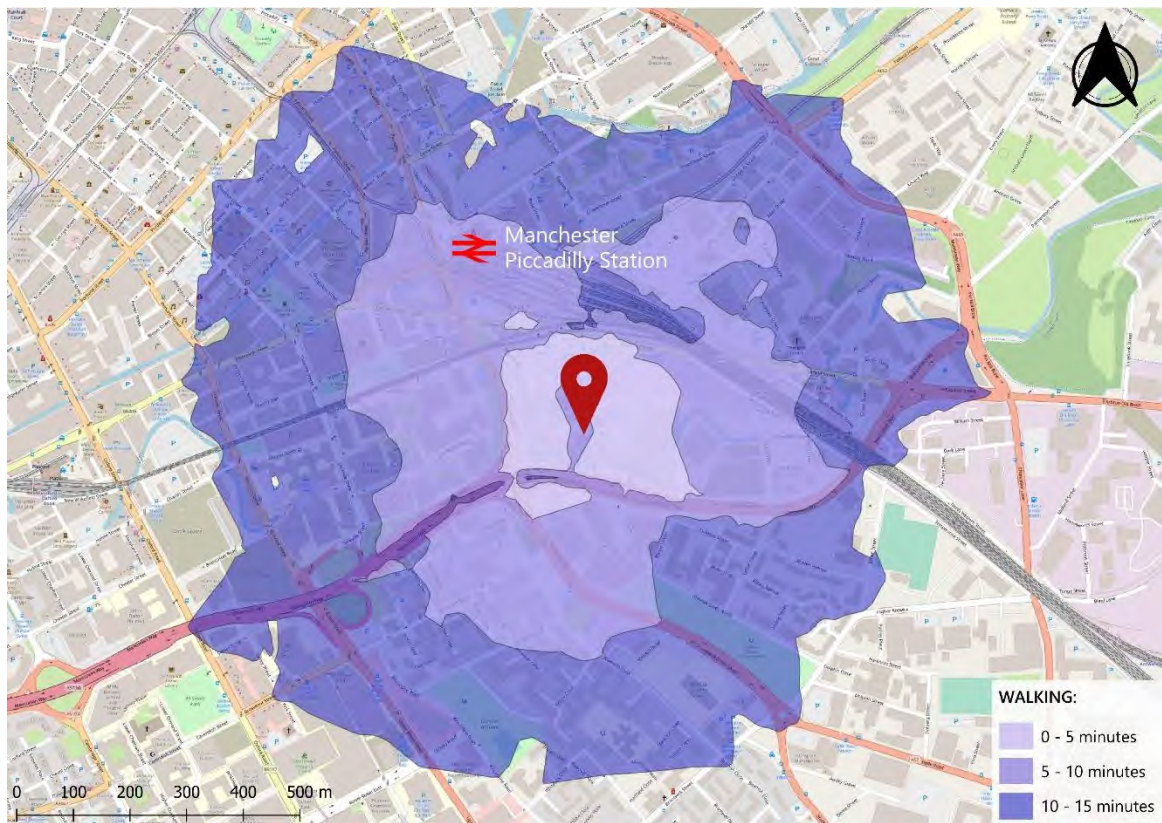
**Figure 3.6 Walking Accessibility**

- 3.3.7 Figure 3.6 shows the walking accessibility for the Site in 5, 10 and 15 minute walk catchments.

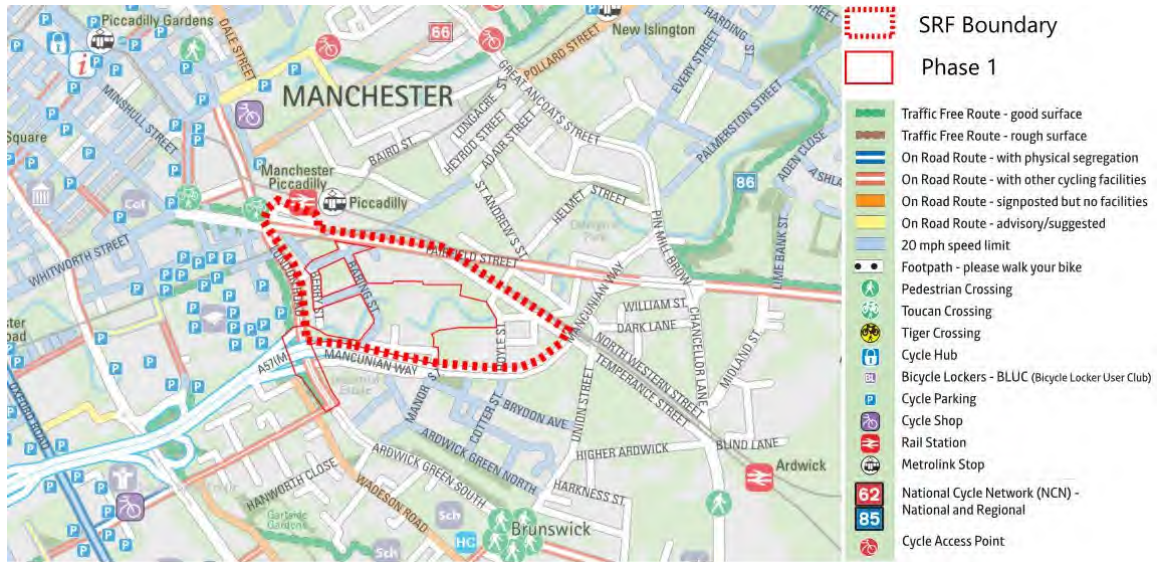
**Figure 3.7: Cycle Routes in the vicinity of the Site (Source: Manchester City Council)**

3.4.6 Figure 3.7 illustrates the cycle routes surrounding the SRF boundary.

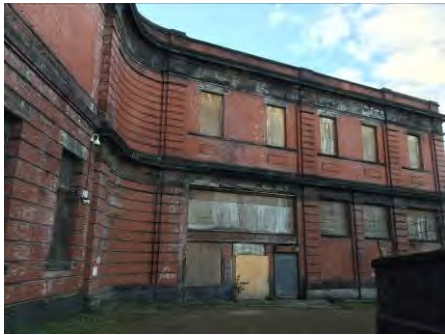
| Reference | Picture | Description | Potential Bat Roost Features and Evidence of Roosting | Assessed Roost Status |
|---|---|---|---|---|
| B1 | | <p>Former Mayfield Station.</p> <p>Brick façade with stone parapet and stone lintels to windows.</p> <p>Large decoratively tiled stairwell and offices/warehouse at ground floor, offices and station concourse at second floor.</p> <p>No roof structure remaining.</p> <p>All windows and doors boarded up.</p> <p><b>No access to interior due to presence of asbestos &amp; lead paint.</b></p> | <p>Damaged wooden fascia boards on external façade providing access to cavity behind.</p> <p>Small crevices in brickwork and around stone lintels on external façade.</p> <p>Unglazed window into stairwell providing potential bat access to internal rooms.</p> | High Potential |

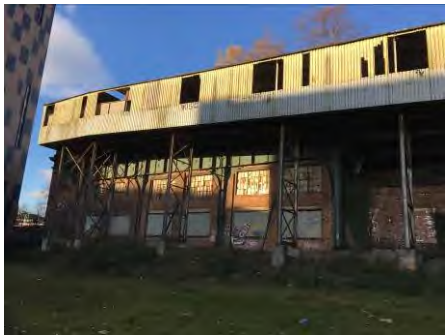
| Reference | Picture | Description | Potential Bat Roost Features and Evidence of Roosting | Assessed Roost Status |
|---|---|---|---|---|
| B2a | | <p>Former station platforms and warehouses.</p> <p>Brick façade with two large internal warehouses.</p> <p>Concrete floor, flat roof supported by concrete pillars.</p> <p>Narrow enclosed ramp from ground level to platforms on southern elevation, supported by metal framework and covered with corrugated sheets. Open ramp on northern elevation.</p> <p>Series of large brick arches beneath platforms at eastern end, each enclosed with wooden boarding and used as warehouse/industrial units.</p> | <p>Crevices on the external façade.</p> <p>Broken windows and gaps around roller shutter doors providing access to internal warehouses. Very limited roost potential within these rooms but considered likely to be used as sheltered foraging site during poor weather conditions.</p> <p>Existing record of pipistrelle roost on northern side, potentially on external façade or at platform level.</p> | Confirmed Roost<br><br>High Potential on rest of structure |

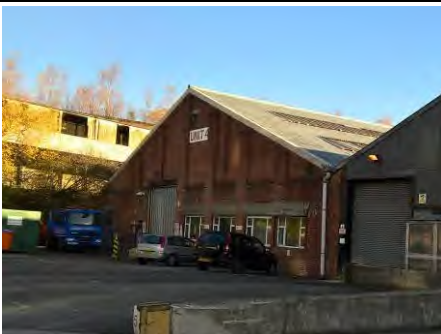
| B3 | | <p>Industrial unit occupied as warehouse.</p> <p>Brick walls with pitched roof covered with corrugated asbestos cement sheets and numerous plastic skylights.</p> <p>Roof supported by metal framework, open to ridge with no roof voids.</p> <p>Concrete floor.</p> | None | Negligible Potential |

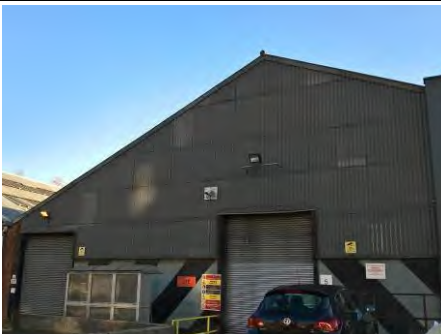
| B4 | | <p>Industrial unit occupied by Fedex as warehouse and distribution centre.</p> <p>Brick walls with corrugated metal sheets on front elevation. Pitched roof of corrugated asbestos sheets with numerous plastic skylights.</p> <p>Open to ridge with no roof void.</p> | None | Negligible Potential |

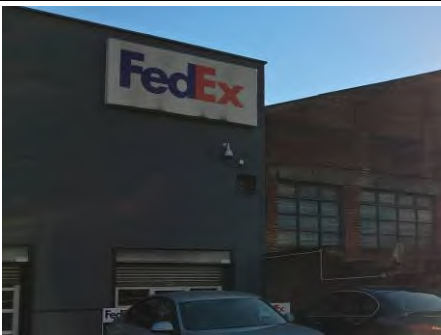
| B5 | | <p>Office unit of warehouse complex occupied by Fedex.</p> <p>Metal sheet walls to front elevation, brick walls with pitched roof of corrugated sheets to rest of building.</p> <p>No roof voids.</p> | None | Negligible Potential |

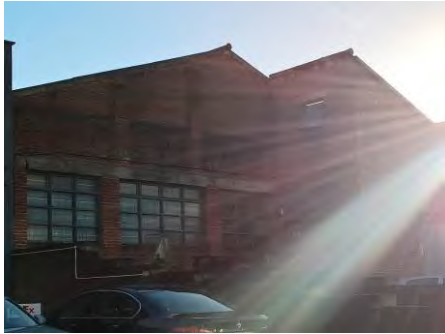
| B6 | | <p>Industrial unit used as storage warehouse together with B9 and B10b.</p> <p>Brick with pitched roof covered with asbestos cement sheets.</p> <p>Roof supported by metal framework, open to ridge with no roof voids.</p> <p>Concrete floor.</p> <p>Large basement, also used for storage.</p> | <p>Crevices on brickwork on northern elevation above River Medlock.</p> <p>Basement provided no obvious crevice features and was too light and disturbed for potential hibernation use.</p> | High Potential |

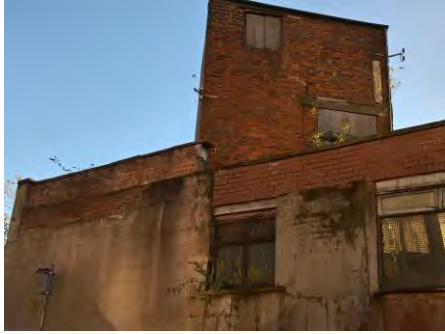
| B7a | | <p>Disused industrial units, part of former Towbar and Trailer Centre.</p> <p>Two-storey section, brick with pitched slate roof, clay ridge tiles and wooden bargeboards at gable ends. Underside visible from interior - open to ridge and appeared to be lined with wooden or metal boards.</p> <p>Two-storey section at SE corner, brick with pitched roof covered with bitumen felt. <b>No access for internal inspection on this section, potentially a roof void present.</b></p> <p>Single storey section with flat bitumen felt roof.</p> <p>Concrete floors throughout and single glazed windows boarded up or secured with wire mesh.</p> | <p>Numerous crevices in brickwork.</p> <p>Crevices around windows providing bat access to interior of two storey sections.</p> <p>Crevices beneath barge boards, potentially providing access to space between slates and lining beneath.</p> <p>Dilapidated fascia boards at eaves on single storey section.</p> | Moderate Potential |

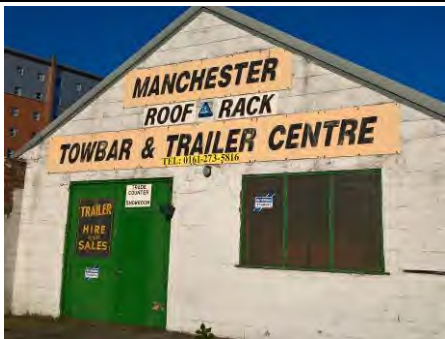
| B7b | | <p>Disused industrial units, part of former Towbar and Trailer Centre.</p> <p>Brick walls with pitched roof covered with metal sheets.</p> <p>Wooden ceiling with roof void above – no obvious hatches to provide access for inspection.</p> <p>Underside of roof partially visible at rear of building (adjacent to two-storey section visible in photo for B7a), supported by wooden rafters and fully lined with membrane.</p> <p>Underground basement.</p> | <p>Basement provided no obvious crevice features but was dark and likely to provide relatively stable temperature conditions.</p> <p>In use until relatively recently and therefore likely to have been too disturbed for hibernation use; however, could potentially be used in future now that the building is disused.</p> | Negligible Potential |

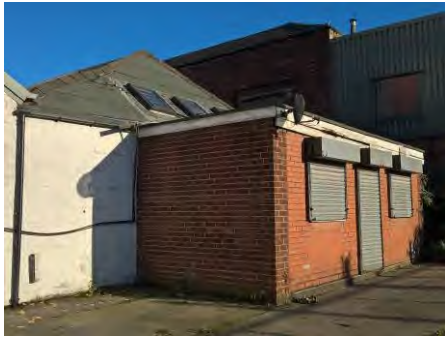
| B7c | | <p>Industrial unit, occupied as religious premises.</p> <p>Brick walls with pitched roof covered with bitumen felt and clay ridge and hip tiles. Skylights on roof suggesting no roof void present.</p> <p>Small section at front with flat roof covered with bitumen felt and narrow wooden fascia boards at eaves.</p> <p><b>No access permission for inspection.</b></p> | <p>None apparent from areas visible.</p> | Full inspection required. |

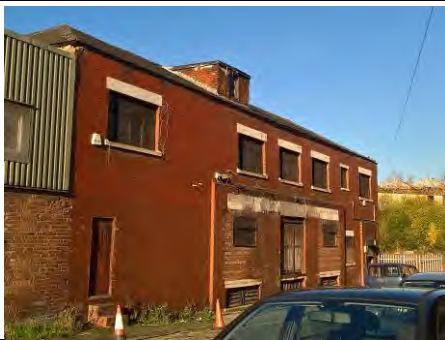
| B8a | | <p>Industrial/office units.</p> <p>Two-storey brick building, two separate pitched slate roofs with hipped gables.</p> <p><b>No access permission for internal inspection.</b></p> | <p>Potentially two roof voids.</p> <p>Crevice on external brickwork.</p> | <p>Moderate Potential</p> <p>Full inspection required</p> |

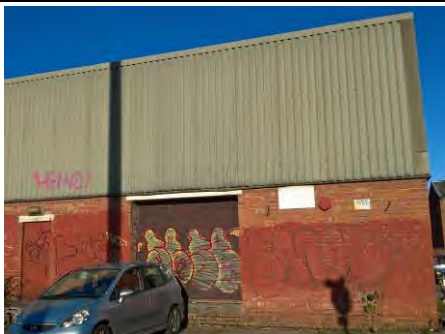
| B8b | | <p>Industrial units.</p> <p>Two-storey flat roofed building with brick walls with metal sheeting at upper level.</p> <p><b>No access permission for internal inspection.</b></p> | <p>Unlikely to be any roof void.</p> <p>No obvious crevices on external façade.</p> | Negligible Potential |

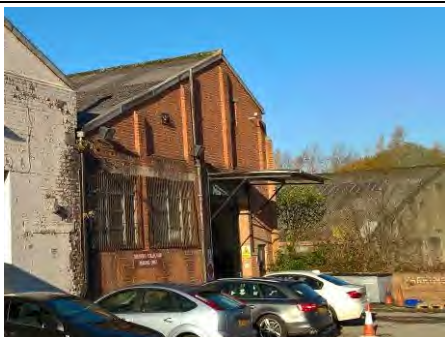
| B9 | | <p>Industrial unit occupied as factory and storage warehouse, together with B10b and B6.</p> <p>Brick with pitched roof of asbestos cement sheets.</p> <p>Roof supported by metal framework, open to ridge with no roof voids.</p> <p>Concrete floor.</p> <p>Large basement beneath, used for storage.</p> | <p>No roof void.</p> <p>Basement provided no obvious crevice features and was too light and disturbed for potential hibernation use.</p> | Negligible Potential |

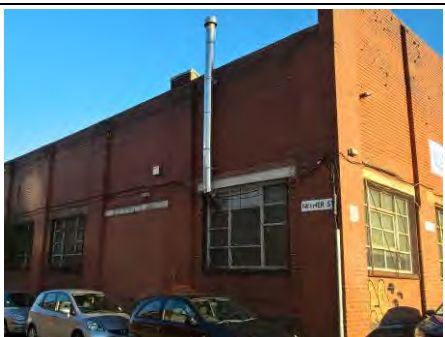
| B10a | | <p>Two-storey brick building with brick parapet at front elevation.</p> <p>Four ridges to the roof, covered with slates and clay ridge tiles.</p> | No access for internal inspection | <p>Moderate Potential</p> <p>Full inspection required</p> |

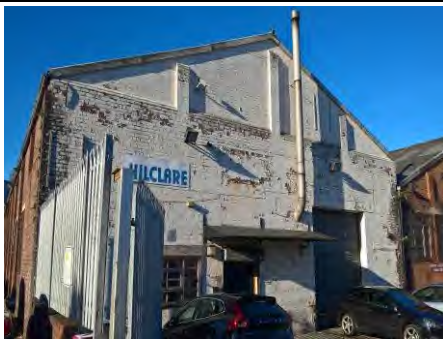
| B10b | | <p>Industrial unit occupied as factory and storage warehouse, together with B9 and B6.</p> <p>Brick with pitched roof of asbestos cement sheets.</p> <p>Open to ridge with no roof void.</p> | None | Negligible Potential |

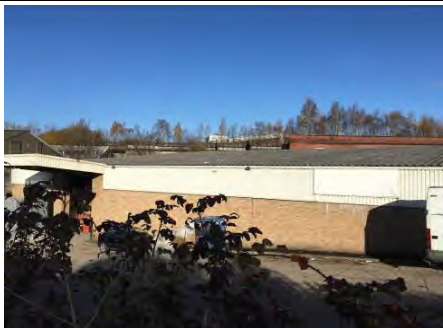
| B12 | | <p>Industrial unit used as a storage/distribution warehouse.</p> <p>Brick walls with corrugated metal sheeting towards roof level.</p> <p>Shallow pitched roof covered with corrugated sheets, open to ridge with no roof void.</p> | None | Negligible Potential |

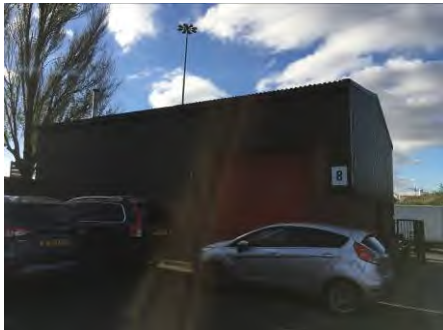
| B13 | | <p>Industrial unit.</p> <p>Two-storey building with brick walls at ground level and metal sheeting at first floor level.</p> <p>Shallow pitched roof covered with metal sheets.</p> | None | Negligible Potential |

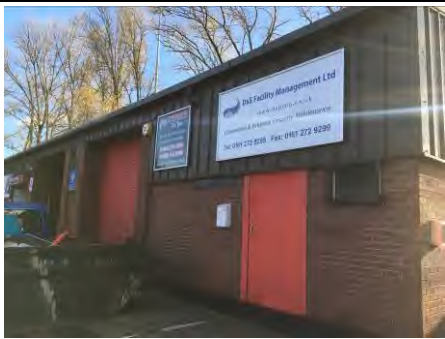
| B14 | | <p>Industrial unit.</p> <p>Two-storey building with brick walls at ground level and metal sheeting at first floor level.</p> <p>Shallow pitched roof covered with metal sheets.</p> | None | Negligible Potential |

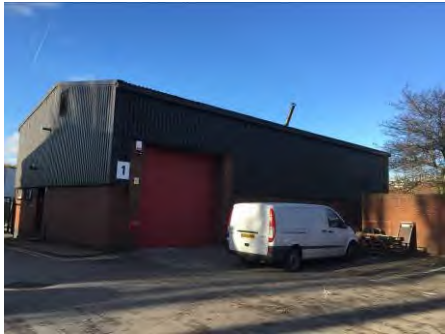
| B15 | | <p>Industrial unit.</p> <p>Two-storey building with brick walls at ground level and metal sheeting at first floor level.</p> <p>Shallow pitched roof covered with metal sheets.</p> | None | Negligible Potential |

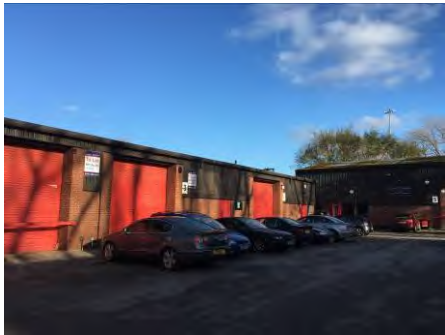
| B16 | | <p>Industrial units.</p> <p>Single-storey building with brick walls at ground level and metal sheeting towards roof level.</p> <p>Shallow pitched roof covered with metal sheets.</p> | None | Negligible Potential |

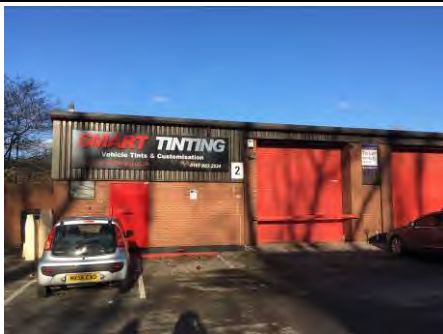
| B17 | | <p>Industrial unit.</p> <p>Brick walls at ground level and metal sheeting towards roof level.</p> <p>Shallow pitched roof covered with metal sheets.</p> | None | Negligible Potential |

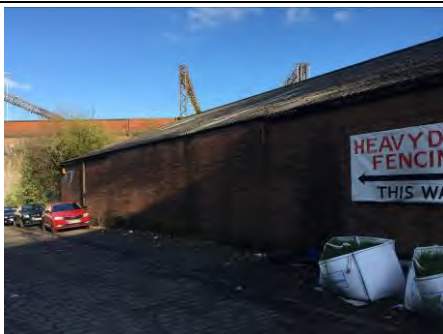
| B18 | | <p>Warehouse/industrial unit, used as storage and recycling facility.</p> <p>Brick walls with pitched roof of asbestos cement sheets, open to the ridge with no roof void.</p> <p>Interior very cluttered.</p> | None | Negligible Potential |

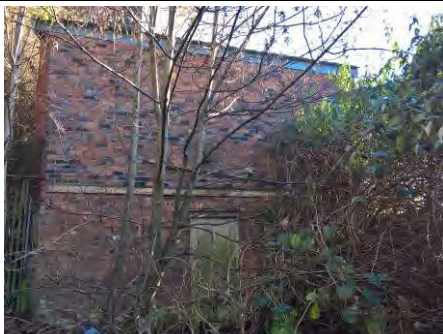
| B20 | | <p>Two-storey brick structure with sloping roof covered with corrugated sheets.</p> <p>Unlikely to have roof void.</p> <p>Narrow wooden fascia board at eaves.</p> <p><b>No access permission for inspection.</b></p> | None apparent from visible areas | Negligible potential |

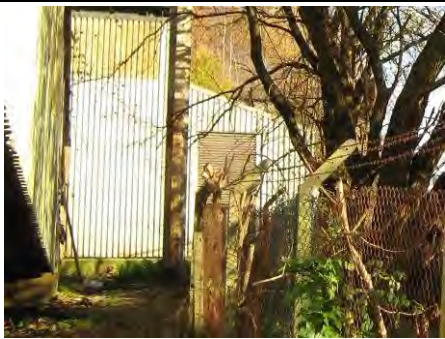
| B21 | | Small lean-to structure adjoined to B2.<br>Corrugated metal walls with roller shutter door and sloping metal roof. | None | Negligible Potential |
