**Mayfield, Phase 1**  
EIA Volume 2

September 2019

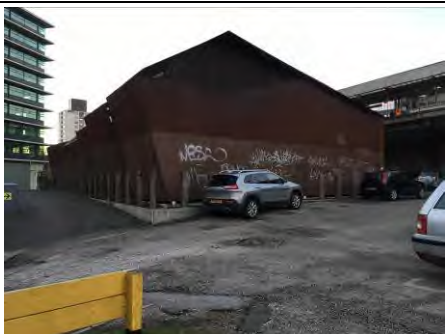
| B22 | | Electricity substation.<br><br>Metal walls.<br><br>Pitched roof with metal sheet covering. | None | Negligible Potential |

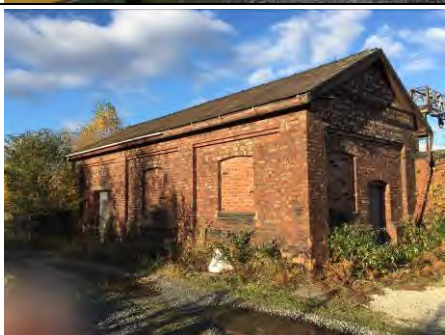
| B23 | | Single-storey brick building. Pitched slate roof with clay ridge tiles and overhanging eaves with wooden soffit and bargeboards at gable ends.<br>Metal roller shutter door (locked) on southern elevation, door and window on eastern gable end boarded up.<br><br>No access permission for internal inspection. | Gaps between brickwork and soffit providing potential access to cavity within soffit and/or interior of building.<br><br>Gap beneath end ridge tile at eastern gable end.<br><br>Gap above roller shutter door. | High Potential |

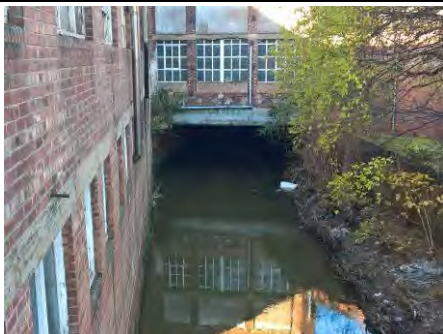
| B24 | | <p>Culverted section of River Medlock.</p> <p>Length approx. 60m, width approx. 4m, height approx. 2.5-3m above water level.</p> <p>No access for internal inspection.</p> | Bats known to roost in a similar culvert on another nearby site in Manchester. | High Potential |

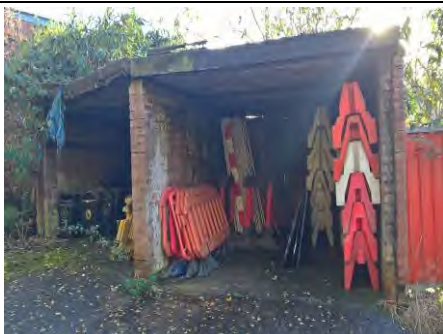
| B25 | | <p>Pair of open fronted garages with brick walls and flat concrete roof.</p> <p>Used for storage but appeared relatively undisturbed.</p> | None | Negligible Potential |

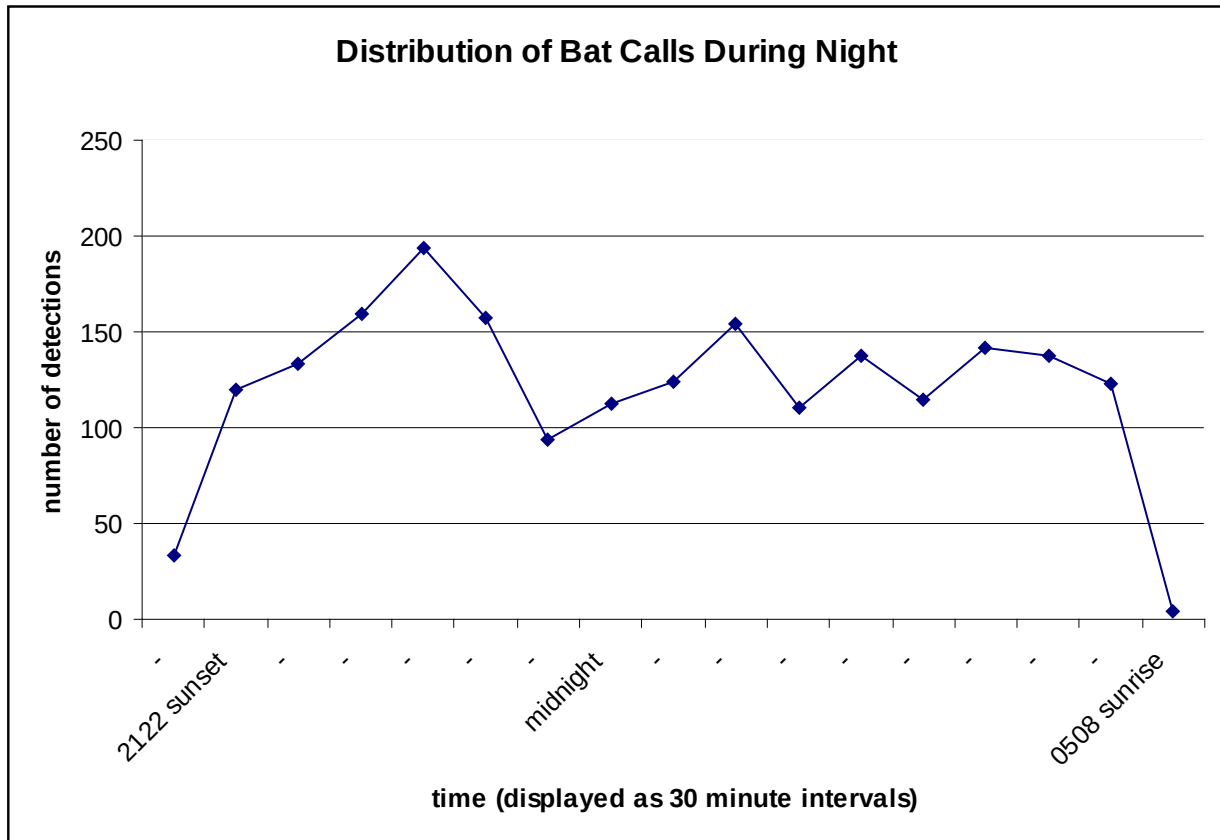
The sonograms typically illustrated long sequences of echolocation calls with numerous feeding buzzes, although there were also shorter sequences of echolocation that suggested commuting behaviour.

The majority of the data illustrated calls of individual bats, but there were also instances where calls of at least two bats were apparent. Social calling was encountered occasionally throughout the monitoring period but most frequently coinciding with the peak time of bat activity between sunset and midnight.

Figure 3—1 Chart illustrating the overall pattern of bat calls detected between sunset and sunrise for the period 21<sup>st</sup> – 25<sup>th</sup> July

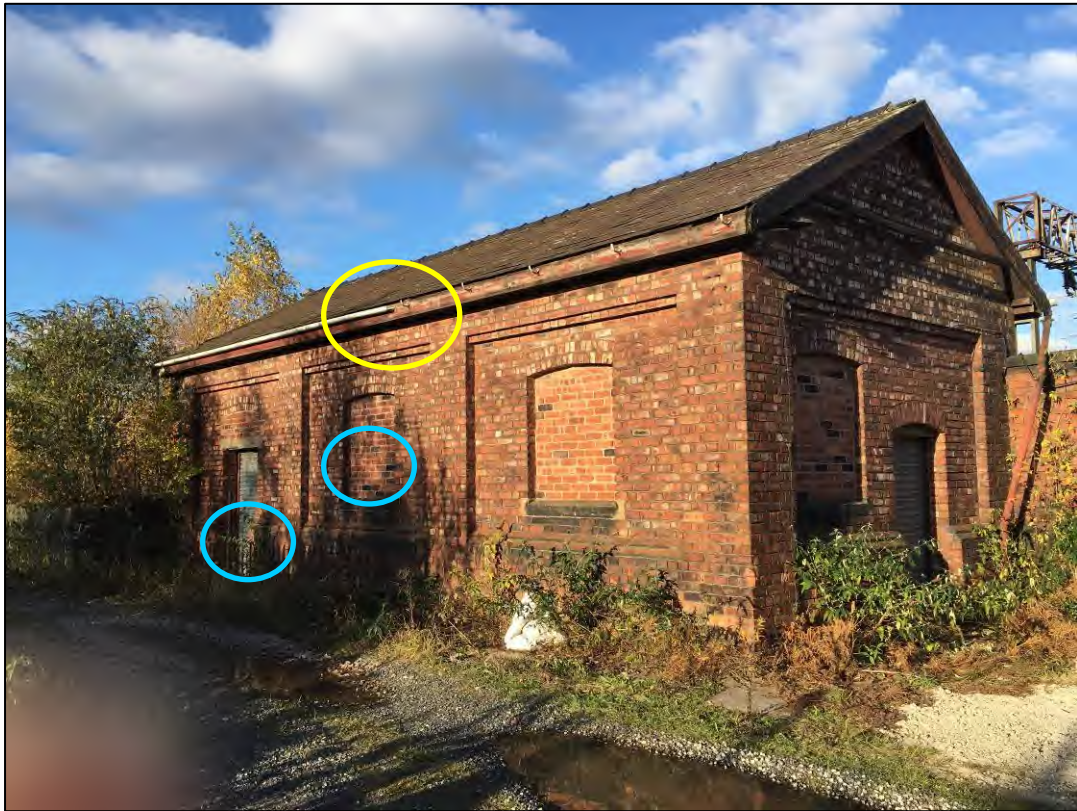
**Plate 1**

Building B23 – two bats seen entering during dusk survey (yellow). Also several fresh bat droppings found stuck to wall (blue).

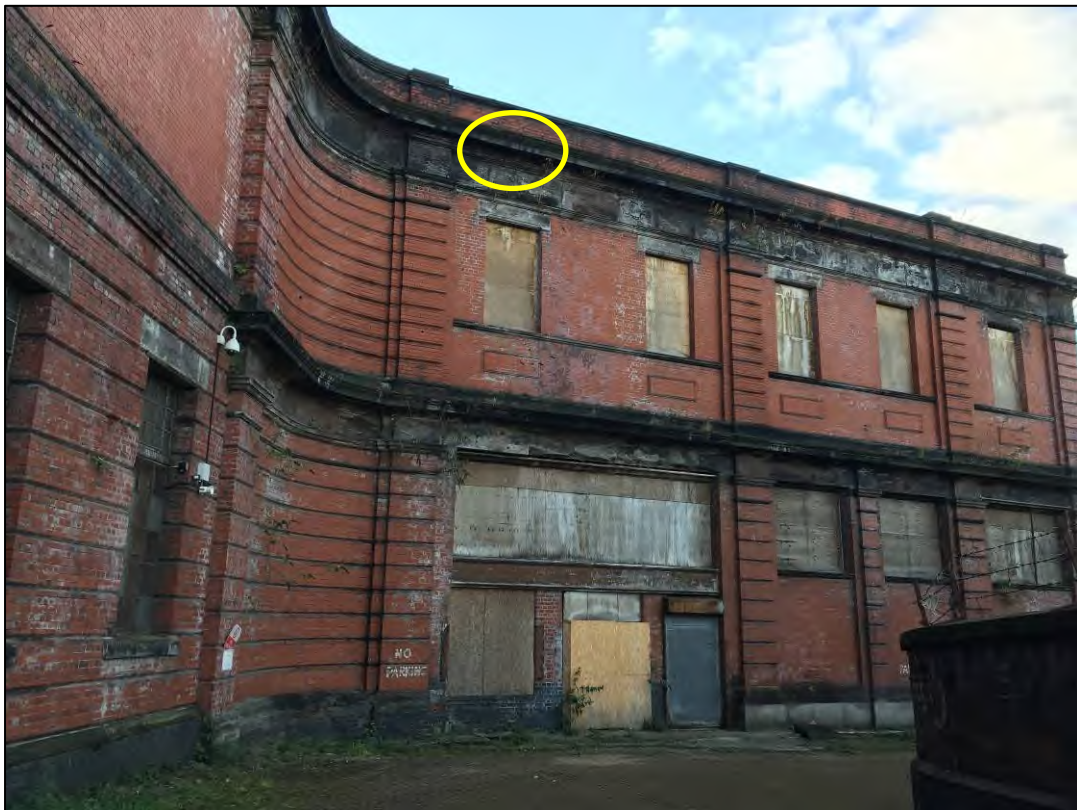
**Plate 2**

Building B1 – a single common pipistrelle was seen emerging during dusk survey (yellow).

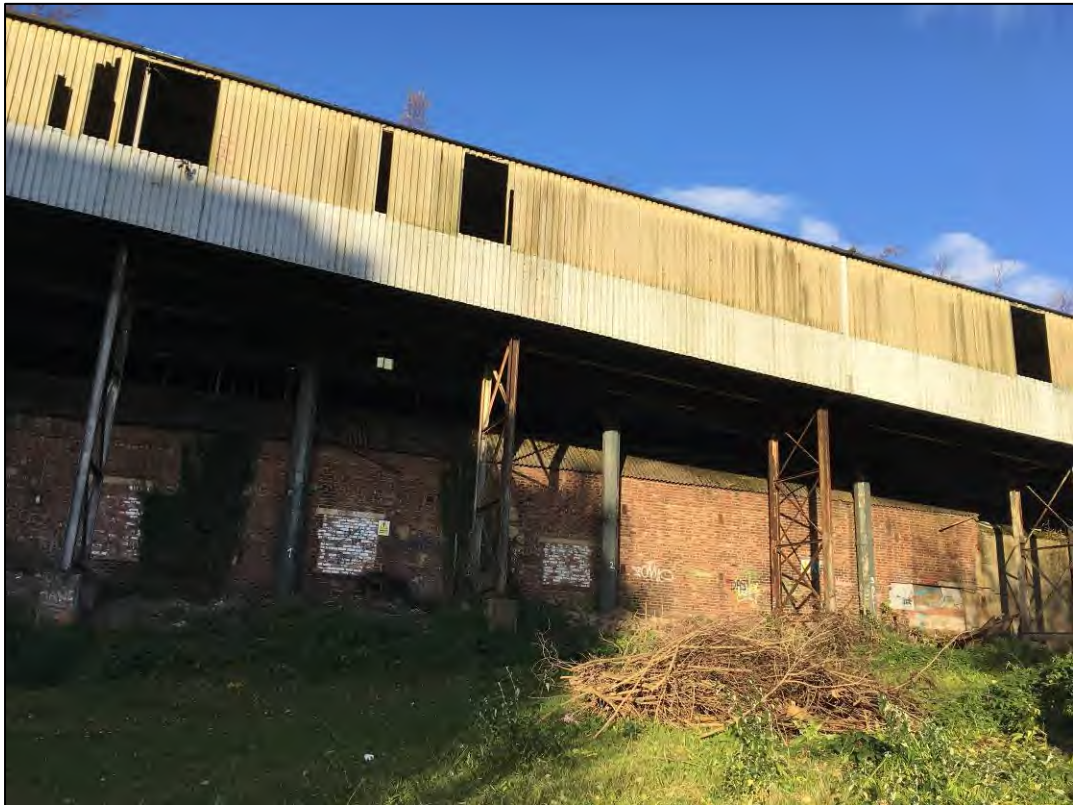
**Plate 3**

Southern side of B2 – 3-4 bats seen close to building at sunset during dusk surveys, considered likely to be roosting but exact roost feature not identified.

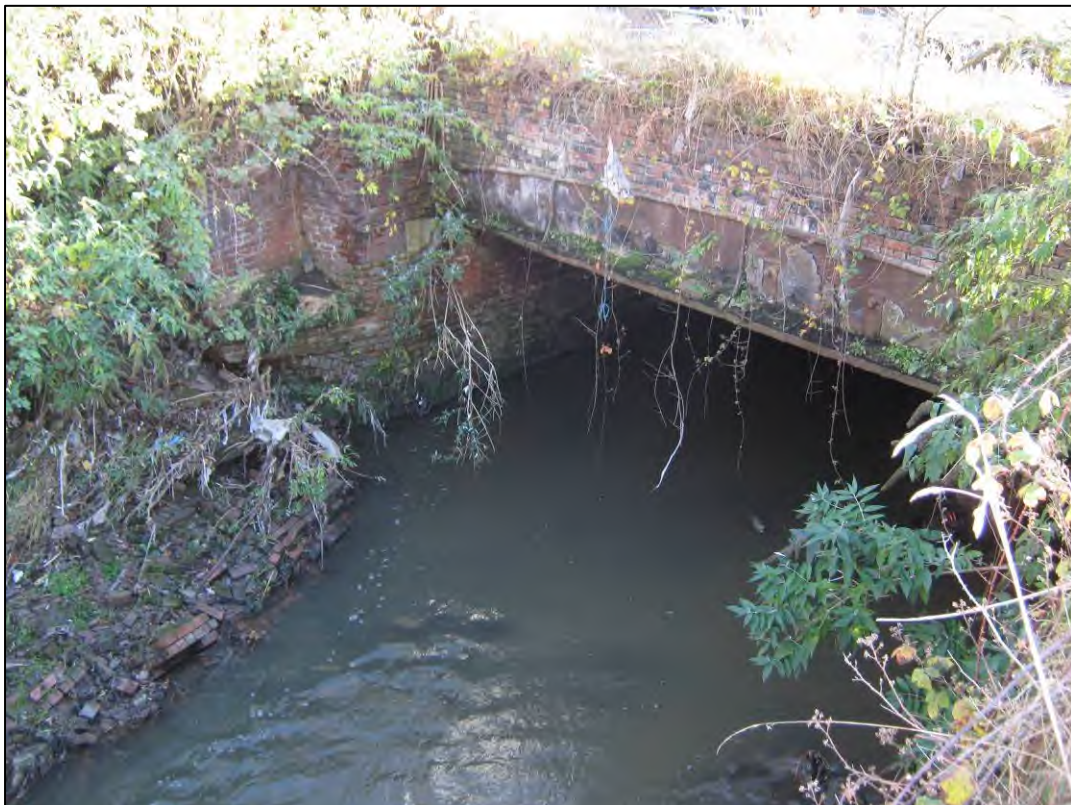
**Plate 5**

Eastern entrance to B24 (culvert). Bats confirmed roosting but precise roost feature inside culvert could not be determined at this stage.

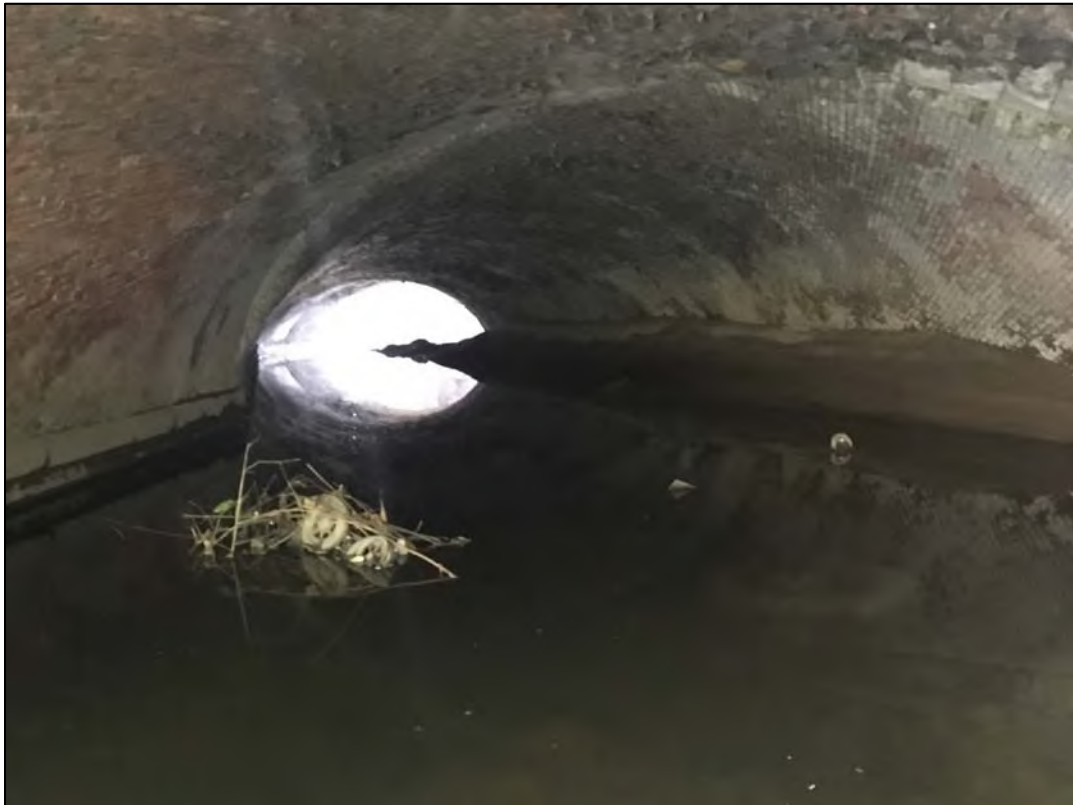
**Plate 6**

Western entrance to B24 (culvert).

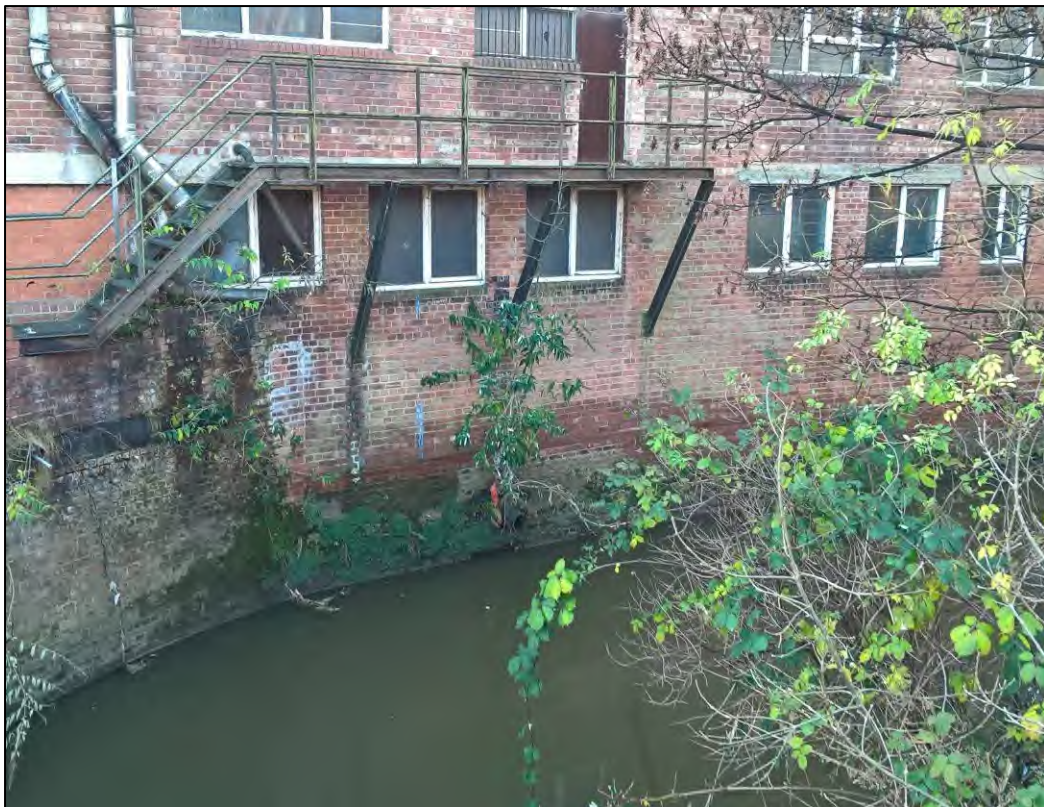
**Plate 7**

B26 (culvert), viewed looking eastwards from river level. Bats confirmed to be roosting during dusk and dawn surveys but exact roost entrance not identified.

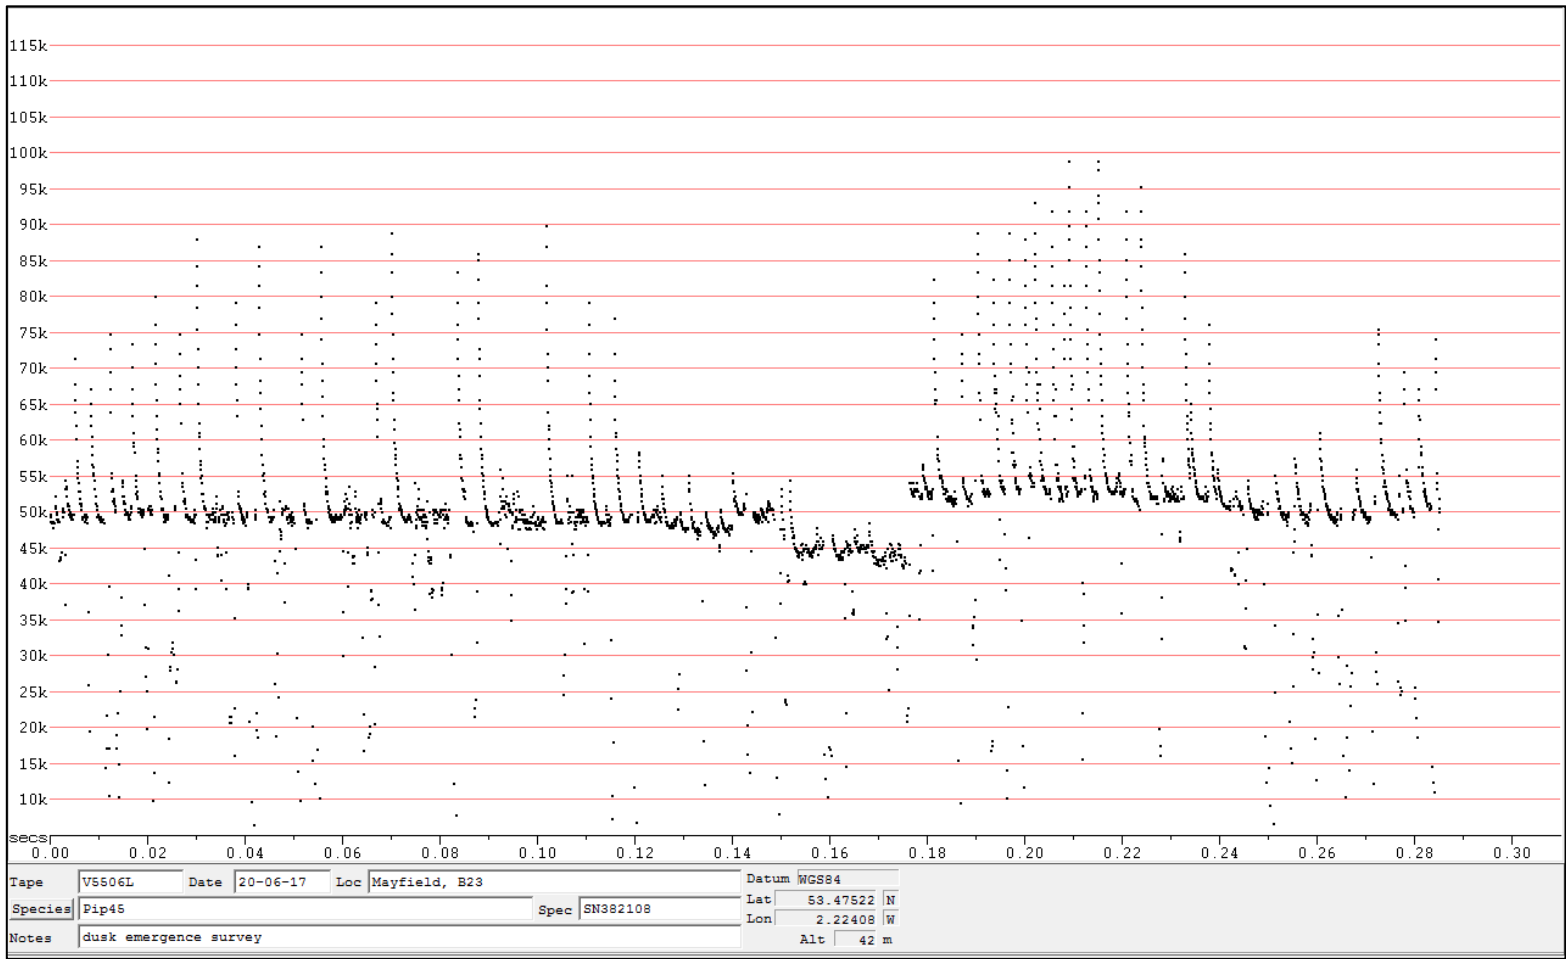
Sonogram 1: Echolocation calls of common pipistrelle bat recorded during dusk emergence survey at the site.  
Recorded by Anabat SD1 and analysed using AnalookW (view: F7 compressed, frequency only).

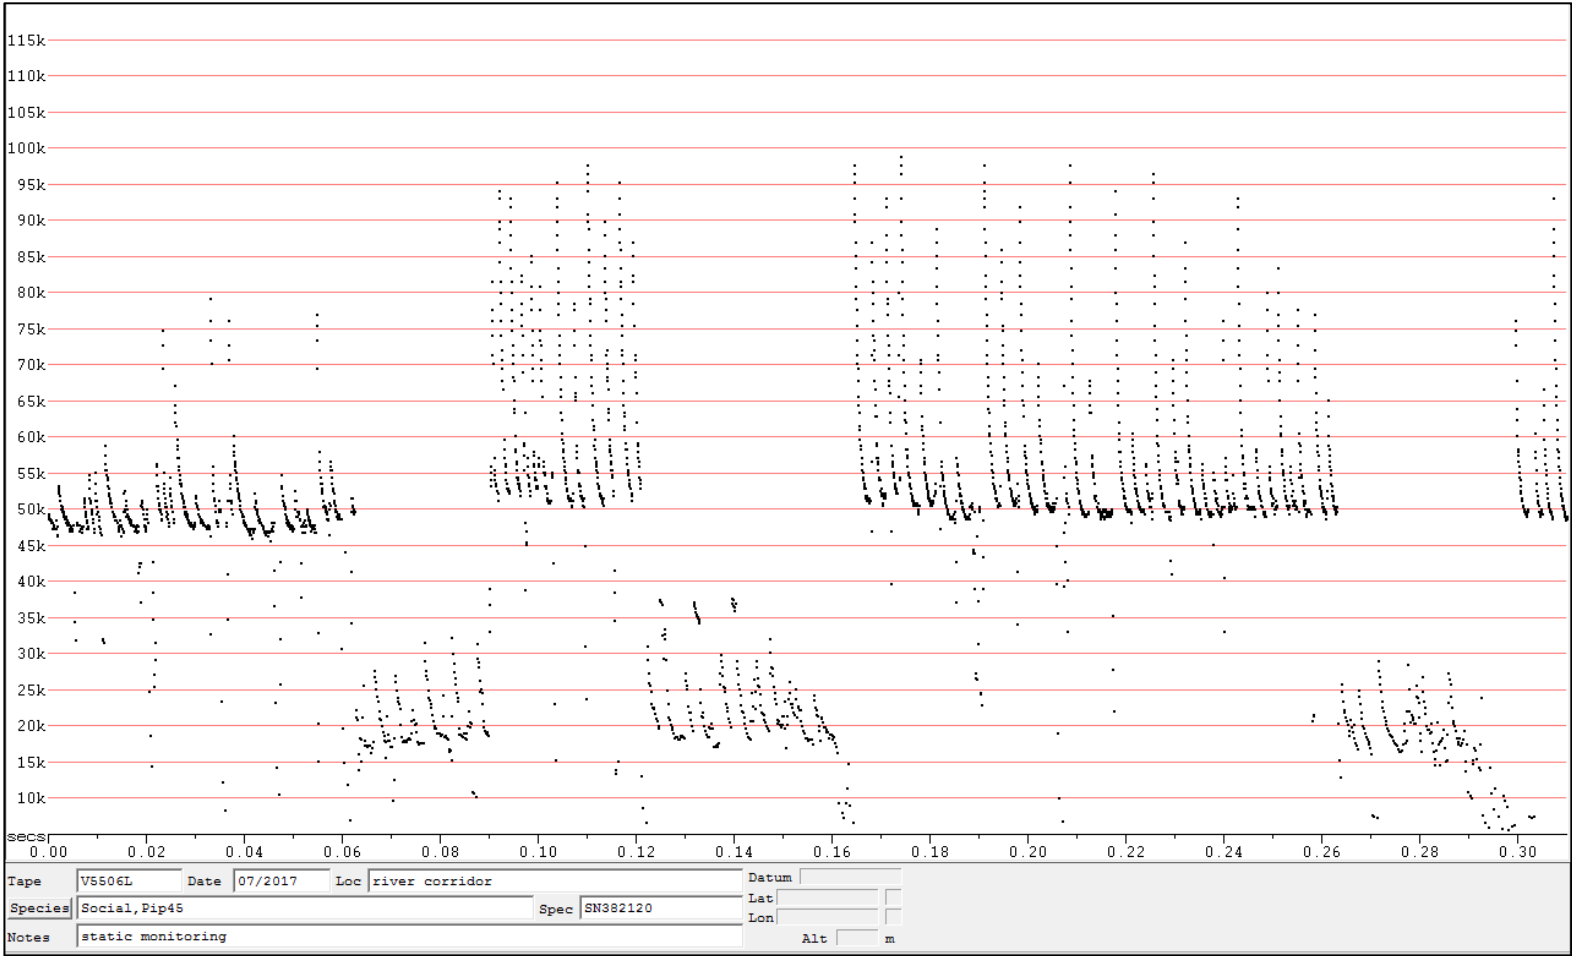
Sonogram 2: Echolocation and social calls of common pipistrelle bats recorded during automated monitoring at the site.  
Recorded by Anabat Express and analysed using AnalookW (view: F7 compressed, frequency only).

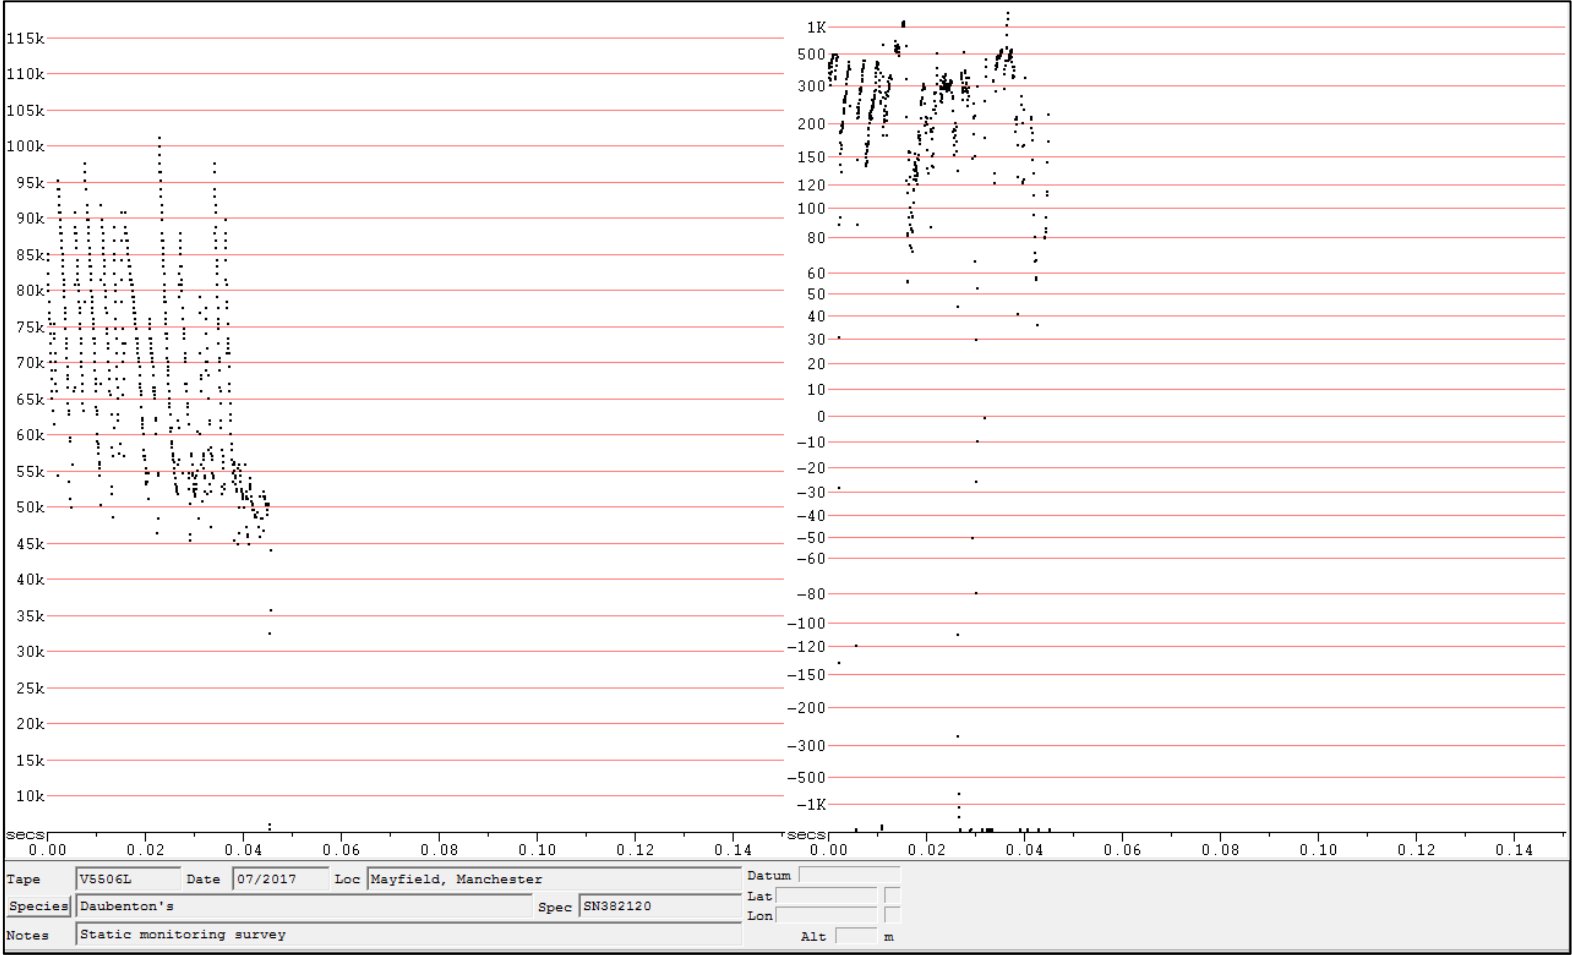
Sonogram 3: Echolocation calls of Daubenton's bat recorded during automated monitoring along the river corridor.  
Recorded by Anabat Express and analysed using AnalookW (view: F7 compressed, frequency and slope).

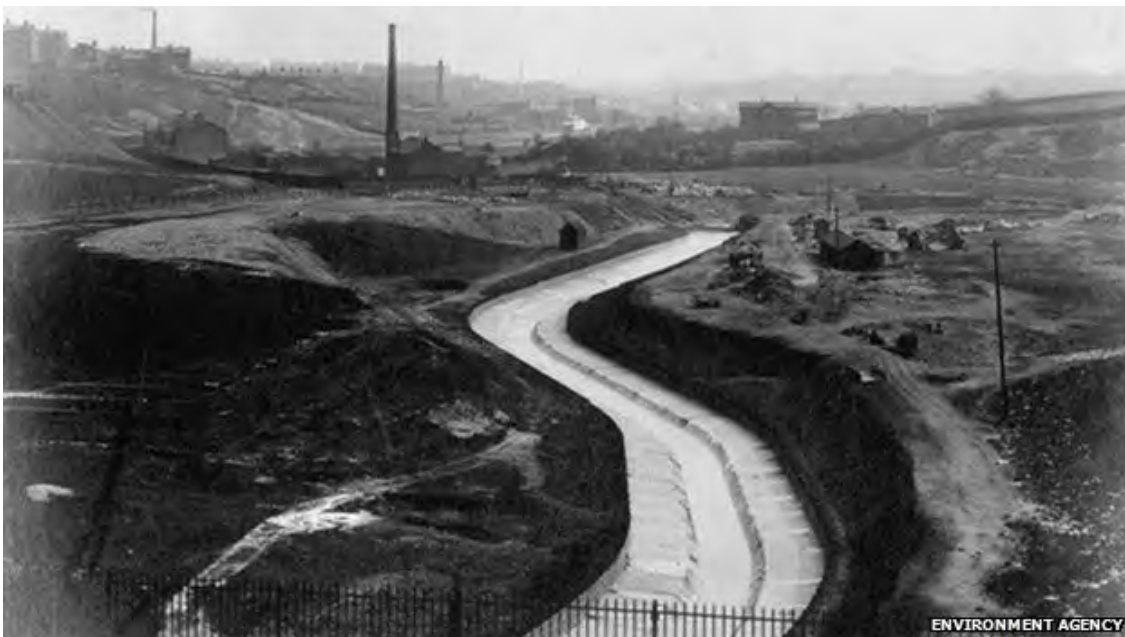
**Figure 1—1 Historic brick channelled section of River Medlock upstream from Mayfield**

Upstream from Mayfield the Medlock was confined to a brick channel. This was done following a major flood in the 1860s. However, the effect was to increase flood risk by accelerating water flow. The section illustrated has subsequently been restored and the bricks removed.

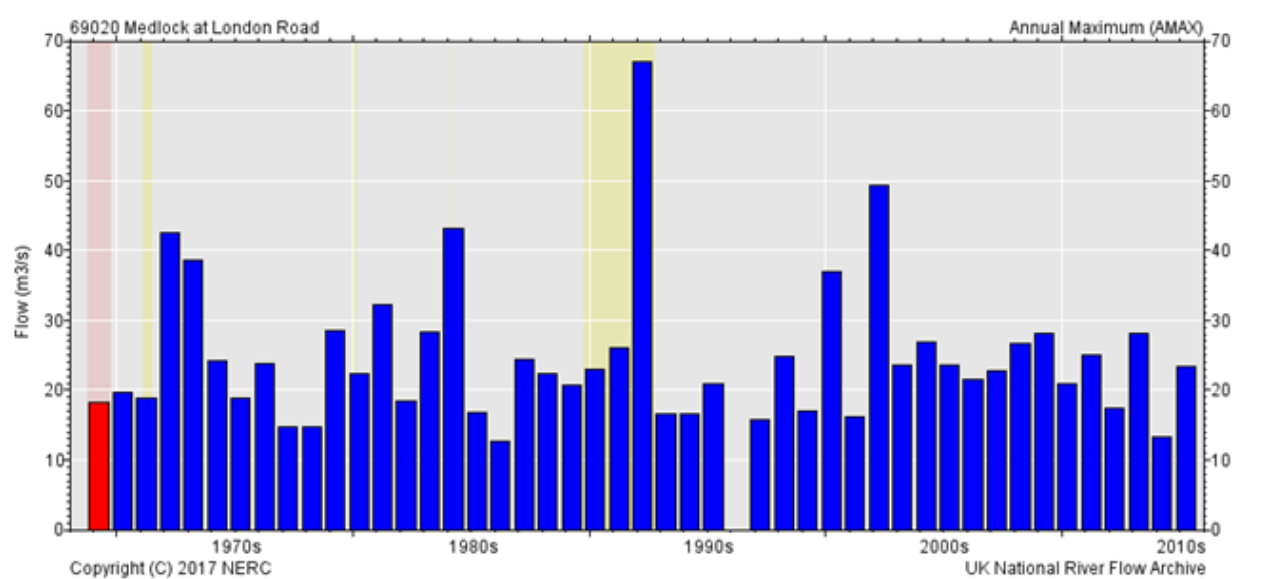
Yellow shading indicates missing data, pink unrepresentative data and red rejected annual maximum values

**Figure 1—2 River Medlock series of maximum peak flows, October to September**

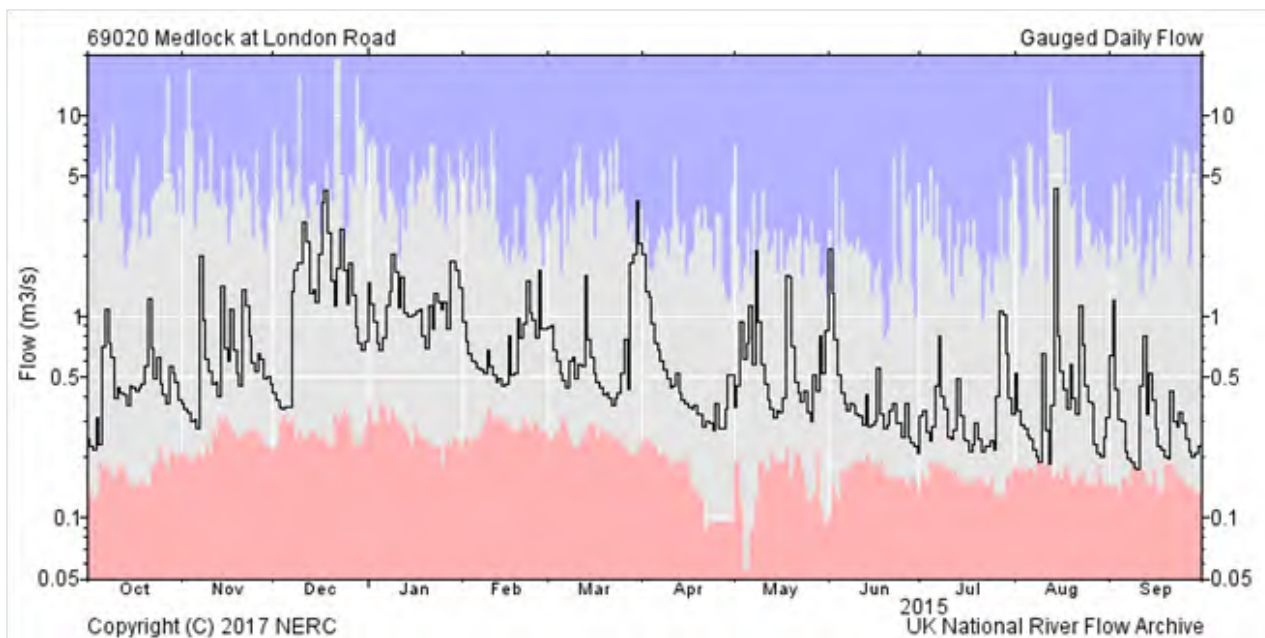
The hydrograph below shows the daily flow from October 2014 to September 2015. Note the relatively rapid rise in flow following a rainfall event, which is a reflection of the urbanised setting.

Red and blue envelopes represent lowest and highest flows on each day over the period of record

**Figure 1—3 Daily flow from October 2014 to September 2015**

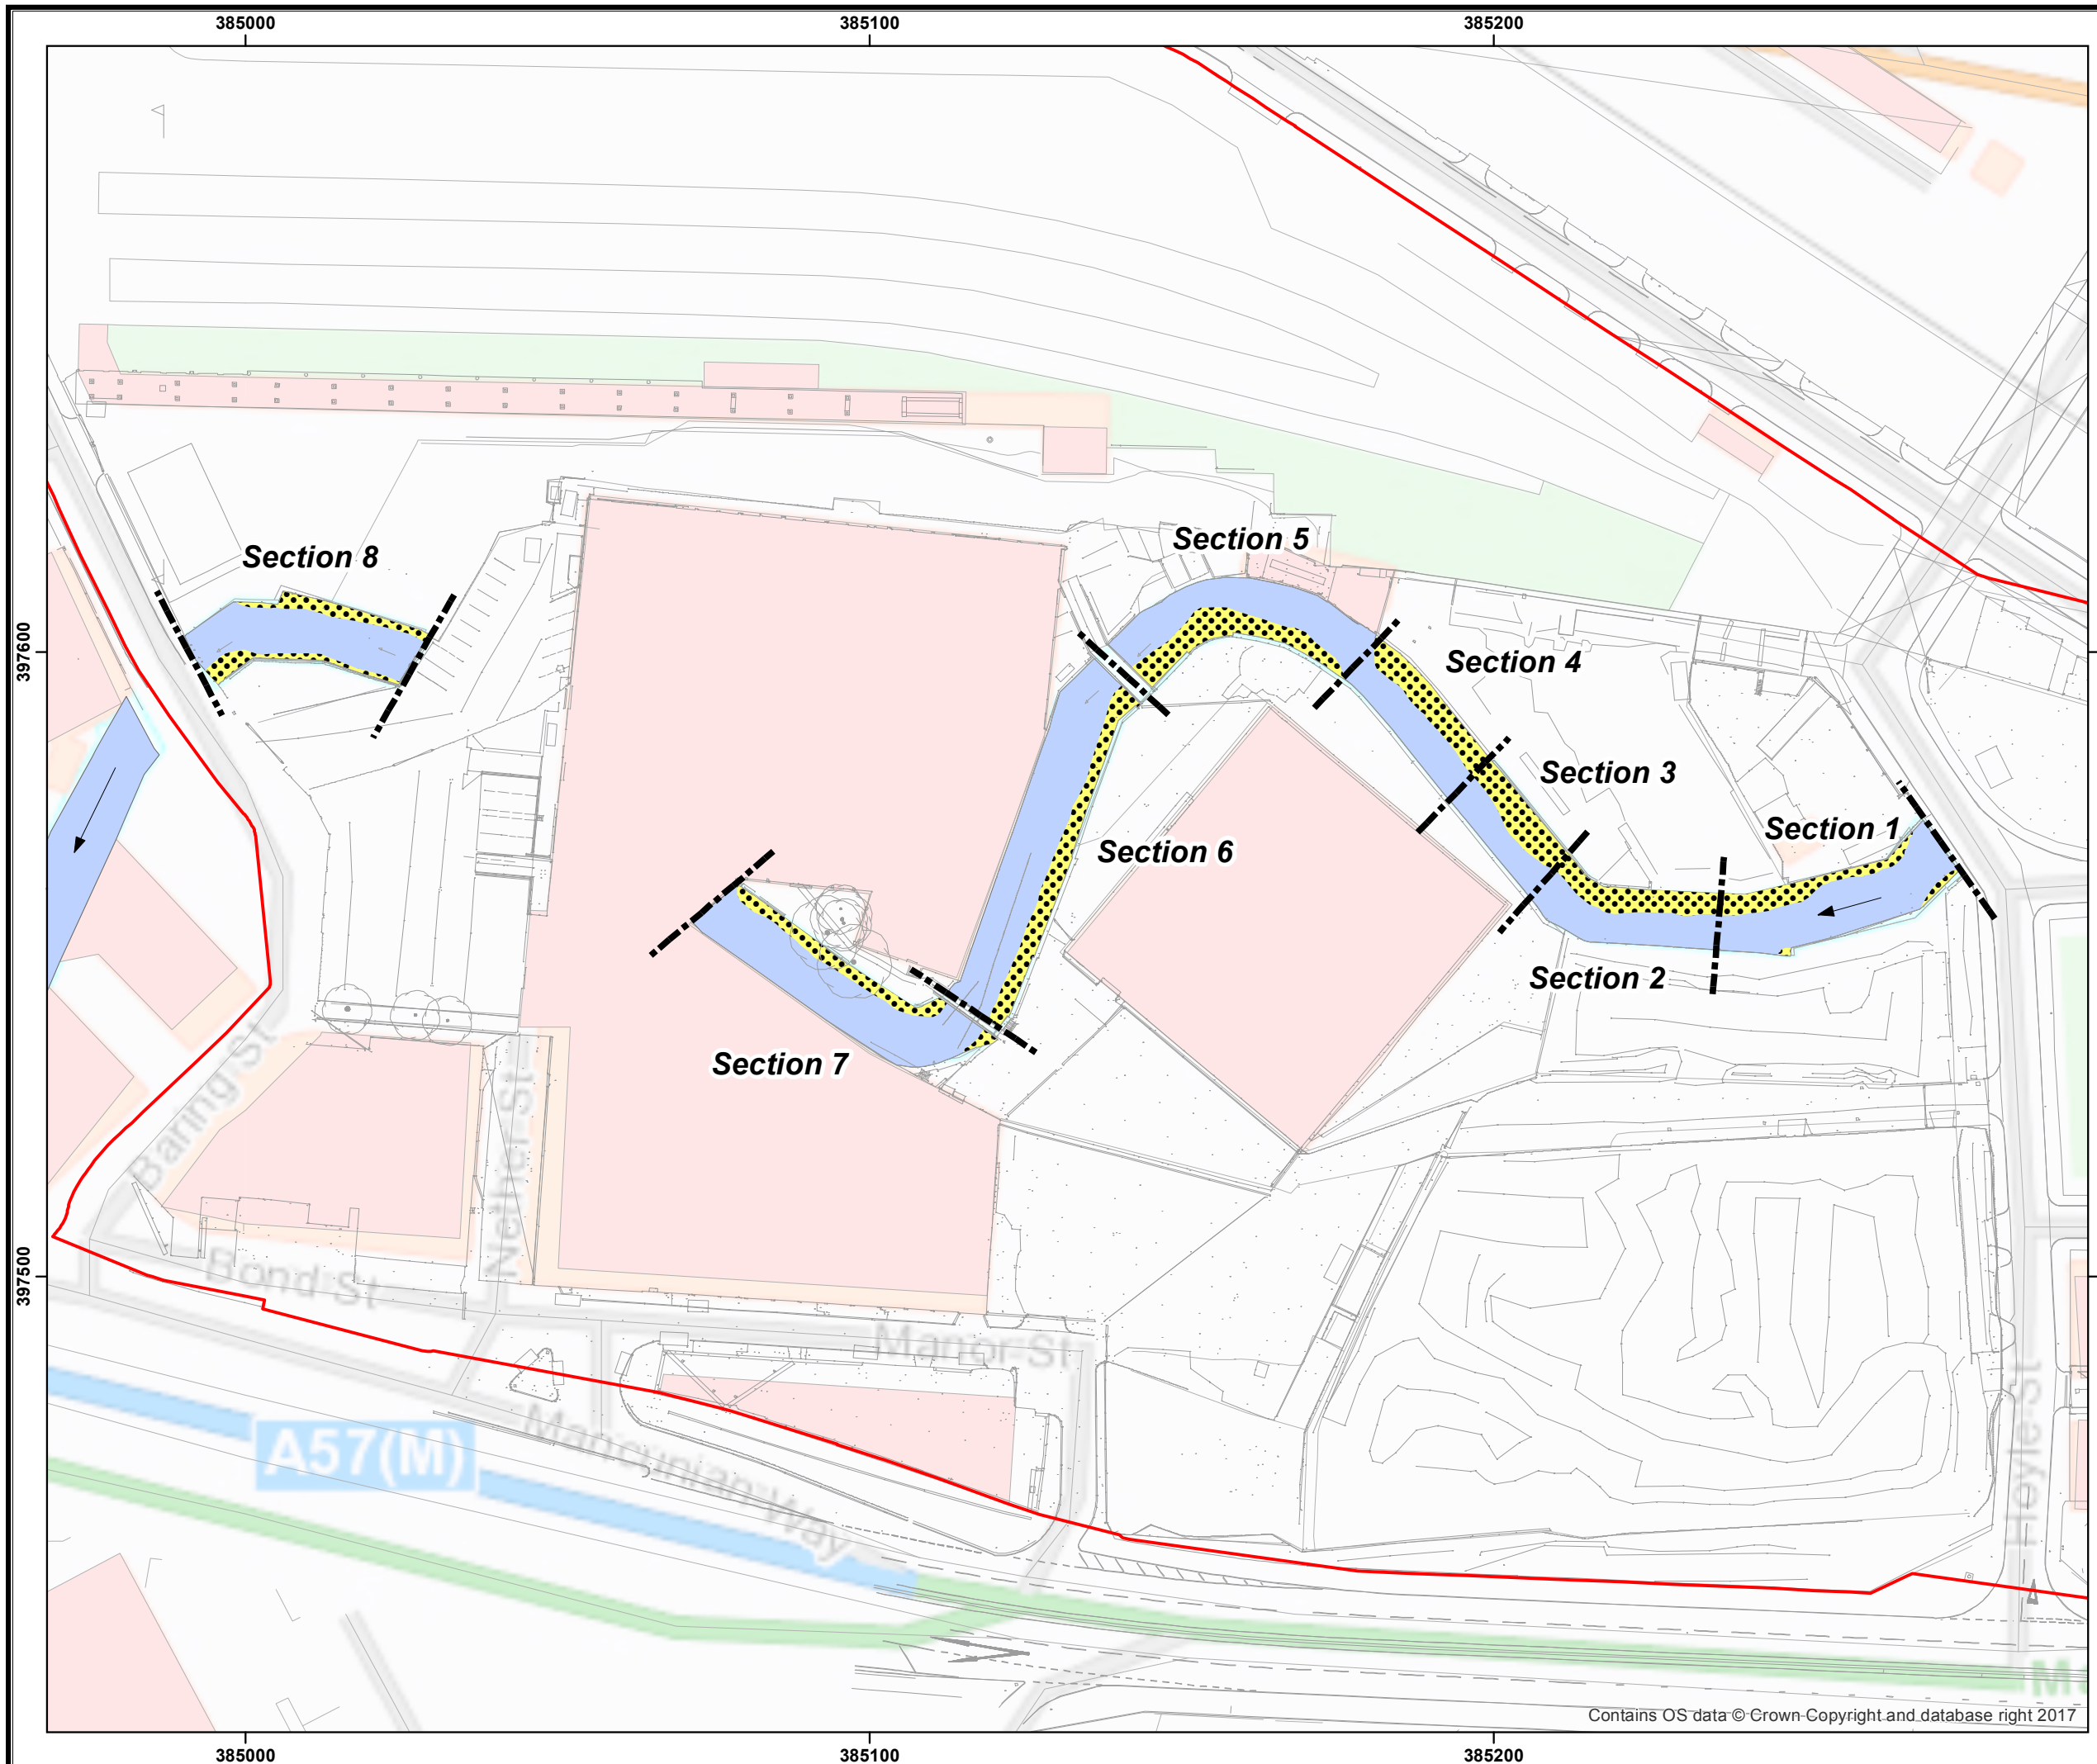
**Figure 1: River Medlock Survey Sections**

- Site boundary
- Survey section division
- River Medlock channel
- In-channel sediment

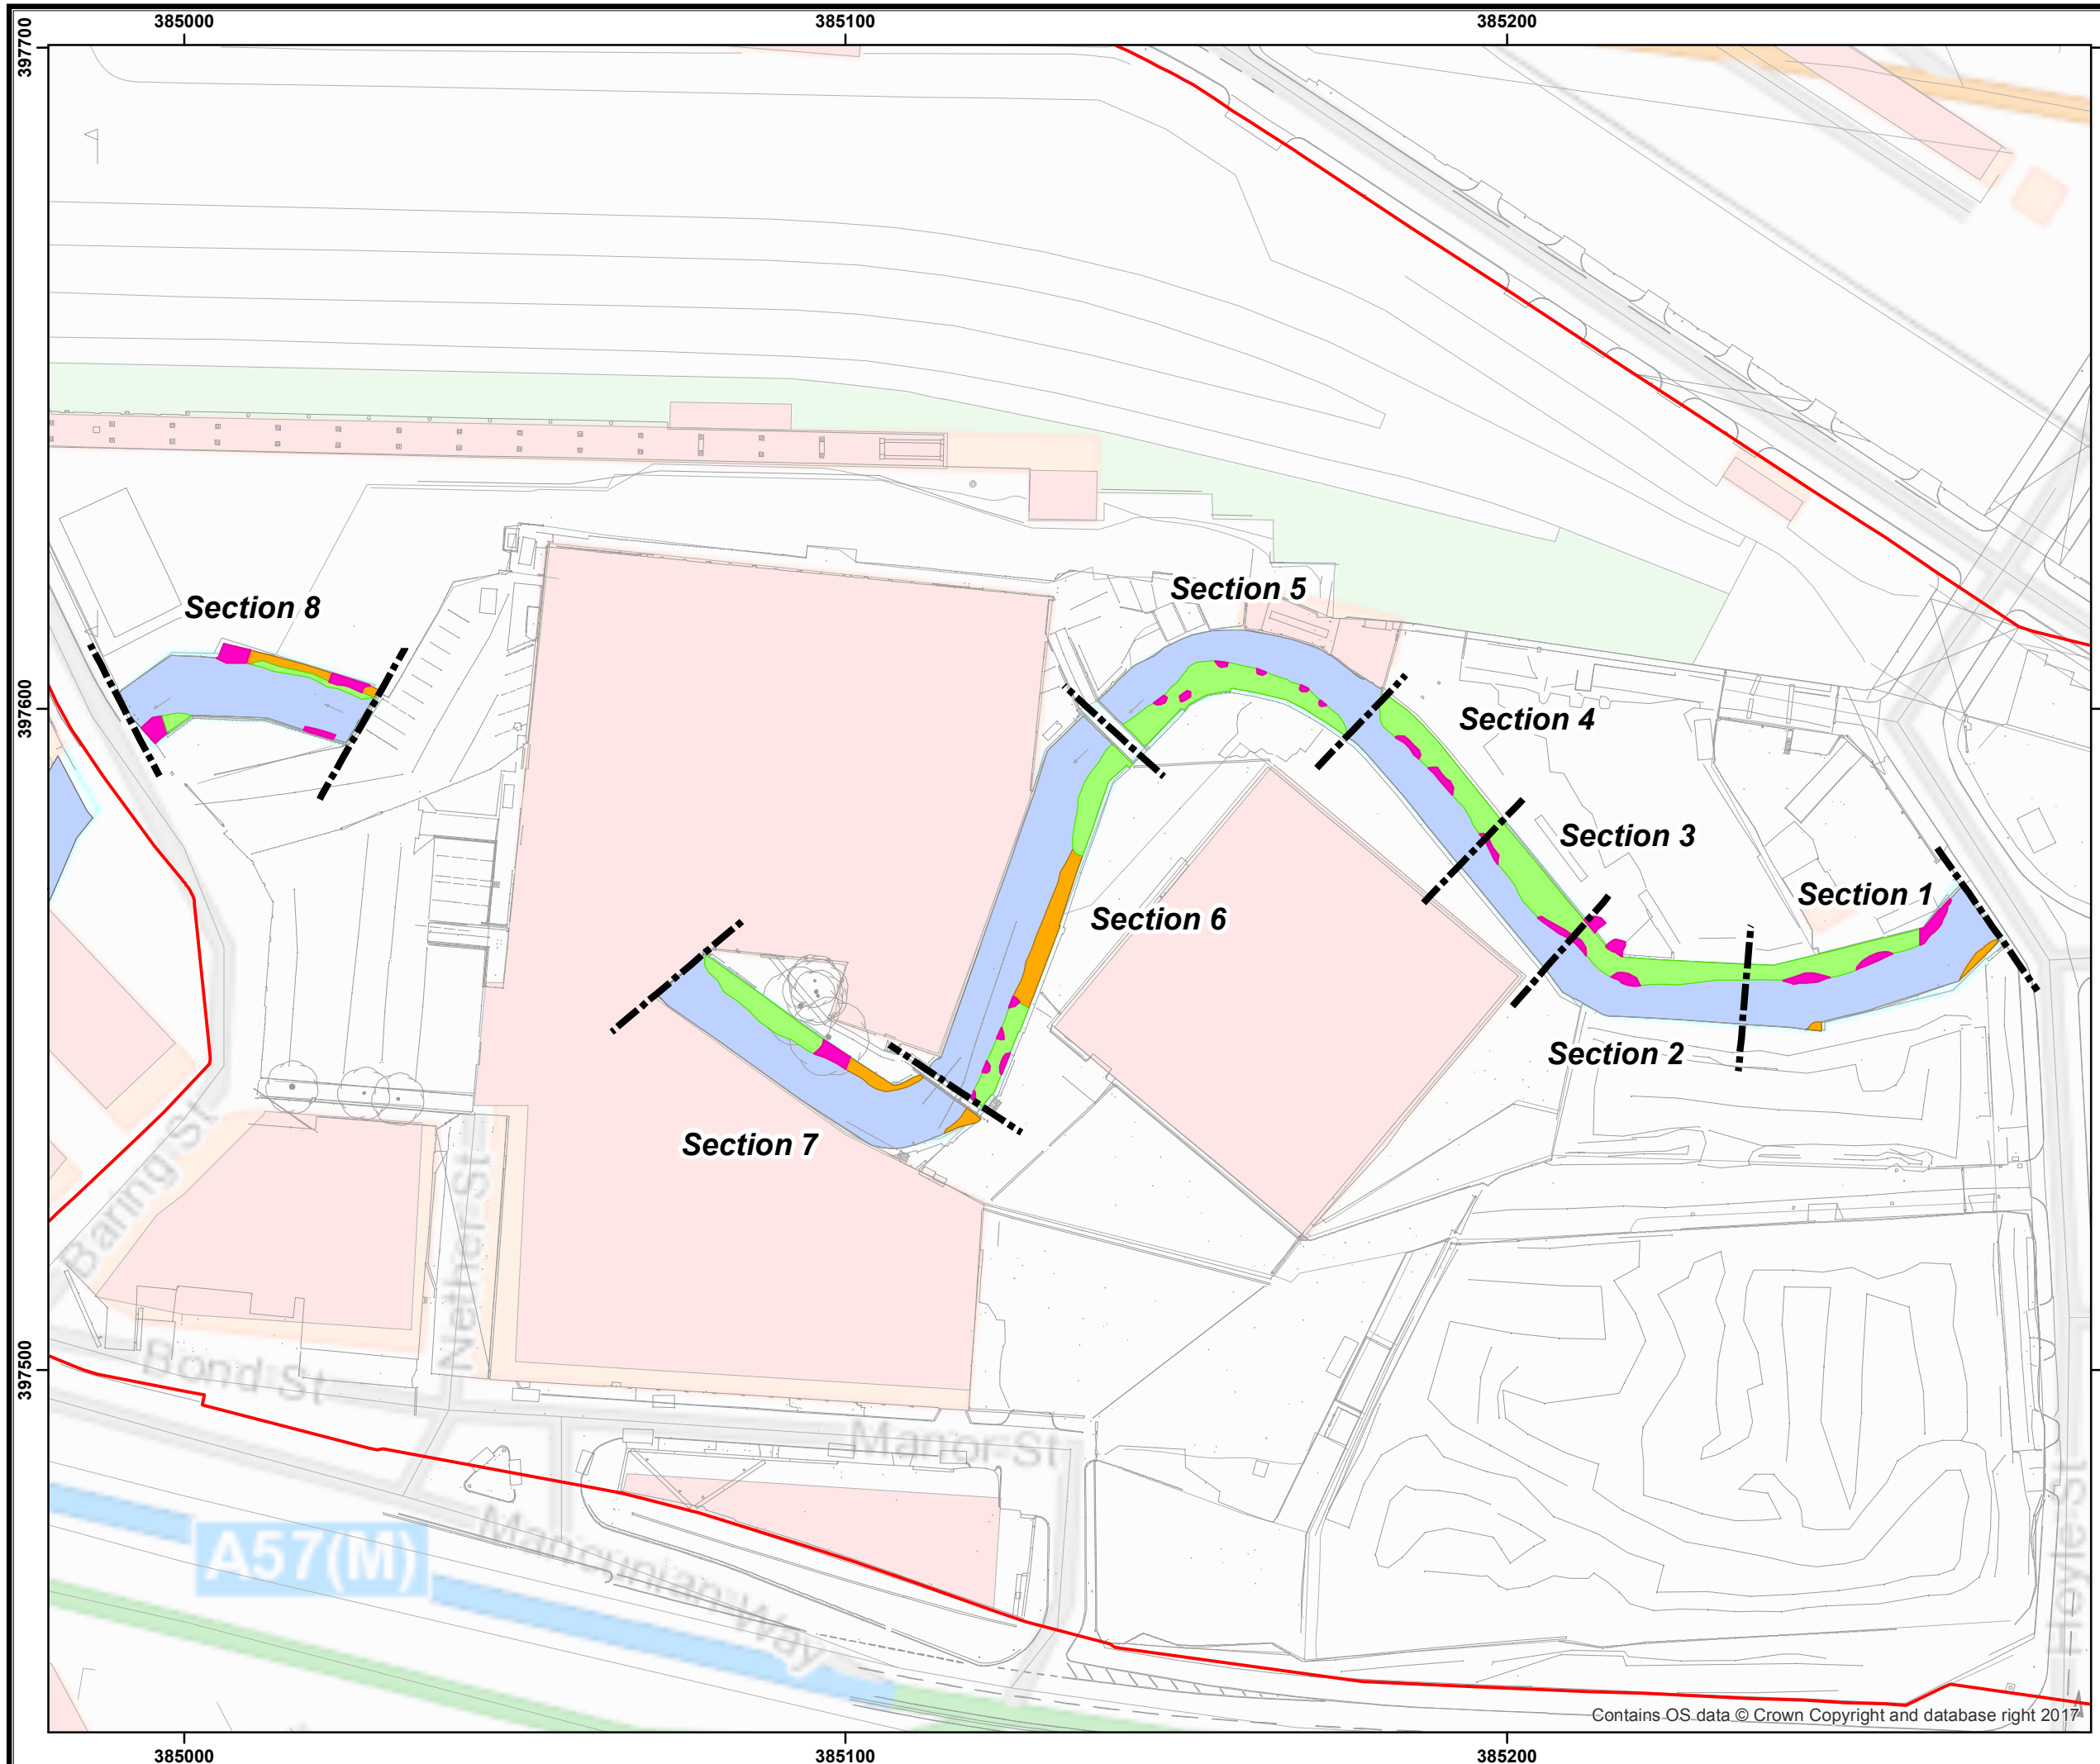
**Figure 2: River Medlock Non-Native Species**

- Site boundary
- Survey section division
- River Medlock channel
- In-channel vegetation**
- Himalayan balsam (invasive non-native)
- Japanese knotweed (invasive non-native)
- Native tall herb vegetation

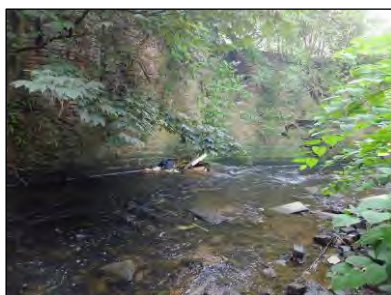
Left bank brick revetment showing debris dam.

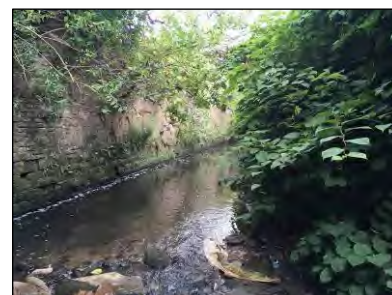
Left bank brick revetment and Japanese knotweed on right bank

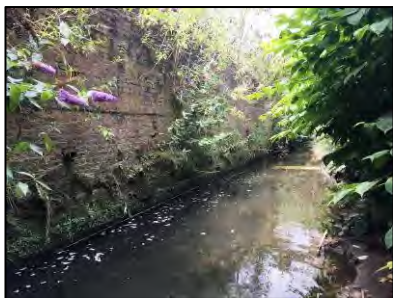
Left bank brick revetment looking downstream with deeper section at base

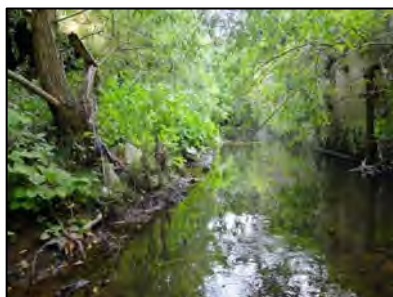
Looking upstream. Note trashline approximately 1.4m above baseflow

Straight section. Trash line visible on both banks, noticeably on willow where material caught at ~1.4m above baseflow. Partial shading.

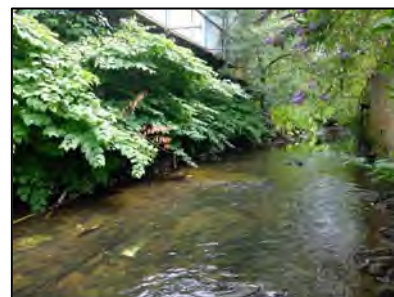
Looking upstream showing overhanging structure on right bank

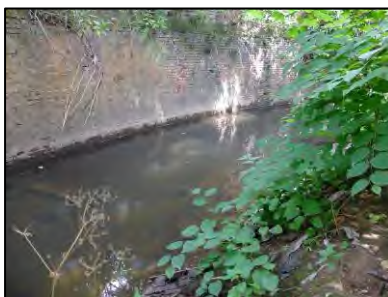
Outer meander showing right bank base of building

Upper section 8m wide, narrowing to 4m. Deeper channel up to 1m deep on the outside of the meander at base of right bank building with sluggish flow. Partially shaded.
