**Mayfield, Phase 1**  
EIA Volume 2

September 2019

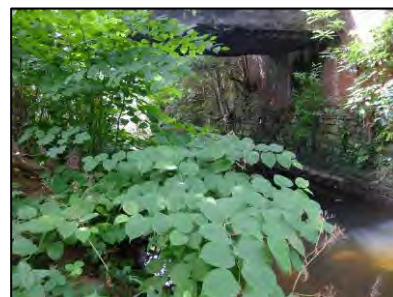
Left bank sandy bank showing base of bridge

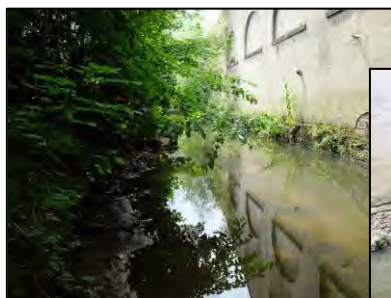
View downstream. Base of building forming right bank

Clear evidence of overbank flooding indicated by trash lines and rippled sandy surface on left bank. Partially shaded.

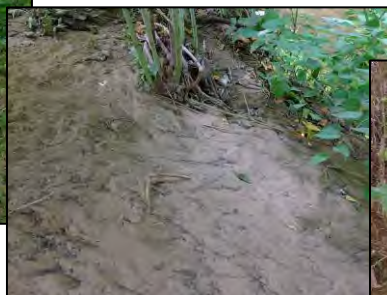
View upstream with right bank in foreground

Ripples in sandy left bank approximately 1m above baseflow indicating overbank flooding

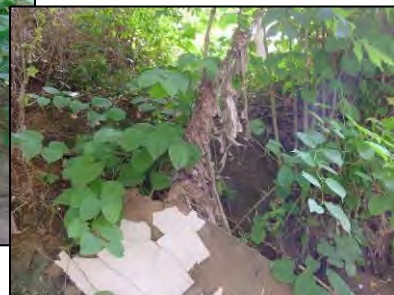
Trashline on the left bank approximately 1.5m above baseflow

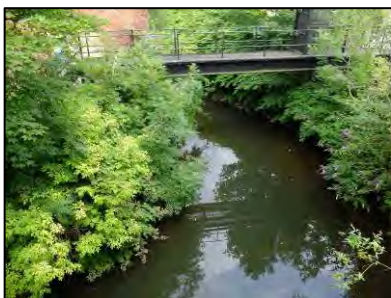
View upstream

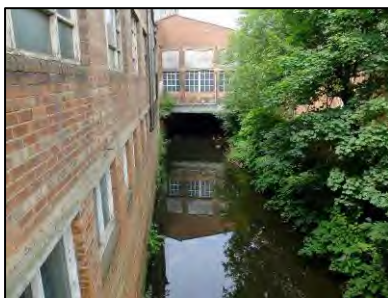
View downstream

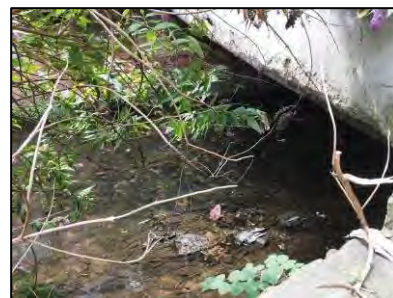
Entrance to culvert

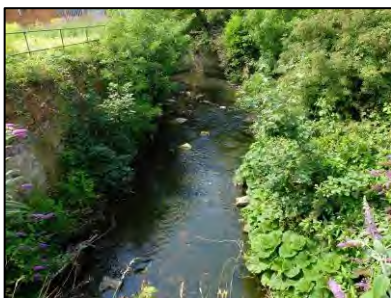
View downstream from top of the culvert

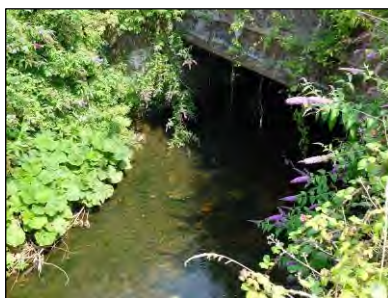
View upstream of culvert exit

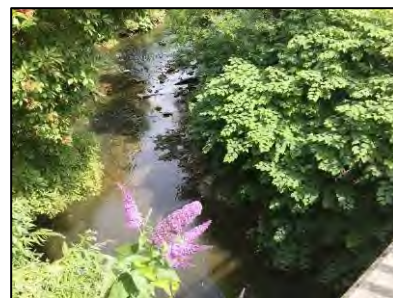
View upstream from road bridge

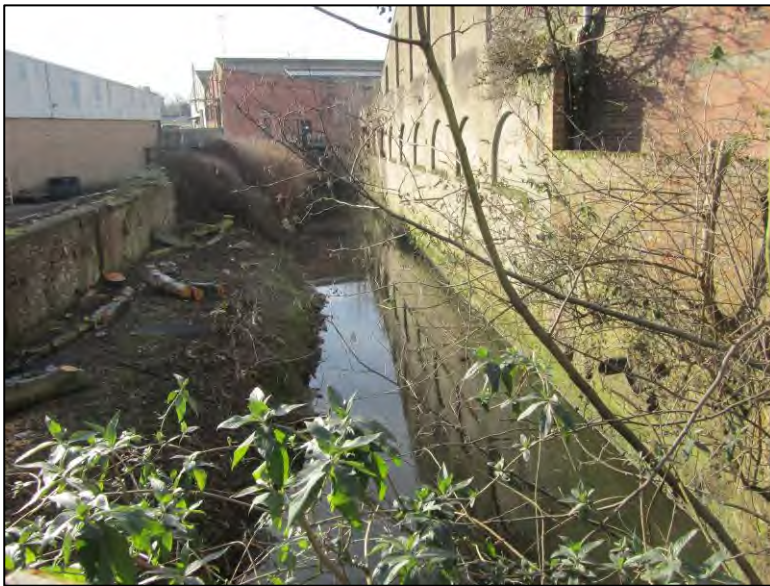
**Plate 5**

**River Medlock looking  
downstream. Felled trees on  
left bank**

- 3.35 A number of scattered broadleaved trees were present in 2016, ranging from immature to mature and comprising a variety of species including ash, sycamore and willow. These are mostly self-seeded. Mature trees also occur along the south-eastern boundary with the Mancunian Way, where they remain today as a row of planted poplars. They are approximately 15m in height and appear to be in good condition. Another area of planted trees occurs at the far western end of the site, associated with a small amenity area.
- 3.36 The River Medlock runs through the centre of the site and the edges of the river corridor were lined with a range of tree species, including ash, sycamore and elder. However, at the time of the 2019 survey these trees had been felled (Plate 5).

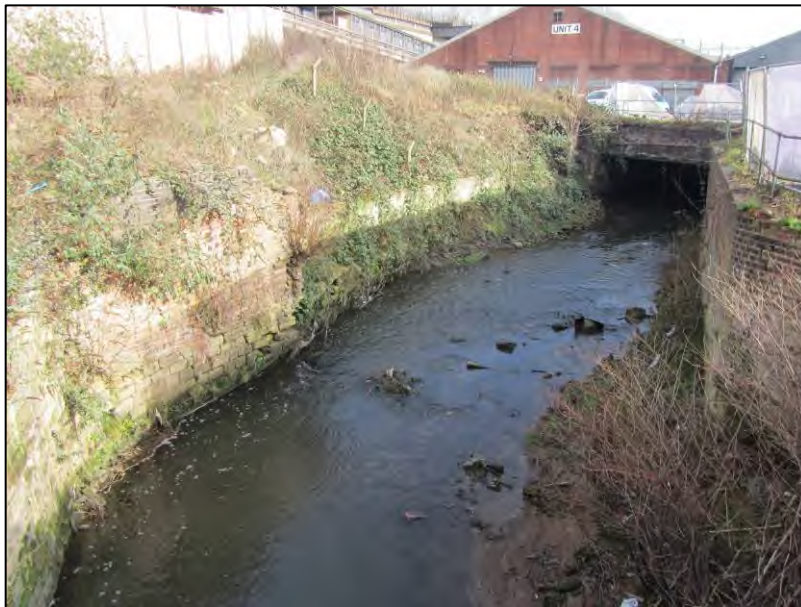
**Plate 10**

**River Medlock looking  
upstream towards culvert  
B24**

- 3.47 The River Medlock runs through the centre of the site. A detailed fluvial audit and Phase 1 habitat survey was carried out in 2017 (PAA 2017b) and the 2019 survey found little had changed. It is incised, heavily engineered and contained by high vertical brick and stone sides. The riparian corridor vegetation is dominated by the invasive non-native species Japanese knotweed and Himalayan balsam. There is no in-channel aquatic vegetation (Plate 10).

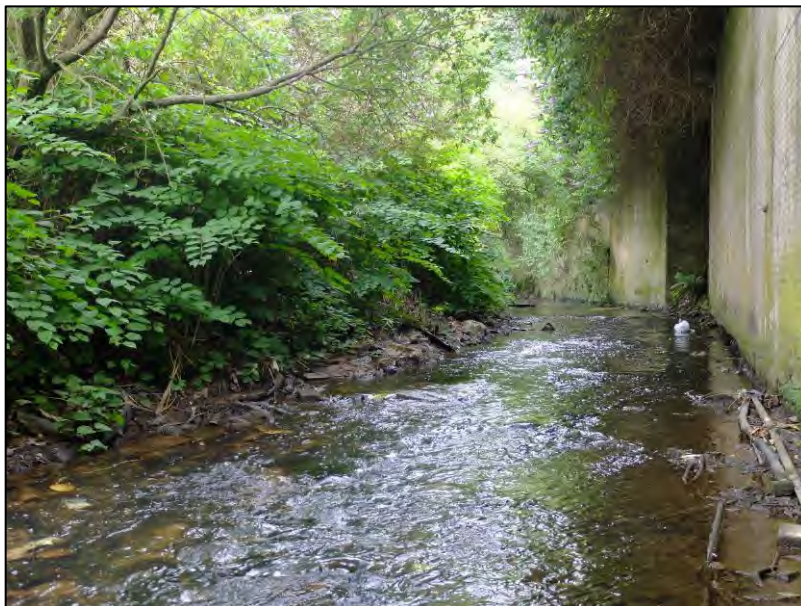
**Plate 11**

**River Medlock showing  
dense stands of Japanese  
knotweed (August 2017)**

- 3.48 Four species listed on Schedule 9 are present within the site: Japanese knotweed, Himalayan balsam, wall cotoneaster and Himalayan cotoneaster.
- 3.49 Japanese knotweed is present on the silt banks of the River Medlock in a number of locations. The extent has been mapped as part of the river corridor survey (PAA 2017) (Plate 11). Japanese knotweed was not found to be present in any area of the site outside of the river channel.

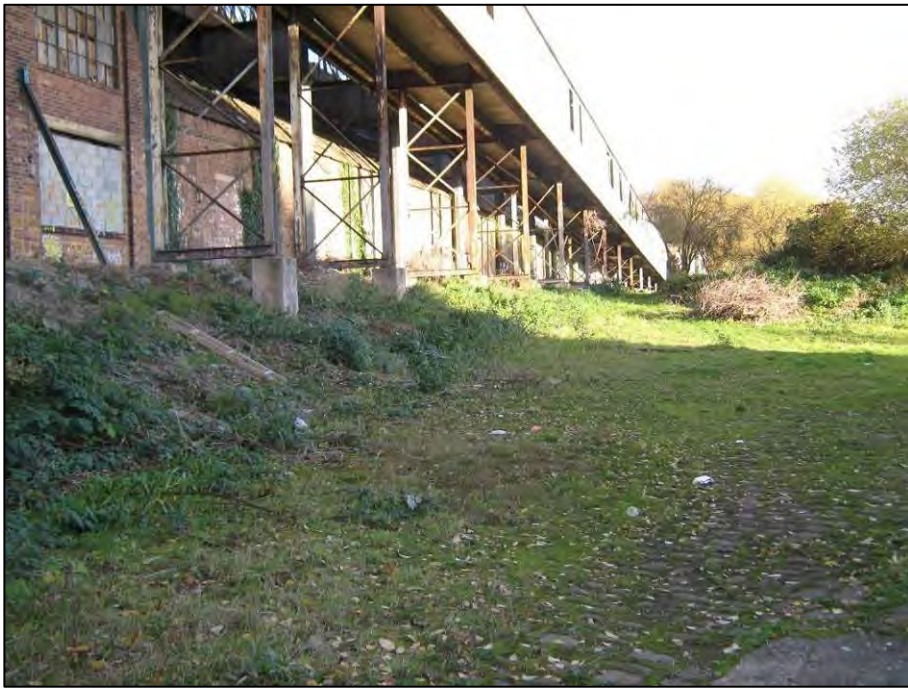
Plate 1 Southern side of B2 – roost entrance identified towards end of ramp during earlier survey work undertaken by other consultants during 2014

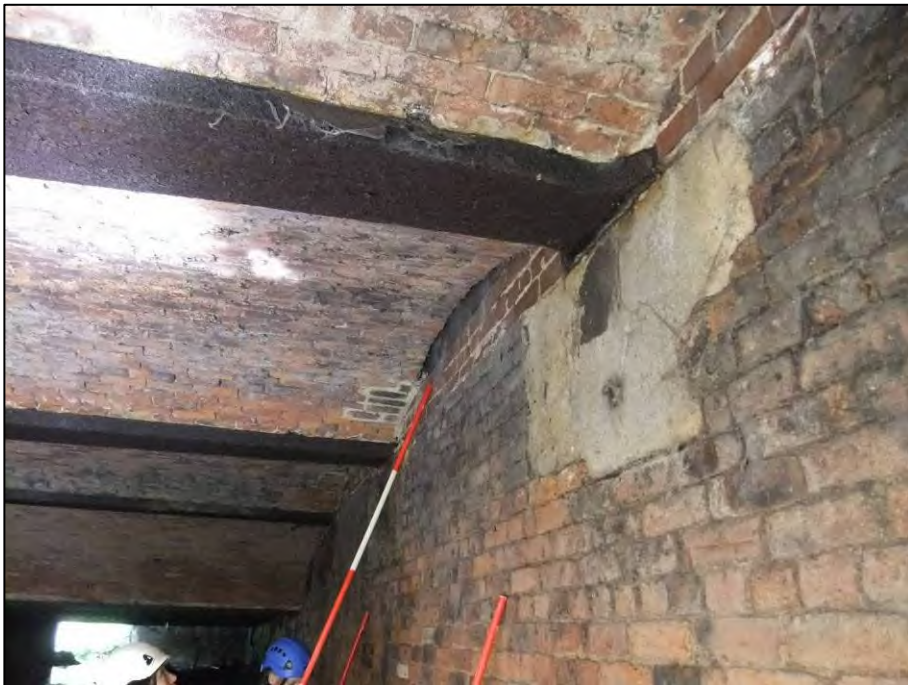
Plate 3 Culvert B24 box section culvert over River Medlock

- 3.6 Culvert B24 was surveyed from the upstream end, entering the river via the B4 warehouse off Baring Street and walking downstream through the tunnel. The stream channel was accessible throughout but a lot of debris, including tyres, fabric and construction materials, was present within the channel. The culvert itself was box-section (Plate 3), with metal girders supporting brick arches perpendicular to the stream (Plate 4). The culvert walls were mainly brick with sections of stone and concrete (Plate 5). The walls appeared to have been modified considerably since construction. No maintenance has been undertaken recently and there were many cracks and crevices that bats could access, particularly in the junction between the walls and the roof (Plate 6), although relatively few were more than superficial. Occasional resting moths were noted and spiders (including old cobwebs) were abundant in more sheltered cavities in the roof, indicating that waters rarely reach these levels.

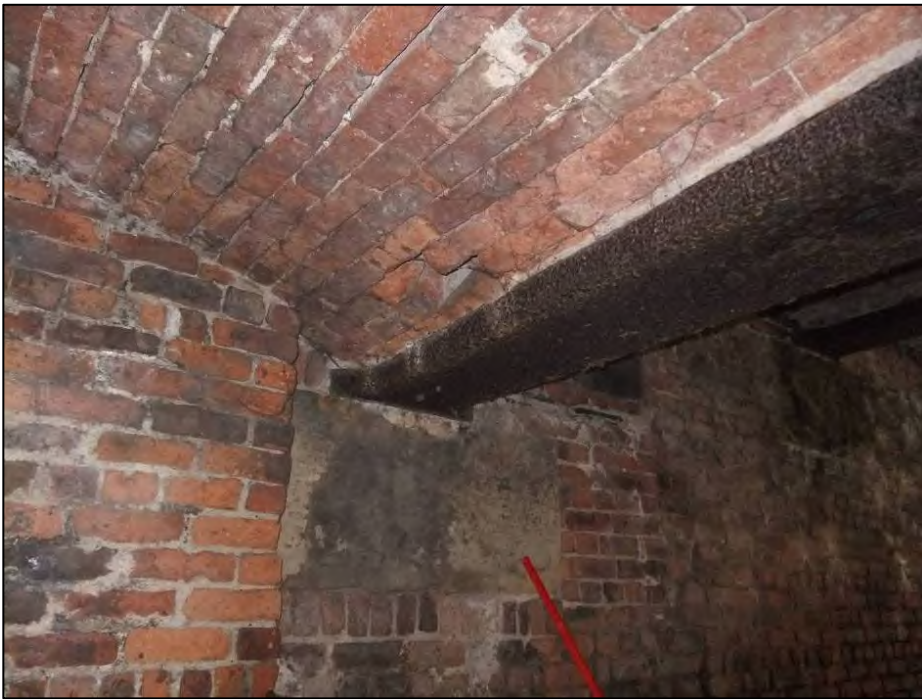
Plate 4 Culvert B24 showing gaps at junction between wall and roof

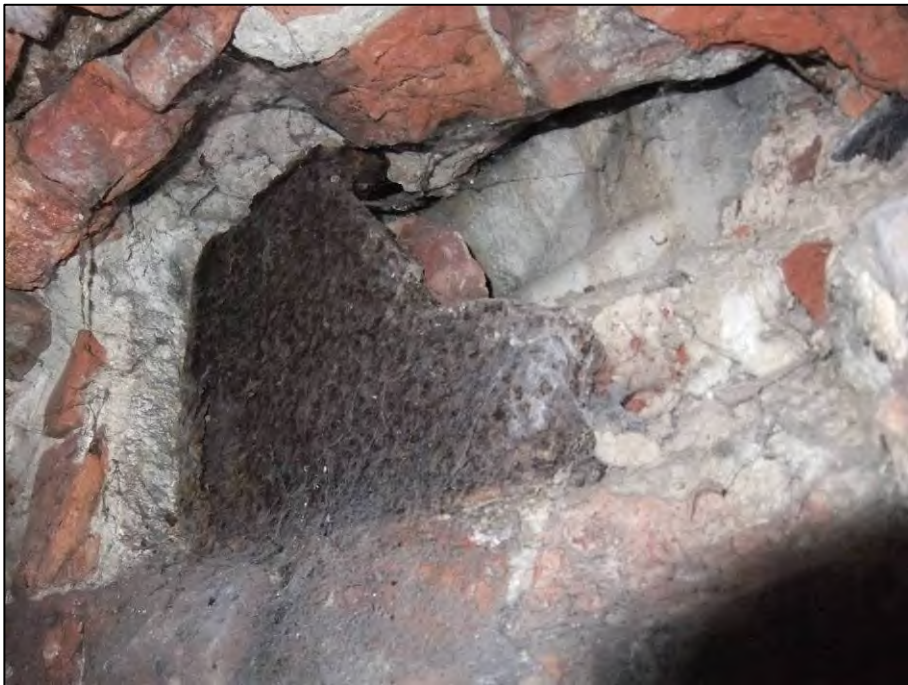
Plate 5 Culvert B24 wall of mixed materials

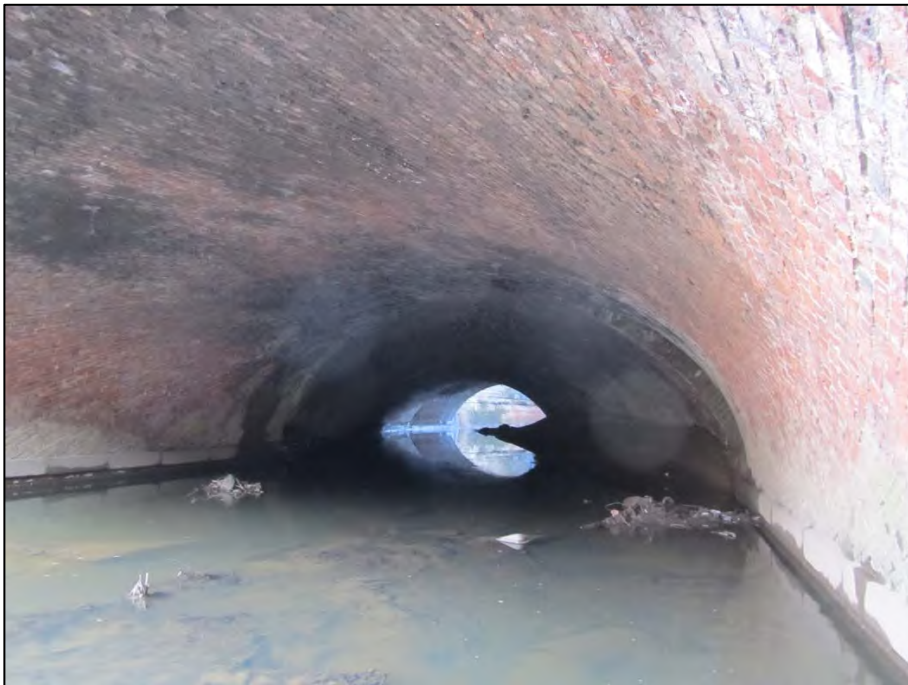
Plate 7 Culvert B26 looking upstream, showing on-site headwall. Brickwork largely intact with few crevices (February 2019)

- 3.8 Culvert B26 is an arched structure with dressed stone lintel and brick interior and headwall. Sidewalls are also of brick. Some opportunities for bat roosts were apparent in gaps in the headwall at the downstream end (Plate 7). Further in, the culvert is a vaulted brick structure, which extends to a longer section under the railway lines into Piccadilly Station, north of Temperance Street. On internal inspection the brickwork was intact throughout and in good condition. Mortar was intact and the roof and walls heavily cobwebbed and conditions indicated that the interior of culvert B26 would not be very suitable for bat roosts, as the condition of the brick is good and crevices were few. Inspections of the headwall and the junction with the culvert revealed no evidence of bats and low suitability for roosting. This is because cracks were either damp, shallow or filled with soil, making them less attractive to bats for roosting (Plate 8).

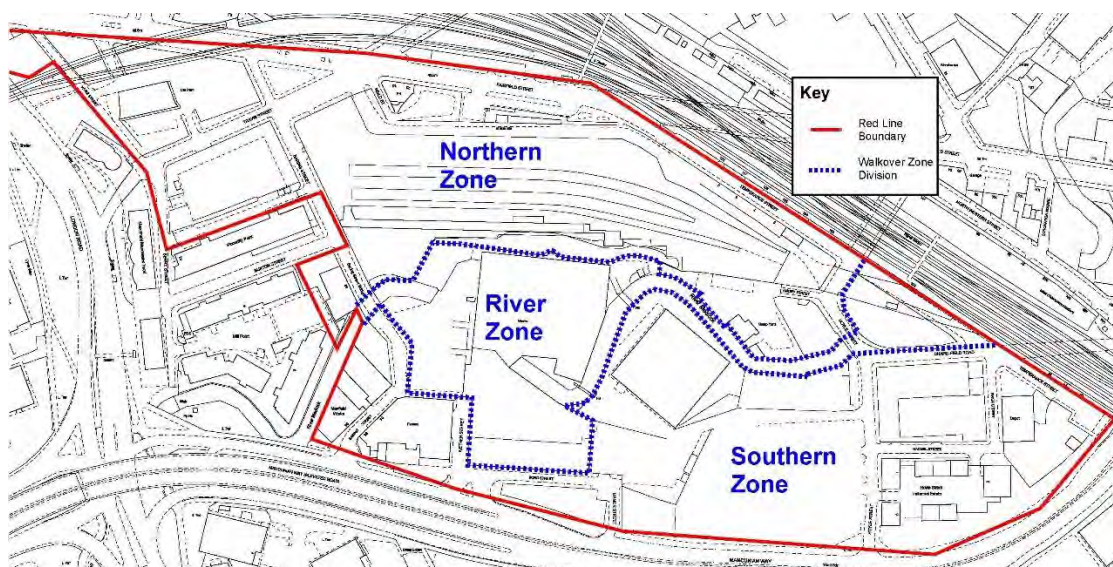
**Figure 2-1** Division of the Site into zones.

The Site walkover survey was carried out on 4<sup>th</sup> July 2017, in mild and overcast weather conditions and was generally limited to external areas, though all external areas were accessible. Philippa Hunsworth and George Mitchell from Buro Happold attended, and were escorted around Site by Jonathan Such (JS) of U+I. An annotated plan showing points of interest identified during the survey is included as Appendix E. To describe its variable nature, the Site has been divided into three zones: northern, southern, and the river zone, for ease of reference (Figure 2-1 refers).

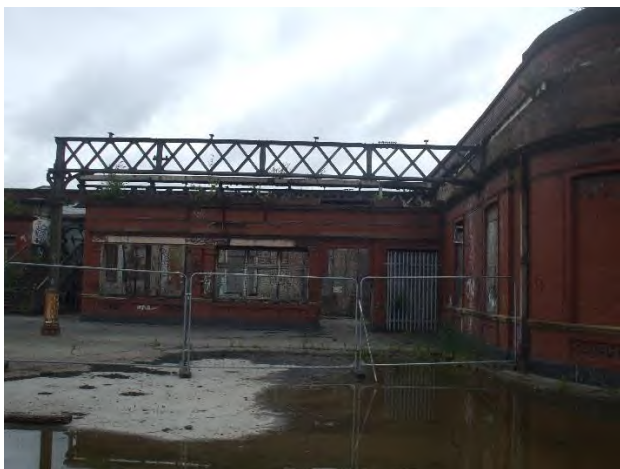
Photograph 7

- Dilapidated old station buildings in western corner of platform. Heras fenced off. (Photograph 7)
  - 2 No. tracks with stoppers at western end. Overgrown.

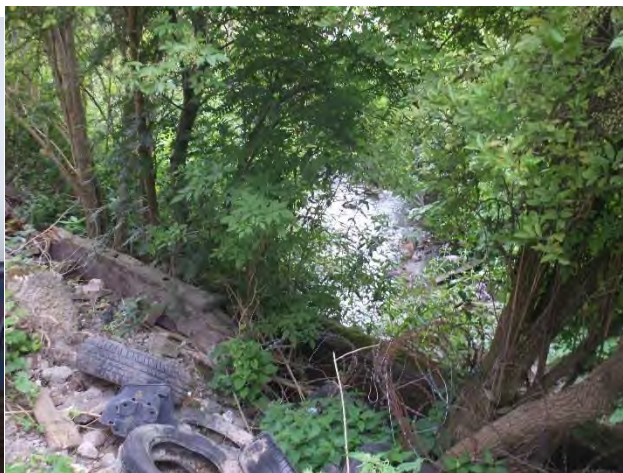
Photograph 10

- Through a gate to the south of the compound: Heavily overgrown area adjacent to the River Medlock, which is at a lower level. Fly tipping (old tyres, brick and concrete rubble) present. River wall in poor state of disrepair. Knotweed present on riverbank but not noted on upper level. (Photograph 10)

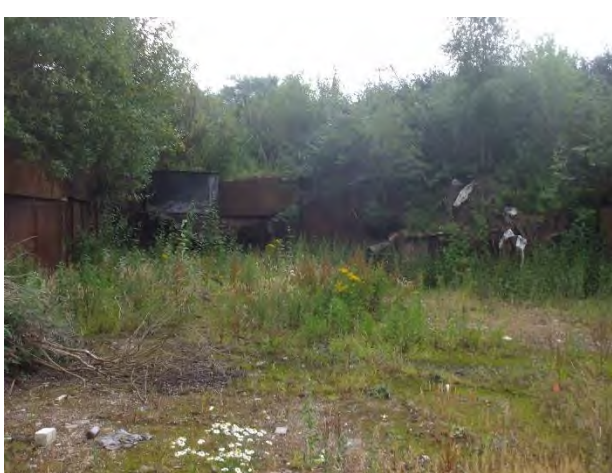
Photograph 11

- Western area: Former scrapyards, now vacated. Metal structures, ~2 m high, present around the edge of the Site, filled with Made Ground/fly tipping. (Photograph 11) Vacant industrial building in west of yard, joined onto Mayfield Station.

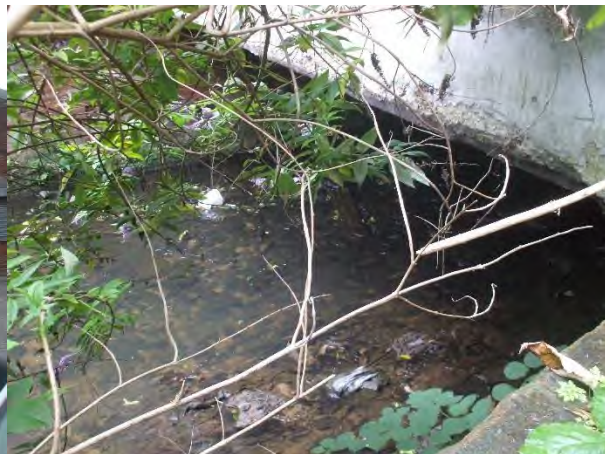
Photograph 14

- Transport for Greater Manchester (TFGM) building area
  - River Medlock is culverted under the car park area.
  - 1 storey brick/steel industrial building (Photograph 13). River Medlock is culverted under the building (Photograph 14). Multiple units:

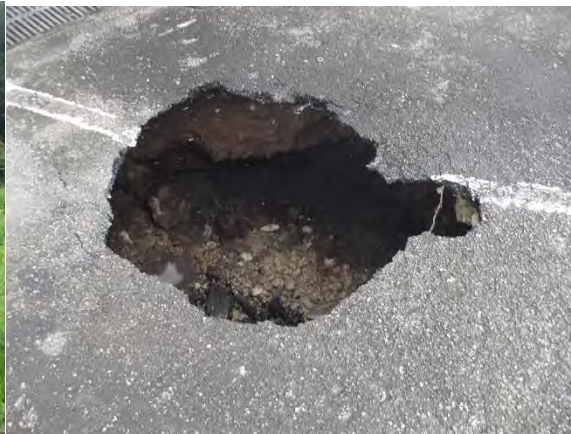
Photograph 16

- Void recently opened up in car park outside Unit 4 (Section 3.5 refers). Cordoned off by barriers at time of walkover. (Photograph 16)
- Area north of Chapelfield Road and east/south of Hoyle Street: Yard with vehicles parked (including tracked excavators). Sign outside advertising 'Free tipping of clean hardcore'. River culverted under this yard. (Photograph 17)

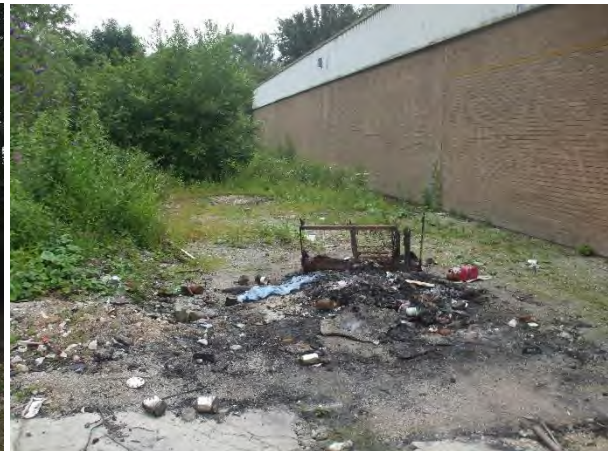
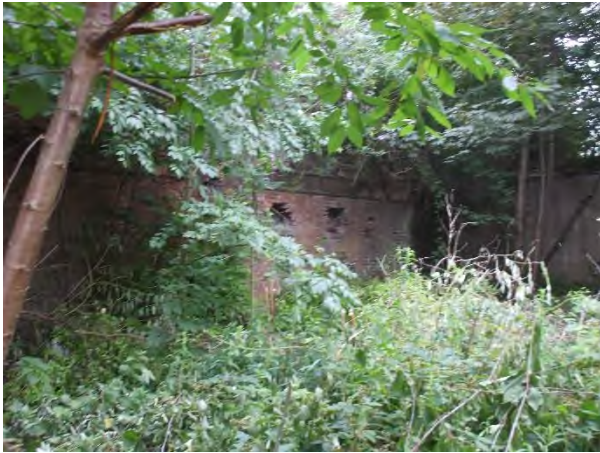
Photograph 21

- N and E of building: Overgrown. Fly tipping and evidence of burning (ashes, charred material). Brick/concrete walls border the plot in the eastern area; poor state of disrepair. (Photographs 21 and 22)

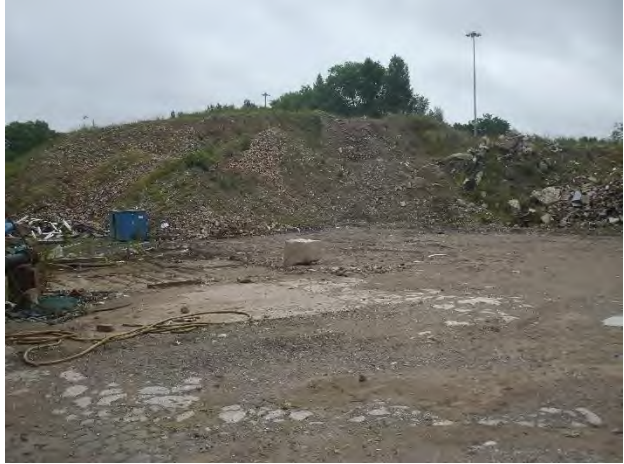
Photograph 25

- East of Manor Street: Wooded area with large amount of fly tipping (Photograph 24)
- East of Hilclare car park and west of Hoyle Street: 'Delaney' Site. Yard area, hoarded off. Material stockpiles ~3 to 5 m high comprising both apparently screened and unscreened material, demolition rubble, piles of whole bricks (Photograph 25)

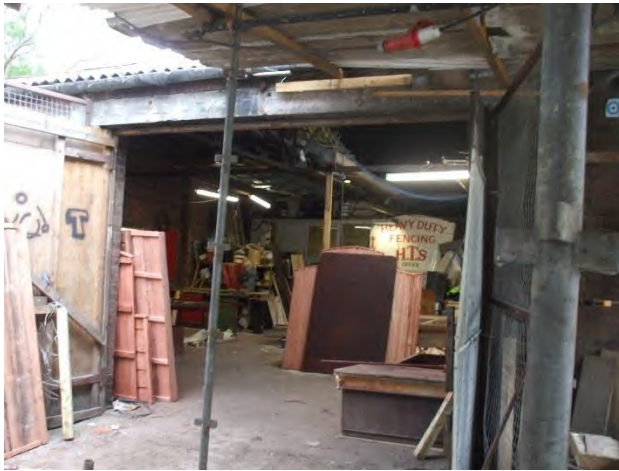
Photograph 27

- JS advised high risk of sharps, needles etc. in the area, and presence of drug users and prostitutes
- Hoyle Street Industrial Estate (Photograph 27)

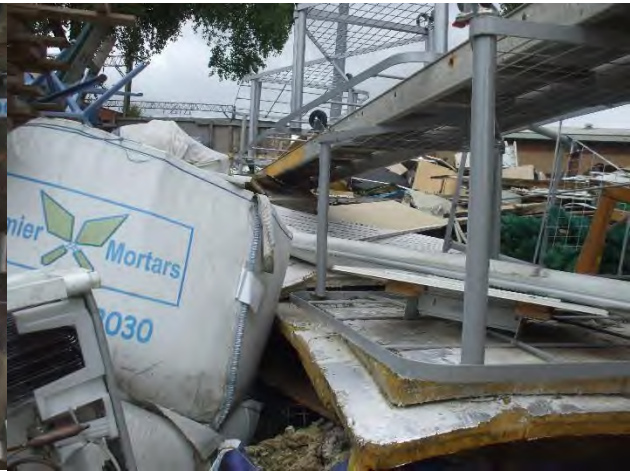
Photograph 28

- Timber yard and car depot
- Western portion of yard full with timber, old vehicles (Photograph 28)
- Eastern portion of yard piled up with doors, oil drums, fridges, rubble, insulation etc. (Photograph 29)

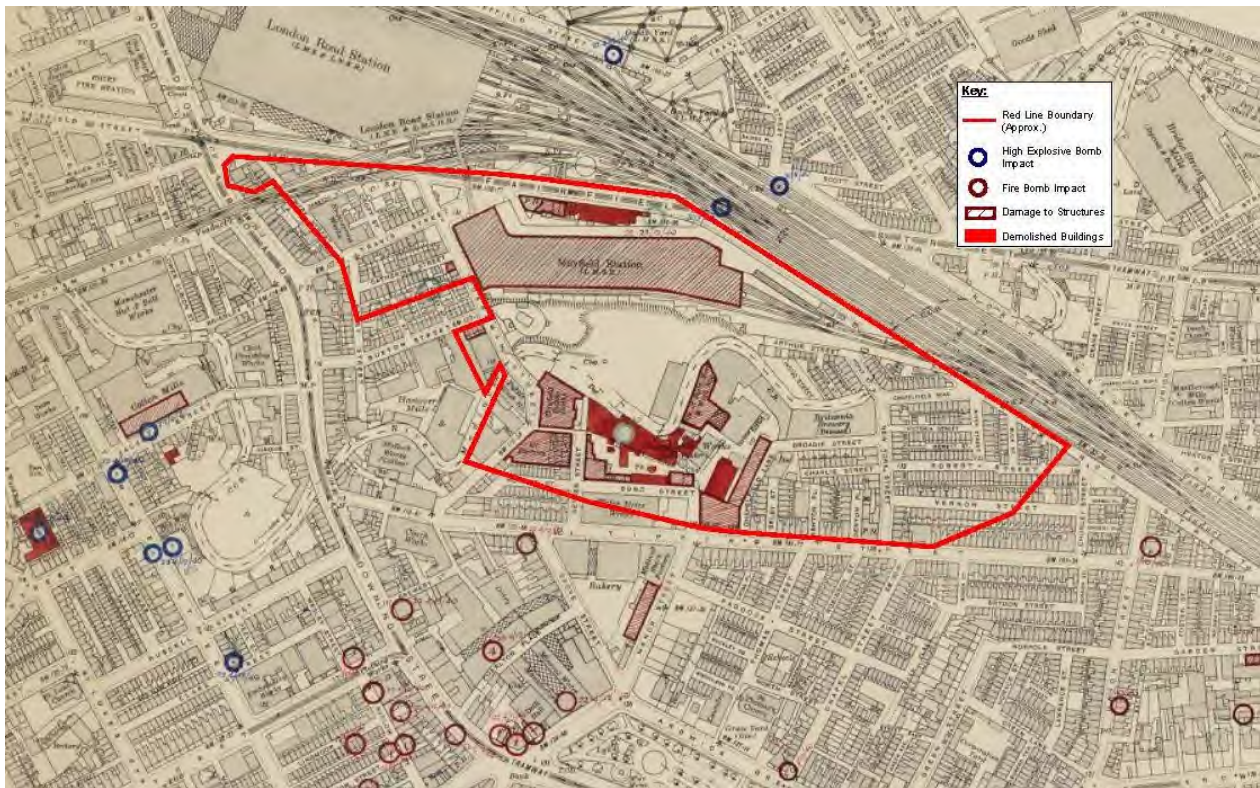
The Manchester bomb map records a number of high explosive and fire bomb impacts in close proximity to the Site, as well as damage to several buildings within the Site (**Error! Reference source not found.** refers). Some buildings, including the Mayfield station building itself, have not been developed since the war and remain on Site.

**Figure 3-1** Manchester bomb map

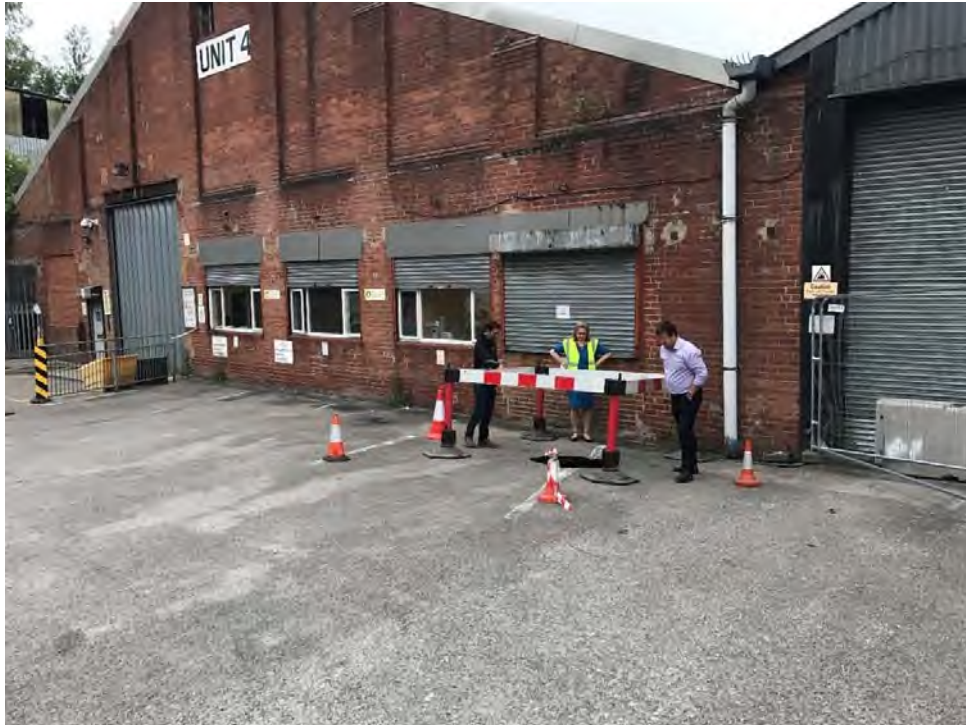
The purpose of the site visit was to identify and determine the cause of the void under the car park present on site. The void is located approximately 1.50 m away from the Unit 4 Building. The void dimensions are approximately 1.50m x 1.00m (length and width, respectively) however there is a degree of undermining beneath the tarmac. The depth is approximately 1.50m bgl. Within the void, it was noted to comprise Made Ground (brick and concrete). There appears to be a concrete slab underlying the tarmac, approximately 300 – 500mm in thickness, which has a type of mesh within/underneath it (slightly unclear due to viewing distance necessitated by health and safety concerns).

1. Location of void under car park

- BuroHappold to supervise excavation around area of void to identify any potential features for the likely cause of the void. – Guy Illingworth can provide contractor next week.
- Depending on the proposed use and time period – removing an amount of the Made Ground in the area and replacing with suitable compacted material and reinstatement of a reinforced concrete slab.

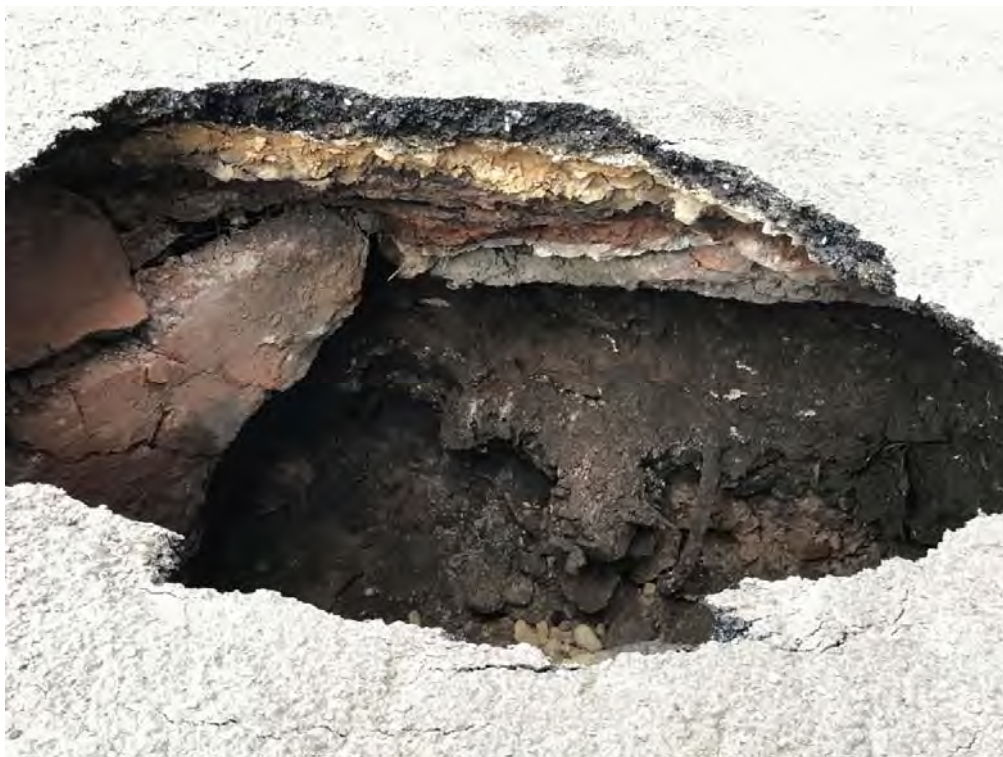
The nearby slot drainage run was tested (water added with a hose) and no evidence of leaks from the drainage was noted into the void, this suggest that the void was not caused by leakage from the slot drain. Site staff suggested that during the winter the greater volumes of rainfall overwhelms the capacity of the drains in the area which leads to overflowing and ponding of water on the tarmac in the area of the void. The undulating nature of the tarmac within much of the northern part of the Unit 4 car park including the area where the void is present suggests that differential settlement of the underlying poorly compacted Made Ground has and possibly is still occurring (best illustrated in image 4 below). This may be in part the cause of the void but it seems likely that the ponding of water in this area may also have contributed to its formation.

2. Void ground profile.

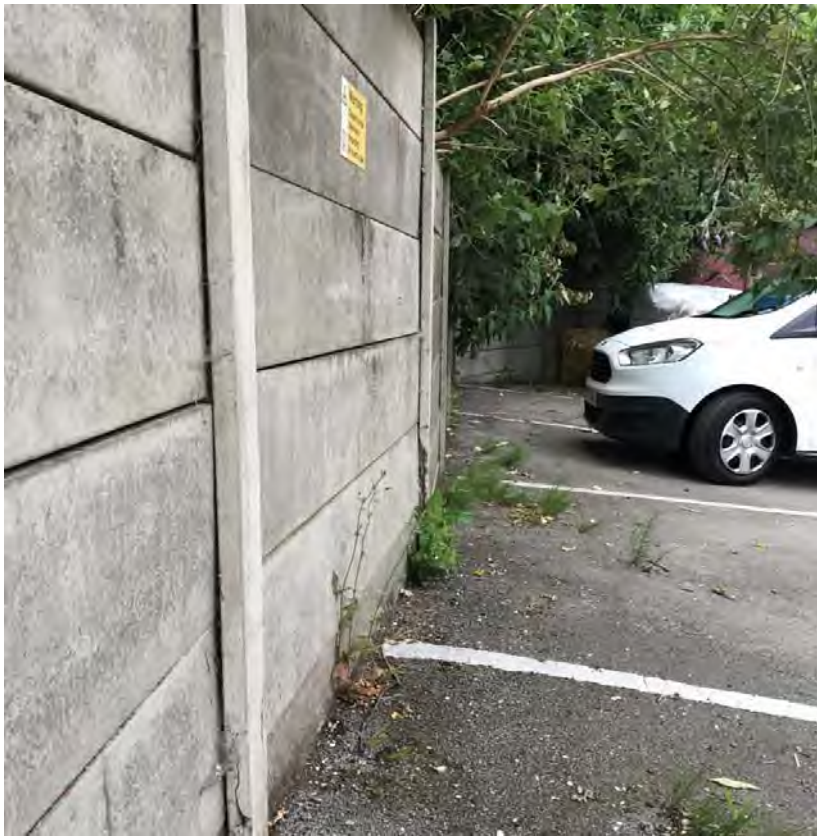
3. Bulging and cracking of retaining wall.

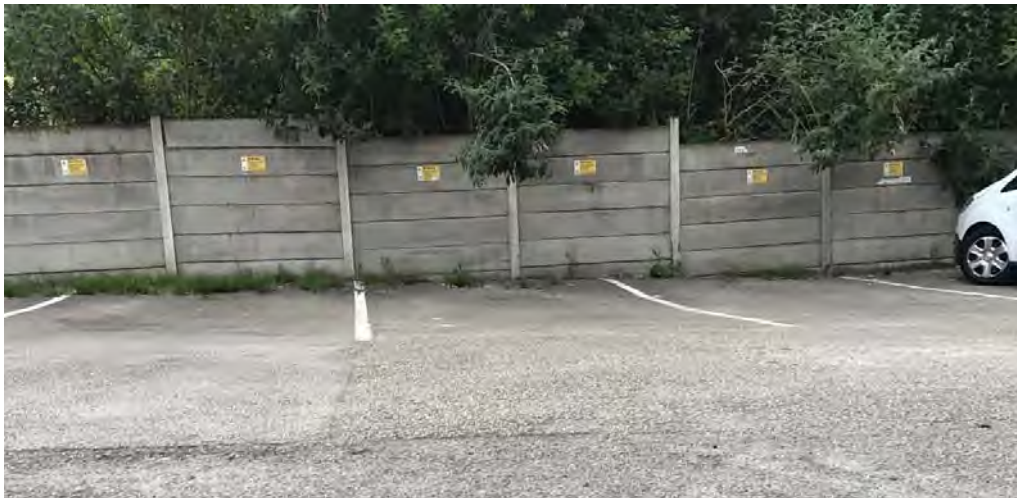
4. Depression in tarmac in front of retaining wall.

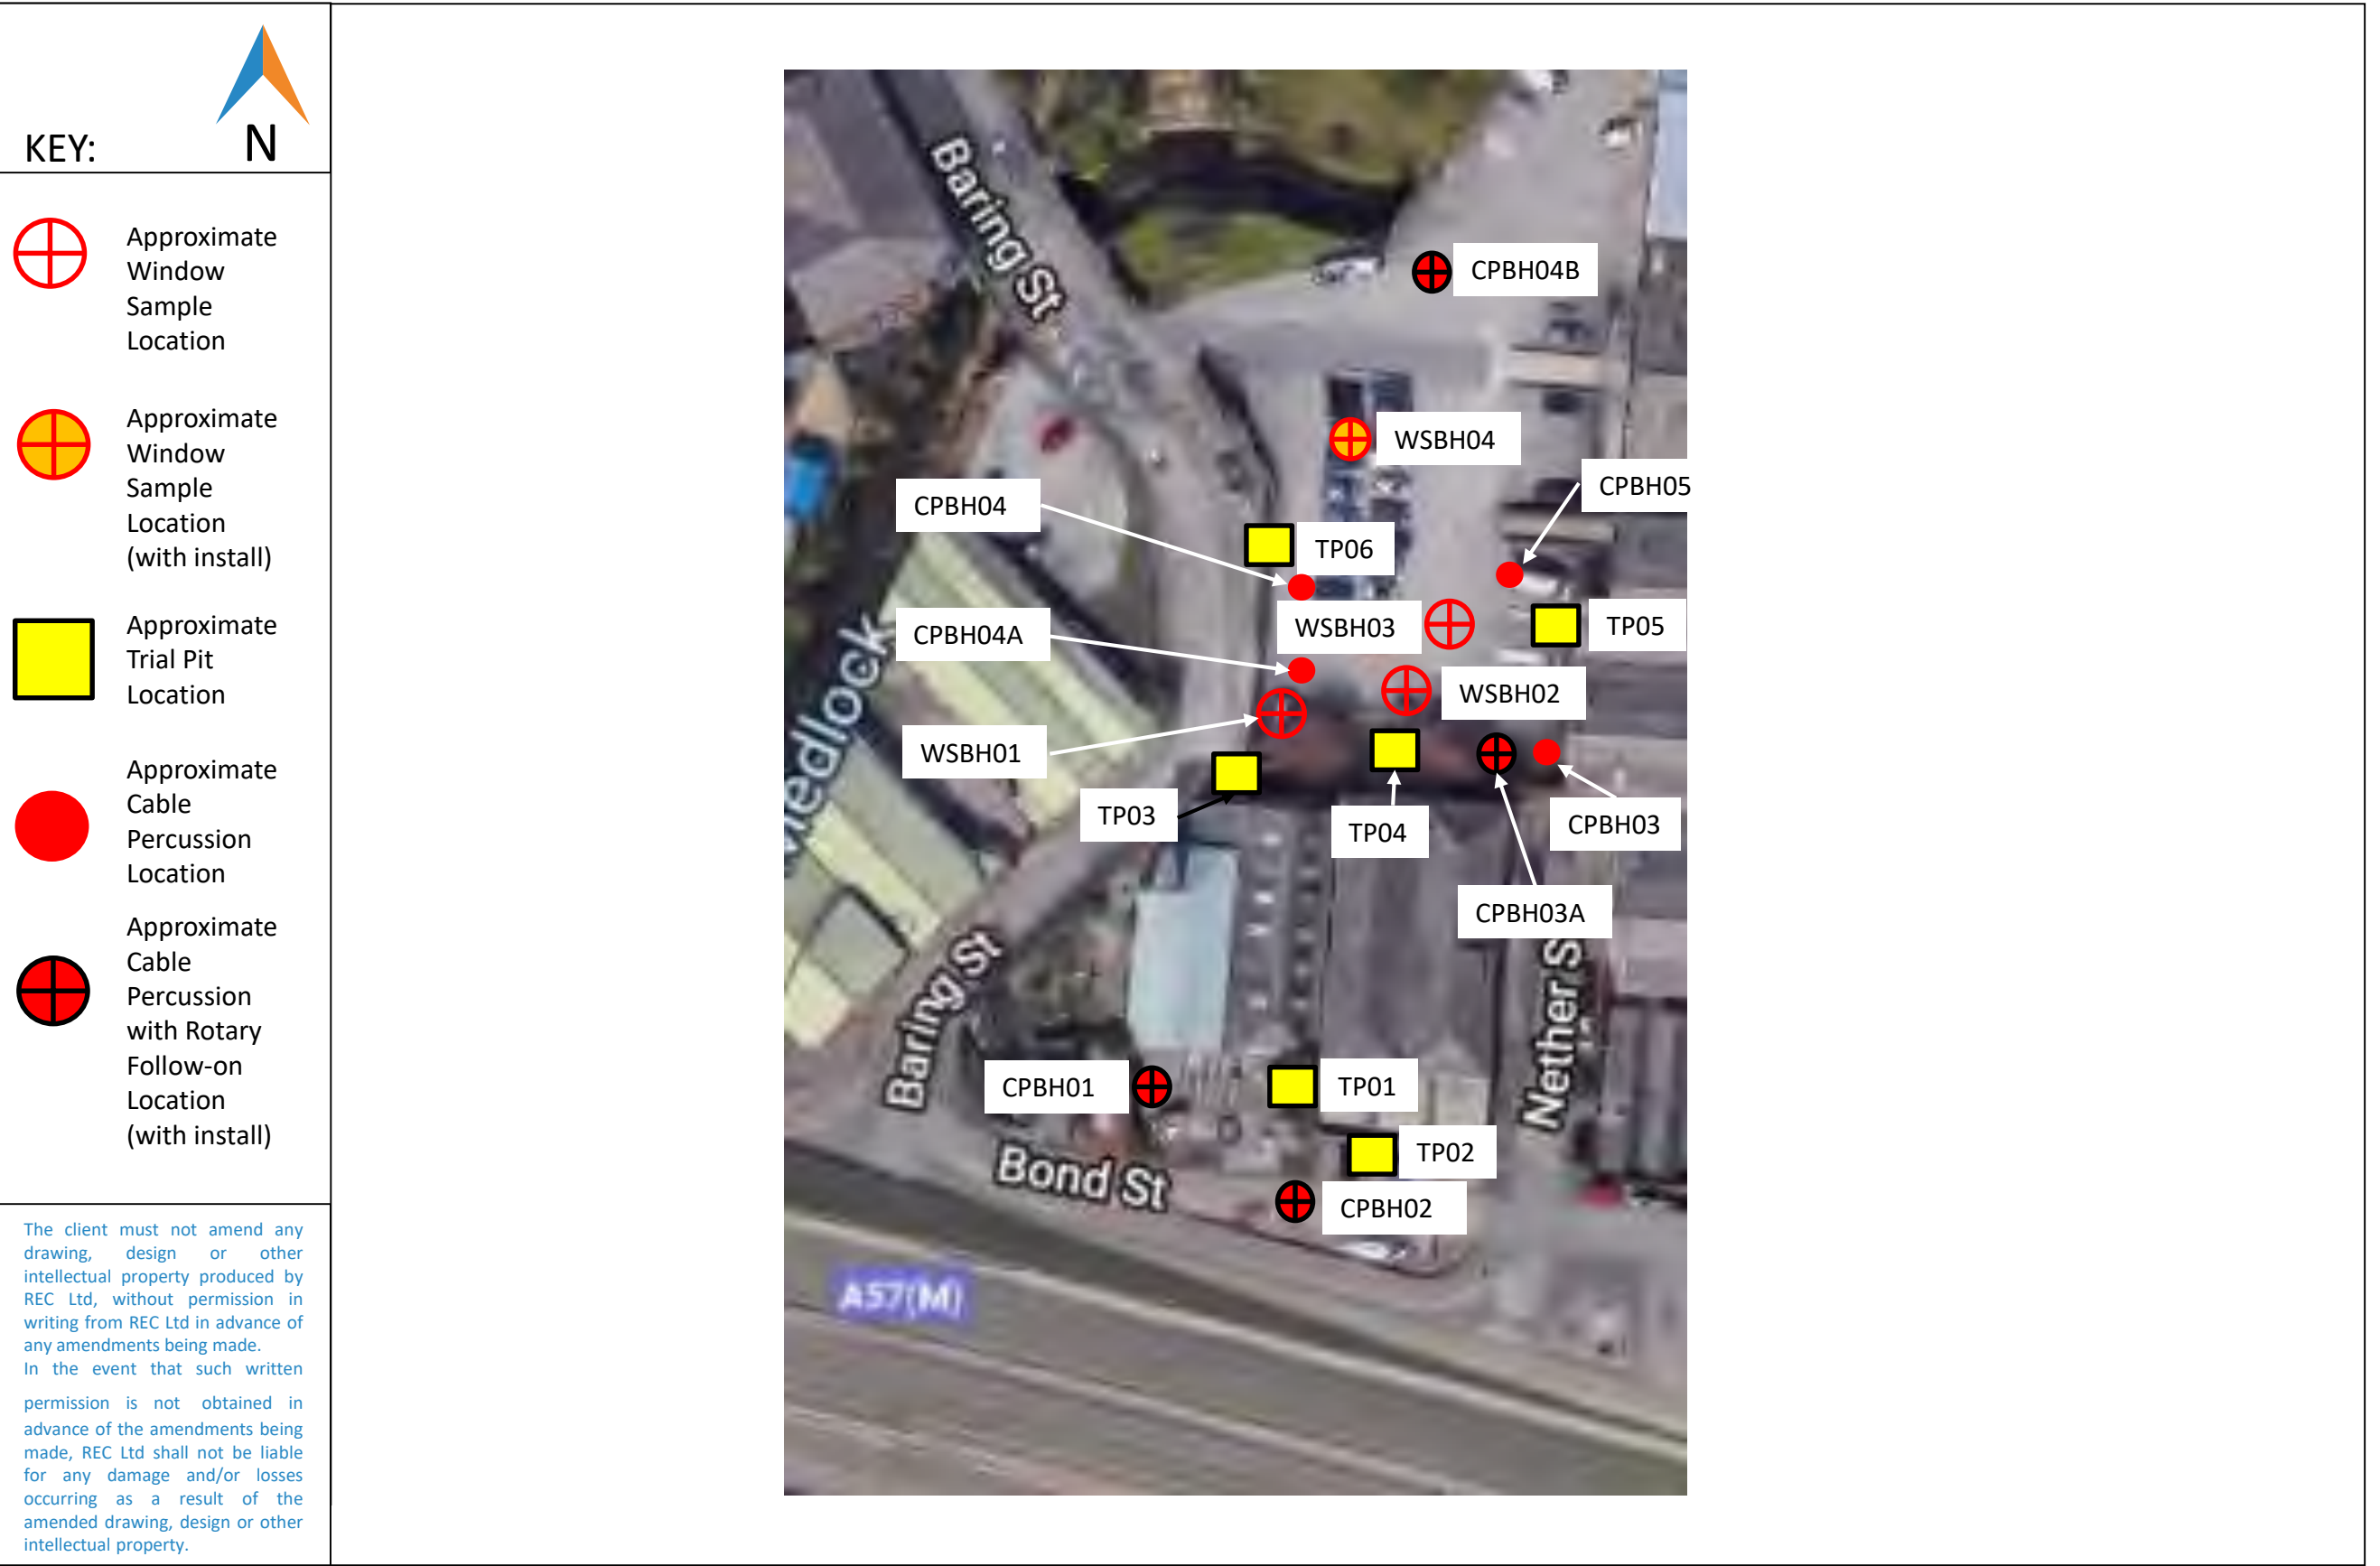
| | REC Ltd<br>Osprey House,<br>Pacific Quay, Broadway,<br>Manchester, M50 2UE<br><br>T: +44 161 868 1300<br>recltd.co.uk | Job Title:<br><br>Plots N+O Mayfield | Client:<br><br>Civic Engineers Ltd | Drawing no. 106841-002 | Notes:<br><br>Not to scale | Drawing Title:<br><br>Exploratory Location Plan |

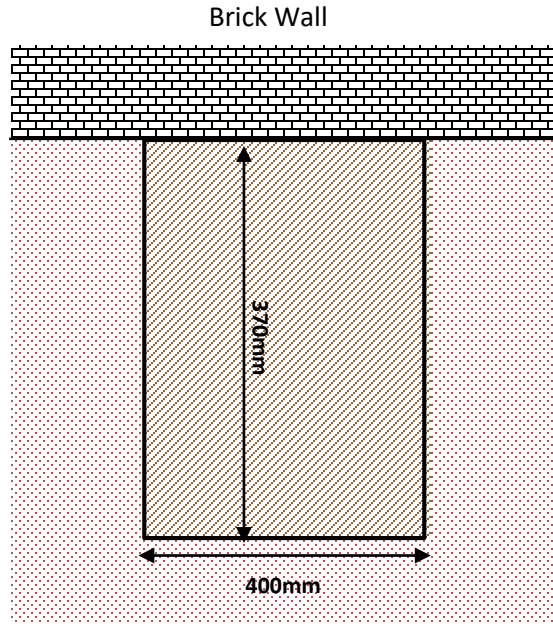
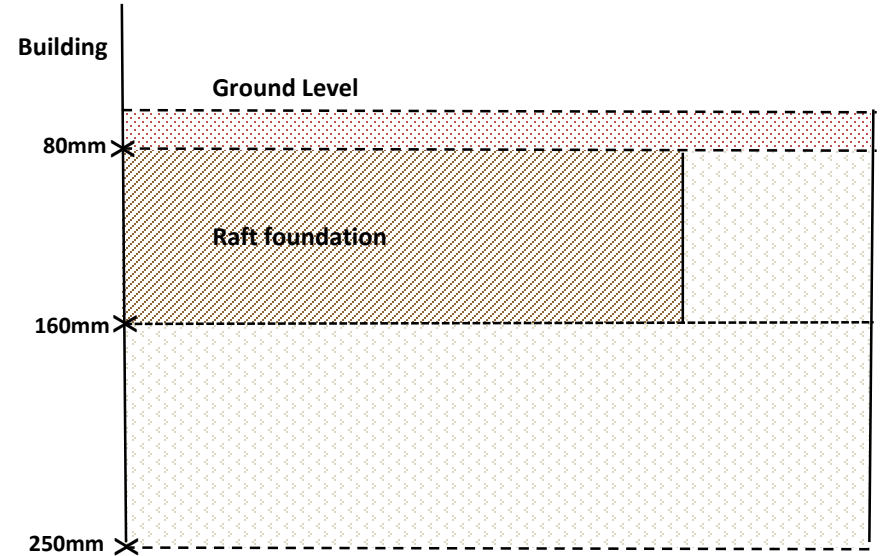
**TP01**

Drawing Title:  
106841 – 001 Foundation  
Inspection Pit Drawing

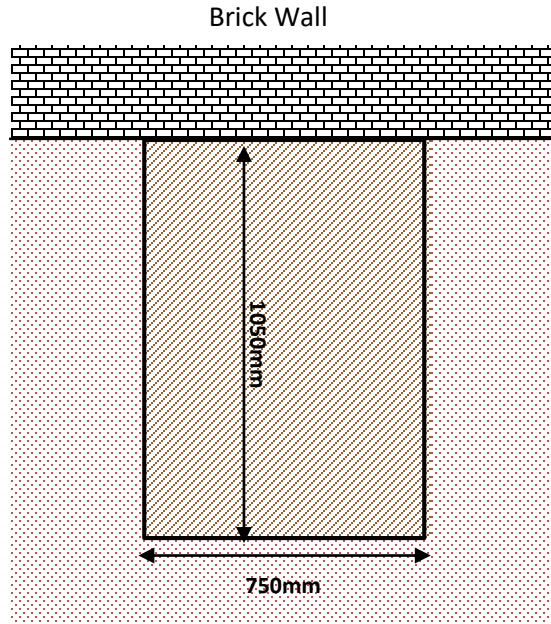
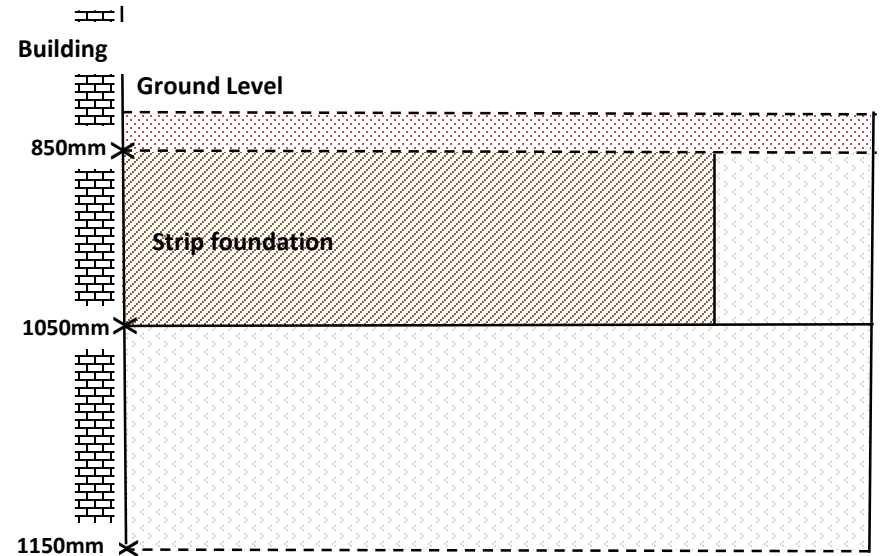
TP02

Drawing Title:  
106841 – 002 Foundation  
Inspection Pit Drawing

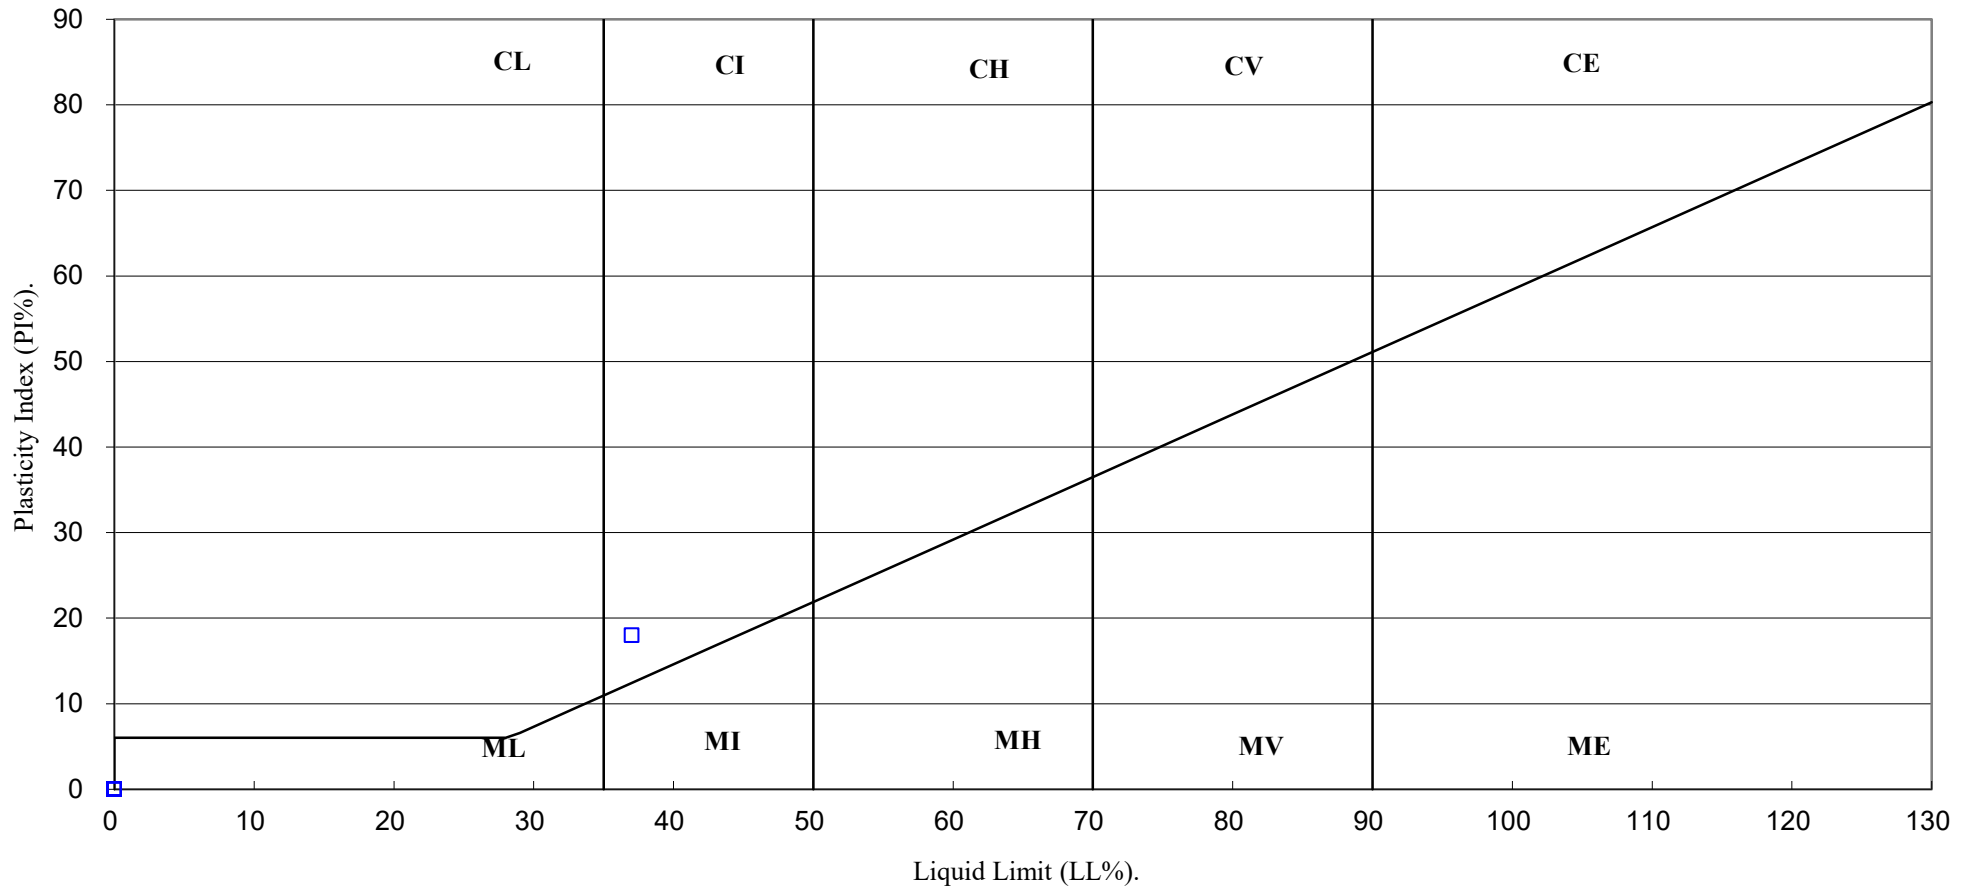
# PLASTICITY CHART FOR CASAGRANDE CLASSIFICATION.
