**Mayfield, Phase 1**  
EIA Volume 2

September 2019

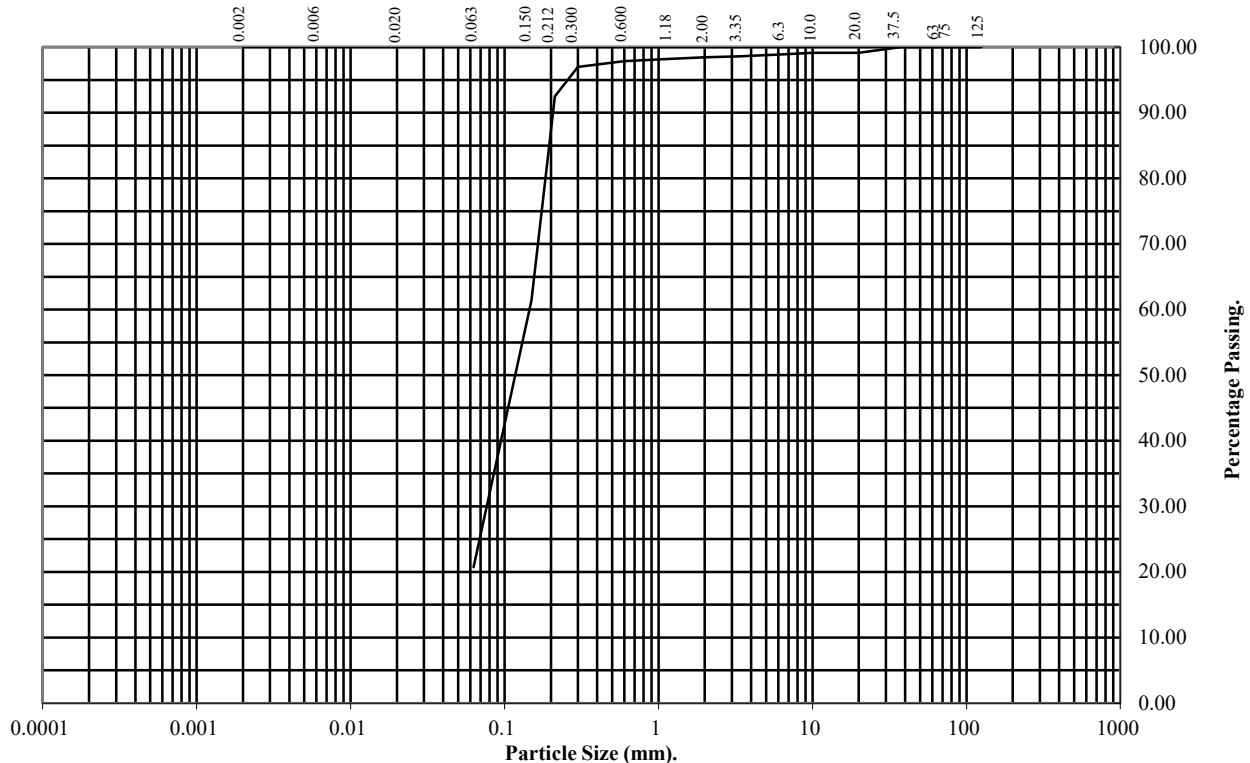
Sample Number: Base Depth(m): 4.70

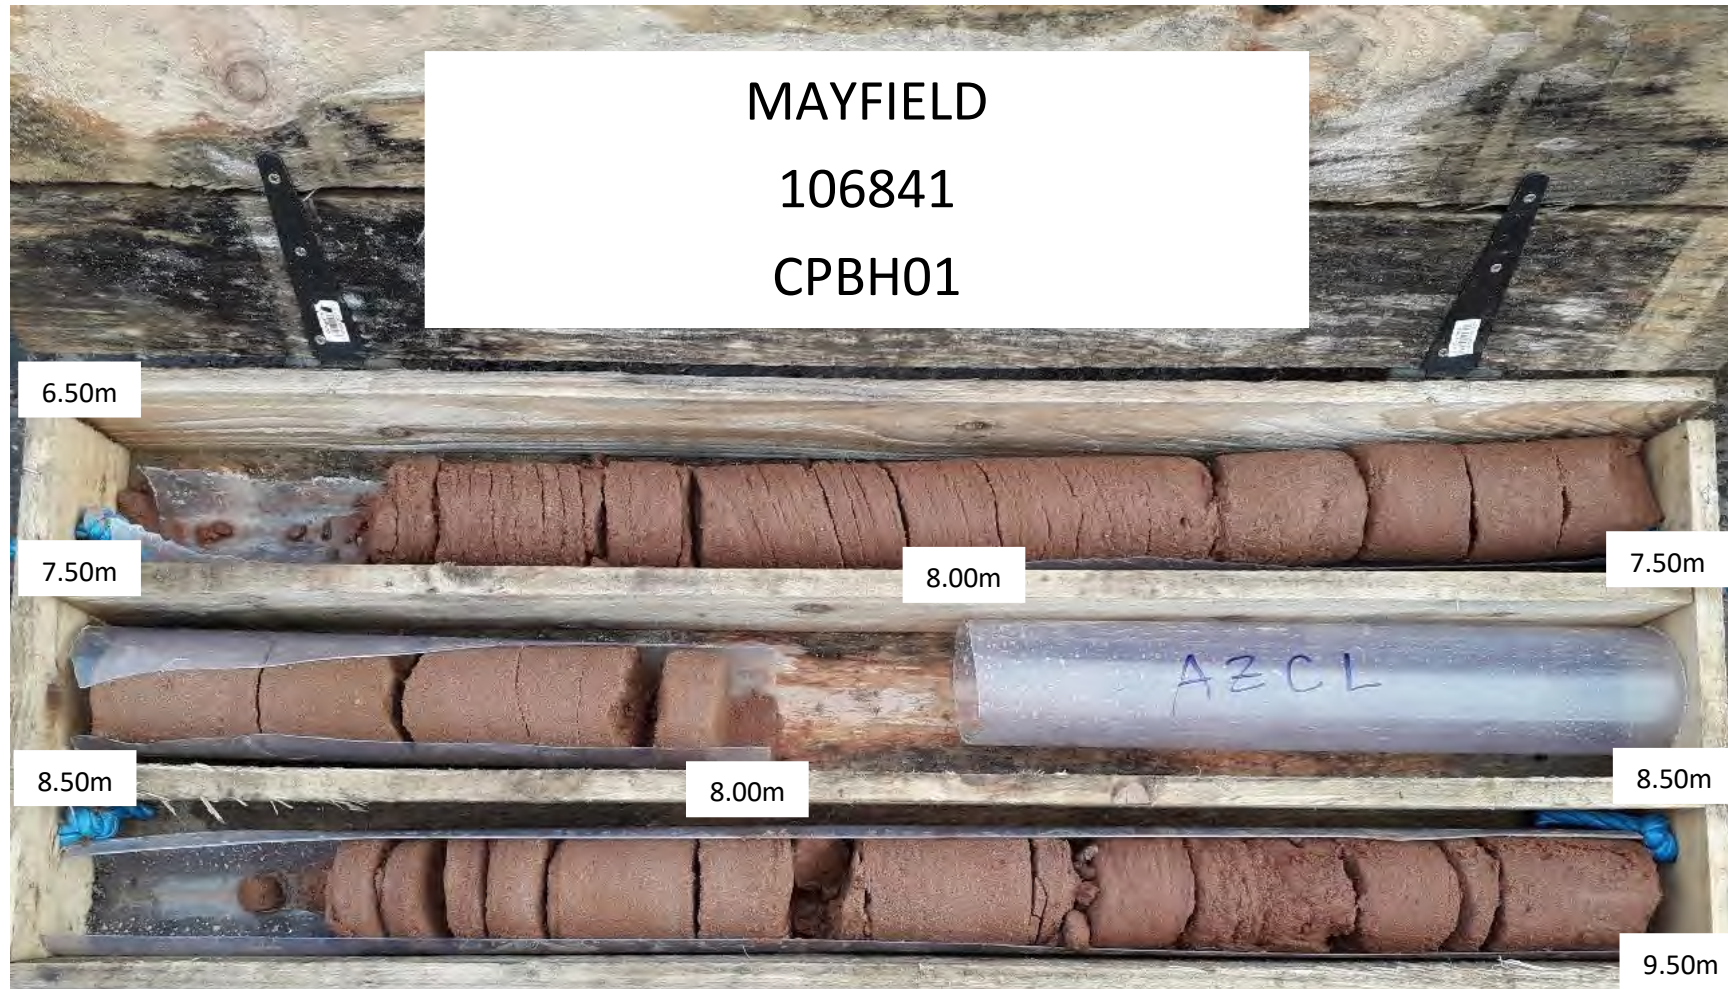
| Core run 1 | 5.00m – 6.50m |
| Core run 2 | 6.50m – 8.00m |
| Core run 3 | 8.00m – 9.50m |

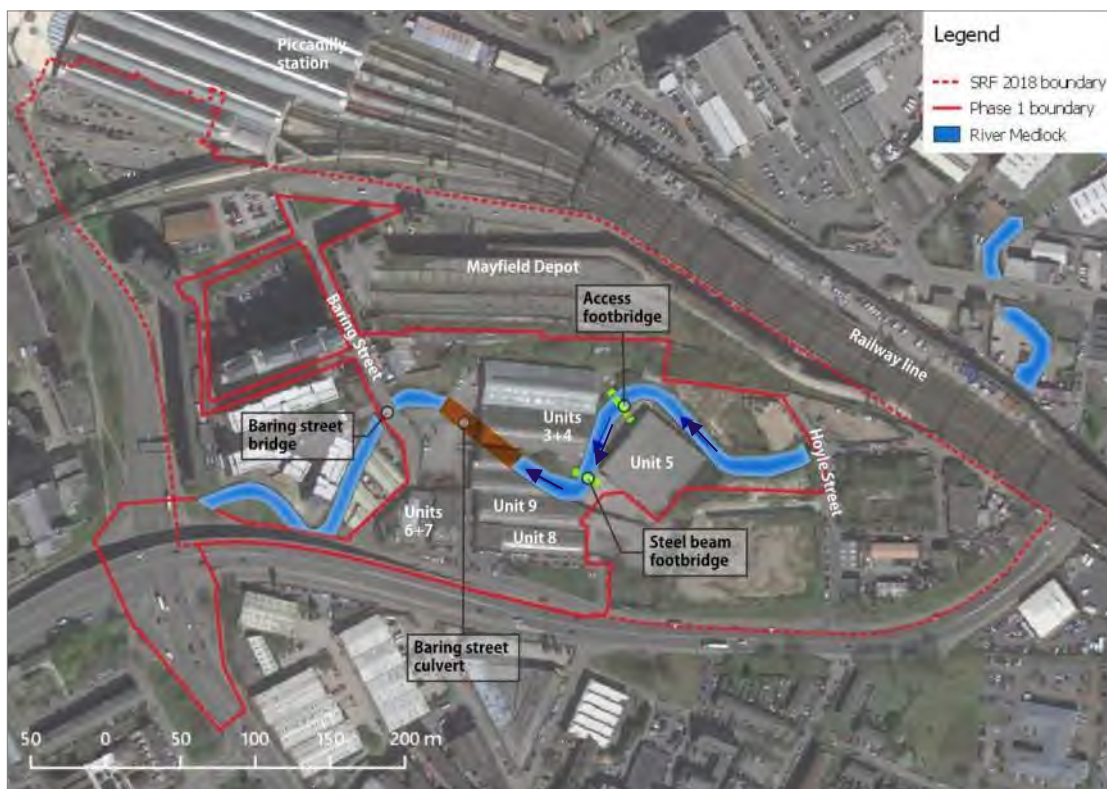
**Figure 1-1 - Mayfield site - existing assets. Open watercourse shown in blue.**

The site is predominantly impervious, currently occupied by low rise warehouses and industrial units, interspersed by open land and surface car park. Small areas of the site are vegetated, the majority of which lie adjacent to the River Medlock. The river flows from east to west through the centre of the site. It is generally contained within a rectangular brick walled channel. Parts of the river have been culverted to allow industrial development. Parts of the site are within Flood Zone 3 in accordance with the Environment Agency (EA) flood maps and EA consultations.

In some sections of the channel the retaining walls also provide support to the external walls of buildings built up to the river's edge. Where this occurs, the river retaining walls are generally in a good condition (e.g. Photos D and I below). The river flows through a box culvert within the central part of the site (see Figure 1-1). This was viewed from upstream and downstream, but not accessed (Photos C and D).

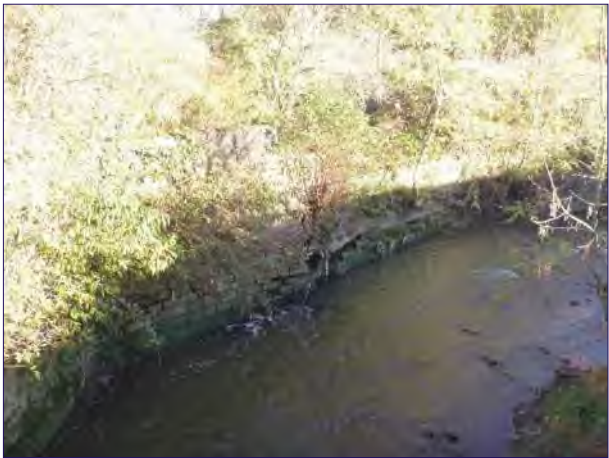
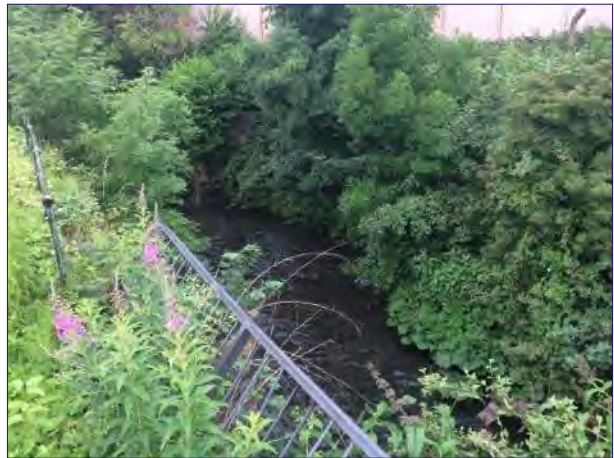
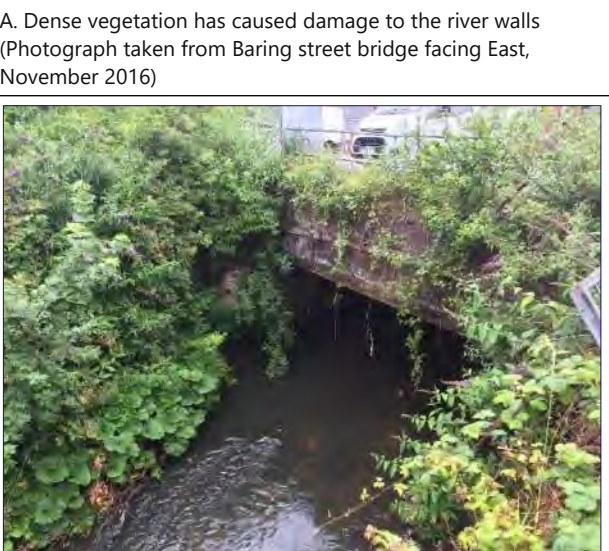
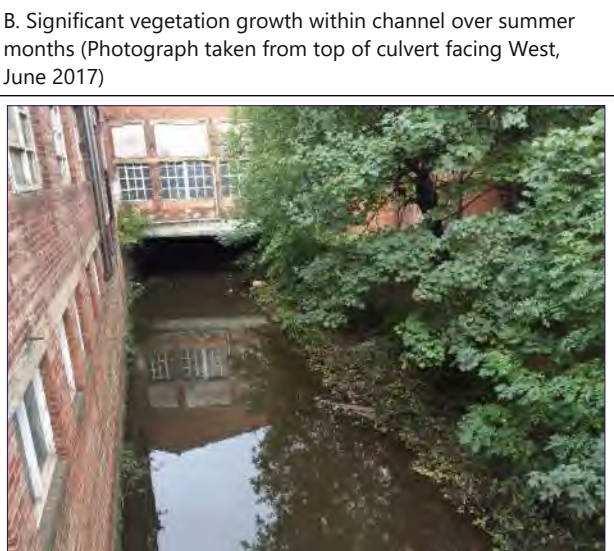
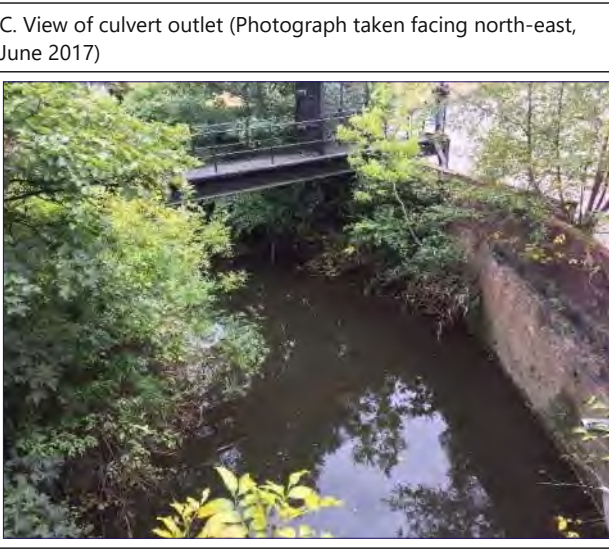
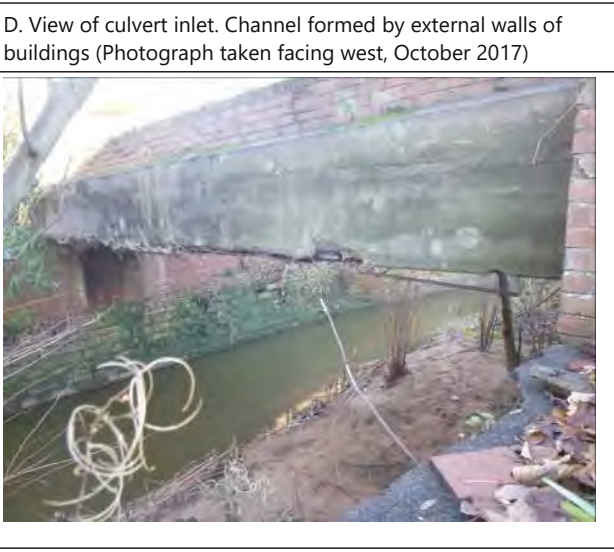
**Table 1-1 - Site visit images**

The condition of the river varies. At the site location, River Medlock is constrained within brick retaining walls, some of which are in a derelict state. Parts of these have collapsed into the river. In many locations, siltation has built up on one or both sides of the river bank. The silt deposits have enabled the dense growth of vegetation along almost the entire corridor. Japanese Knotweed is present along the riparian corridor within the site, as well as within the upstream section of the river.

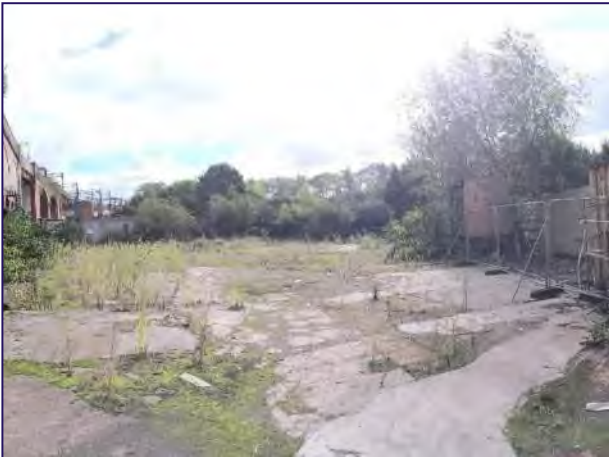
| <p>G. View of scrap yard (Photograph taken facing East, October 2017)</p> | <p>H. Siltation and dense vegetation present at upstream end (view from Fairfield street, November 2016)</p> |

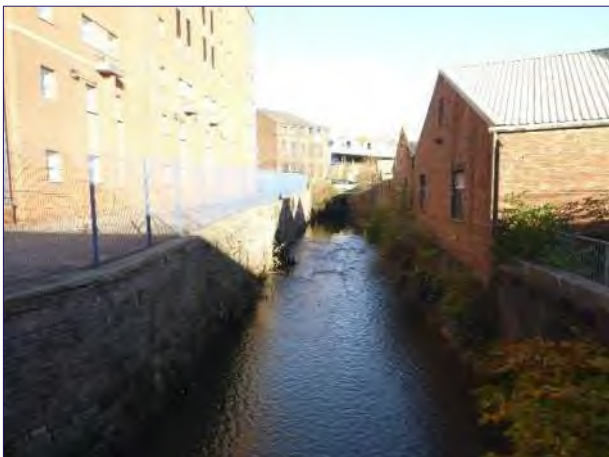
| <p>I. Clear channel section downstream of the site, parallel to Baring street (Photograph taken facing East, November 2016)</p> | <p>J. Environment Agency river gauging station and downstream weir (view from London Road, November 2016)</p> |

At the downstream end of the river, there is a very clear river channel section, well maintained with no siltation building up or presence of vegetation. An Environment Agency (EA) river gauging station (London Road - Medlock) is located here that has been operating since 1969, recording river level and flow measurements.

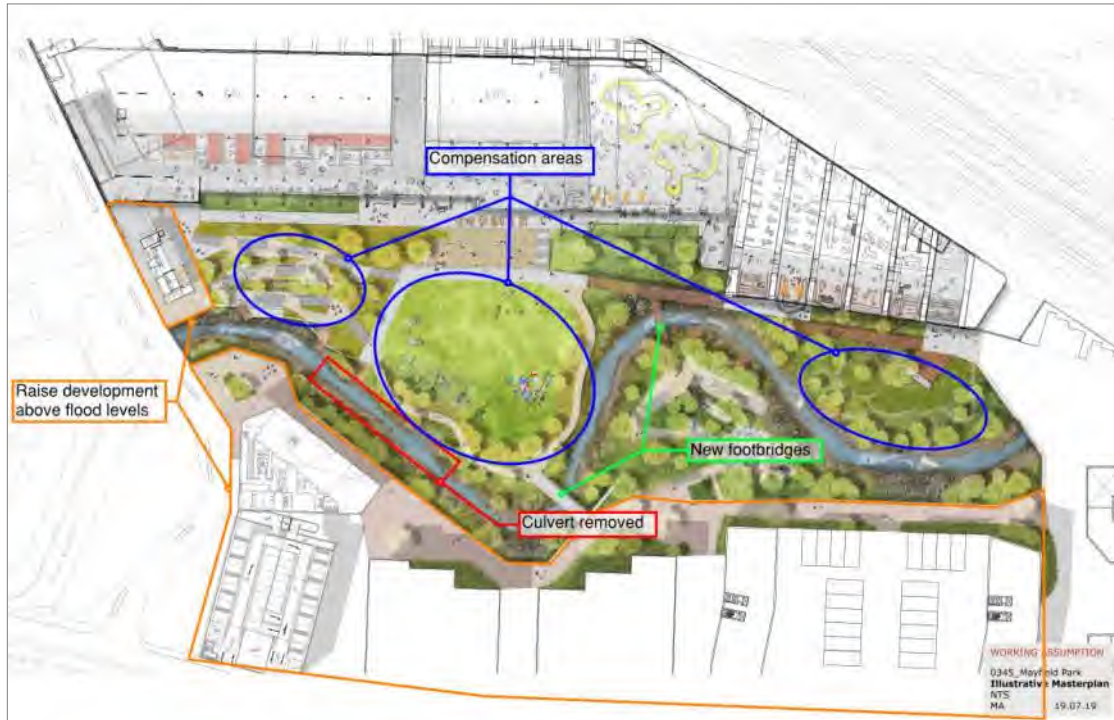
Figure 1-2 - Mayfield proposals and flood risk management principles

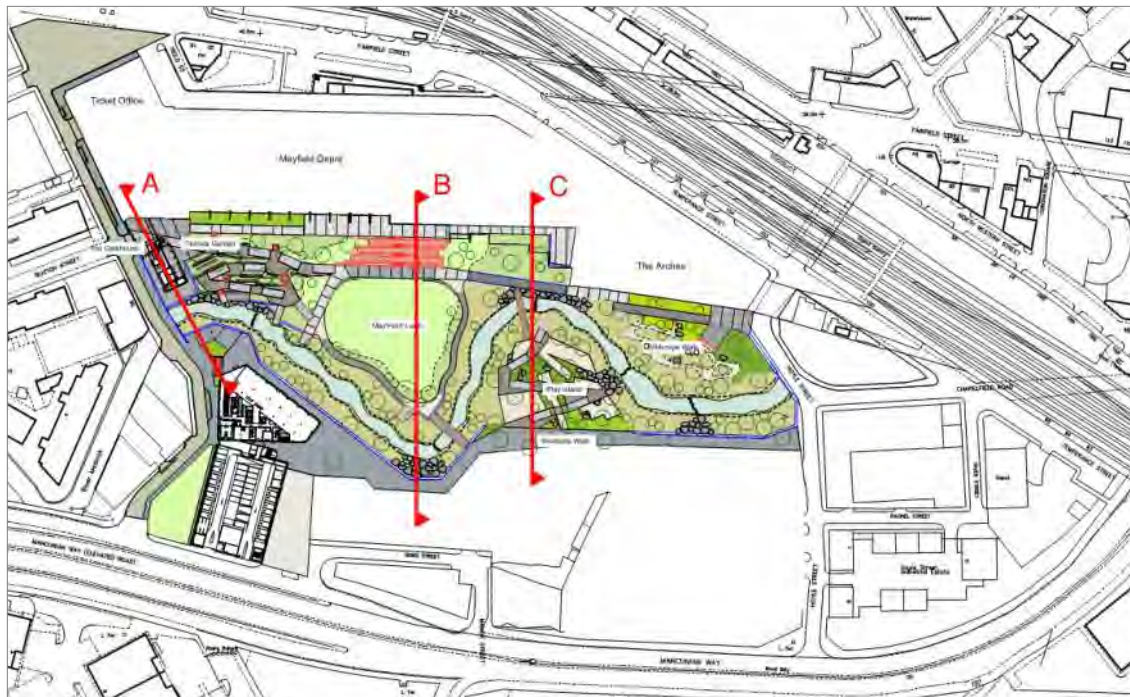
Figure 1-3 - Mayfield sitewide proposals (SEW Draft issue, March 2019)

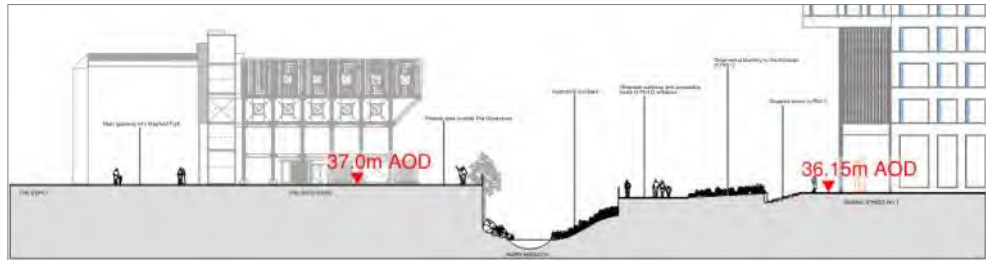
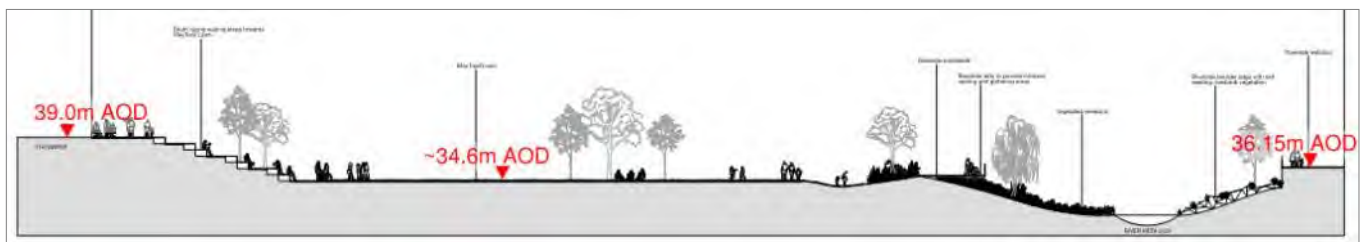
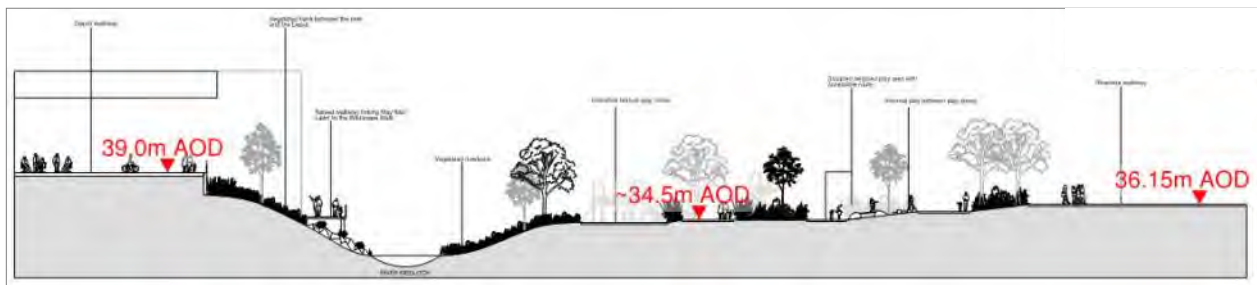
**Figure 1-4 - Cross sections through Mayfield site (SEW Draft issue, March 2019)**

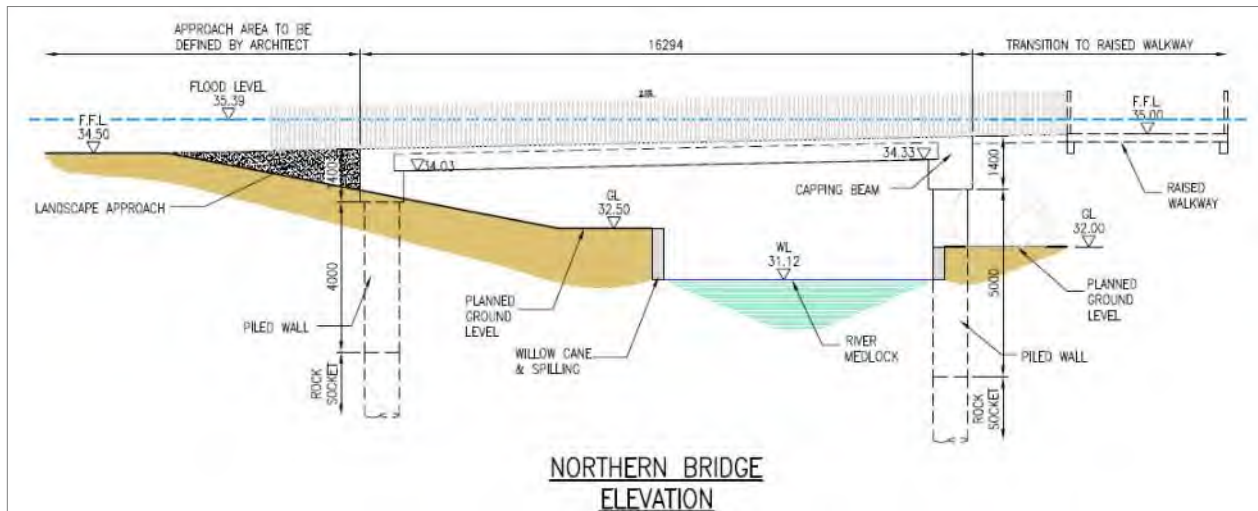
Two new footbridges are proposed across river Medlock to replace the existing derelict footbridges and improve connectivity around the Mayfield site. A 600mm freeboard is normally recommended between the soffit level of a bridge and the design flood levels (DFL). However, in order for the two footbridges to tie in with the adjacent ground level and enable ramped access, the deck levels have been set below the expected DFLs at the locations (DFL: 35.39m AOD).

During consultations with the EA, the inundation of the footbridges by floodwater was discussed. The EA accepted the bridge design concept in principle. It was requested that hydraulic modelling was required to test the impact of the bridges in terms of flood risk. The bridges will be fixed to prevent them from floating off their bearings during a flood.

**Figure 1-5 - Elevation of Northern footbridge (BuroHappold Engineering Draft issue, September 2019)**

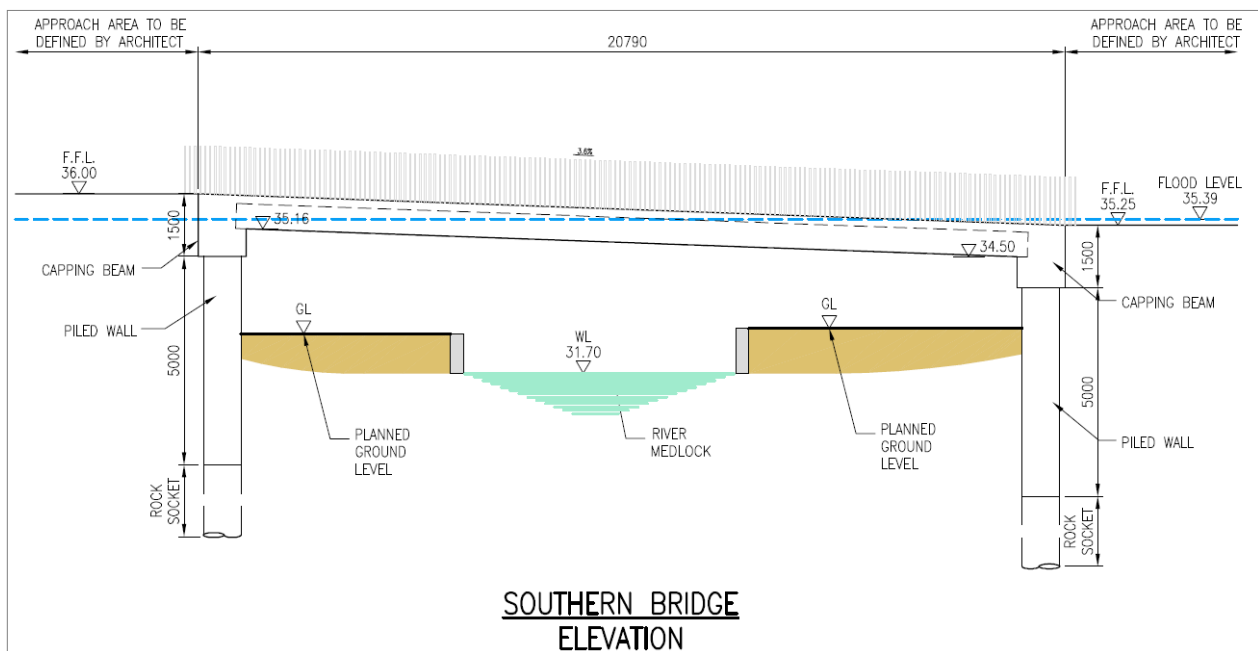
**Figure 1-6 - Elevation of Southern footbridge (BuroHappold Engineering Draft issue, September 2019)**

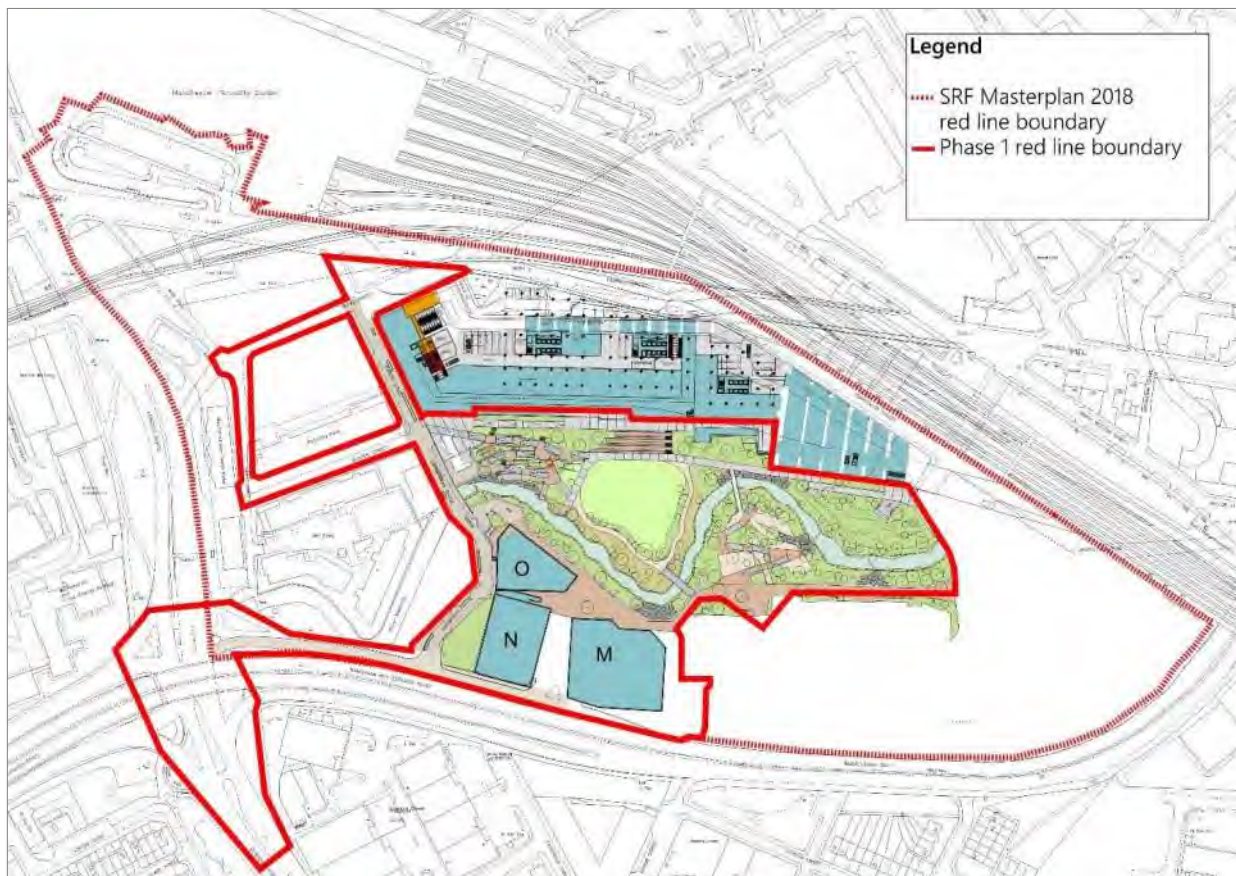
The Phase 1 site is located entirely within the Mayfield SRF area as shown in Figure 1-7 below. Two planning applications will be submitted, including the proposals described below. The proposals are in line with the adopted Mayfield SRF 2018.

**Figure 1-7 - Phase 1 Mayfield masterplan – September 2019**

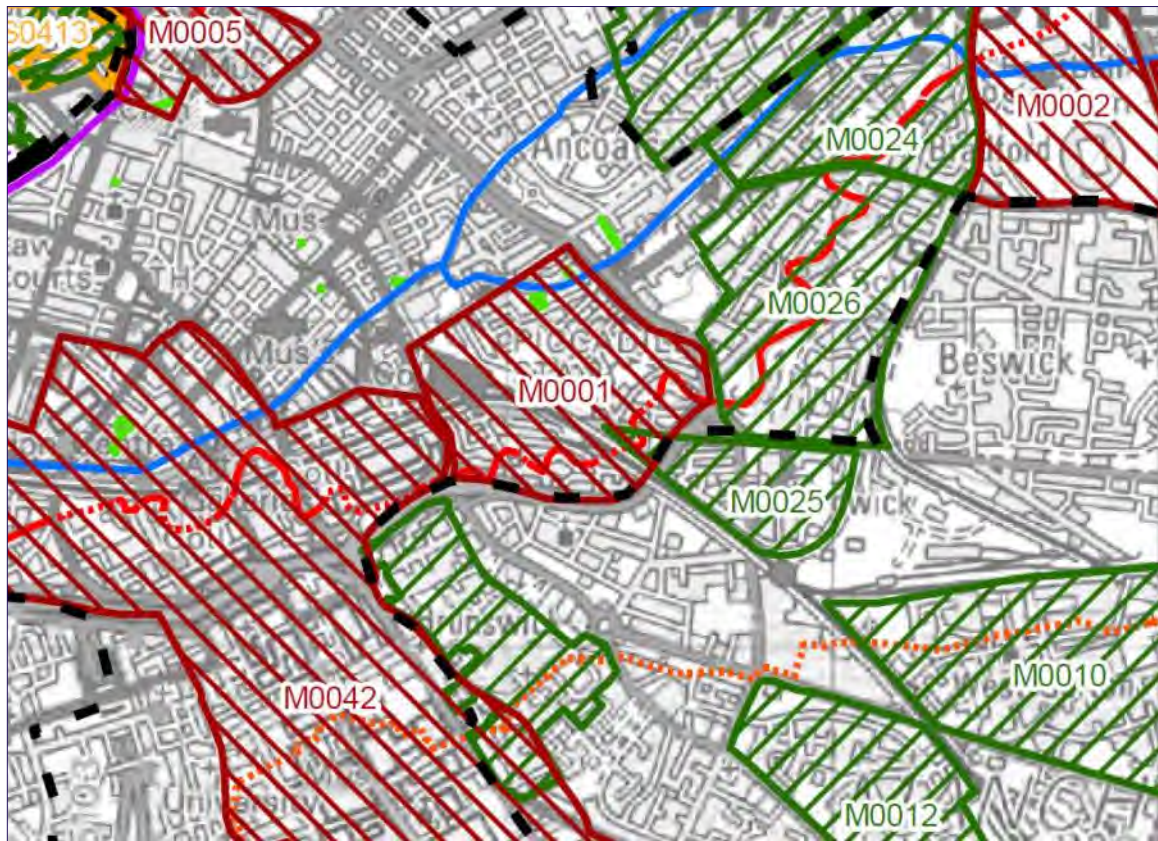
These reports consider flooding from rivers, canals, reservoirs, surface water, groundwater and sewers for the Greater Manchester area; summarises existing and proposed flood risk management; looks at impacts of development on flood risk and can be used to inform a sequential approach to development allocation. The report provides more detailed information on strategic sites identified for development; the Mayfield site has been included in the study and is referred to as Manchester Strategic Employment site – Eastern Gateway (M0001) hatched in Figure 2-1. Findings from the SFRAs have been considered within this assessment.

Figure 2-1 - Level 2 Hybrid SFRA: Significant sites (Mayfield site is under the M0001 Strategic Employment Site)

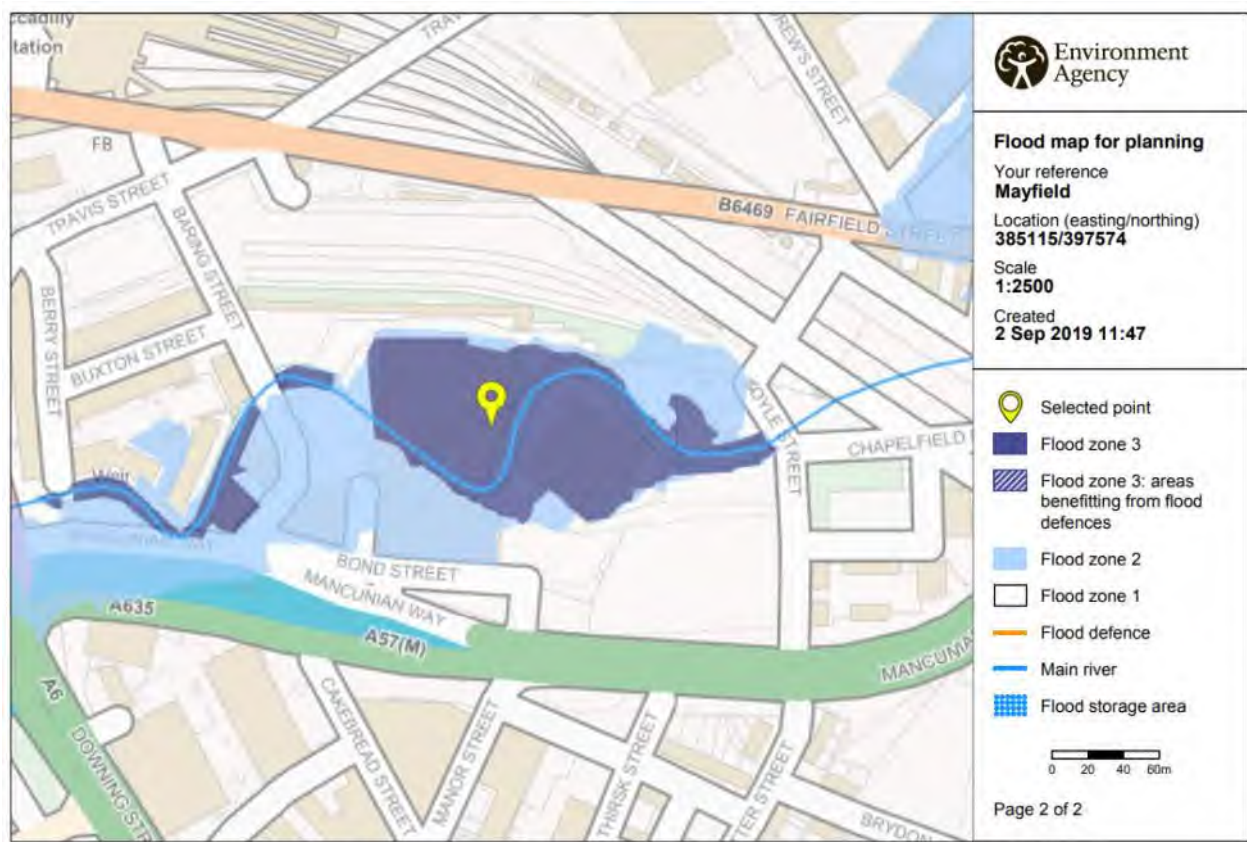
From inspection of the Environment Agency's online flood map for planning (Figure 3-1) the site lies partly within Flood Zones (FZ) 1, 2 and 3, which are defined as having a low, medium and high risk of flooding respectively.

**Figure 3-1- Environment Agency Flood Zone map at the site location, accessed 02/09/2019**

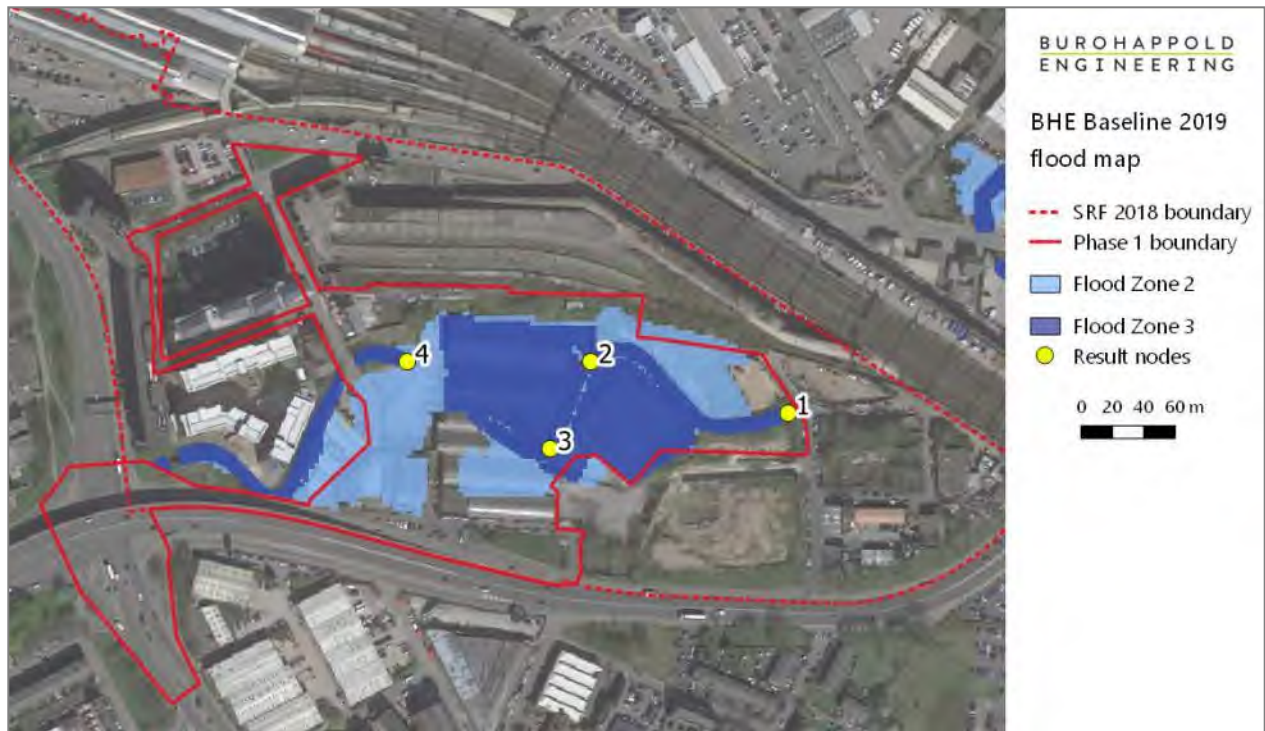
The flood extents and levels for the River Medlock are based on the River Medlock SFRM 1D-2D (ISIS – TUFLOW) model developed by the EA in 2009 and updated in 2011. BuroHappold has attained the model from the EA, reviewed and updated the model with the current best practice methodologies and hydrology data as per 2019. Additional topographic information within the site boundary was added, as per the topographic survey completed by Malcom Hughes in July 2017. The updated flood model is referred to as the BHE Baseline 2019 model.

The updated flood extents for Flood Zones 1, 2 and 3 can be seen in Figure 3-2.

**Figure 3-2- BHE Baseline 2019 flood maps**

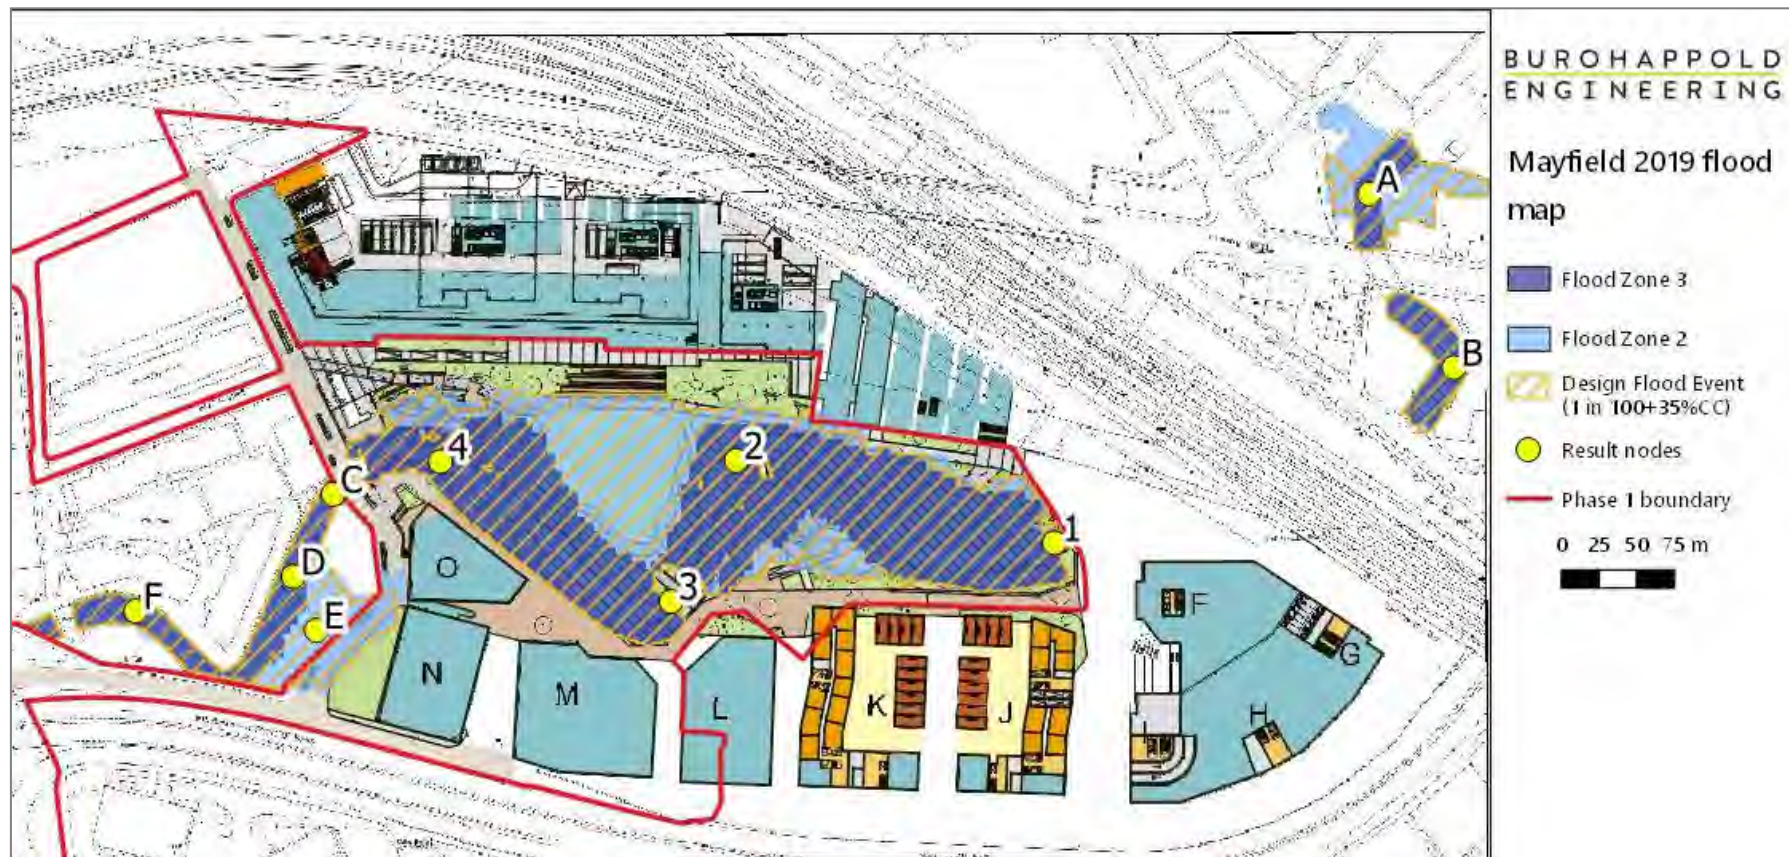
For the purposes of the Mayfield 2019 modelling assessment, the areas within the 1 in 100 +35% flood extents have been represented as accurately possible in terms of proposed levels, channel profile and roughness. The building development sites (outlined in orange) have been modelled as raised well above the DFE flood risk levels and above flood zone 2 levels (1 in 1000) to ensure no flood compensation is provided within these areas. The Mayfield 2019 flood extents and levels are presented in Figure 3-3 and Table 3-2.

The Hydraulic Modelling work undertaken demonstrates that the Mayfield development has negligible impact in terms of flood risk from the River Medlock to areas outside the site boundary and a positive impact in decreasing flood risk within the site. Please refer to Appendix D for further details.

Figure 3-3 - Flood extents due to the Mayfield proposals, Flood Zones 2 and 3 and DFE

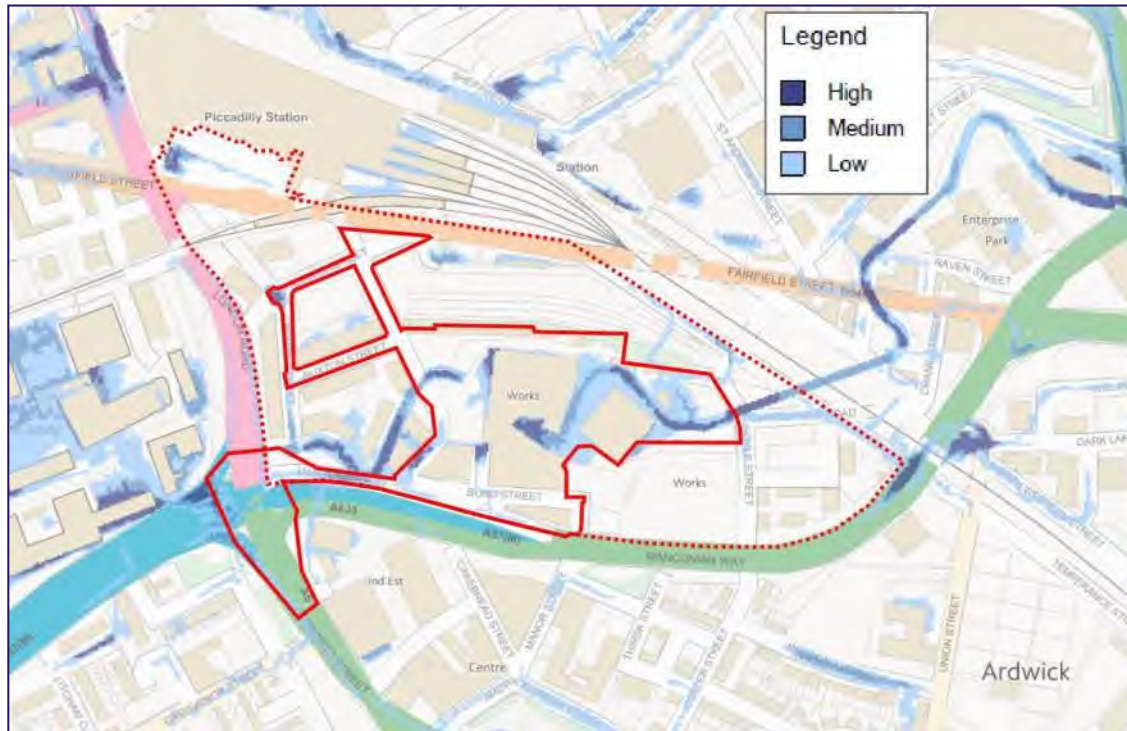
The EA has provided surface water flood risk maps in response to the pre-application information request. The flood map shows that there are areas within the site at very low (less than 1 in 1000 annual probability), low (between 1 in 1000 and 1 in 100 annual probability), medium (between 1 in 100 and 1 in 30 annual probability) and high (more than 1 in 30 annual probability) risk of surface water flooding. The map is shown in Figure 3-4.

**Figure 3-4 - Environment Agency Surface water flood map at the site location, received 11/11/16. (Contains Environment Agency information ©Environment Agency and database right, 2016)**

The EA has used the 2-dimensional modelling software JFLOW to route rainfall over a surface elevation map that has been modified to include roads and buildings in order to help define potential flow paths. The three modelled flood scenarios are the 1 in 30 year flood event (high flood risk), 1 in 100 year (medium) and 1 in 1000 year (low).

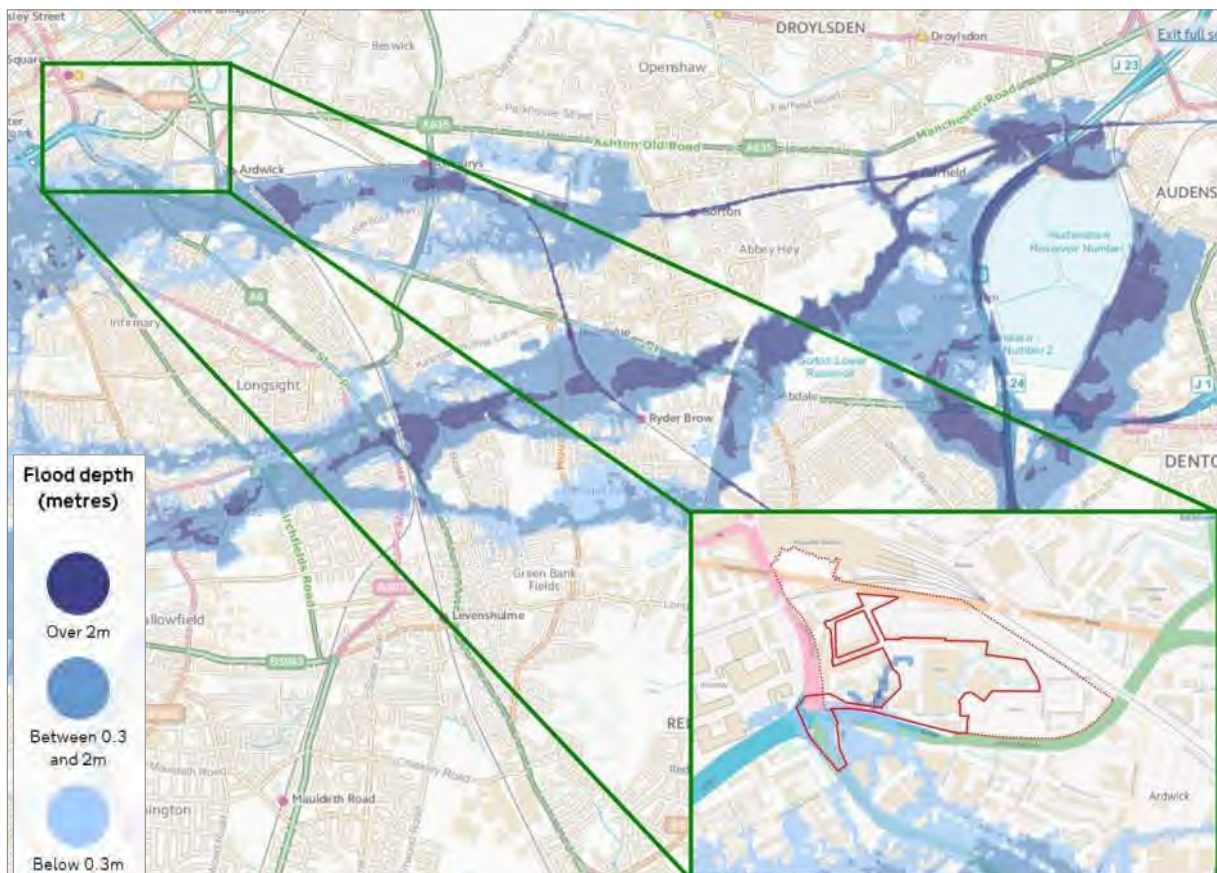
The EA have recently published maps showing areas that could flood in the event of a reservoir failure. Their purpose is not to discourage development but to help authorities and emergency services plan for reservoir flooding. The map shown in Figure 3-5 was obtained from the EA website on long term flood risk (<https://flood-warning-information.service.gov.uk/long-term-flood-risk/map?map=Reservoirs>). According to this map, only very small part of the site might be affected by a sudden reservoir failure. The reservoirs that could affect the site are: Gorton Lower, Gorton Upper and Audenshaw No. 1, 2 and 3. The owner of the reservoirs is United Utilities.

The risk of reservoir failure is extremely unlikely and the impact of such an event to the site is considered low.

**Figure 3-5 - Environment Agency Flood Risk from Reservoir at the site location and surroundings (Contains Environment Agency information ©Environment Agency and database right, 2019)**

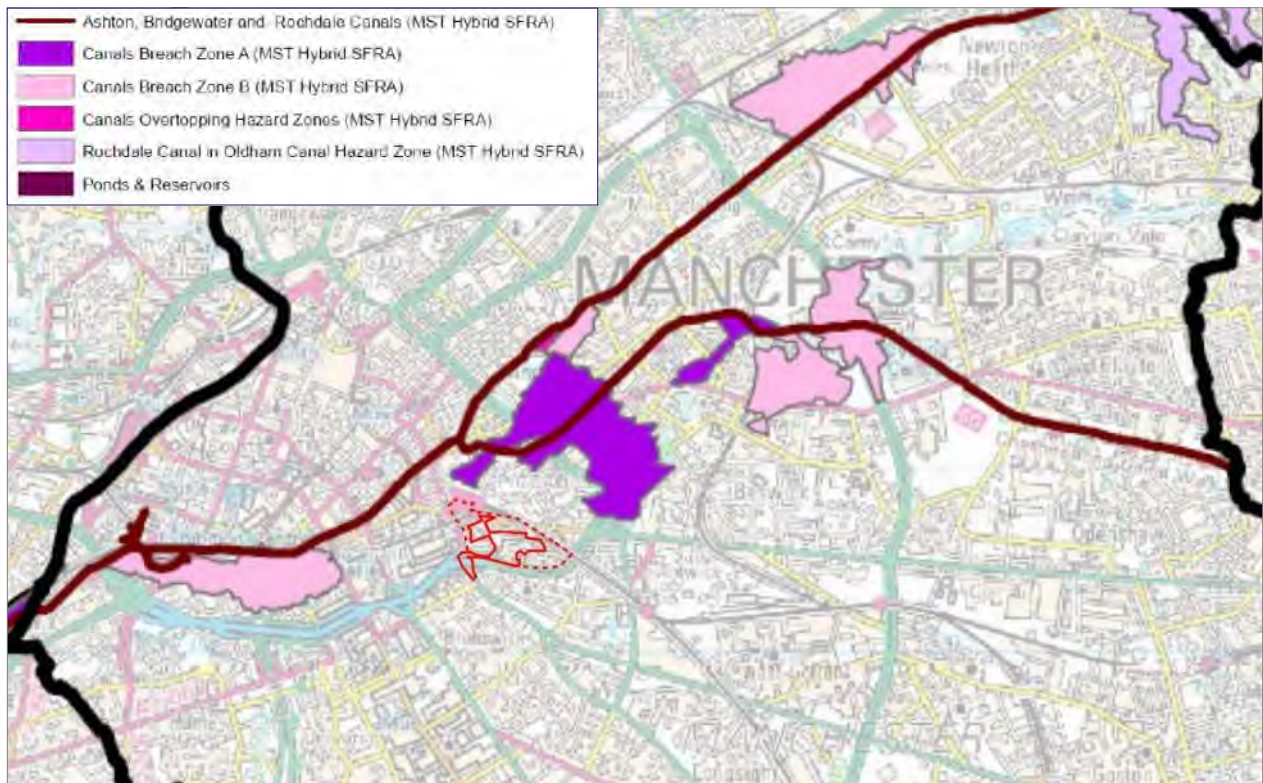
The Lead Local Flood Authority (LLFA) is responsible for leading the management of risk of flooding from ordinary watercourses, canals, ponds and reservoirs smaller than 25,000 cubic metres. Manchester City Council has therefore prepared a Local Flood Risk Management Strategy (LFRMS)<sup>2</sup> to ensure a coordinated way of properly managing local flood risk. The LFRMS has been informed by the Level 2 SFRA prepared in 2011 to produce a map with combined information of the canals breach zones and locations of ponds and small reservoirs, as shown in Figure 3-6.

The extents of flooding due to overtopping or breach of these canals are shown in Figure 3-6. None of the canals are shown to impose flood risk to the site.

Figure 3-6 –Flood Risk from Canals, Ponds and Reservoirs at the site location and surroundings (Manchester City Council LFRMS, 2014)

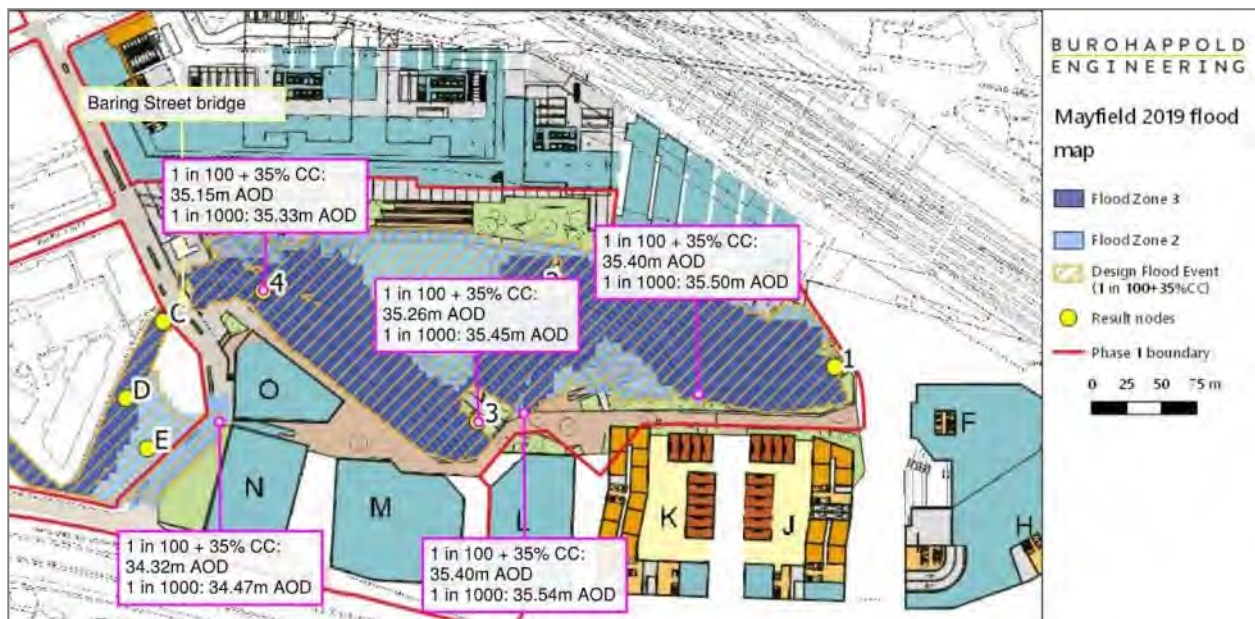
**Figure 4-1 – Expected flood levels within the Mayfield site**

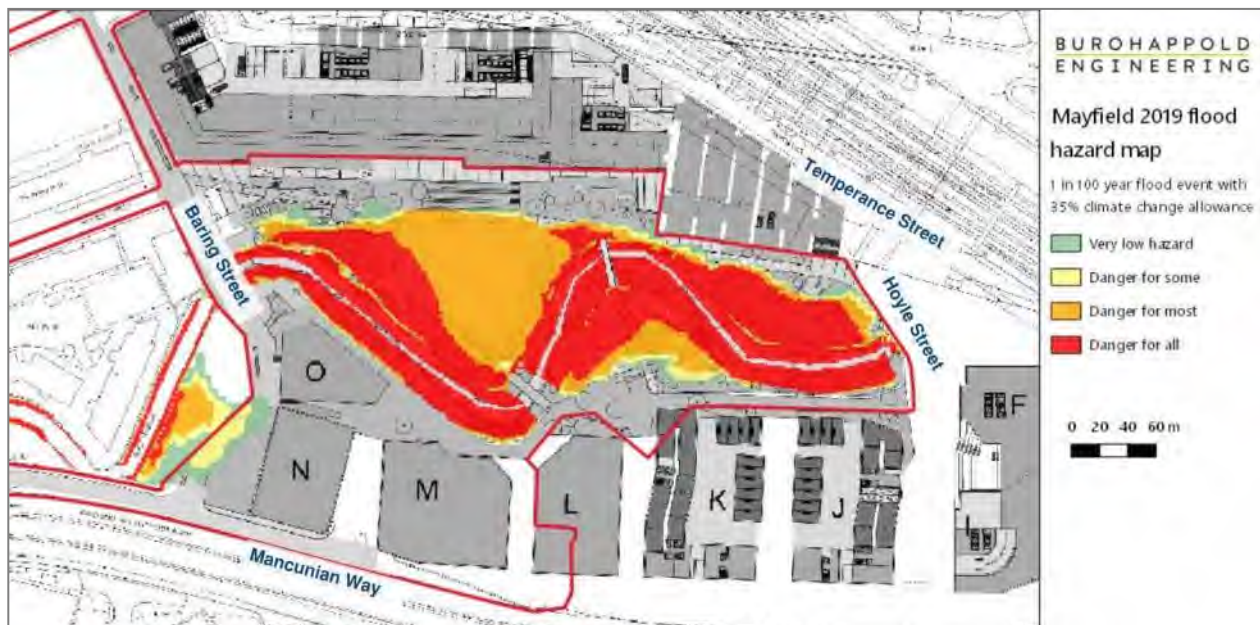
The changes to the levels within the site and the creation of large compensation areas within the site could cause an increase to the exposure of the public to flood hazard. Refer to Figure 4-2 for the maximum flood hazard classification within the site, in accordance with FD2320/TR2 produced by DEFRA/EA). The hazard rating depends on the depth and velocity of floodwater. Danger for some includes children, the elderly and the infirm, danger for most includes the general public and danger for all includes the emergency services.

Figure 4-2 - Flood hazard map for the 1 in 100 year event+ 35%CC

As demonstrated in Figure 4-2, the general public should not have access to Mayfield Park during the DFE. In some areas shown in red, the fast and deep flowing water could also prove dangerous to the emergency services.
