**Mayfield, Phase 1**  
EIA Volume 2

September 2019

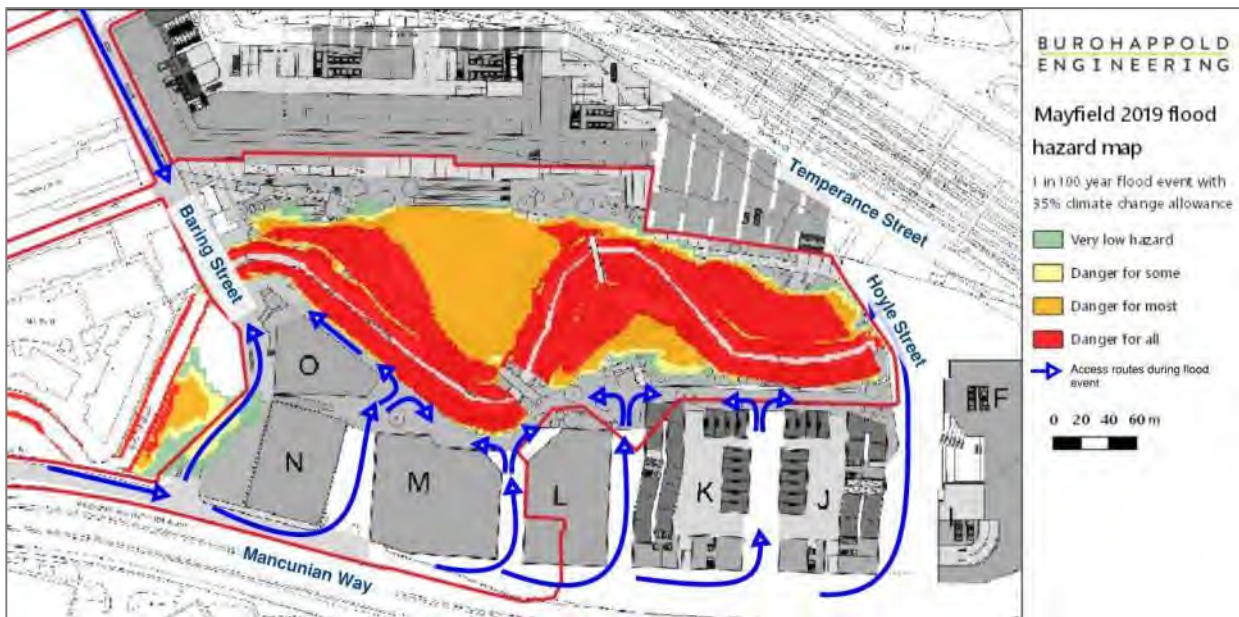
During the event of flood, safe access and egress to and from the buildings is provided for pedestrians and emergency vehicles from the south boundary of the Mayfield site. The routes shown in blue arrows can be accessed via emergency vehicles.

Parts of Baring Street are shown to be under water during the design flood event. It is not possible to raise Baring Street above the DFL due to the existing levels of surrounding plots. The street can be accessed by all from Fairfield Street and only by emergency vehicles via Mancunian way. Hoyle Street is well above the flood levels; access to Hoyle Street can be achieved via Mancunian Way and Temperance Street.

Figure 4-3 - Access routes for emergency vehicles during a flood event (background: flood hazard map for the DFE)

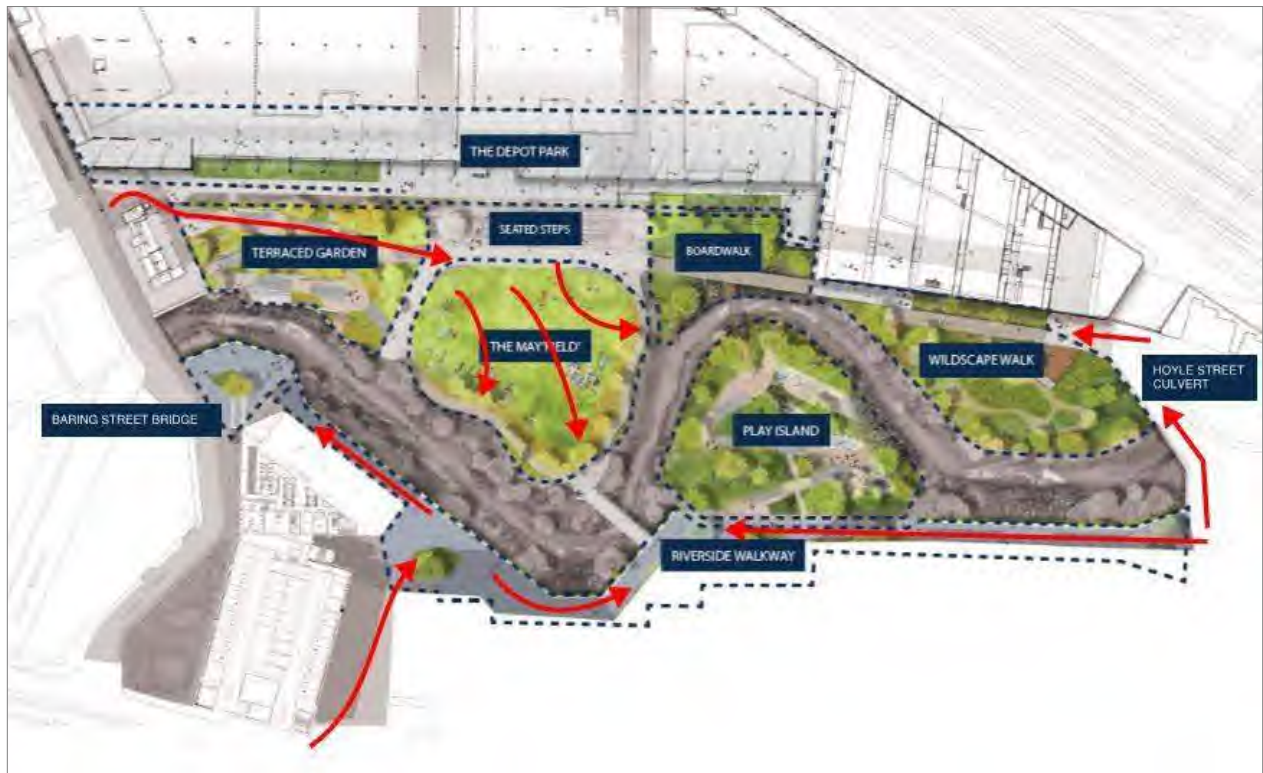
All buildings have been set back at least 5m from the top of bank to allow clear and unobstructed access for maintenance, as previously discussed and agreed with the EA. The riverside walkway along the south podium will consist of a retaining wall, designed to accommodate loads from emergency vehicles and other potential maintenance equipment. This will provide clear access to most parts of the river from the south bank.

**Figure 4-4 - Access to river for maintenance**

Vehicular access (4x4 car) can also be achieved through the ramps along the terraced garden down to the Mayfield Park. The wildscape walk will consist of a narrow boardwalk and therefore vehicular access is restricted to the eastern entrance. Access to the river can also be achieved via Hoyle Street culvert and Baring Street Bridge.

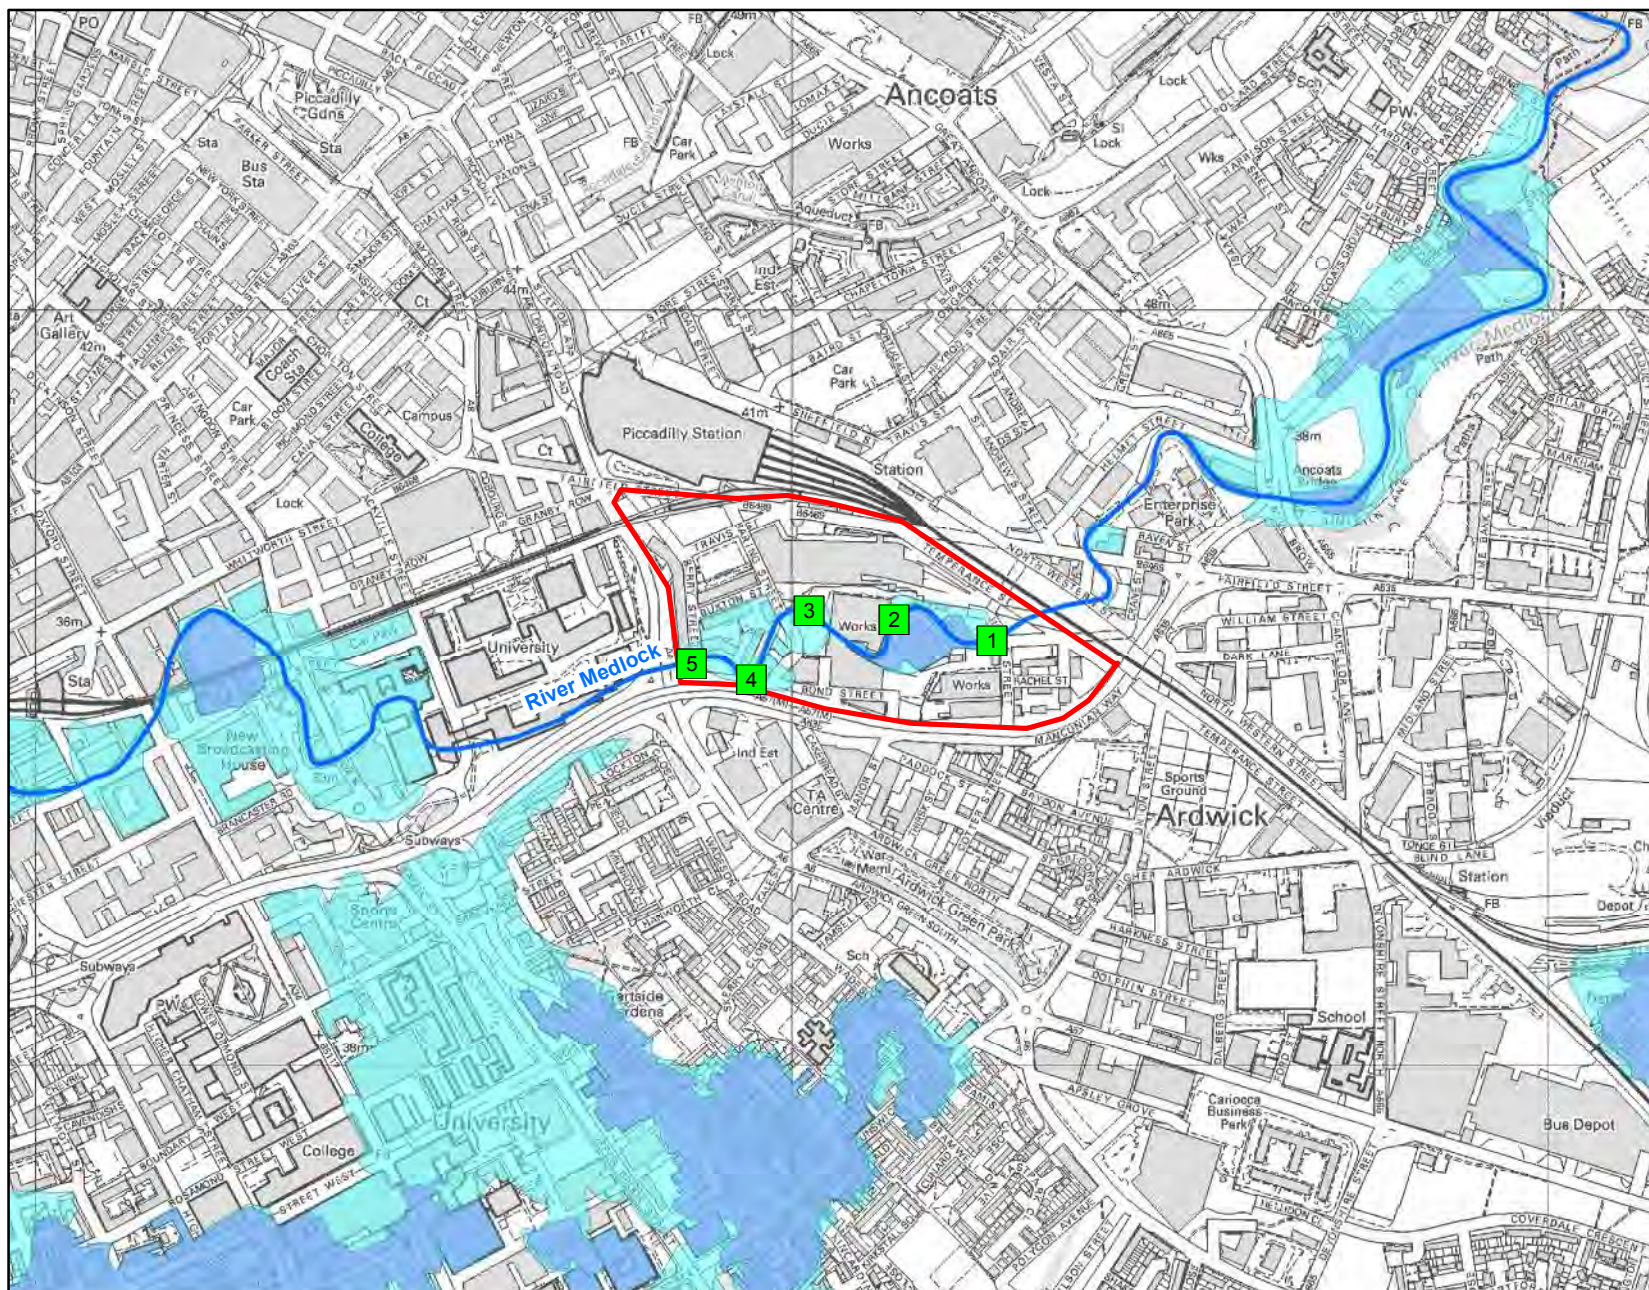
# Detailed Flood Map centred on Mayfield area, Manchester. Created 10/11/2016 [GMMC28626AB]

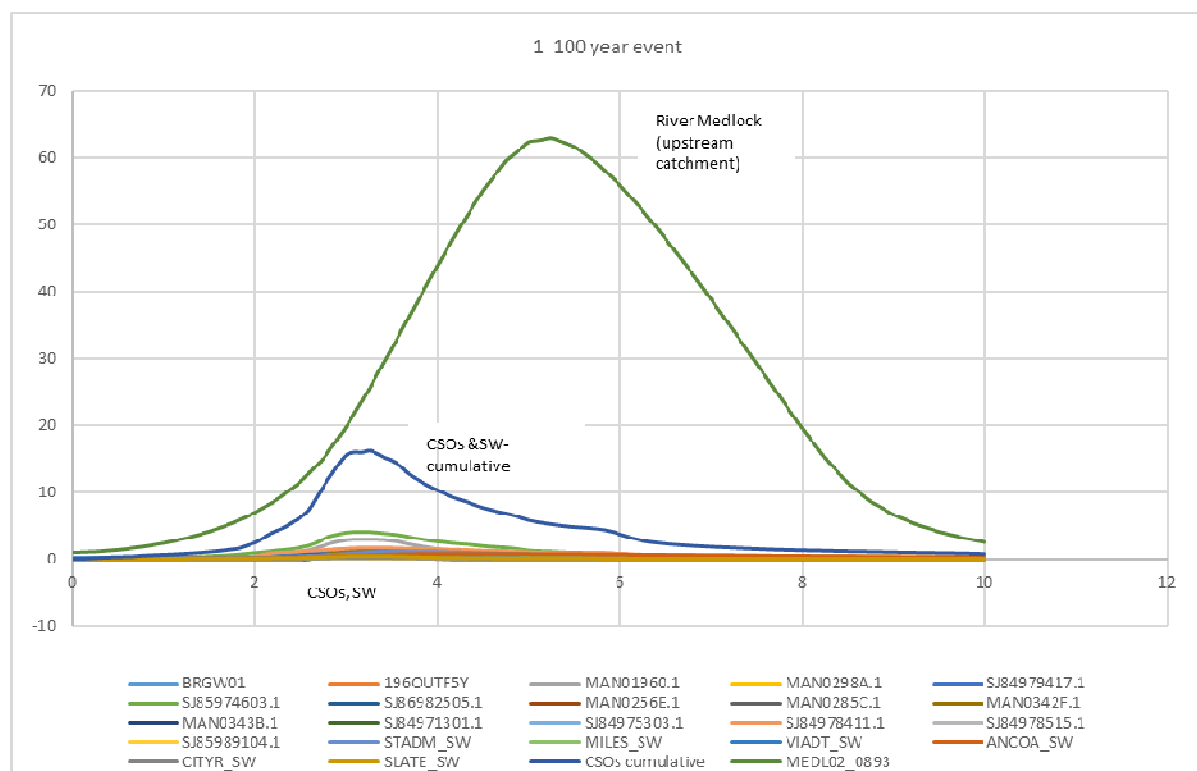
*Inspection of the river inflow hydrograph indicates that the peak flow occurs at approximately 5 hours after the start of the storm event. The CSOs and stormwater inflows peak at approximately 3 hours as shown in the chart below:*

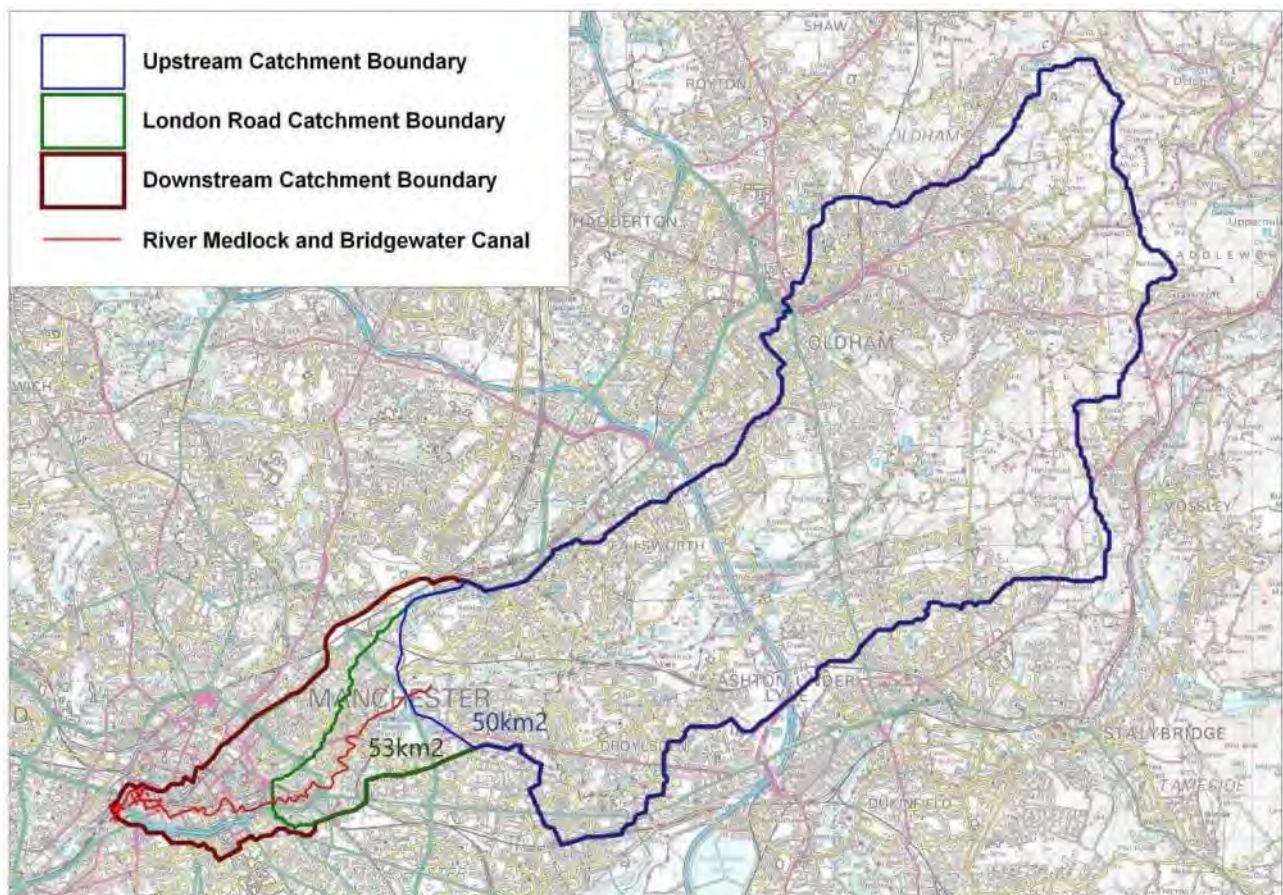
**Figure 3.1 Hydraulic modelled watercourse and associated catchment extents (source: River Medlock SFRM, 2009)**

The upstream inflow of the model drains a catchment area of approximately 50km<sup>2</sup>(see figure below). The catchment drains both rural agricultural areas and some urban areas. An existing gauging station is located in the catchment at London Road.

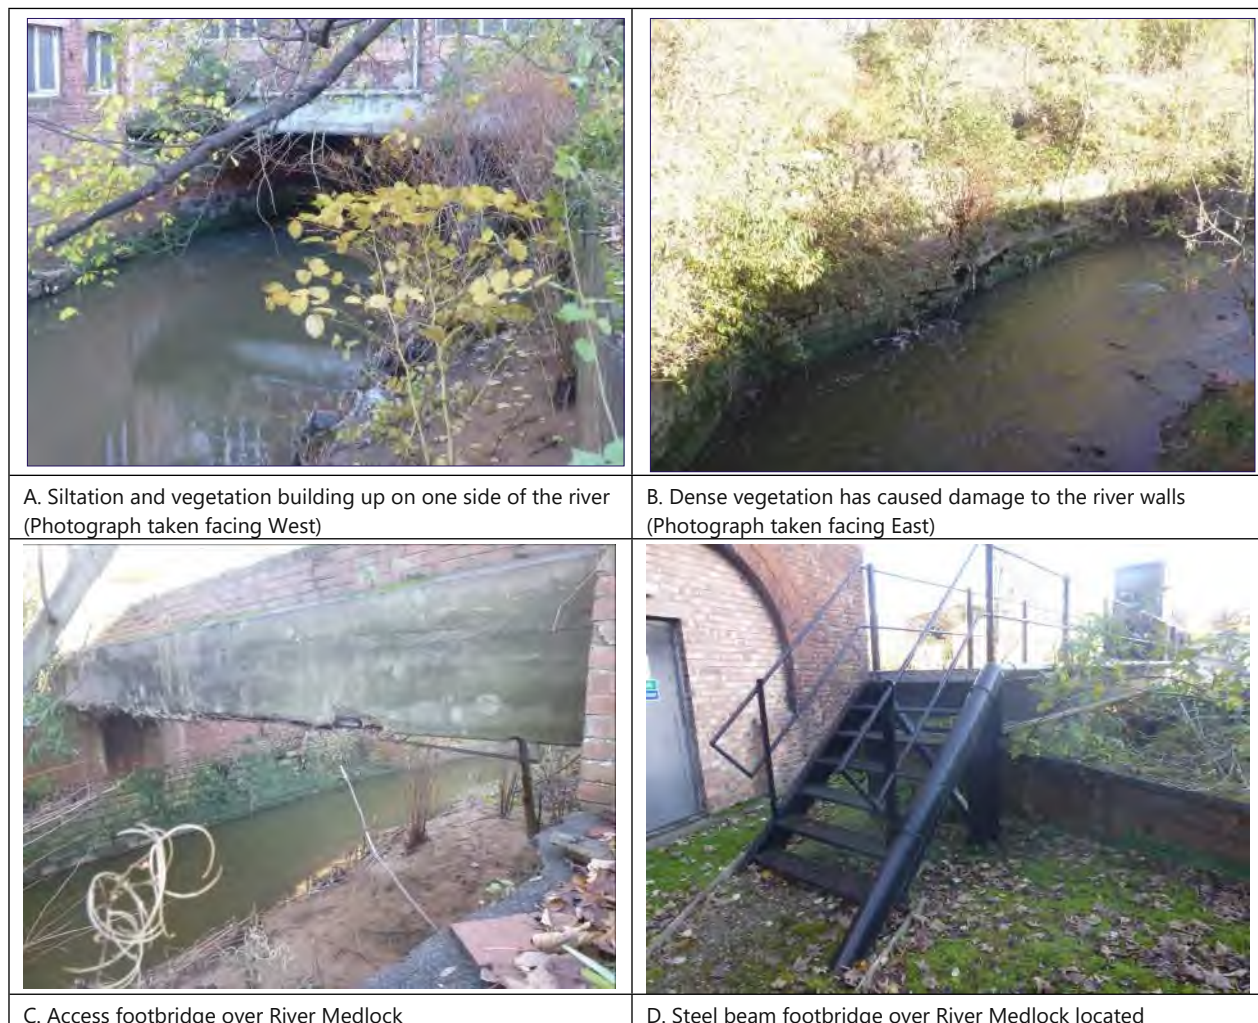
**Figure 4.1 - Photos from past site visits**

Site walkovers along the channel and within the site have been undertaken during the past 3 year. There were no noticeable changes to the river channel and hydraulic structures within the site since the EA Medlock 2011 model. Therefore the channel data within the 1D domain of the BH Baseline model are mainly maintained as per the existing model. Photographs of the River Medlock within the Mayfield site can be seen below.

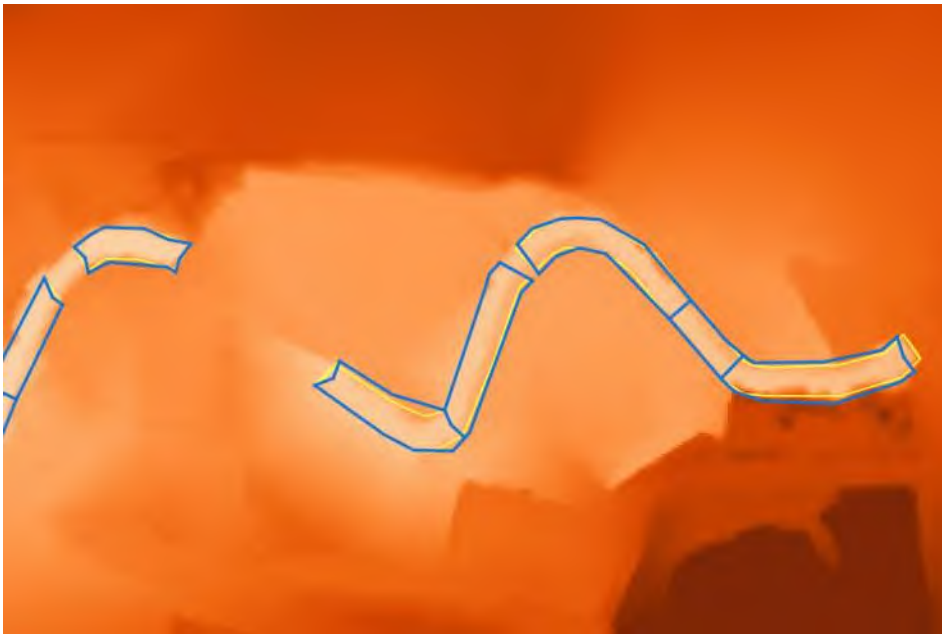
**Figure 4.2 - 1D space at Mayfield site (blue – Medlock 2008 model, yellow – BHE Baseline 2019)**

Following the review of the 1D nodes against the 2D inactive space and using the Mayfield topographic survey, minor adjustments were carried out to the 2D inactive space shape file, as shown in Figure 4.2. These adjustments had negligible impact in terms of flood levels or extents.

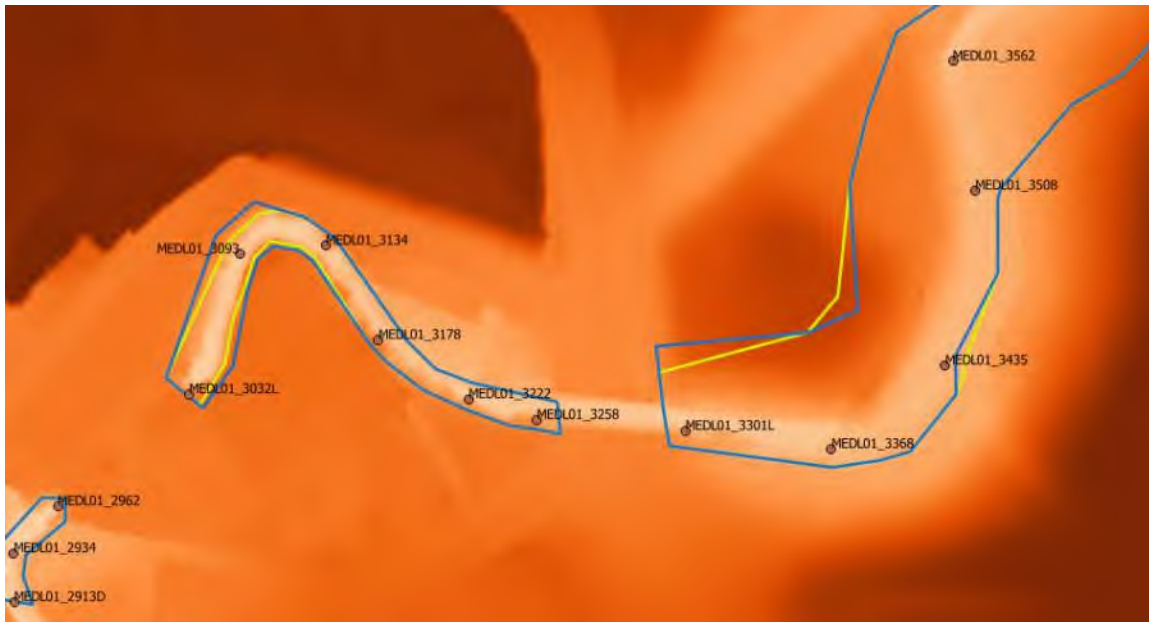
**Figure 4.3 - 1D space around Pin Mill Brow area (blue – Medlock 2008 model, yellow – BHE Baseline 2019)**

The stretch of the River Medlock between Pin Mill Brow and Helmet Street Culvert was found to have some inconsistencies between the widths indicated in the 1D space and the areas set as inactive in 2D. Some of the cross sections were found to be wider in 1D (MEDL01\_3435 is 85m wide in 1D compared to 48m in 2D) and other areas narrower (MEDL01\_3093 is 10m in 1D and 20m in 2D). The following cross sections were corrected by adjusting the 2D inactive space to match the width of the cross sections in 1D:

MEDL01\_3435, MEDL01\_3301L, MEDL01\_3134, MEDL01\_3093, MEDL01\_3032L.

The above changes resulted in negligible impact in areas downstream of Pin Mill Brow (less than 5mm). The changes have caused increase in levels within Pin Mill Brow area of approx. 20mm.

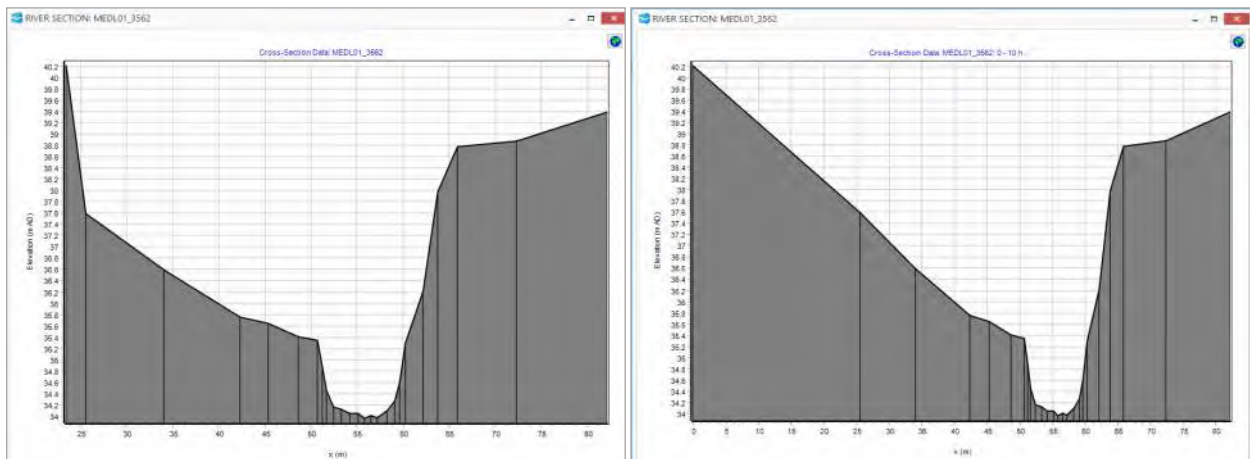
**Figure 4.4 - MEDL01\_3562 1D cross section (left - Medlock 2008, right - BHE Baseline)**

The cross section at MEDL01\_3562 (within Pin Mill Brow area) was found to be represented as 58m wide in 1D and 74m in 2D. The latest Lidar data provided by the EA in 2019 were referred to when widening the Left Bank of the section in 1D space, as shown below.

The above change had negligible impact in terms of levels or extents (<5mm increase/decrease).

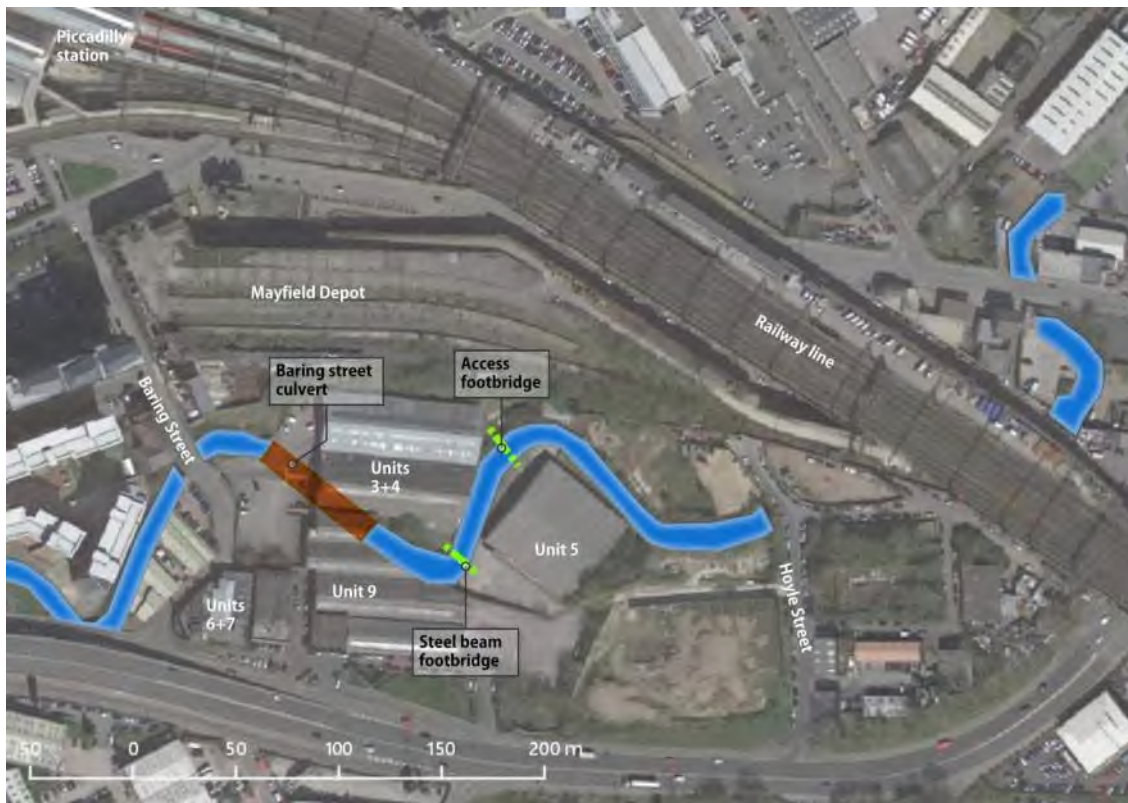
The Mayfield site currently consists of a number of industrial, storage and distribution units at the centre of the site and the Mayfield train depot along the north of the site. River Medlock meanders through the centre of the site. The 65m Baring street culvert covers parts of the river within the site. Two footbridges currently provide access across the river. As discussed earlier, the Baring Street culvert and access footbridge have been represented in the model; the steel beam bridge has not been included.

Figure 4.7 - Mayfield site - existing assets. Open watercourse shown in blue.

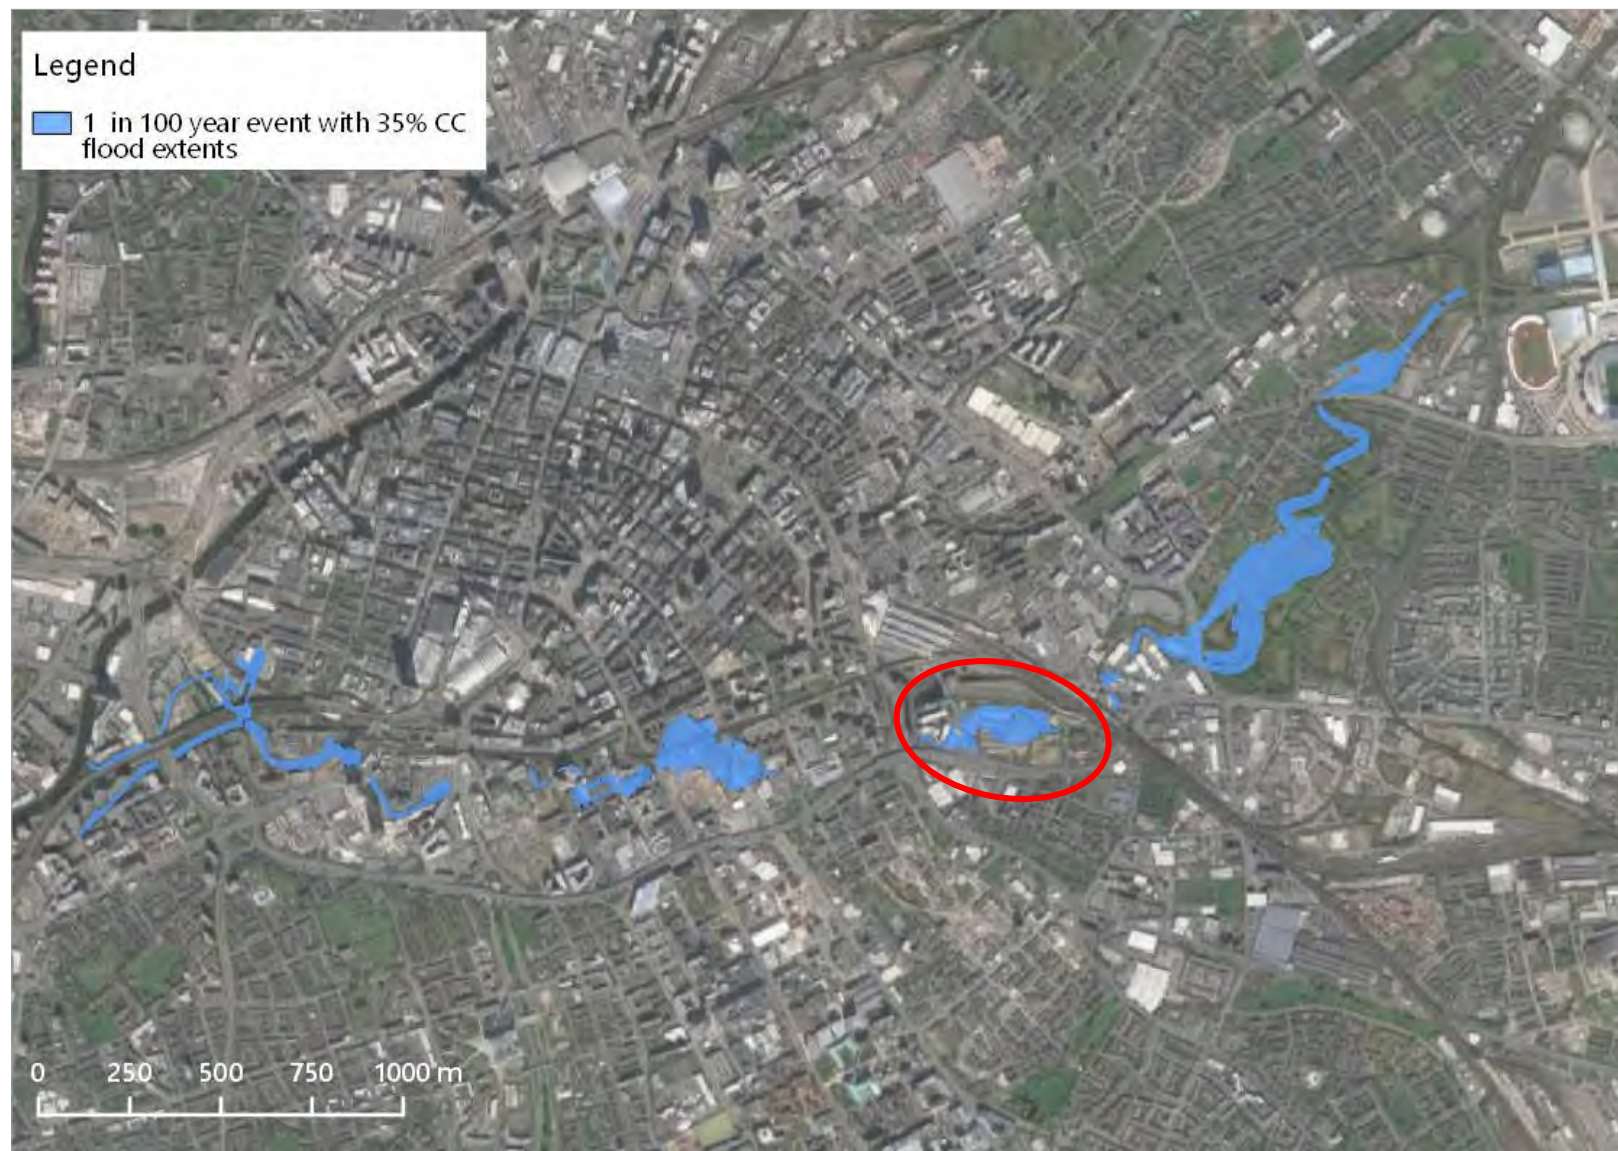
The BHE Baseline model flood levels for the DFE can be seen in Figure 4.8.

Figure 4.8 – BHE Baseline 2019 flood extents for the 1 in 100yr event +35% climate change, modelling area. Site location indicated in red circle.

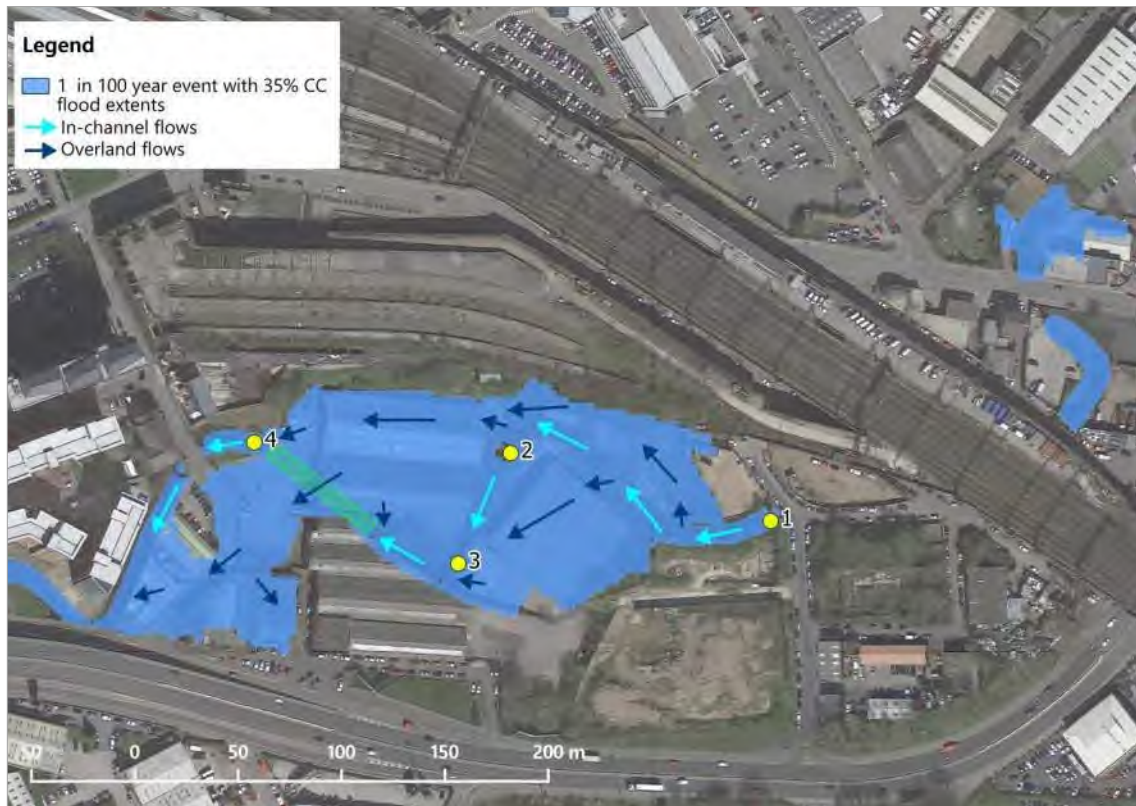
The flood extents map of the site can be seen in Figure 4.9.

**Figure 4.9 – BHE Baseline 2019 flood extents for the 1 in 100yr event + 35%CC, Mayfield site showing direction of flow and location of existing culvert (in green).**

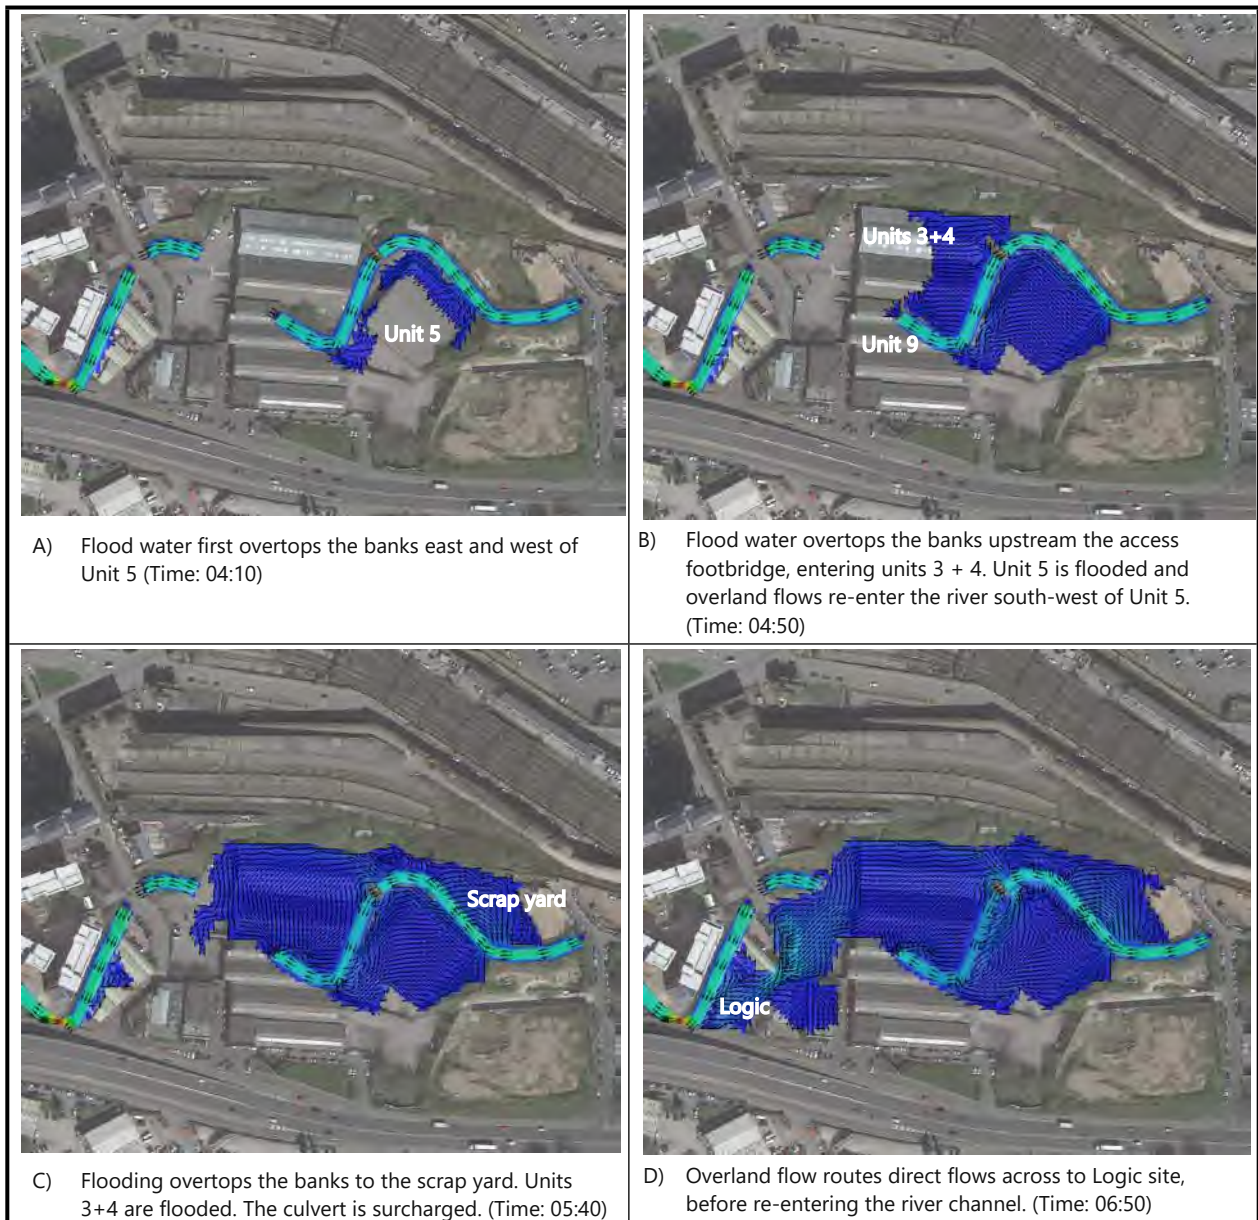
**Figure 4.10 – Flooding mechanism across Mayfield site, existing flow condition at various timesteps following start of storm event. Light blue to red indicates relative increase in flow rate.**

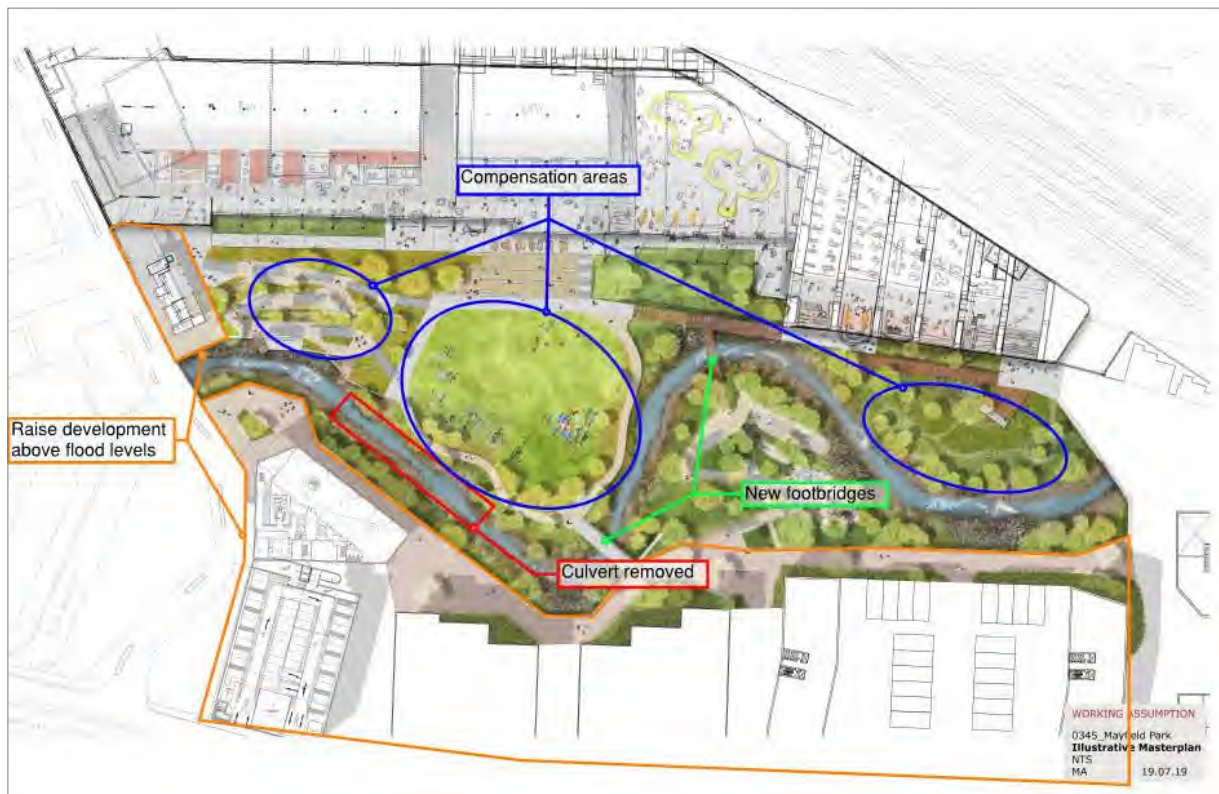
The principles described above are illustrated in Figure 5.1.

**Figure 5.1 – Development flood risk management principles**

The Baring Street culvert as well as the two existing footbridges within the site are proposed to be demolished. The footbridges will be replaced with two new footbridges at similar locations as illustrated in Figure 5.1.

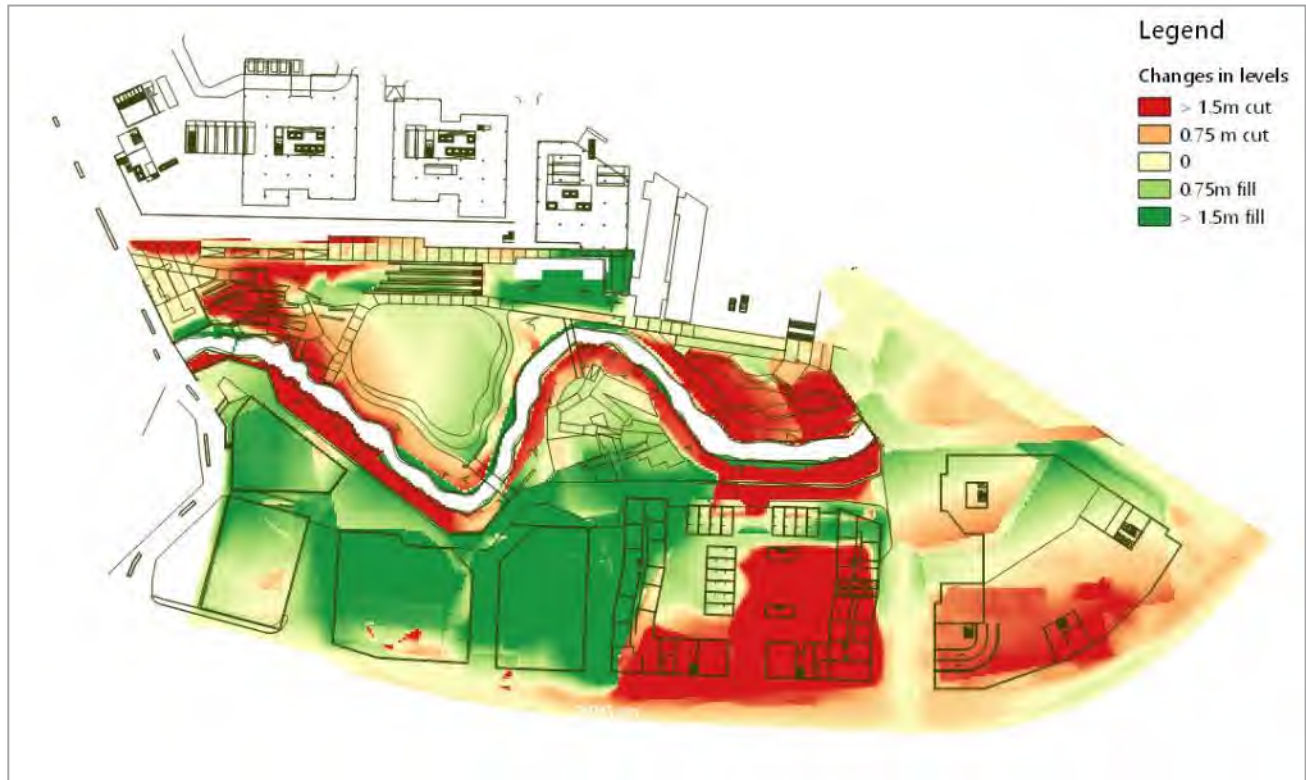
The changes in levels between the baseline and masterplan proposal are illustrated in Figure 5.2.

Figure 5.2 – Changes in levels across the site due to the Mayfield development proposals (proposal outlines shown above)

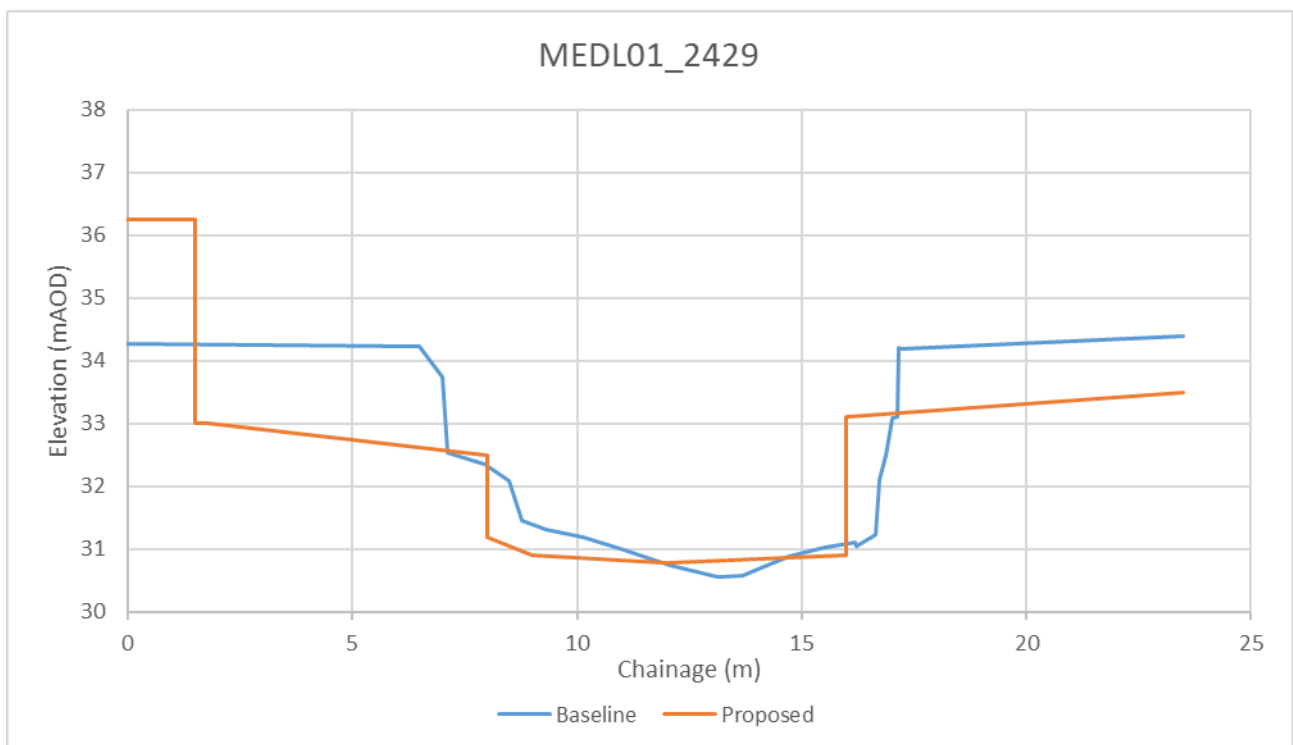
Figure 5.3 – Example cross section illustrating difference in Baseline and with proposals scenario at MEDL01\_2429.

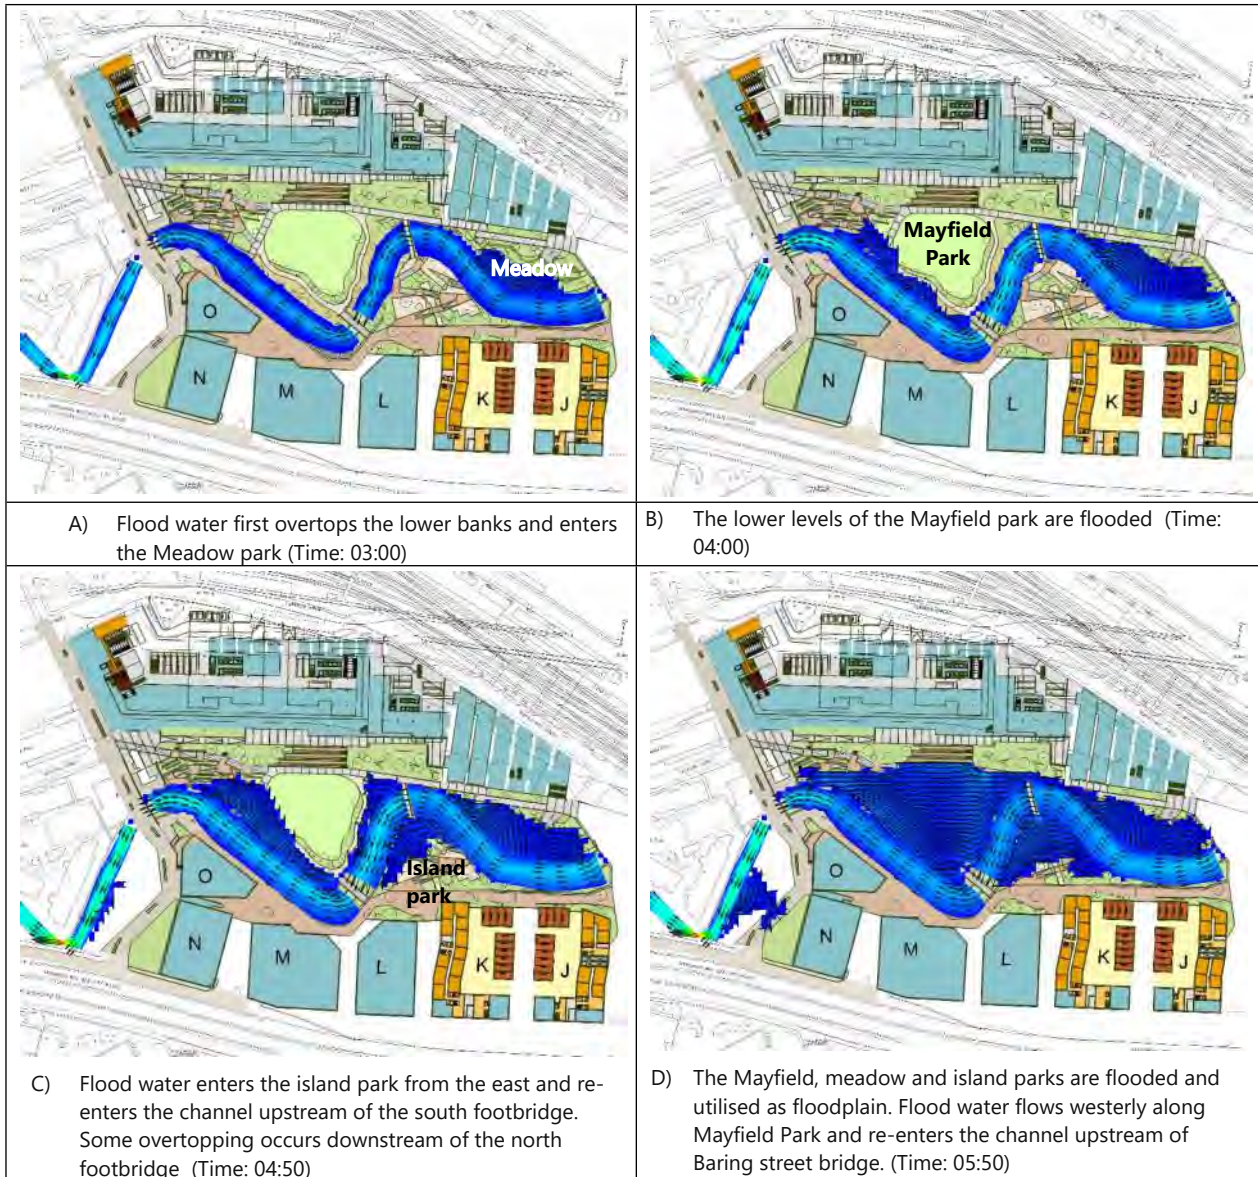
**Figure 5.4 – Flooding mechanism across Mayfield site, proposed flow condition at various timesteps following start of storm event.**

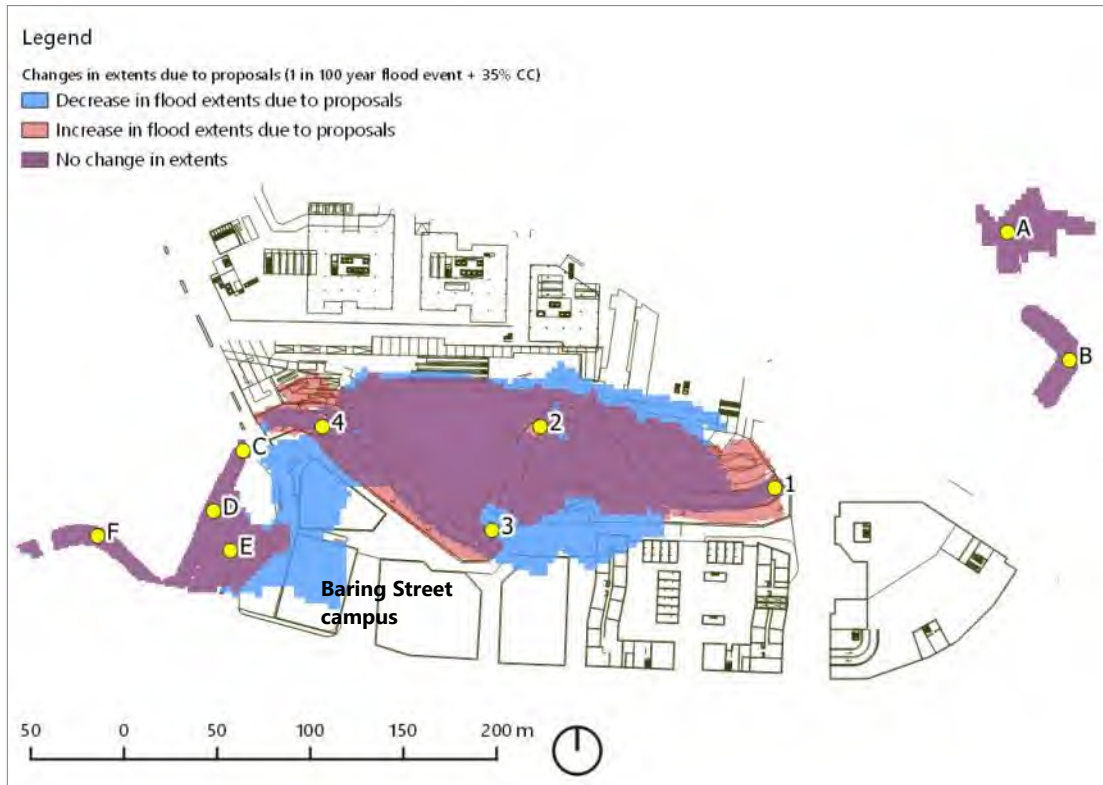
The results have been compared to the BHE Baseline 2019 model to assess the impact the proposals have to areas within the modelling domain and are described below. Areas in red indicate increase in flood extents compared to the BHE Baseline 2019 model whereas areas in blue indicate decrease in flood extents (area no longer at risk of flooding during the DFE). Areas shaded purple indicate no change in extent.

Figure 5.5 - Changes in flood extents due to the Mayfield proposals during the DFE, site surroundings
