**Mayfield, Phase 1**  
EIA Volume 2

September 2019

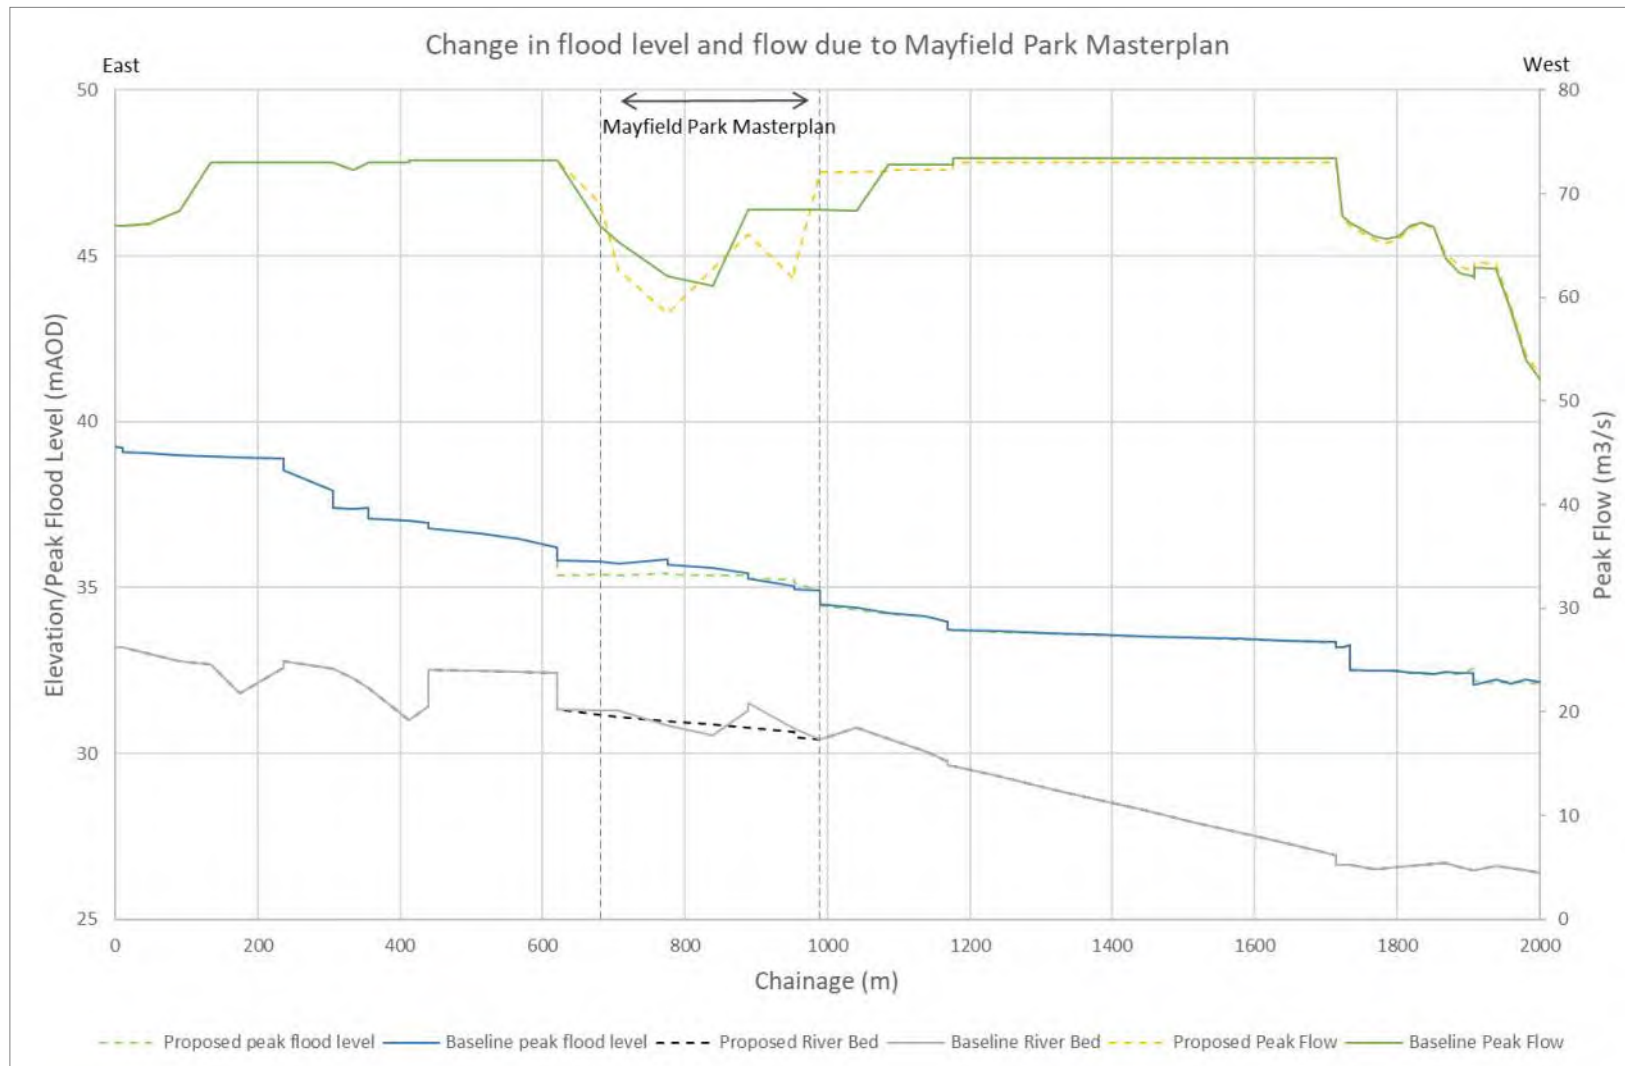
**Figure 5.6 - Comparison of change in peak flood level and flow due to proposals shown approximately 1km upstream and downstream of the site (data taken between 1D Nodes MEDL01\_3301L to MEDL01\_1377A).**

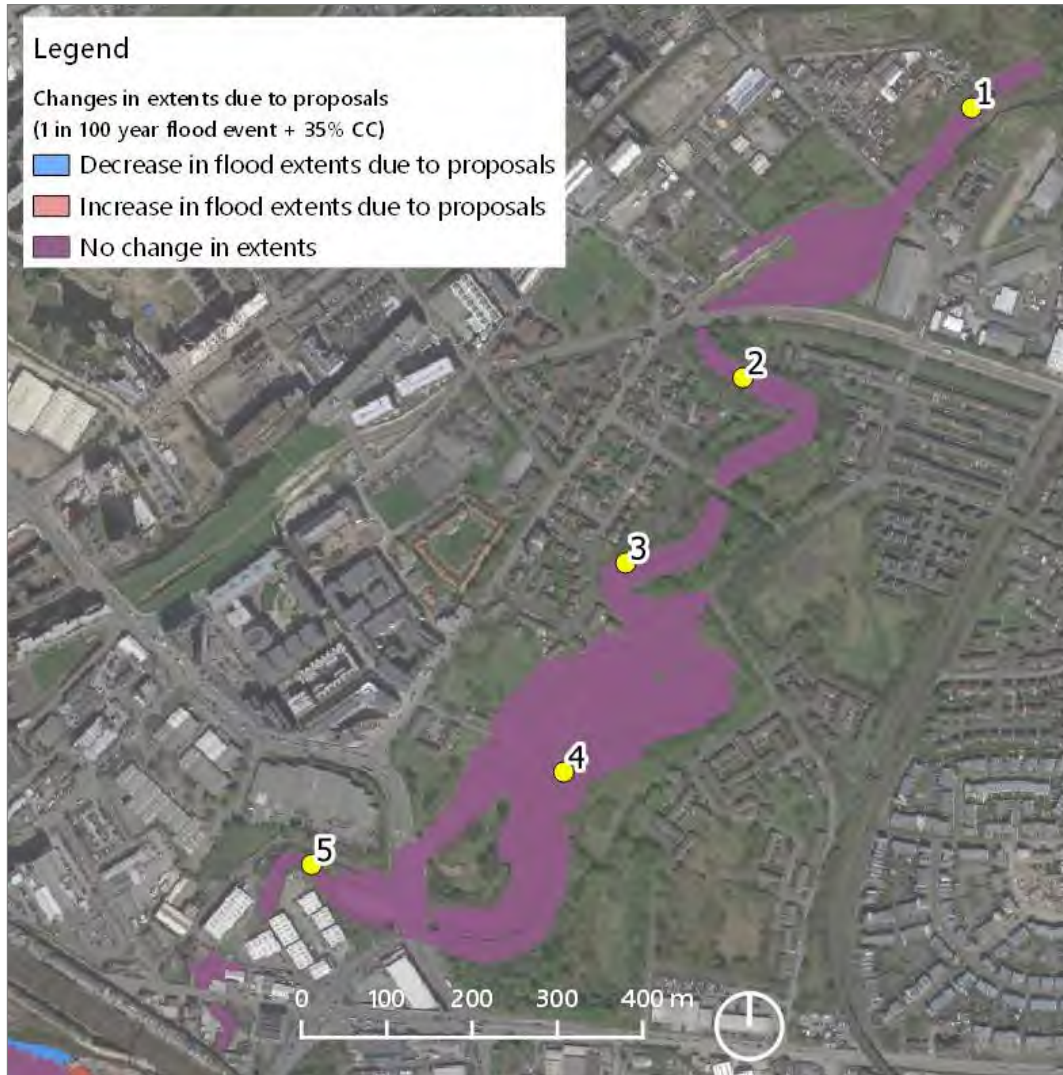
Changes in flood level upstream and downstream of the site were not significant (<1mm decrease upstream and generally less than 10mm change in levels downstream), which is considered within modelling tolerances rather than as a result of impacts of the proposals. No additional properties are at risk of flooding due to the proposals.

Figure 5.7 – Comparison of Mayfield 2019 model to the BHE Baseline 2019 model, flood extent changes for the DFE, upstream of site.

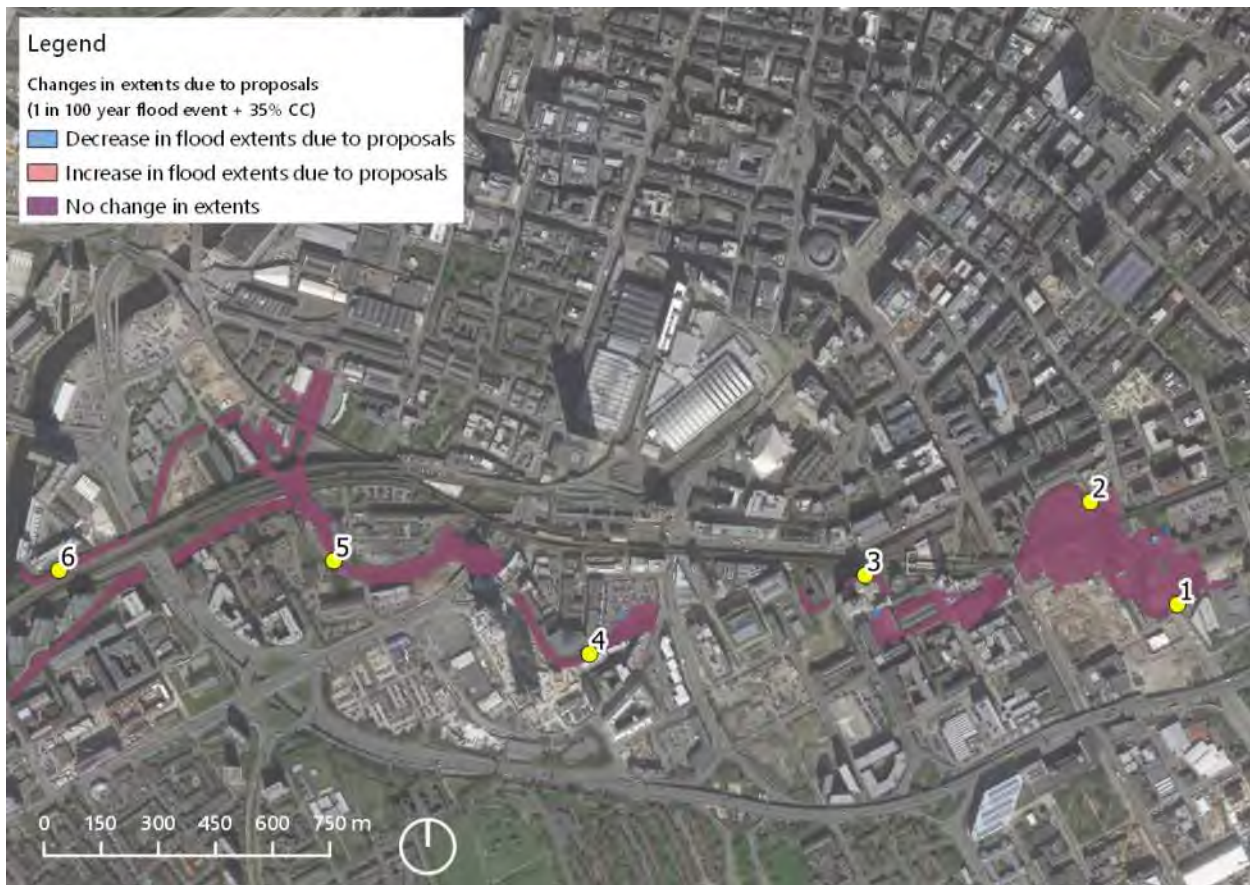
Figure 5.8 - Comparison of Mayfield 2019 model to the BHE Baseline 2019 model, flood extent changes for the DFE downstream of site.

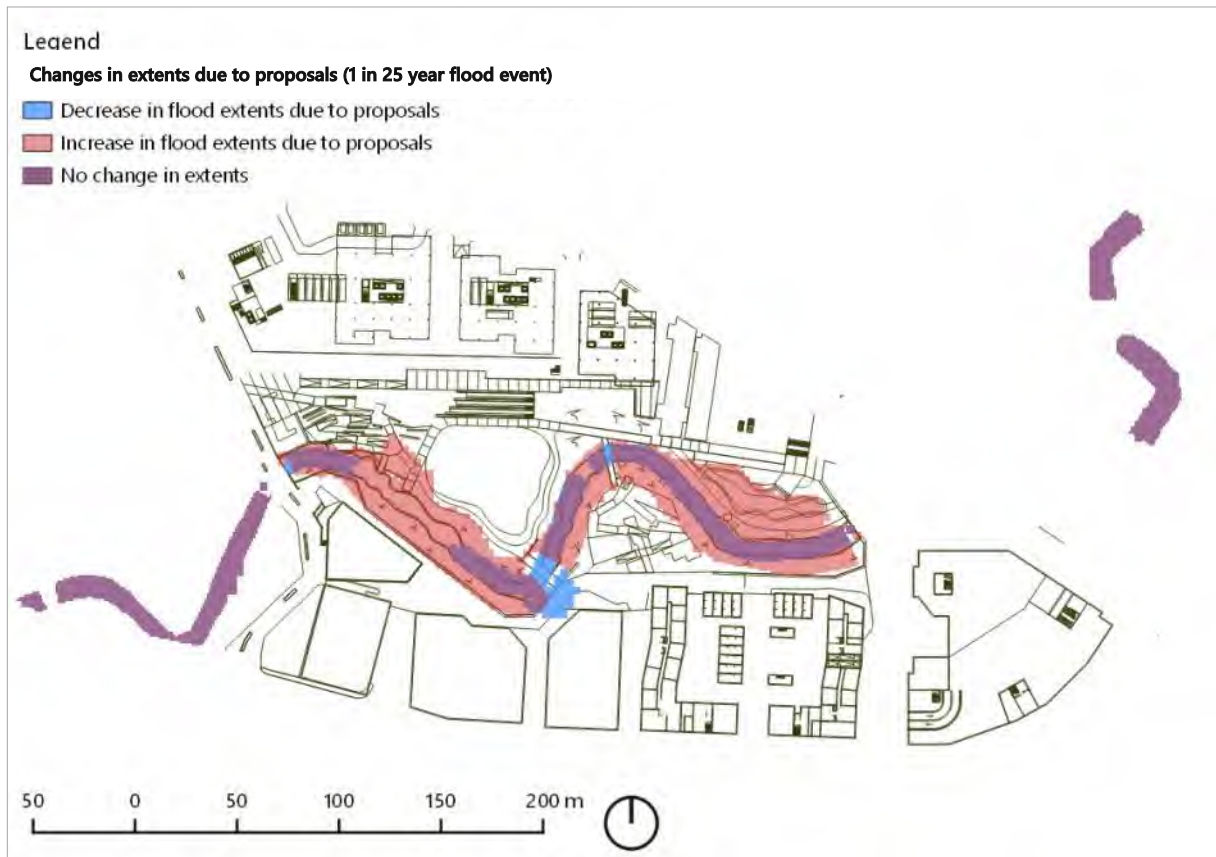
A comparison of the peak level model results from the BHE Baseline 2019 and the Mayfield 2019 models for the 1 in 25 year event demonstrates that the proposals have no adverse impact to levels. The levels decrease due to the proposals by up to 12mm. Within the site, the levels decrease on average by 150mm due to the wider, open channel.

**Figure 5.9 - Changes in flood extents due to the Mayfield proposals during the 1 in 25 year event, site surroundings**

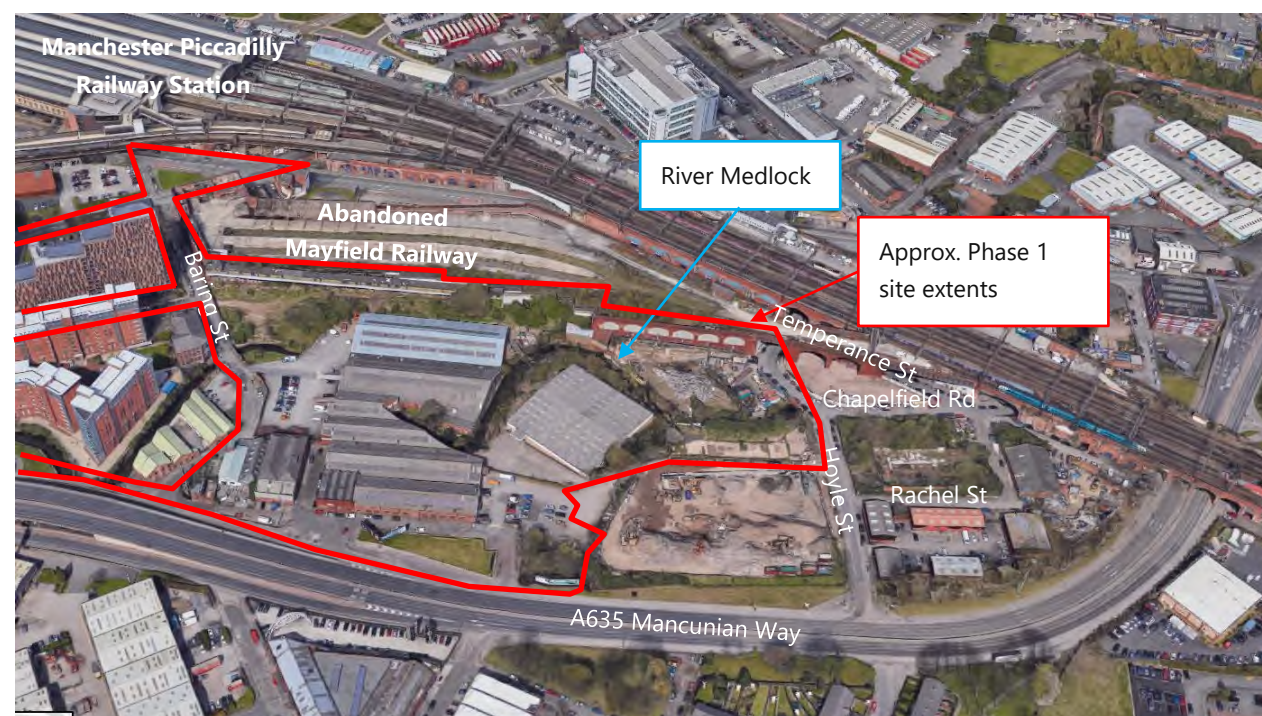
The Mayfield Phase 1 Development Site is a 7ha and is located in Manchester City Centre to the immediate south/southeast of Piccadilly Railway Station, centred at NGR 385006 397717. The River Medlock meanders through the central area of the Site, flowing from east to west within a deep rectangular brick/stone walled channel. It is culverted beneath Hoyle Street.

Figure 4-1 Existing Site with the Phase 1 Site Boundary

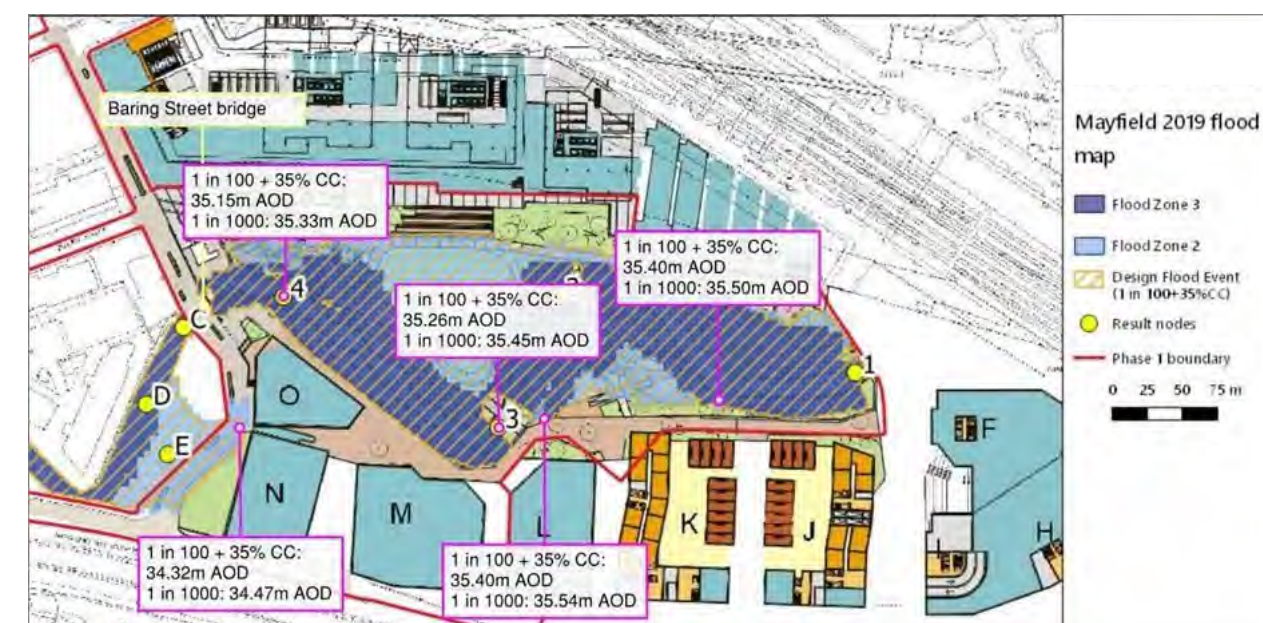
*"The Environment Agency's flood risk mapping shows parts of the existing site to be highly susceptible to flooding with the River Medlock canalised between the high walls and under industrial buildings. Flooding of the site is concentrated around the Medlock in the central area (Flood Zone 3 High risk) with some Flood Zone 2 (Medium risk) on the margins. However, the majority of the site is situated within Flood Zone 1 (Low risk) with a flood risk less than 0.1% (on average one occurrence in 1000 years). Flood risk from ground water, surface water and artificial sources is currently considered low to very low at the site.*

Figure 4-2 Mayfield 2019 Flood Map extract from the Flood Risk Assessment

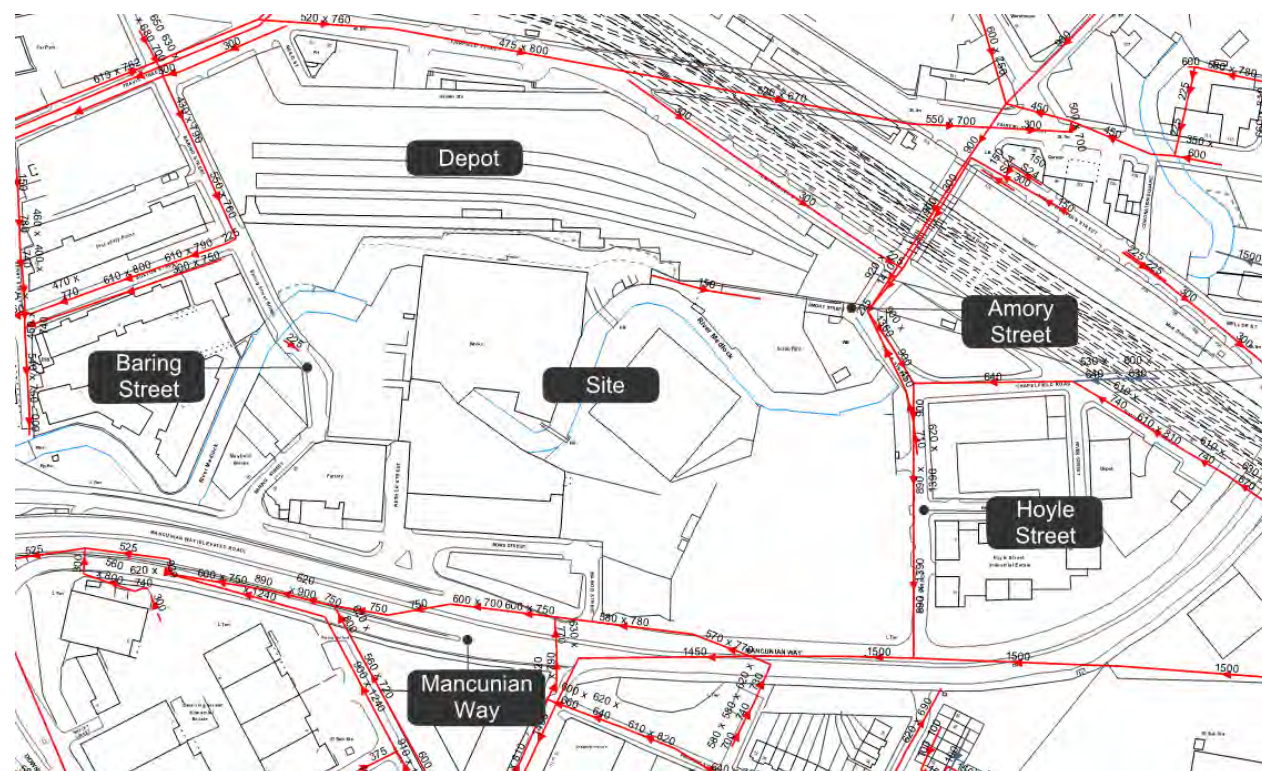
**Figure 6-1 United Utilities Sewer Asset Record.** (Image courtesy of the United Utilities © United Utilities Water PLC 2017)

UU network pipes sizes vary from 150mm diameter to 1500mm in Mancunian Way. Pipe materials are a mix of vitrified clay and brick and sewer shape varies from circular to egg. Sewer depths appear significant, up to 10m in places, suggesting that they have excavated in rock or possibly constructed within a tunnel heading. UU sewer levels and exact manhole locations are unknown in the majority of cases. A line and level survey at probable points of connection will be required at the next stage.

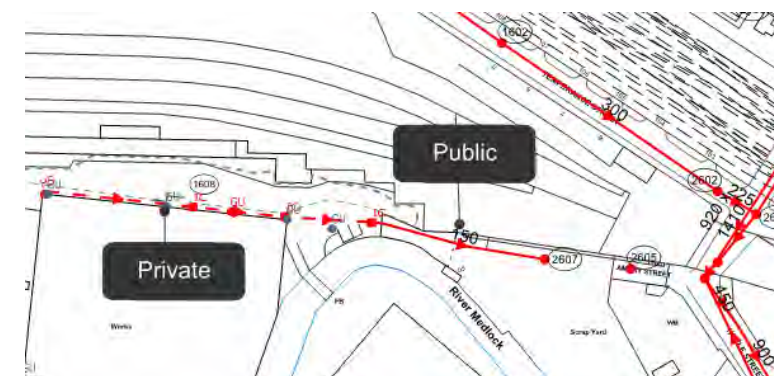
Information pertaining to the private site foul drainage is limited, and no as-built data is available. UU asset records record a length north of the river serving the Fedex building, does not appear to drain to an obvious discharge point on the sewer records, however, it is assumed to connect to the public sewer in Amory Street. A known private combined sewer is connected to this run.

**Figure 6-2 Known private site sewerage** (Image courtesy of the United Utilities © United Utilities Water PLC 2017)

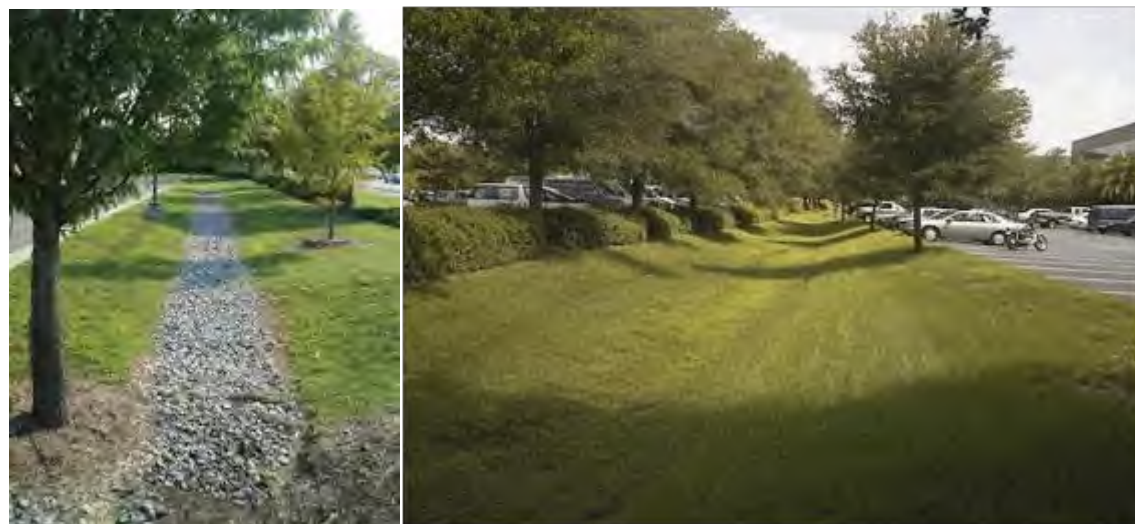
There is insufficient space for large open water features such as lakes outside of the flood zone, however, in some areas within the flood zone, swales/infiltration trenches will be introduced to contain 1 in 30 year storm event runoff from neighbouring softscape and footpaths. The remaining runoff from a 1 in 100 year storm event will overflow into the River Medlock. There is no need to generate enough hydraulic head to push the water into the River Medlock during a flood event as these areas will have flooded. Examples of a swale and an infiltration trench are shown below.

Figure 7-2 Infiltration Trench Example (Left); Swale Example (Right)

Swales/Infiltration trenches have been proposed in some areas of the flood zone to contain 1 in 30 year storm event runoff from neighbouring softscape and hardstanding. The remaining runoff from a 1 in 100 year storm event will overflow into the River Medlock. Footpaths within the river bank areas are proposed to be permeable and include a SuDS system geotextile between its foundations and subgrade that will filter any potential contaminants.

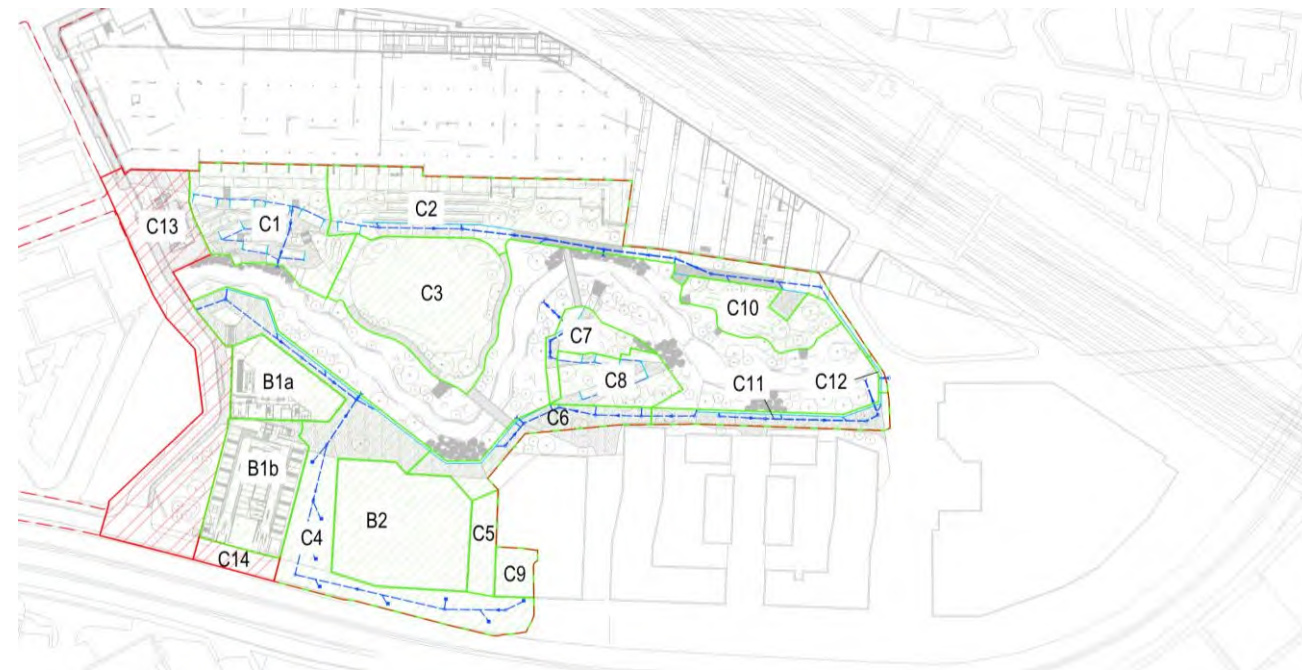
**Figure 7-3 Catchment Areas Plan**

Catchment area C13 shown in the plan is to be drained by the surface water system that runs along Baring Street and is design by Civic Engineers and therefore has not been included in the surface water sewer design. Catchment area C14 is to be drained via the same method as it currently drains. It's drain paths are to be unaffected.

There is potential for rainwater runoff in catchment area C1 to fall into the planting areas between the hardscaping during low rainfall intensities, however, during higher rainfall return periods, this area will need to be provided with a flow path to the Medlock to avoid localised flooding.

Indicative surface water sewer runs were created within the masterplan. Catchment areas were then created based on the sewer runs and the landscaping layout. Catchment areas are shown in Table 7—1. The effective areas for each catchment have been calculated using the runoff coefficients of 0.95 for hardscaping and buildings and 0.3 for softscape landscaped areas. The locations of the catchment areas can be seen in Figure 7-3.

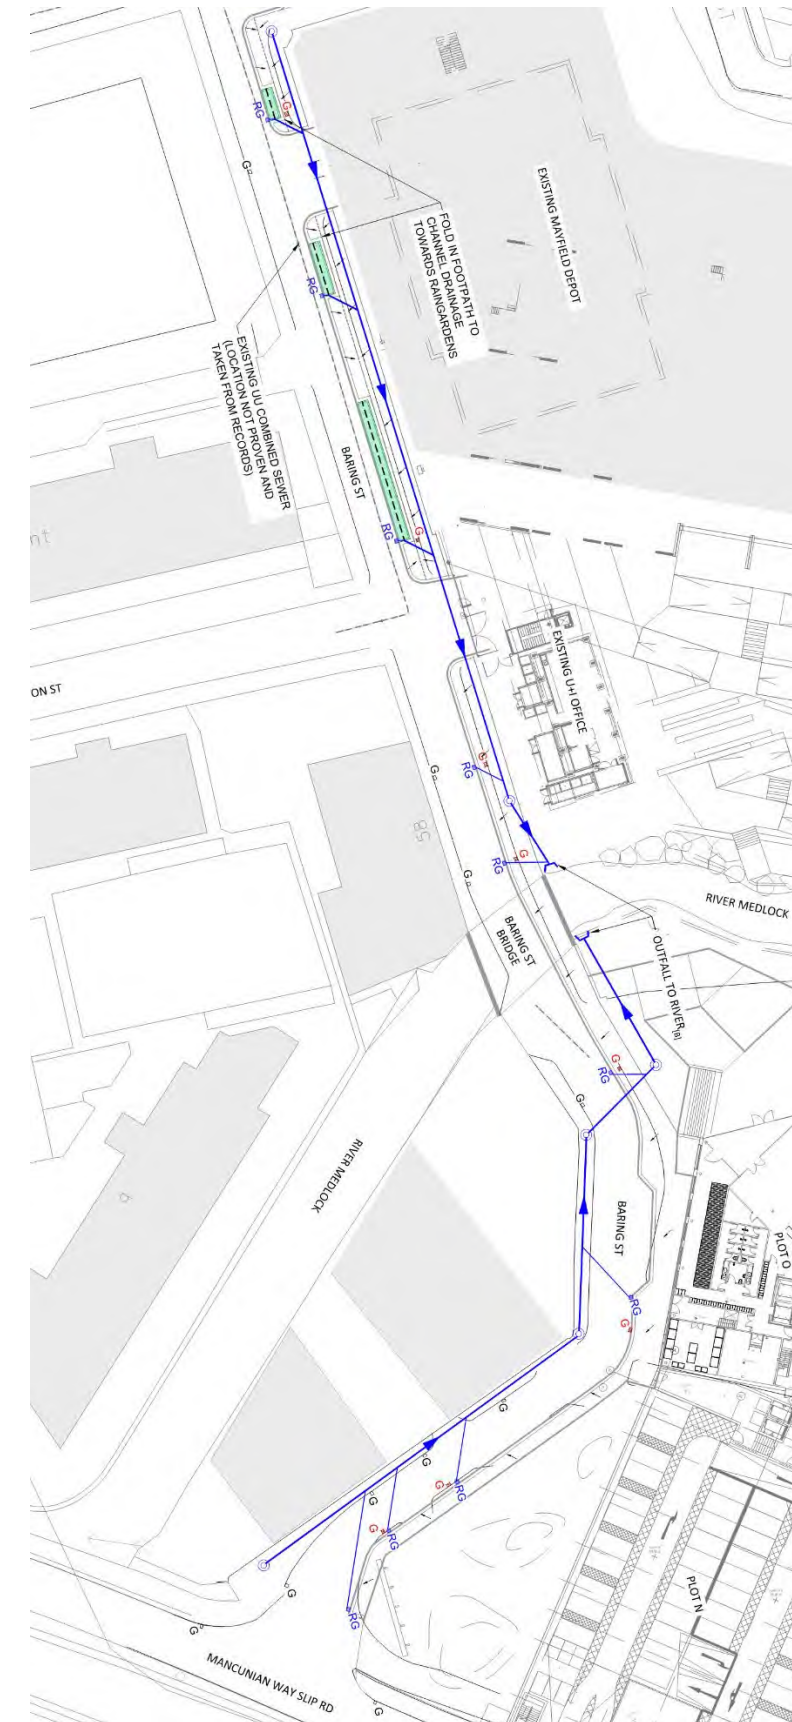
**Figure 7-4 Civic Proposed Surface Water Sewer Run**

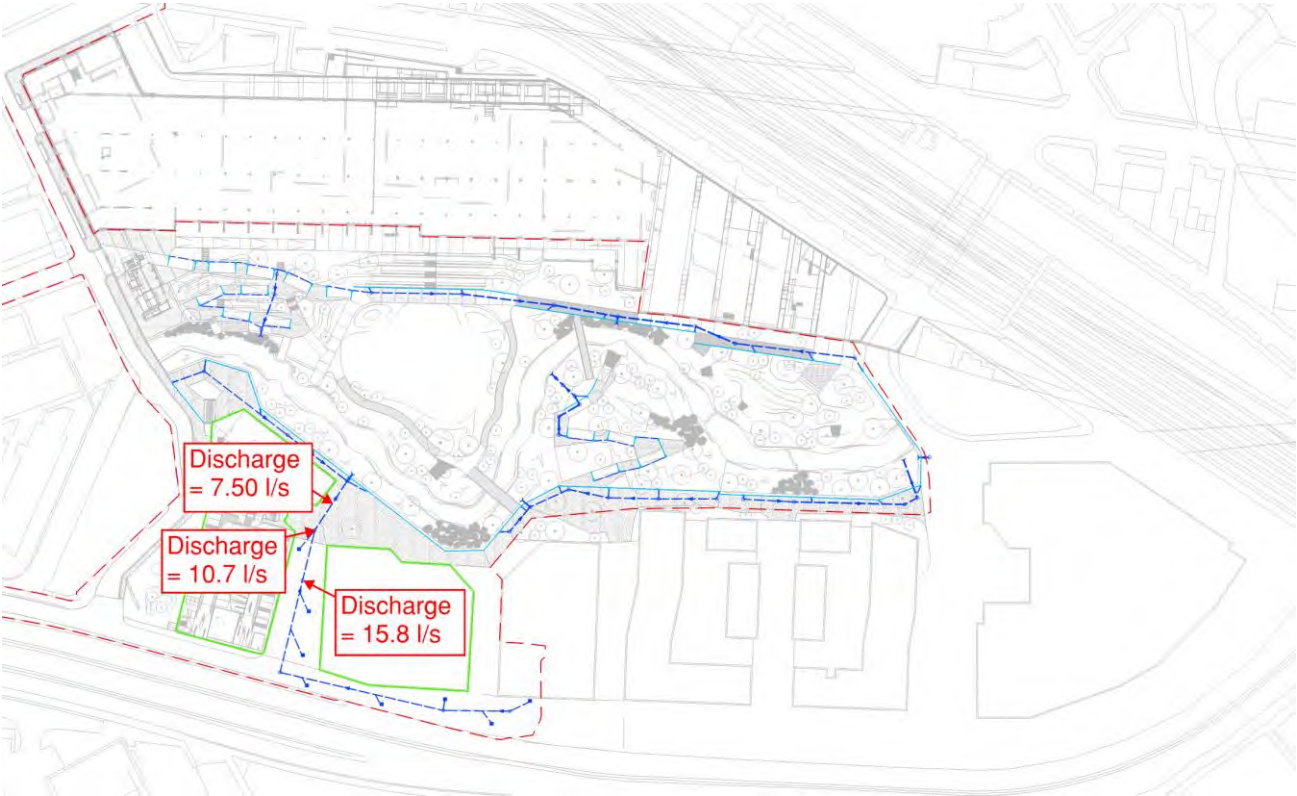
The surface water system will also need to take into account future runoff from the proposed buildings around the site. Points of connection to the proposed external surface water system for the on plot attenuation tanks at the required maximum discharge rates are shown in the figure below. See Appendix F for drainage strategies from the plot teams.

Figure 7-5 Surface Water Plot Connection Points into proposed surface water sewer

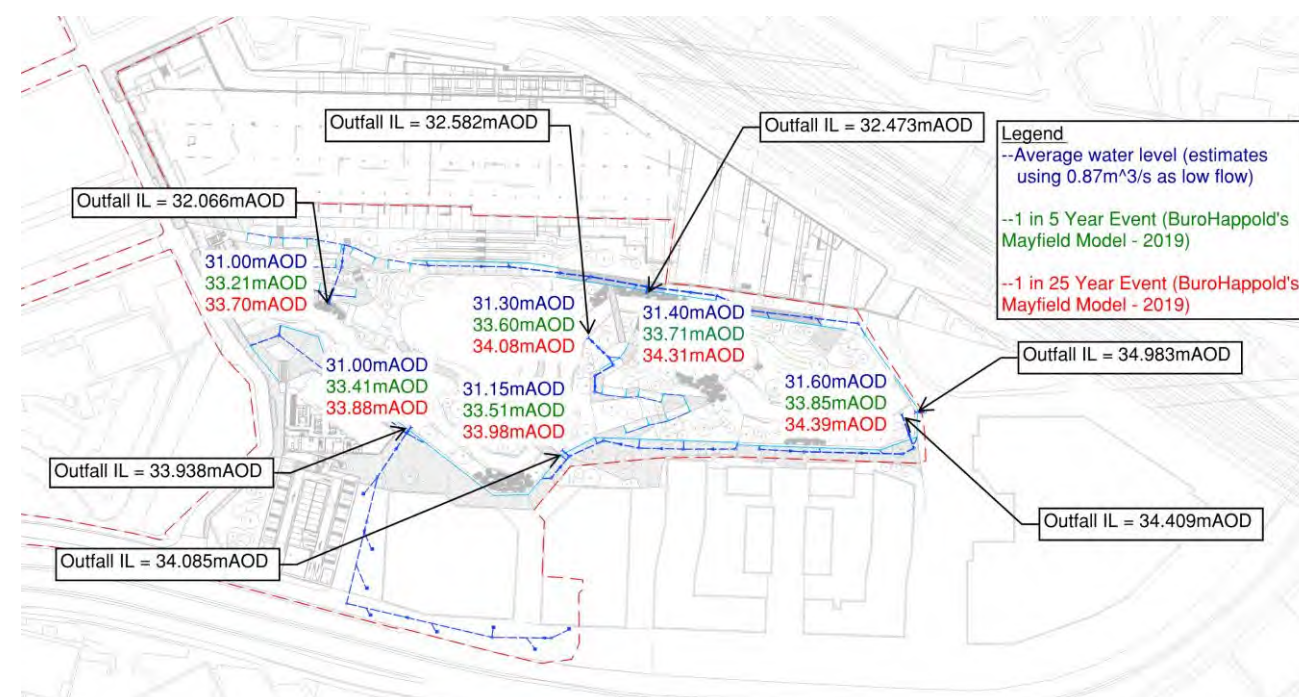
Where possible, the invert levels of the outfalls have been proposed to be above the 1 in 25 year flood event. However, due to the levels and gradients around the site in some locations it is not possible to achieve this. Instead the average river level has been used as the minimum outfall invert level. There are three outfalls where this occurs, two of which are within the river bank areas of the Phase 1 site. However, it is deemed unlikely that a high intensity fluvial event will coincide with a high intensity rainfall event. If a convergence occurs, there is sufficient hydraulic head within the surface water network to prevent flooding to the buildings/plots if the outfalls are submerged.

Figure 7-6 1 in 25 Year fluvial flood levels and Average Water Levels near proposed outfalls

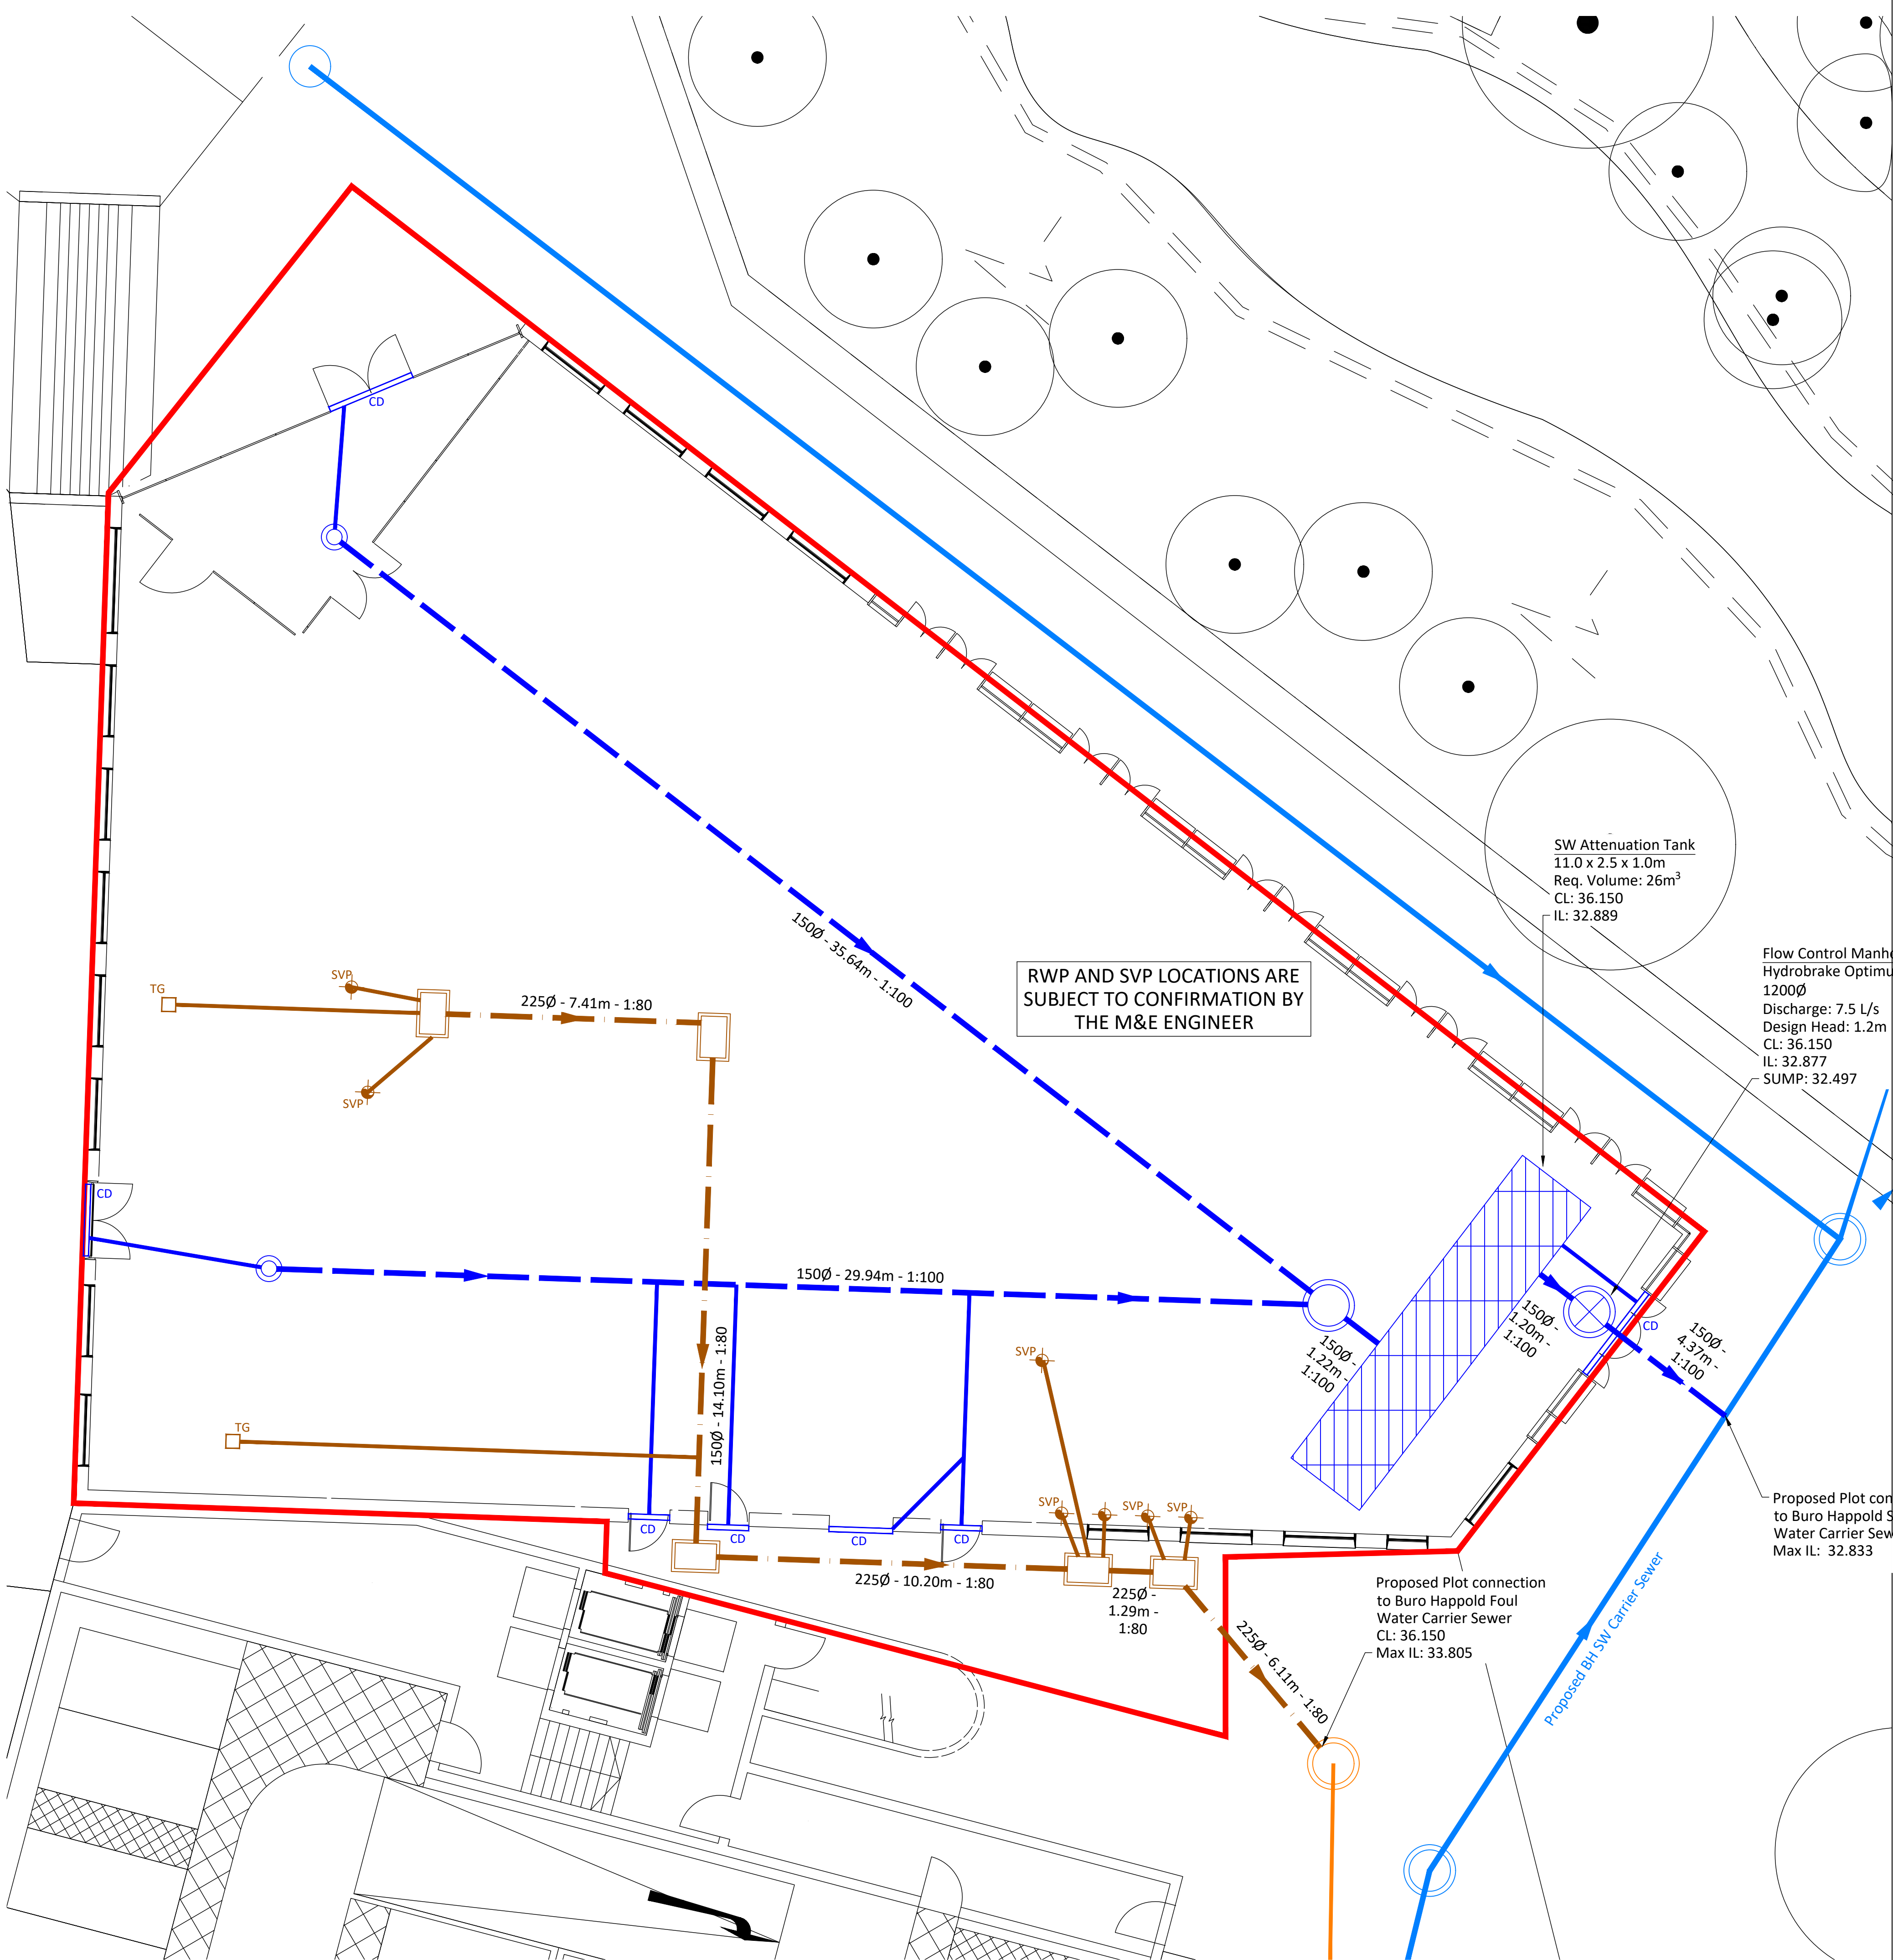
Title  
**DRAINAGE STRATEGY  
GENERAL ARRANGEMENT**

All underslab drainage shall be laid at gradients of 1:80 min. for foul pipework and 1:100 min. for surface water unless noted otherwise. All pipework to be: Foul 100mm and Surface Water 150mm unless otherwise stated.

All underslab drainage shall be clear of foundations unless shown otherwise with long radius bends kept to a minimum and used where unavoidable. All surface water drop down positions shall have a bend set at invert level no greater than 1.3m below finish floor level.

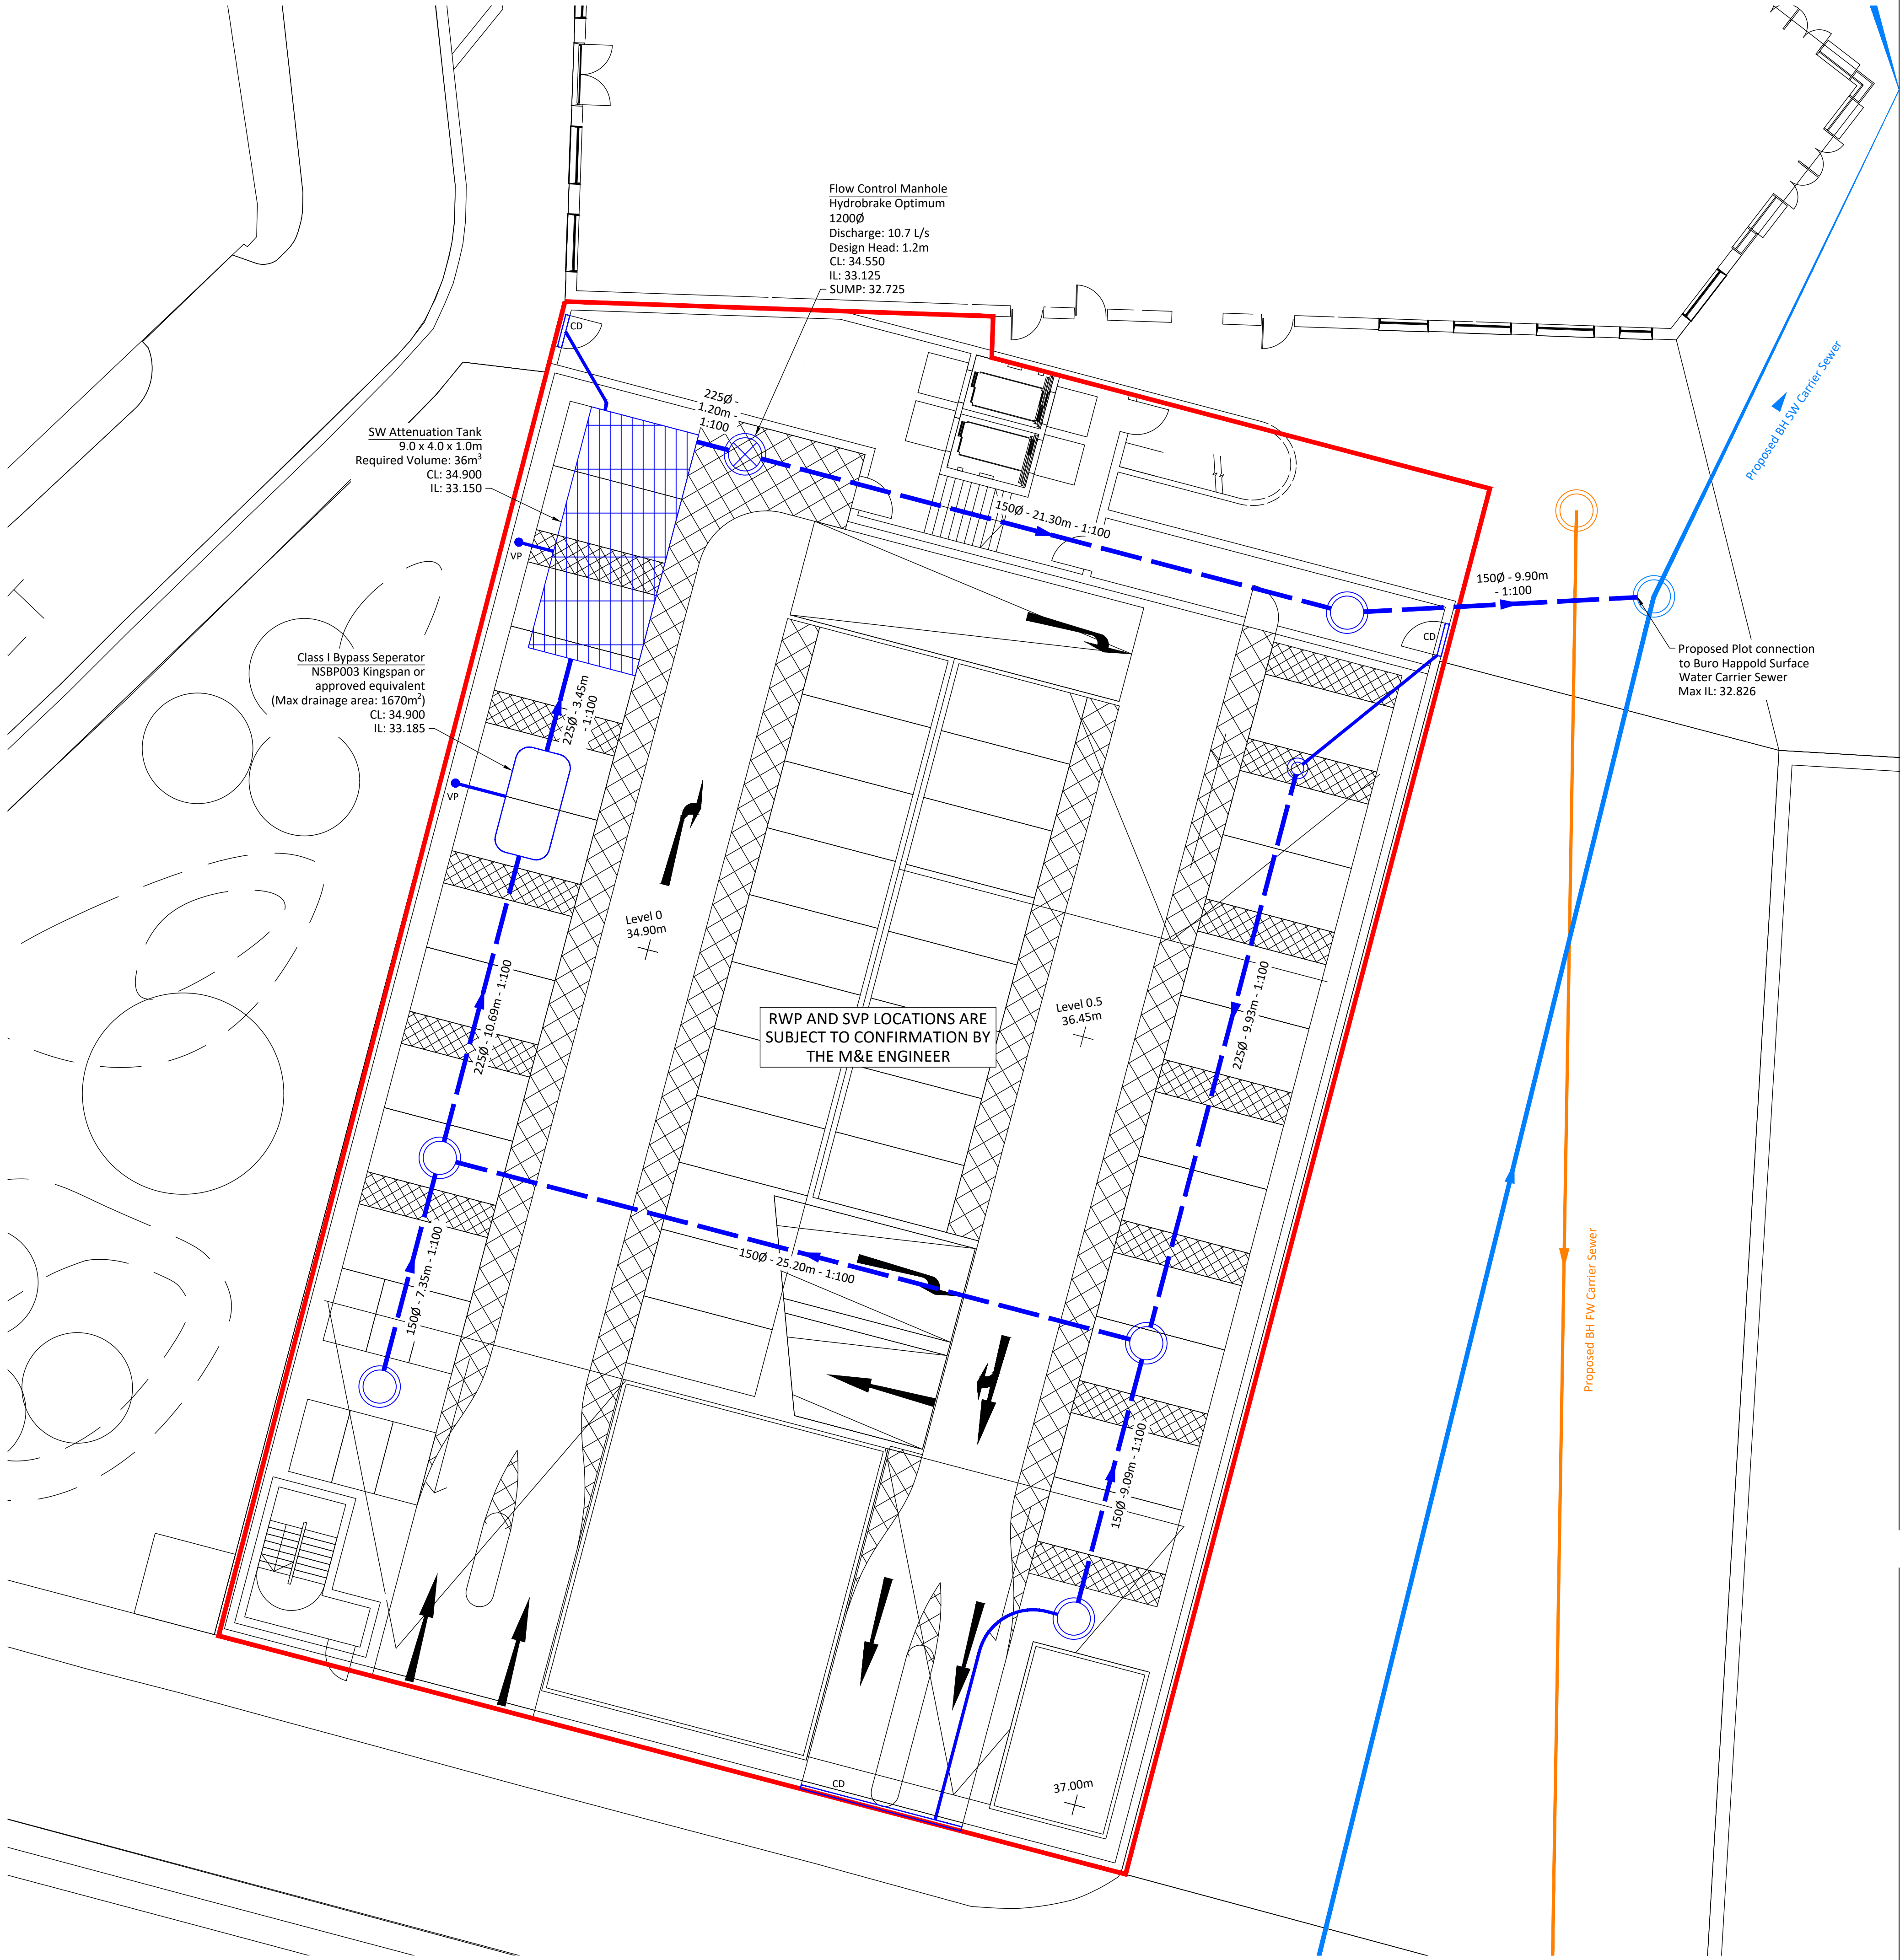
Title  
**DRAINAGE STRATEGY  
GENERAL ARRANGEMENT**

All underslab drainage shall be laid at gradients of 1:80 min. for foul pipework and 1:100 min. for surface water unless noted otherwise. All pipework to be: Foul 100mm and Surface Water 150mm unless otherwise stated.

All underslab drainage shall be clear of foundations unless shown otherwise with long radius bends kept to a minimum and used where unavoidable. All surface water drop down positions shall have a bend set at invert level no greater than 1.3m below finish floor level.
