Validation Report  
Mayfield Parks and Plots M, N and O

Reference:14-575-R1-Rev 1  
Date: November 2021

# REMEDIATION AND ENABLING WORKS VALIDATION

Mayfield Park  
Mayfield Parks and Plots M, N and O

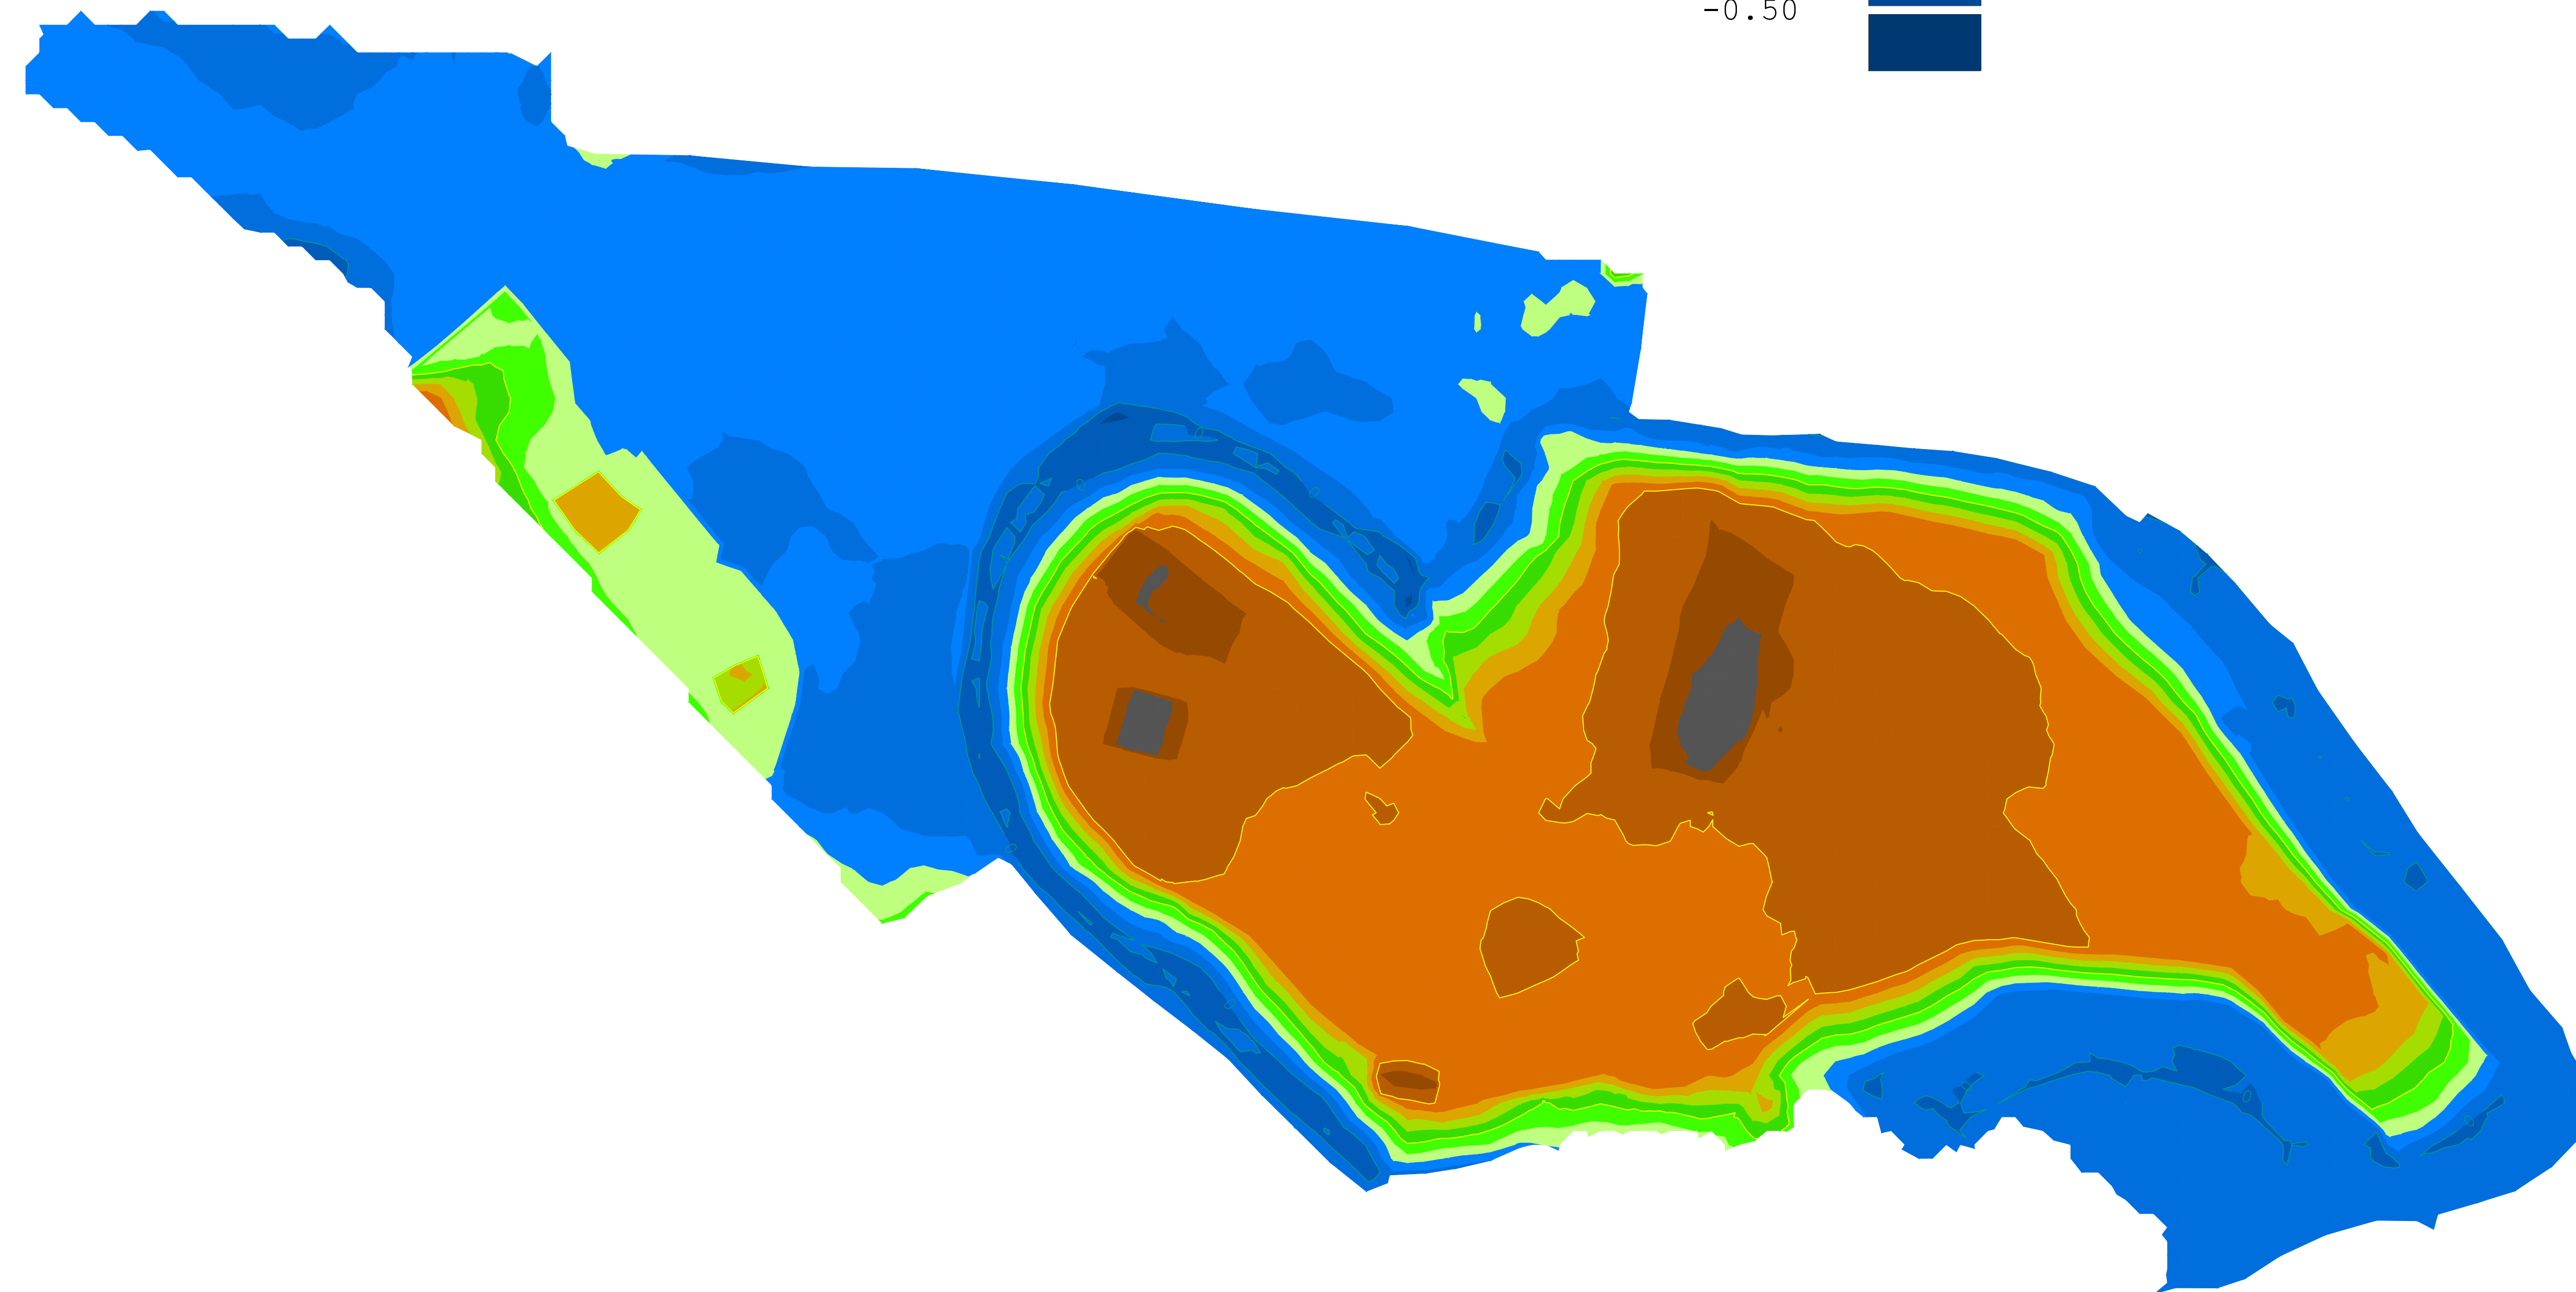
WETLANDS FILL VOLUME  
= 2435m3

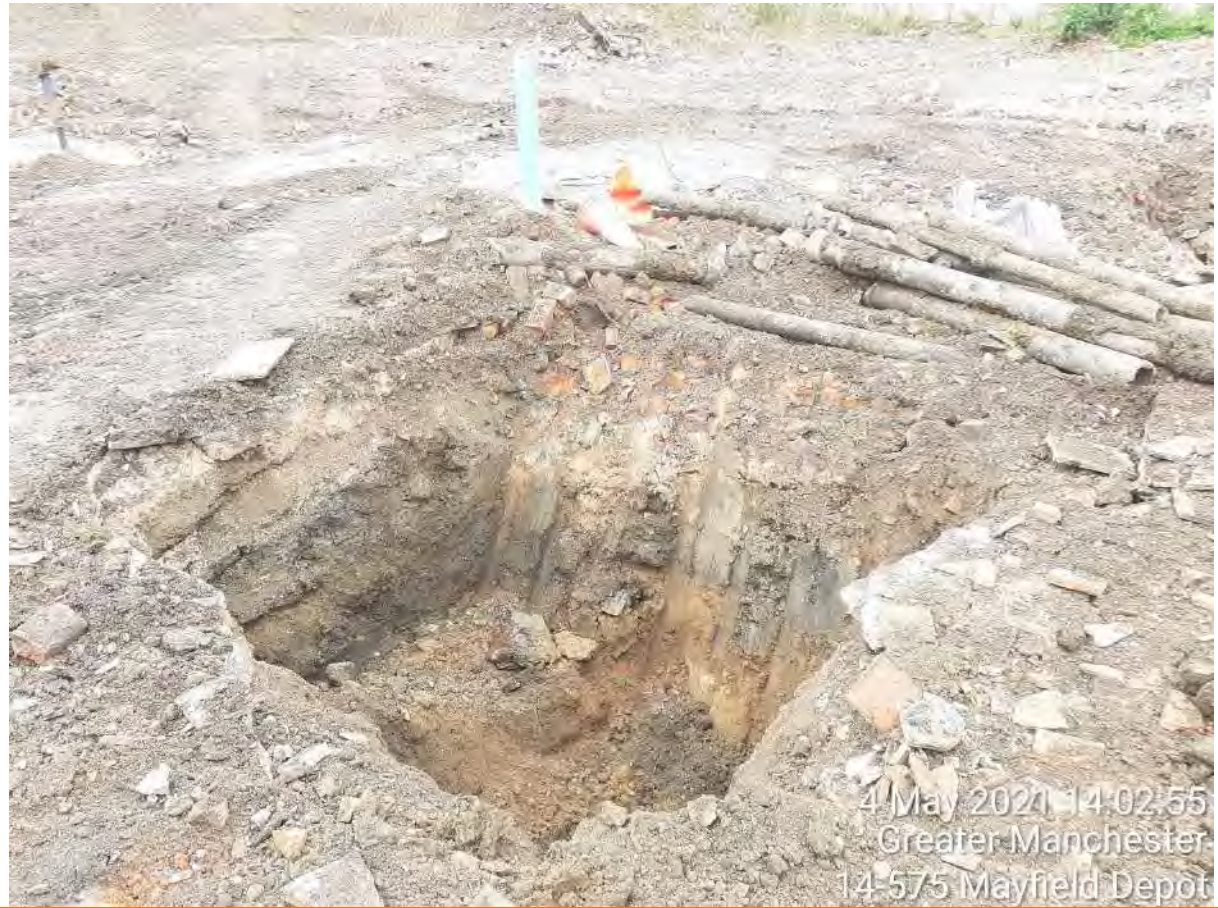
TP102 HOTSPOT REMOVAL

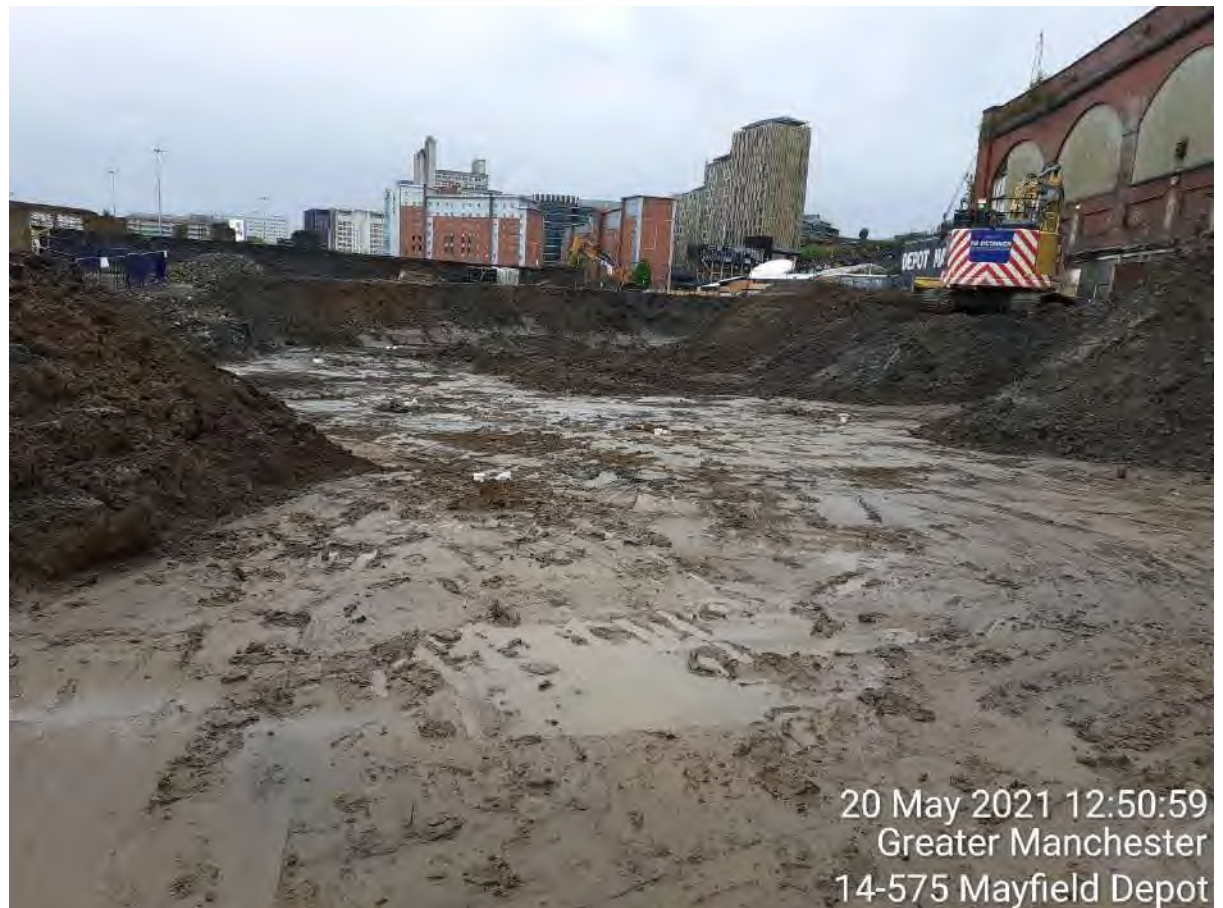
PLATE 9 HYDROCARBON SOURCE 1 REMOVAL

All visual evidence of hydrocarbon material was removed and stockpiled on an impermeable membrane to prevent leaching of contaminative material. Excavation was carried out to reach the natural clay barrier layer. Visual inspection of the natural clay showed no signs of contamination therefore, excavation of 200mm of the top of the natural clay noted within the remediation strategy was not carried out as it was not necessary to potentially compromise the integrity of the natural clay barrier layer if the clay appeared to not have any visual or olfactory evidence of contamination. Validation samples were taken from both the base (21-76648) and walls (21-78144) of the excavation. Samples were analysed for both leachate analysis as well as solid Speciated PAH and TPHCWG to ensure validation of all contaminated material results showed that all hydrocarbon impacted material has been removed. Leachate results showed very slightly elevations in arsenic highest of which found in HC1 S samples at 32µg/l however due to the minor and isolated exceedances it is not considered to pose a risk to controlled waters.

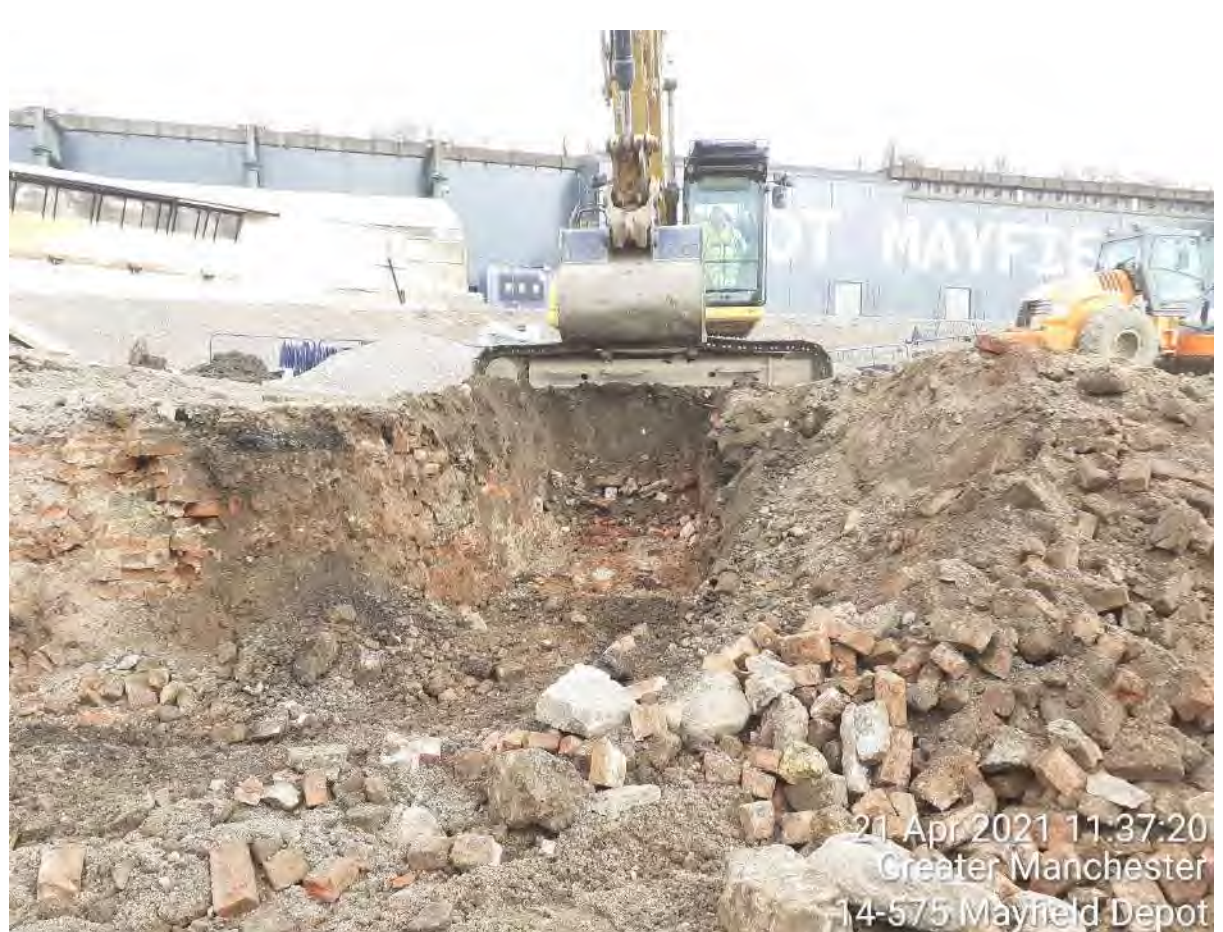
PLATE 10 HYDROCARBON SOURCE 3 HOTSPOT REMOVAL
