Validation Report  
Mayfield Parks and Plots M, N and O

Reference:14-575-R1-Rev 1  
Date: November 2021

# REMEDIATION AND ENABLING WORKS VALIDATION

Mayfield Park  
Mayfield Parks and Plots M, N and O

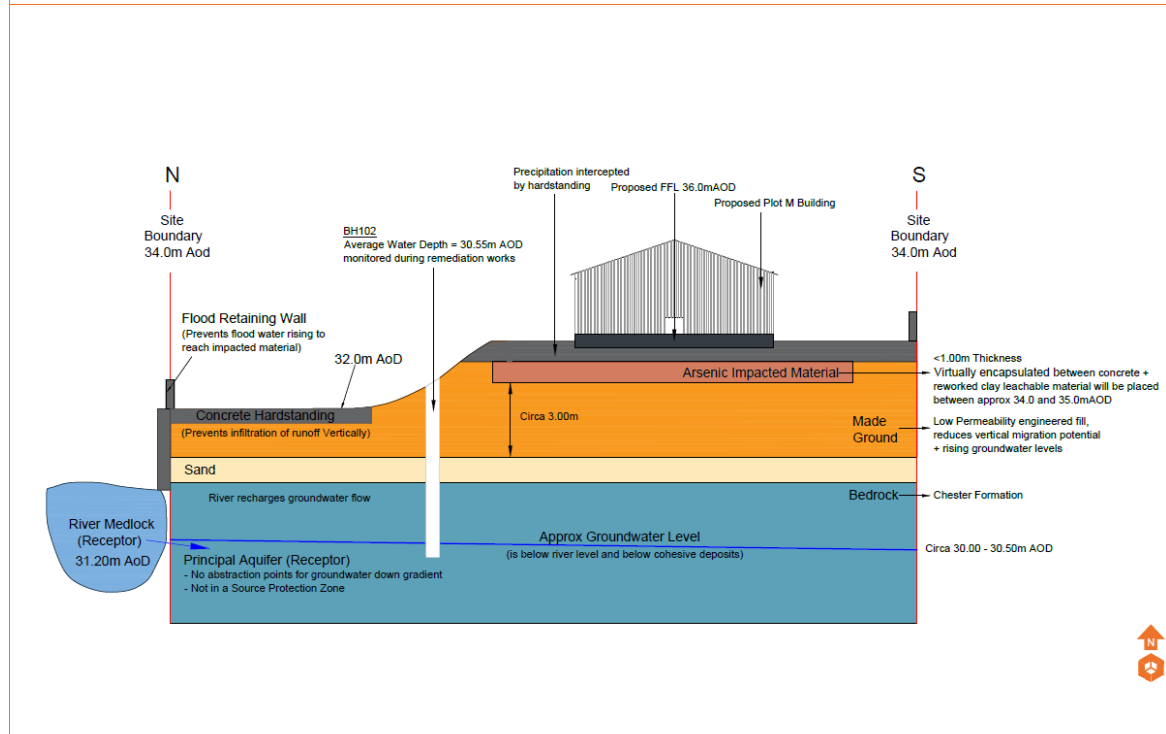
#### POST MATERIAL PLACEMENT CSM

Furthermore, when considering the conceptual site model for the site (Figure 4), the soils will be placed above low permeability engineered fill materials and below impermeable surface that is the concrete slab of the proposed building. Therefore, there will be very limited potential for any infiltration to reach the soils and mobilise the arsenic. The low permeability engineered fill will act as a barrier to the vertical migration of contaminants and limited infiltration to the soils will ensure no unacceptable levels of lateral migration occurs.

The results of the historical data review, Tier 1 qualitative and preliminary Tier 2 quantitative risk assessment has allowed E3P to draw the following conclusions in respect to the risk to controlled waters:

- ✳ There has been sufficient testing of soils at the site during remediation and enabling works;
- ✳ The primary receptors are identified as the River Medlock and the underlying principal aquifer. Although there are no recorded groundwater abstraction points down the hydraulic gradient of the site and the site does not lie within a source protection zone, therefore reducing the sensitivity of the aquifer receptor.
- ✳ The water level of the River Medlock is above that of the groundwater level at the site. Therefore, the River is likely to recharge the groundwater and not vice versa as shown on the post works CSM;

Should the construction of the development be delayed at any point, an impermeable membrane should be placed across Plot M to ensure no infiltration potential arises as a result of surface water. A slight grading to the membrane towards the river would be beneficial and ensure no pooling of surface water occurs.

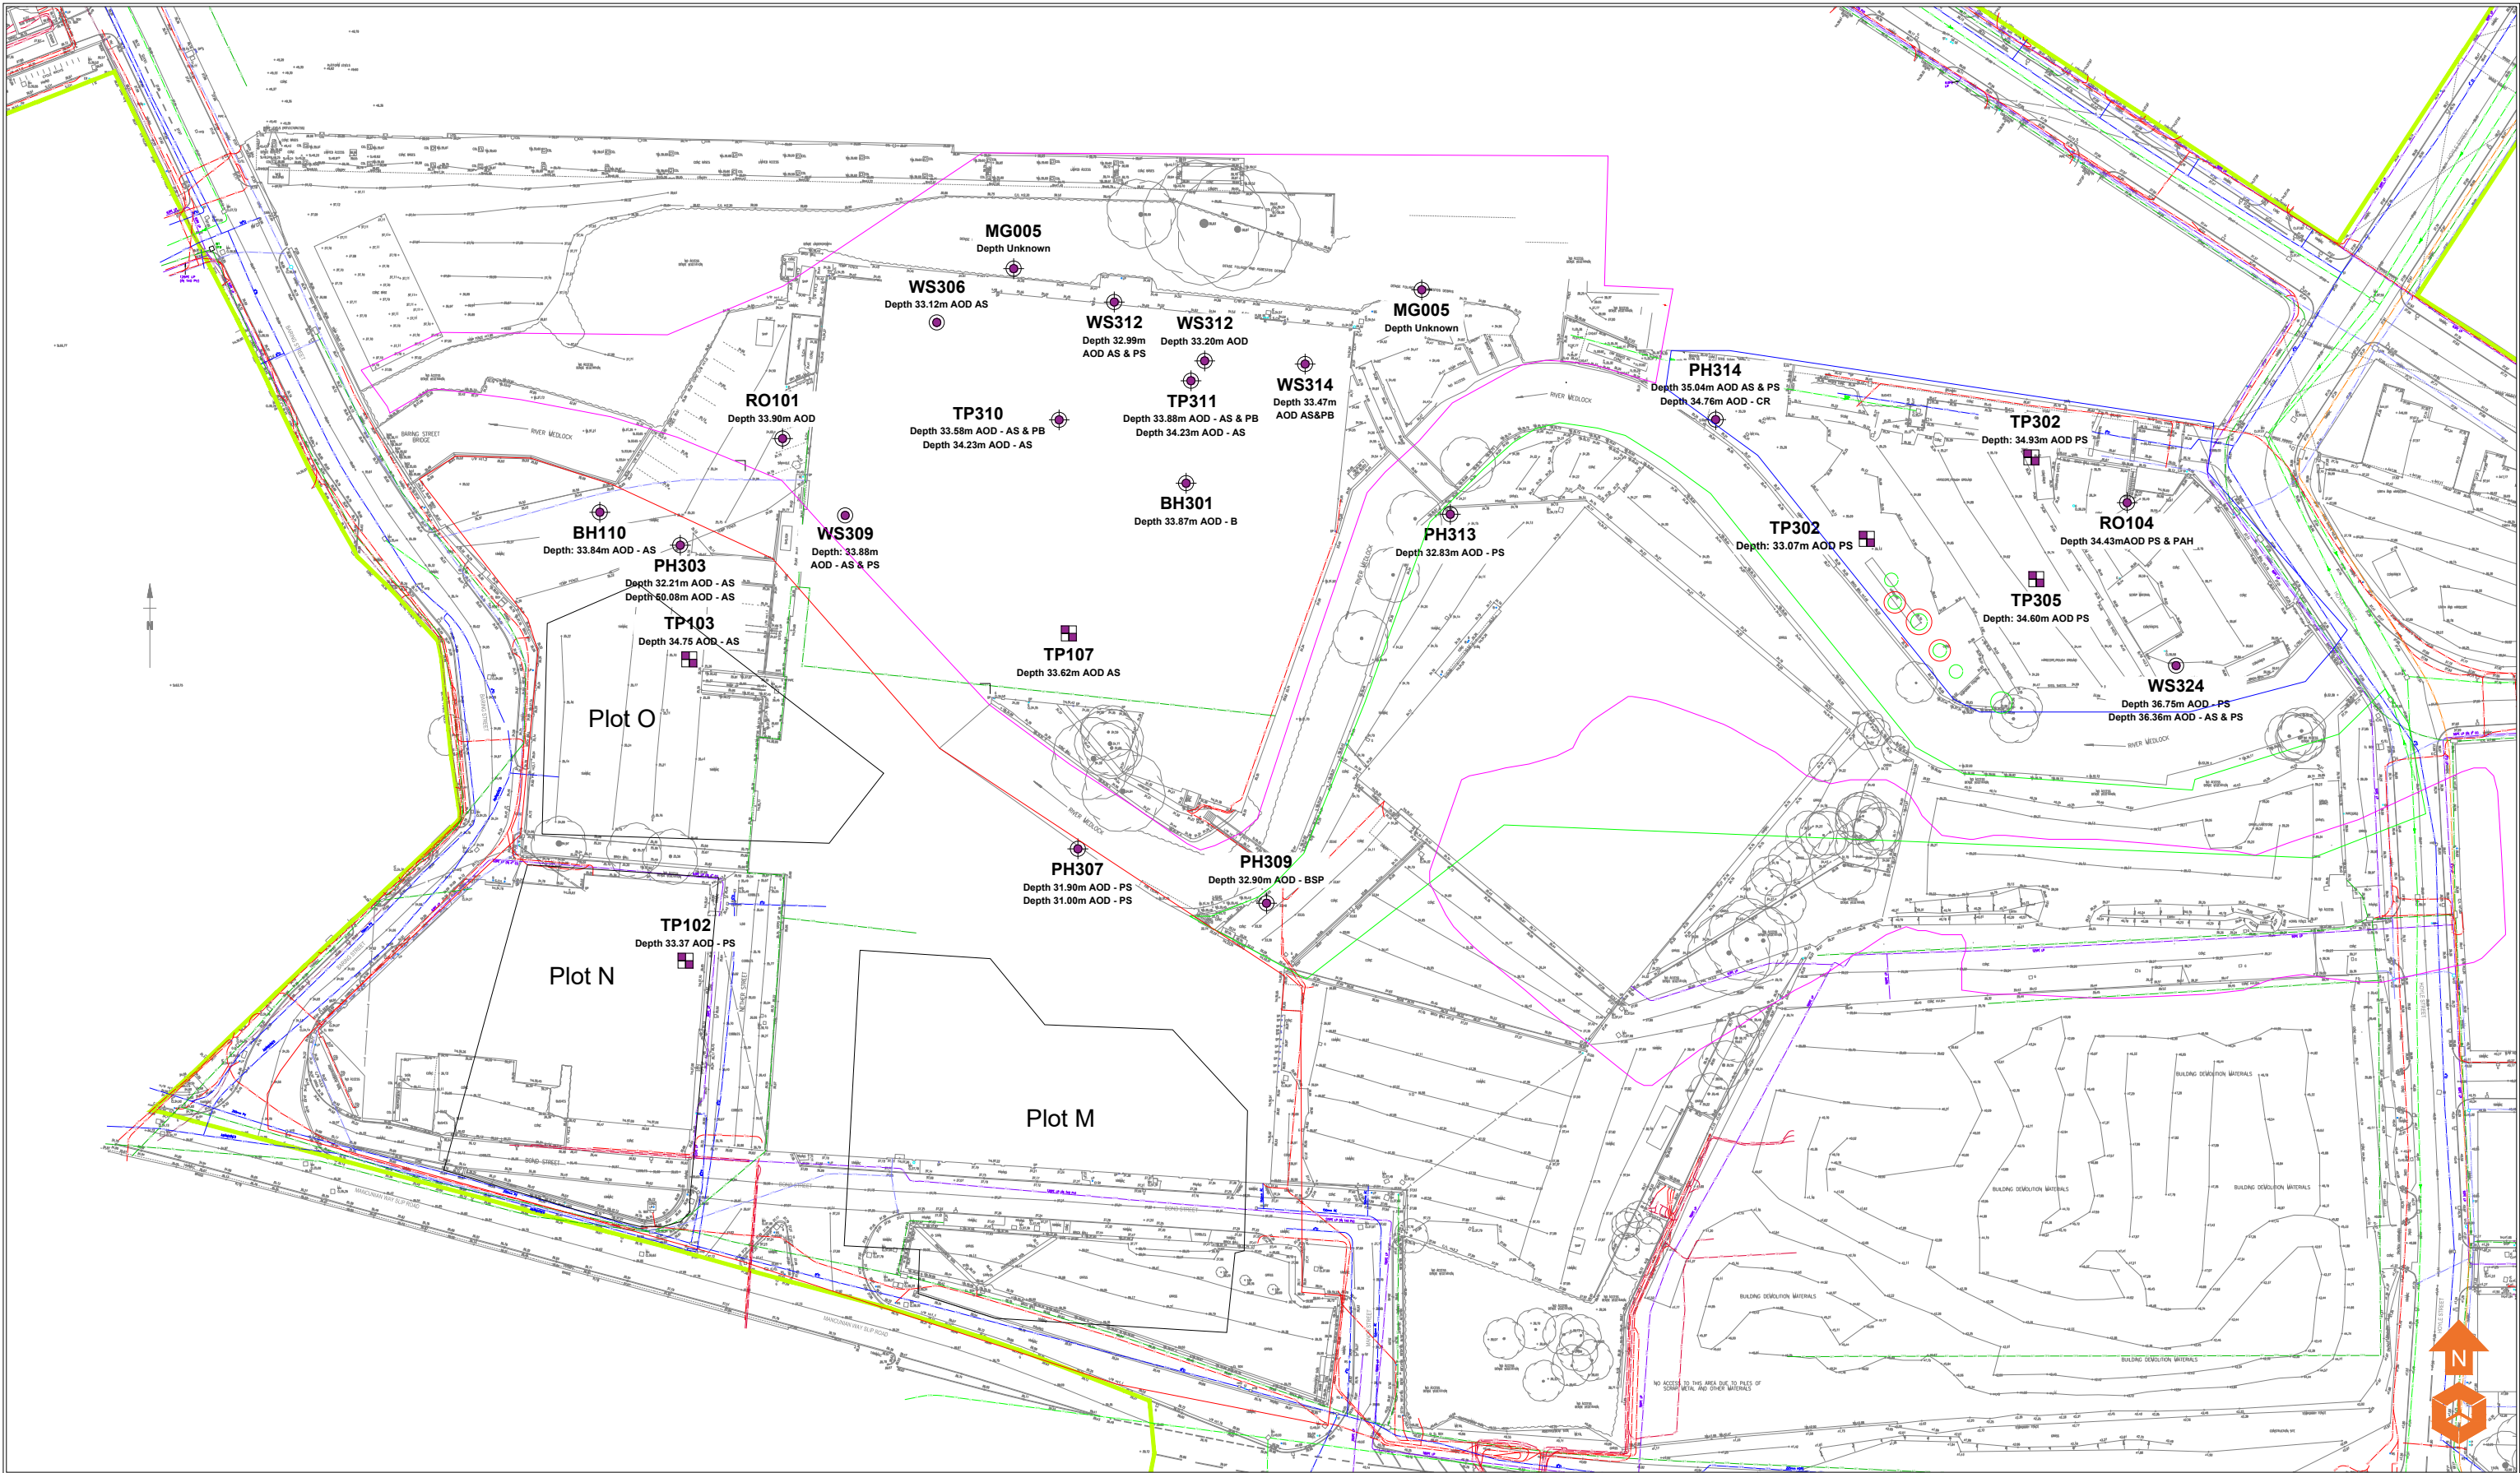
Hotspots

Exceedance of Tier 1 Groundwater values with details

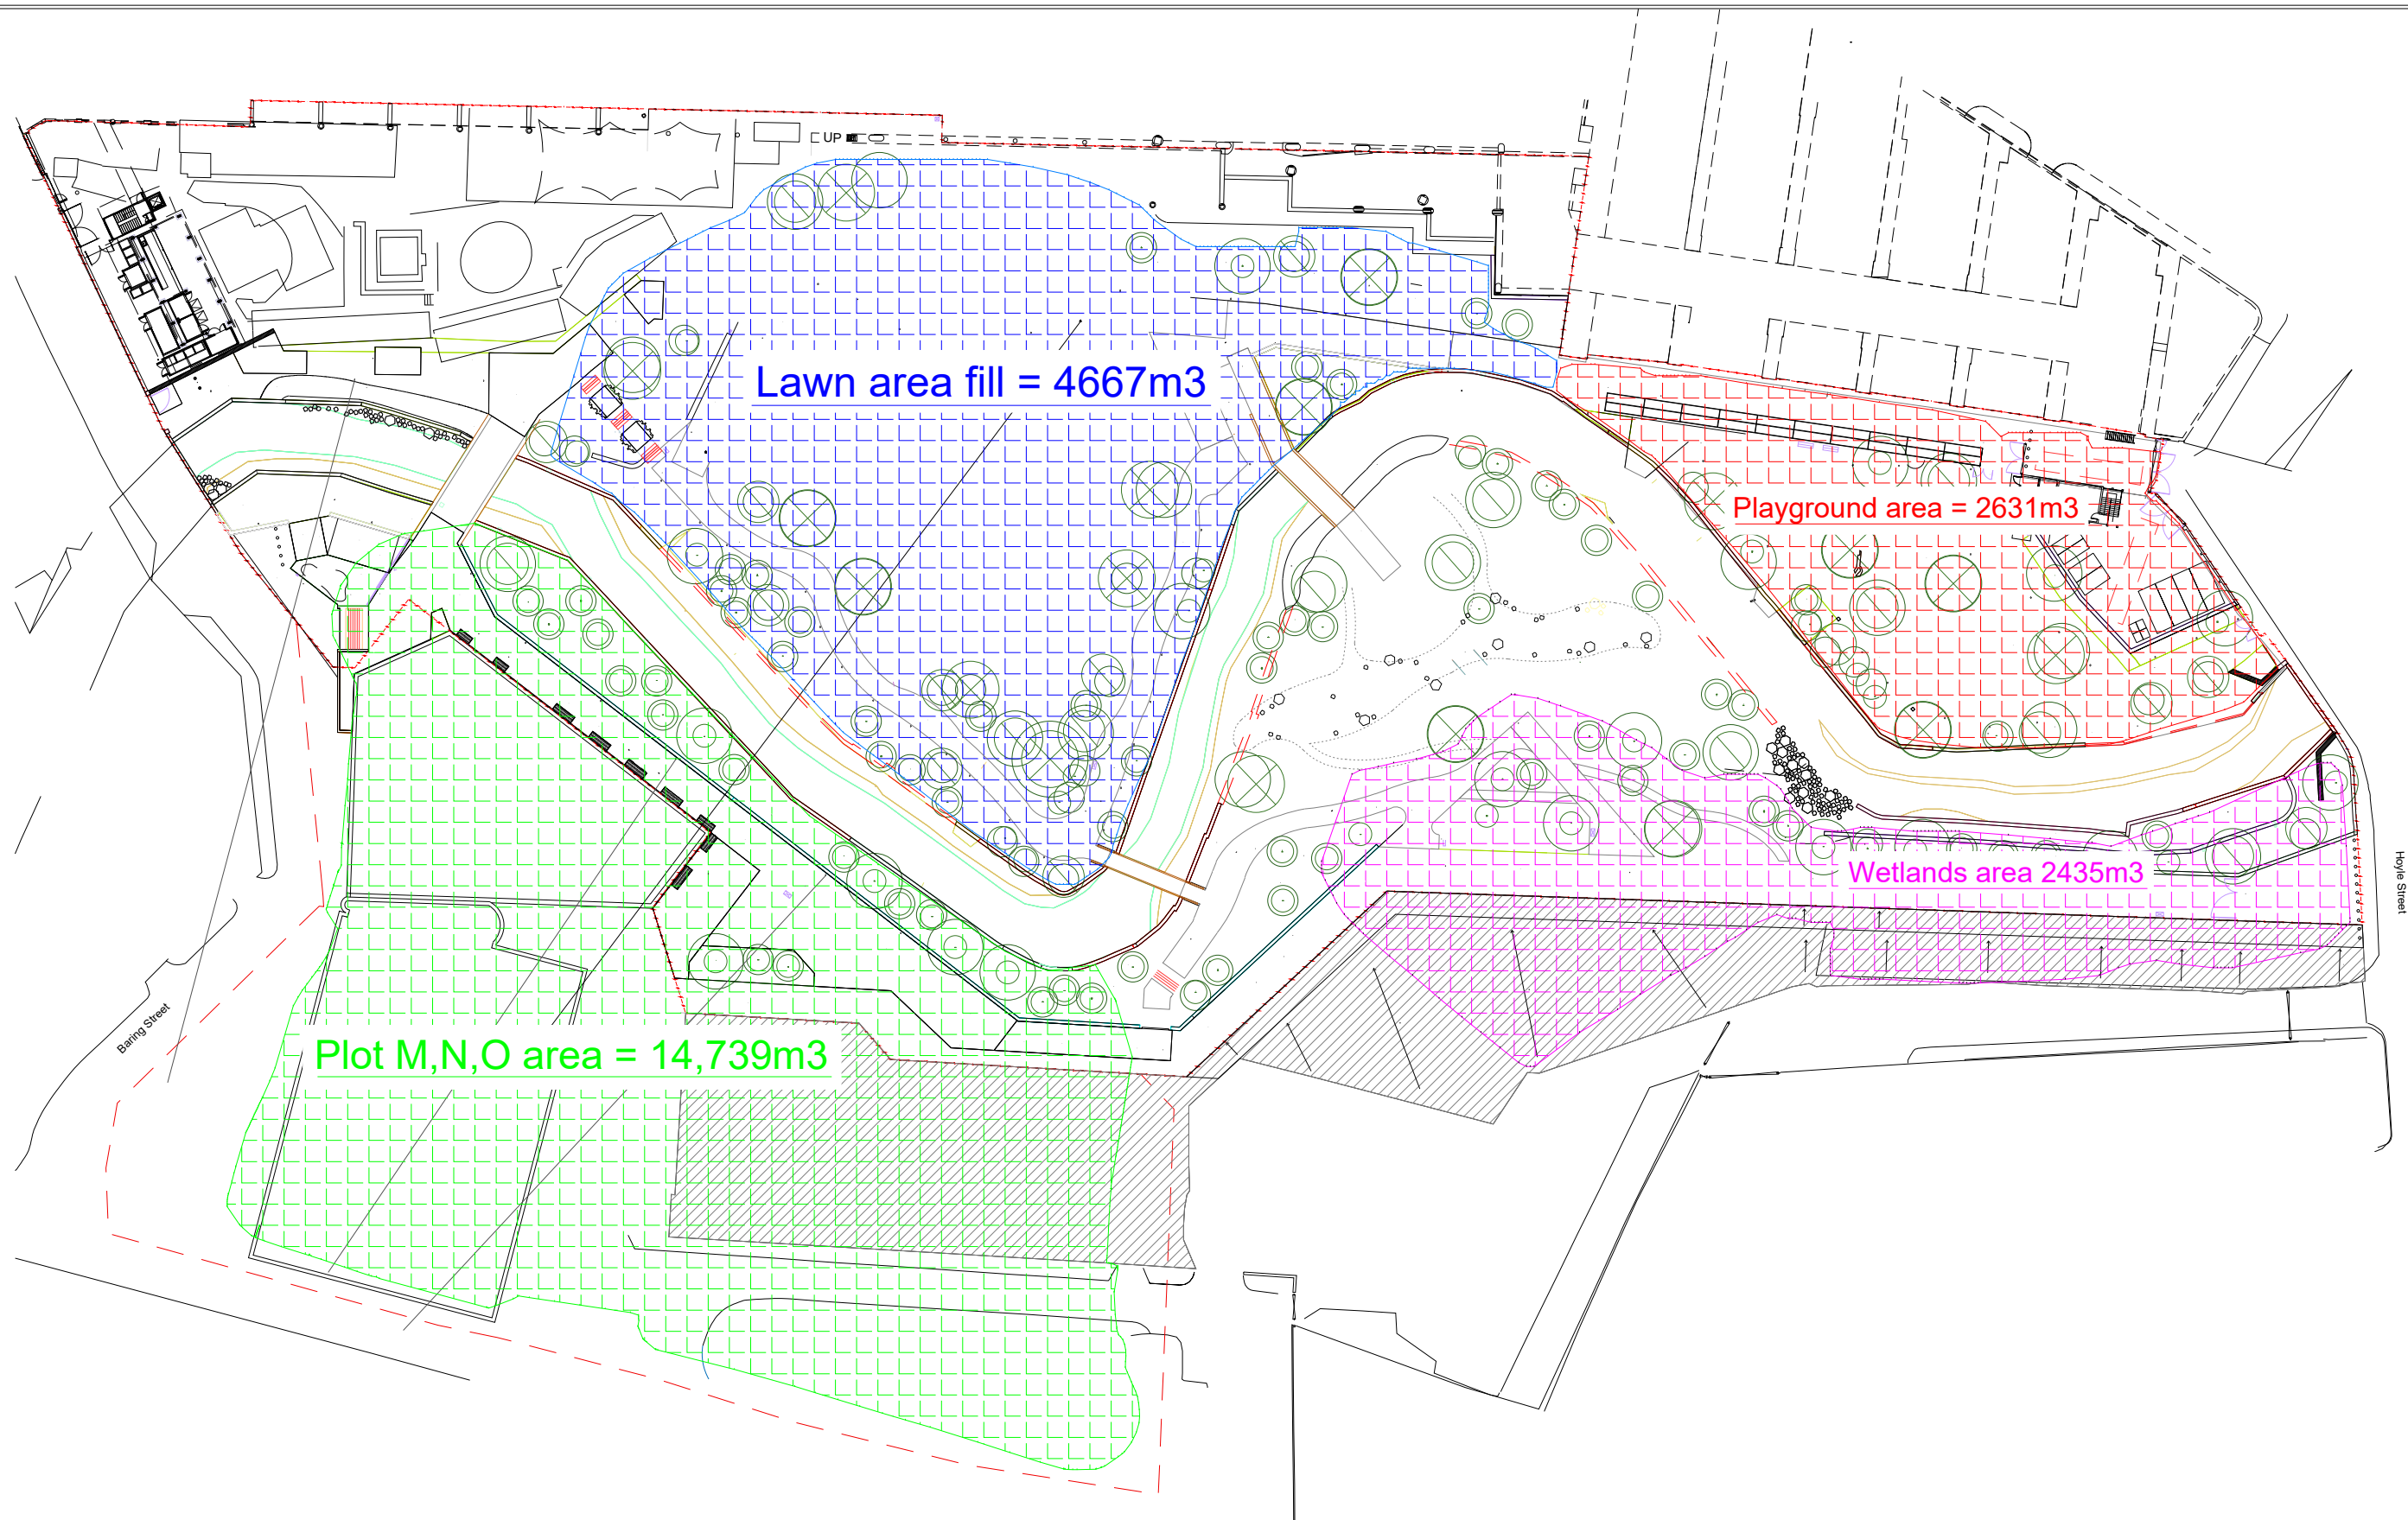
| P1 | REVA | 02.11.2021 | LM | NG | Job Title:<br><br>Mayfield Depot | | Drawing Title:<br><br>Fill Level Plan | | The client must not amend any drawing, design or other intellectual property produced by E3P Ltd without permission in writing from E3P Ltd in advance of any amendments being made. In the event that such written permission is not obtained in advance of the amendments being made, E3P Ltd shall not be liable for any damage and/or losses occurring as a result of the amended drawing, design or intellectual property. |

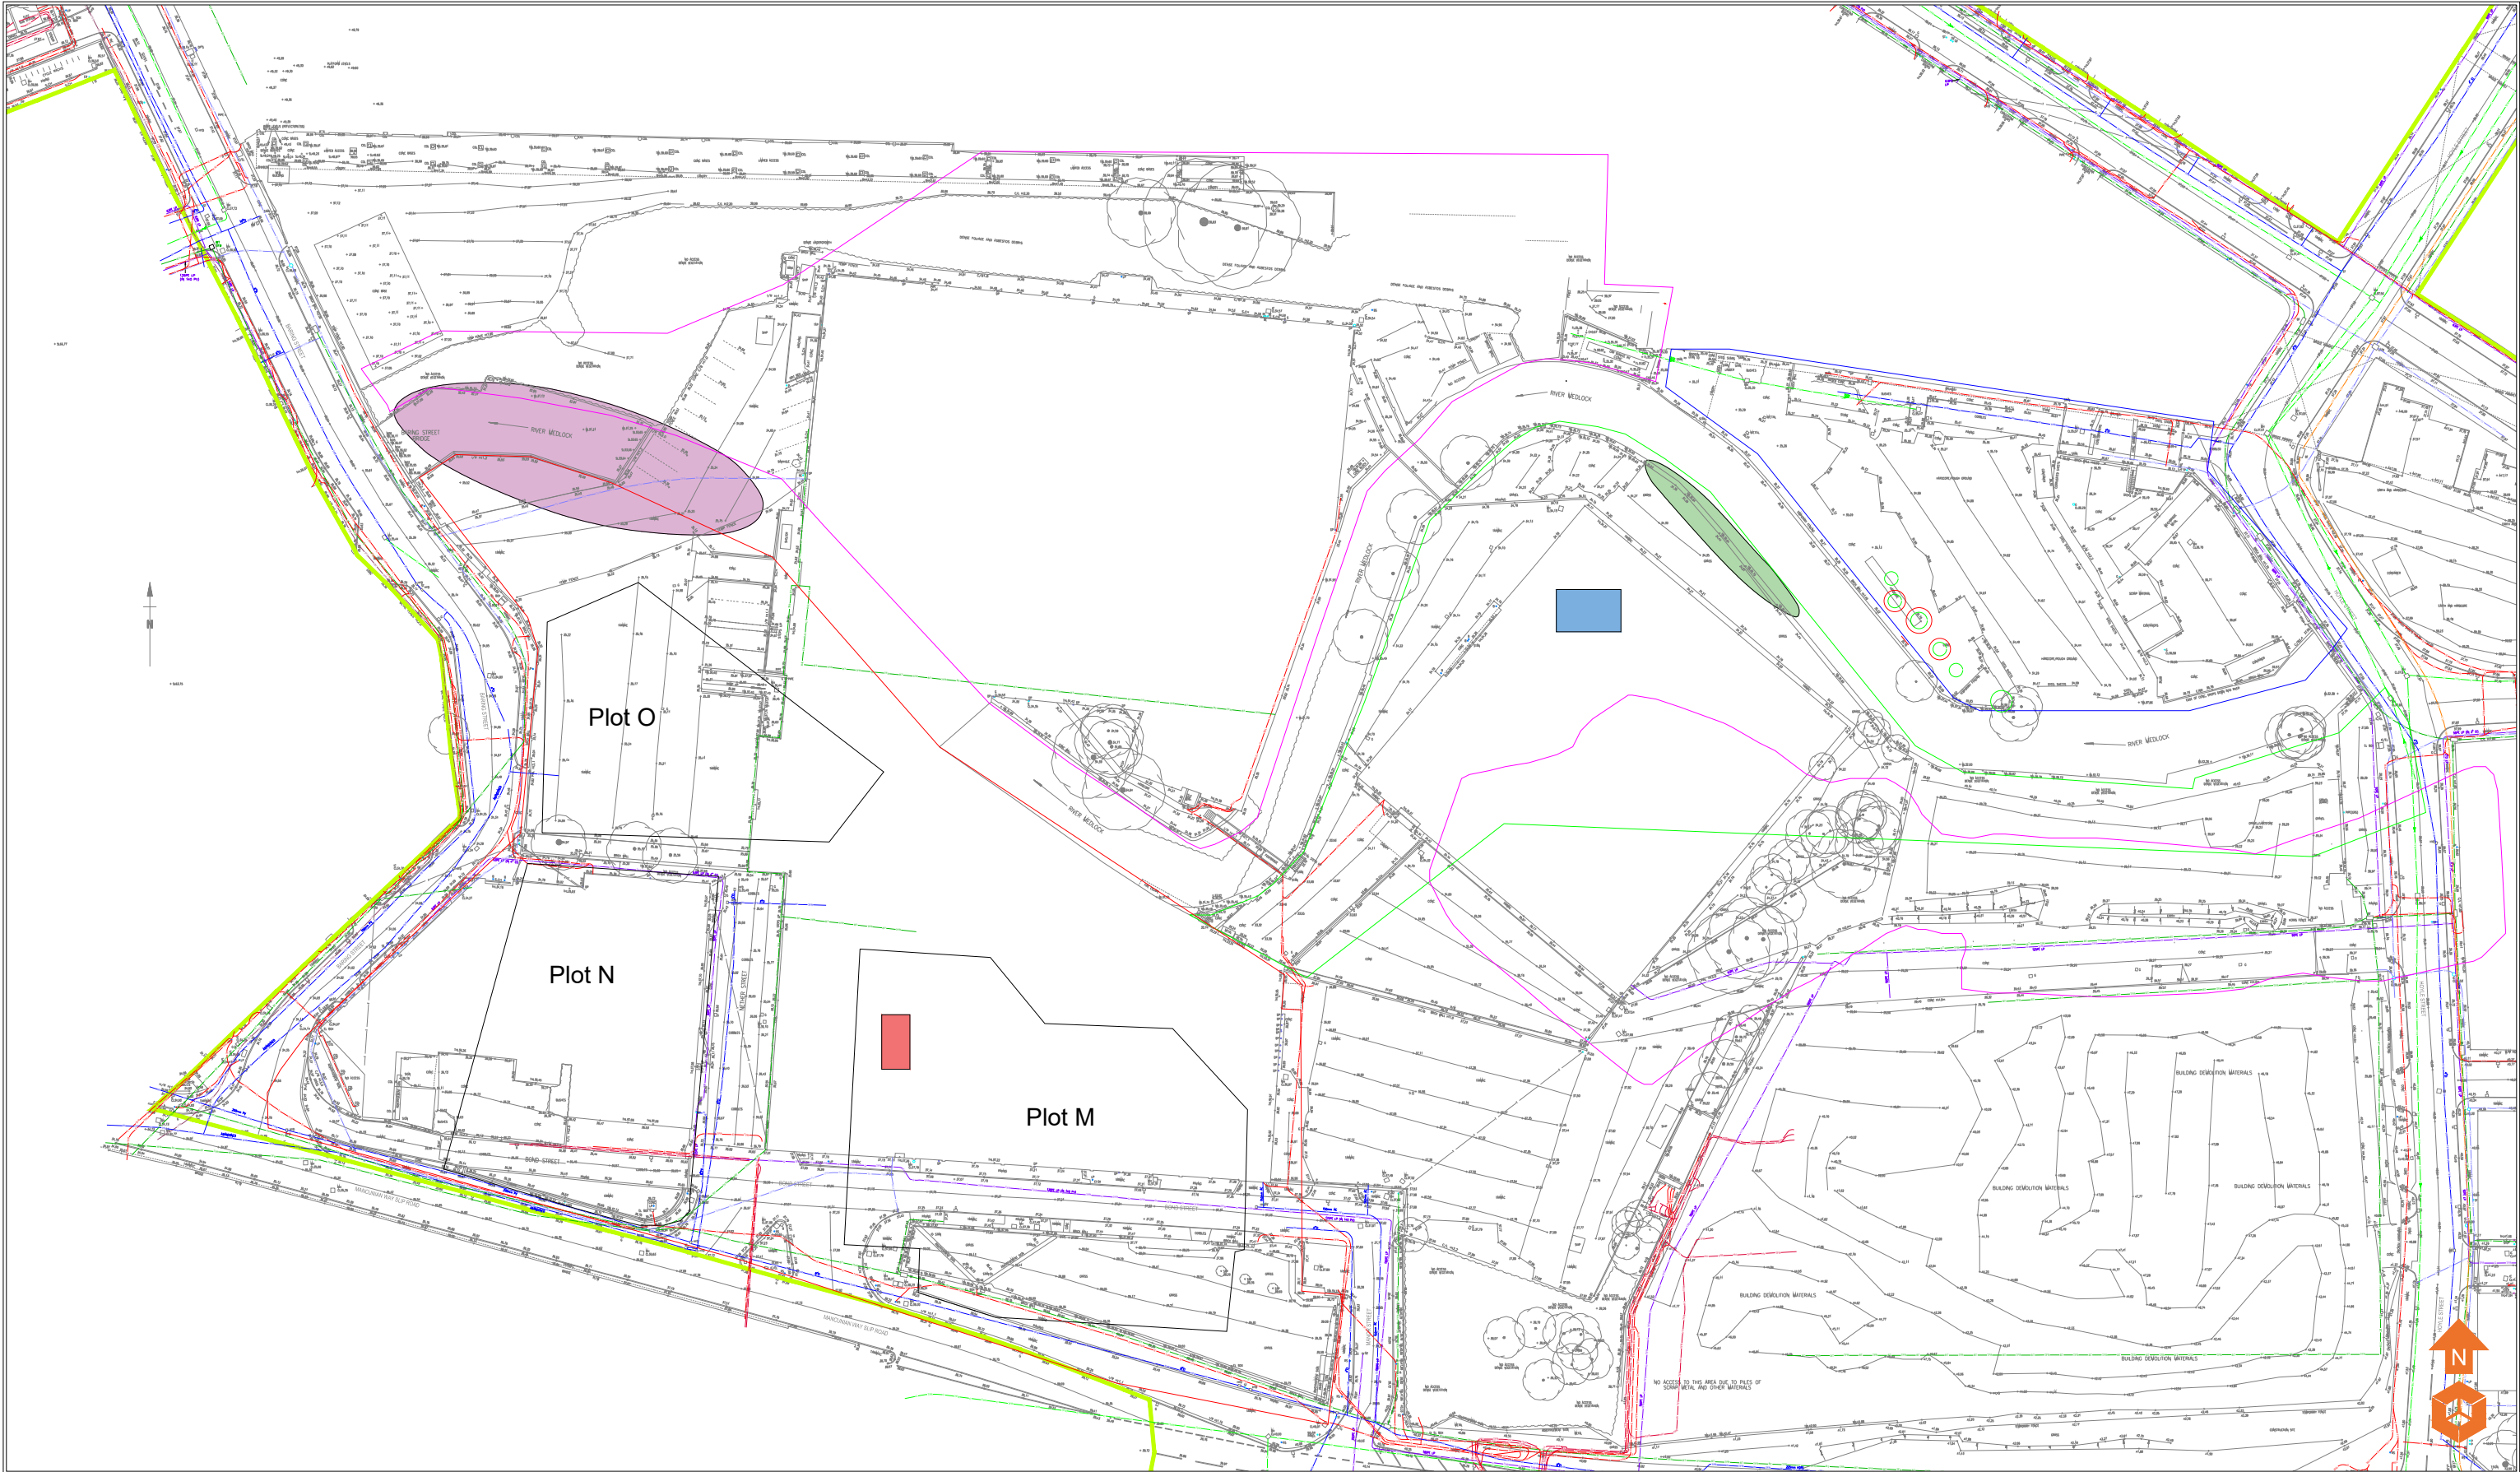
- Boundaries**
- The Lawns
  - Play Area
  - The Wildscape
  - Plots M, N & O
- Unforeseen Items**
- Decommissioned Tank Location
  - Arsenic Leachability Concentration
  - Hydrocarbon present within wildscape area
  - Hydrocarbon present against Culvert retaining wall

During the excavated of Plot M, a small 1m x 3m tank was found, the tank was filled with concrete and appeared to be decommissioned. Validation samples of the arisings North, South, East, West and Base of the tank were taken to ensure no residual contamination was present within the resulting void. All results showed no exceedances wer present (I2 Analytical Report – 21-80774).

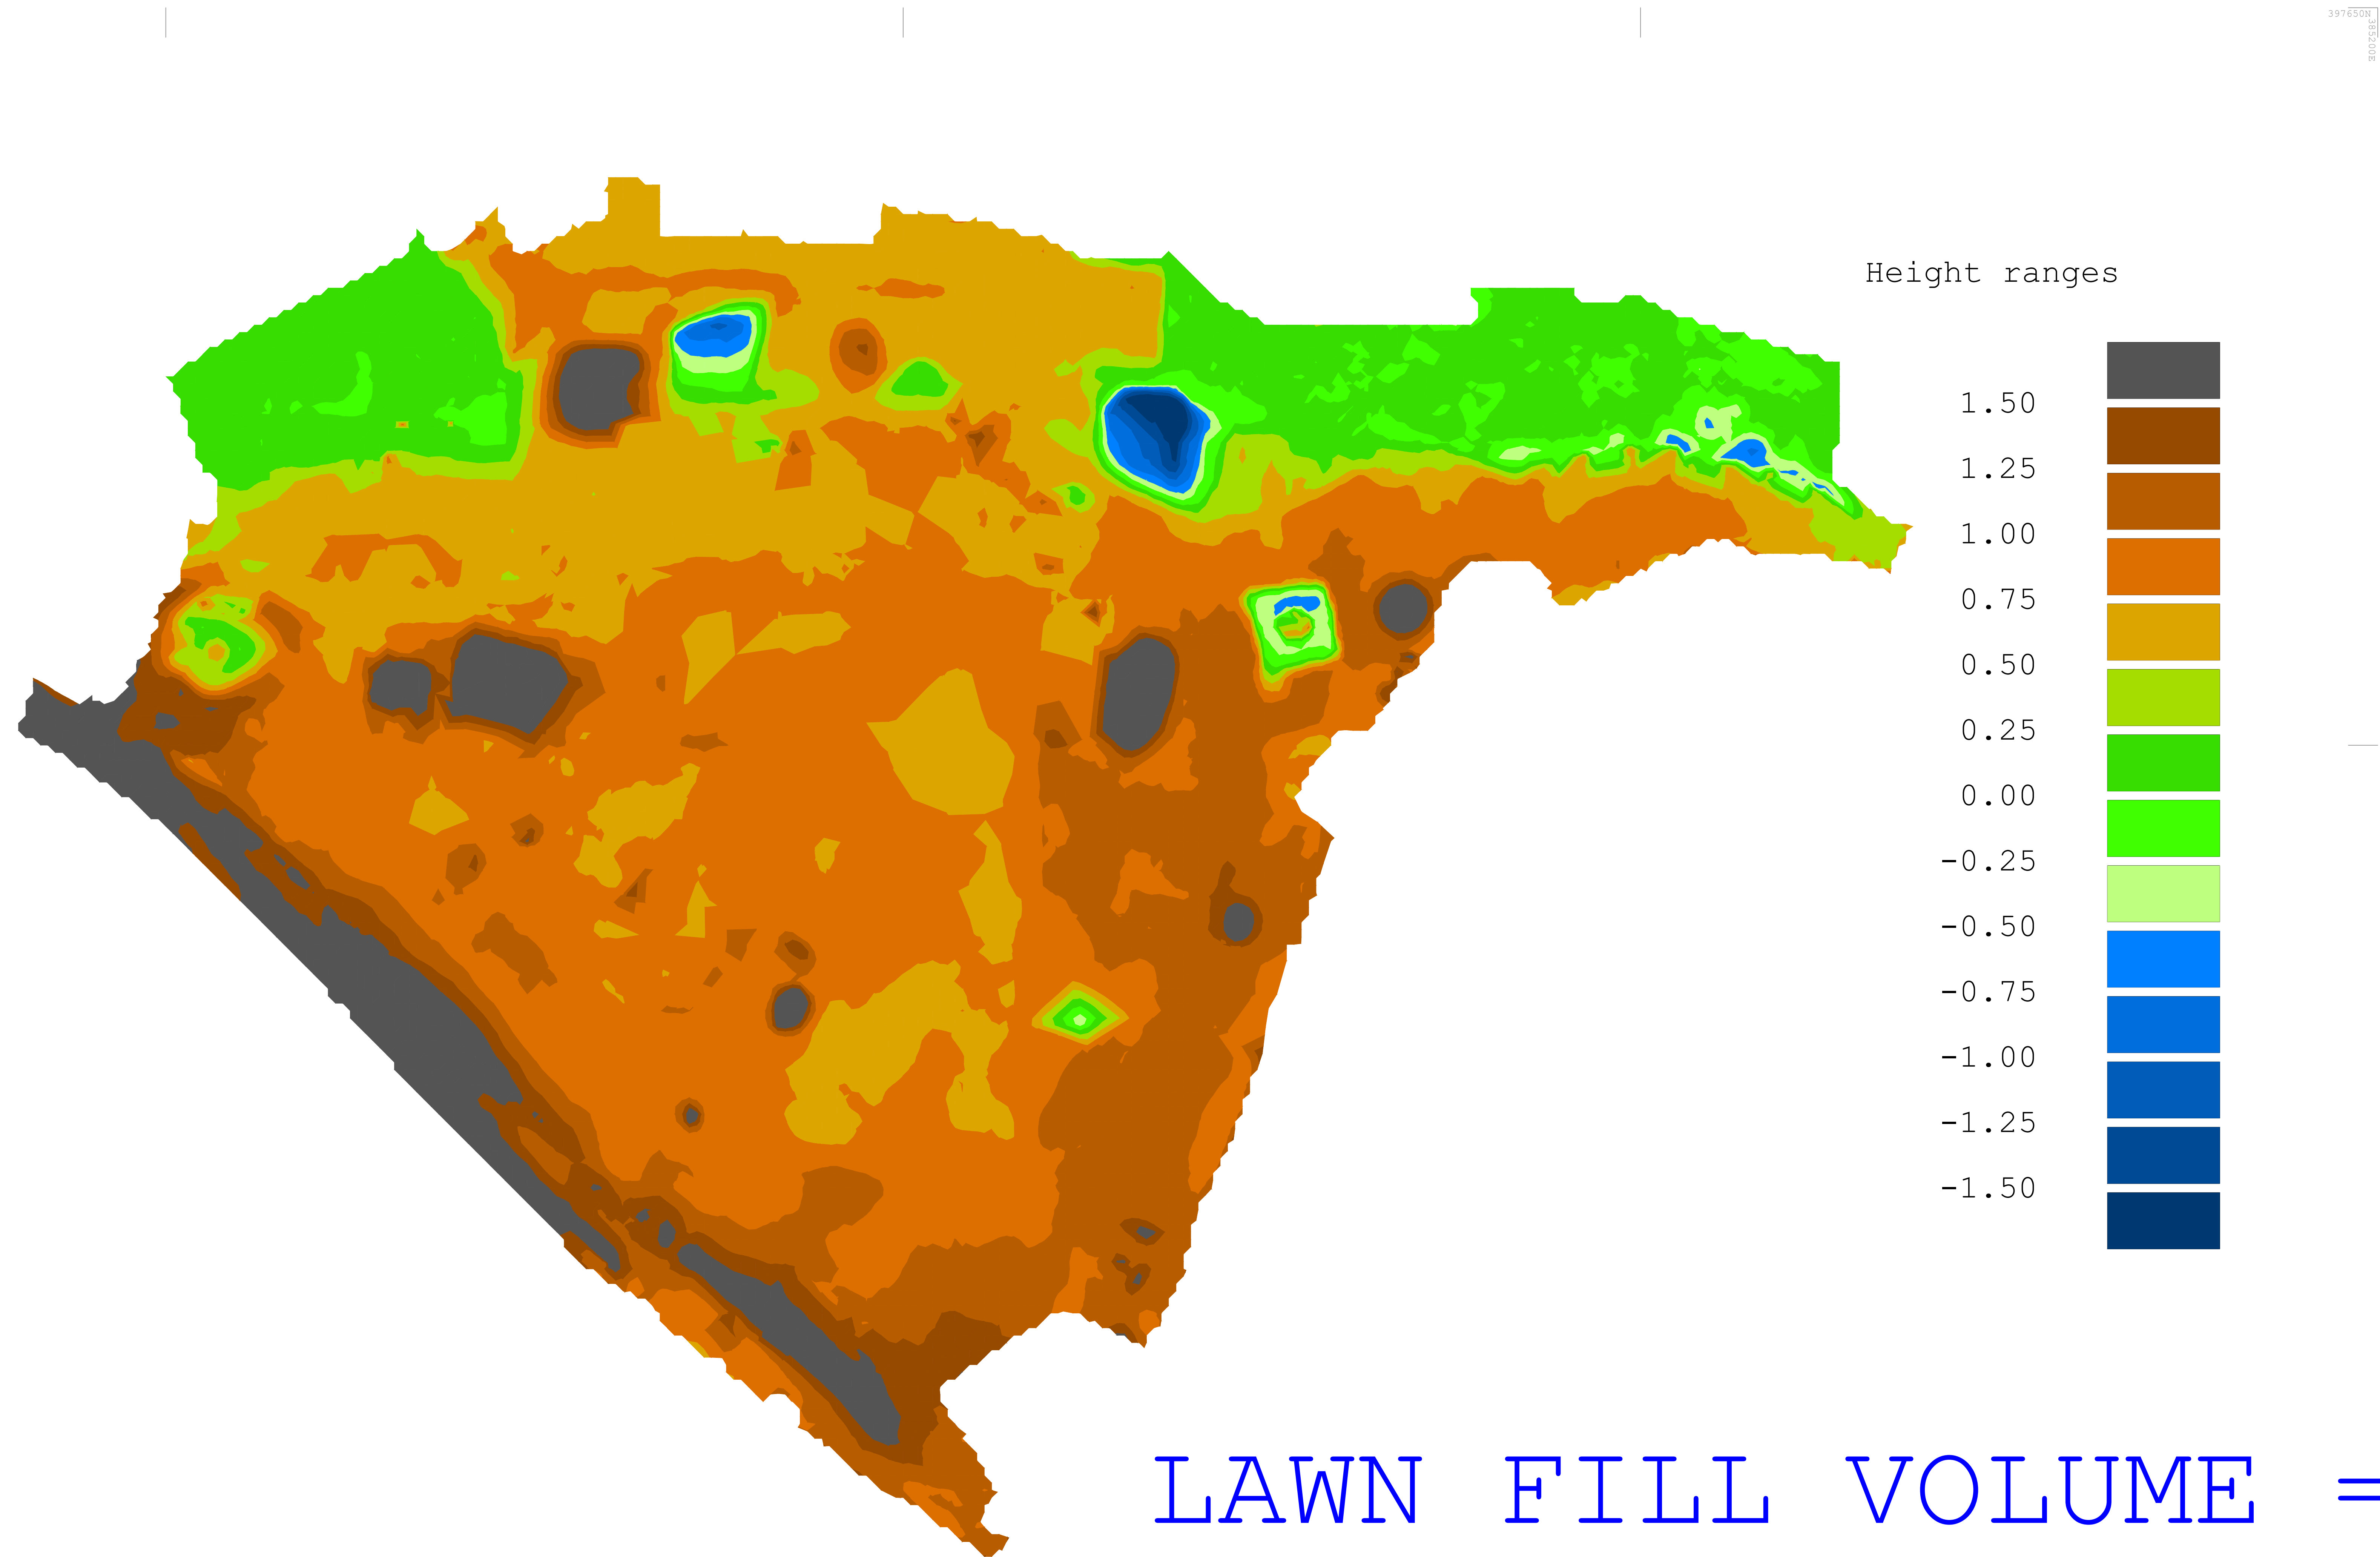
LAWN FILL VOLUME =  
4666.62m3

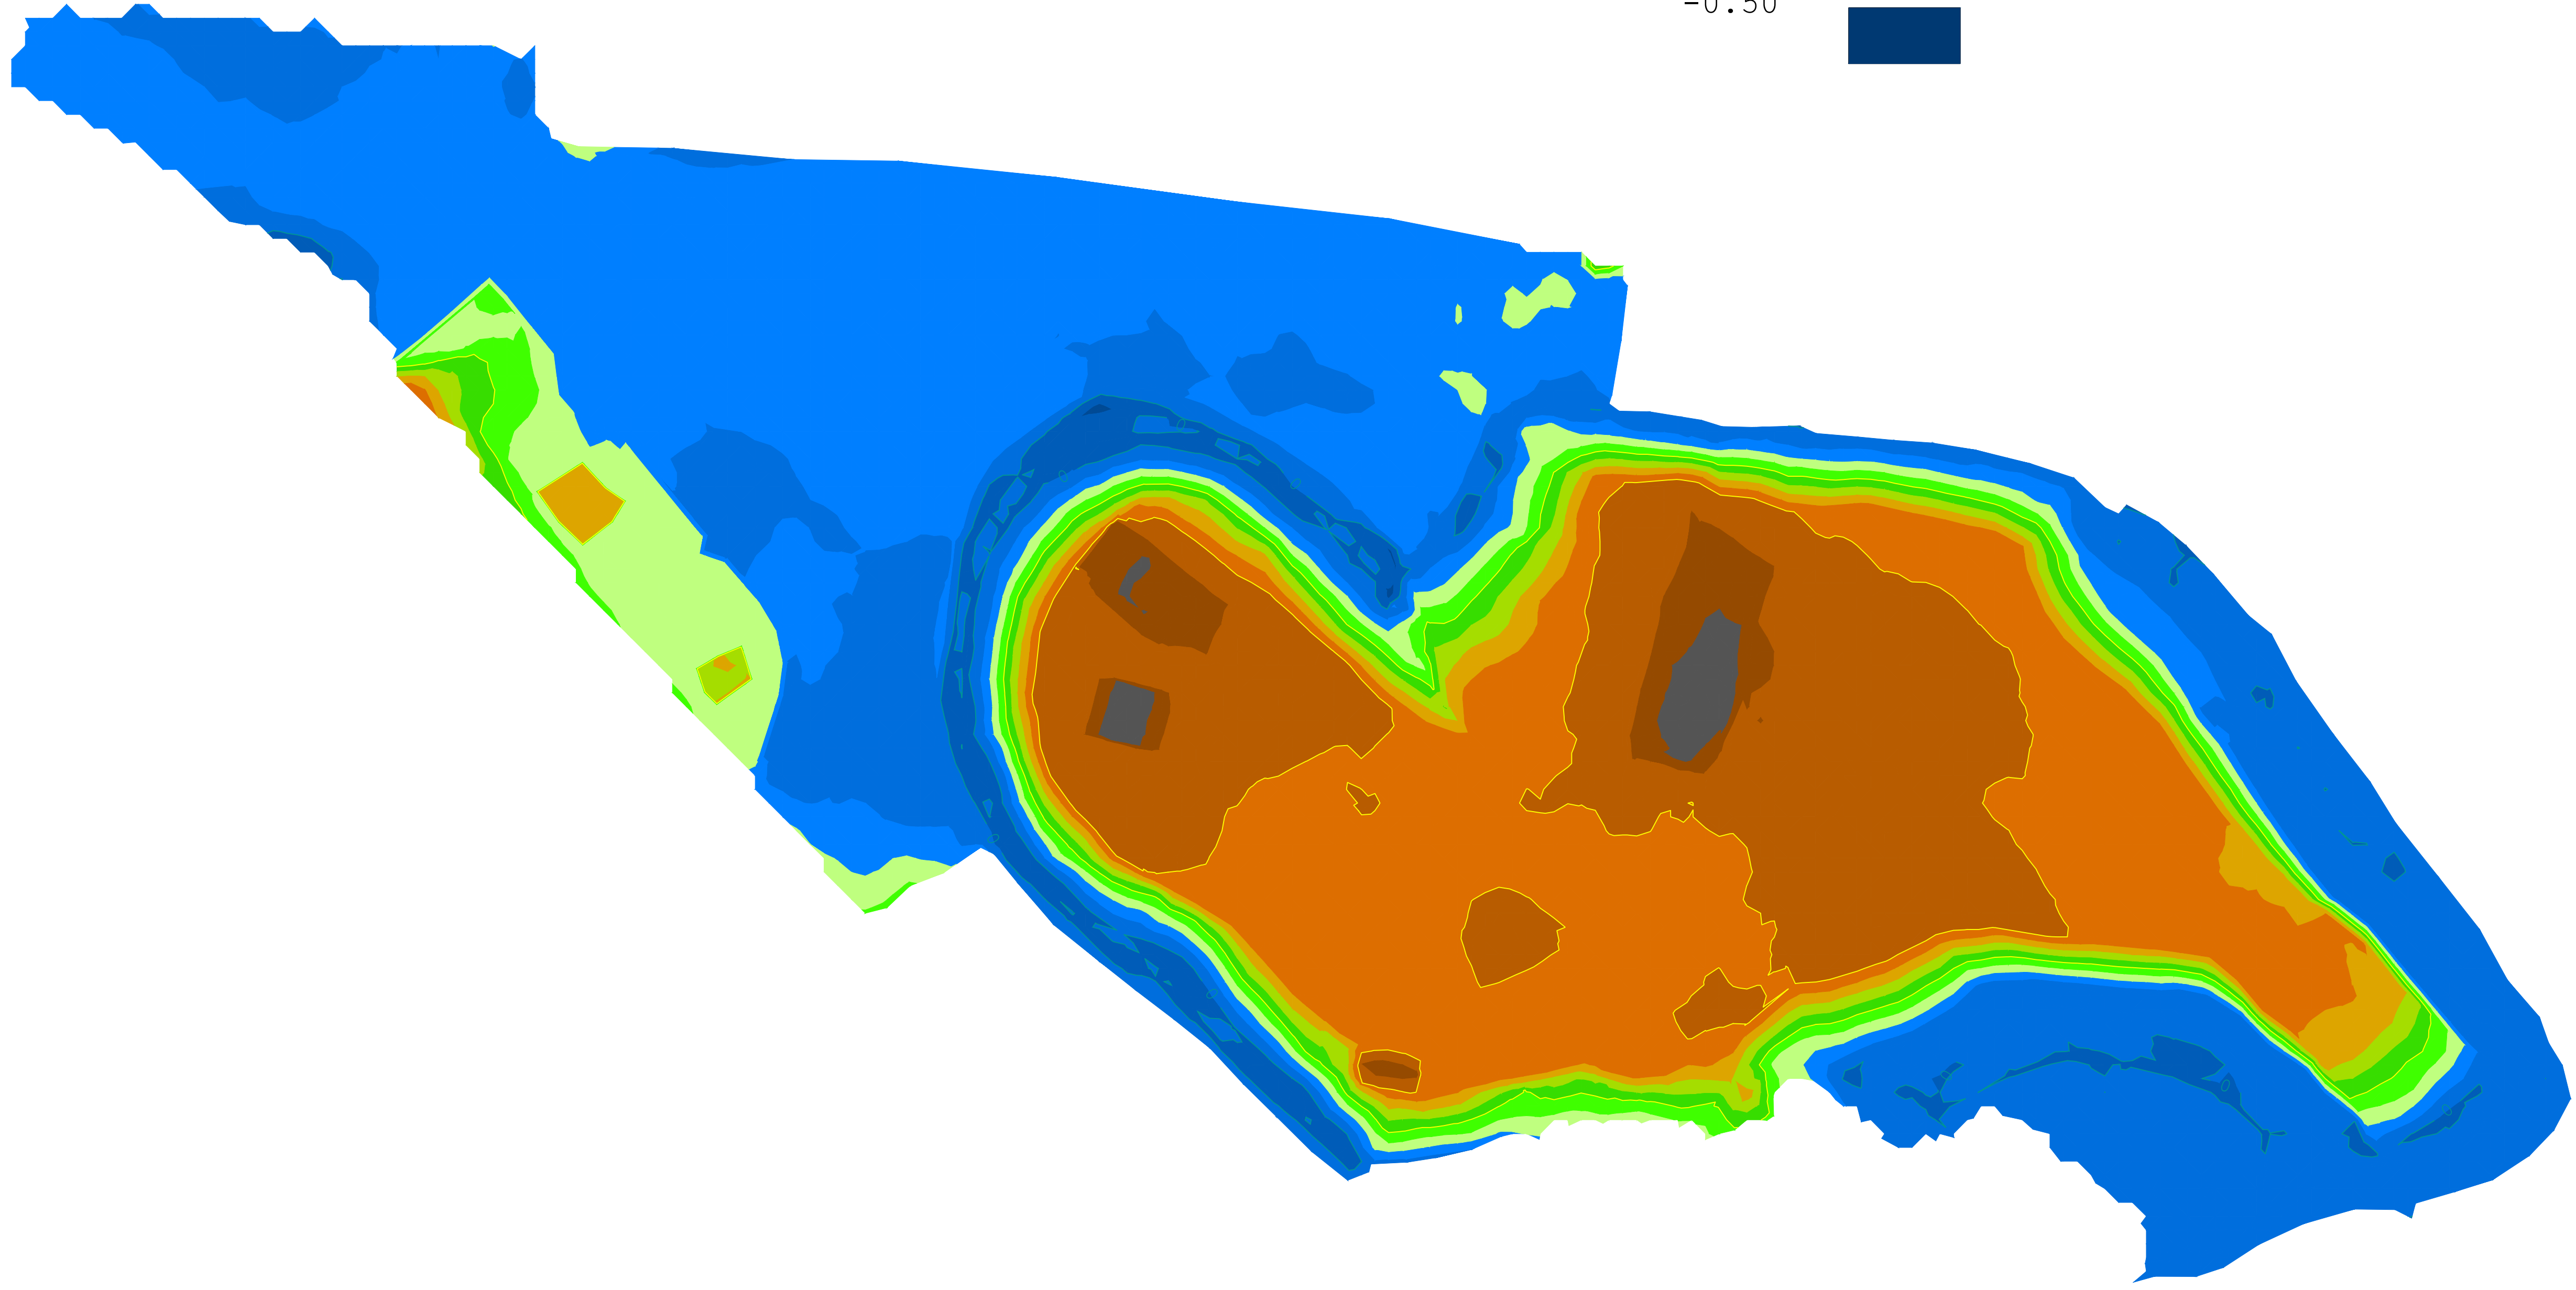
WETLANDS FILL VOLUME  
= 2435m3

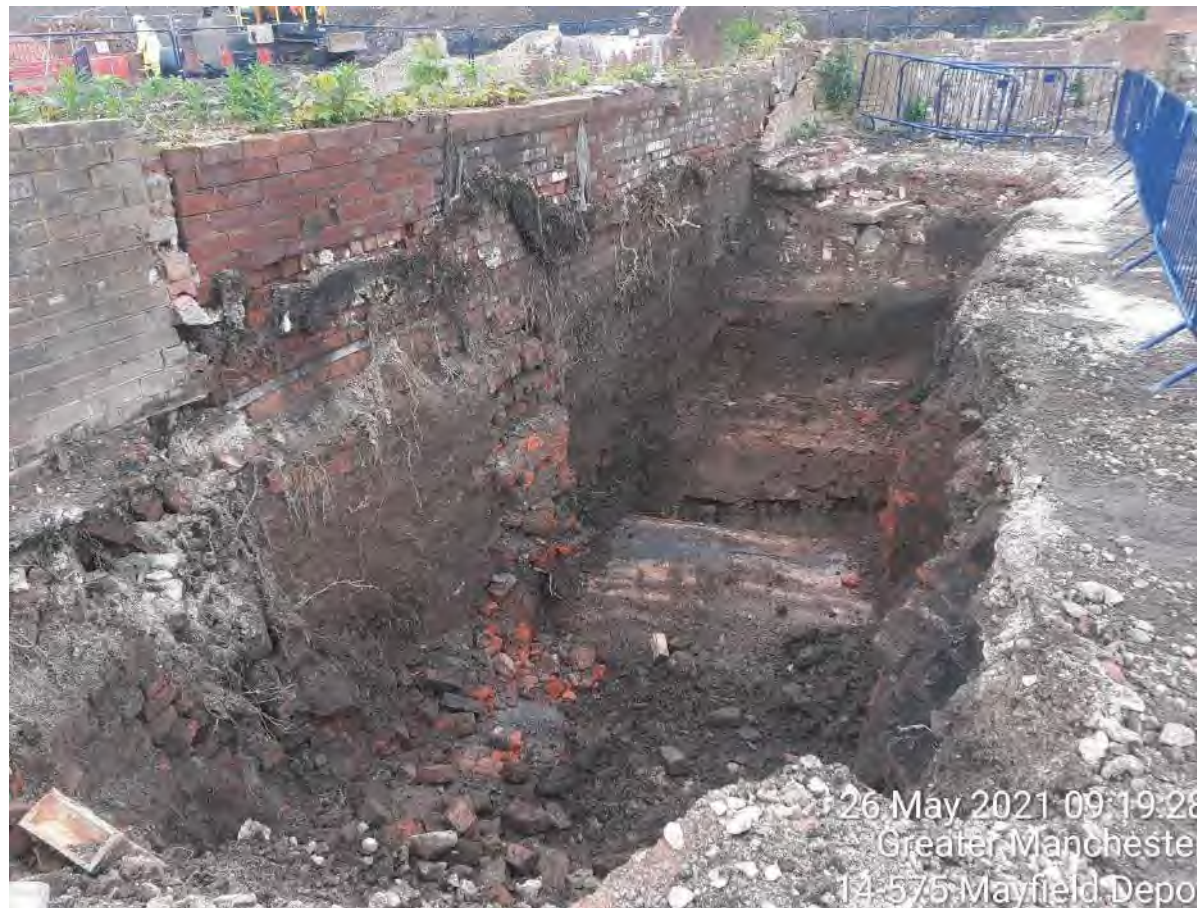
PLATE 2

PH313 HOTSPOT REMOVAL

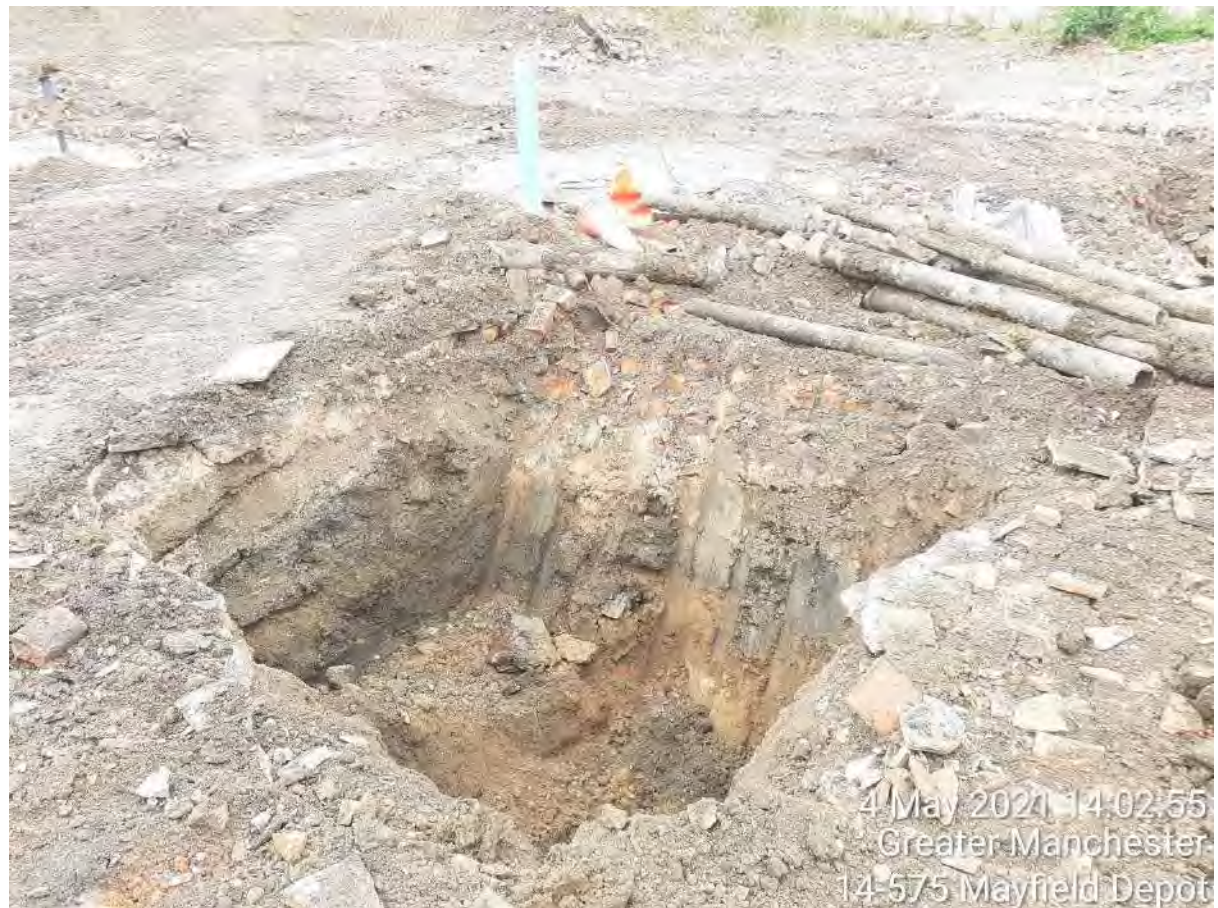
PLATE 8

TP102 HOTSPOT REMOVAL
