Validation Report  
Mayfield Parks and Plots M, N and O

Reference:14-575-R1-Rev 1  
Date: November 2021

# REMEDIATION AND ENABLING WORKS VALIDATION

Mayfield Park  
Mayfield Parks and Plots M, N and O

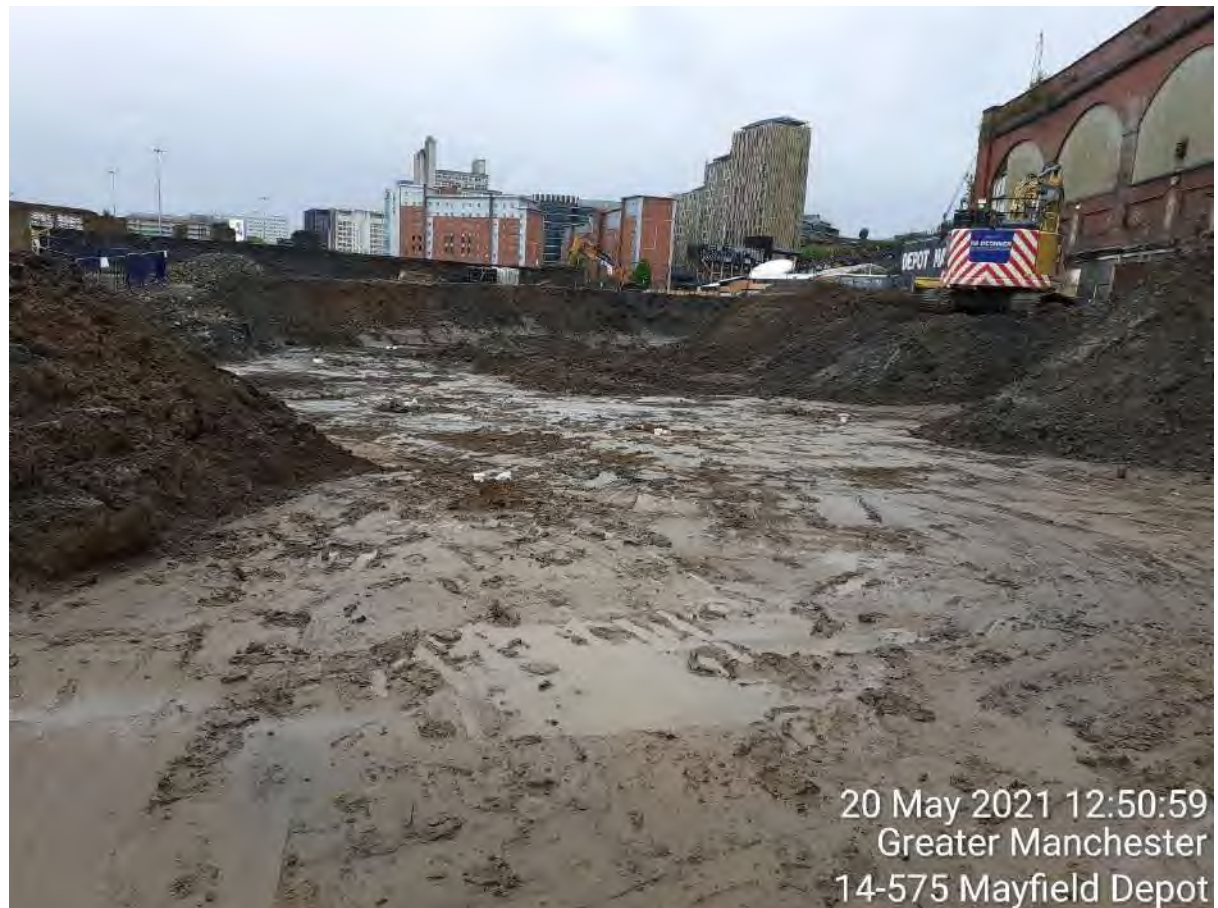
HYDROCARBON SOURCE 1 REMOVAL

All visual evidence of hydrocarbon material was removed and stockpiled on an impermeable membrane to prevent leaching of contaminative material. Excavation was carried out to reach the natural clay barrier layer. Visual inspection of the natural clay showed no signs of contamination therefore, excavation of 200mm of the top of the natural clay noted within the remediation strategy was not carried out as it was not necessary to potentially compromise the integrity of the natural clay barrier layer if the clay appeared to not have any visual or olfactory evidence of contamination. Validation samples were taken from both the base (21-76648) and walls (21-78144) of the excavation. Samples were analysed for both leachate analysis as well as solid Speciated PAH and TPHCWG to ensure validation of all contaminated material results showed that all hydrocarbon impacted material has been removed. Leachate results showed very slightly elevations in arsenic highest of which found in HC1 S samples at 32µg/l however due to the minor and isolated exceedances it is not considered to pose a risk to controlled waters.

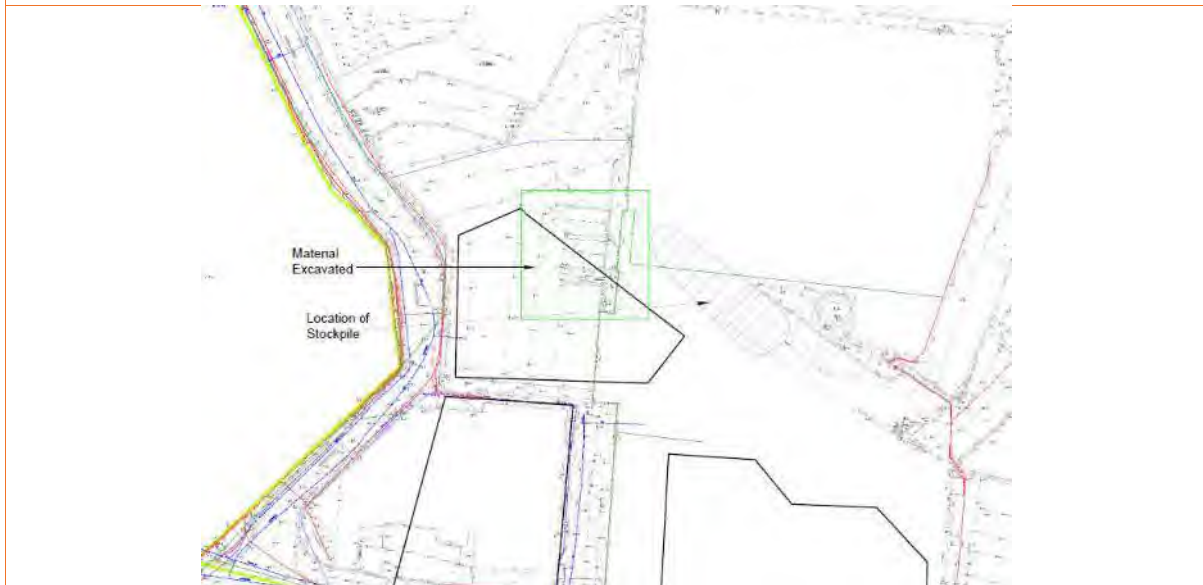
FIGURE 3 APPROXIMATE ORIGIN (CULVERT AT PLOT O) AND STOCKPILE LOCATION OF MADE GROUND MATERIAL

The samples were scheduled for a suite of chemical analysis covering the determinants required for reuse under the remediation strategy. The results are presented within the reports appended to this letter (i2 Analytical Reports 21-79947 and 21-79953). All the determinants passed the Tier 1 screening value with the exception of leachable arsenic, which ranged between 28 – 180 µg/l. As a result, 15 out of 16 leachate samples failed the arsenic criteria.

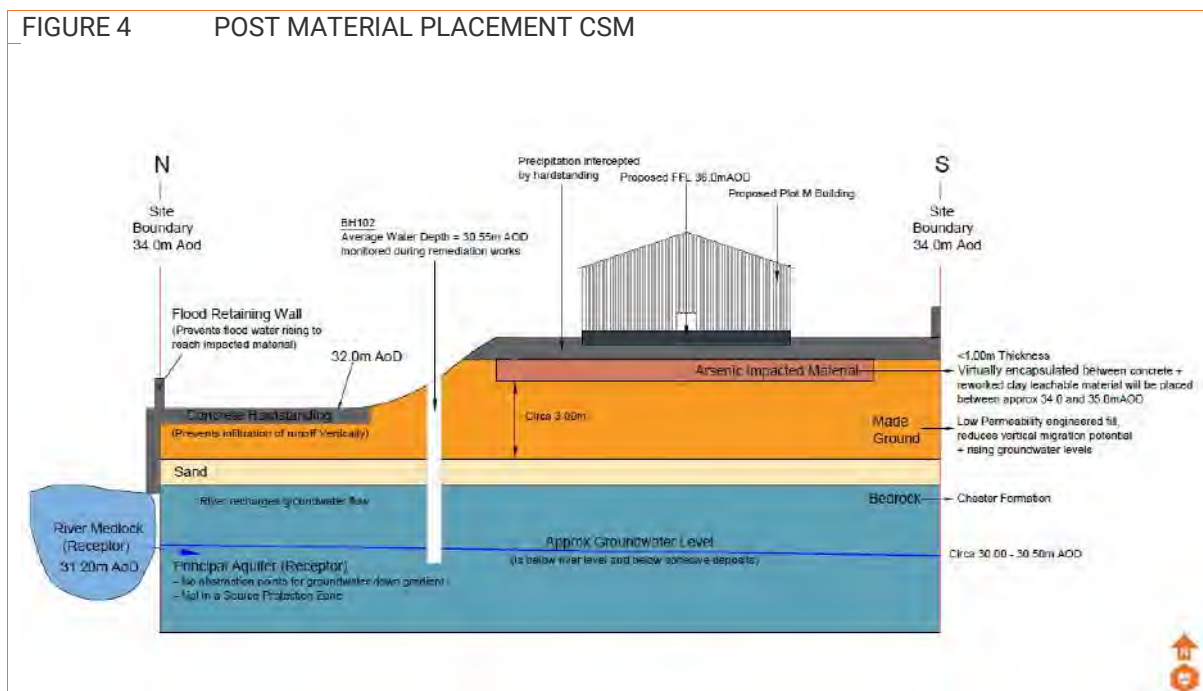
FIGURE 4 POST MATERIAL PLACEMENT CSM

The results of the historical data review, Tier 1 qualitative and preliminary Tier 2 quantitative risk assessment has allowed E3P to draw the following conclusions in respect to the risk to controlled waters:

- ✳ There has been sufficient testing of soils at the site during remediation and enabling works;
- ✳ The primary receptors are identified as the River Medlock and the underlying principal aquifer. Although there are no recorded groundwater abstraction points down the hydraulic gradient of the site and the site does not lie within a source protection zone, therefore reducing the sensitivity of the aquifer receptor.
- ✳ The water level of the River Medlock is above that of the groundwater level at the site. Therefore, the River is likely to recharge the groundwater and not vice versa as shown on the post works CSM;

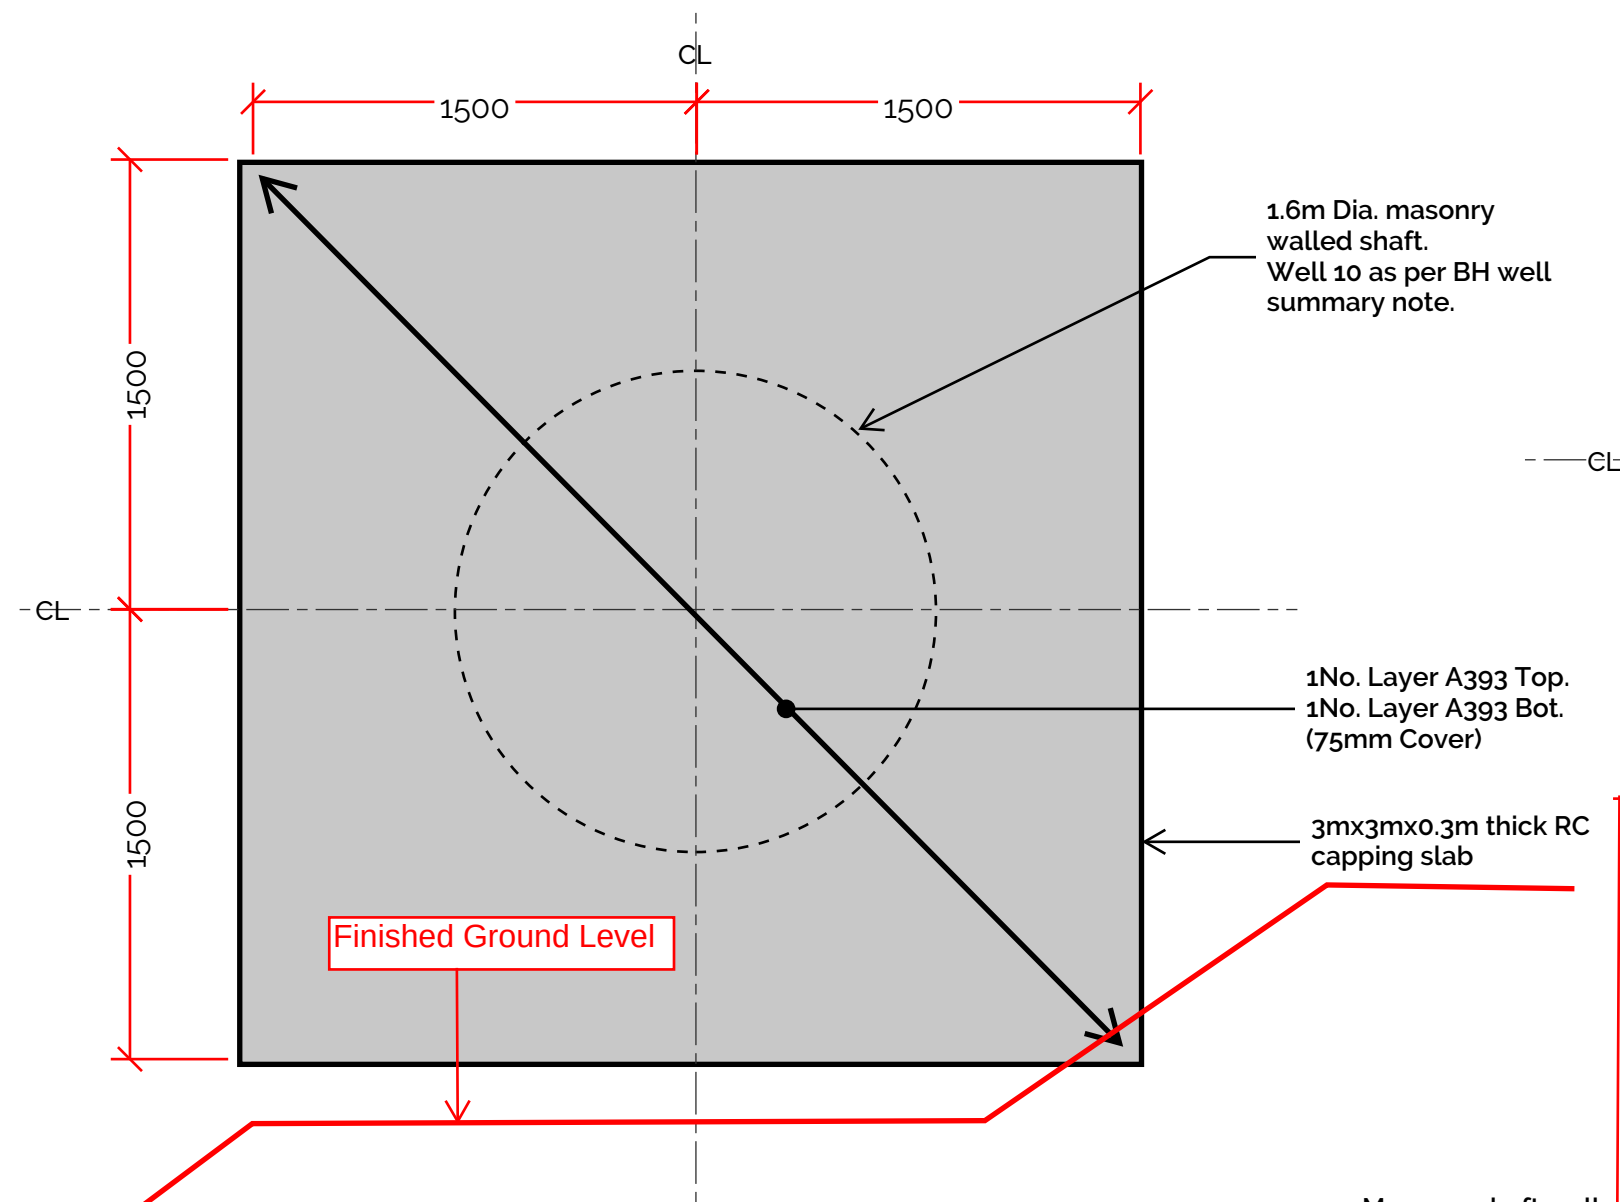
**WELL 10 CAPPING SLAB PLAN**  
SSL = 34.4m & FFL = 35.445m to 36.165

In addition to the 12 listed above an additional well was found in The Plots which was subsequently capped.

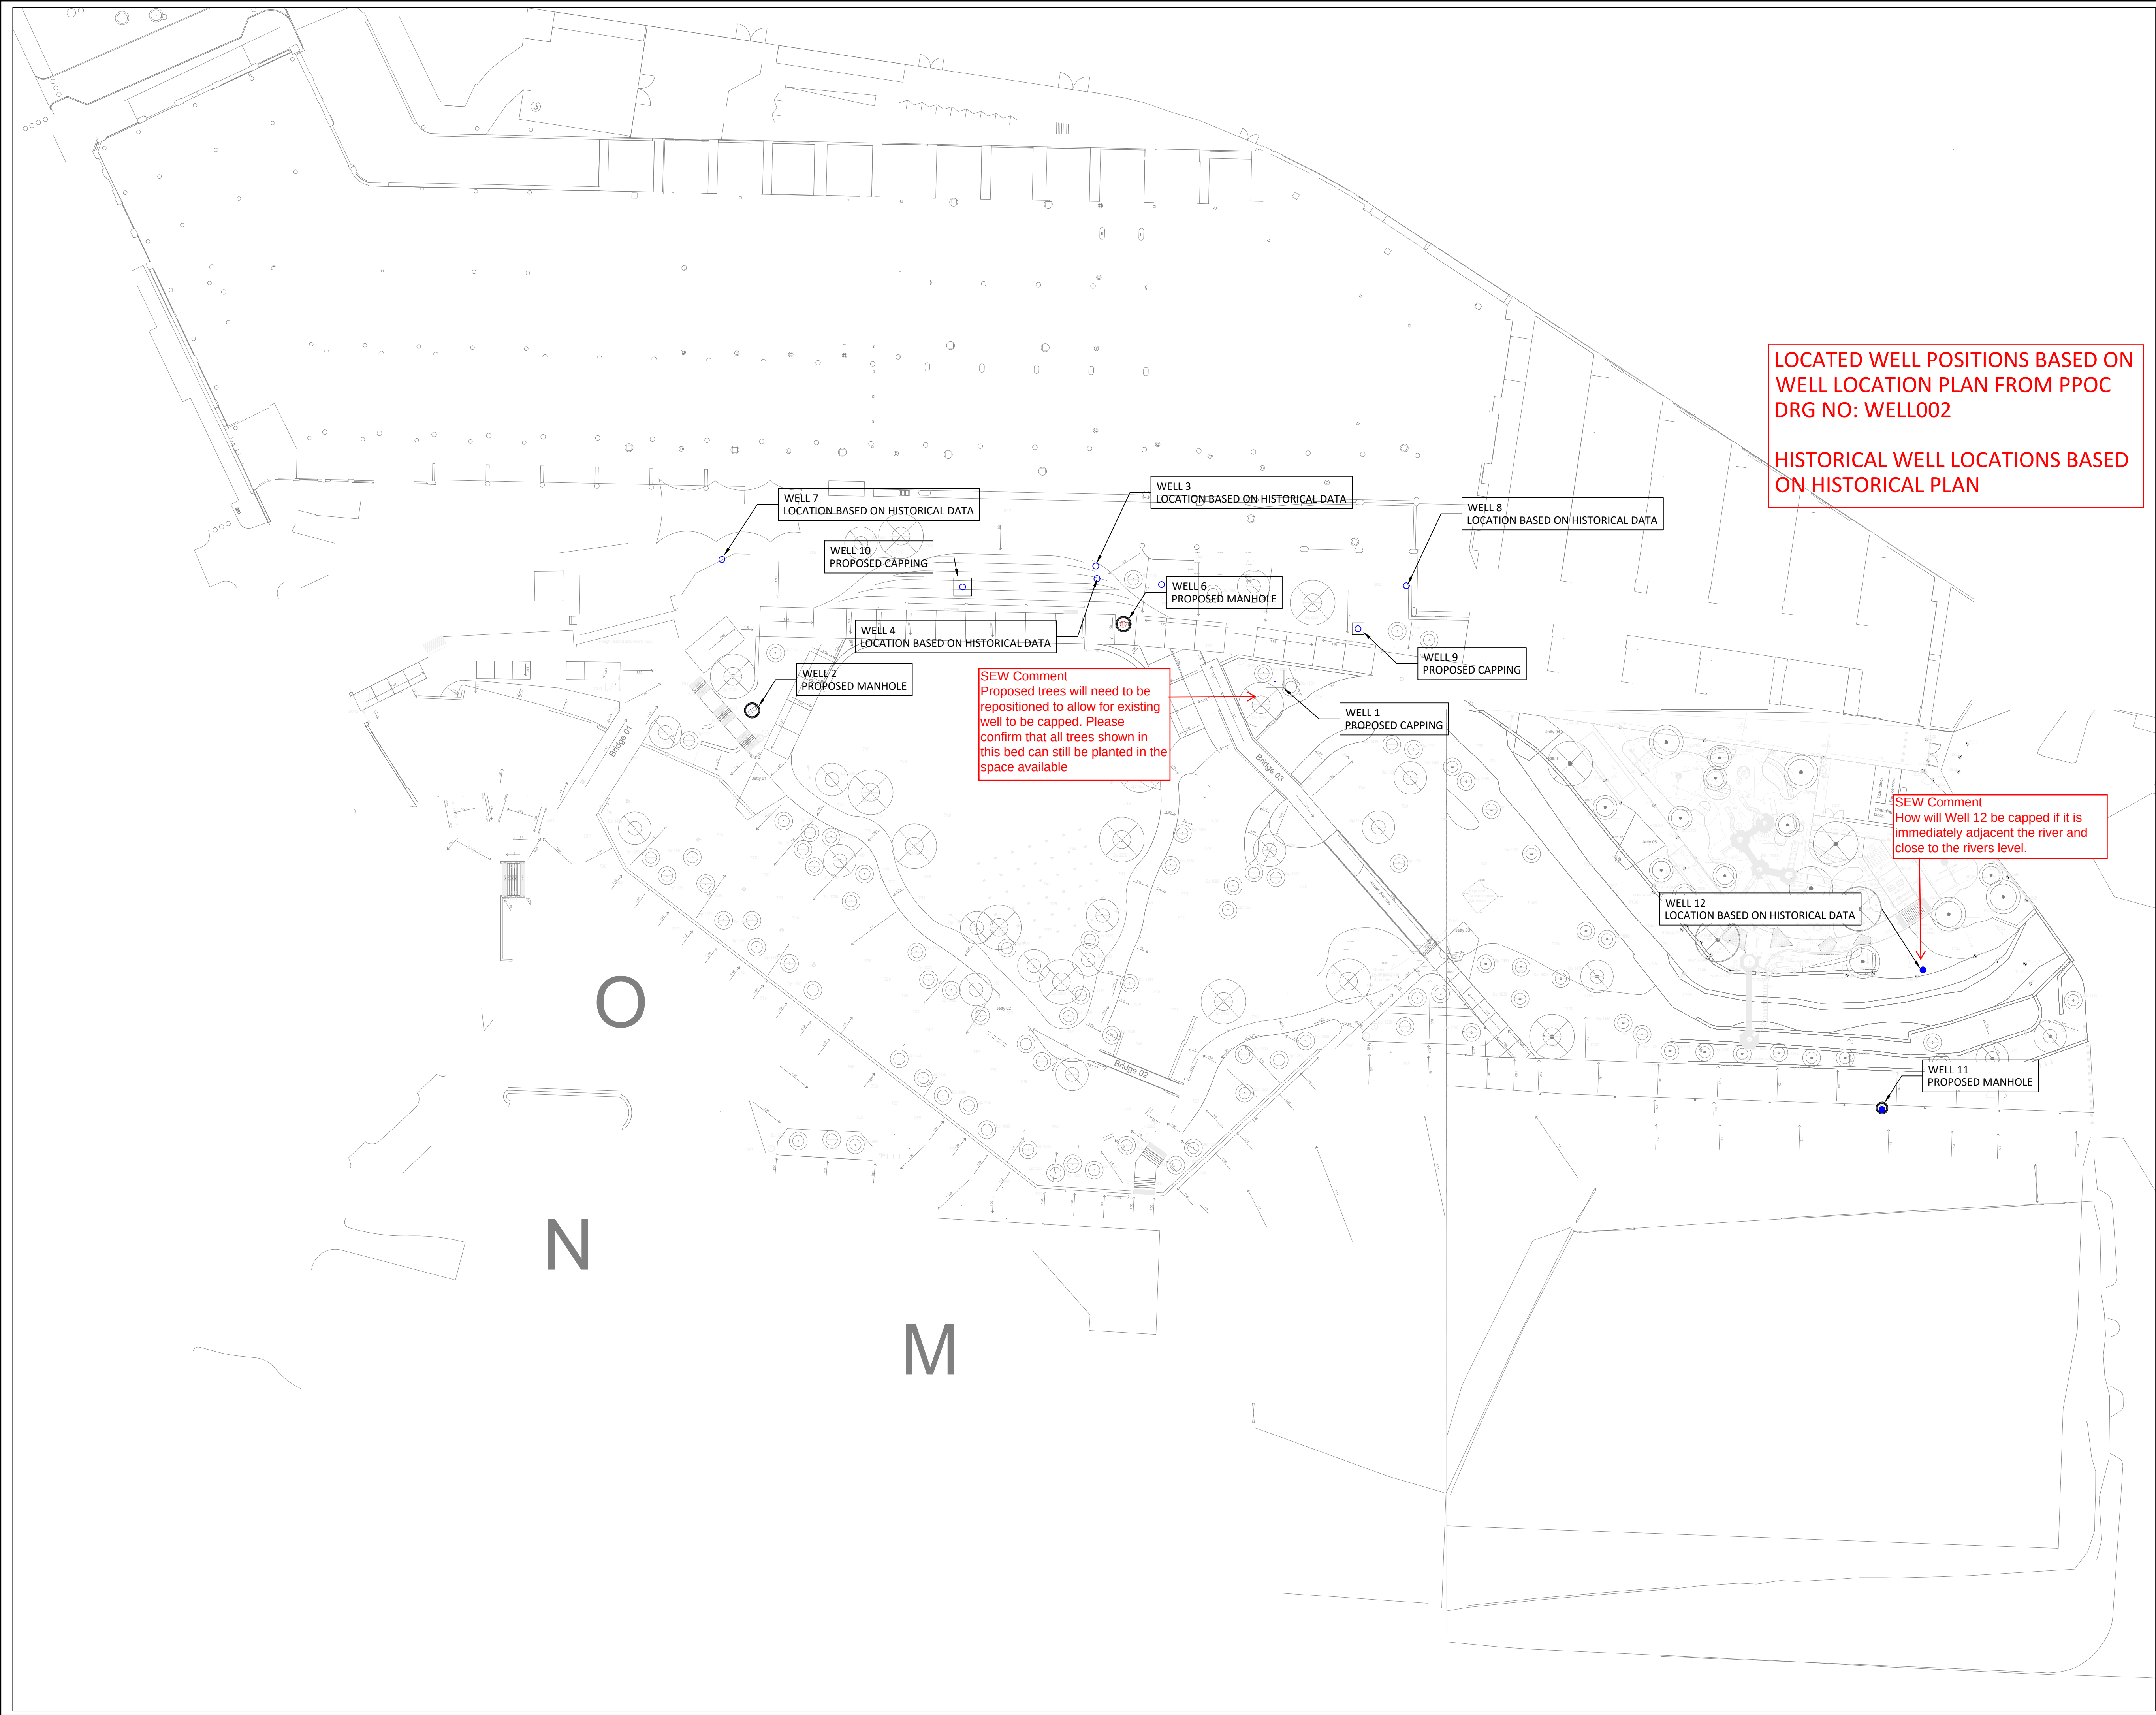
| 19.04.21 | P01 | FOR APPROVAL | LH | RD |
|---|---|---|---|---|
| Drawing Number<br><b>1076-14-CIV-XX-EW-DR-S-300</b> | | | | Revision<br><b>P01</b> |

LOCATED WELL POSITIONS BASED ON  
WELL LOCATION PLAN FROM PPOC  
DRG NO: WELL002

HISTORICAL WELL LOCATIONS BASED  
ON HISTORICAL PLAN

- ✿ 4 were treated and capped
- ✿ 3 were retained for possible future use
- ✿ 1 was dismissed as a double plot after searching revealed no well
- ✿ 4 were located beneath substantial depths of cover in areas close to the site boundary where searching was unsafe and impractical
