Arboricultural  
Impact Assessment  
with  
Arboricultural Method Statement

**Abraham Moss Community School  
Crescent Road  
Crumpsall  
M8 5UF**

Project No. AIA.14122.01

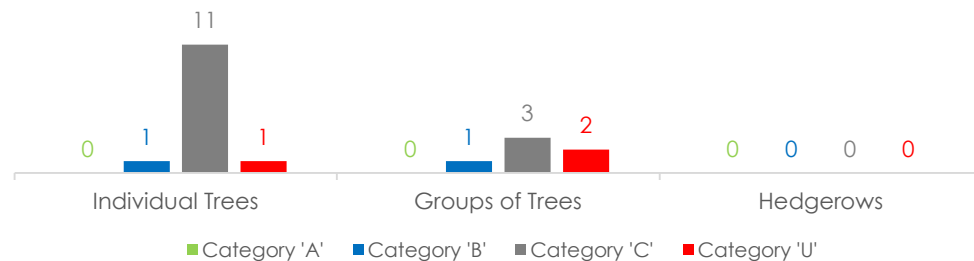
2.1.1. Thirteen individual trees and six groups of trees were recorded. In accordance with *BS5837:2012 Trees in relation to design, demolition and construction*, one individual tree and one group of trees were recorded as retention category 'B'; and a mixture of eleven individual trees and three groups of trees were recorded as retention category 'C'.

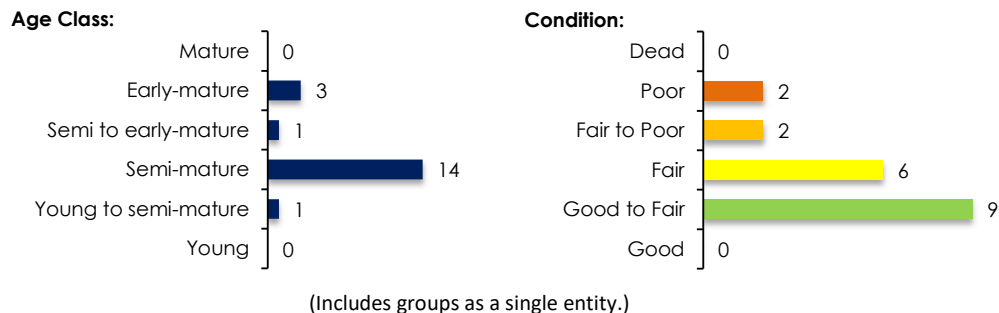
2.2.1. Please see *Appendix 1* for the detailed list of existing species, age class, dimensions and condition of trees within the site, and *Appendix 2* for an explanation of retention category criteria. Tree locations can be seen on the *Tree Constraints Plan* at the rear of this report (*Drawing 1*).

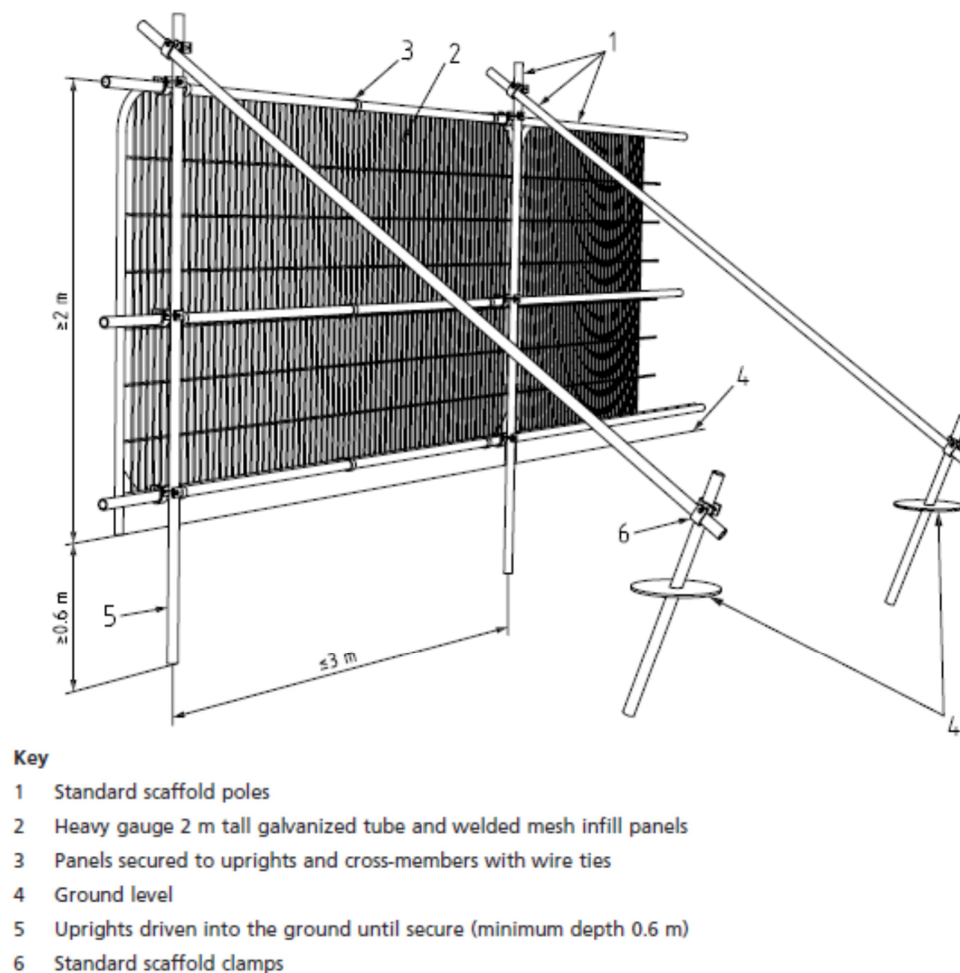
Figure 1. Default protective fencing barrier as detailed in BS 5837: 2012.

- A4.1 The default specification for protective barriers should consist of a vertical and horizontal scaffold framework, well-braced to resist impacts, as illustrated below. The vertical tubes should be spaced at a *maximum* interval of 3 m and driven securely into the ground. Onto this framework, welded mesh panels should be securely fixed. Care should be exercised when locating the vertical poles to avoid underground services and, in the case of the bracing poles, also to avoid contact with structural roots.

- 4.2.3. Please see *Appendix 4* for suggested barrier construction detail. In this instance, the protective barrier shown in Figure 1 is recommended. The suggested location for protective fencing is shown on the *Tree Protection Plan (Drawing 2)*.

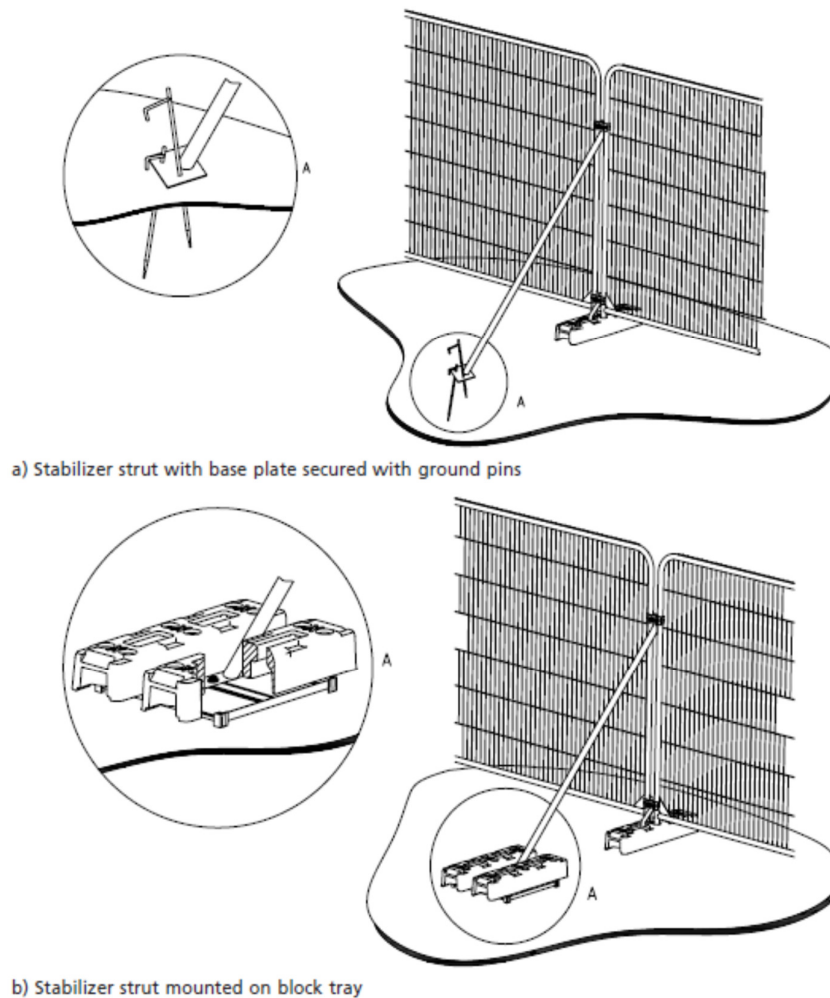
Figure 2. Examples of above-ground stabilizing systems

- A4.2 Where the site circumstances and associated risk of damaging incursion into the RPA do not necessitate the default level of protection, an alternative specification may be adopted. This system includes 2 m tall welded mesh panels on rubber or concrete feet, secure enough to provide an adequate level of protection from cars, vans, pedestrians and manually operated plant. In such cases, the fence panels should be joined together using a minimum of two anti-tamper couplers, installed so that they can only be removed from inside the fence. The distance between the fence couplers should be at least 1 m and should be uniform throughout the fence. The panels should be supported on the inner side by stabilizer struts, which should normally be attached to a base plate secured with ground pins (Figure 2a). Where the fencing is to be erected on retained hard surfacing or it is otherwise unfeasible to use ground pins, e.g. due to the presence of underground services, the stabilizer struts should be mounted on a block tray (Figure 2b).
