**Mayfield, Phase 1**  
EIA Volume 2

September 2019

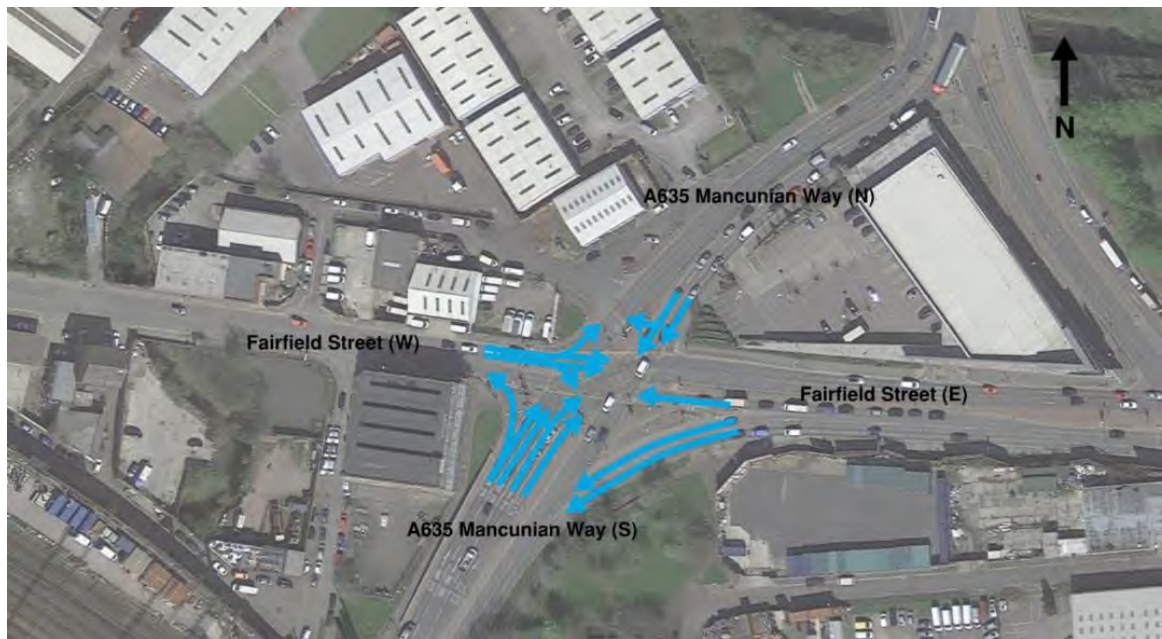
Figure 3.16 Mancunian Way – Fairfield Street Junction Layout

- 3.5.23 The north arm of Mancunian Way has two approach lanes; one providing southbound movement towards Mancunian Way south, and another providing southbound movement and a right turn onto Fairfield Street west. It is noted that there is no left turn on to Fairfield Street east from this arm. The east arm of the junction is Fairfield Street east, which has two left turn lanes onto Mancunian Way south and one lane towards Fairfield Street west; it is noted that a right turn onto Mancunian Way north is prohibited. The Mancunian Way south arm has four approach lanes, with slip road providing access to Fairfield Street west. There are two lanes towards Mancunian Way north and two right turn lanes towards Fairfield Street east. Fairfield Street west arm has one approach lane, and allows movement to all other arms of the junction.

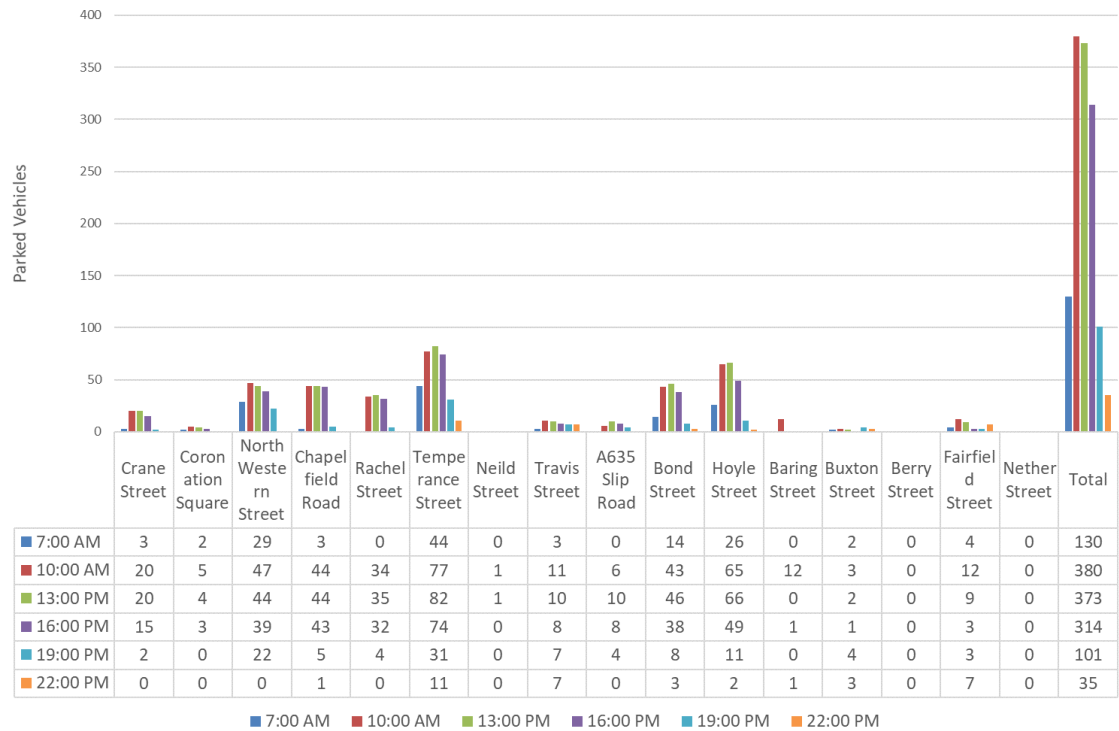
Figure 3.20 Total On-street Parking Occupancy

3.6.5 The on-street parking observed on each road is shown in Figure 3.20.

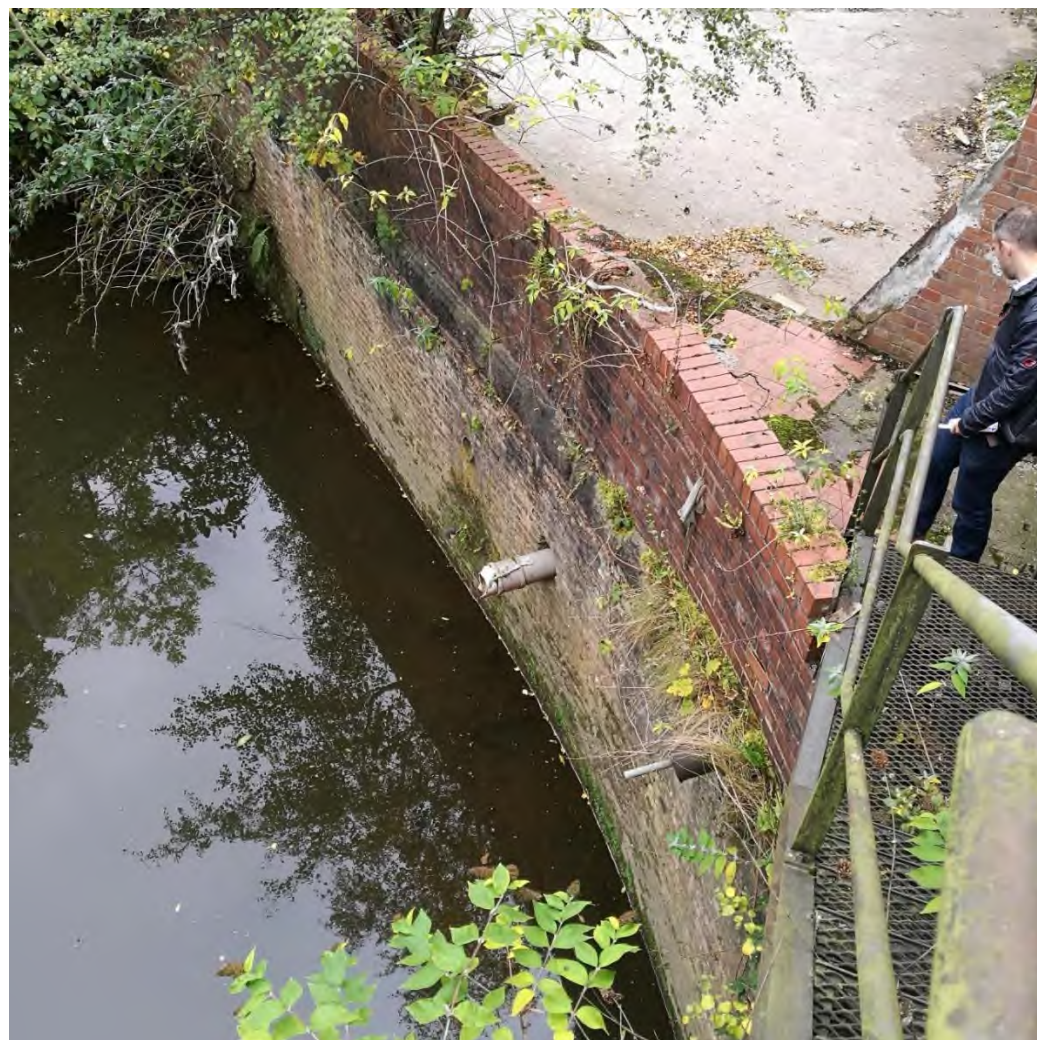
**Figure 5-1 Existing Outfall Observed During Site Visit**

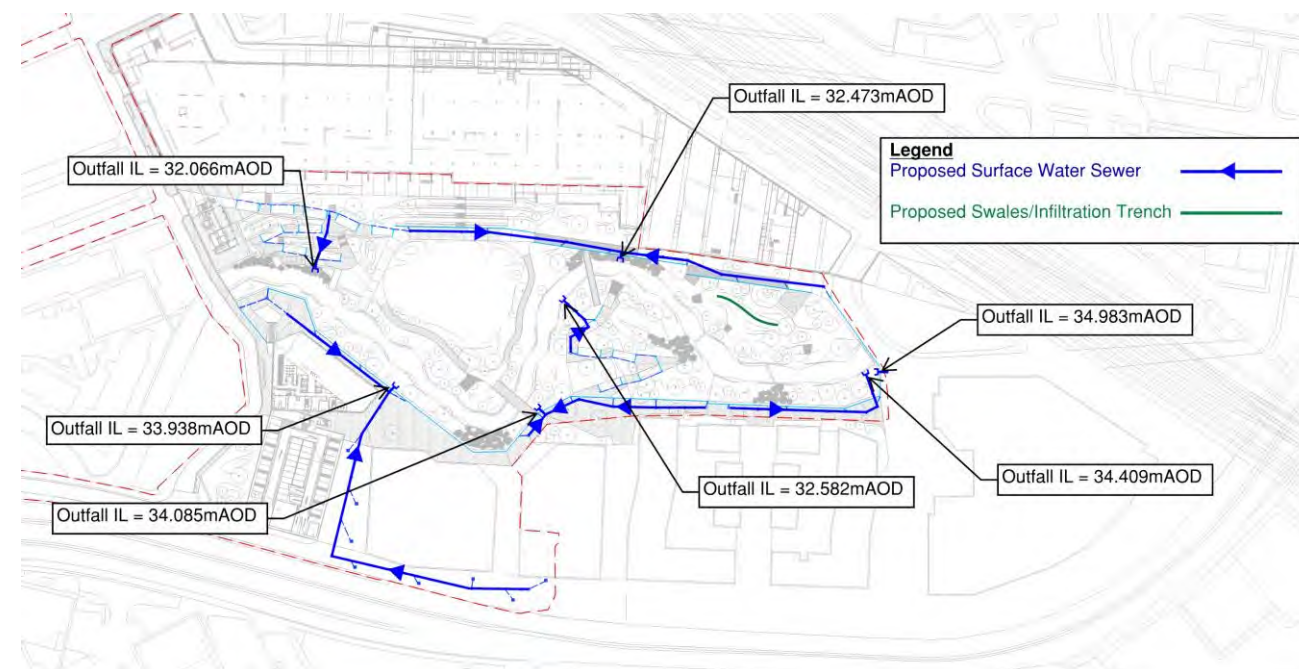
Figure 7-7 Proposed Surface Water Drainage Layout Plan

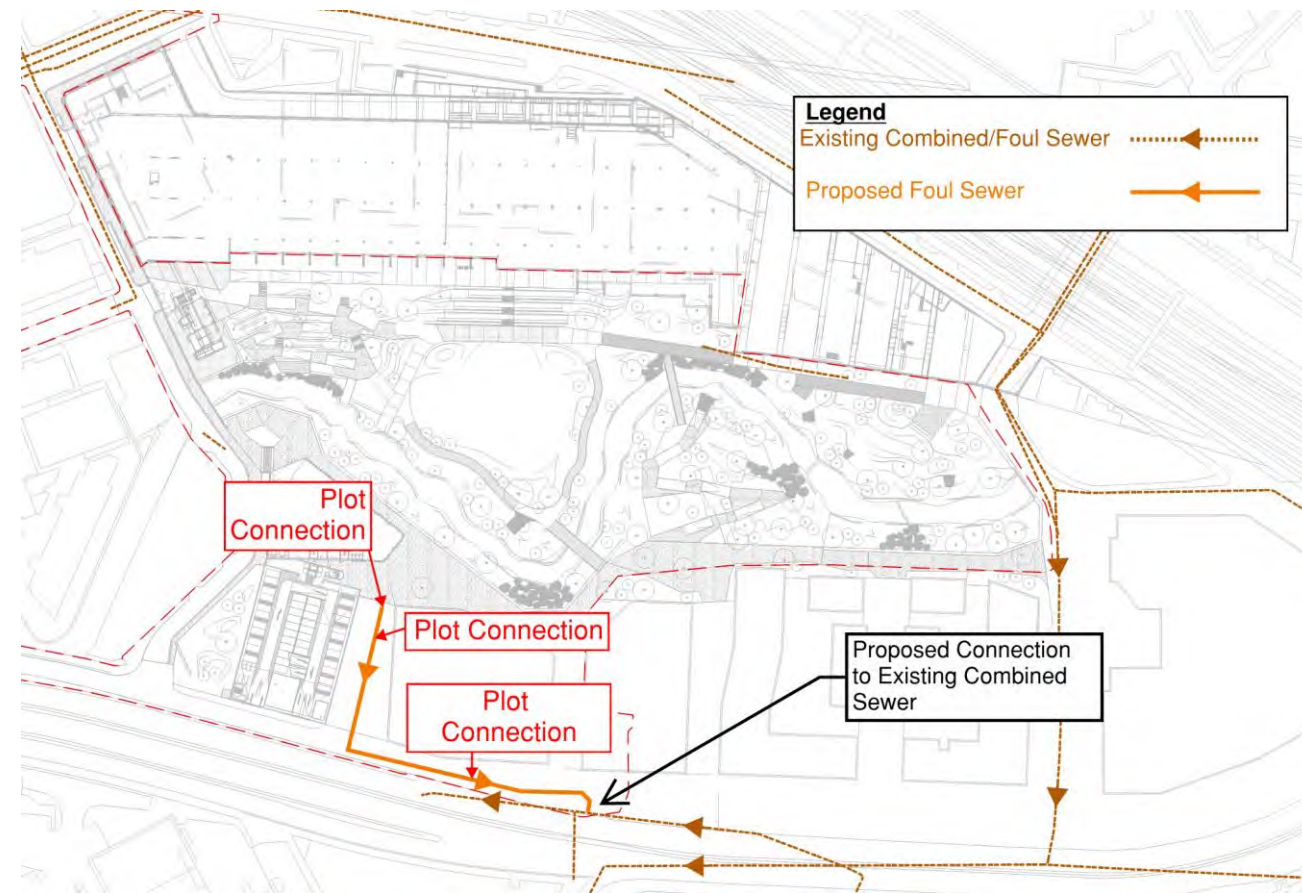
Figure 8-1 Proposed Foul Network
