# Discharge of Planning Condition Report

**Condition 4 full discharge of application after partial discharge of condition under** Application number: CDN/25/0917  
**Gas Membrane (Completion / Verification Report)**  
**Planning Permission Ref:** 141183/FH/2024  
**Site Address:** 12 Redcliffe Drive, Manchester, M4 7BS

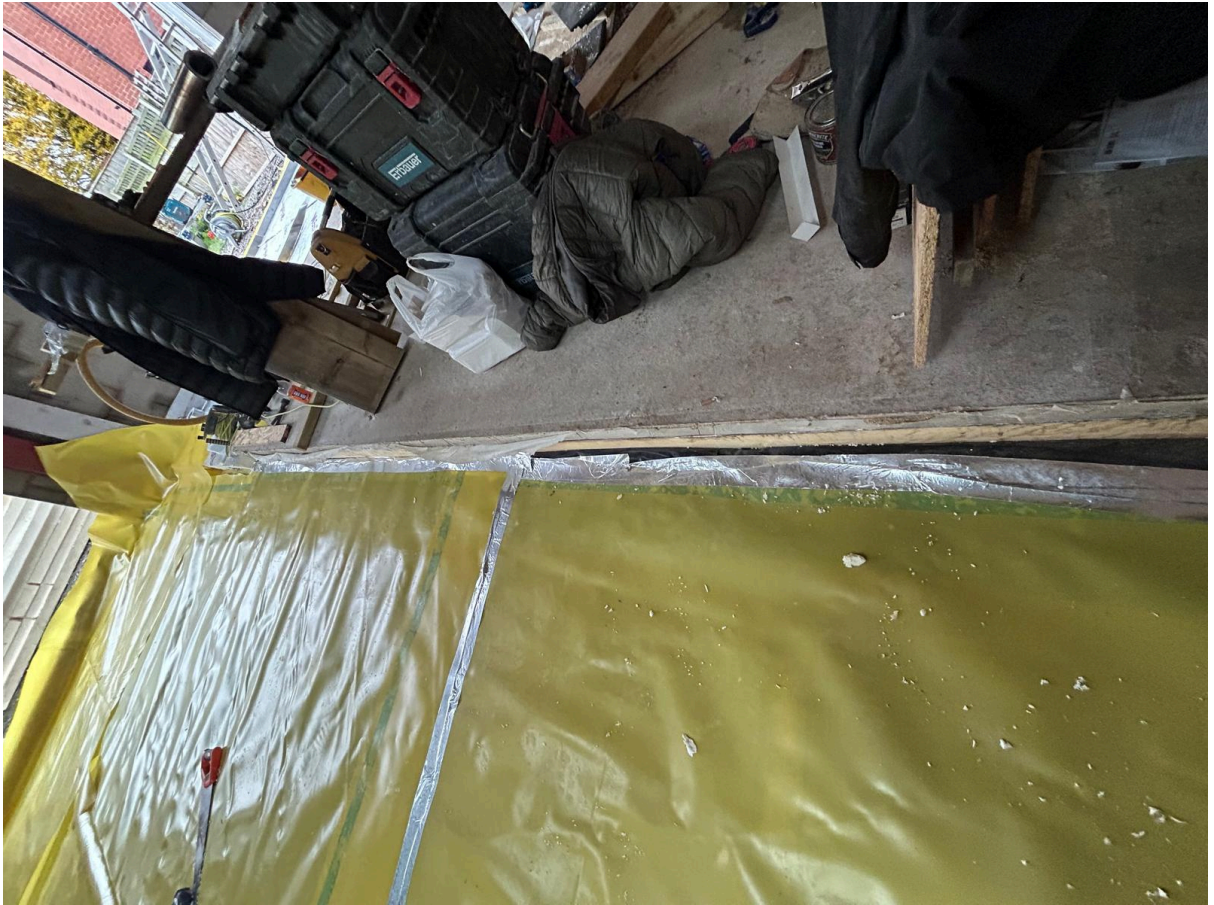
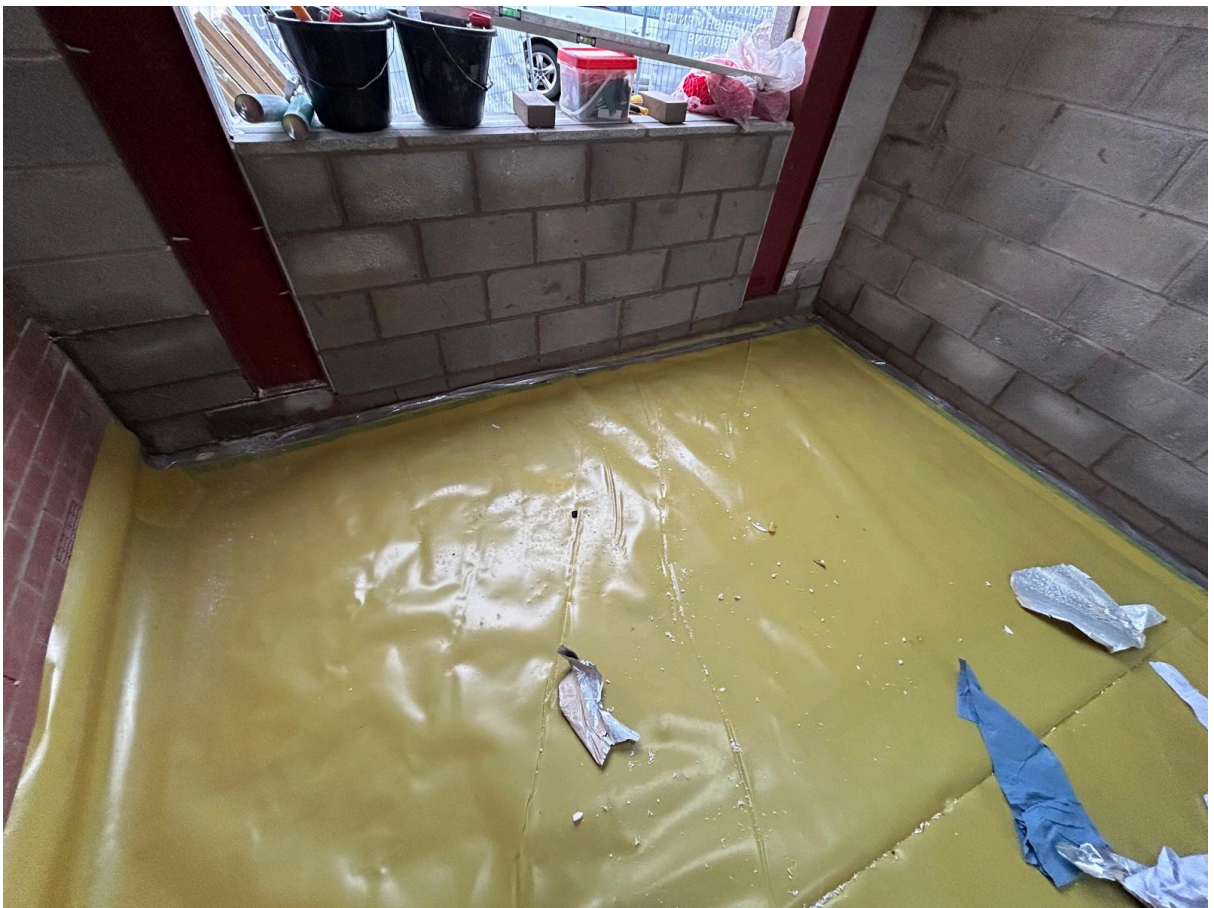
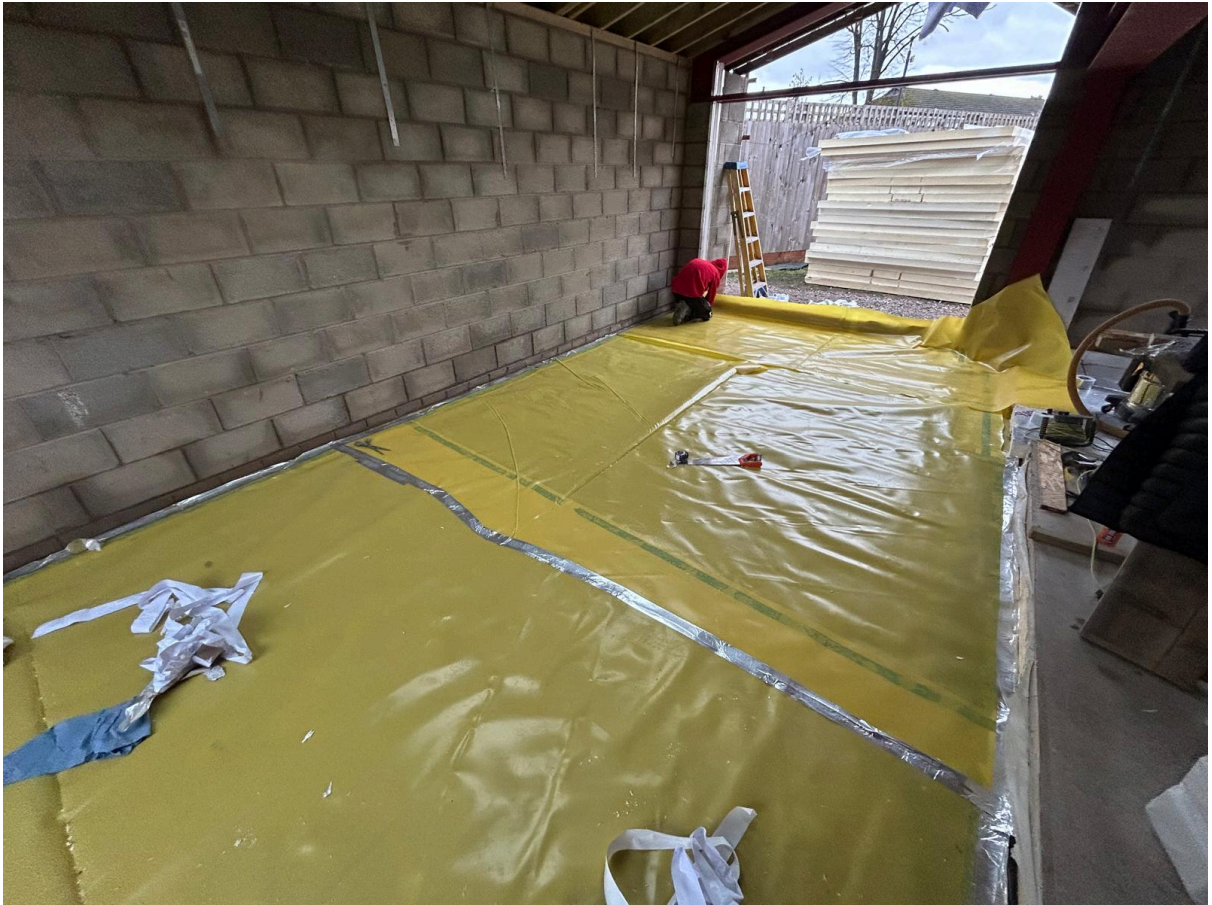
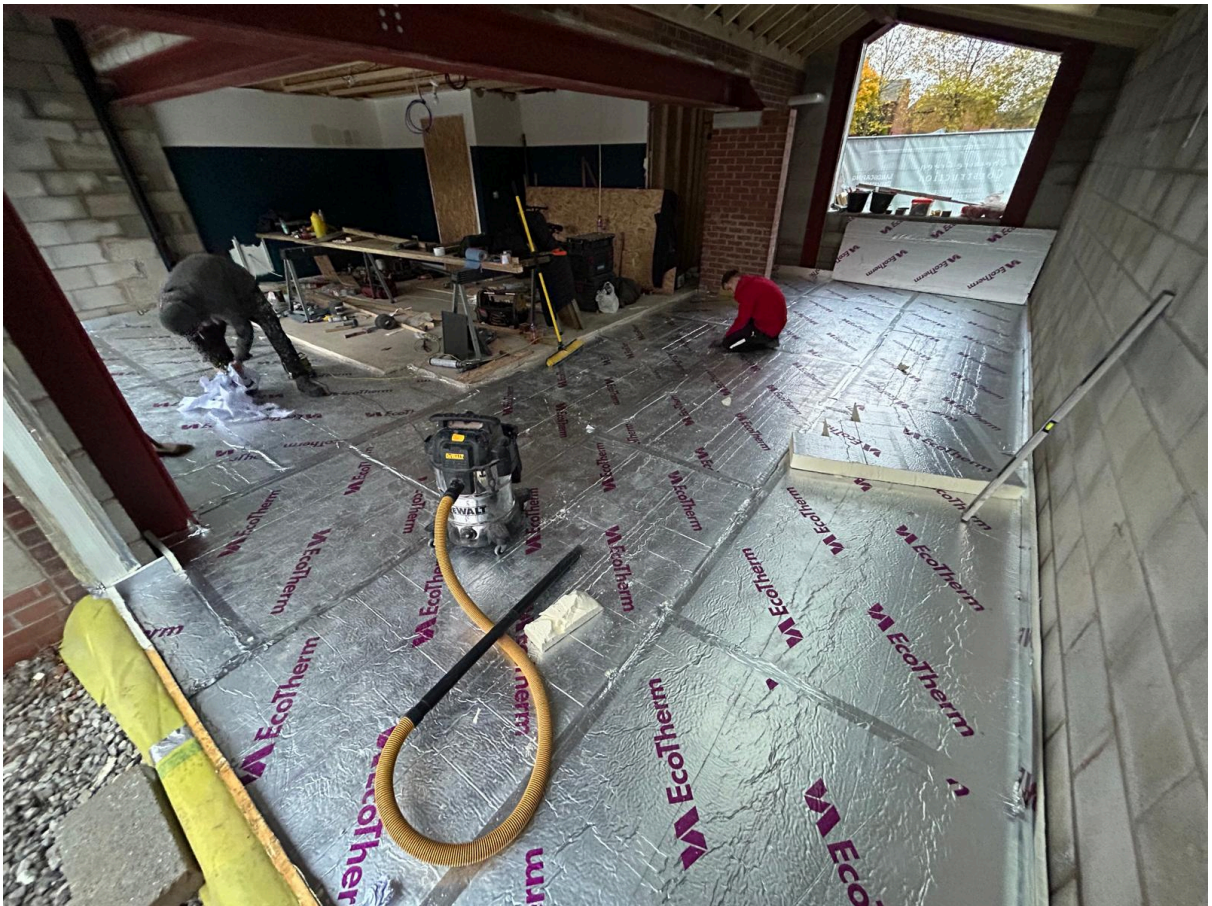
- A gas membrane layer installed continuously across the floor area
- Double-sided jointing tape beneath laps, with an additional foil layer applied
- Gas membrane tape applied over joints to ensure sealing and continuity
- Installation of 100mm insulation above the membrane, with a 25mm upstand at perimeter walls
- All insulation joints foil taped, preparing the assembly for the subsequent vapour control layer

Photographic evidence provided by the contractor demonstrates the installation sequence and confirms the detailing described above.
