## **Heritage Statement**

### **Proposed Alterations/Refurbishment**

### **Mr Thomas's Chop House**

### **52 Cross Street**

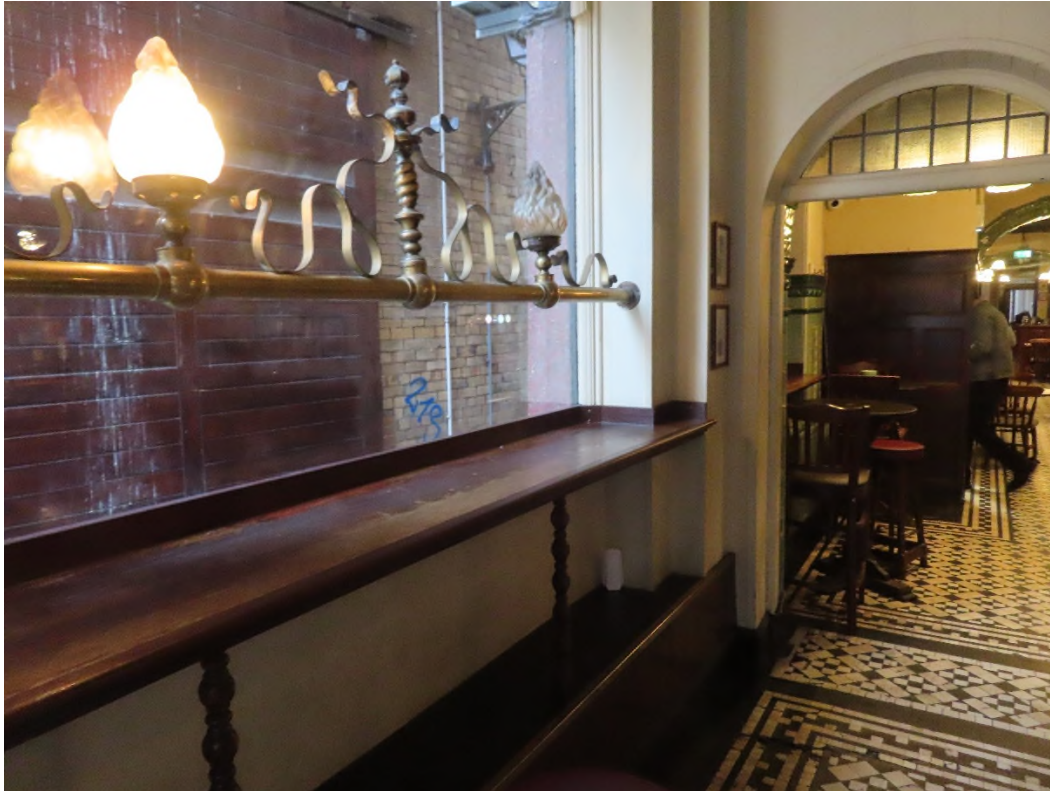
Photograph 1

Existing window, brass work and refurbishment of existing shelving.

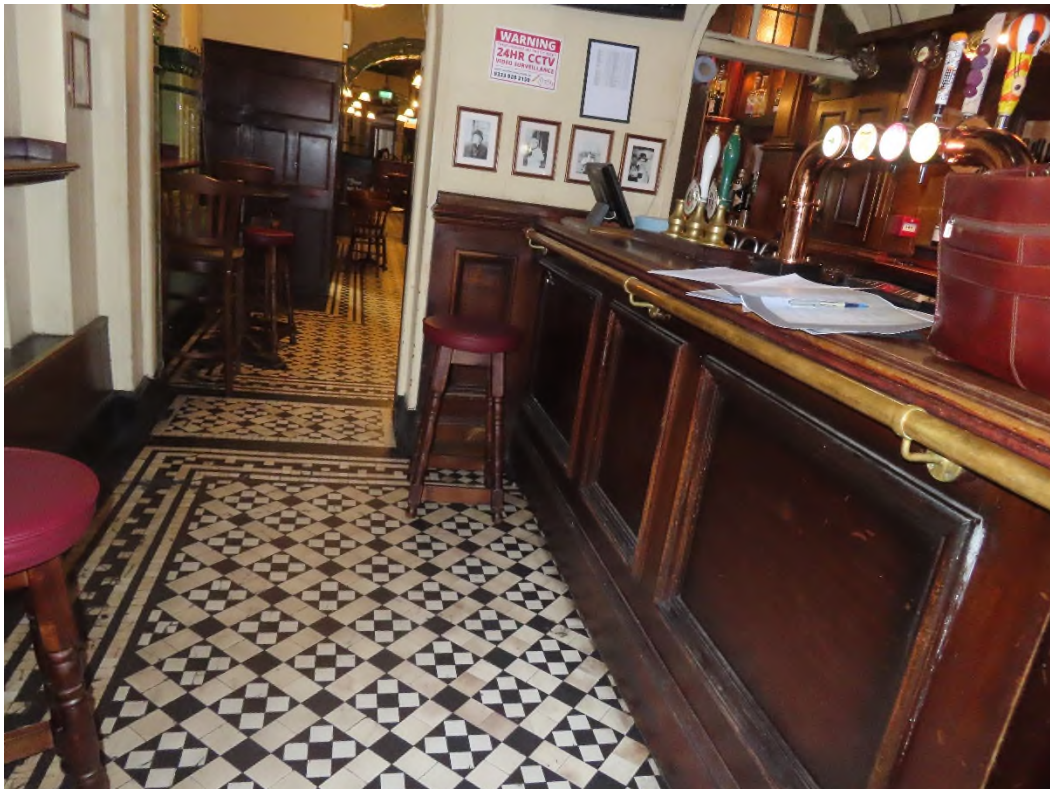
Photograph 2

Existing bar to remain together with general refurbishment.

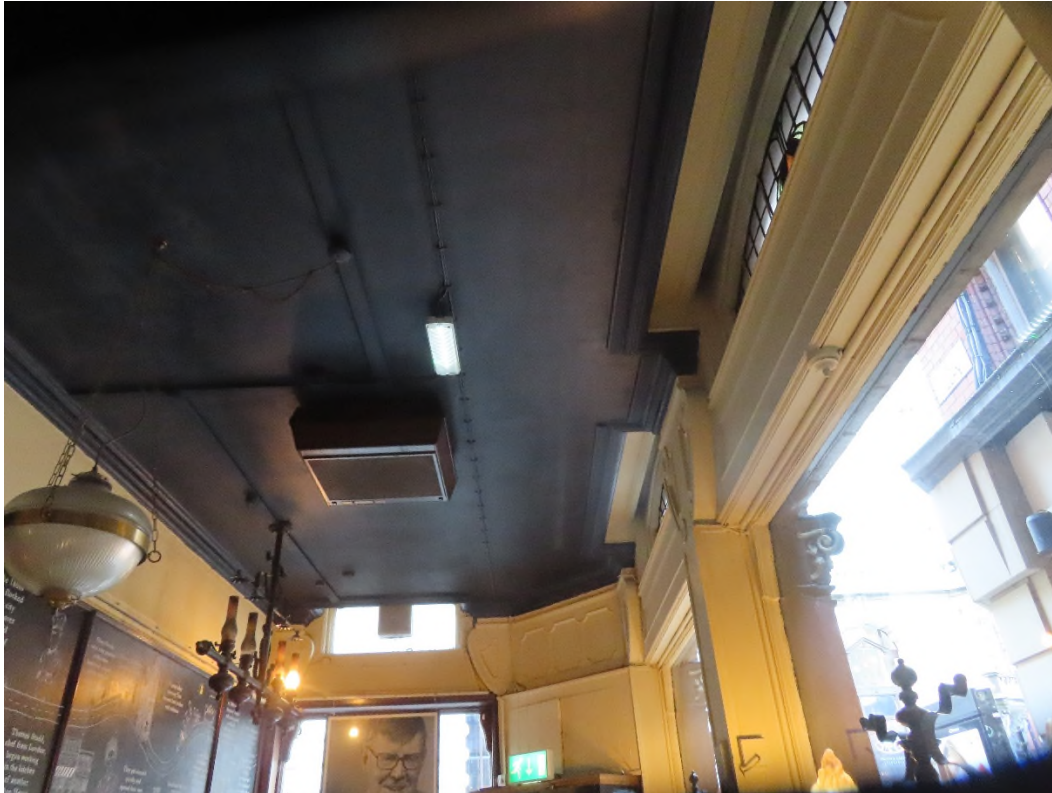
Photograph 3

Air conditioning surface trunking to be removed, ceiling to be made good.

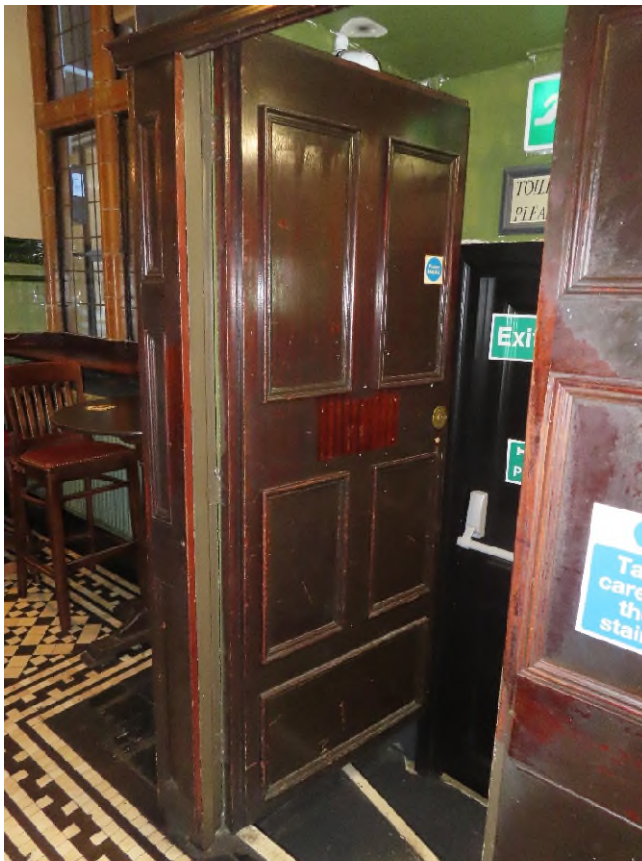
Photograph 4

Doorway to cellar to be changed as indicated on drawing 0015 together with associated ironmongery.

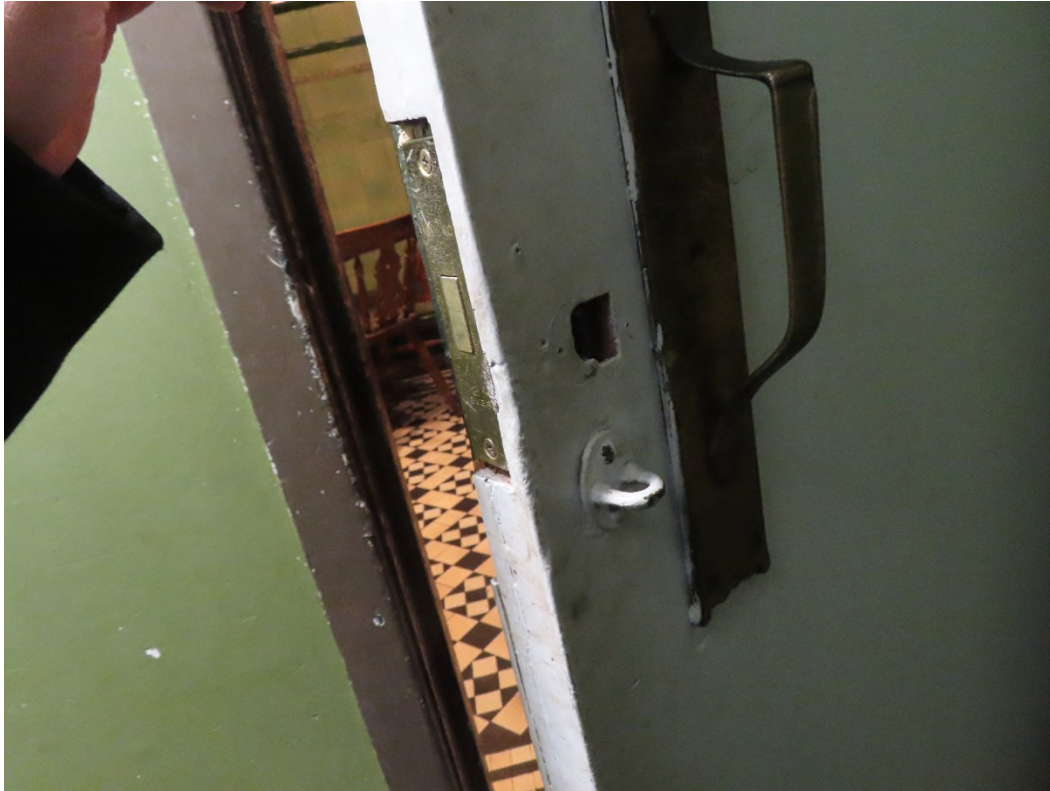
Photograph 5

Poor quality of existing cellar door, re-use pull handle on this photograph to rear of door and not the proposed brassware indicated on the drawing.

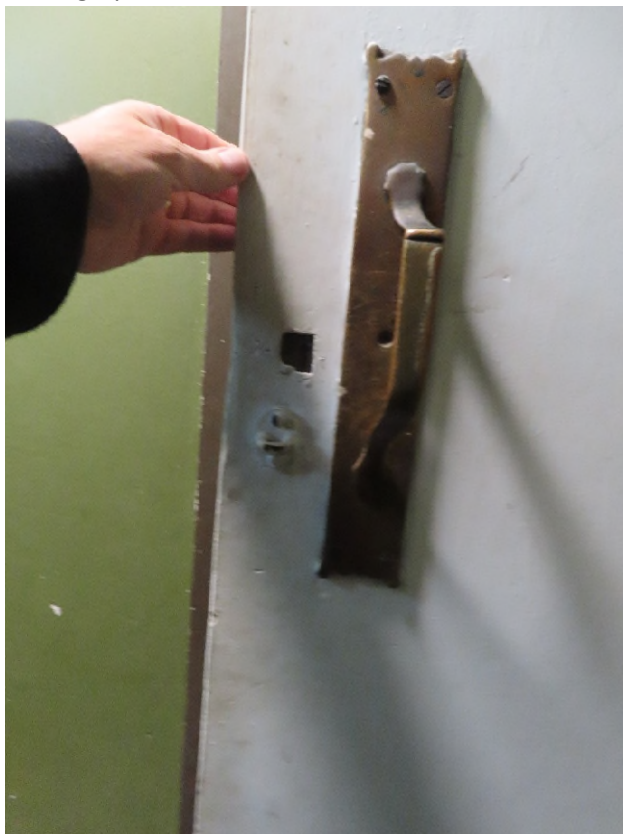
Photograph 6

Door brassware to be reused.

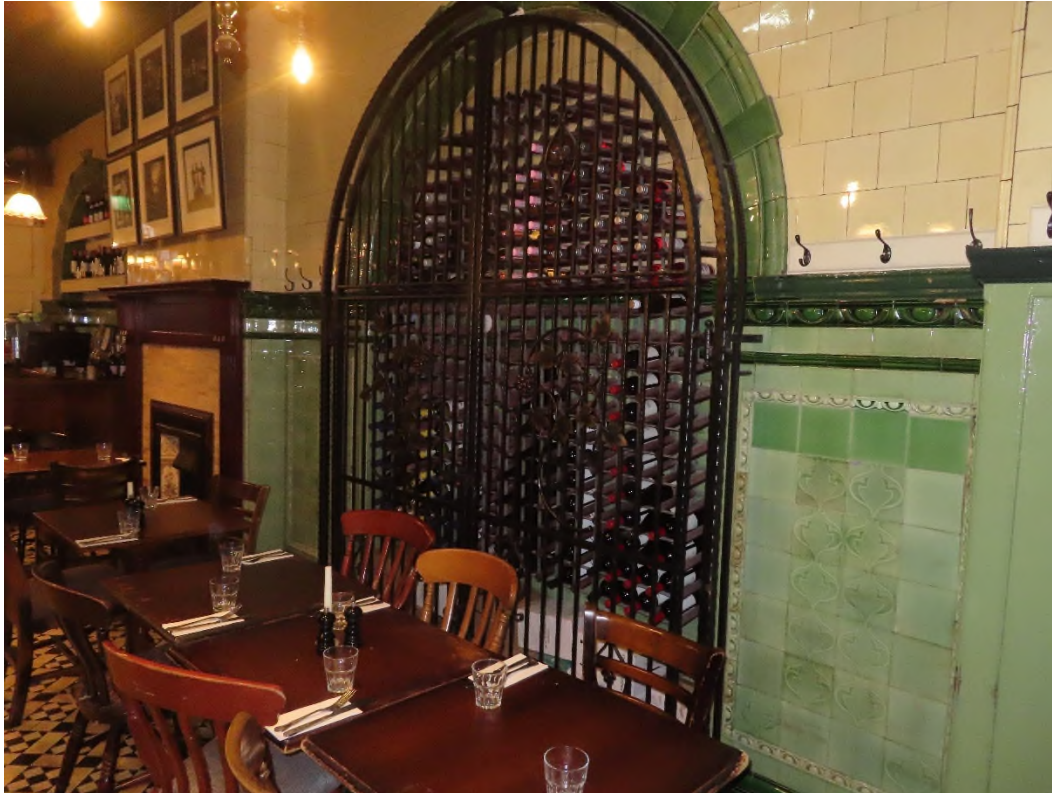
Photograph 7

Existing wrought ironmongery doors to be removed and replaced with brass gantry as indicated on drawing 0014.

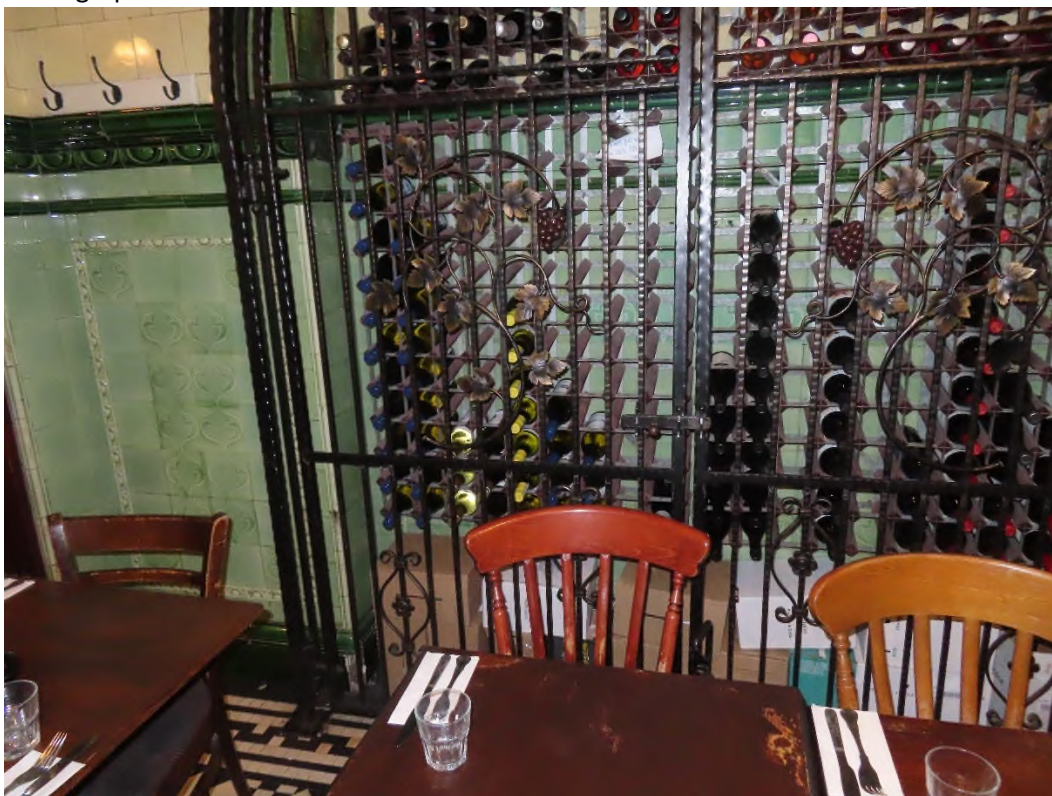
Photograph 8

Existing wrought ironmongery doors to be removed and replaced with brass gantry as indicated on drawing 0014. Carefully remove existing fixing and make good to tiling where possible.

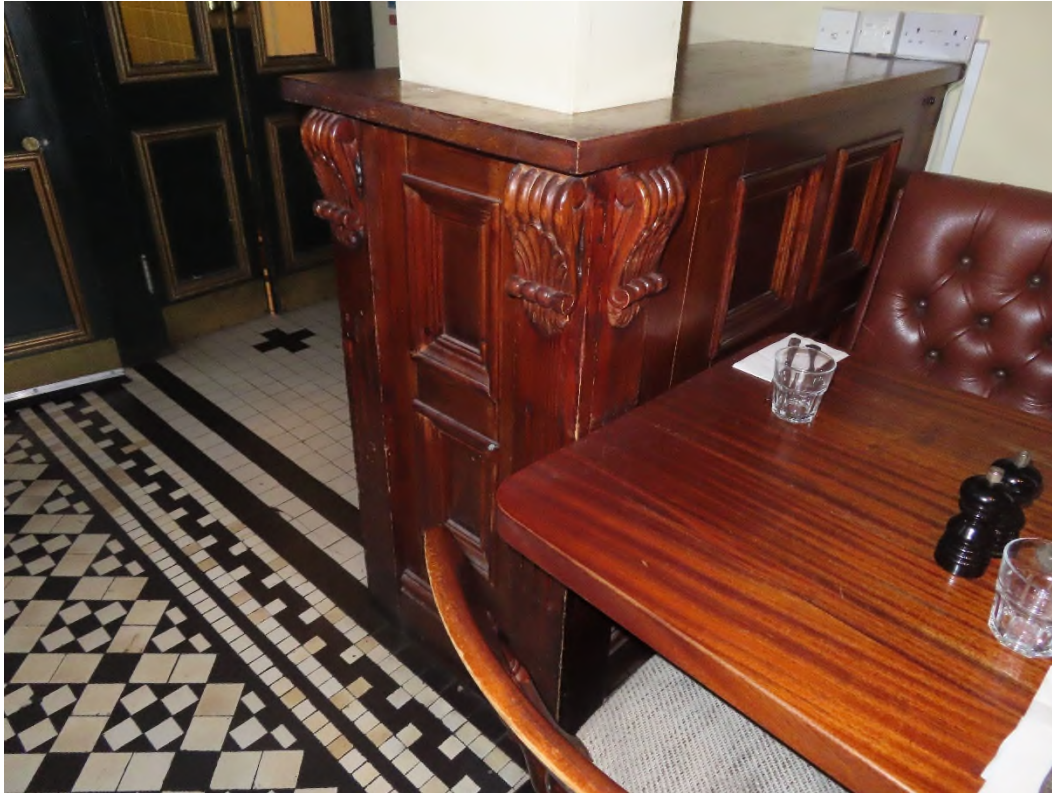
Photograph 9

Existing panelling to be replicated in detail as per drawing 0012.

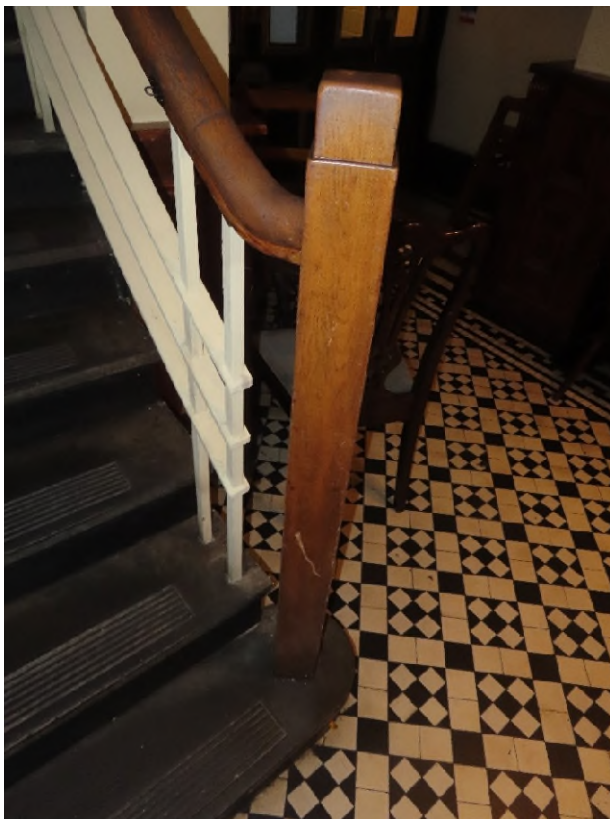
Photograph 12

Current implant in staircase is Ruberoid finish which is going to be replaced by the proposed treads which is a tile finish in drawing 0013. This element of the building is in my view a later addition, possibly 1930's particularly looking at the detail of the balustrade newel post.

*The overlaying of the floor with tiles onto the treads, again is not particularly significant. There is some question as to whether the detailed vinyl type of tread would have been original or whether this has been overlaid at a different period.*

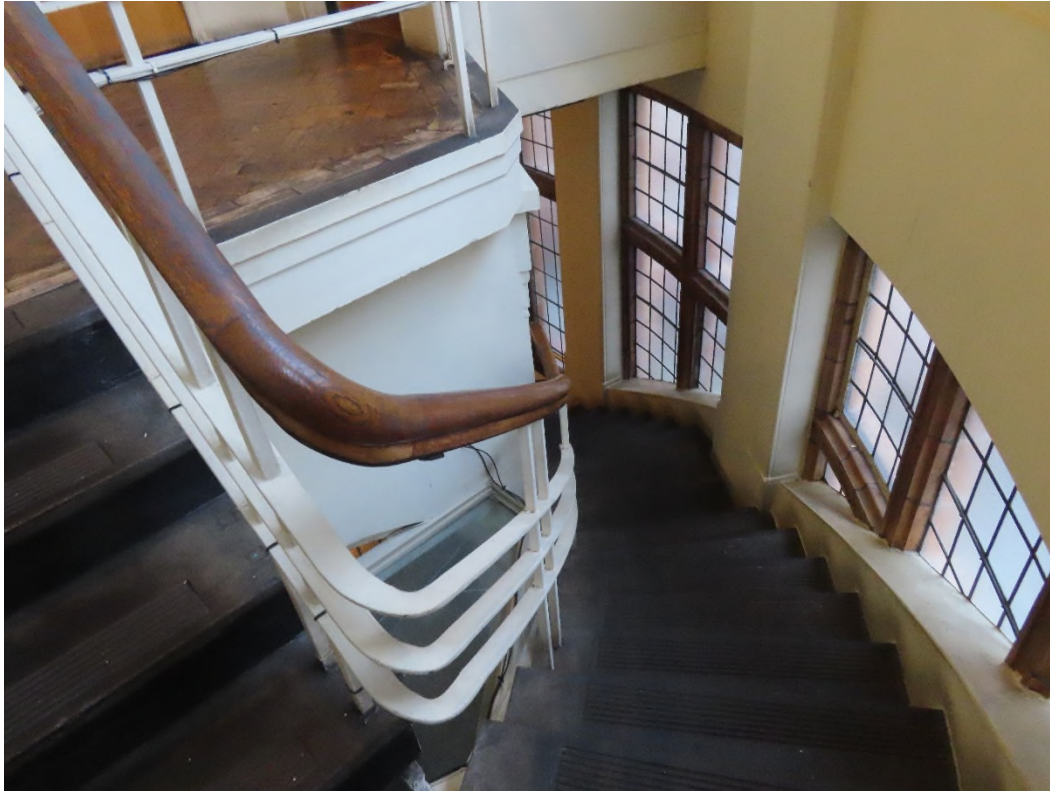
Photograph 13

Detailed 1930's style balustrade to staircase remaining unaltered.

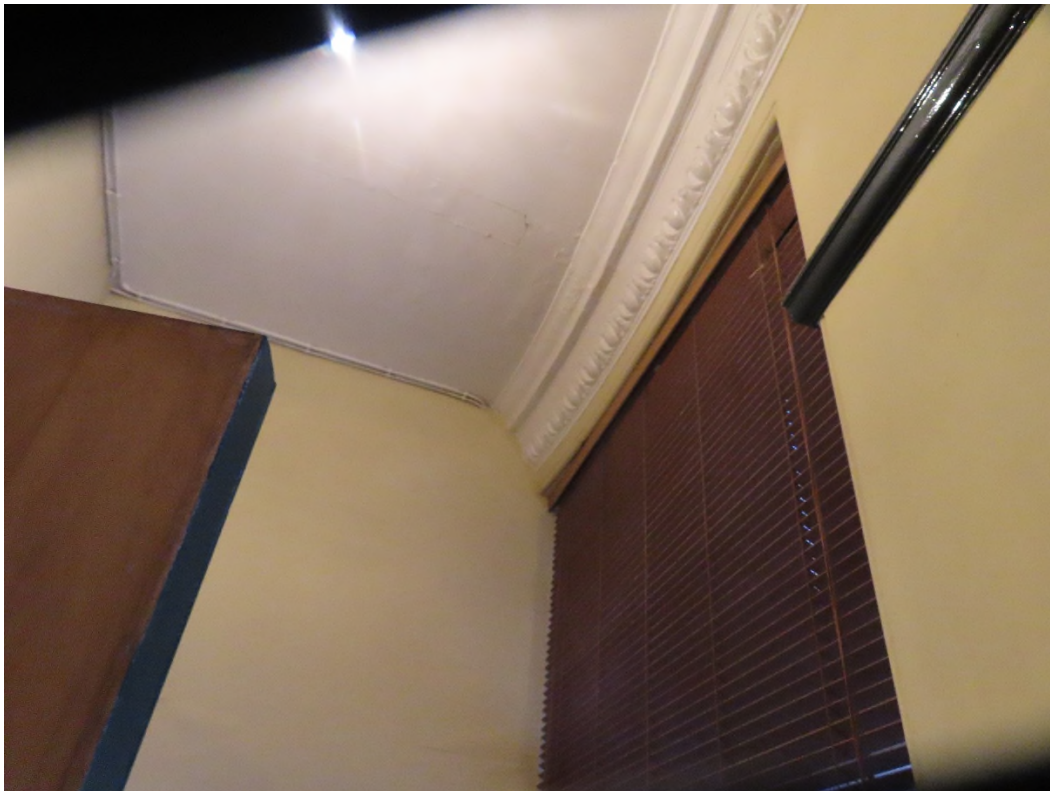
Photograph 14

Existing cornice to be cut round to avoid any impact on the ceiling.

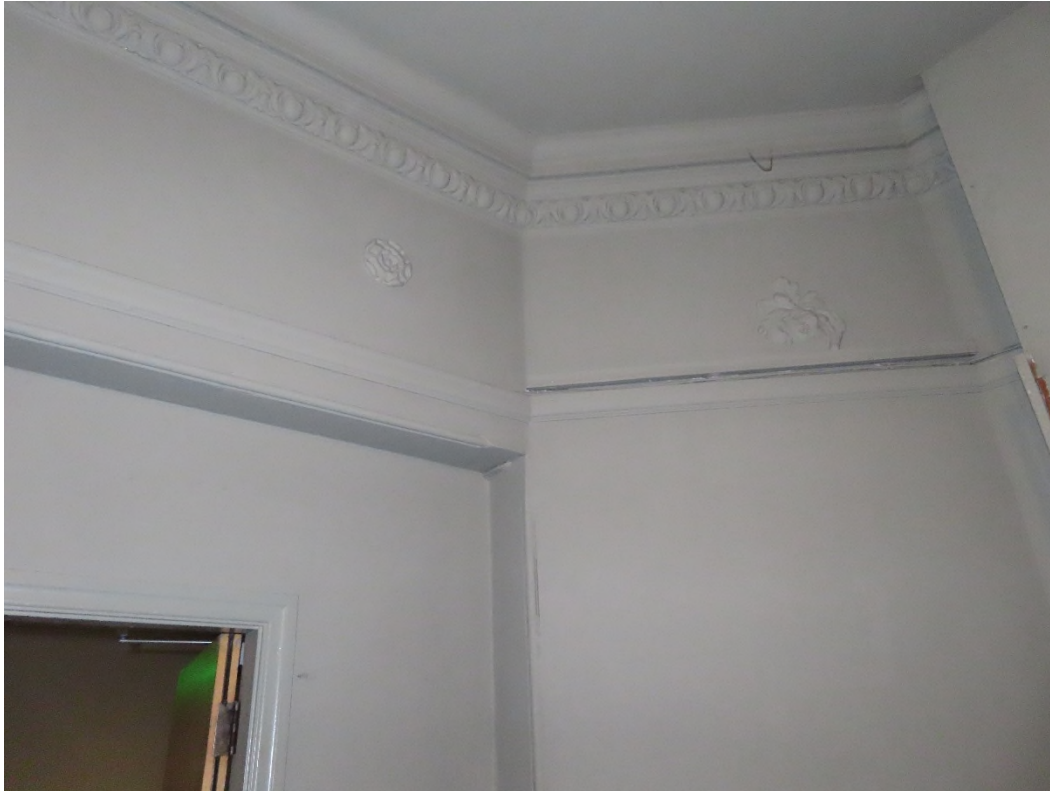
Photograph 15

Careful interface between new walls to ceiling to avoid any damage to existing ceiling finishes, Cornice and frieze.

*The main proposal involves the creation of timber studded walls on the first floor to create toilets. These will be erected in such a way as to not damage the existing cornice or freeze as stated on the drawings. Also, any tiling on the existing walls could be done in such way as to be screw panels and then tiled so that this again could be reversible. The floor detail obviously is a tile but with a separating layer onto the current hardwood floor, really for the purposes of protecting that floor and allowing reversibility.*

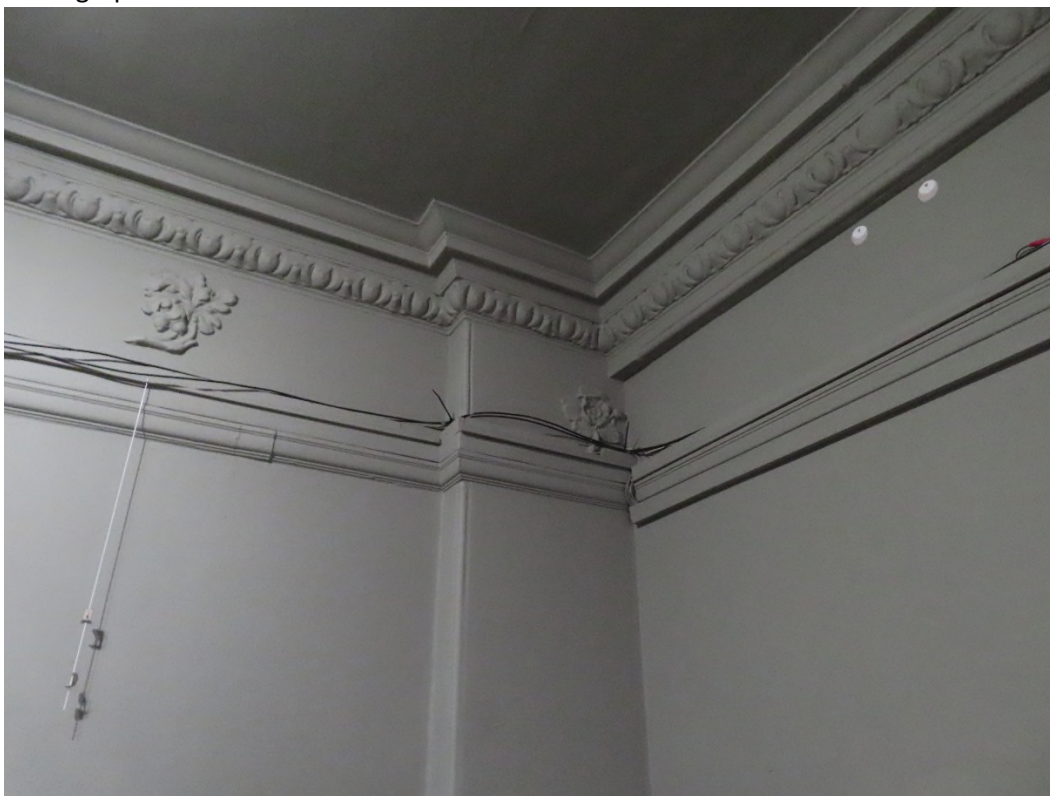
Photograph 16

Ceiling finishes in proposed toilet area not to be disturbed by proposal.

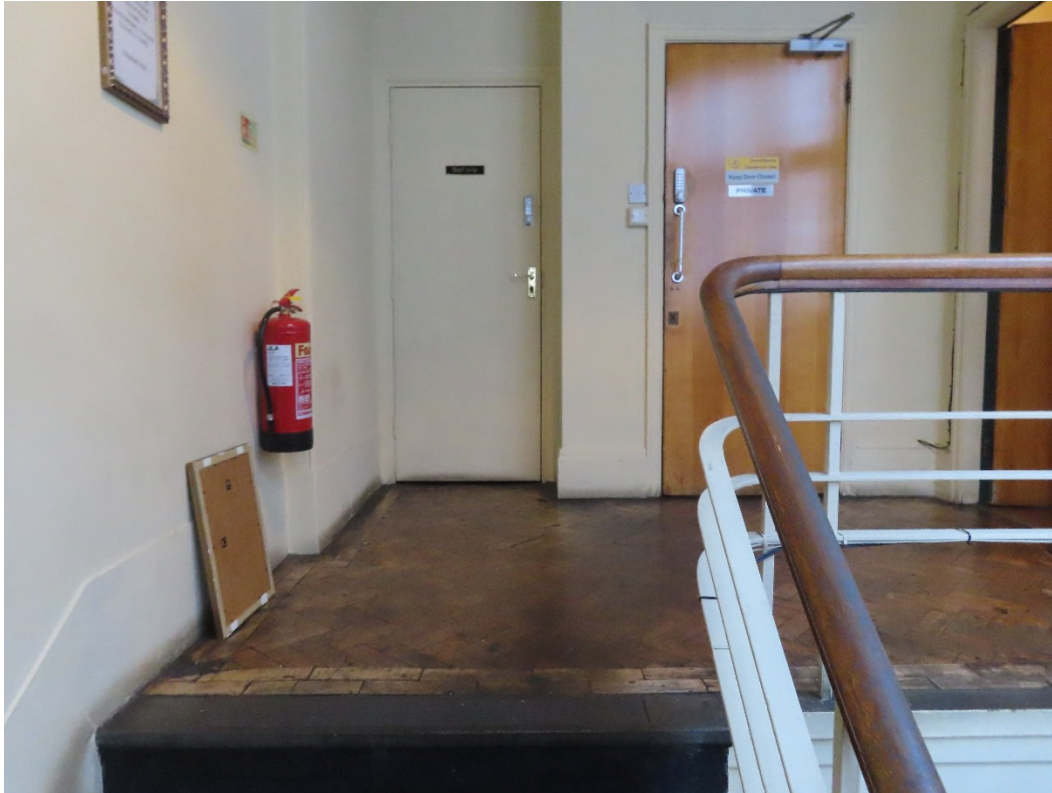
Photograph 17

Current doors to private accommodation, toilets are of modern style.

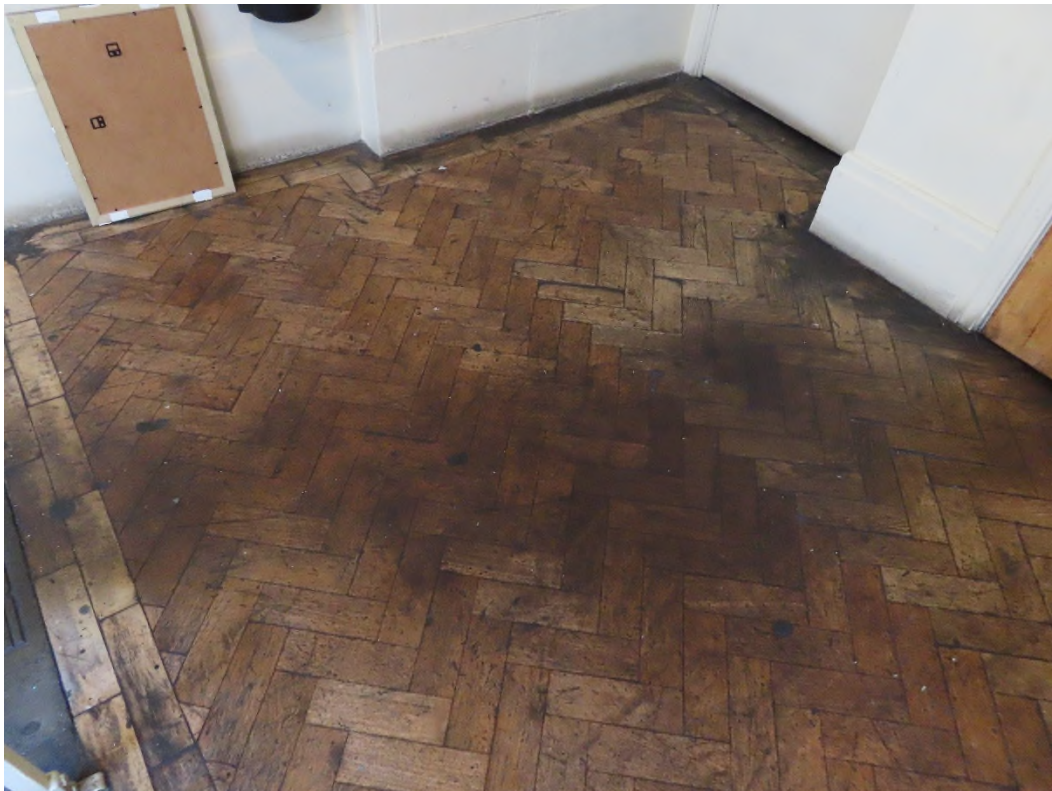
Photograph 18

Existing hardwood blocks to have separating laying before being tiled to allow for reversibility.

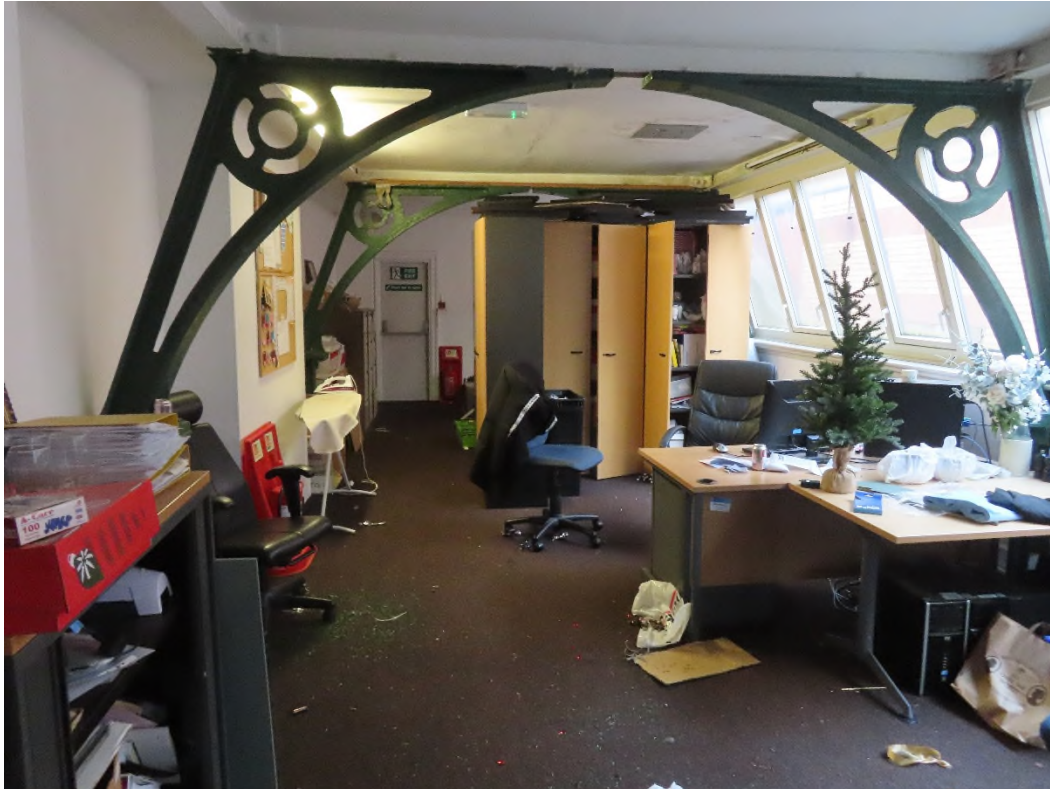
Photograph 19

Indications of part of the steel frame exposed supporting the flat roof subdividing the front and rear building on the third floor.

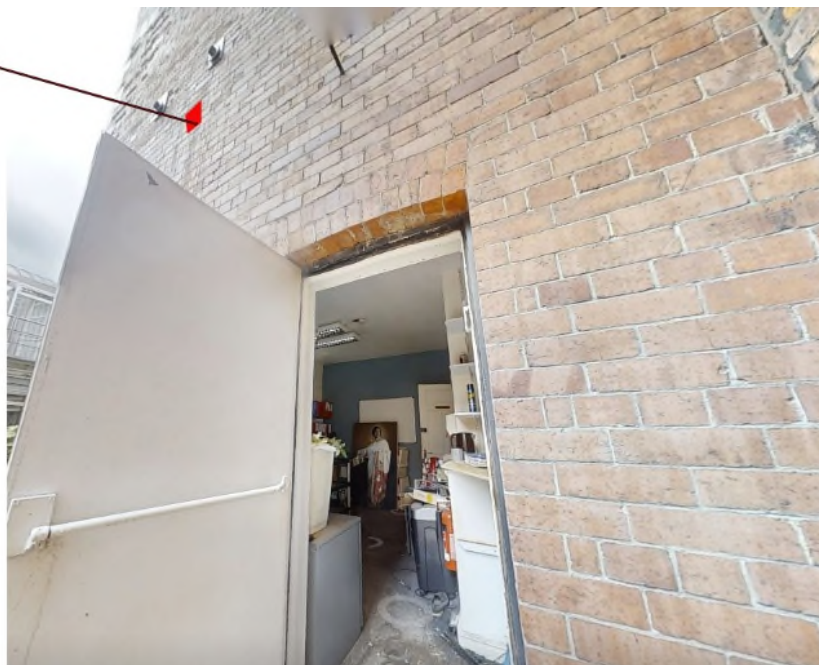
Photograph 20

Indicates location of  
extract vent  
penetration through  
exterior wall on third  
floor adjacent to  
existing boiler flue  
vents.

Proposed extract vent location.

The only external alteration is an extraction duct for ventilating toilet which will be on the third floor wall facing onto a flat roof, this wall currently contains to gas terminal and cannot be seen by the public see photograph 20.
