# Dilapidation Survey

Varsity Quarter - Sale Road and Wythenshawe Road

Date: 22.01.26

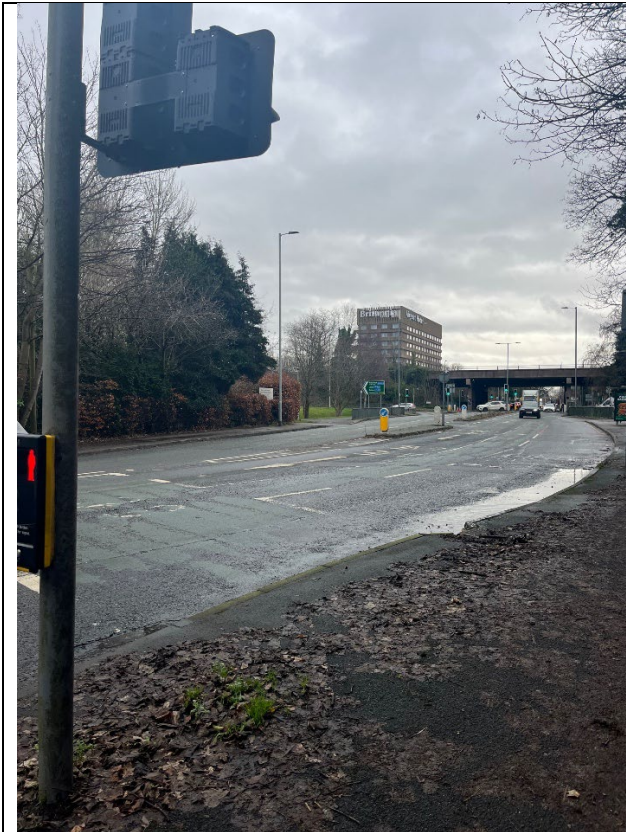
| <p>Location:<br/>1 - Junction of Wythenshawe Rd and Sale Rd.<br/>Facing East.</p> | <p>Location:<br/>1 - Junction of Wythenshawe Rd and Sale Rd.<br/>Facing East.</p> | <p>Location:<br/>2 - Junction of Wythenshawe Rd and Sale Rd.<br/>Facing West.</p> |
| <p>Highway Condition:<br/>Surfacing and lining in poor condition. Kerbs in fair condition. <b>NO CHANGE</b></p> | <p>Highway Condition:<br/>Surfacing and lining in poor condition. Kerbs in fair condition. <b>NO CHANGE</b></p> | <p>Highway Condition:<br/>Surfacing and Kerbs in fair condition. Lining in poor condition. <b>NO CHANGE</b></p> |

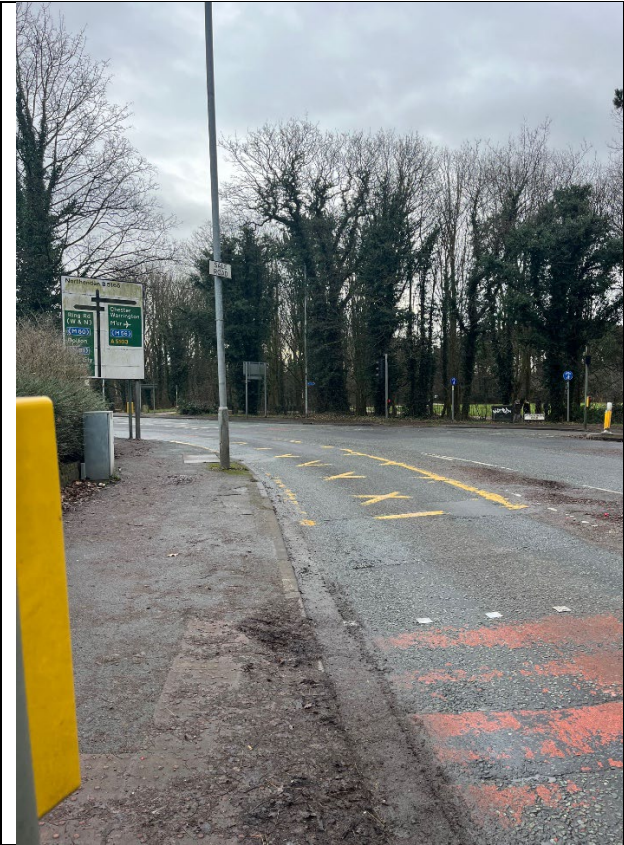
| <p>Location:<br/>2 - Junction of Wythenshawe Rd and Sale Rd.<br/>Facing South.</p> | <p>Location:<br/>3 – Sale Road. Facing North.</p> | <p>Location:<br/>3 – Sale Road. Facing North.</p> |
| <p>Highway Condition:<br/>Surfacing and Kerbs in fair condition. Lining in poor condition. <b>NO CHANGE</b></p> | <p>Highway Condition:<br/>Surfacing and Kerbs in fair condition. <b>NO CHANGE</b></p> | <p>Highway Condition:<br/>Surfacing and Kerbs in fair condition. <b>NO CHANGE</b></p> |

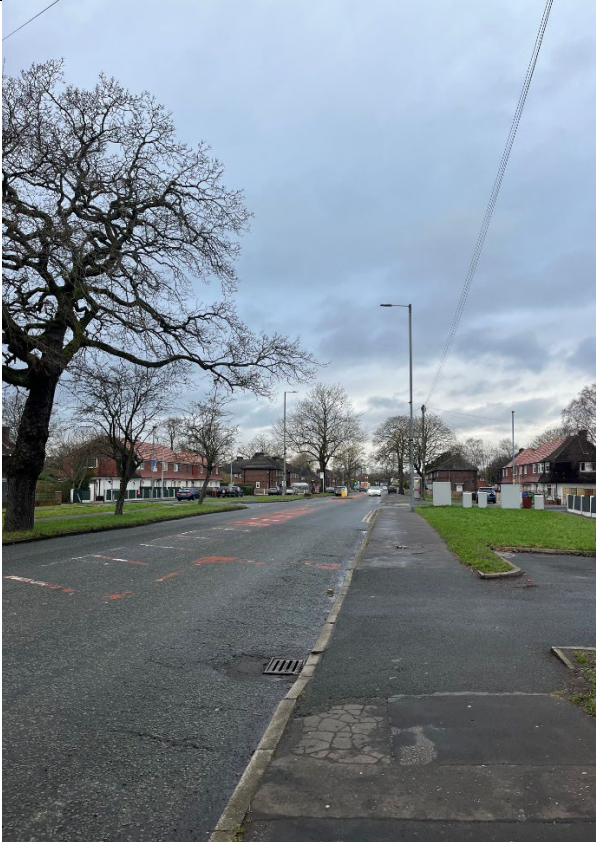
| <p>Location:<br/>4 - Sale Road facing North.</p> | <p>Location:<br/>5 – Junction of Sale Road and Moss Hey Drive facing North.</p> | <p>Location:<br/>6 – Moss Hey Drive.</p> |
| <p>Highway Condition:<br/>Surfacing in poor condition. Lining and kerbs in fair condition. <b>NO CHANGE</b></p> | <p>Highway Condition:<br/>Surfacing and kerbs in poor condition. All tactile pavers are broken. <b>ROAD PATCHED, LINING TO BE REINSTATED. NEW HOLES TO BE FILLED</b></p> | <p>Highway Condition:<br/>Surfacing and kerbs in good condition. Lining in fair condition. <b>NO CHANGE</b></p> |

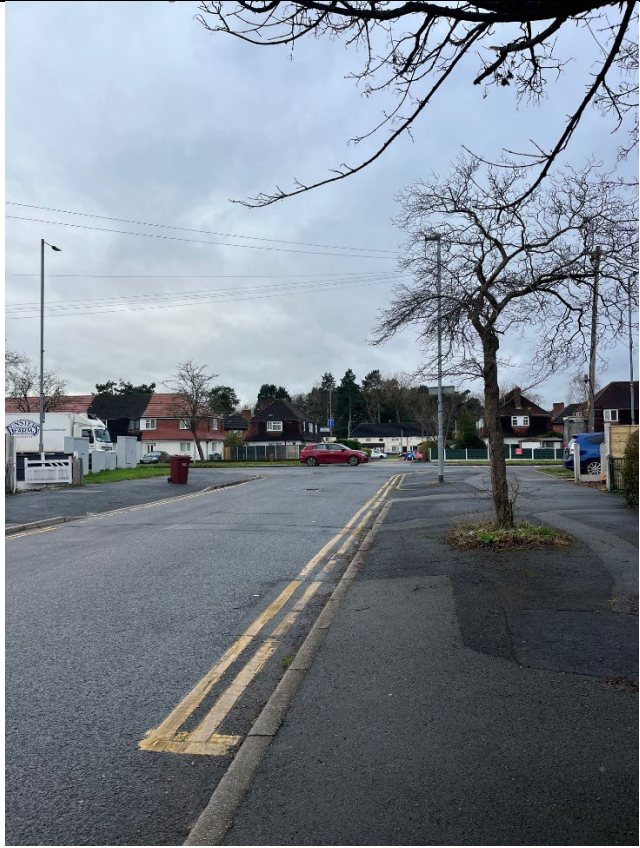
| <p>Location:<br/>7 - Moss Hey Drive.</p> | <p>Location:<br/>8 – Junction of Sale Road and Moss Hey Drive facing South.</p> | |
| <p>Highway Condition:<br/>Surfacing and kerbs in good condition. Lining in fair condition – <b>IMPROVED SINCE PREVIOUS SURVEY</b></p> | <p>Highway Condition:<br/>Surfacing and kerbs in poor condition. All tactile pavers are broken. <b>LINING TO BE REINSTATED</b></p> | |

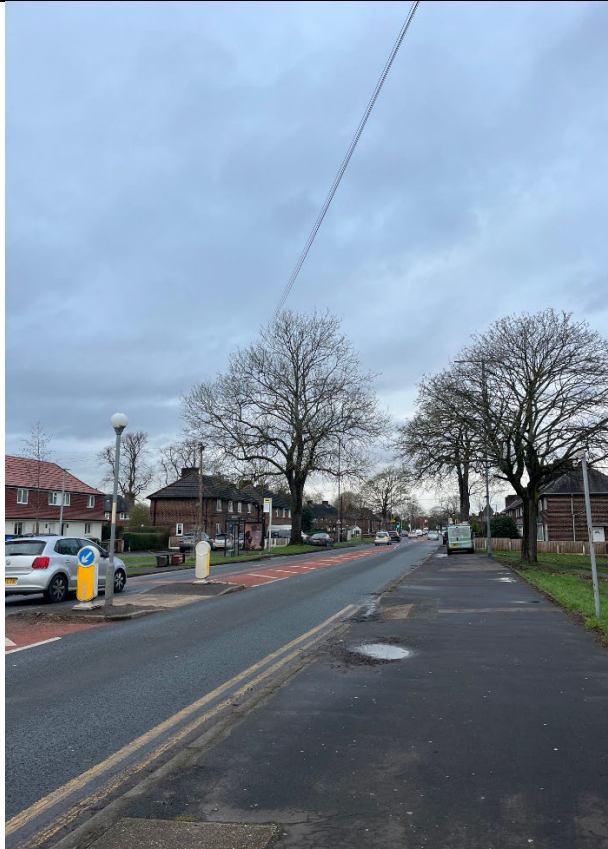
| <p>Location:<br/>9 – Sale Road facing North.</p> | <p>Location:<br/>10 – Junction of Sale Road and Shevington Gardens facing South.</p> | <p>Location:<br/>11 – Sale Road and Shevington Gardens facing North.</p> |
| <p>Highway Condition:<br/>Surfacing, Kerbs and lining in good condition. <b>NO CHANGE</b></p> | <p>Highway Condition:<br/>Surfacing, Kerbs and lining all in good condition. <b>NO CHANGE</b></p> | <p>Highway Condition:<br/>Surfacing, Kerbs and lining all in good condition. <b>NO CHANGE</b></p> |

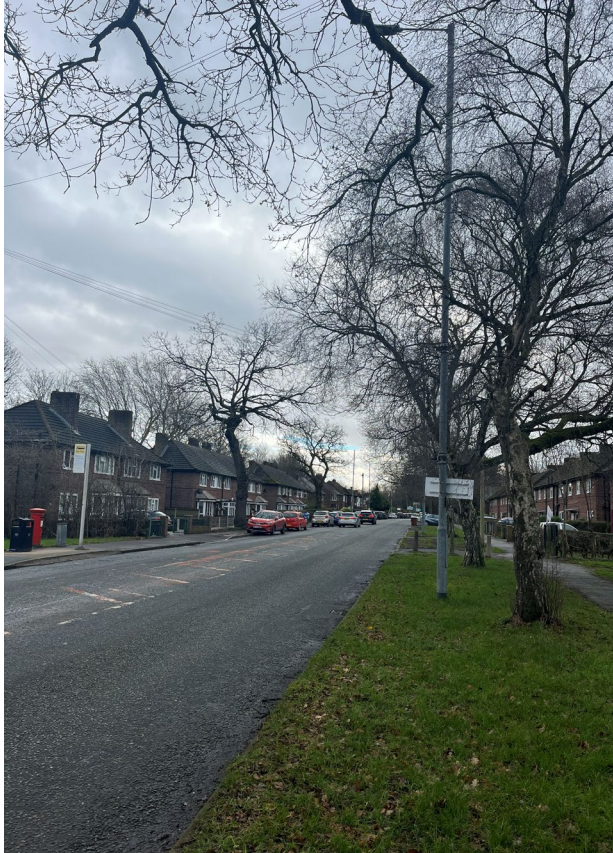
| <p>Location:<br/>12 – Sale Road facing South.</p> | <p>Location:<br/>13 – Sale Road facing South.</p> | <p>Location:<br/>14 – Sale Road facing South.</p> |
| <p>Highway Condition:<br/>Surfacing in good condition. Lining and kerbs in fair condition. <b>NO CHANGE</b></p> | <p>Highway Condition:<br/>Surfacing in good condition. Lining and kerbs in fair condition. <b>NO CHANGE</b></p> | <p>Highway Condition:<br/>Surfacing, lining and kerbs in fair condition. <b>NO CHANGE</b></p> |

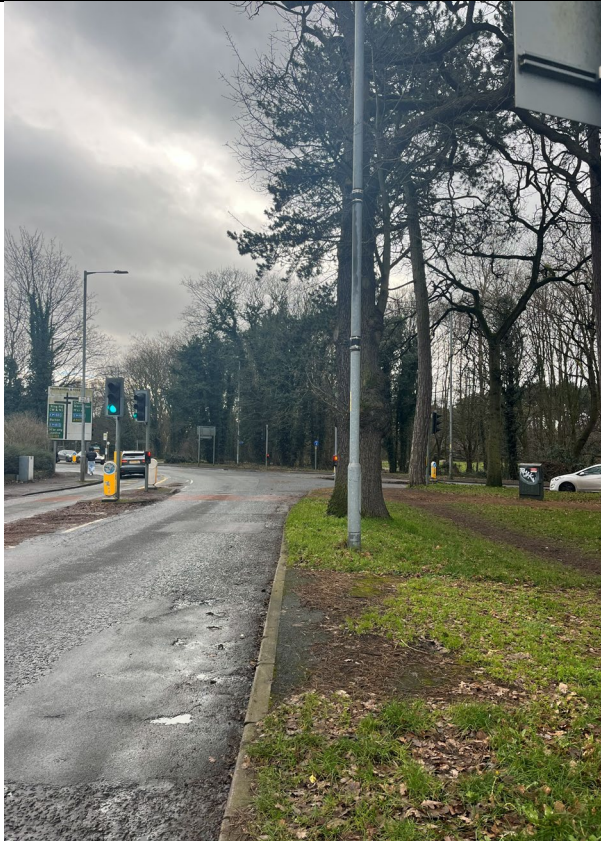
| <p>Location:<br/>15 – Sale Road facing South.</p> | <p>Location:<br/>16 – Junction of Wythenshawe Rd and Sale Rd.<br/>Facing South.</p> | <p>Location:<br/>16 – Junction of Wythenshawe Rd and Sale Rd.<br/>Facing East.</p> |
| <p>Highway Condition:<br/>Surfacing, lining and kerbs in fair condition. <b>NO CHANGE</b></p> | <p>Highway Condition:<br/>Surfacing, lining and kerbs in fair condition.<br/>Tactile paving in good condition. <b>NO CHANGE</b></p> | <p>Highway Condition:<br/>Surfacing, lining and kerbs in fair condition.<br/>Tactile paving in good condition. <b>NO CHANGE</b></p> |
