**RUTHERFORD BUILDING REFURBISHMENT**

# Design & Access Statement

**Submitted by** Arcadis  
December 2023

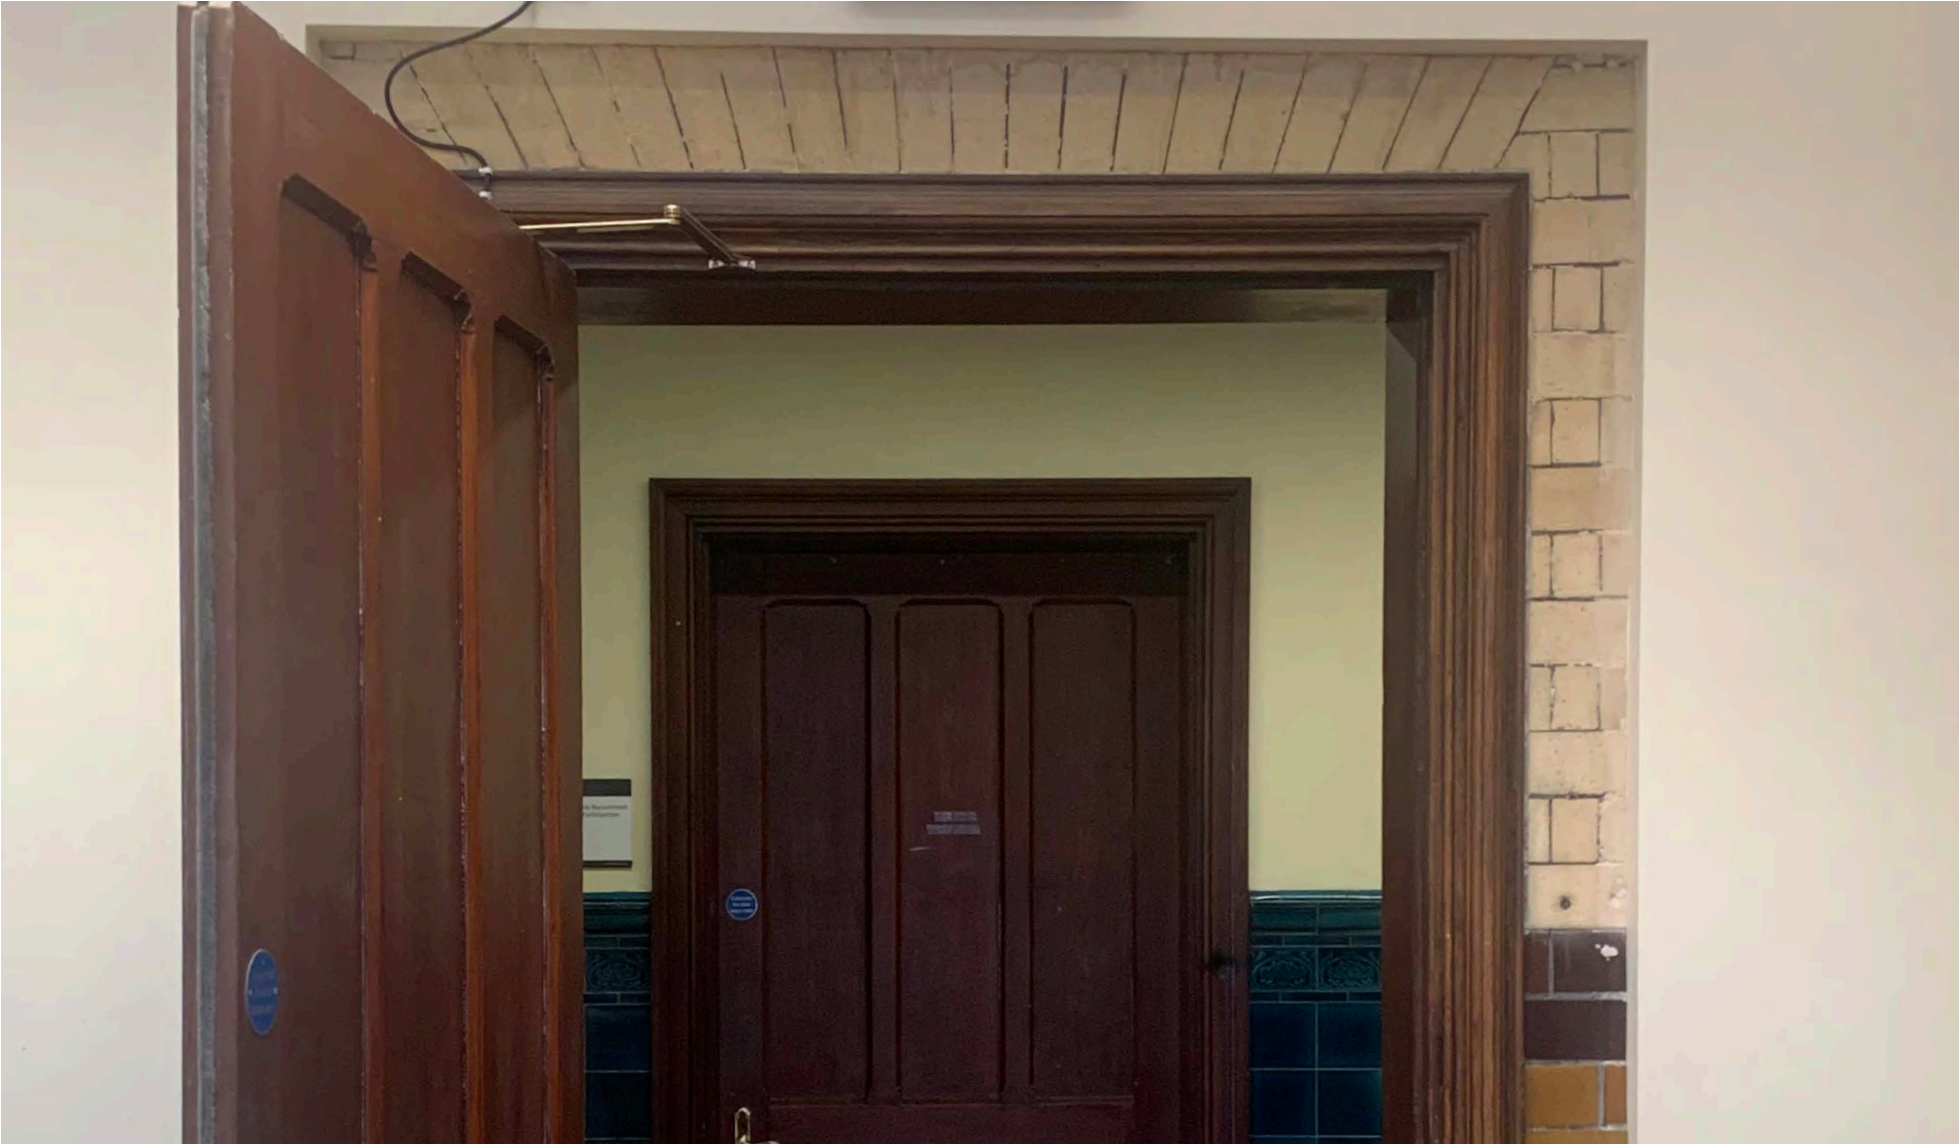
▲ Insulated Plasterboard Lining to be Removed if safe to do so to Reveal Historic Brickwork

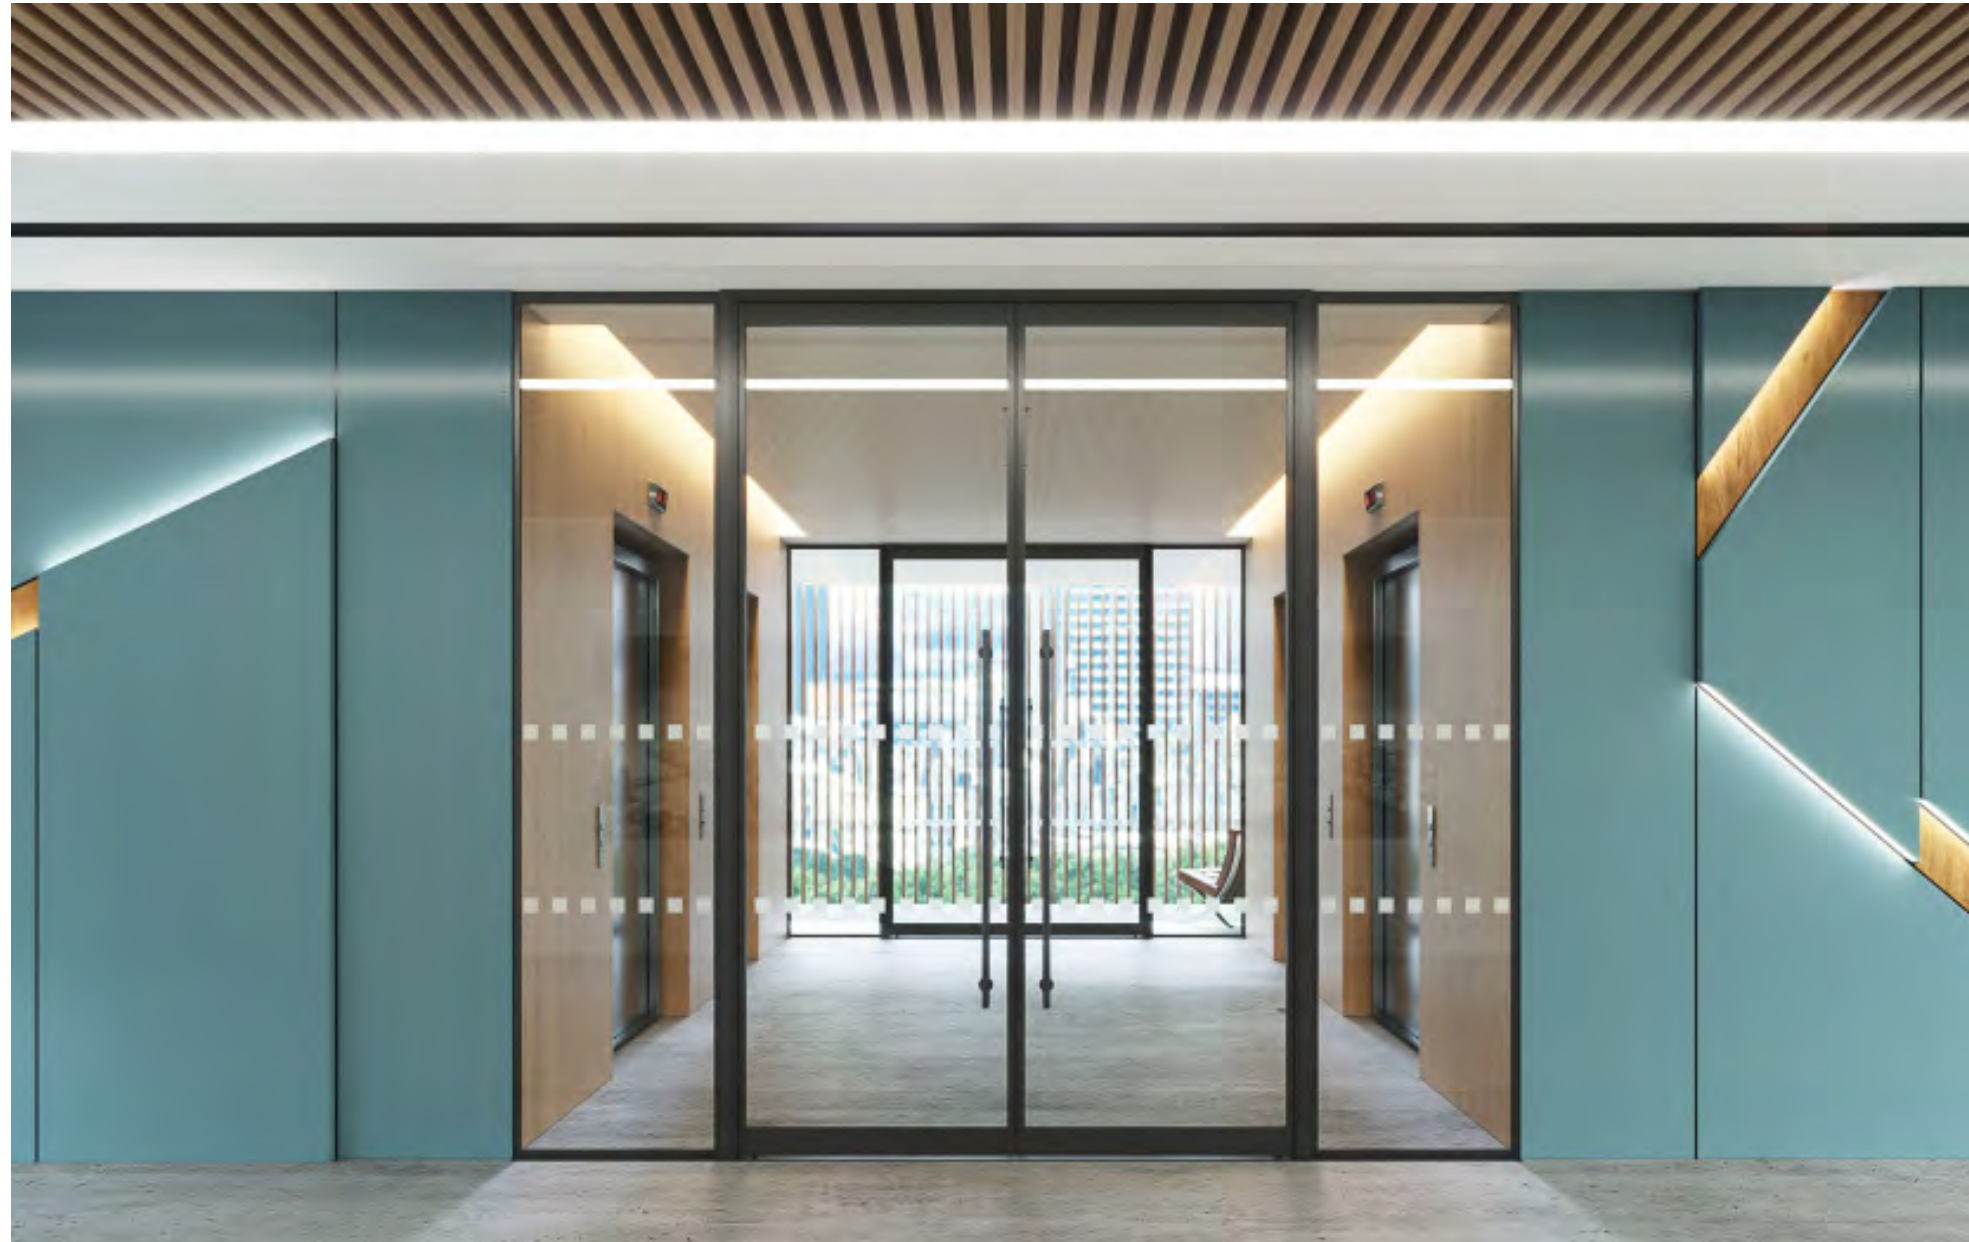
▲ New Slim Profile Metal Screens to Celebrate Historic Fabric

1980s hardwood fire screens will be replaced to maintain compartmentation within the building. New slim profile screens have been selected to reduce the visual impact on significant circulation spaces. Wherever possible, new fire screens are located within decorative arched openings to circulation spaces to minimise the impression of the historic fabric, strengthening the visual coherence of the intervention.

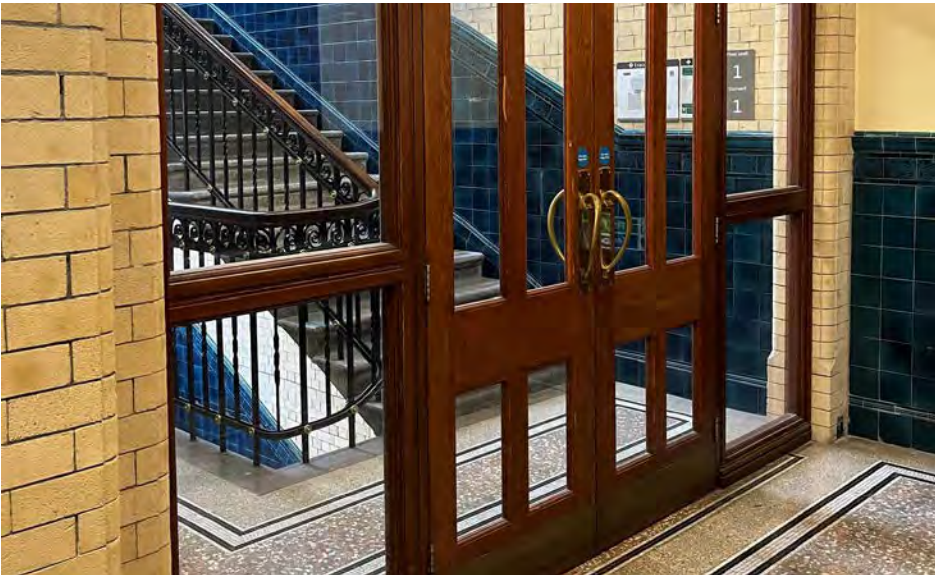
▲ Glazed Tropical Hardwood Fire Screens to Circulation Areas

- Insulated plasterboard overcladding to decorative internal brickwork.
- Glazed tropical hardwood fire screens to circulation areas.
- Sanitary accommodation including associated partitions, ceilings and finishes.
- Surface mounted dado trunking, containment and services infrastructure from circulation and cellular spaces at all floor levels.
- Electrical, security and left safety systems infrastructure and fittings
- Modern timber skirtings
- Glazed screens to meeting rooms
- Internal plasterboard partitions
- Modern fire doors between the Rutherford and adjacent museum accommodation.

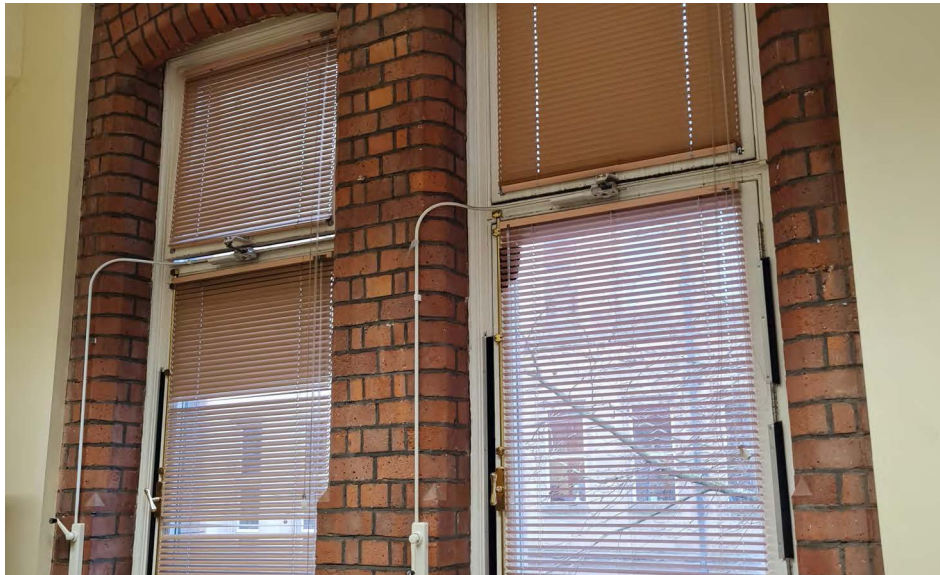
▲ Surface mounted dado trunking, containment and services within cellular spaces

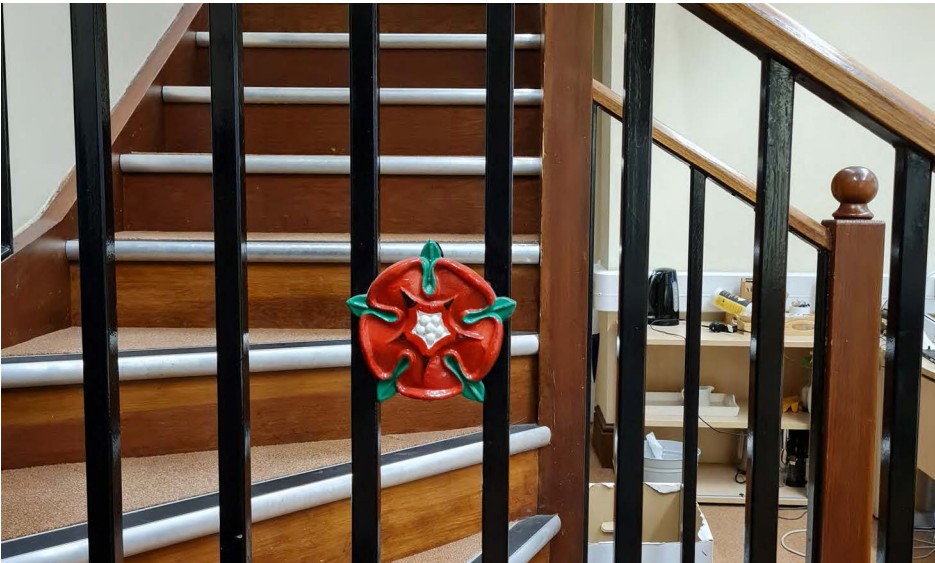
▲ Late addition - balustrade to mezzanine floor

- Replacement of glass and ash balustrade within a bespoke painted steel and oak handrail inspired by the main staircase design
- Concealment of ash stair treads with a carpet wrap.
- Rationalisation of mezzanine ceiling surfaces to present a cleaner aesthetic and enhanced acoustic controls.

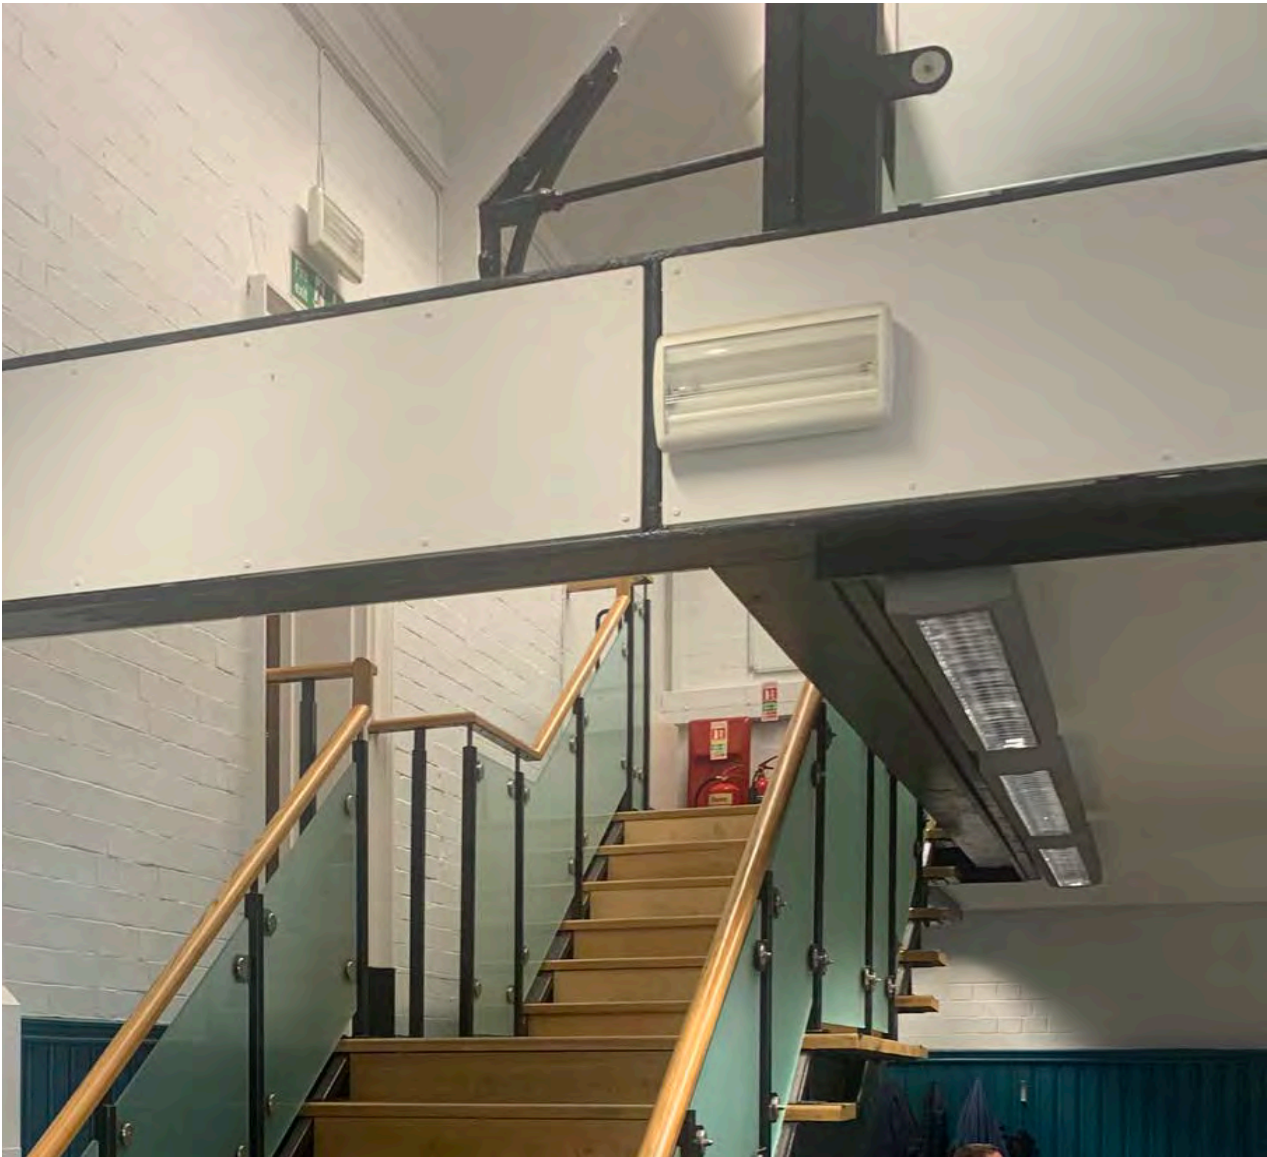
▲ Cladding Added to Mezzanine Floor Fascia in 1990s to be removed

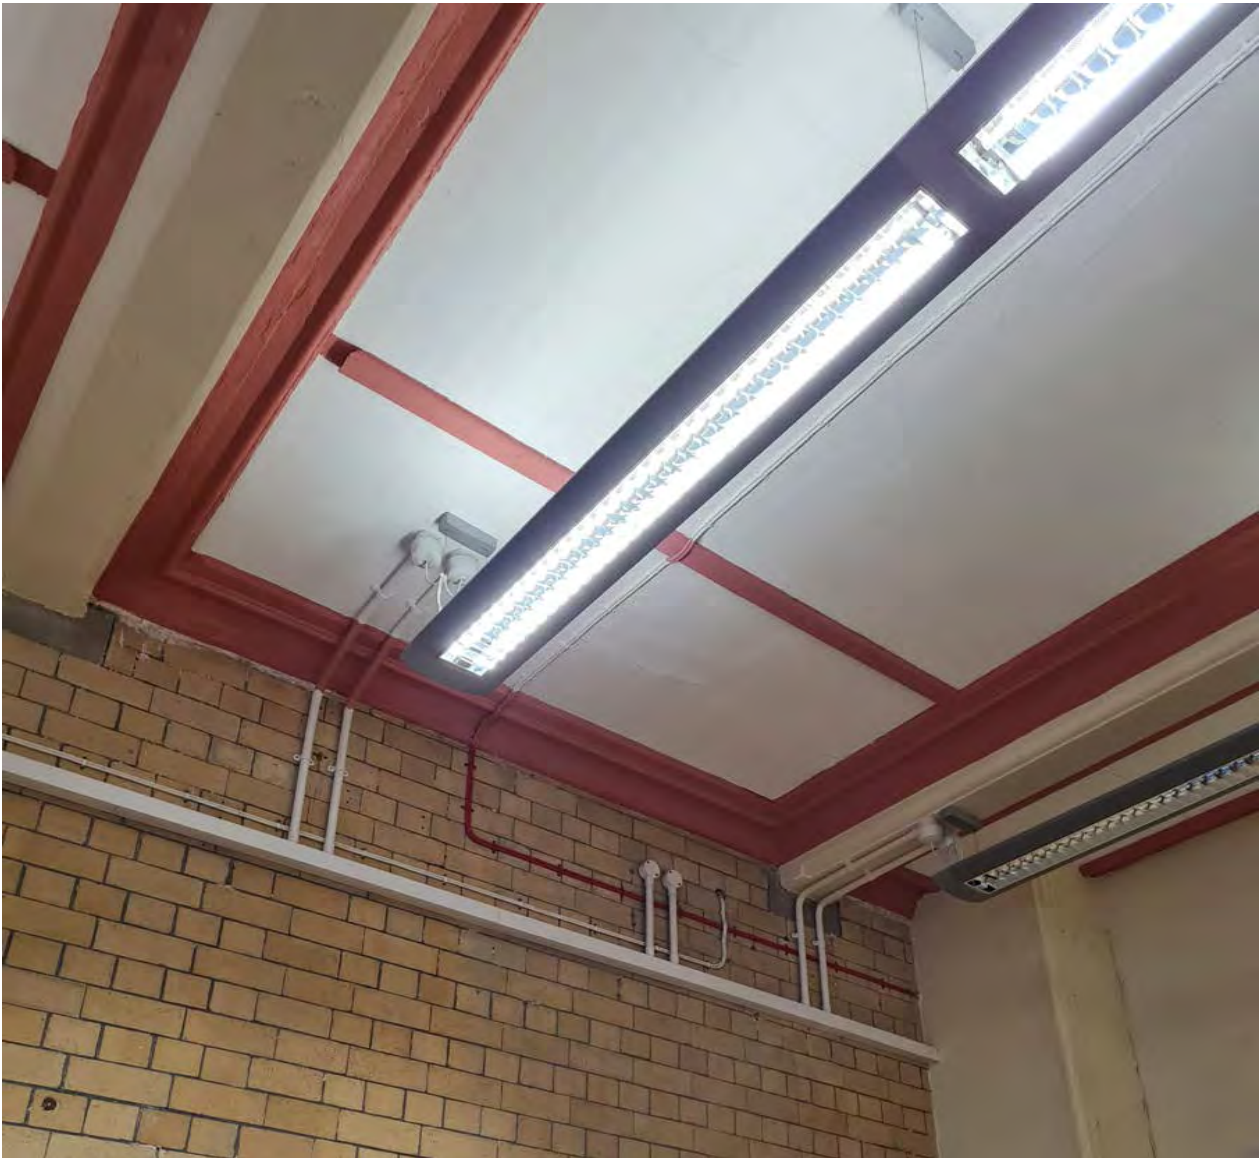
▲ Existing Cornices to be Retained wherever Possible and Reinstated like-for-like, where Removal due to Remediation is Required

The ambitions for the redevelopment project are to retain, repair and preserve all lime plaster ceilings and cornices. All efforts will be made to achieve this objective.

Where there is a need to repair, patch of stabilise lime plaster ceilings and/or decorative plaster cornices, traditional wet craft techniques will be used exclusively/ sample repairs will be carried out for approval before executing any restoration of ceilings and cornices. Lime plaster will be used for any repairs.

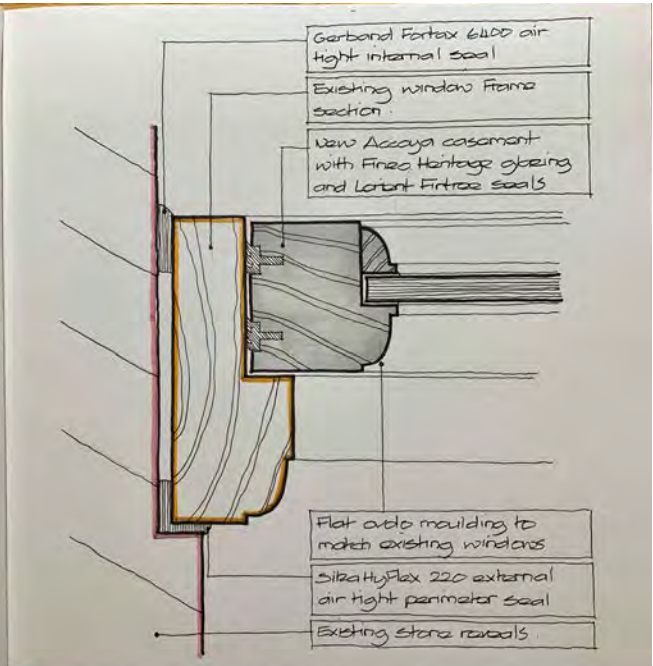
▲ Proposed Window Jamb Detail

It is recommended that the original single glazing should be replaced either with a high performance vacuum evacuated heritage glass system or slim profile conservation double glazed units. Discussions with the conservation officer have highlighted concerns about the

introduction of double glazing. Therefore, Arcadis recommend Option 3 [refer to attached table for more detailed technical information] -introduction of Fineo Heritage vacuum evacuated glass panels. This system provides very high levels of thermal performance and is used within the listed building and conservation arena to give contemporary standards of insulation whilst minimising the visual impact of the upgrade process. It is important to highlight that MCC have not formally accepted the Fineo vacuum evacuated glass and samples will need to be submitted for approval when the formal listed building application is lodged with the council.

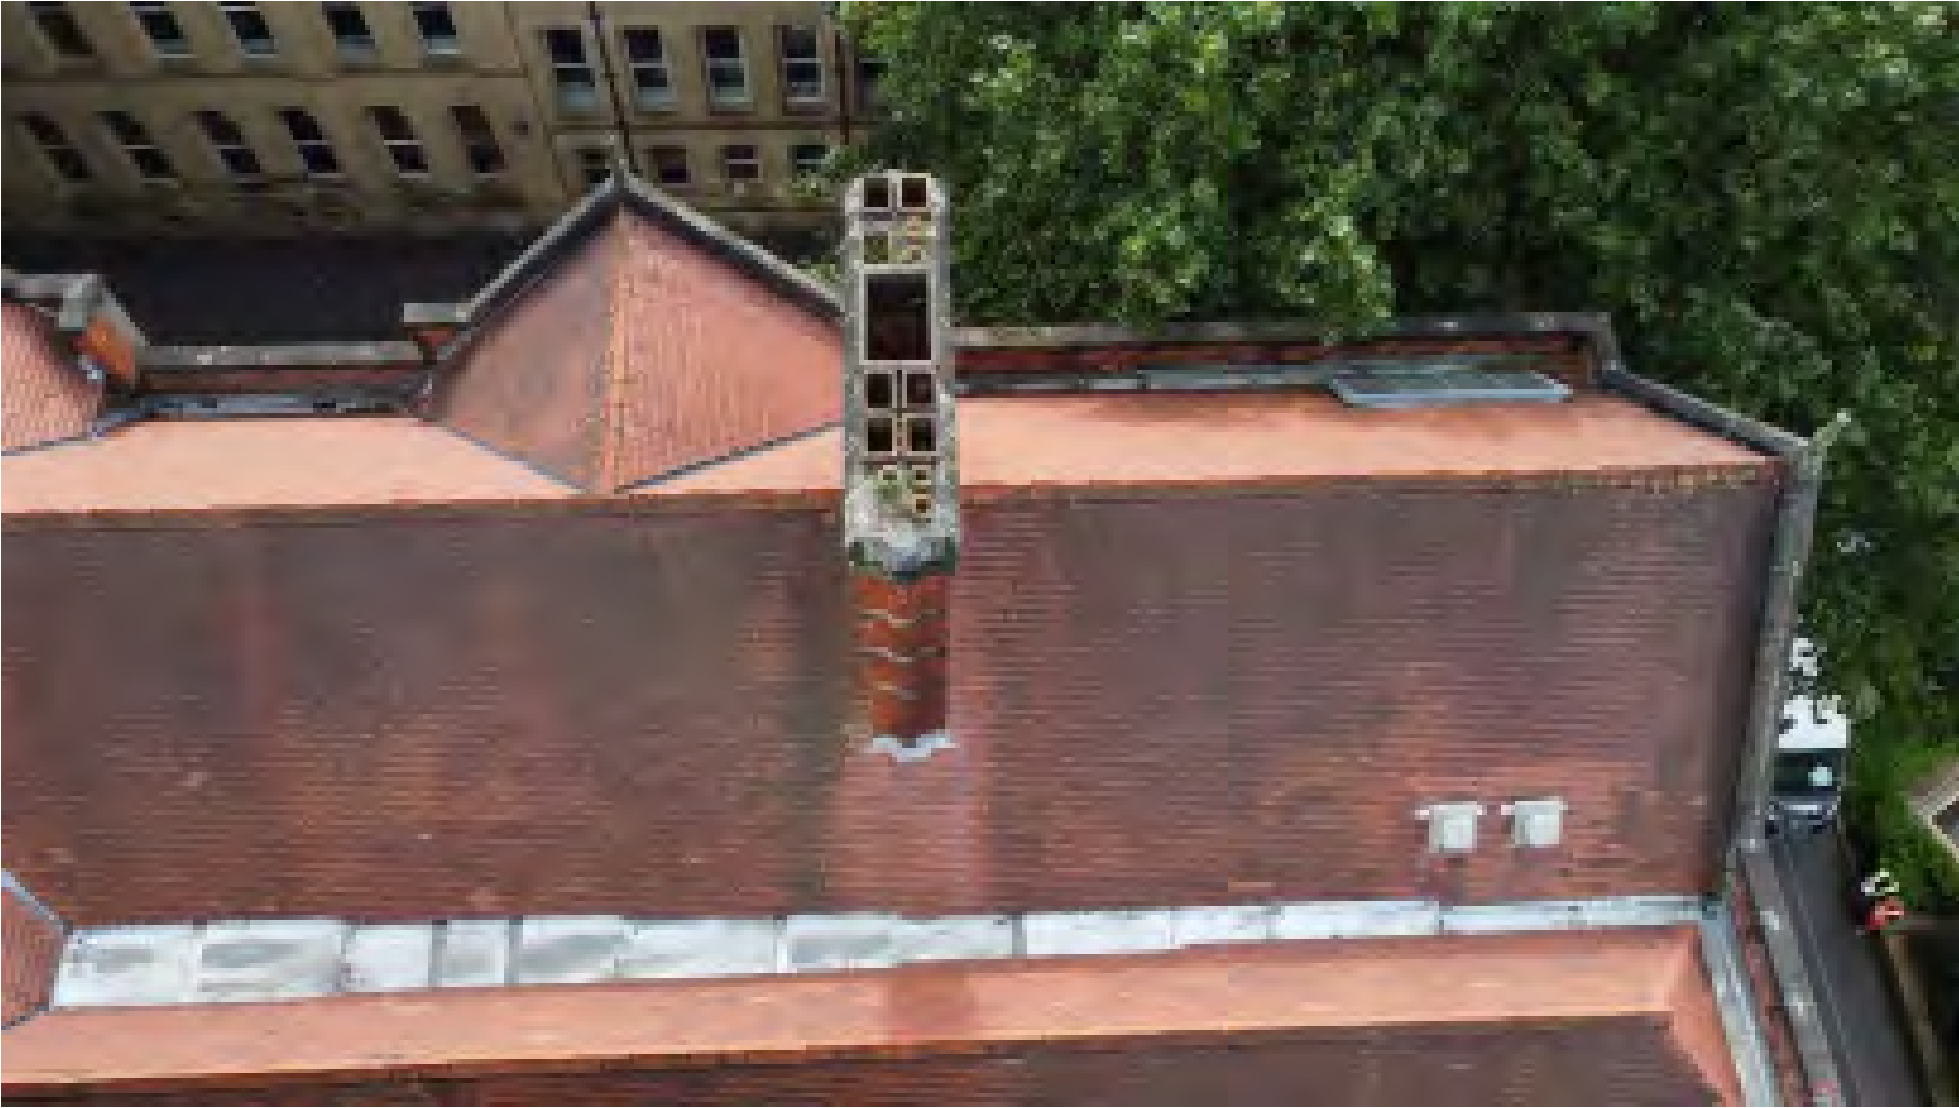
▲ Existing Lead Gutter over Corridor

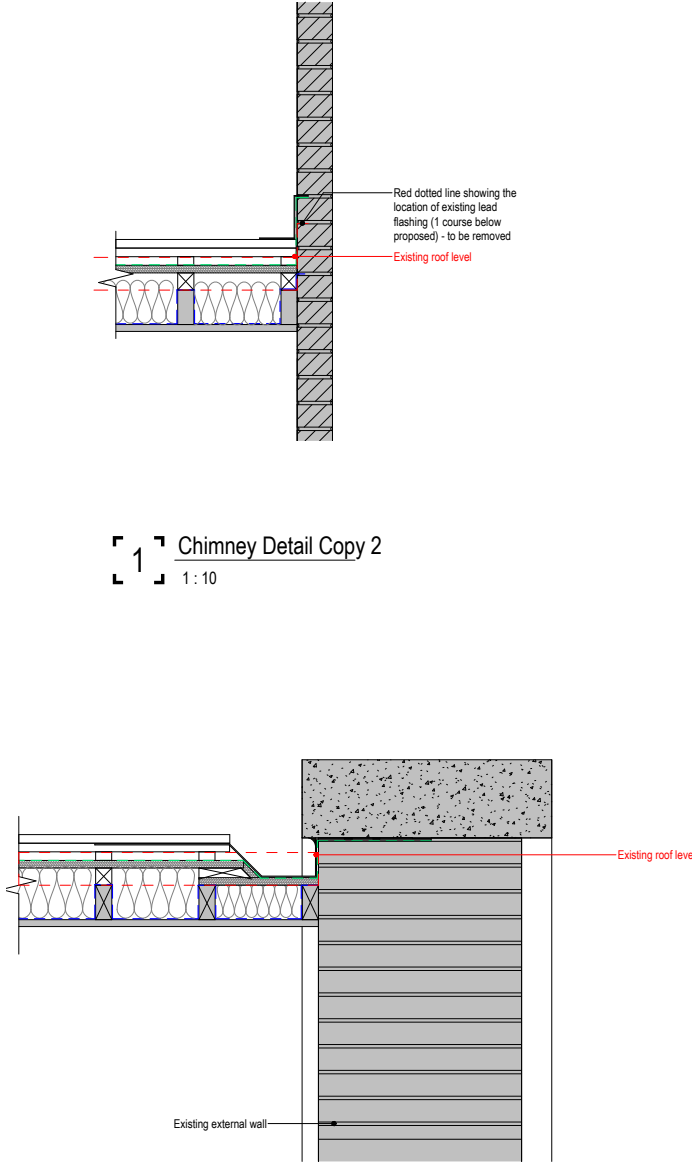
RUTHERFORD BUILDING  
Existing roof parapet eaves

Note :  
Existing construction to be confirmed  
All existing dimensions to be confirmed

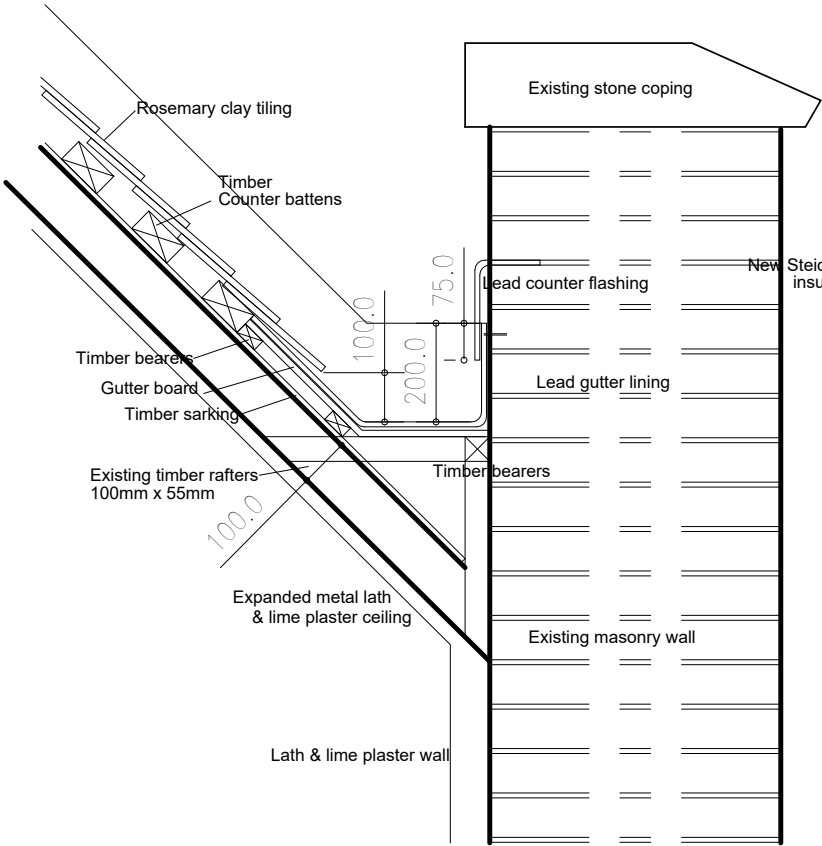
RUTHERFORD BUILDING  
Proposed roof parapet eaves  
OPTION 5

Note :  
Roof ventilation to BS 5250:2021  
Roof insulation U value = 0.26 W/m2K  
All dimensions to be confirmed

Taking account of the requirement to provide good levels of insulation, excellent vapour control and robust airtightness, Arcadis recommend Option 5 as a sensible and progressive approach. With a modelled U value of 0.26 w/m2k, this proposal would require modest changes to the external profile and detailing of the roof and is likely to be considered as a reasonable and proportionate upgrade to the Rutherford Building. Changes to the roof detailing would not detract from the profile of the building within its context and would allow verge, eaves and roof penetration details to be preserved, an important consideration.

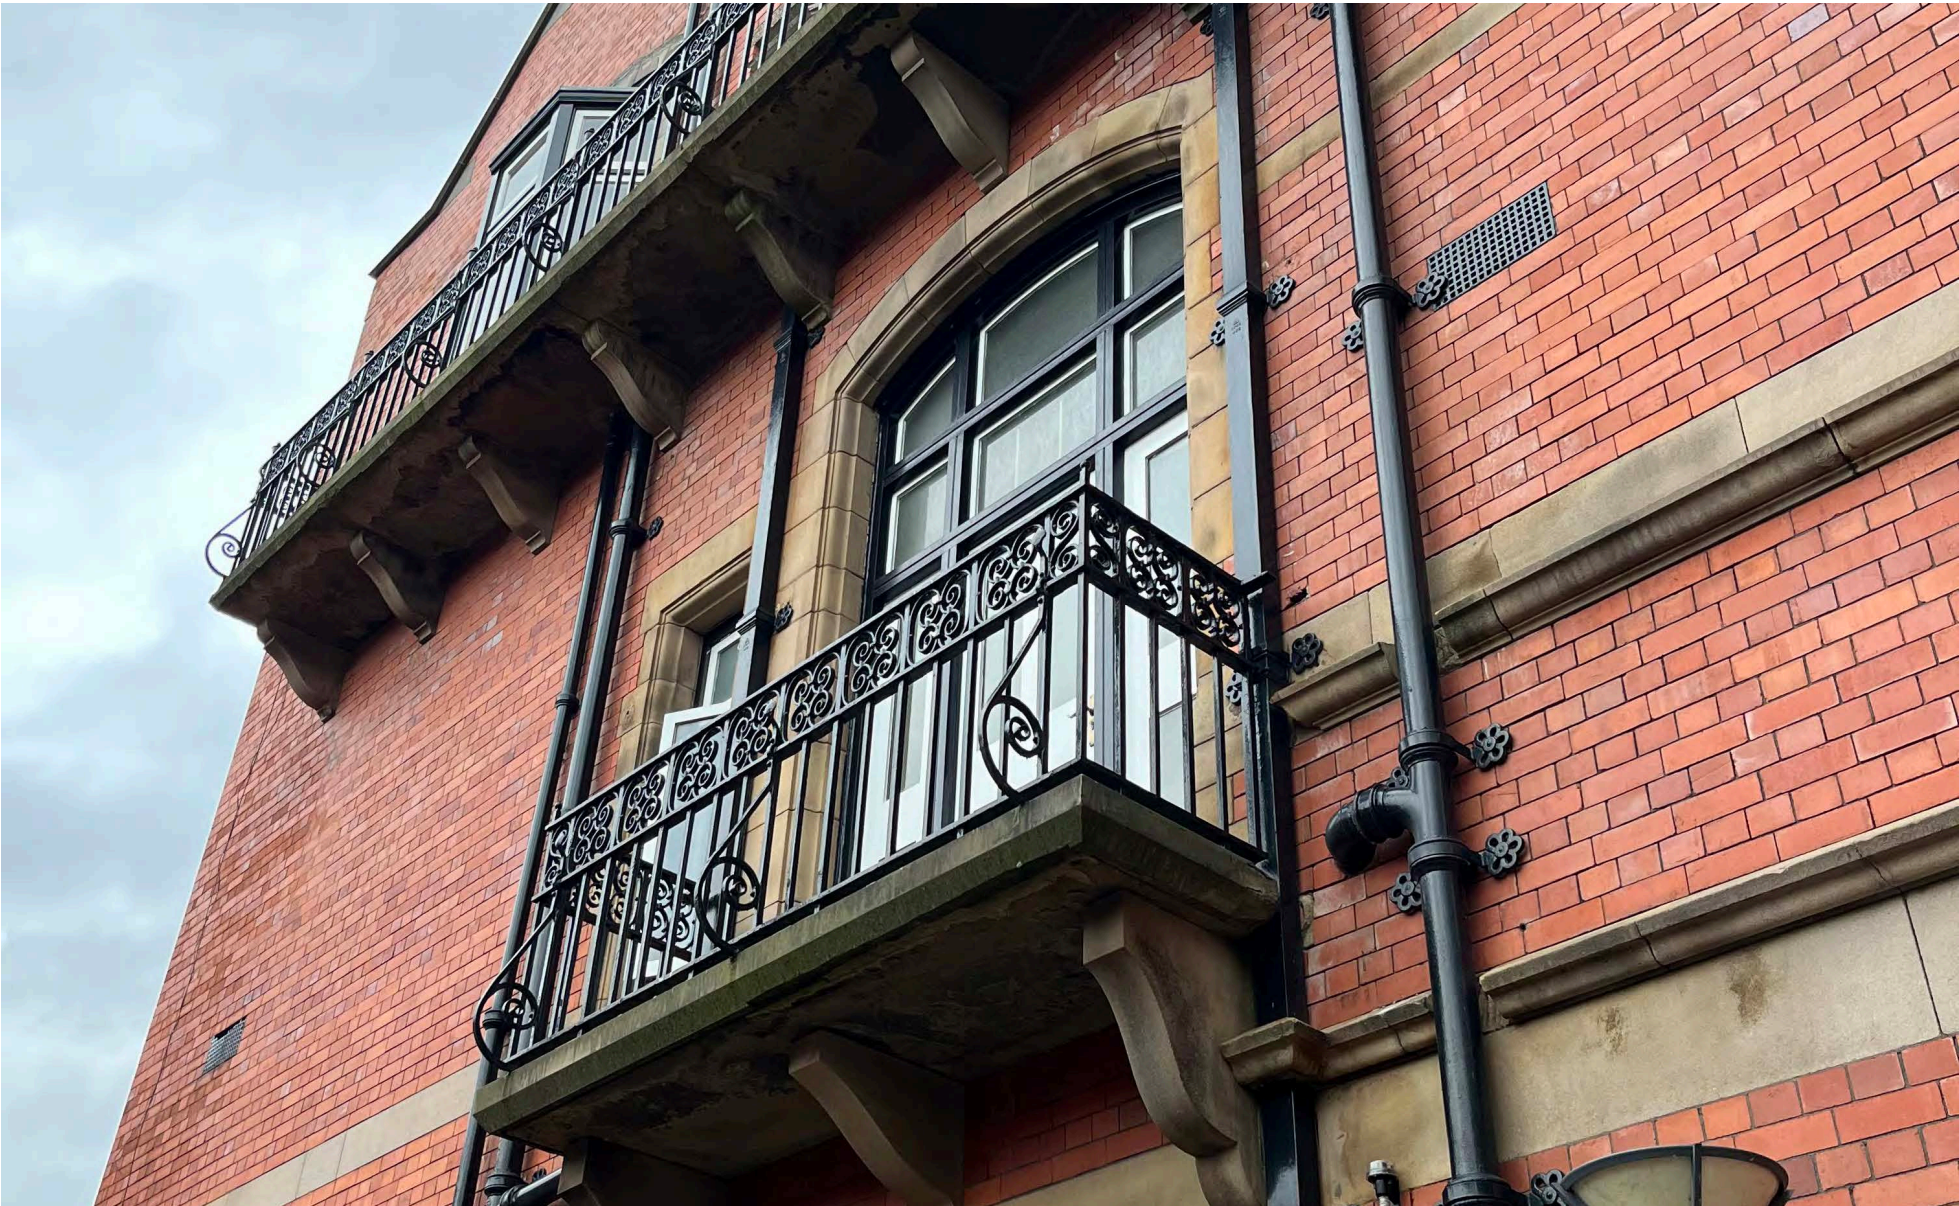
▲ External Balcony

Urgent repairs are required to the projecting stone balconies to the west elevation of the Rutherford Building. At present, there is evidence of water ingress along the west elevation, potentially linked to the construction of the cantilevered balconies. Works to these areas will include repointing of horizontal and vertical bed joints with lime mortar, repairs to cover flashings where required, cleaning of horizontal stone surfaces and comprehensive repainting of the decorative wrought iron balustrades.

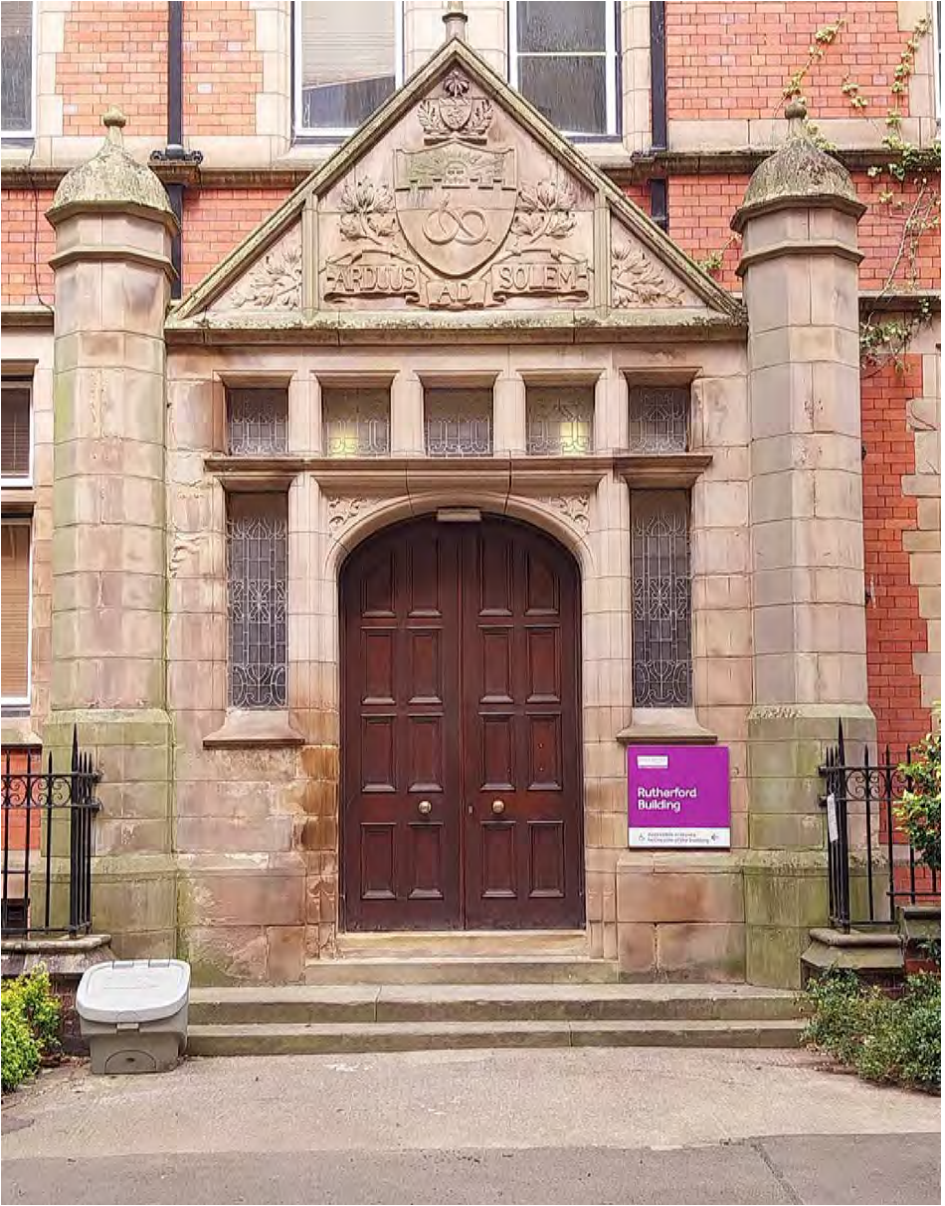
▲ Stonework + Leadwork Repairs to Main Entrance on Coupland Street

Water ingress above the former main entrance originates from the narrow lead roof and has caused significant damage to the decorative ashlar masonry below. Robust repairs to the lead roof are planned using traditional materials and craft techniques. Repairs to the stonework will be quantified and categorised in collaboration with accredited stone masonry specialists. A detailed method statement will be provided highlighting proposed repair methods, materials and techniques. This schedule will be agreed with Manchester City Council before repair samples are prepared for approval. All repairs will use traditional craft techniques to provide sensitive restoration of the main entrance façade.

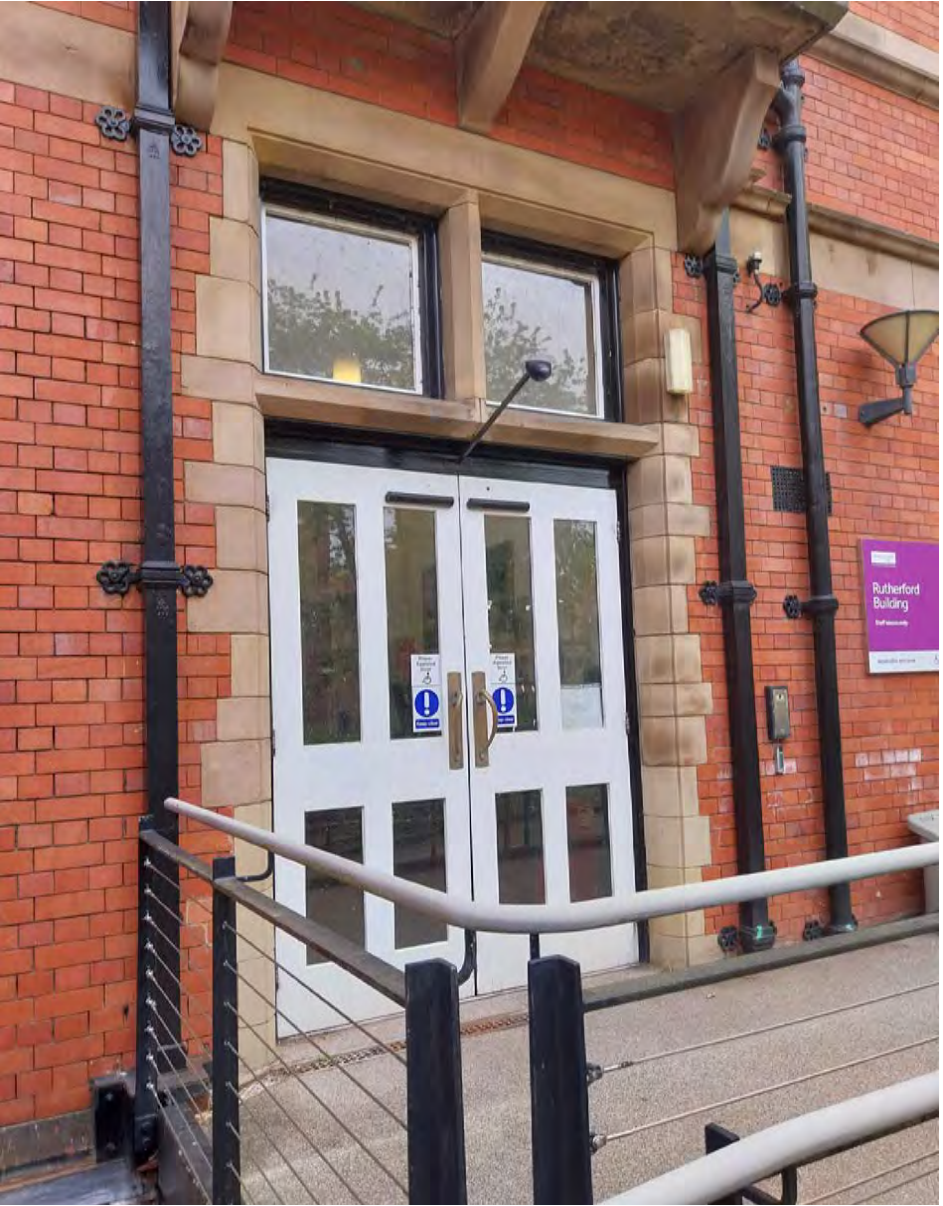
▲ Replacement of Entrance Doors to West Elevation

The existing entrance doors to the west elevation are of painted timber construction. Installed in the late 1990s, the doors are of modern manufacture and do not have the stature of main entrance doors to an important university building.

It is proposed to replace the current doors with bespoke European oak doors, designed to match the main entrance arrangement on Coupland Street. The new doors will include an oak frame with glazed fanlight, traditional raised and fielded panels, and mortise and tenon construction. Doors will be clear finished. Samples of timber, construction and finishes will be submitted for approval prior to construction.

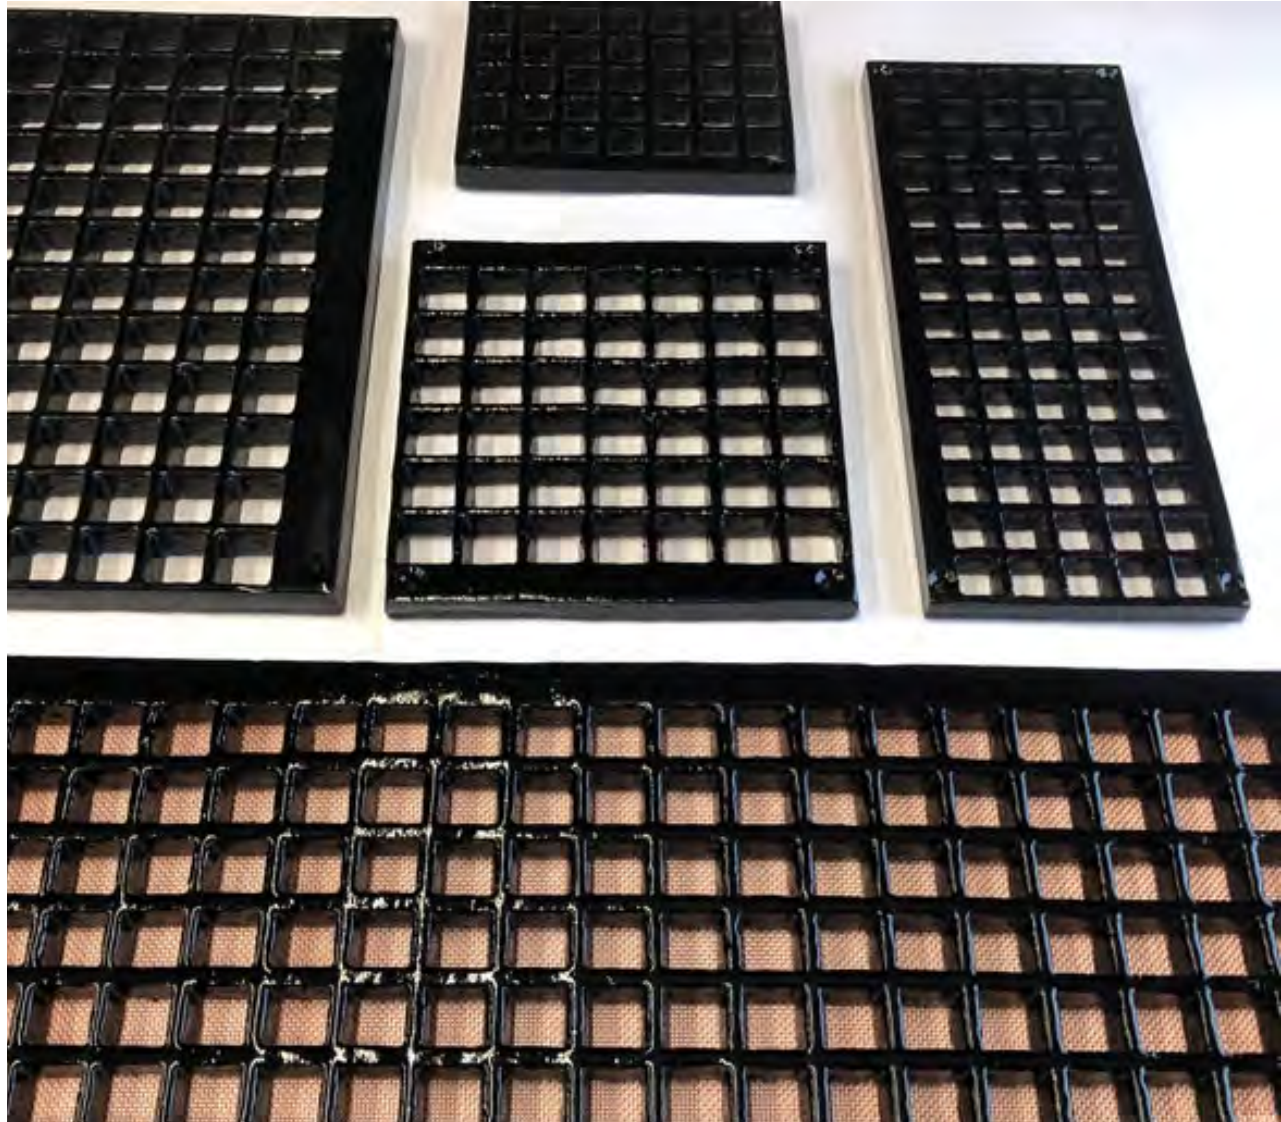
▲ Example of Grills

Replica cast iron grilles are proposed to develop the existing vernacular language of the Rutherford Building and provide additional apertures through the façade for ventilation purposes. Grilles have been carefully positioned to maintain the crafted composition of the external elevations. Please refer to the detailed drawings or further information about the proposed arrangement. A sample of the grille will be submitted for approval prior to construction.
