**RUTHERFORD BUILDING REFURBISHMENT**

# Design & Access Statement

**Submitted by** Arcadis  
December 2023

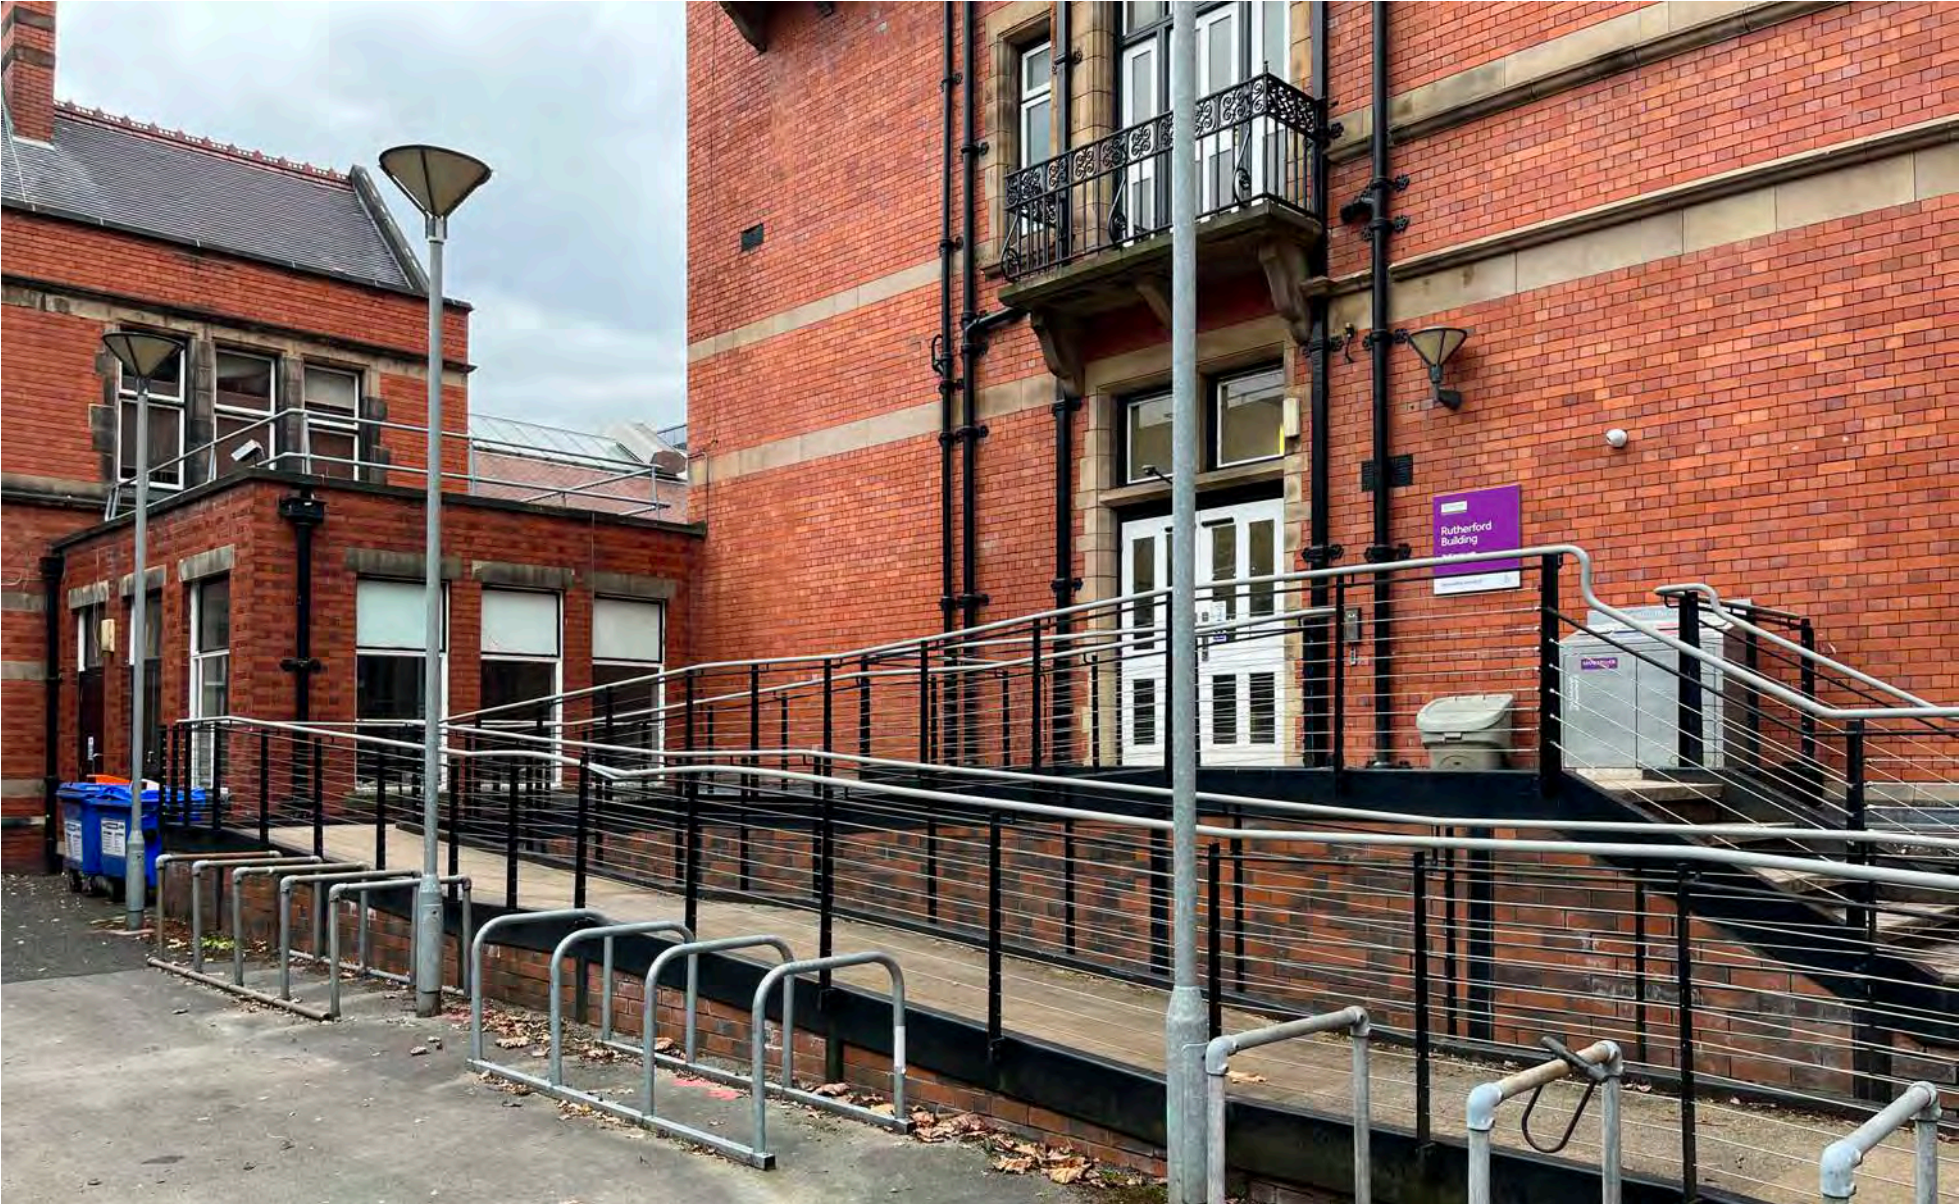
▲ Remodelling and Upgrade of 1990's Access Ramp and Stairs to the West Elevation

It is proposed to redevelop the ramp to provide a more sensitive aesthetic and to develop a complimentary language following the construction of the new access ramp to the neighbouring University Museum. The metal balustrade to the ramp will be replaced with a welded and painted steel fabrication, referencing the patterns of the historic wrought iron balustrades along Coupland Street. Exposed structural steel sections will be repainted, changing the colour from black to a natural earth

tone to compliment the stonework detailing of the Rutherford Building. Brickwork infill panels will be replaced with traditional ashlar masonry, reinforcing the architectural language. samples of stone and jointing techniques will be submitted for approval prior to construction.

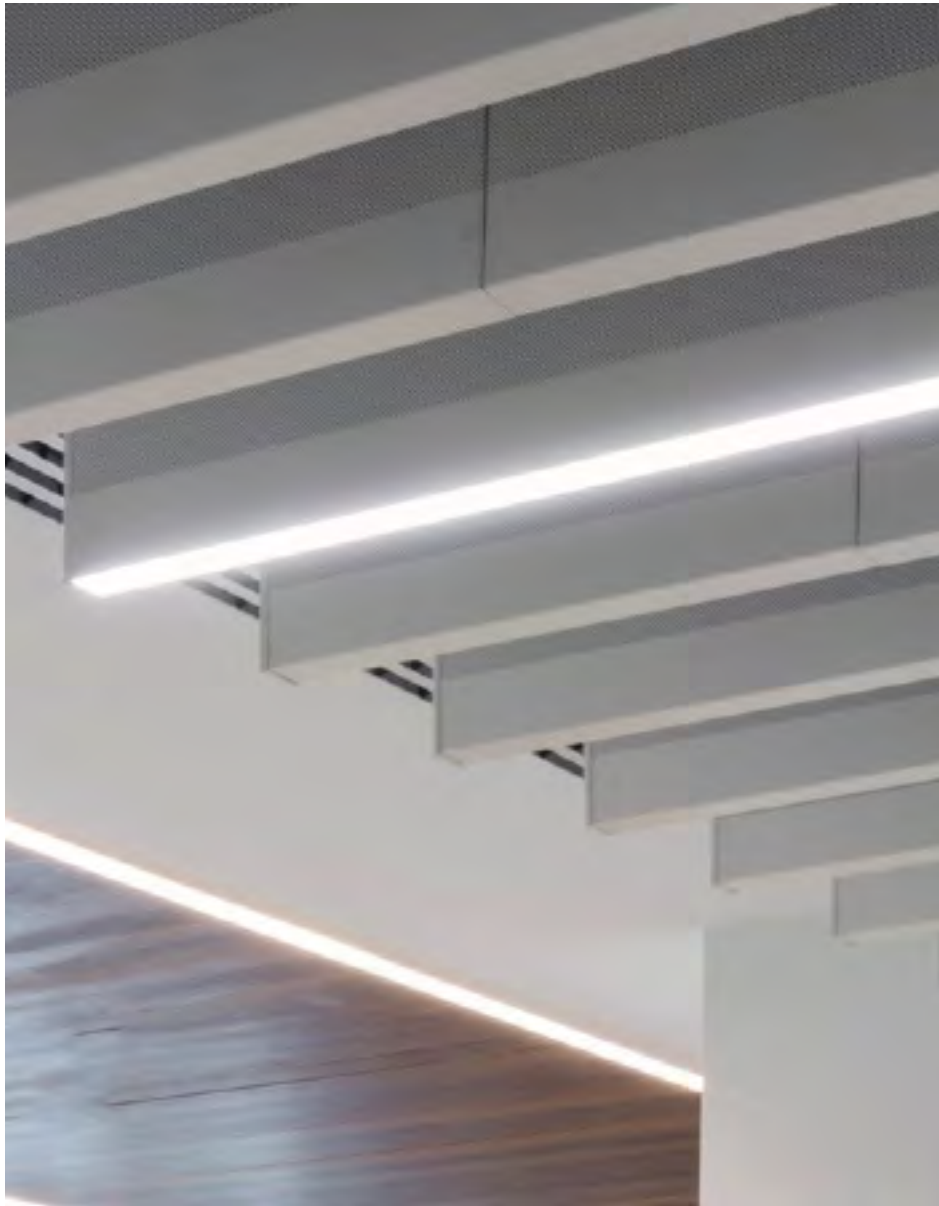
▲ Integrated Lighting with Linear Acoustic Baffles

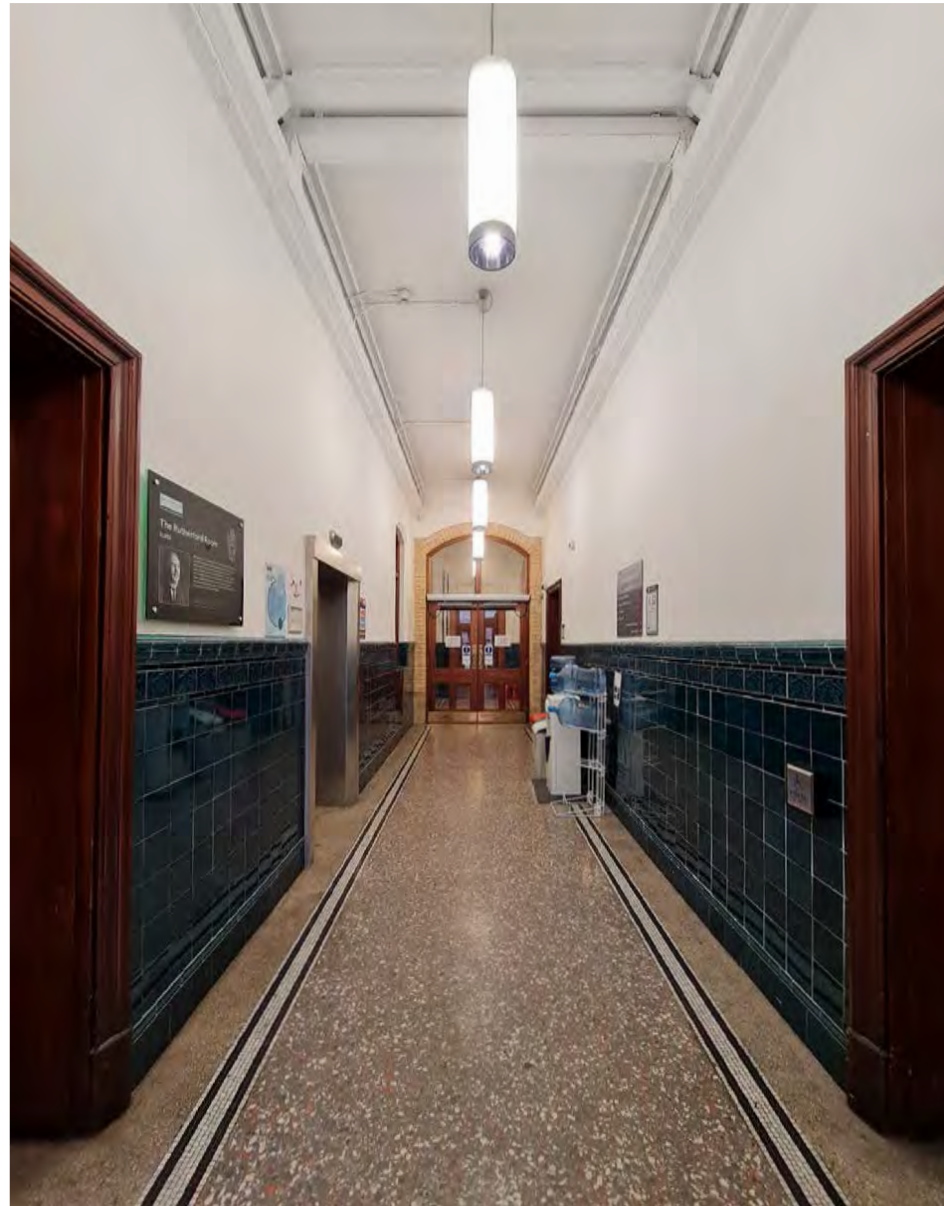
▲ High Level Trunking in Corridor to be Removed to Reveal Historic Ceiling

Primary services distribution of most systems will make use of new accessible floor trunking. This approach will allow conduit drops to be reintroduced, providing power, data and building management to individual work, research and collaboration spaces. There will be minimal requirements for horizontal dado trunking. In addition, to this benefit, the introduction of floor trunking will remove the requirement for surface mounted electrical containment within circulation zones. This will allow building occupants to appreciate the historic ceilings and decorative cornices
