Land off Crabtree Lane,  
Manchester

# REMEDIATION STRATEGY & ENABLING WORKS

**Keepmoat  
Homes**

Project no: BSH2258

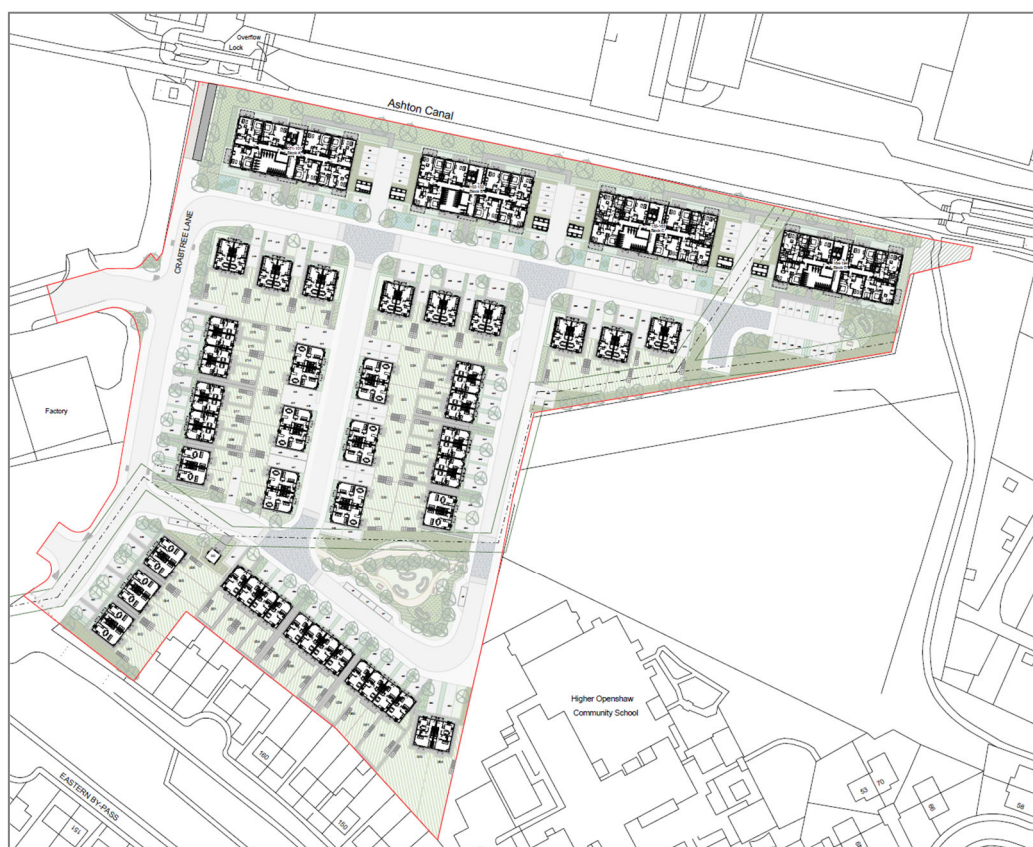
It is understood that the client is intending to develop the site with 195 No. low-rise residential properties with private gardens and associated infrastructure and parking as illustrated below. The site layout, Proposed Site Plan is presented as Drawing No. 02292\_JTP\_MP\_00\_DR\_A\_1100 Rev P02 within Appendix A.

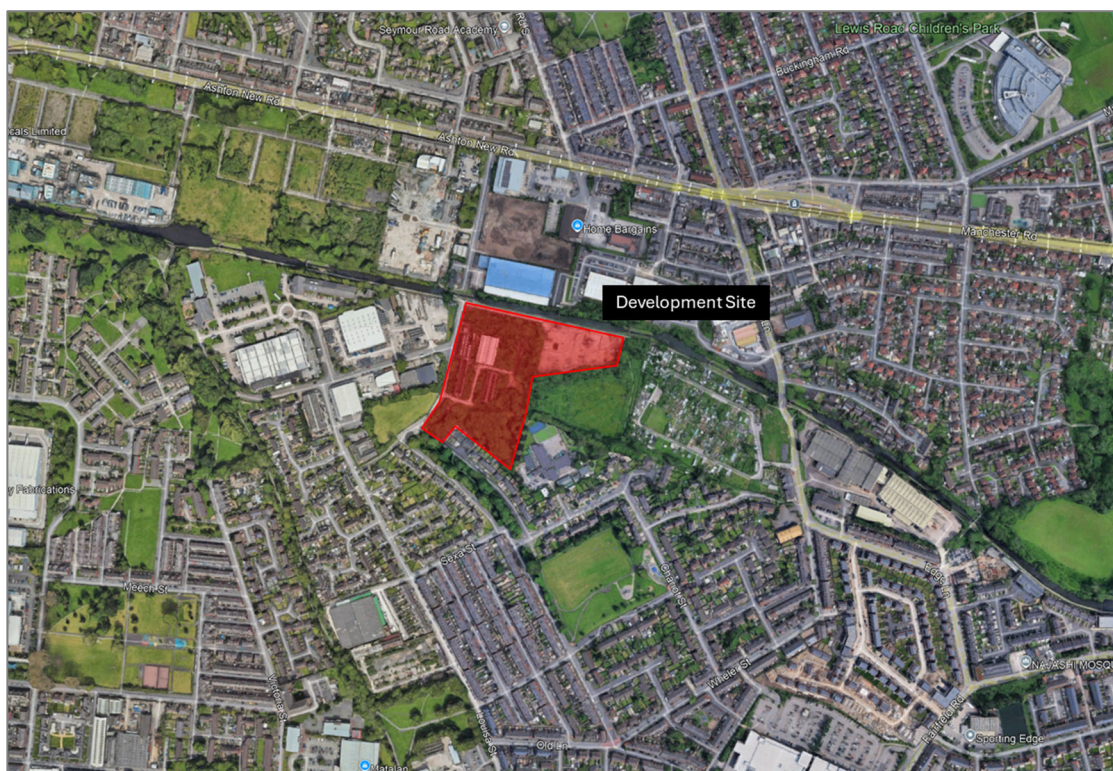
The site is generally flat at approximately 92.0m Above Ordnance Datum (AOD). The plan below shows the context of the site and adjacent land uses.

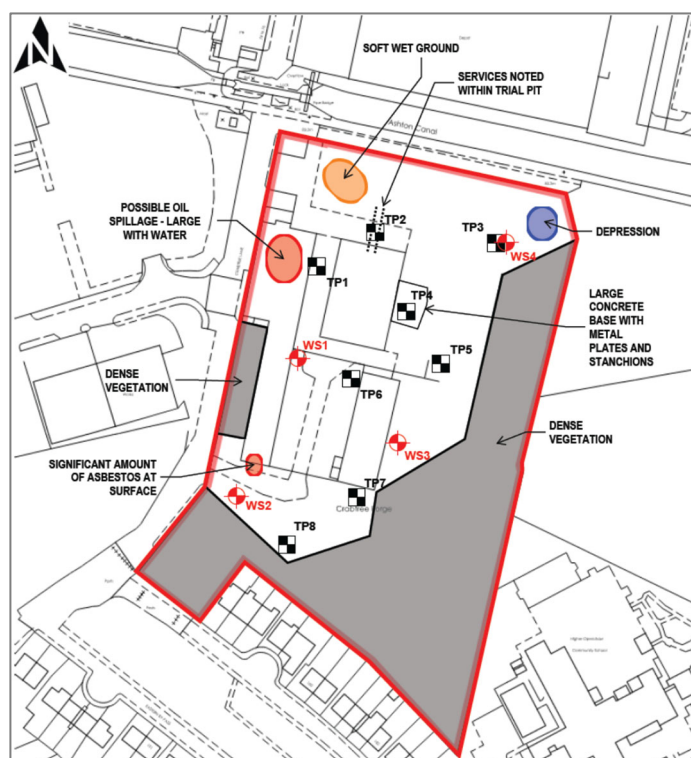
As shown on the sketch below, some areas were not accessible due to dense vegetation. This area has now been cleared by BSH Remediation.

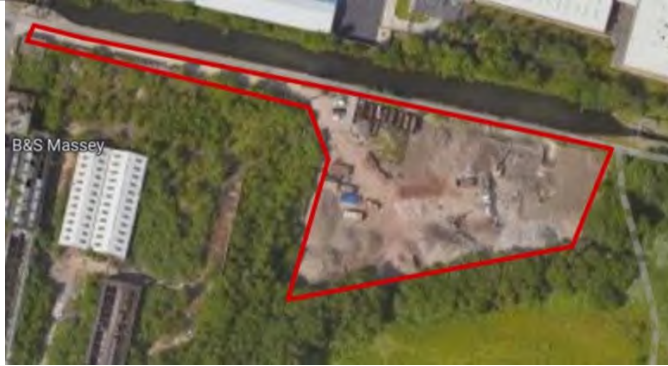
| FEATURE | DESCRIPTION | PHOTOGRAPHIC EVIDENCE |
|---|---|---|
| <b>Occupancy/Use</b> | <p>The subject site is an irregular-shaped parcel of land located east of Crabtree Lane and currently occupied by a service yard.</p> <p>The site is currently being cleared with stockpiled material being screened and crushed.</p> | |

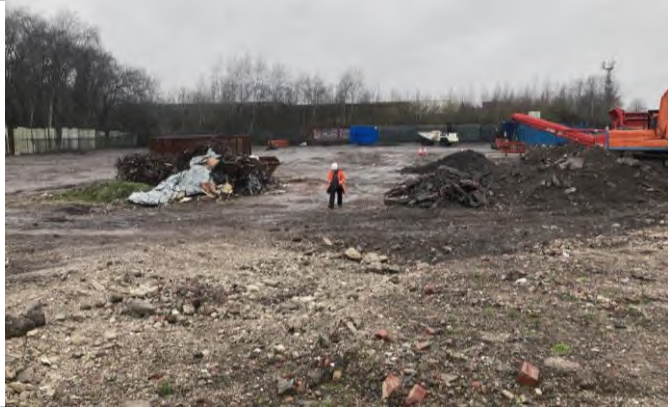
| FEATURE | DESCRIPTION | PHOTOGRAPHIC EVIDENCE |
|---|---|---|
| <b>Structures</b> | <p>There are no permanent structures on site though brick walls form the northern perimeter of the site.</p> | |

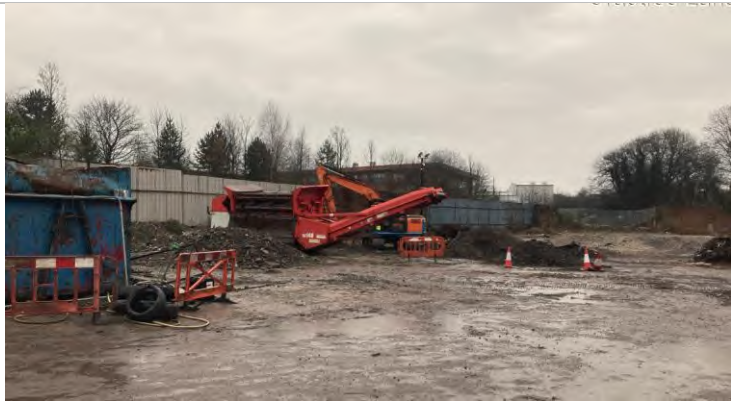
| FEATURE | DESCRIPTION | PHOTOGRAPHIC EVIDENCE |
|---|---|---|
| <b>Slope</b> | The site is topographically level though a small area of raised slab is present in the northeast of the site. There are mounds of materials on the site which are currently being processed for removal. | |

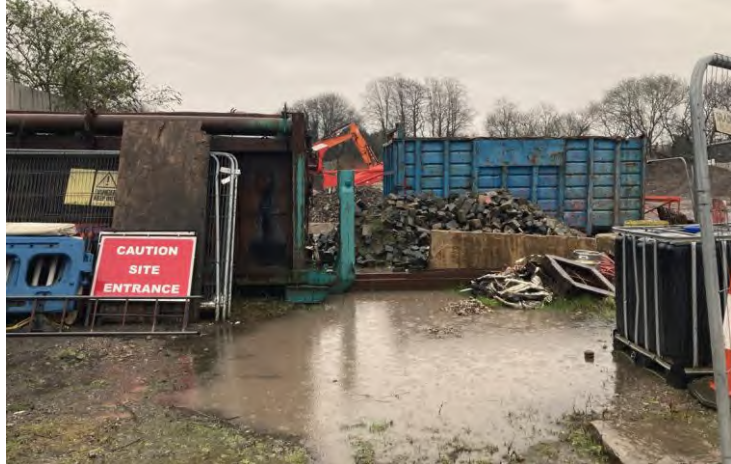
| FEATURE | DESCRIPTION | PHOTOGRAPHIC EVIDENCE |
|---|---|---|
| <b>Hazardous Material Storage</b> | No above-ground storage tanks (ASTs) or underground storage tanks (USTs) were observed during the preliminary desk-based walkover.<br><br>Temporary diesel storage and skips containing waste materials are currently present associated with the site clearance works. | |

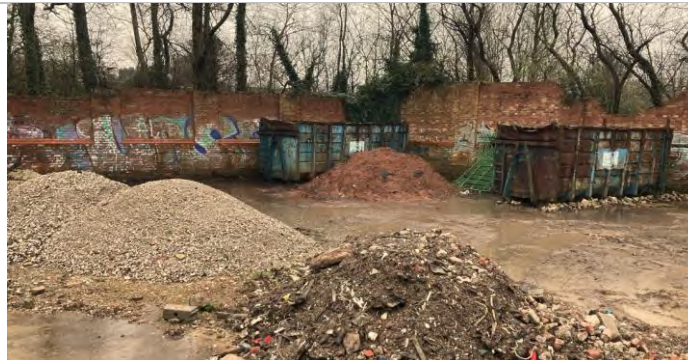
| FEATURE | DESCRIPTION | PHOTOGRAPHIC EVIDENCE |
|---|---|---|
| <b>Waste Storage</b> | There are currently skips stored on the site that relate to the site clearance operations being completed. | |

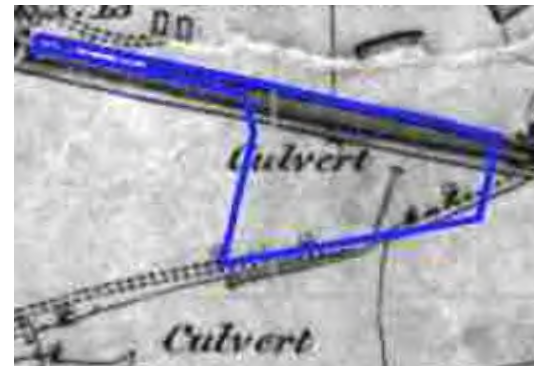
| Table 5 Historical Development | | |
|---|---|---|
| 1848<br>1:10,560 | The site is recorded as undeveloped land. However, there is a culvert present. | |

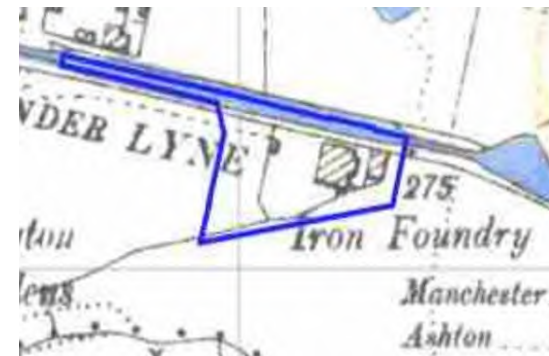
| Table 5 Historical Development | | |
|---|---|---|
| 1890-1892<br>1:10,560 | An Iron Foundry is recorded on the site comprising two buildings in the west. | |

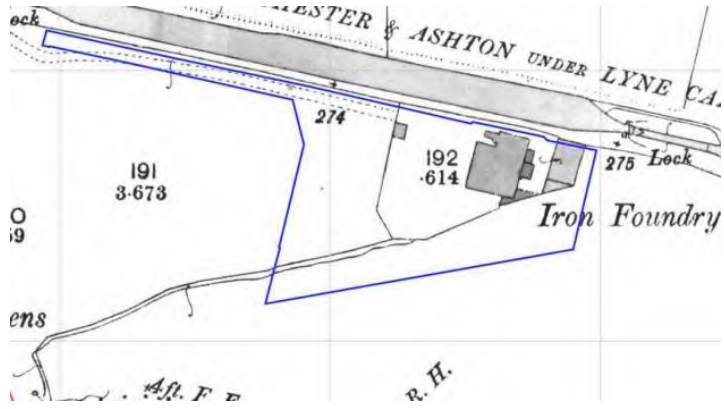
| MAP EDITION | HISTORICAL LAND USE | HISTORICAL MAP EXCERPT |
|---|---|---|
| <p>1893<br/>1:2,500</p> | <p>The earliest large-scale mapping provides a greater detailed insight into the Iron Foundry. The map also suggests that an open watercourse may have been present in the southwest though the culvert is no longer marked.</p> | |

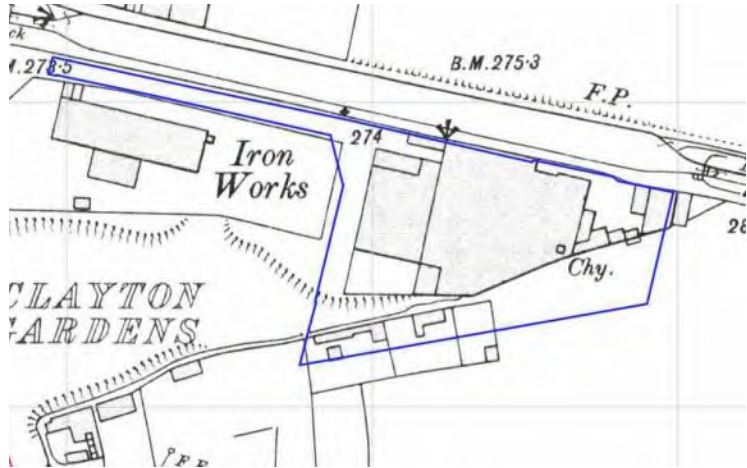
| MAP EDITION | HISTORICAL LAND USE | HISTORICAL MAP EXCERPT |
|---|---|---|
| <p>1908<br/>1:2,500</p> | <p>The iron works have expanded and there is now a chimney detailed in the central eastern sector of the site. Markings also suggest that the site levels have been raised with a slope marked in the southwest.</p> | |

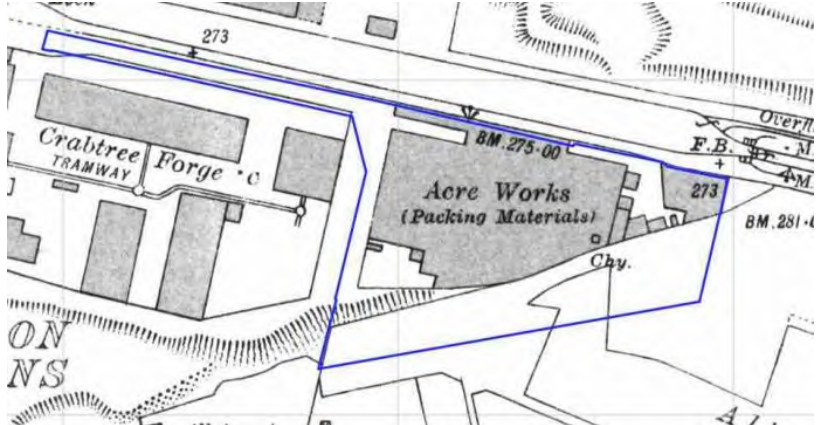
| MAP EDITION | HISTORICAL LAND USE | HISTORICAL MAP EXCERPT |
|---|---|---|
| <p>1932-1933<br/>1:2,500</p> | <p>The site's layout remains the same but is has now been relabelled Acre Works (Packing Materials). The watercourse is no longer recorded with markings suggesting it has been covered or infilled.</p> | |

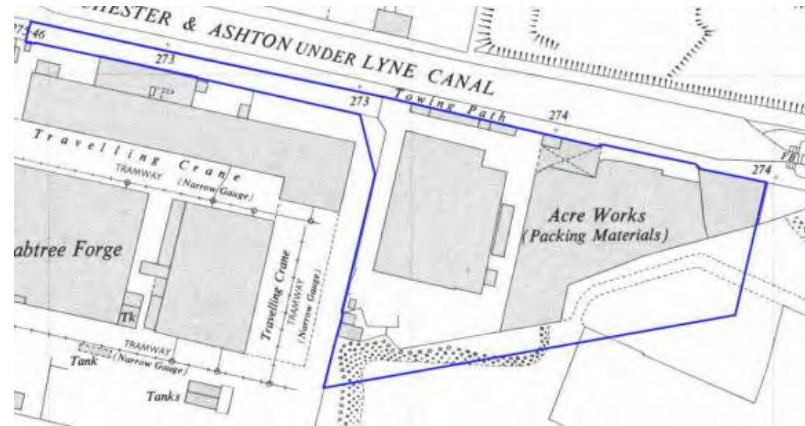
| MAP EDITION | HISTORICAL LAND USE | HISTORICAL MAP EXCERPT |
|---|---|---|
| <p>1949-1950<br/>1:1,250</p> | <p>The site remains the same. However, the more detailed mapping demonstrates that the site has multiple buildings as opposed to one large building which is detailed in the smaller scale mapping.</p> <p>A refuse heap is also present in the south of the site but is considered to be predominantly located to the south.</p> | |

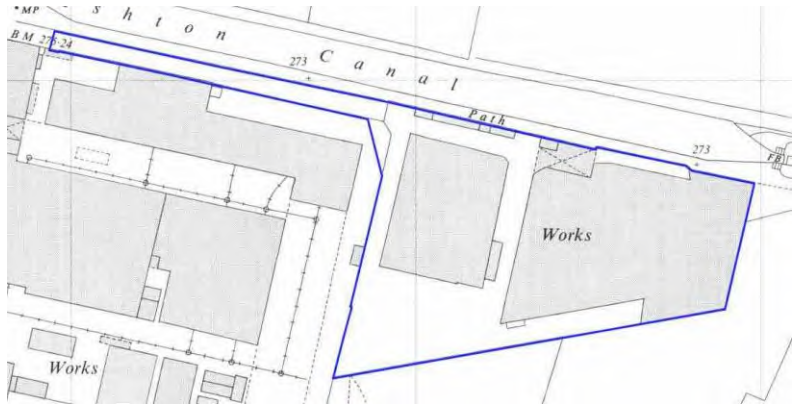
| MAP EDITION | HISTORICAL LAND USE | HISTORICAL MAP EXCERPT |
|---|---|---|
| <p>1964-1968<br/>1:1,250</p> | <p>The site remains unchanged but has been detailed as an unspecified works.</p> <p>There is no longer a refuse heap present in the south of the site.</p> | |

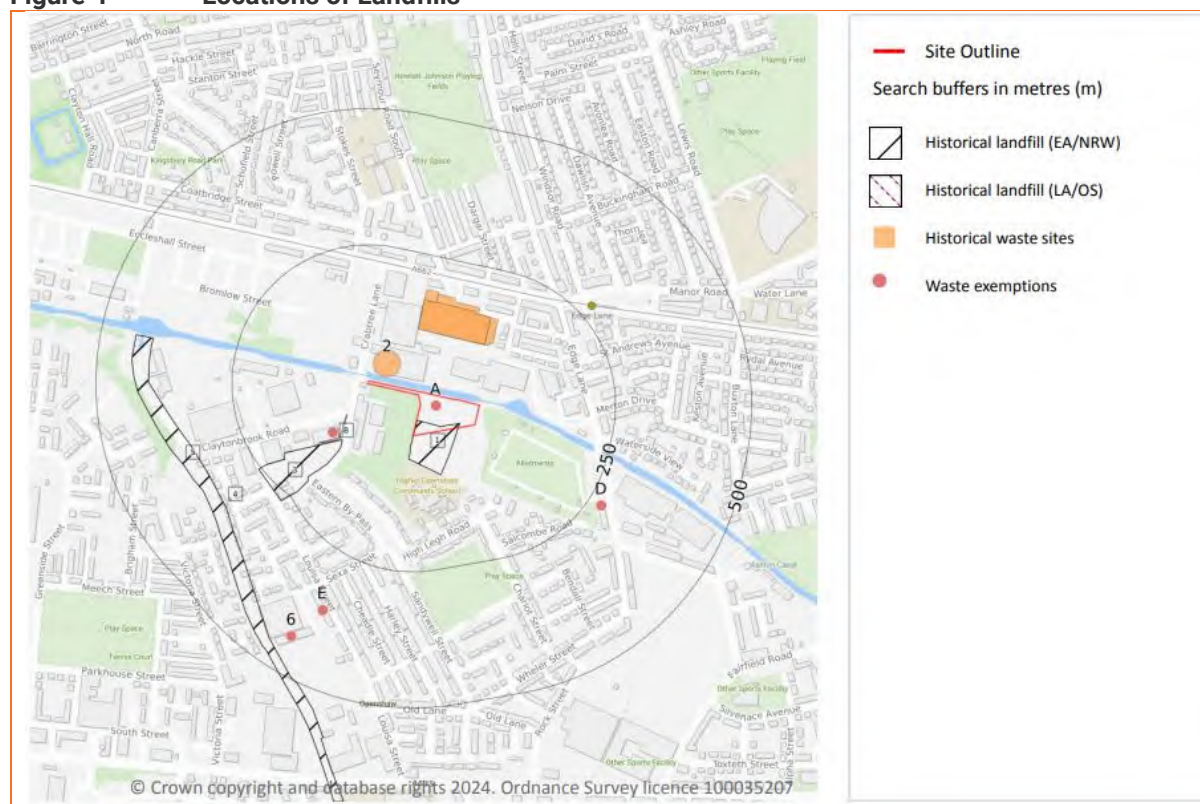
**Figure 4 Locations of Landfills**

A screenshot of the mapping showing landfill locations within 250 m radius of the site is included in Figure 4.

The Crabtree Forge and Clayton Industrial Estate landfill sites are recorded as a historical landfill and pre-date the Control or Pollution Act (COPA) and current environmental permitting requirements.

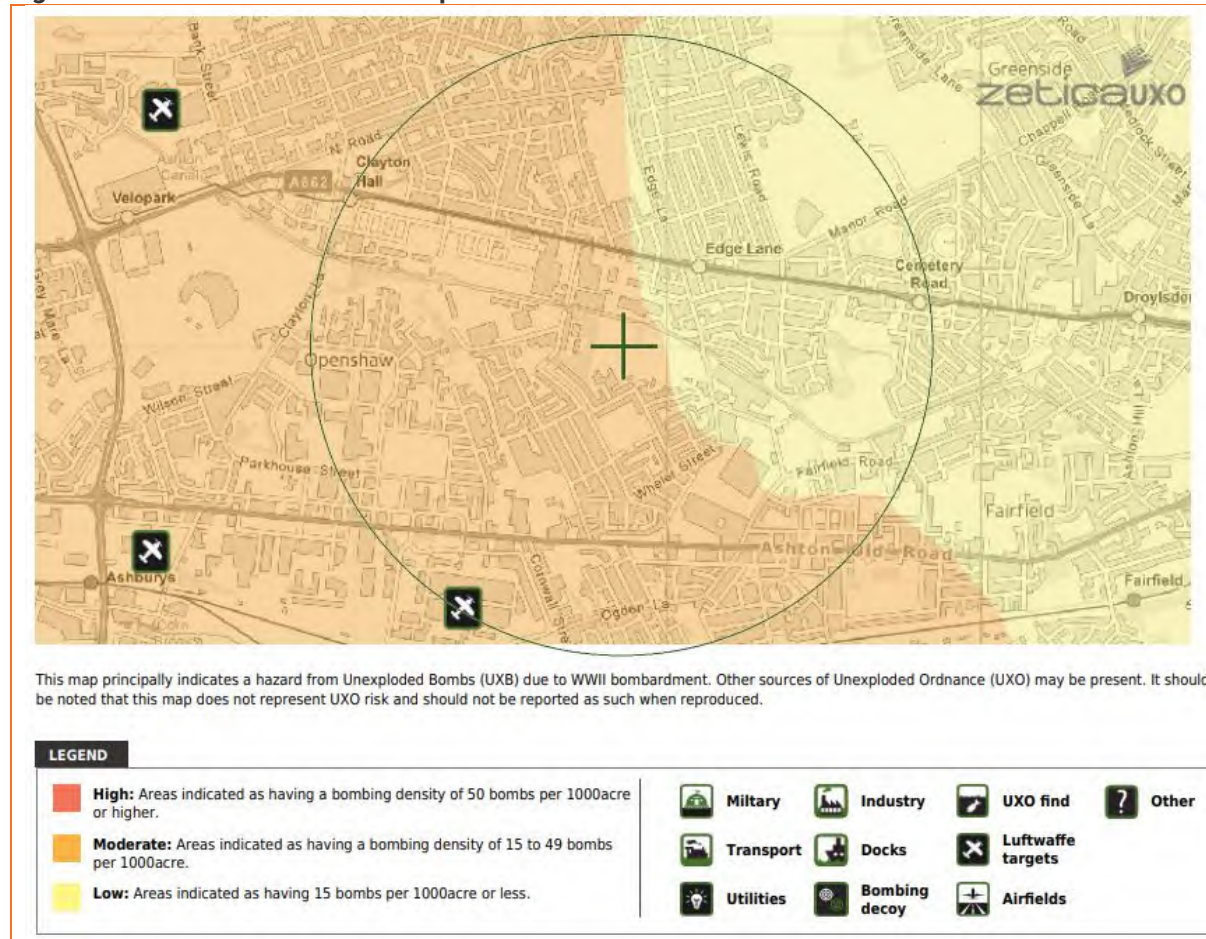
**Figure 5** Zetica UXO Risk Map

The regional unexploded bomb risk map from Zetica (2014) indicates that the Site is in an area at moderate risk from possible unexploded ordnance (UXO) resulting from the Second World War. The Zetica UXO Risk Map is presented in Figure 5.

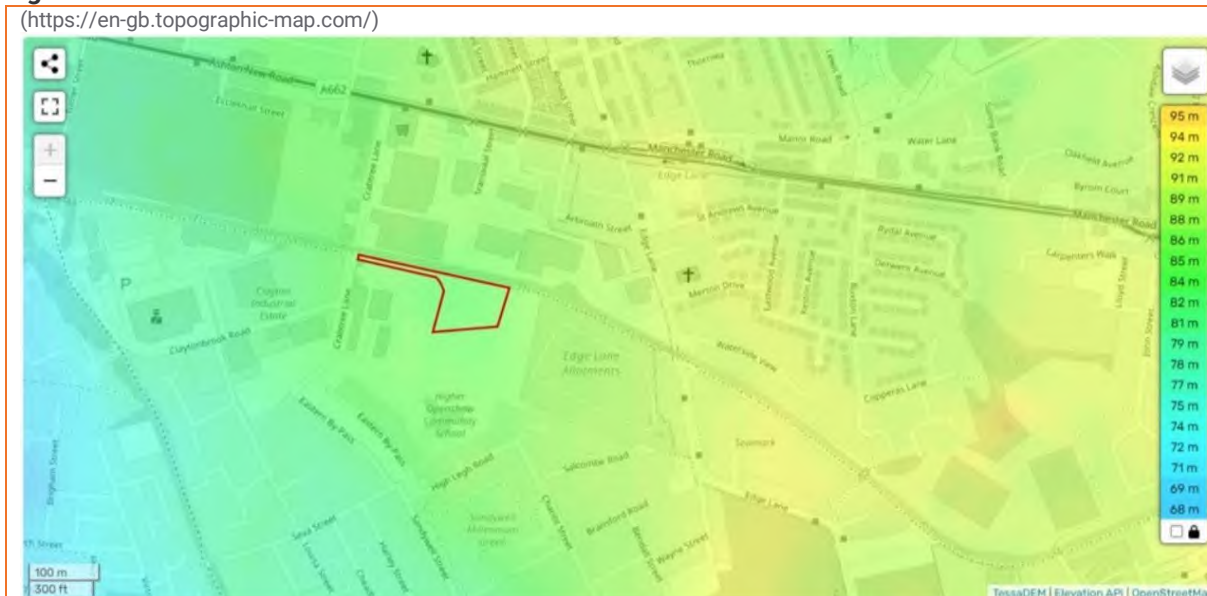
**Figure 6** Surface Lidar Data

The LIDAR imagery shown in Figure 6 shows topography within the local area context.

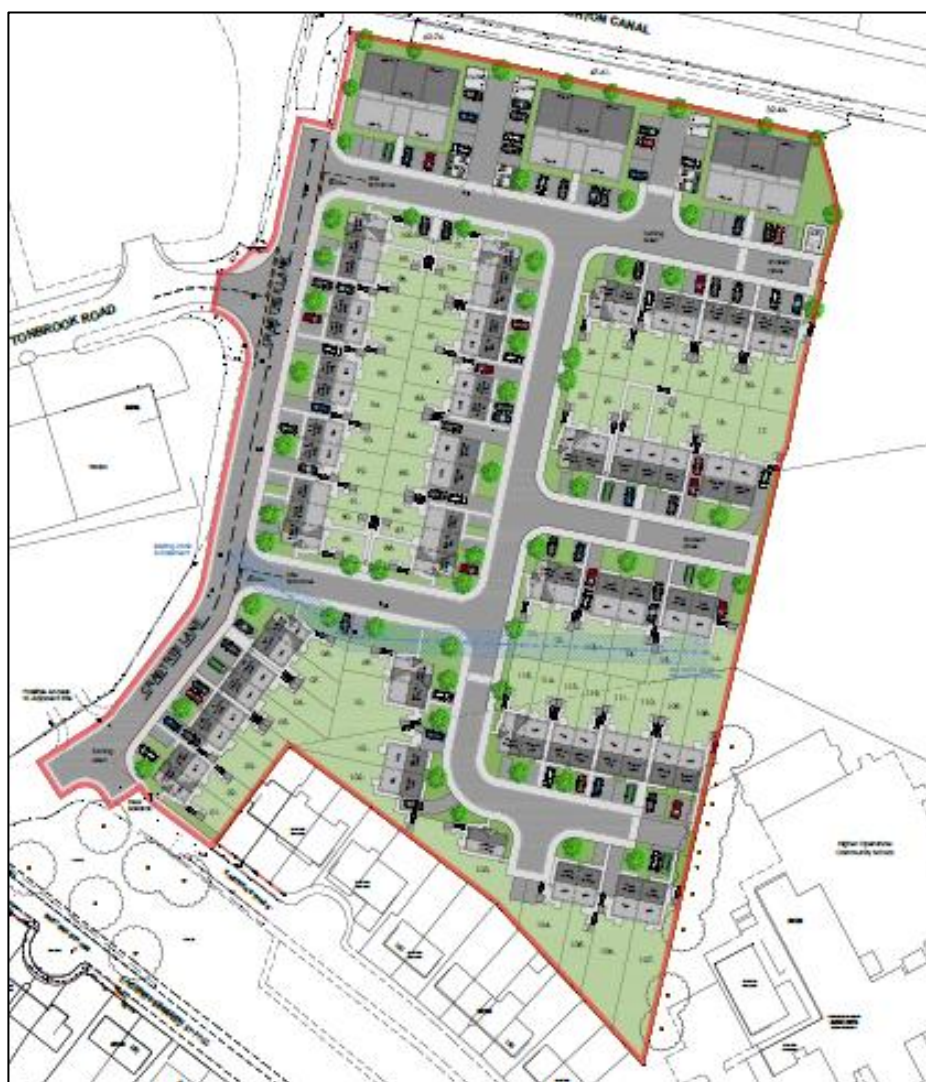
The proposed site layout is shown below;

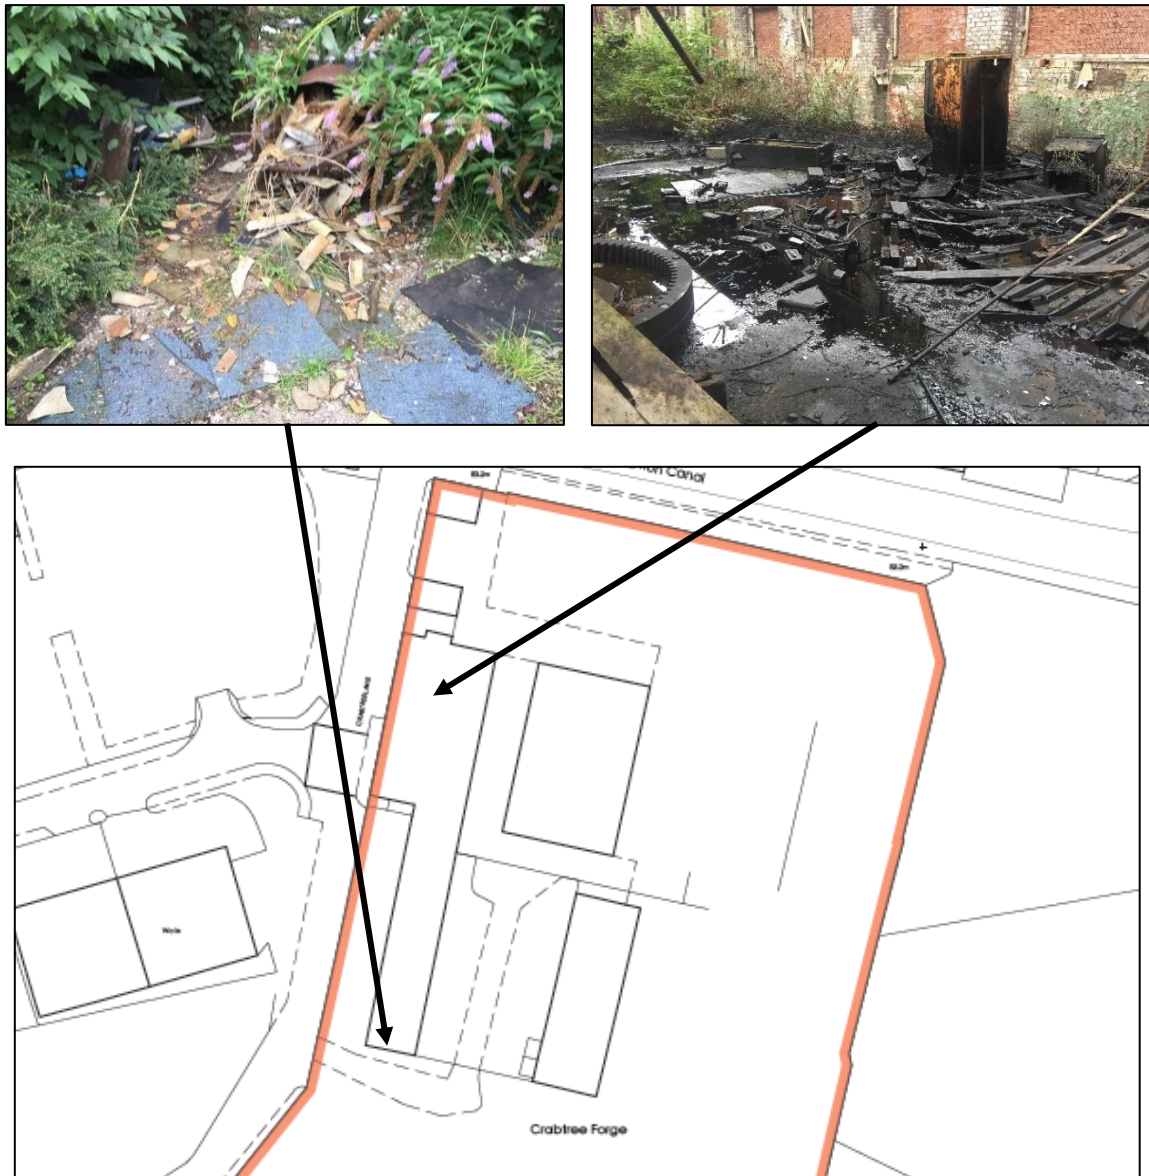
The buildings are largely empty however, some machinery remains, as does significant amount of waste. Asbestos was noted at the surface across the site but was focussed on the southern end of the western building. Also, within this building was a large 'oil' spill. These are shown on the photos below;

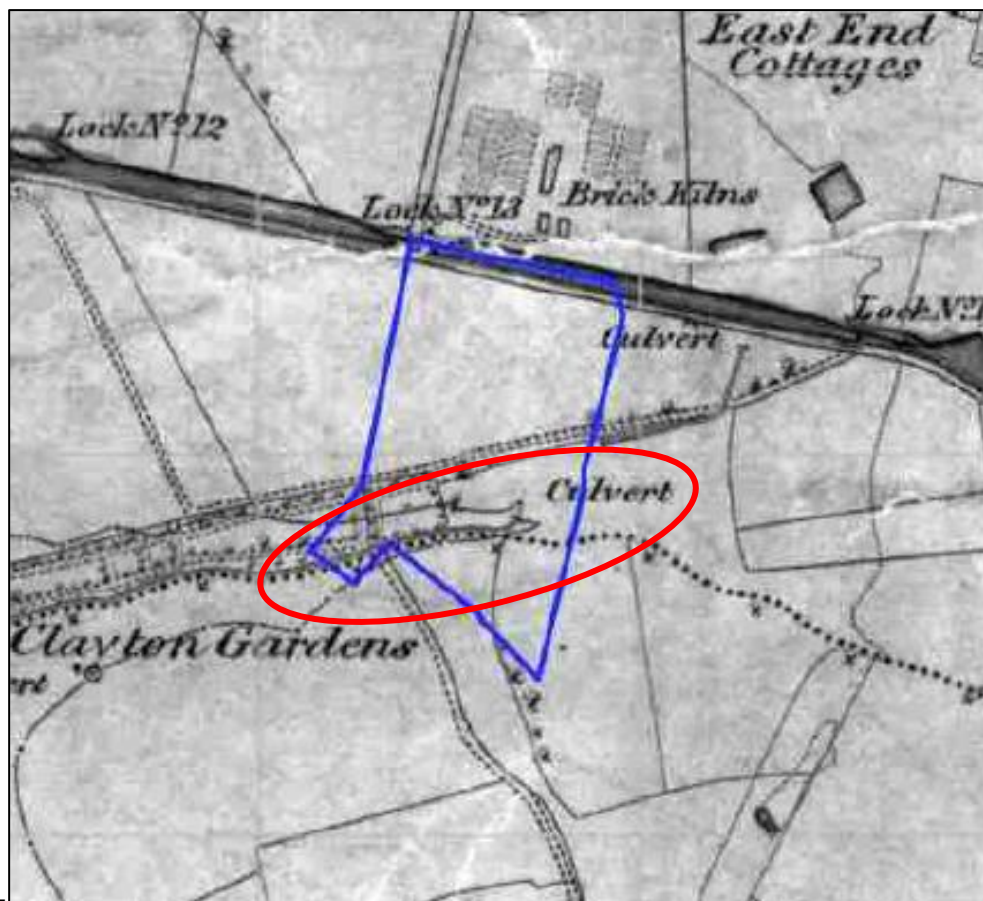
1845 1:10,560 Map

The earliest available map of site is the 1845 1:10,560 map which shows the site to be largely undeveloped land with a culvert crossing the site. An extract of this map is shown below;

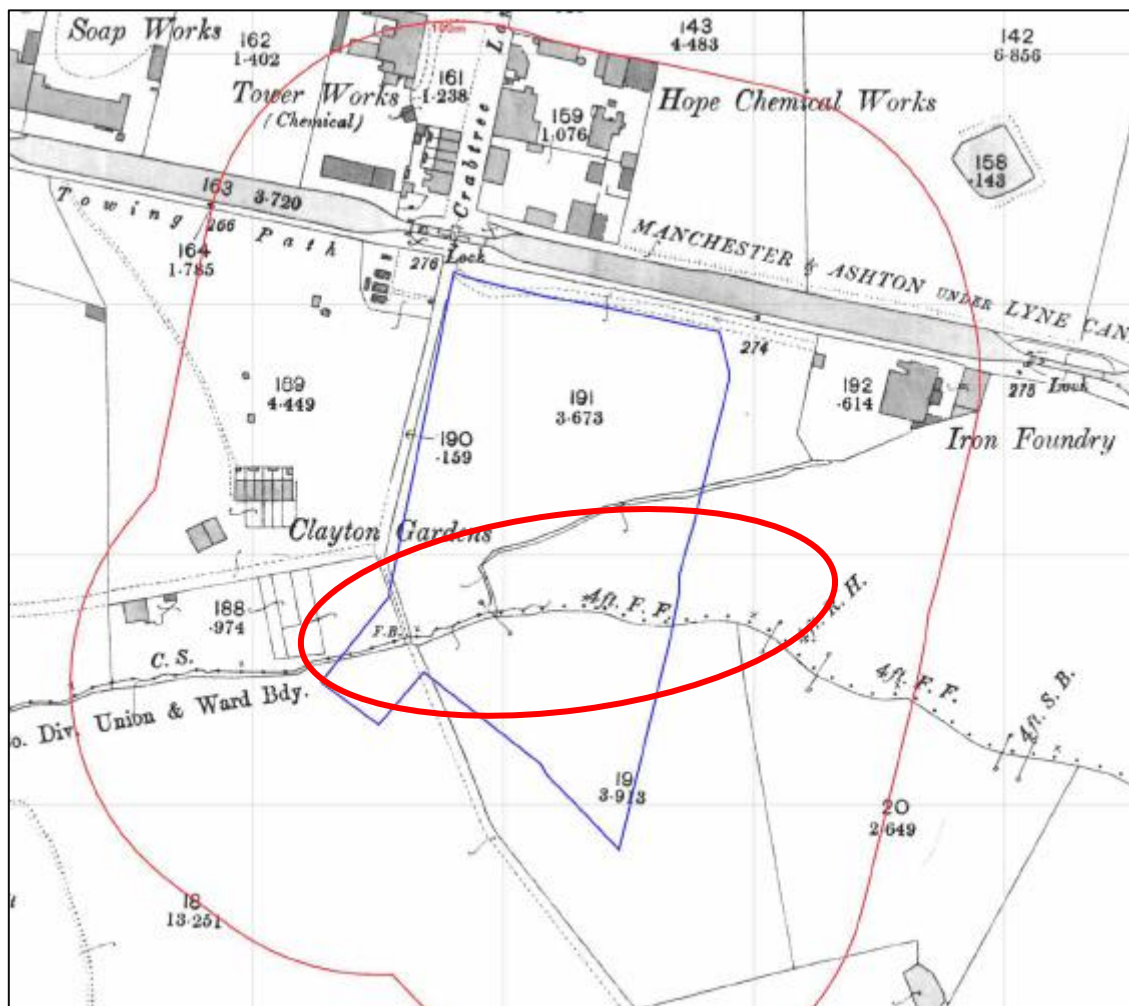
1893 1:2,500 Map

The 1893 1:10,560 map which shows a change of position of the culvert / stream. An extract of this map is shown below;

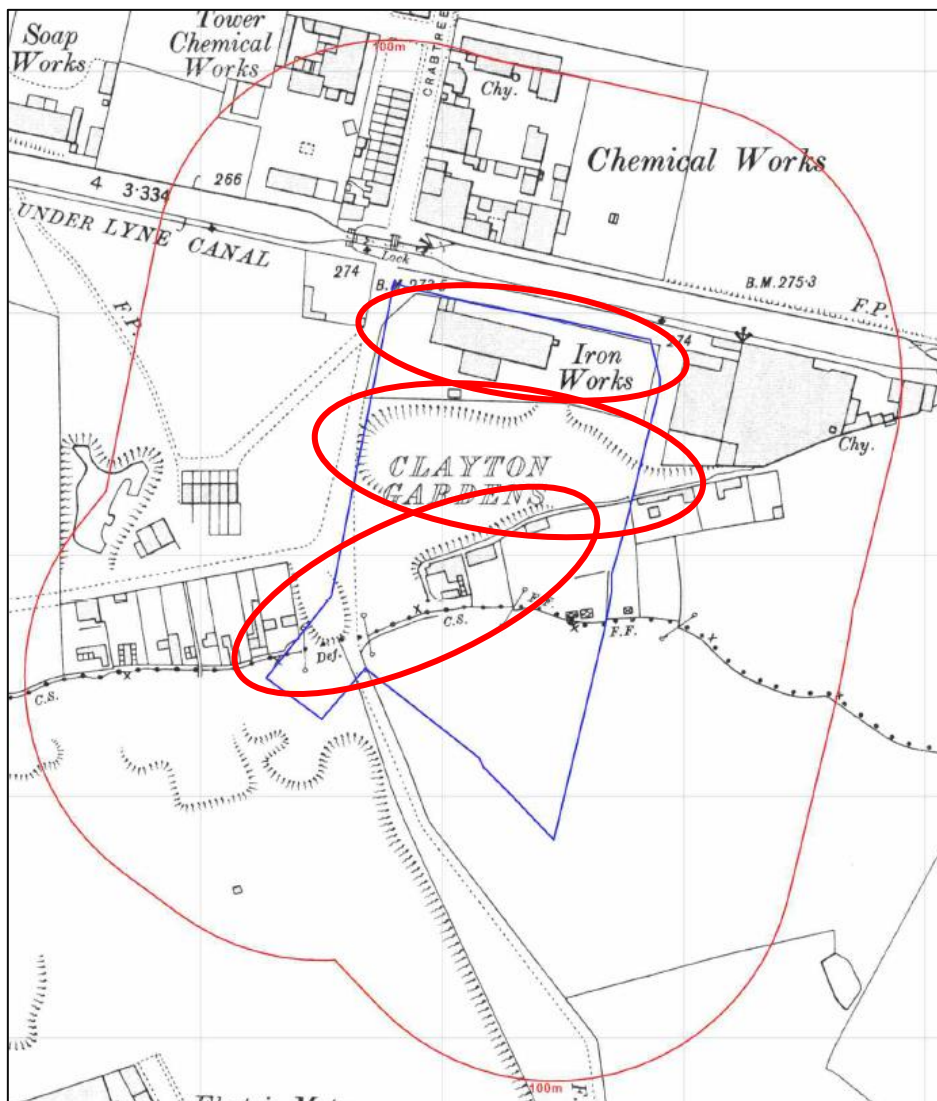
**1908 1:2,500 Map**

The 1908 1:2,500 map which shows the construction of a number of buildings in the north, and central areas of the site. The northern building is labelled as an iron works. The area to the south of the works is detailed as steep slopes indicating removal of materials. A smaller slope is also present in the southwest. An extract of this map is shown below;

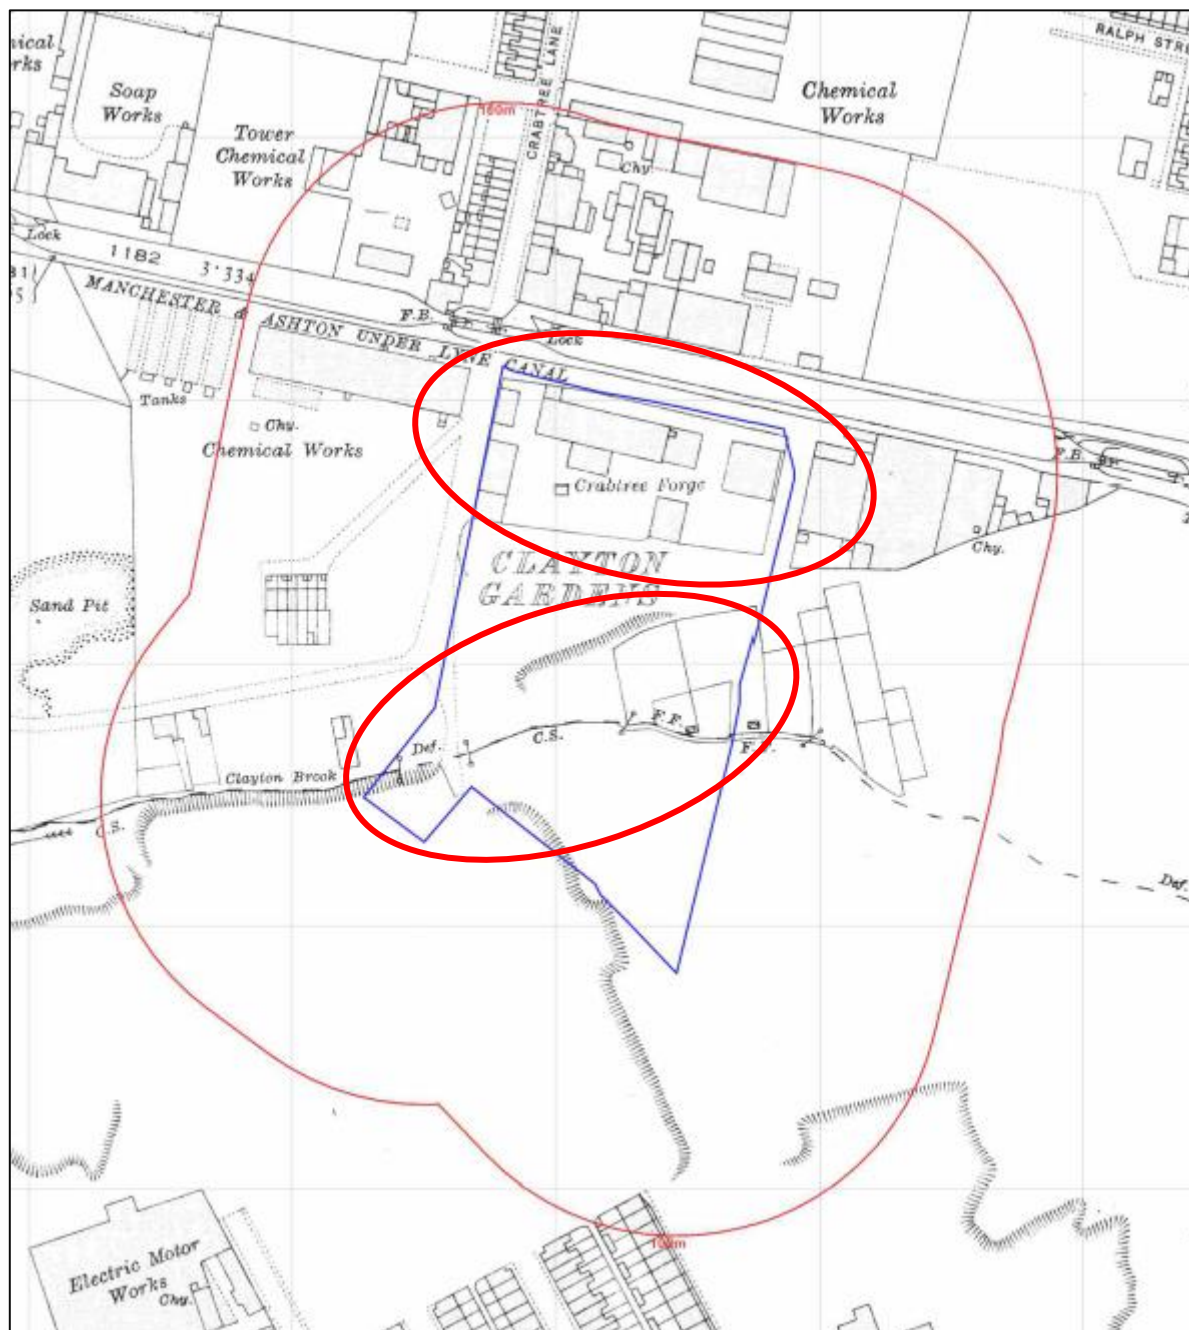
**1922 1:2,500 Map**

The 1922 1:2,500 map which shows the construction of additional buildings in the north, and demolition in the south with alterations of the steep slopes. An extract of this map is shown below;

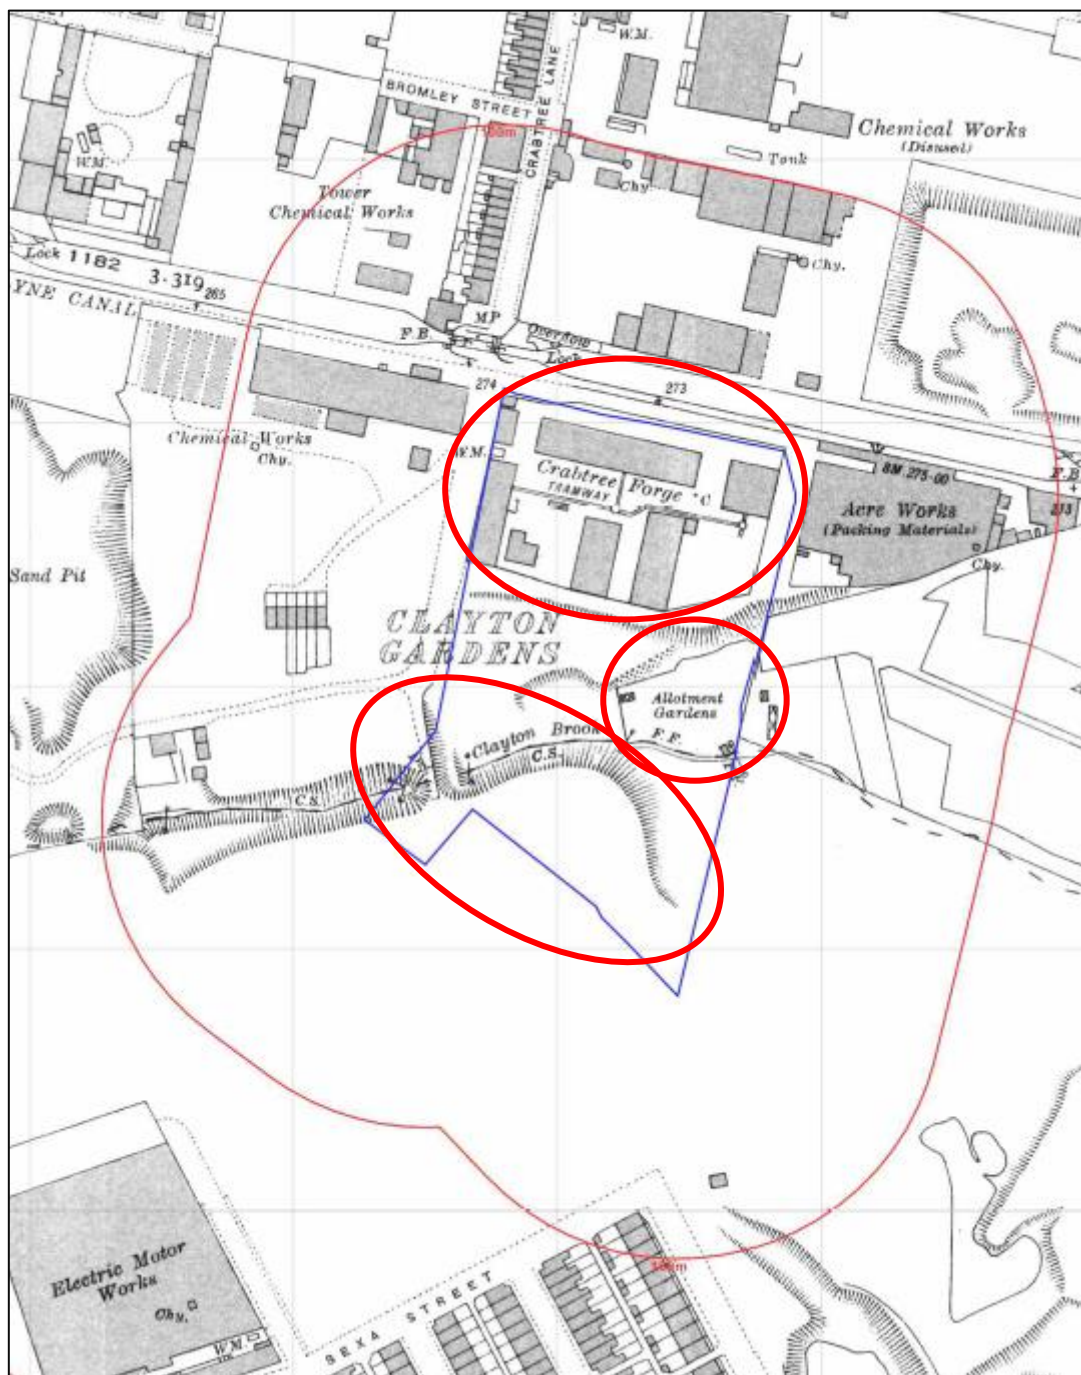
1932-1933 1:2,500 Map

The 1932-1933 1:2,500 map which shows further construction in the north, and demolition with creation of allotment gardens in the south, again with alterations of the steep slopes. An extract of this map is shown below;

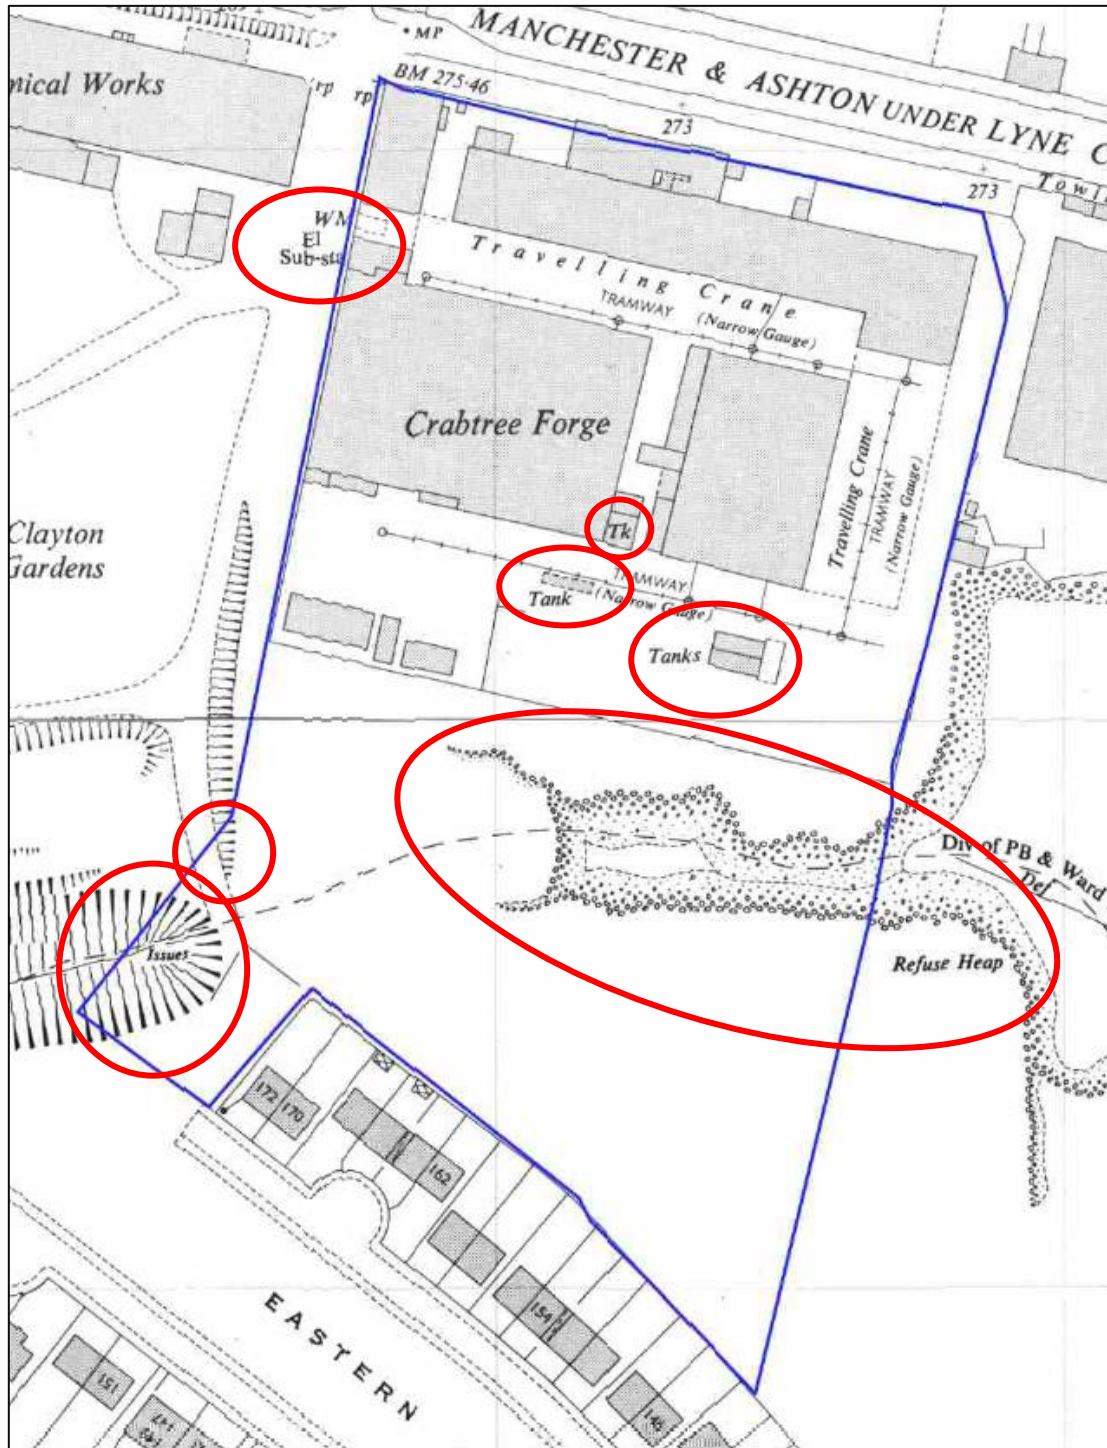
1949-1950 1:1,250 Map

The 1949-1950 1:1,250 map shows significant extension to the buildings in the north of the site with the introduction of travelling cranes and tanks. An electrical substation is also shown on the western boundary. The steep slopes are shown as a refuse heap along Clayton Brook. Steep slope is still shown around the stream in the southwest. An extract of this map is shown below;

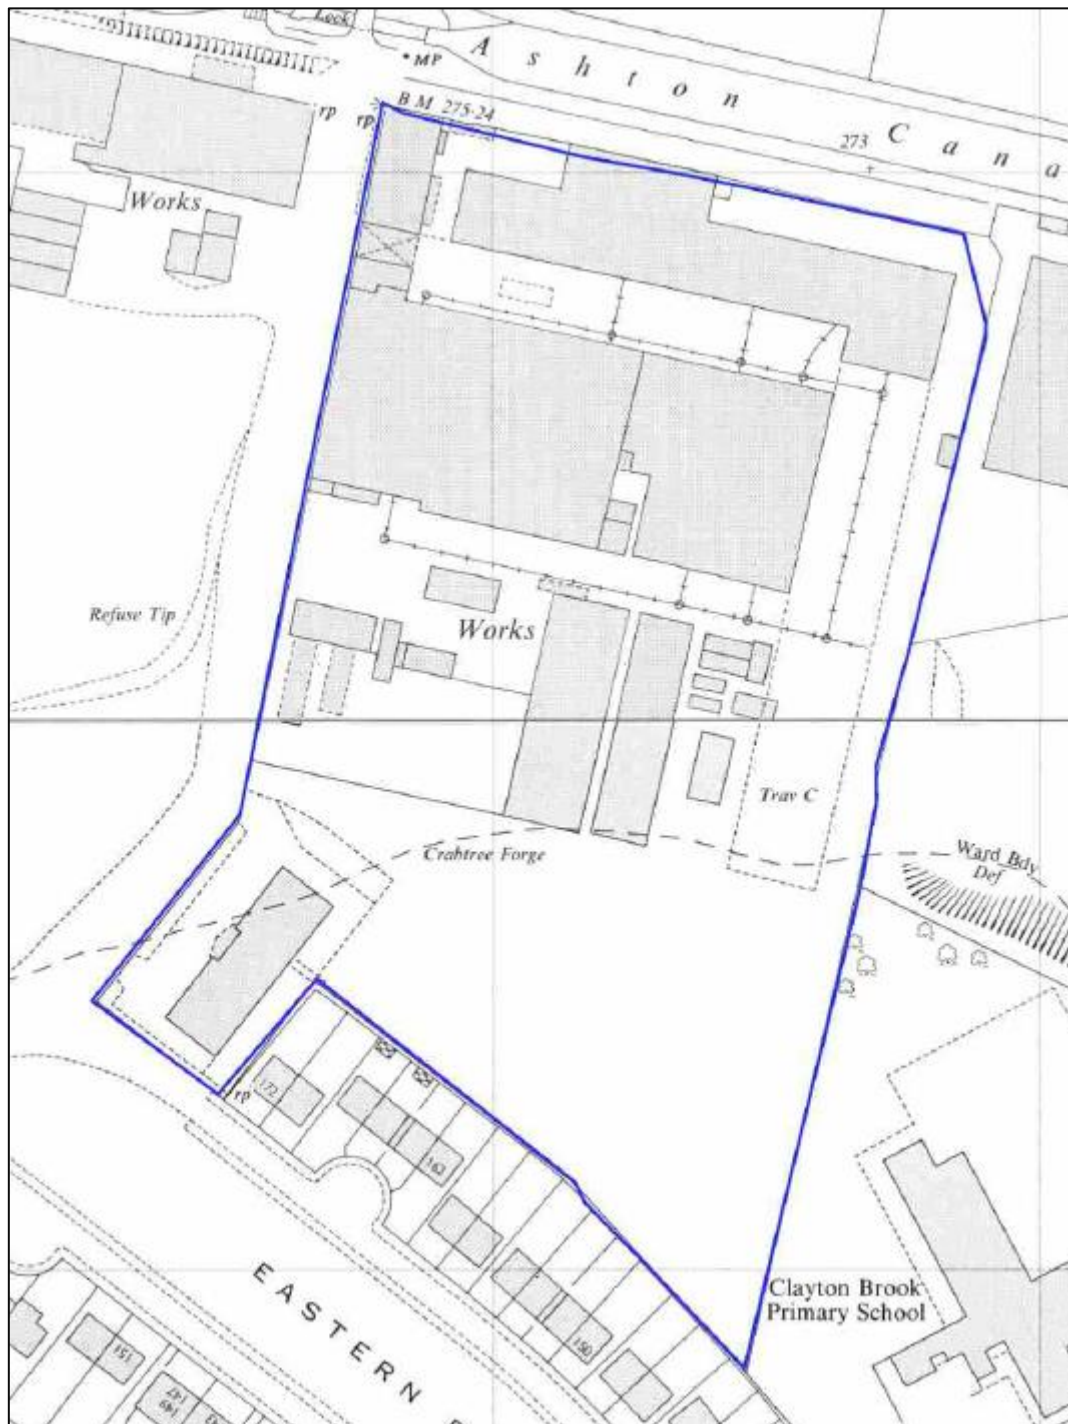
**1964-1968 1:1,250 Map**

The 1964-1968 1:1,250 map shows significant changes across the site, with the extension of existing buildings and construction of new ones. An extract of this map is shown below;
