Land off Crabtree Lane,  
Manchester

# REMEDIATION STRATEGY & ENABLING WORKS

**Keepmoat  
Homes**

Project no: BSH2258

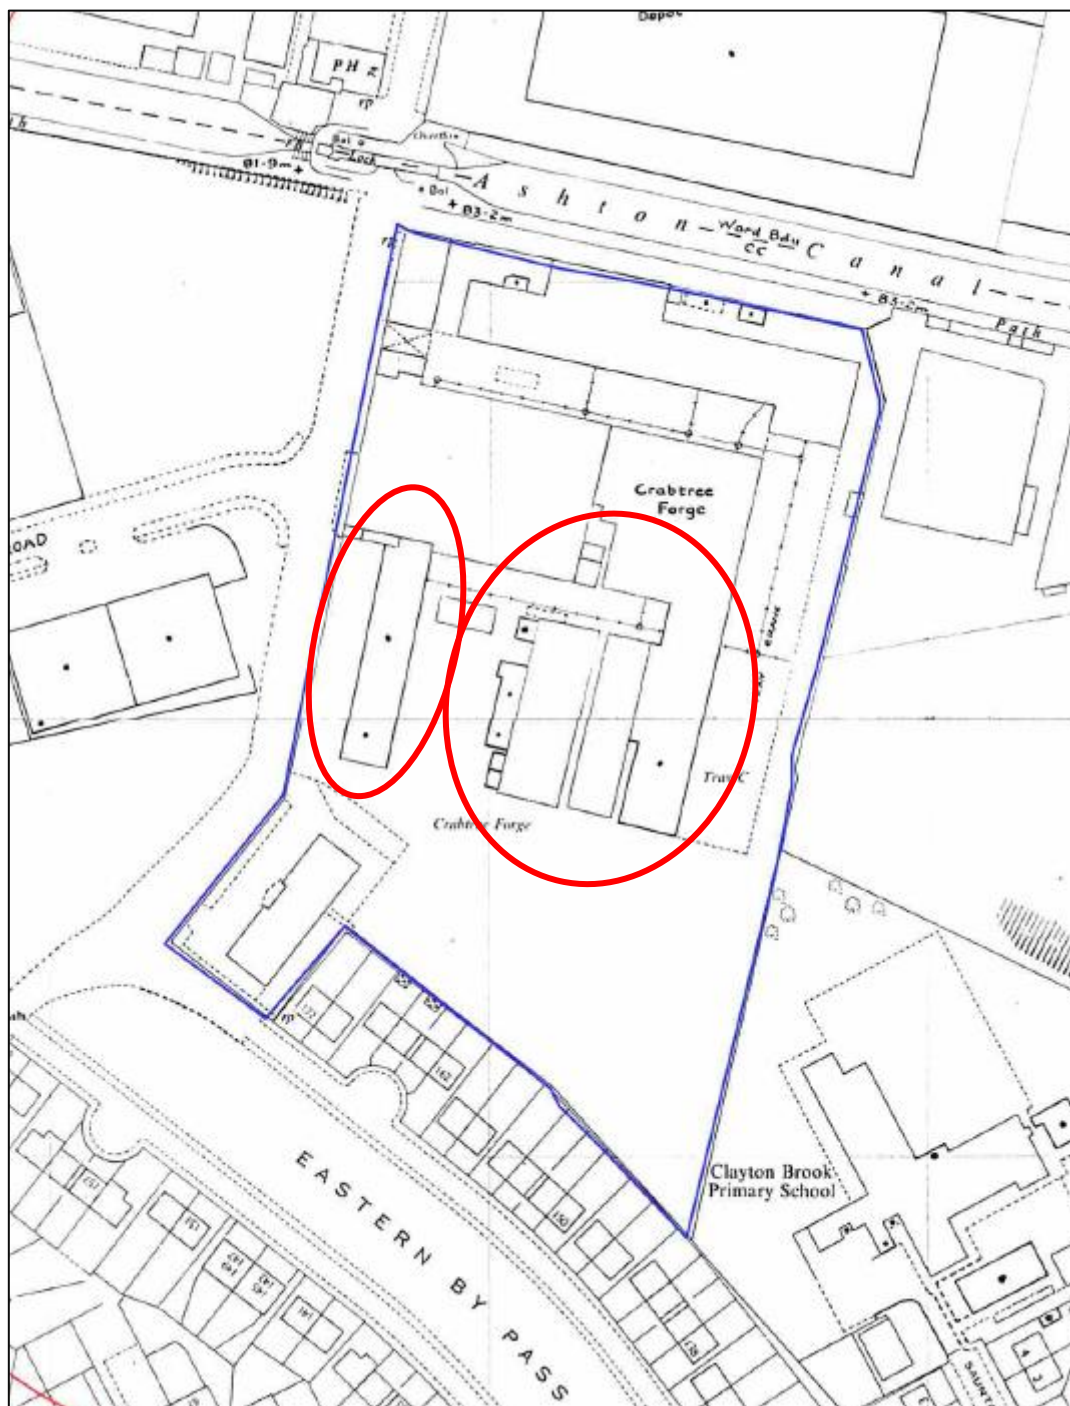
**1983-1986 1:1,250 Map**

The 1983-1986 1:1,250 map shows significant changes across the site, with the extension of existing buildings and construction of new ones. Clayton Brook no longer shown. An extract of this map is shown below;

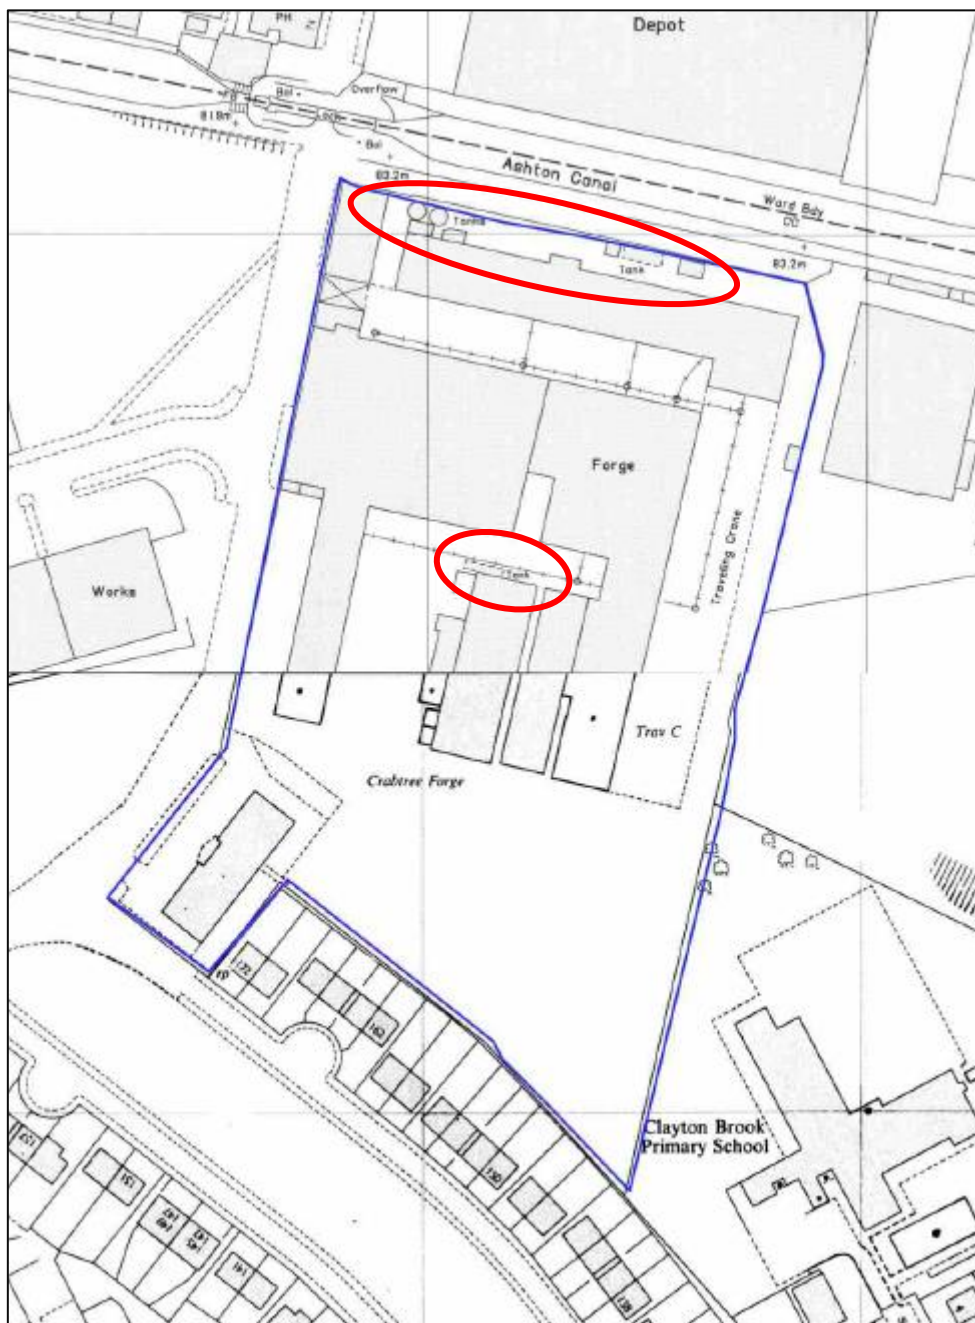
**1983-1986 1:1,250 Map**

The 1988-1991 1:1,250 map shows additional tanks in the north and the centre of the site. An extract of this map is shown below;

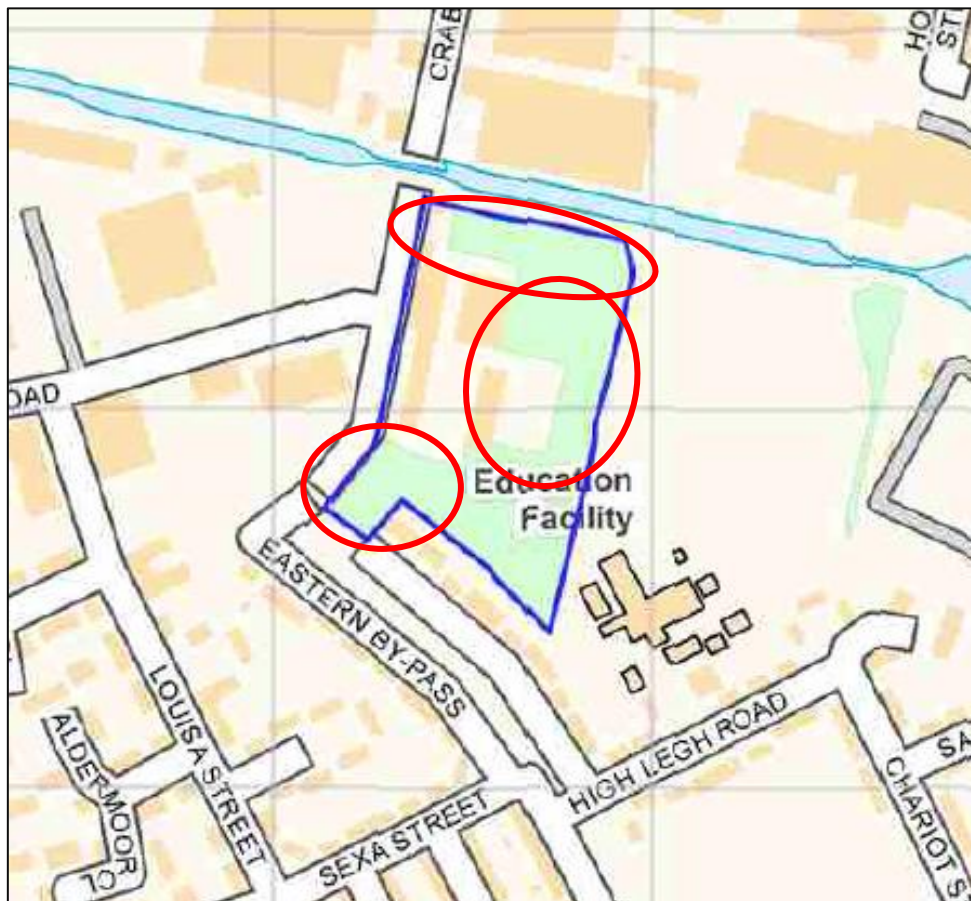
**2021 1:10,000 Map**

There were no significant changes until the 2021 1:10,000 map which shows the site in its current state following demolition of several buildings. An extract of this map is shown below;

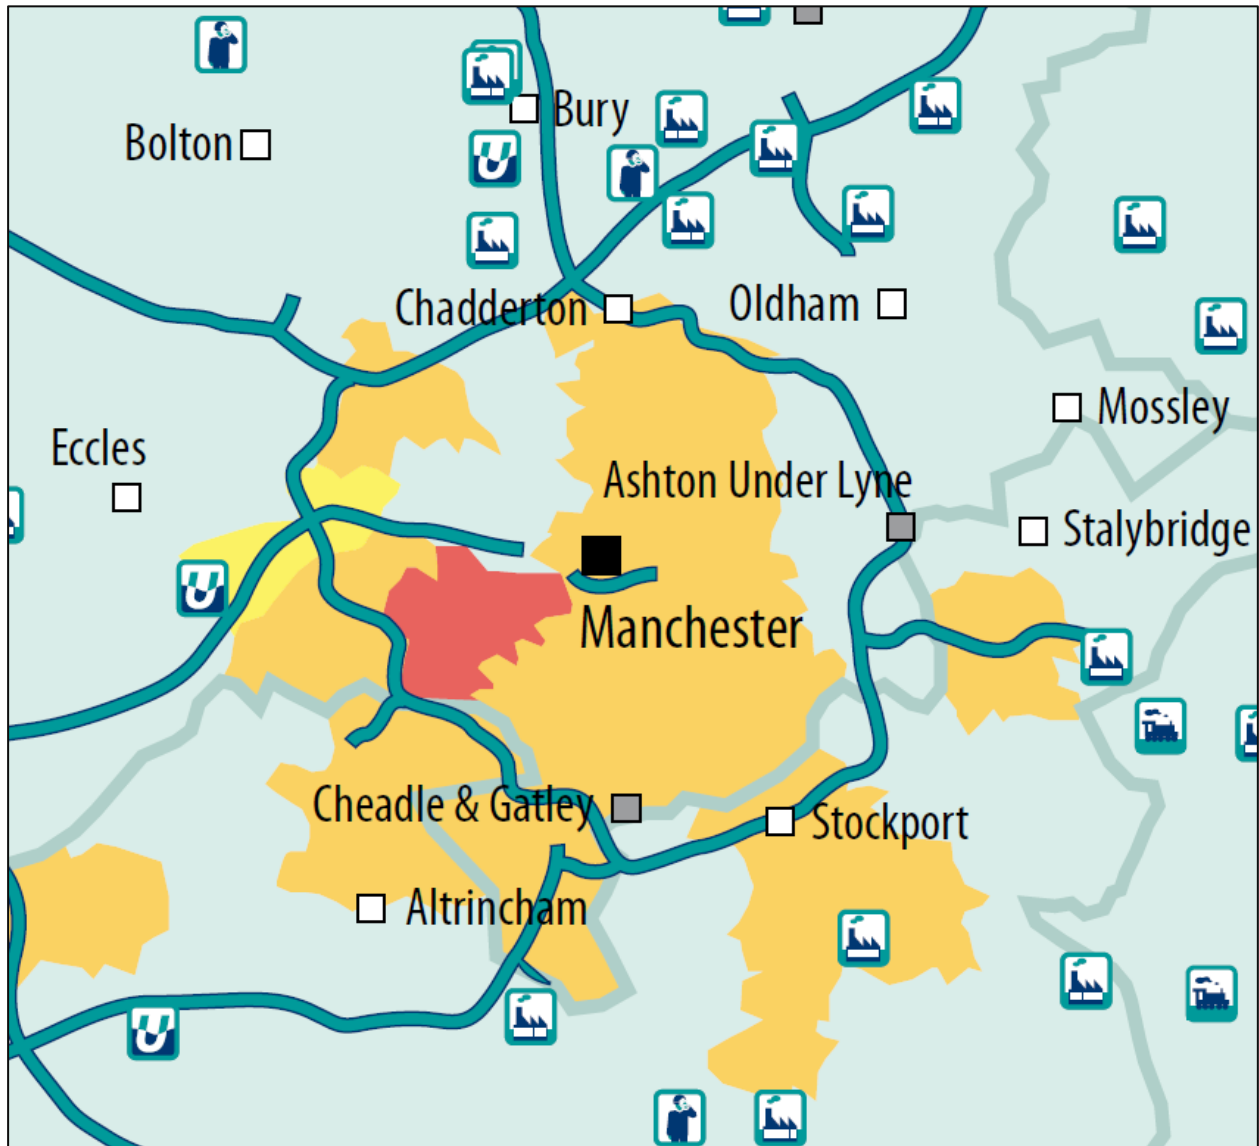
Zetica's indicative UXO risk mapping places Manchester, and the site, within a 'moderate bomb risk' area. As shown below;

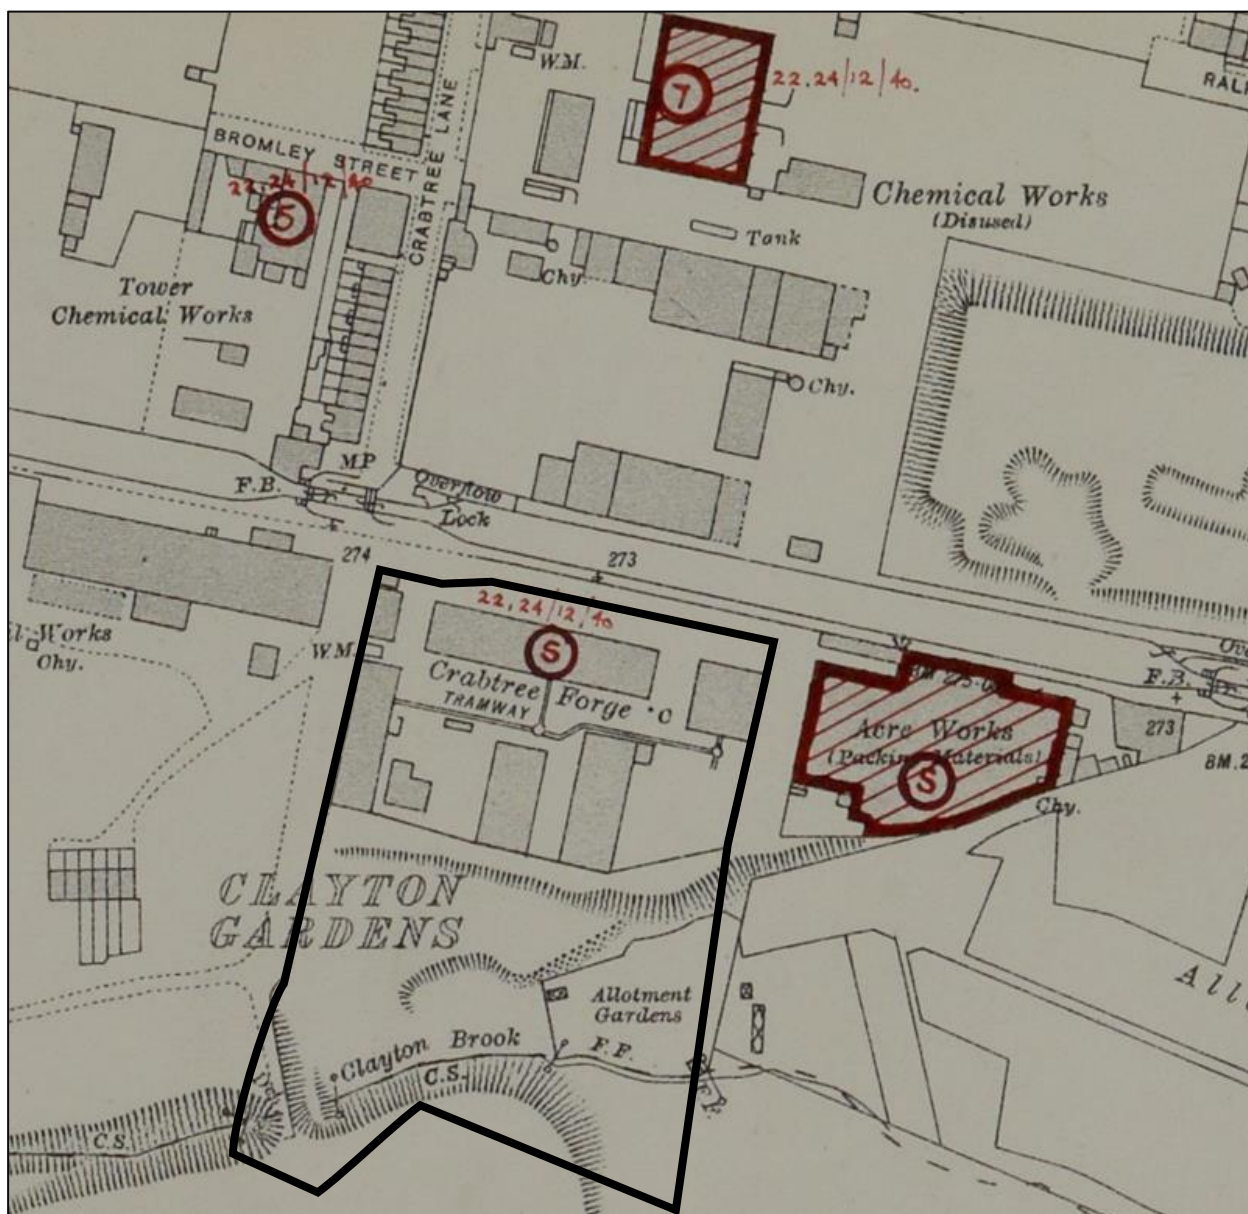
A brief internet search of open source records and historical mapping provided by GroundSure has shown there were a number of bomb strikes on and around the site, with at least one recorded strike on the north of the site (firebombs), as shown on the extracts listed below. This mapping ONLY covers the Blitz period 1940-1941, and is therefore not exhaustive;

**Description:**

Original map of Manchester: Ordnance Survey Revisions of 1932-1935. Scale: 25" to 1 mile. Annotated with: red circles for fire bombs; blue circles for high explosives; pink shading for damaged buildings; red shading for demolished buildings; green marks: line mines, indicating bomb damage by the Luftwaffe during the Blitz. Detailing Openshaw and Gorton.

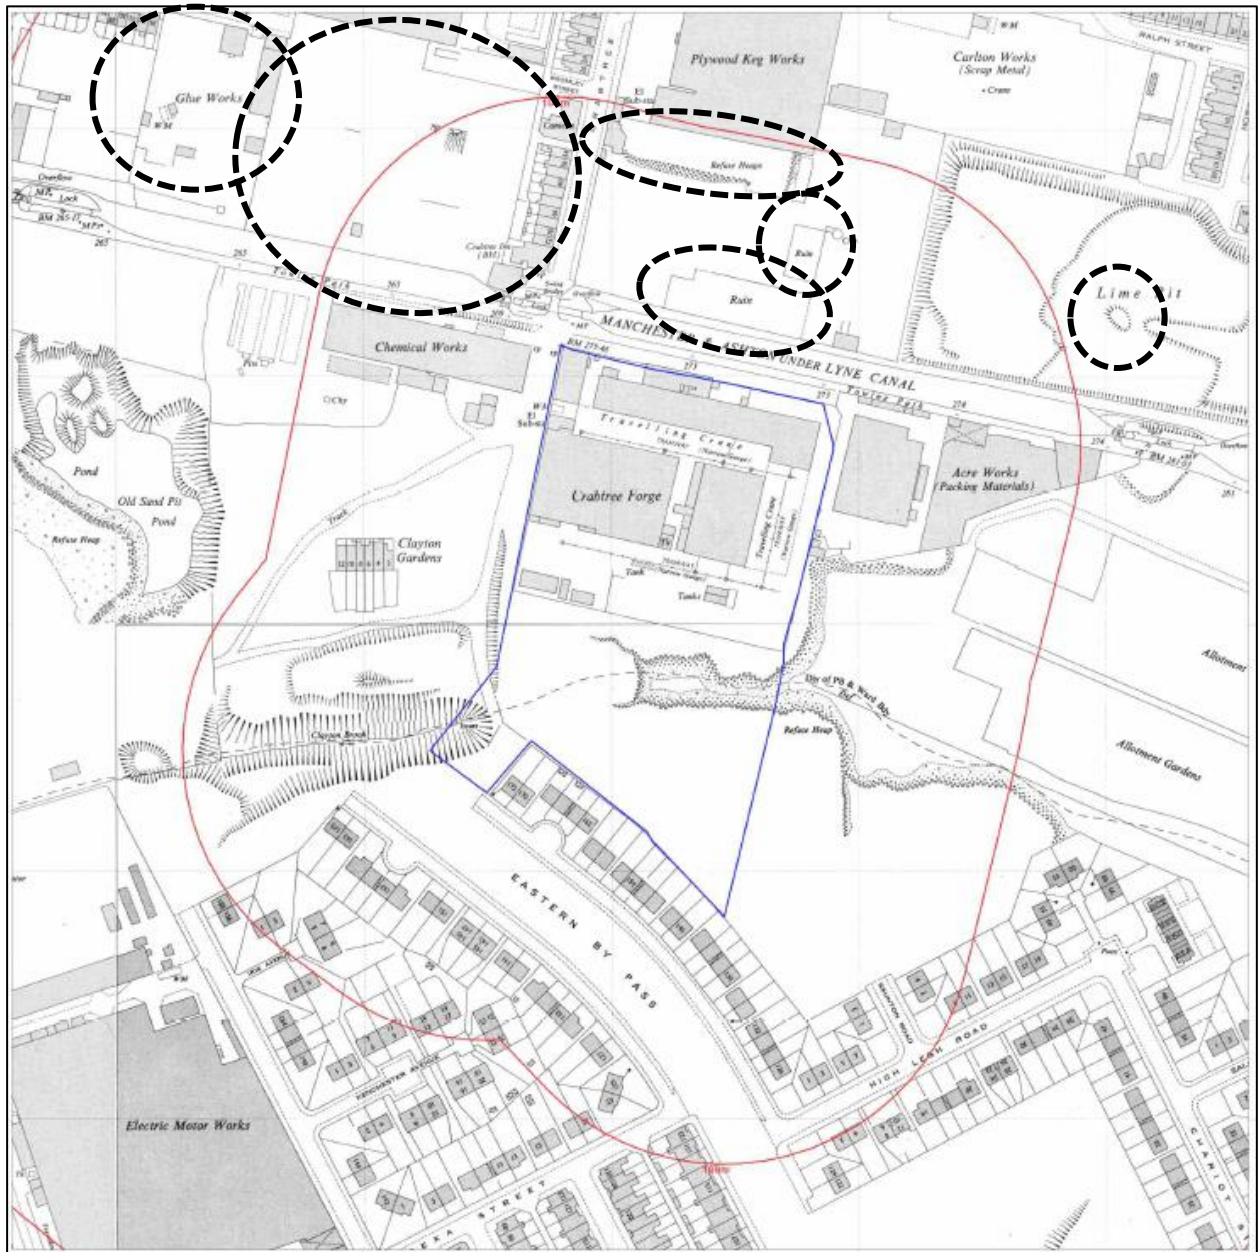
Mapping from 1949-1950 shows a number of ruins located around the site, as well as the disappearance of buildings not listed as a ruin, but have gone during WWII period. Bomb strikes outside of developed areas are unlikely to be recorded. These are shown on plan below;

As the site has been developed prior to, during and after WWII, the likelihood of UXO remaining on site from a direct strike is considered **unlikely**. However, dropped ordnance can hit the ground outside of the site boundary and migrate under the boundary in a typical 'J' shape. Due to the number of strikes around the site, and the strikes recorded on the north of the site, discussion with a suitably qualified and experienced UXO consultant is considered prudent.

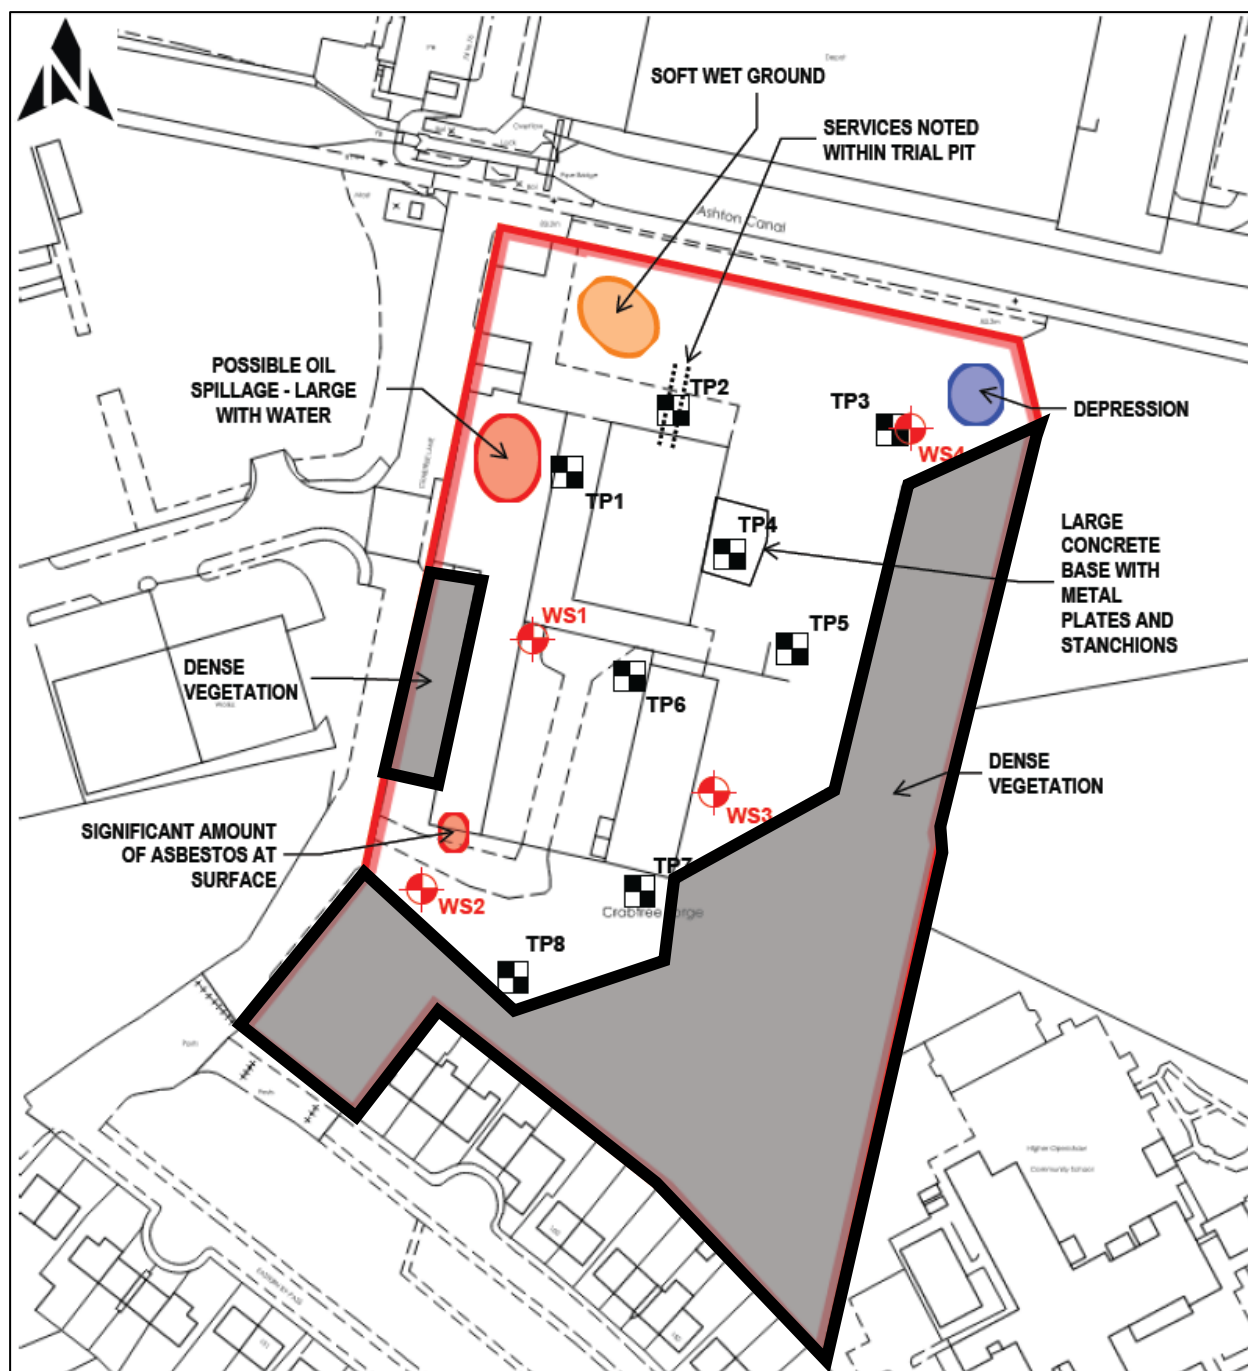
As shown on the sketch below, some areas were not accessible due to dense vegetation.

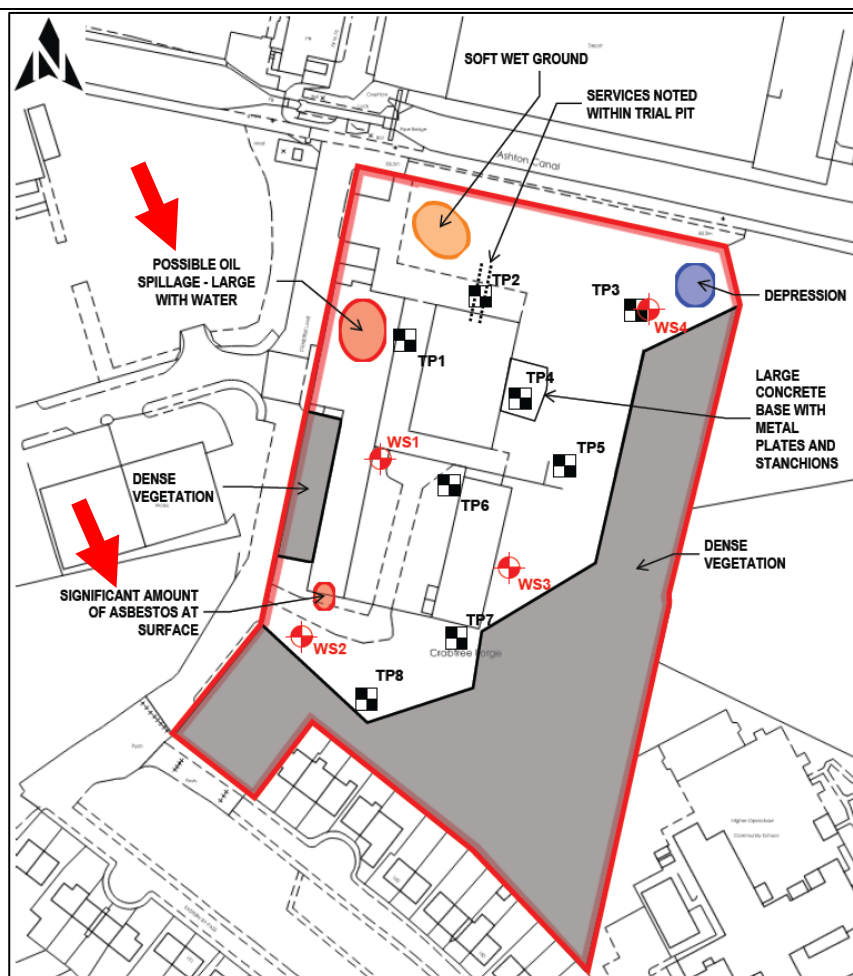
Surface contamination was noted in the locations below;

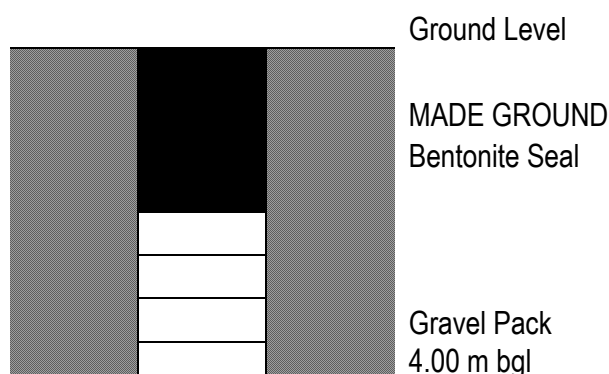
Three (3 No.) window sample boreholes were all installed to depths between 3.00mbgl and 4.00mbgl into both Made Ground. An example installation is shown below;

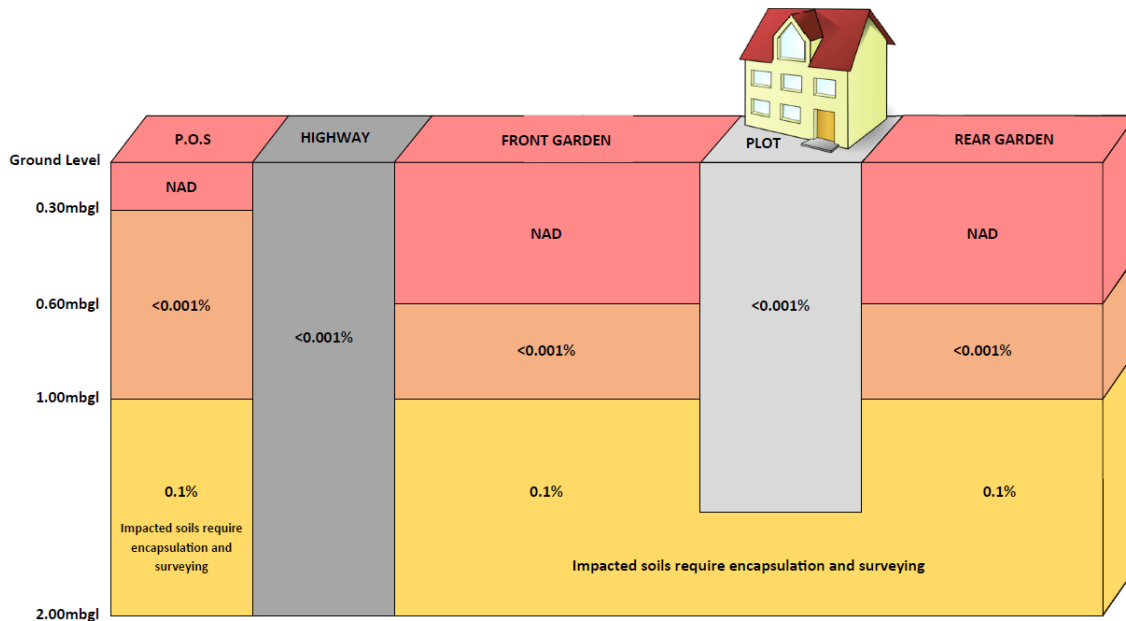
Below is a sketch showing levels of asbestos concentrations and locations where they are commonly accepted / unacceptable. This should be confirmed with the Local Authority prior to implementation, and should therefore only be used as a guide;

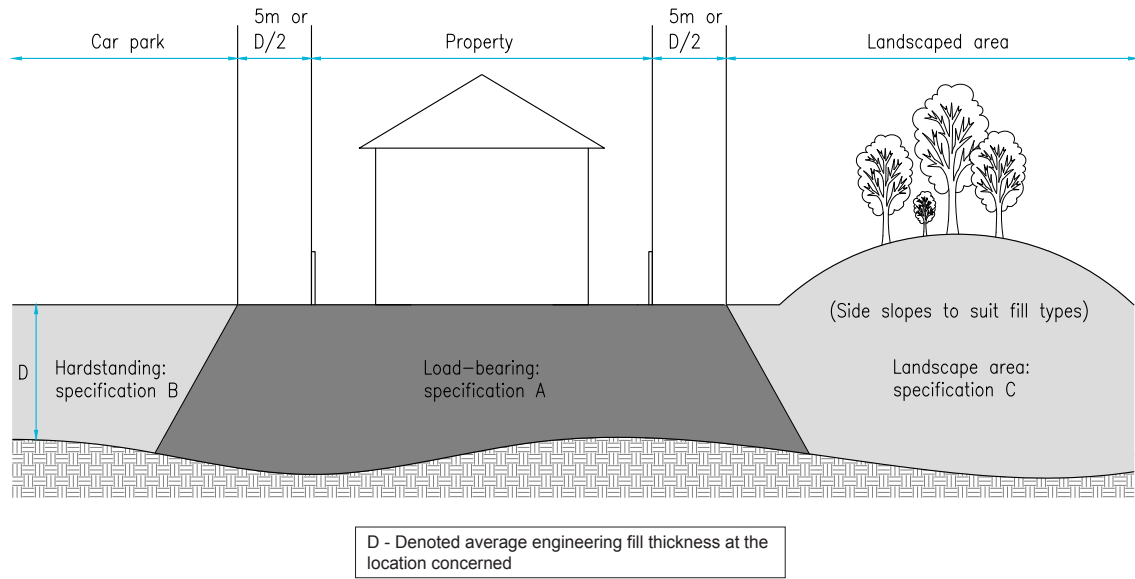
Figure 2: Compaction and differing end use

- NOTES:
- 1. Specifications A & B to be to Table 7
  - 2. Specifications C may be Method or End Product or no defined compaction regime
