**RWP 96**

**Cooper Street courtyard  
Repairs behind rainwater  
pipe at mosaic locations**

**OTH-PUR-TH-RF-SKE-A-3647**

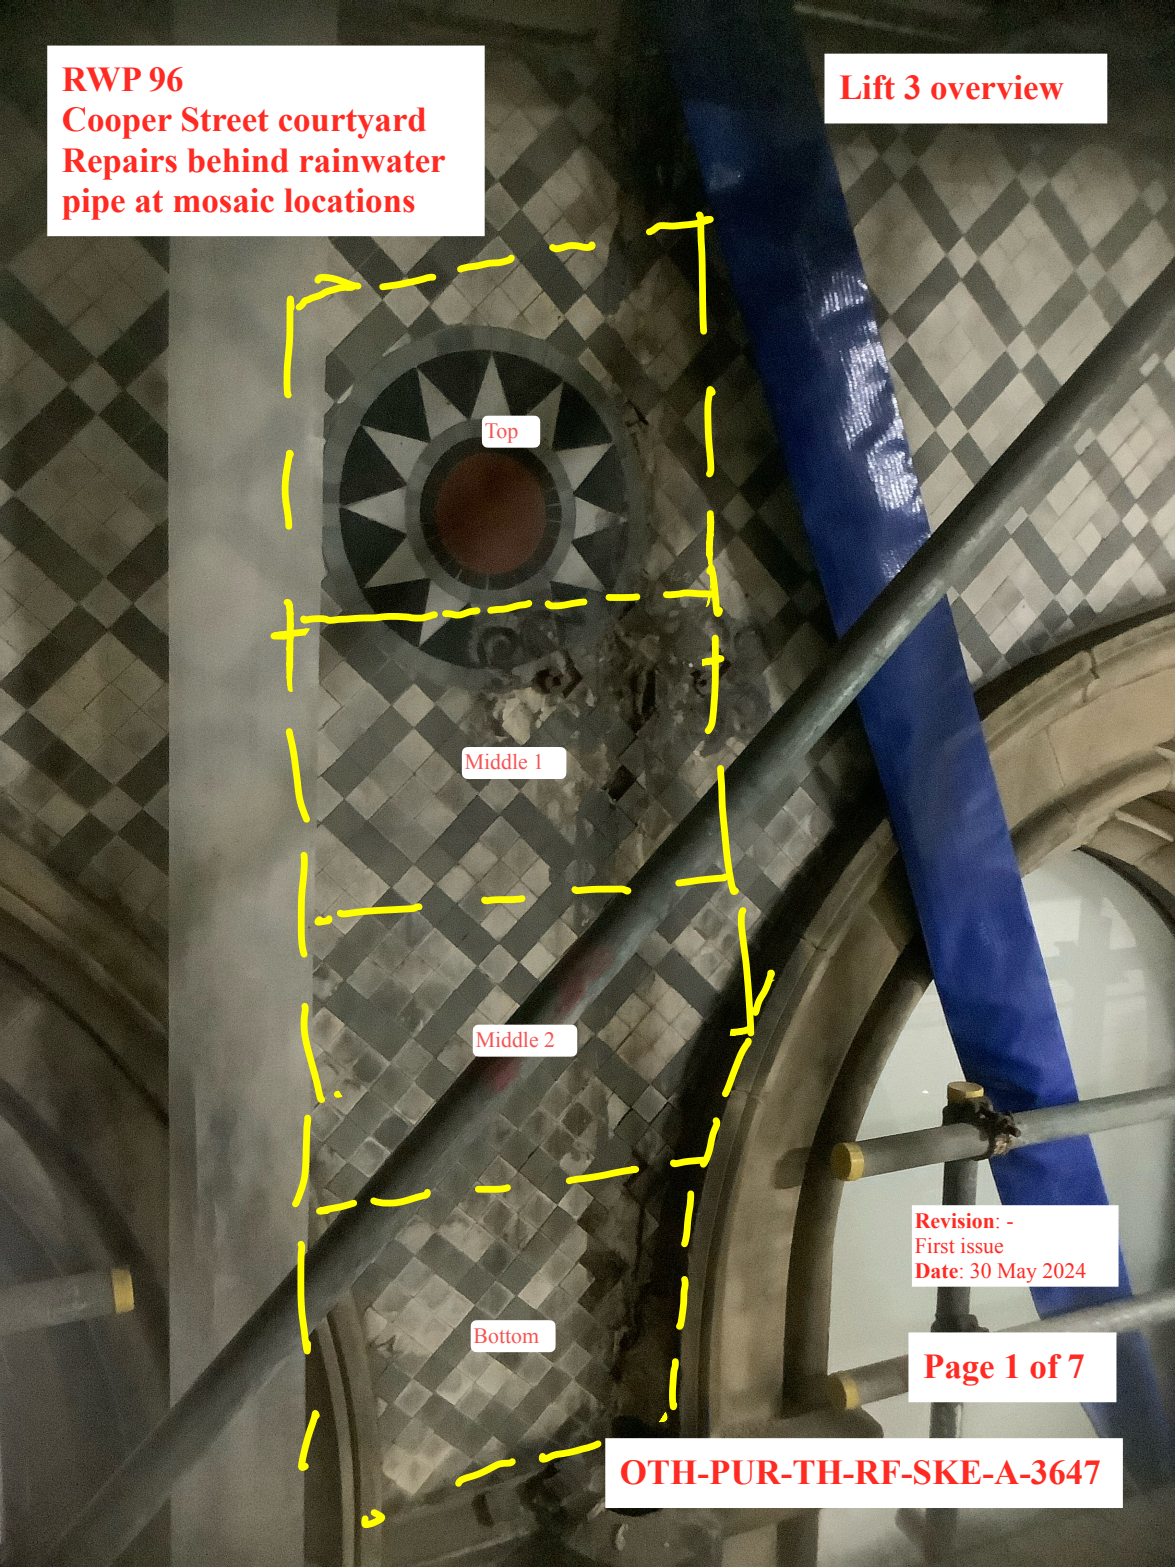
**Lift 3 overview**

**Top**

**Middle 1**

**Middle 2**

**Bottom**
