**Parapet wall on east side of  
roof WCR02 repairs to  
brickwork**

**OTH-PUR-TH-RF-SKE-A-3524**

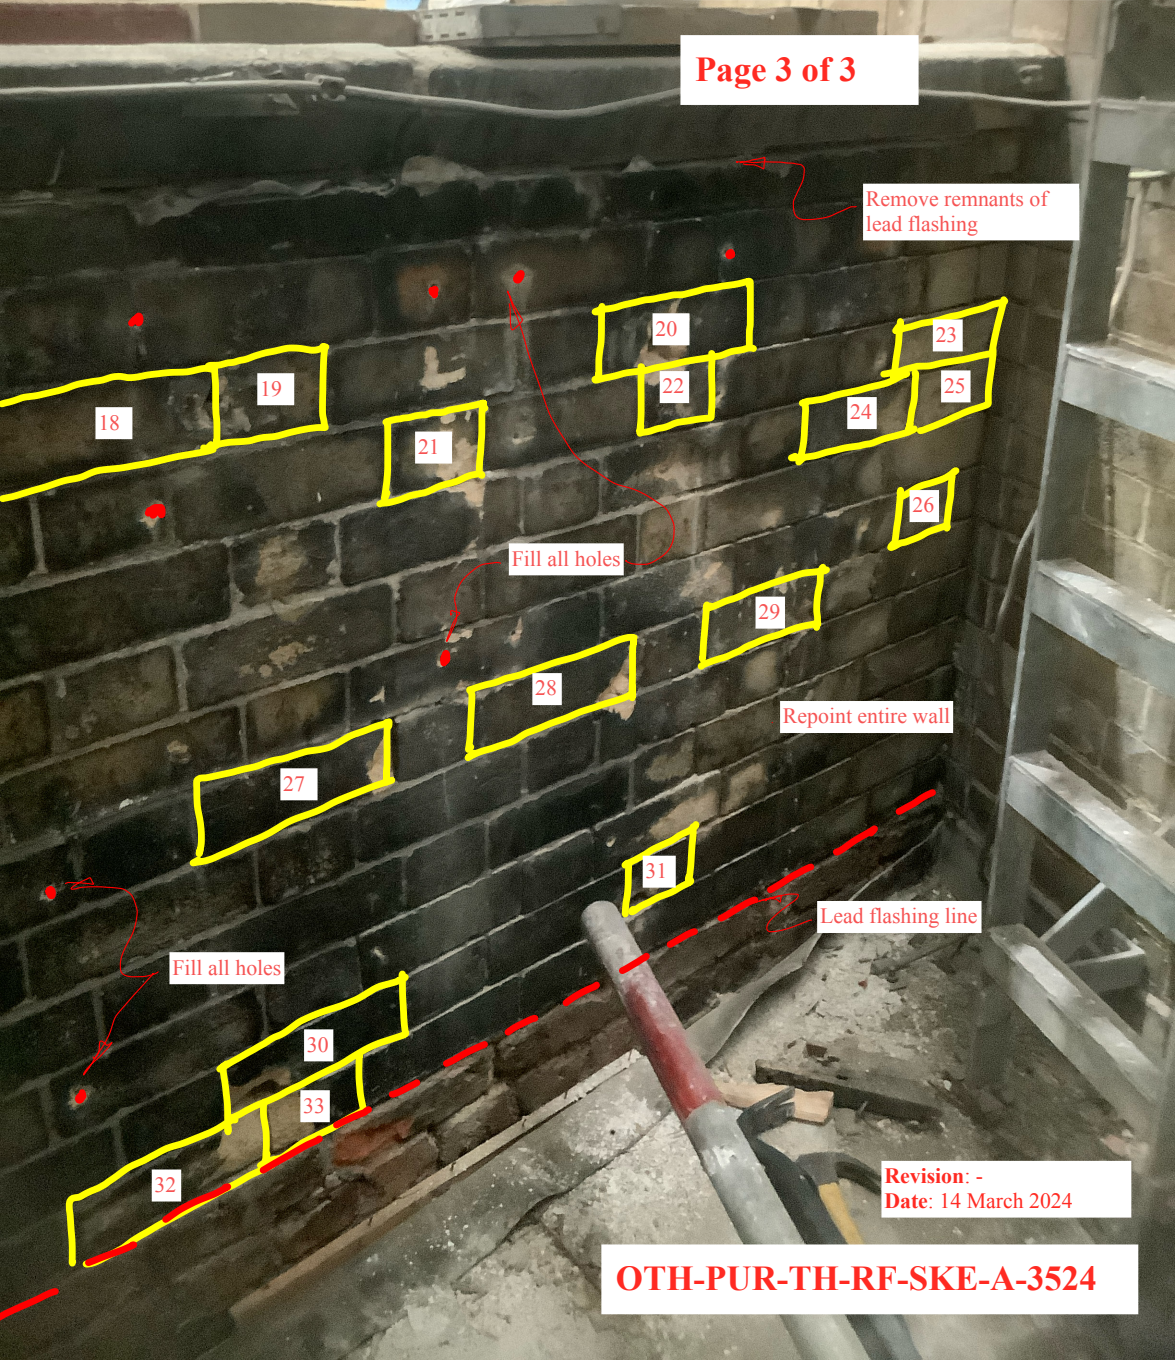
Page 3 of 3

Lead flashing line

Remove remnants of  
lead flashing

Fill all holes

Repoint entire wall
